NORTH PENNINES ARCHAEOLOGY LTD

Client Report No. CP/472/07

In March 2007, North Pennines Archaeology Ltd was commissioned by Brown and Armstrong Limited to undertake an archaeological desk study, site visit and field evaluation in advance of a proposed redevelopment of land situated at the junction of Fleming Street and Church Street, Maryport, Cumbria (NGR NY 0378 3674).

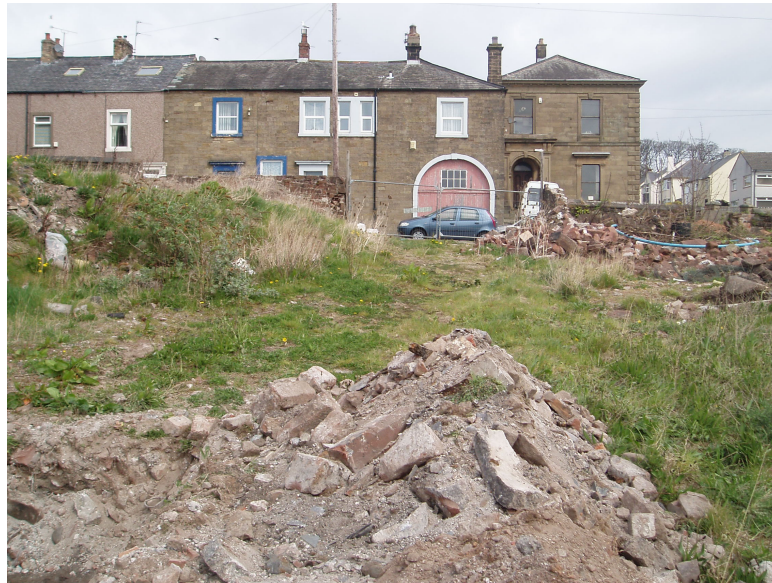
Plate 1: Looking north across the site.

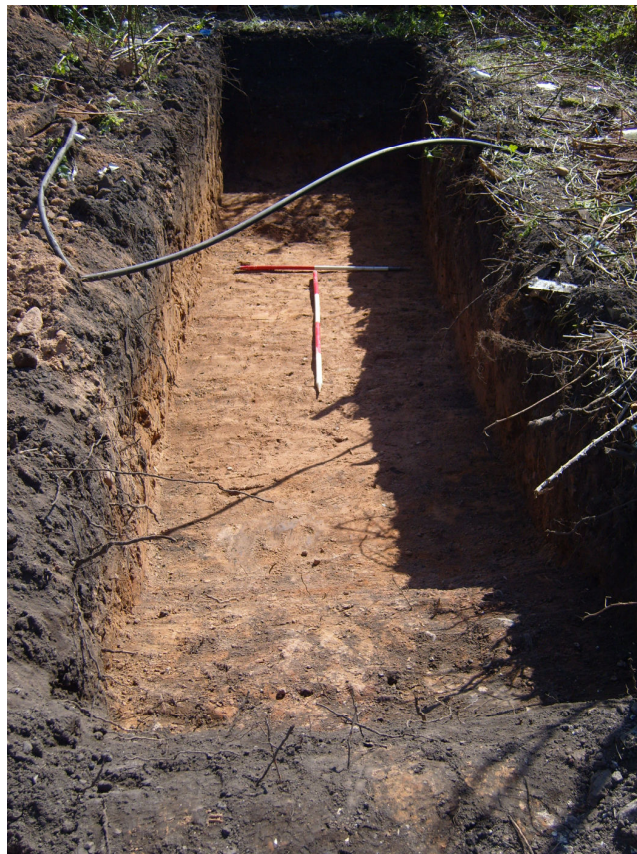
- 6.2.1 The trench was 8.5m long by 1.5m wide; the maximum depth of the trench was 1.2m. The trench was orientated east west and ran parallel to the site's northern boundary on the east side. The natural substrate (**101**) was observed at 0.50m from the surface and comprised of well-compacted orange sand that showed occasional outcrops of sandstone. This was overlain by a very dark brown / black garden soil (**100**), the remnants of the allotment that previously existed in this area. The layer held very few inclusions of small sub rounded stones and was moderately compacted.

Plate 2: Trench 1 after cleaning looking east.

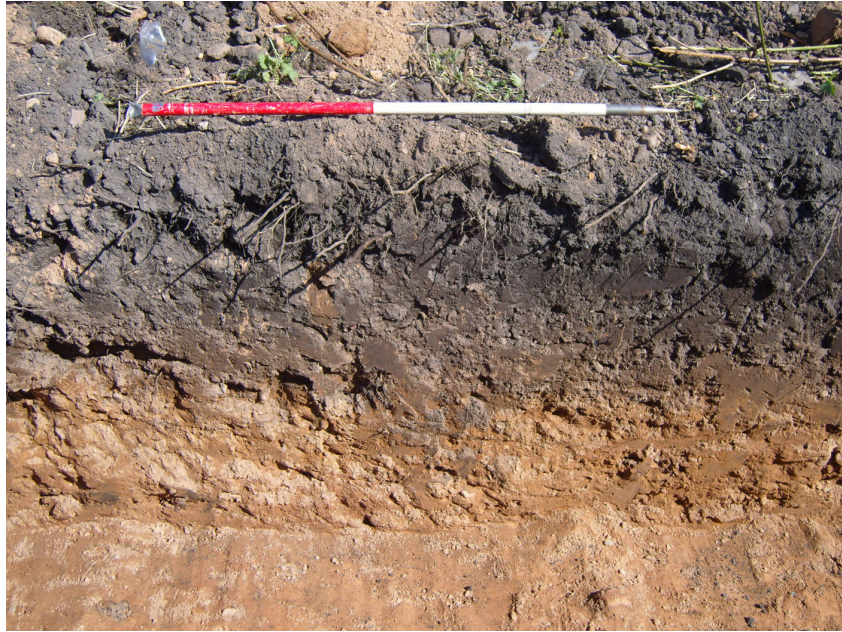
Plate 3: South facing section in Trench 1, looking north.

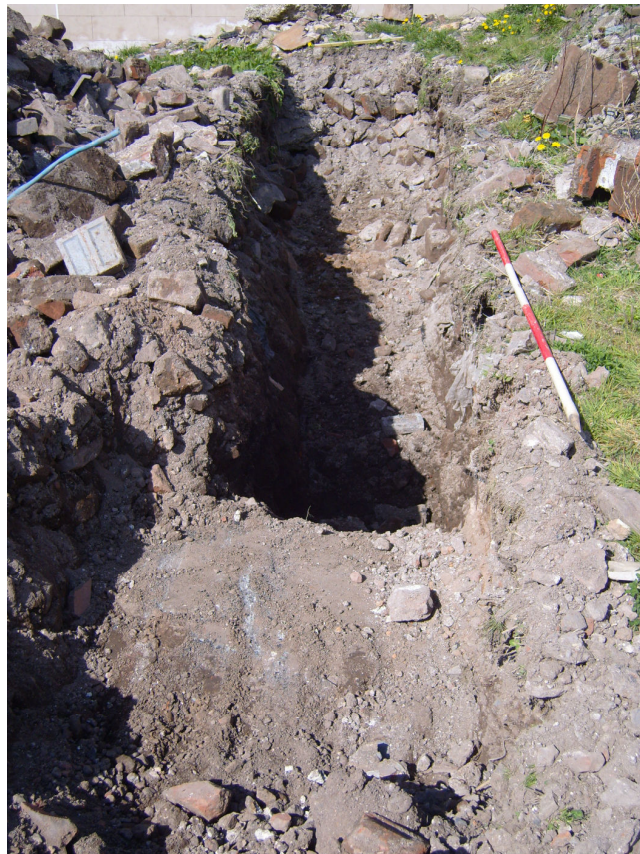
- 6.3.1 The trench was 10.5m long by 1.5m wide; the maximum depth of the trench was 1.2m. The trench was orientated east west and was parallel to the northern boundary of the site on the west side. The natural substrate was not observed within any part of the trench, the deposit removed consisting of only building rubble to the depth reached. Excavation did not extend beyond this depth as the material was loose and prone to collapsing into the trench from the sides.

Plate 4: Trench 2 looking west.

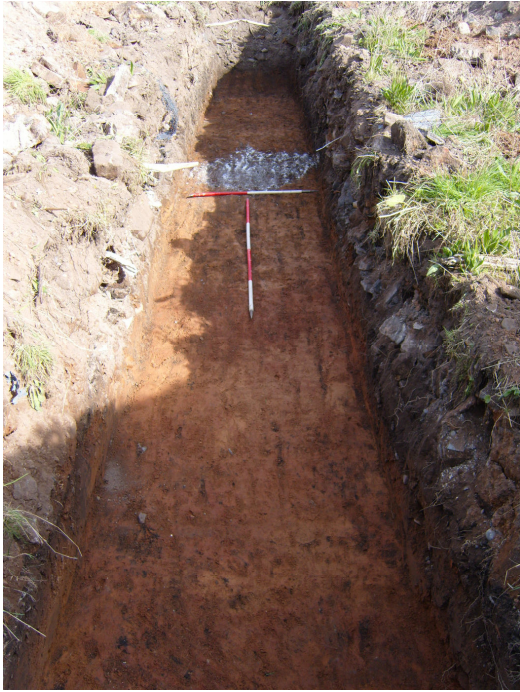
- 6.4.1 The trench was 13m long by 1.5m wide; the maximum depth of the trench was 1.3m. The trench was orientated north south towards the southeast corner of the site. The natural substrate (**302**) observed at 1.10m from the surface of the trench and consisted of well-compacted orange sand that contained occasional pieces of sandstone. This was overlain by layer (**301**) at the northern end of the trench, which comprised dark brown / black, moderately compacted, slightly sandy garden soil. This layer thinned out towards the south until the point where layer (**300**) was in direct contact with (**302**). The uppermost layer of this trench (**300**) was again an extensive deposit of both building rubble and modern rubbish that was loosely compacted, the average depth being approximately 0.80m.

- 6.4.2 The only feature observed in this trench was a square cut into the natural, approximately in the centre of the trench, it measured approximately 2.5m² and up to 0.20m in depth. It was interpreted as a modern intrusion as a white indurated layer that appeared to be a concrete type material filled it. Nothing of archaeological interest was recovered from this feature.

Plate 5: Trench 3 looking southeast.

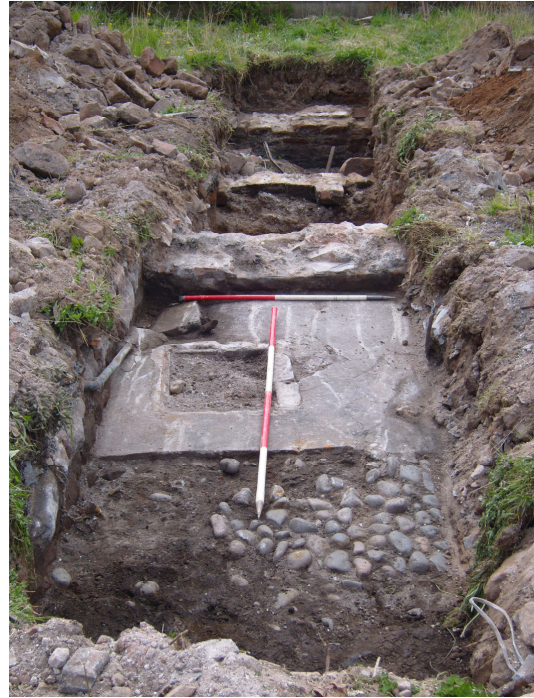
- 6.5.1 The trench was 13m long by 1.5m wide; the maximum depth of the trench was 1.20m, which happened to be the maximum safe limit due to the potential of loose material collapsing the trench sections. This occurred in the southern part of the trench that encountered the cellared area of the school building.

Plate 6: Trench 4 looking south.

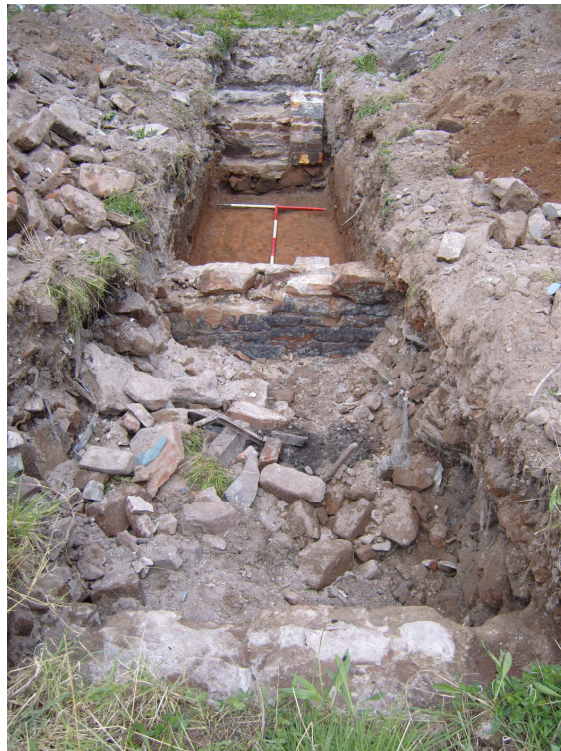
Plate 7: Trench 4 looking north.

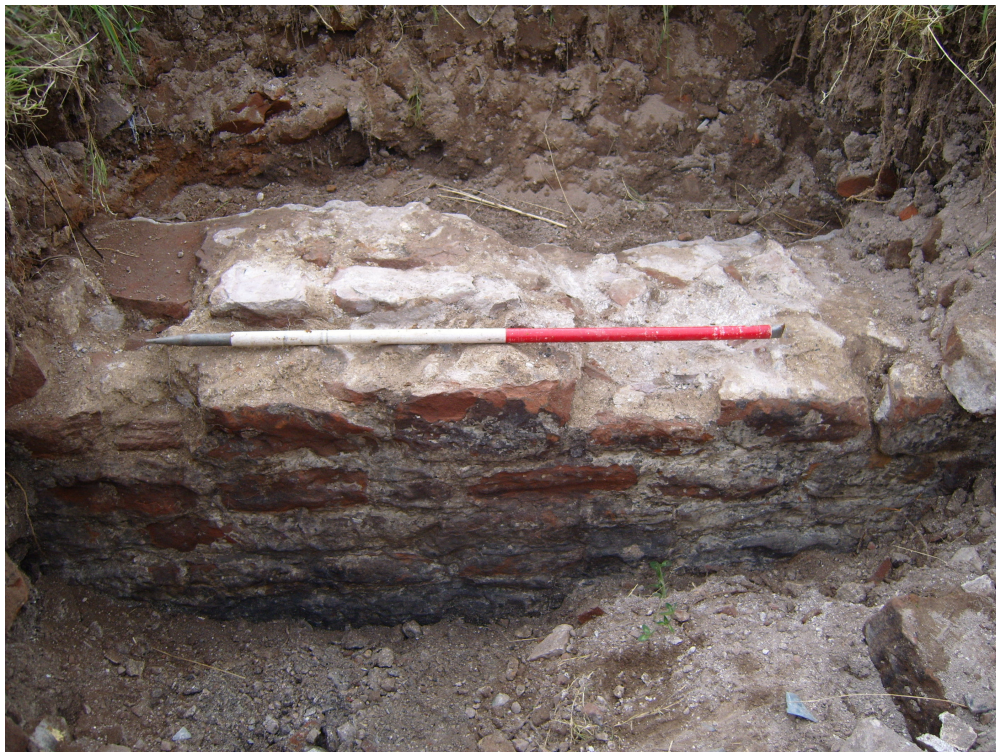
- 6.5.2 The first structural feature uncovered was wall [402] at the southern end of the trench; measuring 0.60m wide, it extended across the trench, aligned east-west and was constructed from sandstone blocks. The top of the wall that remained *in situ* was 0.70m below the ground surface. A concrete render was observed on the south side of the wall. Immediately north of this was the cellared area of the National School building, measuring 2.80m in width. Any floor surface of this area was not seen due to it being filled by rubble layer (400). Defining the southern side of the cellar was wall [404] that was of a similar construction to wall [402], being made from local sandstone. This wall was also 0.60m thick, with five courses of stone (each approximately 0.30m long and 0.10m thick) visible on the southern side, reaching an observable height of 0.75m, although the bottom of the wall was not seen.

Plate 8: Wall 402 in Trench 4, looking south.

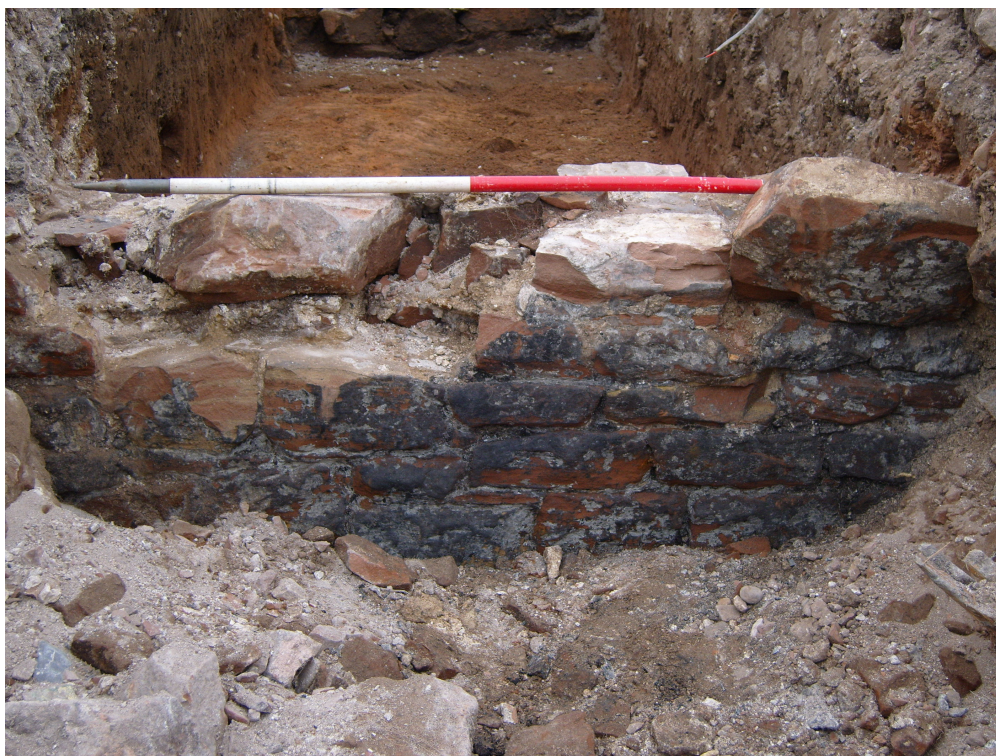
- 6.5.3 To the north of [404] was an area of natural ground that was overlaid by several layers of material. Cut [403] was the foundation cut for the wall and this was backfilled by (405), a friable pale grey, mortar type material. Context (408) was defined as a sub-soil layer that was moderately well compacted, mid to dark brown in colour and a sharp sand texture with only very occasional small stone inclusions. It was seen in the east facing section of the trench and measured up to 2.25m in length and reached a depth of 0.63m. It was cut by [403] at its southern end and by [409] at its northern end. Layer (408) was overlain by (407), interpreted as being re-deposited natural sand that was a levelling or make up layer for a floor or surface above. It was mid brownish-orange small grained coarse sand that was observed for a maximum length of 3.20m and a maximum thickness of 0.20m. Above (407) was (406), a loosely compacted dark grey to black mix of soft silt and gritty sand that frequently included small stones. This layer was observed for 2.30m in length and was only 0.08m thick. It was subsequently interpreted as a reduced or rotted organic layer, with occasional pieces of non-degradable materials, possibly the remnants of whatever lay on the floor surface within the building, as it was quite thinly spread on a horizontal plane. This layer was covered by (400), the uppermost deposit seen in the trench and primarily made-up of the building debris and rubble that was left on the site after the demolition of the building.

Plate 9: Wall 404 in Trench 4, looking north.

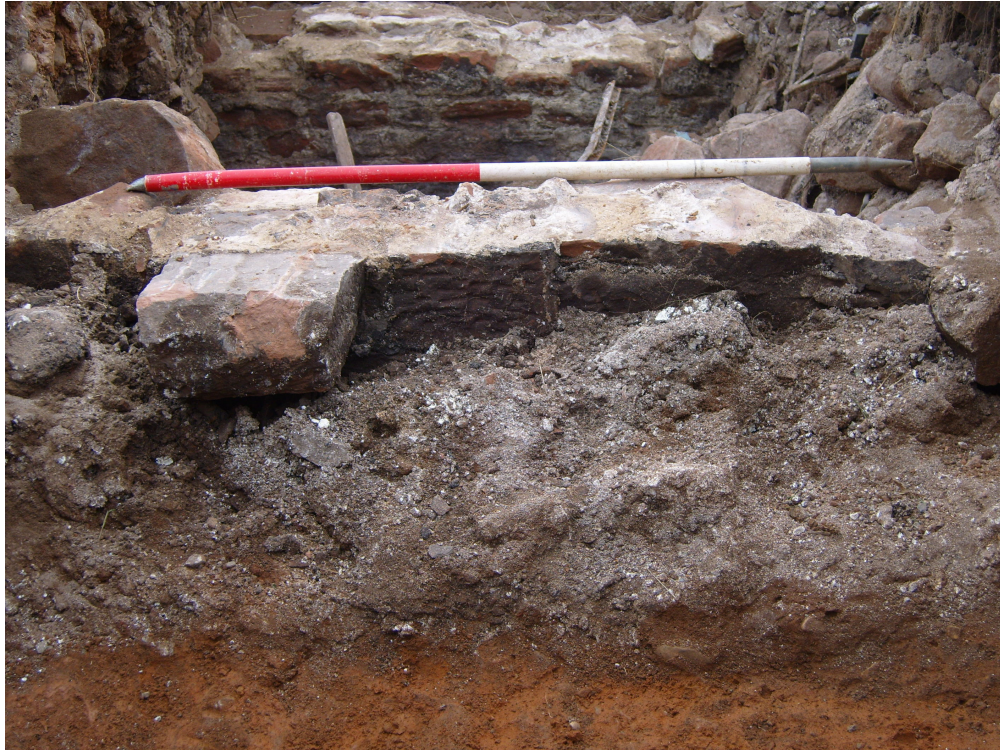
Plate 10: Wall 404 in Trench 4 looking south.

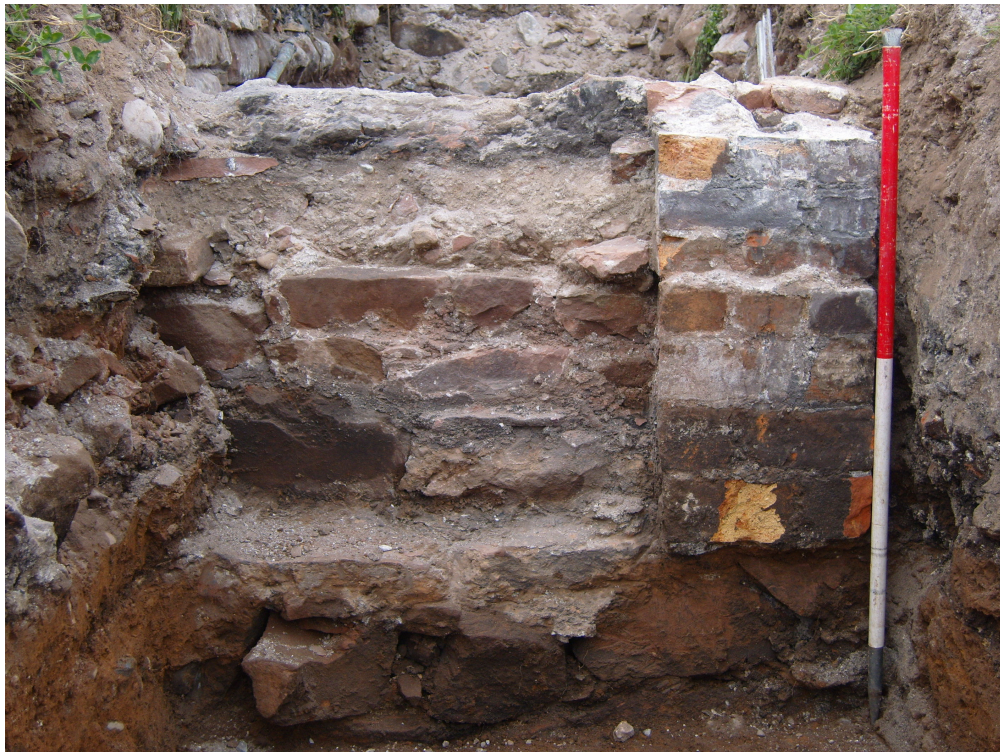
- 6.5.4 The cut [409] formed the foundation cut for the wall [411]. This cut was backfilled with (410), a moderately compacted orangey grey slightly silty sand, with occasional stone inclusions that has been interpreted as a re-deposited natural material. The wall [411] was seen to be 0.70m wide aligned east-west across the trench and reaching a

Plate 11: Wall 411 in Trench 4, looking north.

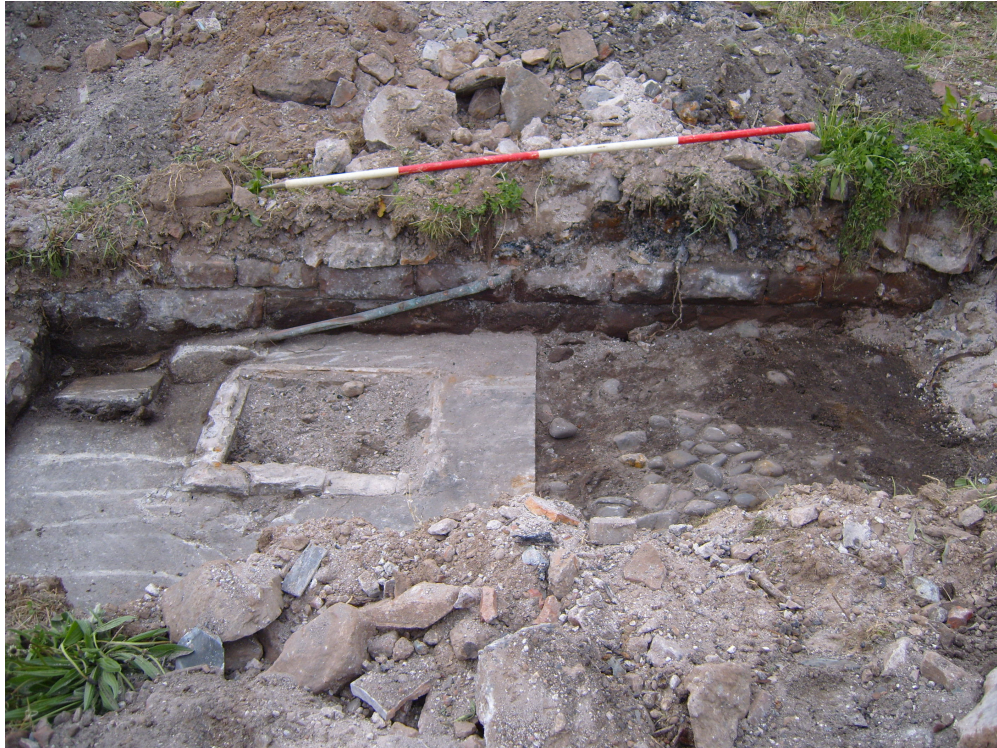
Plate 12: Wall 412 in Trench 4, looking west.

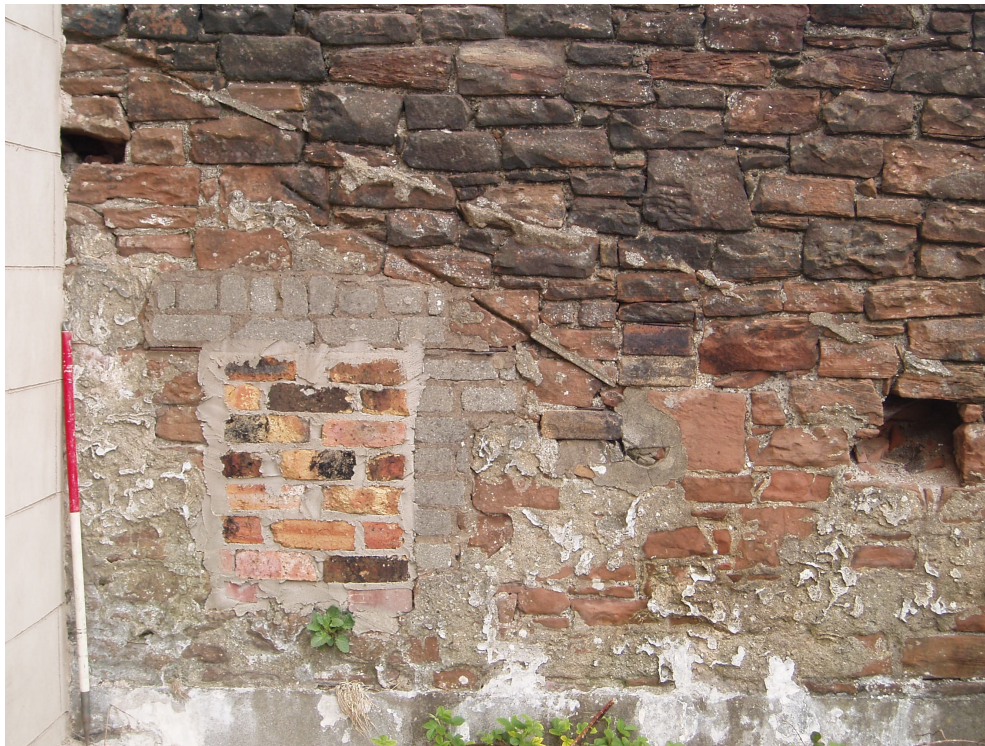
Plate 13: The northern site boundary wall showing roof scars, looking north.

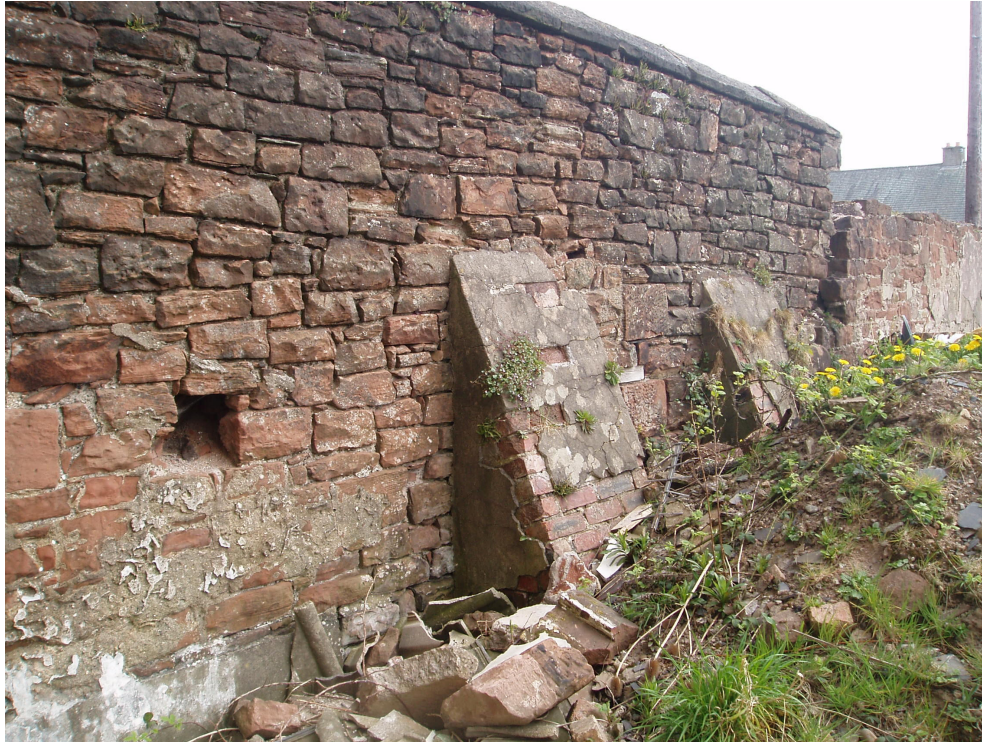
Plate 14: The northern site boundary wall with buttresses, looking northeast.

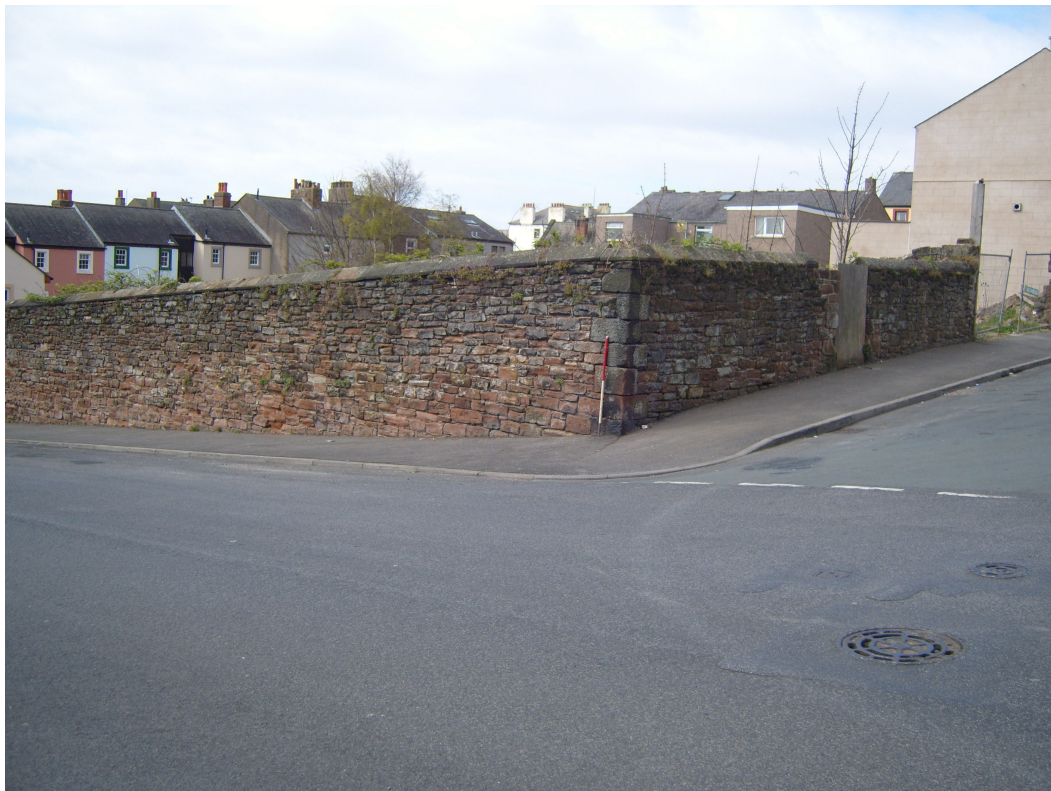
- 5.1.2 The southern side of the site boundary respects the extent of a house plot on Church Street and of those that extend north from Eaglesfield Street. This wall is partly brick and partly sandstone. The brick section appears to be more worn and older in date, it may have once formed part of the school while the sandstone section appears to be more recent, machine cut blocks that may have been erected when the houses on Eaglesfield Street were developed (after 1970). The western boundary is similar in appearance to both the northern and eastern sides. Again, it is probably an original boundary, built at the same time as the school. The northern end of the western boundary is formed by the sidewall of 37 Fleming Street.

Plate 15: The northern and eastern site boundary walls, looking southwest.
