NORTH PENNINES ARCHAEOLOGY LTD

Client Report No. CP/364/06

Beginning August 2006, North Pennines Archaeology Ltd undertook an archaeological watching brief during redevelopment works on redundant farm buildings at Chapel House Farm, Casterton, Kirkby Lonsdale, Cumbria.

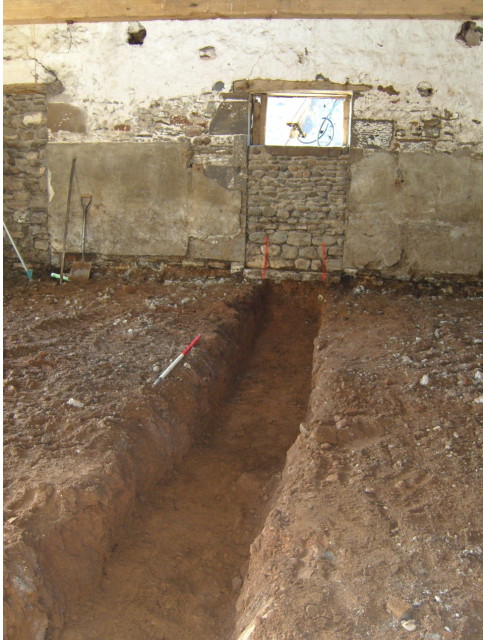
- 5.2.1 In total, three trenches (Trenches 2, 3, and 4) were excavated inside Barn A to accommodate foundation trenches for new partition walls within the building (see Figure 2). Trench 2 was located in Room 2 of Barn A and was aligned northeast by southwest. It measured 7.5m in length (the entire length of the room), and was 0.80m wide by 0.40m deep. Only one layer was observed during the excavation of the trench which consisted of light to mid brown silty clay which was moderately well compacted with up to 70% stone inclusions which varied in size from small to large sub-rounded river washed cobbles. The appearance of this material was that it was a naturally formed layer rather than a deliberate dump of material (see Plate 1).

Plate 1: Barn A, foundation trench 2
inside the building

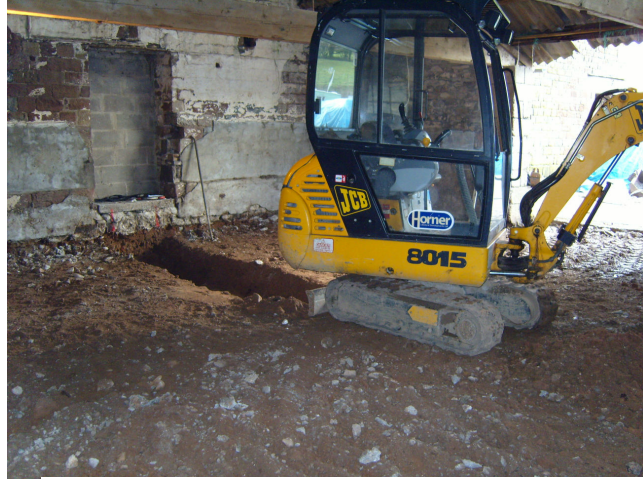
Plate 2: Excavation of trench 2, inside Barn A

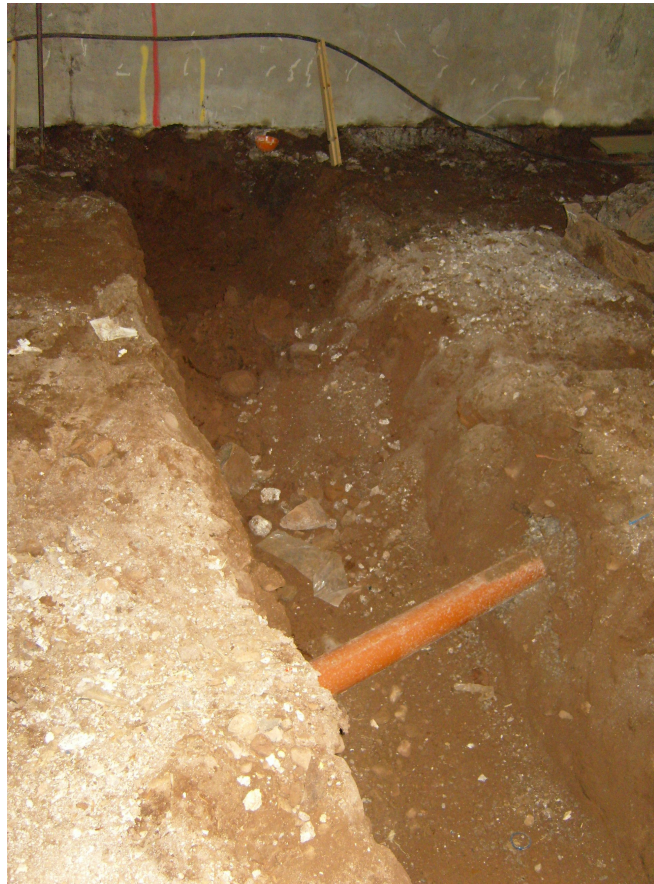
- 5.2.2 Trenches 3 and 4 were located in the main area of the barn, with Trench 3 positioned 2.4m southeast of the doorway into room 2. The length of the trench was 5.3m (the width of the room) and was 0.80m wide. The minimum depth of the trench was 0.60m. The concrete floor that was previously in this part of the barn had already been removed, below that and seen throughout the extent of the trench was the natural substrate. This comprised dark brown clayey silt that carried up to 75% inclusions of sub-rounded water worn cobbles that varied in size from small to large and also other pieces of medium sized angular limestone.

Plate 3: Excavation of trench 3, inside Barn A

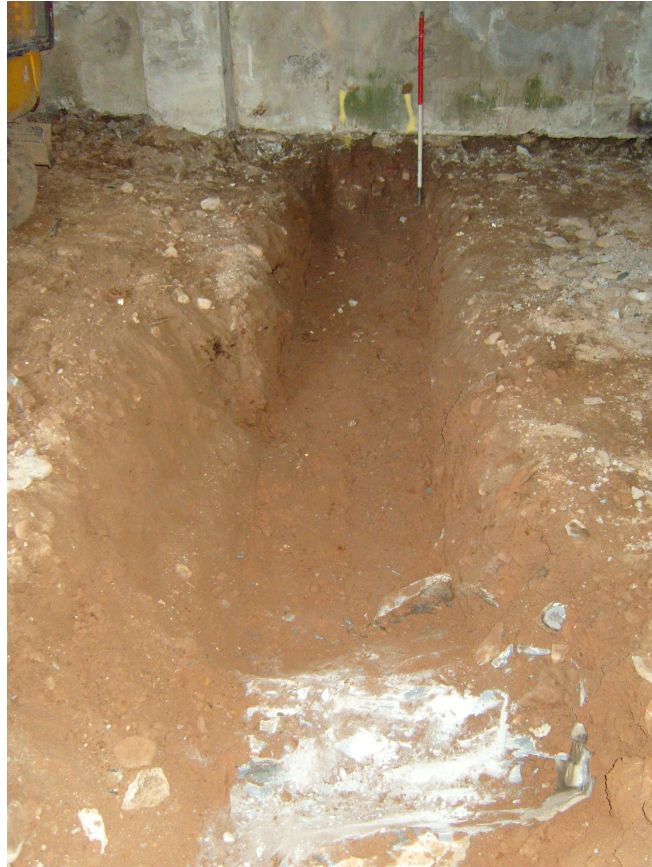
- 5.2.3 Trench 4 was positioned 6.9m to the southeast of Trench 3. It measured 5.30m in length, was 0.80m in width and was 0.60m in depth. On the surface of the trench were a number of loose cobbles that may have previously formed a floor surface under the concrete one, however, they were greatly disturbed. The natural substrate material encountered within the trench was the same as in Trench 3, a dark brown clayey silt that carried up to 75% inclusions. Approximately 1.75m from the southwestern end of the trench was a very large bluestone boulder (Plate 4), this had to be mechanically reduced by a pecker to achieve the necessary trench depth as it could not be removed from the trench as a whole piece.

Plate 4: Excavation of trench 4, inside Barn A

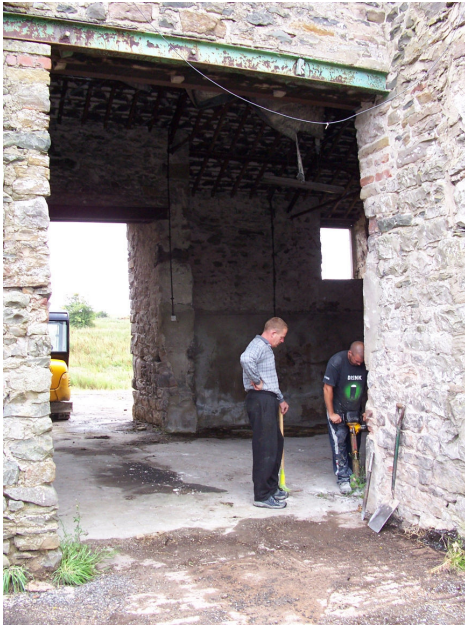
- 5.3.1 A single trench (Trench 1) was excavated inside Barn B (Figure 3, Plates 5 and 6), which was aligned north-northwest by south-south east across the central section of the building to accommodate a new internal load-bearing wall. The trench was approximately 0.8m wide by 5.5m long. A modern concrete surface, up to 0.2m deep, was removed which overlaid a loose mid brown silty sand which contained 70% small to medium sized inclusions, which were predominantly sub-rounded to round in shape. This layer was up to 0.40m deep and likely represents a deliberate dump of material, perhaps to raise the floor in the barn to accommodate the relatively modern concrete surface above. Observed at the base of the trench was the foundation of an earlier partition wall, which was presumably removed when the barn was enlarged to accommodate larger agricultural machinery. It consists of a randomly coursed limestones measuring 0.30m by 0.30m by 0.20m deep and was bonded with a pale grey mortar.

Plate 5: Inside Barn B

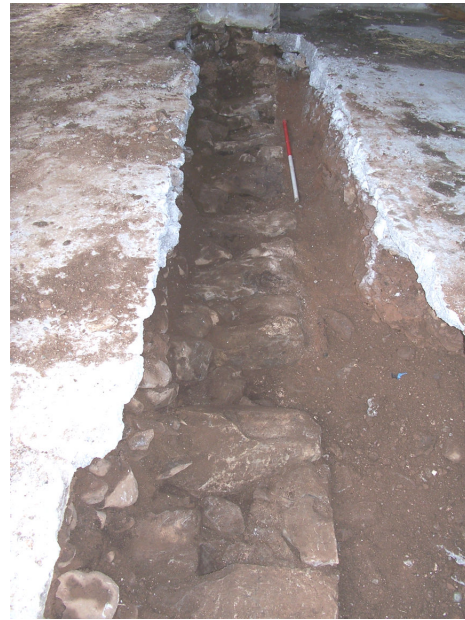
- 5.3.2 As the new internal wall was to be constructed in order to create a stable foundation, the area immediately to the south of the original trench was expanded to create more roof space. The wall was partially revealed which showed it to be six courses high (see Plate. No 6) finds or archaeological features were exposed during the excavation of this material.

Plate 6: Foundation trench 1, in Barn B, showing earlier internal partition wall

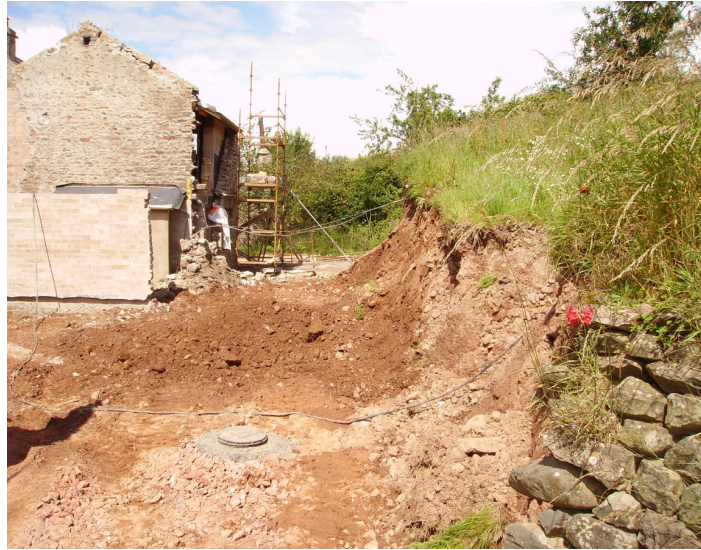
- 5.4.1 Over two consecutive days ground intervention work was carried out to the rear of Barn A (Plate 7). Due to the unstable nature of the rear wall on the northeast side this had been almost completely demolished. Only a section, 6m long, on the northern end was left standing. In order to facilitate the demolition work the ground adjacent to the rear wall had been previously excavated down approximately 2.30m for a distance 5m out from the wall.

Plate 7: Excavation into the bank at the rear of Barn A. Note that the majority of the rear wall has been demolished.

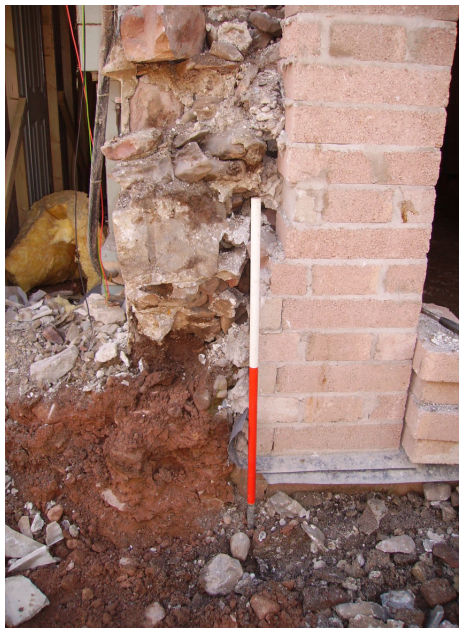
- 5.4.3 On completion of the levelling work adjacent to the barn rear, work proceeded in scraping out a layer of subsoil, 0.20m thick, from what would be a future room within the barn conversion. This revealed some of the original foundation stones lying on the natural sub-strata (Plate 8).

Plate 8: Barn A, an original stone dividing wall (on left) lying on the light brown/orange natural soil horizon

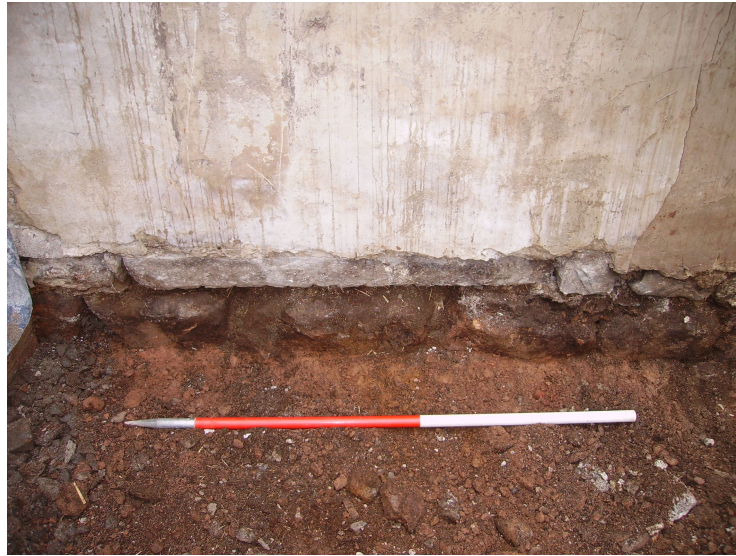
Some of the stone was quite large, up to 0.60m in size. The original barn foundations had been laid on to the natural soil horizon (Plate 9).

Plate 9: Internal foundation stones lying on the natural substrata

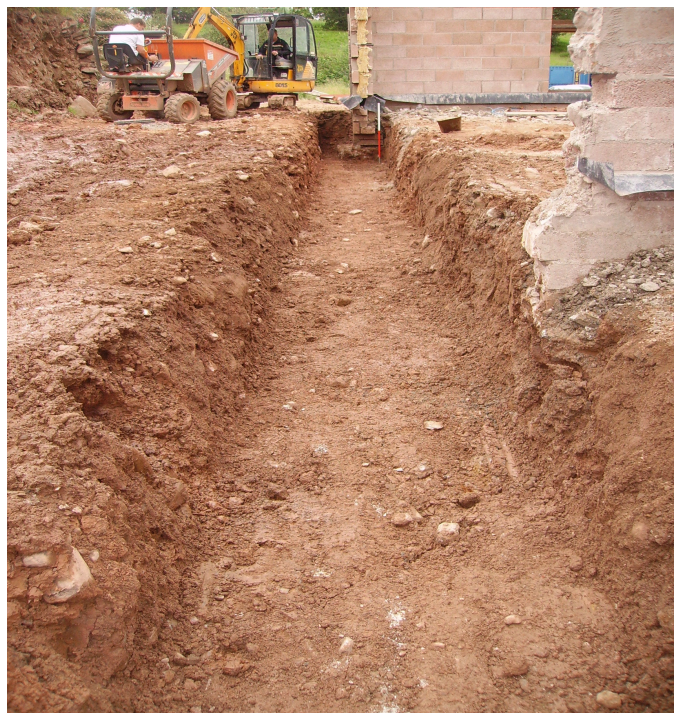
- 5.4.4 In order to reconstruct the barn rear wall it was necessary to excavate a trench (Trench 5) for concrete foundations. This trench ran along the line of the original rear wall for a distance of 16.70m, measured 1m wide and was excavated into the natural to a depth of 0.80m (Plate 10).

Plate 10: Foundation trench 5 along the line of the rear wall

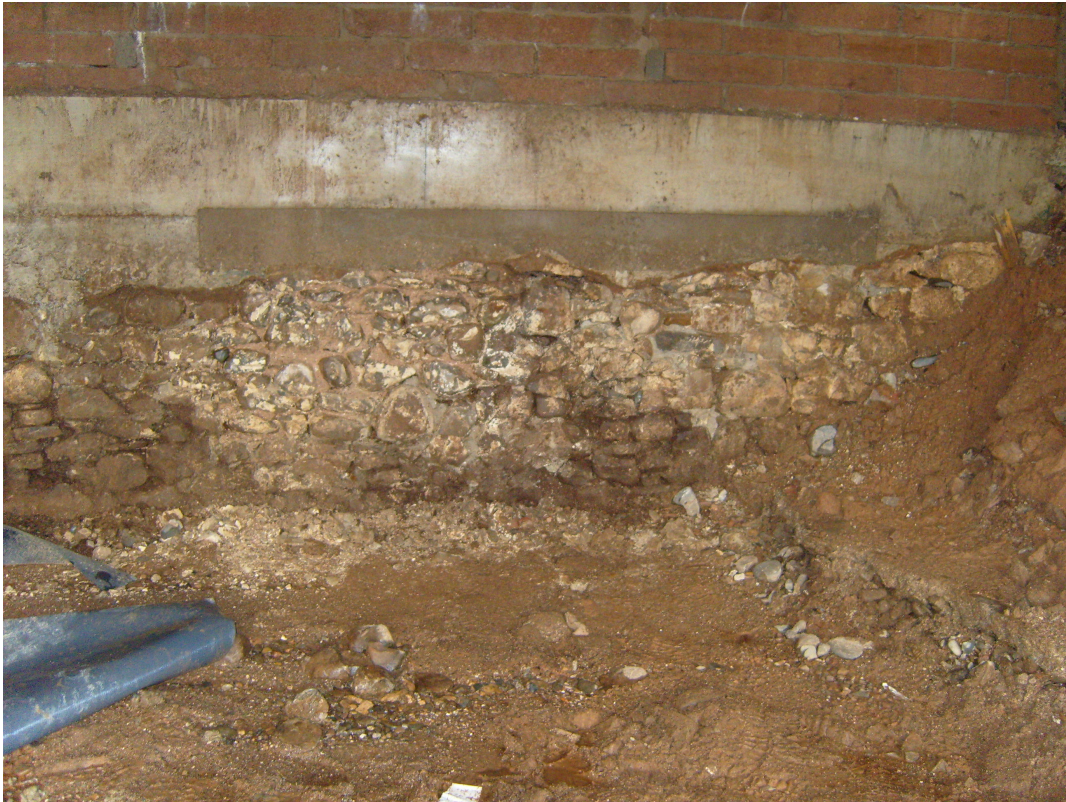
Plate 11: Original dividing wall, in Barn B

- 6.1.1 The watching brief undertaken at Chapel House Farm, Kirkby Lonsdale, Cumbria failed to locate any significant archaeological remains. It is evident that the barns were constructed directly on to the natural soil horizons and therefore any archaeological features relating to any earlier activities on site would have been severely truncated by the construction of the barns in the 18th century.
- 6.1.2 The watching brief did reveal a wall inside Barn B, (Plate 11) relating to an internal wall that was possibly removed to increase available space inside the barn. This wall has been covered with a concrete beam, to construct a new dividing wall within the barn, preserving the wall in situ.
