Client Report No. CP/463/07

**ARCHAEOLOGICAL
WATCHING BRIEF
FOR A PROPOSED WASTE
WATER TREATMENT
WORKS AT
WILLOWFORD FARM
GILSLAND CUMBRIA**

NGR NY 362484 566526

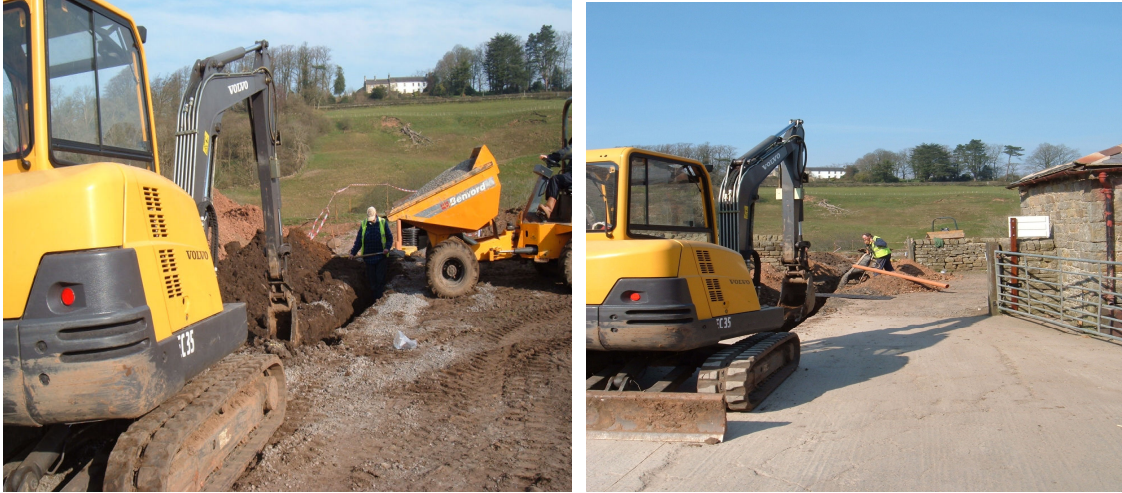
Plate 1 and 2: Excavation of the pipe trench, facing north

- 4.1.5 A linear trench was excavated for the insertion of a sewage pipe which linked the septic tanks with the main farmhouse (see Figure 2). Trench 1 was 50m long and 0.72m wide with an average depth of 0.85m. The northern extent of the trench was evaluated in May 2006; therefore the ground was heavily disturbed. The natural substrate varied considerably across the trench, which showed it had been laid in thin bands consisting of clayey sand to patches of fine sand. The area that had not been previously excavated, through the yard, had a covering of concrete over laying dark brown soil with occasional medium sized sub-rounded inclusions. A number of post-medieval ceramic drains crossing the trench were observed, cutting the natural. At the north end of the yard there was a thin covering of tarmac directly below the concrete surface. Towards the south end of the trench the concrete overlay a patch of cobbles, suggesting that the yard surface had been previously cobbled over. The main water pipe for the farm crossed the trench on an east-west alignment near the house.

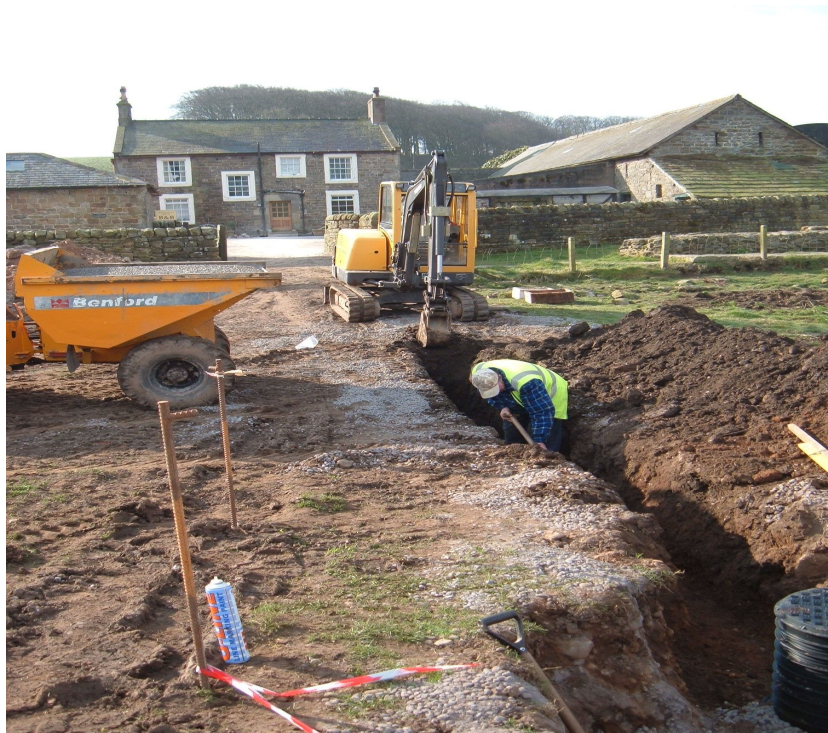
Plate 3: Pipe trench, facing south, Willowford Farmhouse in the background

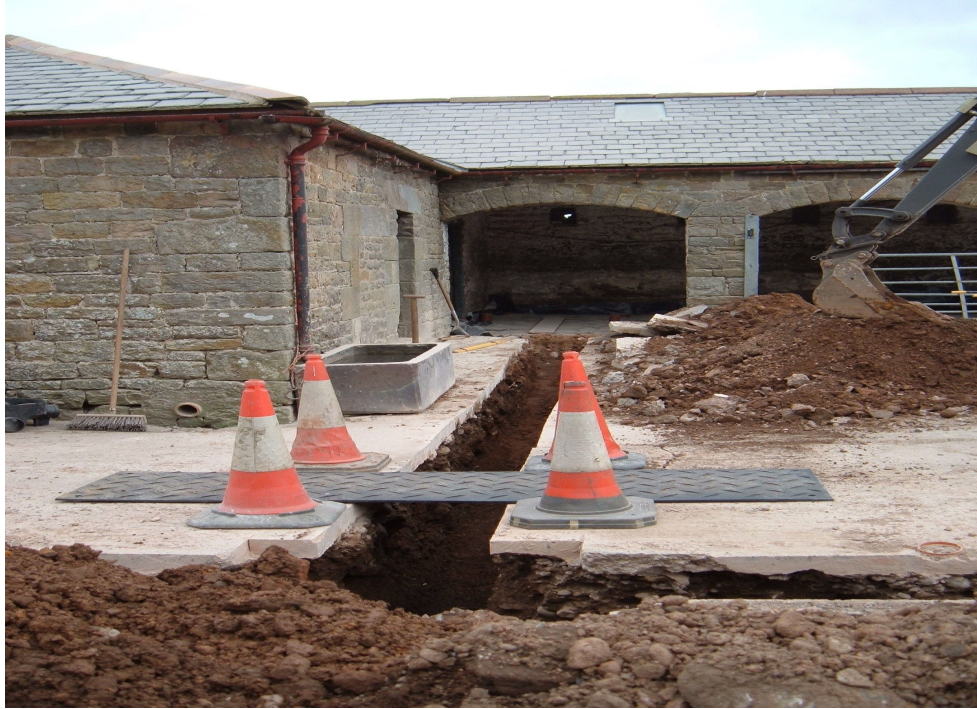
Plate 4: Trench 2, facing west

- 4.1.6 A further three trenches were excavated to join waste pipes up to the main waster water pipe (Trench 1) (see Figure 2). Trench 2 was 9m long by 0.70m wide and had a maximum depth of 0.90m. The trench was located on the eastern side of the farmyard and was aligned east west. The disturbed nature of the natural made secure

identification difficult, however the fill of the trench consisted of dark reddish brown silty sand. There was a patch of cobbles below the concrete surface by the barn, which may represent an earlier yard surface. A single red ceramic drain was noted which had been partly demolished and was no longer in use.

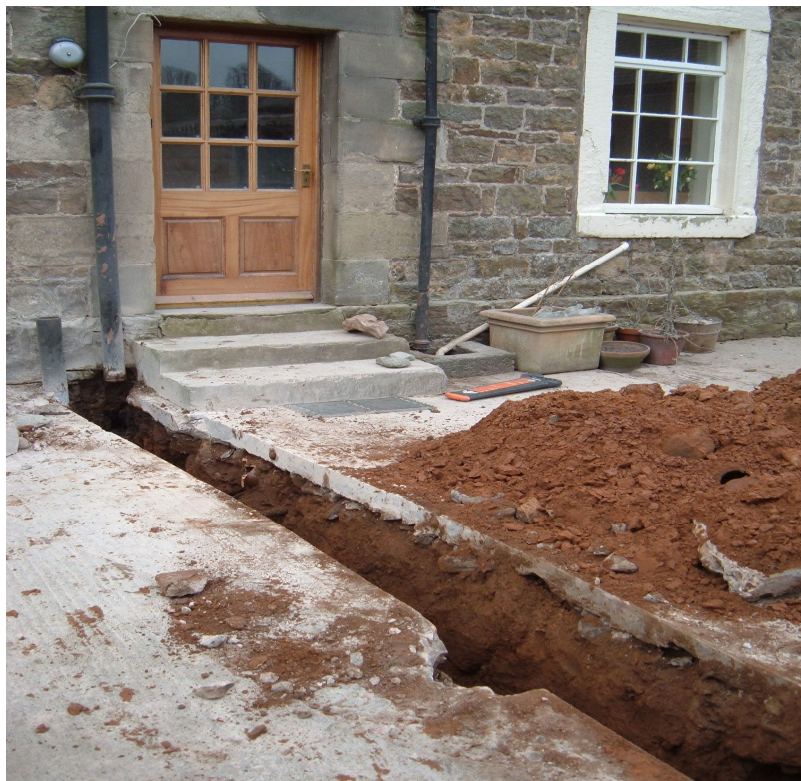
Plate 5: Excavation trench, in front of Willowford Farmhouse entrance

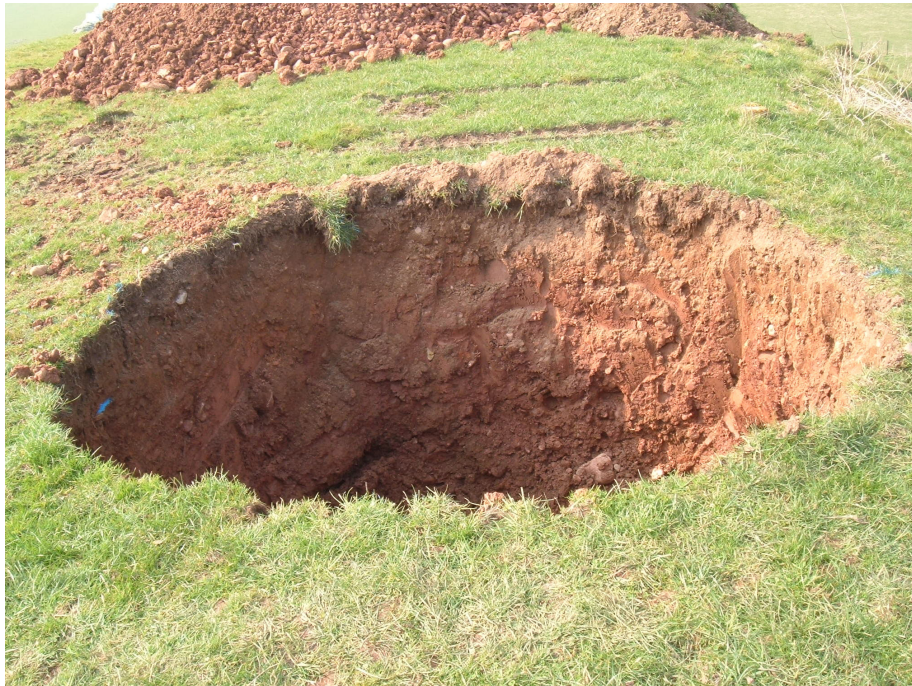
Plate 6: Excavation of Tank 1 (Septic Tank), facing northeast

- 4.1.2 The two construction trenches were excavated immediately to the north of Hadrian's Wall. The trench for Tank 1 (see Figure 2) was excavated to a maximum depth of 3.1m by 2.3m wide. The natural soil horizon consisted of reddish brown clayey sand with 80% inclusions of sub-rounded cobbles and small rounded pebbles. This was overlaid by 0.40m to 0.50m of light to mid reddish brown sand clay with occasional sub-rounded stone inclusions. The topsoil, consisting brownish red silty sand, approximately 0.30m deep made up the remaining depth of the trench.

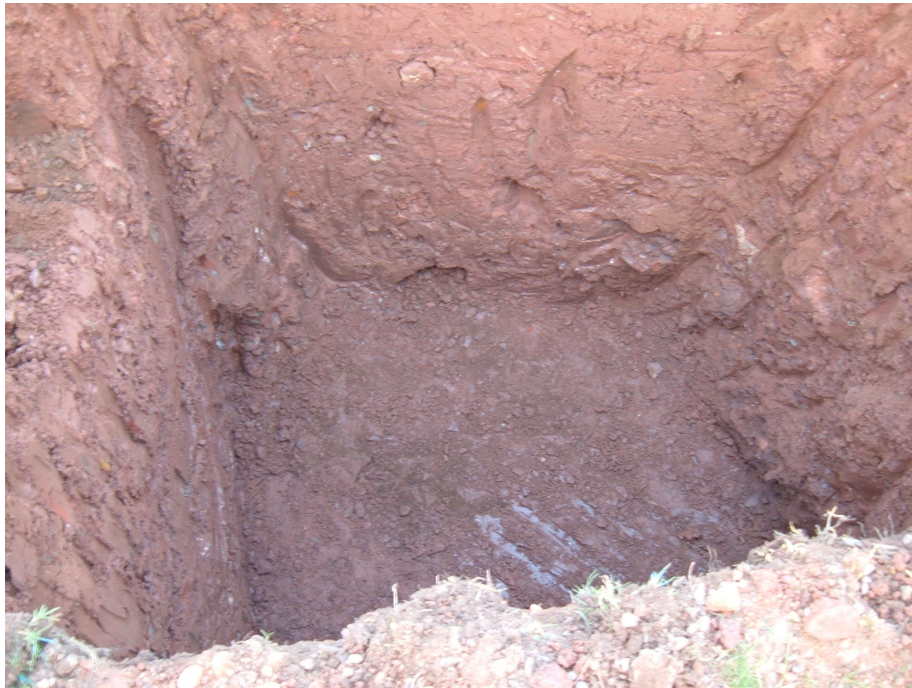
Plate 7: Base of septic tank trench
