# **NORTH PENNINES ARCHAEOLOGY LTD**

**Client Report No. CP/563/08**

In March 2008, North Pennines Archaeology Ltd was commissioned by Magnus Homes to undertake an archaeological building recording in advance of a proposed redevelopment of Pears House, Whitehaven Harbour, Whitehaven, Cumbria, (NGR NX 9733 1836). A previous desk-based assessment had revealed that the existing building had 1925-1938 origins, and its elaborate frontage made it worthy of further study prior to demolition.

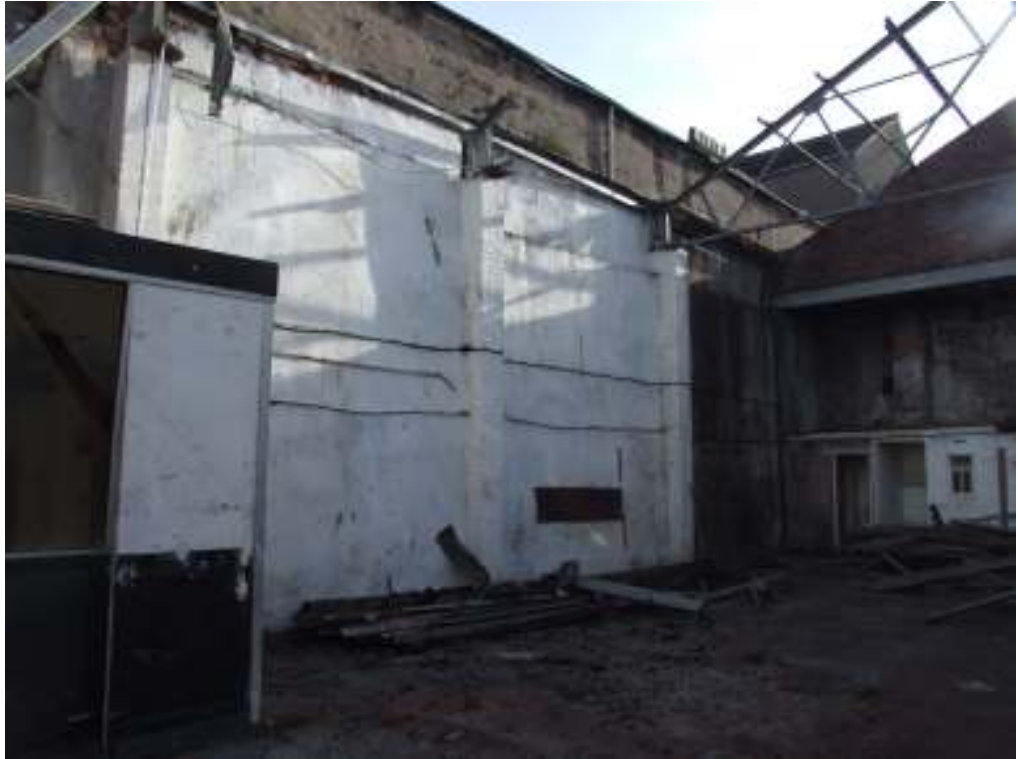
**Plate 1:** Southwest-Facing Elevation

- 4.2.3 The fact that the building occupied what was essentially, a gap between adjoining properties, meant that some of its walls appeared to be made of board, stood against adjoining boundary walls, plastered white. This was the case for the longest wall, the southwest facing one, the part of the northeast facing wall not obscured by the modern two-storey structure, and both walls forming the internal L-Shape, adjacent to Numbers 3 and 4 Duke Street (Plates 1, 2 and 3 below).

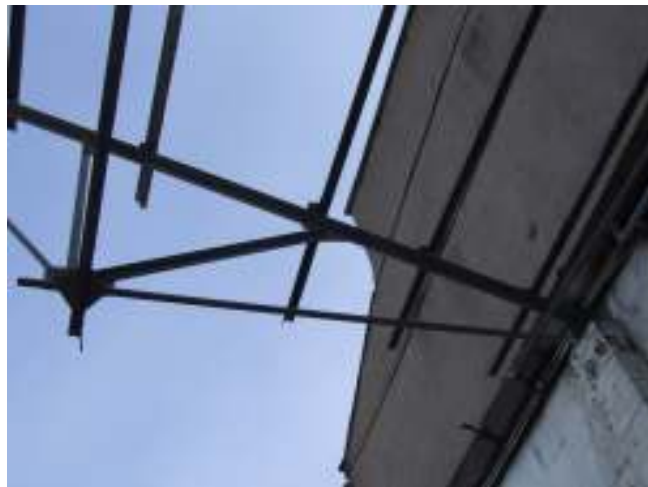
**Plate 4:** Roof Detail

- 4.2.4 All of these elevations were further supplied with square pillars, at regular intervals across their length, to provide support for the roof trusses above. The roof structure is shown in Figure 4a and Plate 4. The roof presumably consisted of corrugated iron segments, with plastic skylights, allowing light into the windowless, and otherwise natural-light-free building.

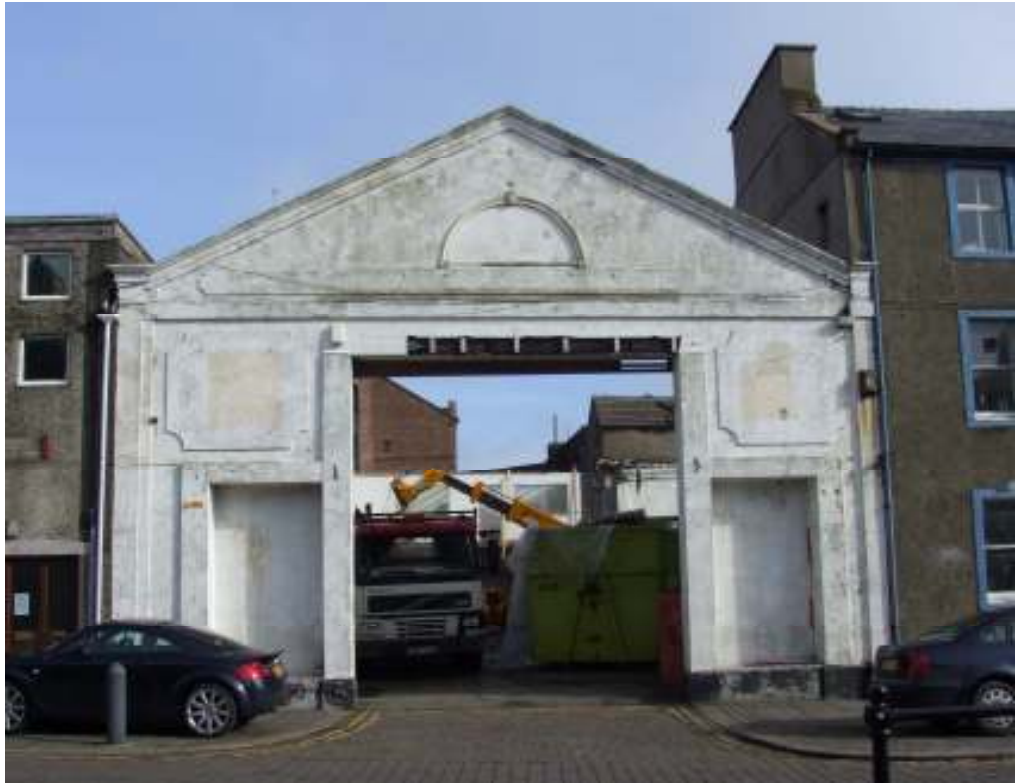
**Plate 5:** Entrance Façade

- 4.2.5 The main entrance to the building, the southwest facing façade was the basis for the building recording, highlighted by the desk-based assessment (Peters 2007). It consisted of a whitewashed sandstone façade, with columns and decorative features

(Figure 4b; Plate 5), perhaps as a way of tying the industrial building in with its more ornate neighbours.

- 7.1.1 The ornate entrance façade to Duke Street, was unusual, and perhaps the result of an attempt to tie it in with buildings in the vicinity in the 1920s and 1930s. It betrayed an empty and somewhat featureless interior. The building recording survey found that of most interest, internally, was the northwest facing internal wall. This wall had evidence for the incorporation of pre-existing adjacent boundary walls into the fabric, shown by differing fabrics of different style and period, particularly in the southern half of the elevation. In addition, it showed that the building extended southeastwards into the back plot of the Public House, extended its known boundary.

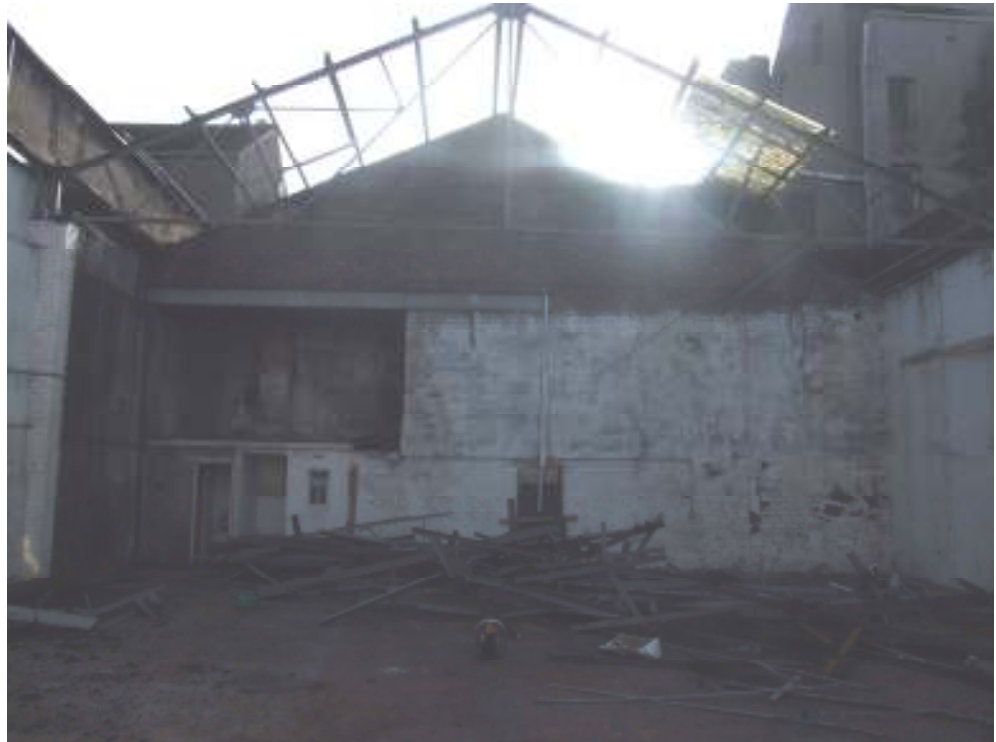
**Plate 6:** Northwest-Facing Elevation

- 4.2.6 Of most interest, internally, was the northwest facing internal wall (Figure 4c; Plate 6). This included an inaccessible Fire Exit, which was located approximately halfway along the elevation. From modern Ordnance Survey Mapping (Figure 2), this appears to correlate directly with a northwest to southeast aligned alleyway between Number 17 Tangier Street, and the Public House. Furthermore, the appearance of two lavatories, with a recess above, extending southeastwards from the elevation, showed that the building actually encroached into the back plot of the Public House. The occurrence of a steel girder above the recess shows the need for further support for the red brick elevation above. The bricks on this elevation were English Garden Wall Bond one and five, painted white below the level of the steel girder, and left red above. Unlike the other elevations, this wall had evidence for the incorporation of pre-existing adjacent boundary walls into the fabric, shown by differing fabrics of different style and period, particularly in the southern half of the elevation. Three clear brick boundary walls of 0.5m widths could be seen at regular intervals, matching back plot walls seen behind Number 17 Tangier Street, shown on modern Ordnance Survey Mapping (Figure 2). In between these walls, was a mixture of sandstone and brick, in the far southern corner, barely more than a rubble dump, to make up the wall. All was whitewashed, consistent with the rest of the building.

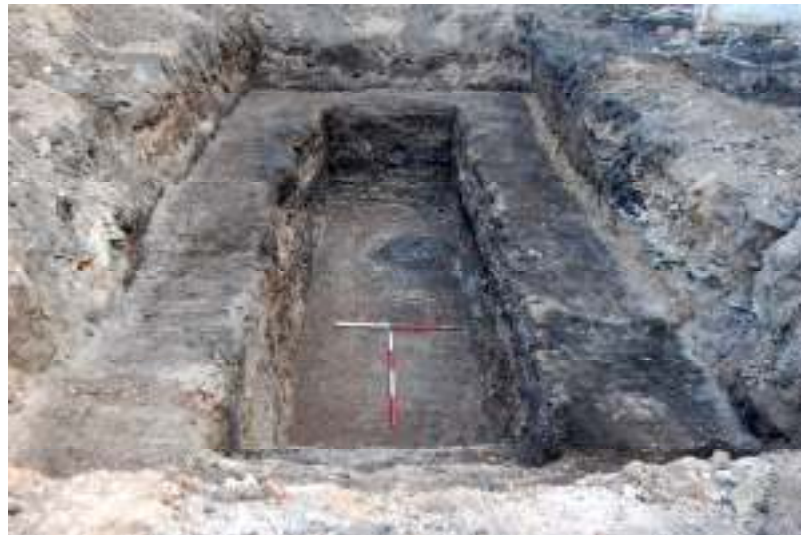
**Plate 7:** Trench 1, facing north

5.2.1 Trench 1 was located at the northeastern extent of the development site, aligned with the partly demolished west-facing wall of a nightclub on Williamson Lane (see Figures 5 and 6; Plates 7 and 8). The trench measured 10m long by 3.40m wide. Due to the depth of the trench, all four sides were stepped by 1.20m to create access and to adhere to the recommended health and safety constraints for deep excavations. The initial machining involved the removal of remnant sections of concrete flooring and an east west aligned wall from a previous structure; these deposits are described as modern overburden **100**, **103**, **106** and **115** and due to their disturbed nature, are not described in detail within the assessment.

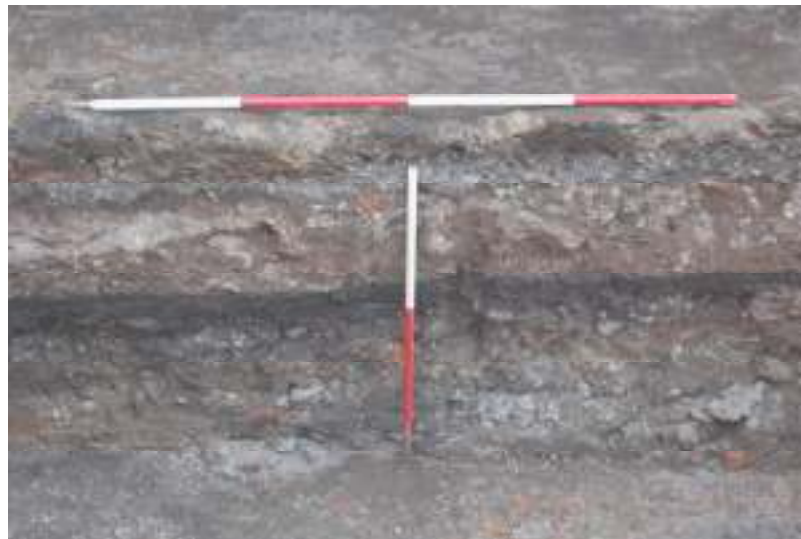
**Plate 8:** Trench 1, west facing section, note context **112**

5.2.3 Approximately 3m from the western extent of the trench, a brownish grey, moderately compacted sandy gravel, containing post-medieval pottery sherds was observed **113**, overlying **114**. Overlying all layers so far discussed was *c* 0.20m of dark brown to black silty loams **112**, which was interpreted as a tip or dump deposit, mixed with ashy, charcoal rich demolition and industrial debris and redeposited topsoil. It is possible that this layer is the remnant of a buried garden soil horizon (see Plate 8).

5.2.4 A number of layers were observed sealing context **112**, all of which have been interpreted as levelling or dumped deposits. Context **111**, was 0.22m deep and consisted of moderately compacted brownish grey sandy silt with numerous inclusions of brick, tile and contained a large amount of lime mortar fragments. This was overlaid by three distinct layers of building rubble **108**, **109** and **110**, approximately 0.27m thick.

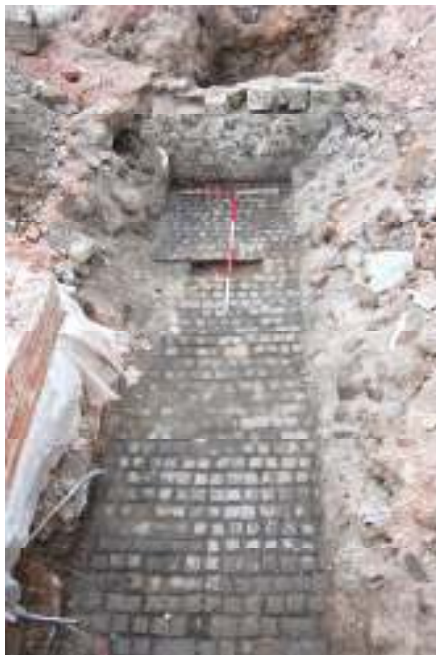
**Plate 9:** Trench 2, facing west

5.3.1 Trench 2 was located within the southern sector of the development site and is aligned east west with Duke Street (see Figures 5 and 7; Plates 9 and 10). The original length of the trench was 12m long; however the discovery of a substantial cellar necessitated the movement of the trench approximately 3m eastwards. Due to space limitations and the detection of live services, the trench was reduced in size to 10m with agreement from Cumbria County Council Historic Environment Service (Parsons *Pers comm.*). The machining involved the removal of remnant sections of concrete and rubble associated with the demolished building fronting Duke Street: these layers are described as overburden **200** and **203**. The removal of the overburden uncovered two walls, which effectively sub-divided the trench into two sections. These sections, 2(a) and 2(b), will be discussed separately for ease of clarification. The section runs from east to west in sequence.

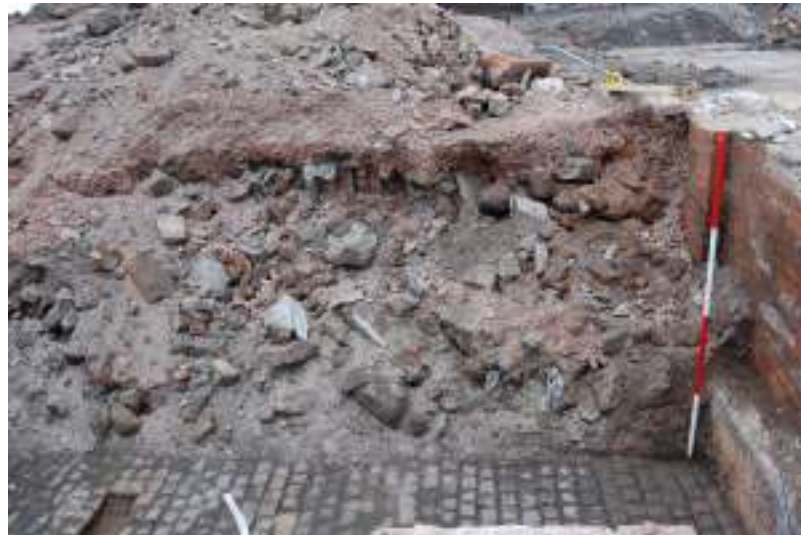
**Plate 11:** Overburden **201** and **203**, facing north

5.3.2 **Section 2(a):** The first section measured 5.58m in length from the eastern end of the trench to a north-south aligned wall **204** (see Figure 7; Plate 11). The natural soil horizon **213**, was exposed at a depth 2.54m, within a hand excavated sondage at the base of the trench. The natural consisted of pale greenish grey silty sand with numerous small rounded sandstone inclusions. Observed cutting the natural was wall **204**, measuring 0.55m wide by 1.60m long and heading north from the Duke Street frontage. The wall was constructed from irregularly dressed, randomly coursed sandstone blocks with a rubble core; the stonework also incorporated five

courses of handmade bricks on the west facing elevation. The east facing elevation has been whitewashed with lime-wash. It is likely that this structure represents the western wall of a small square building visible on the 1874 OS Map for Whitehaven.

- 5.3.4 Overlying the natural was **214**, consisting of *c* 0.37m of dark brown to black silty sand loam which was interpreted as a dump deposit, mixed with ashy, mortar rich building rubble. Five sherds of post-medieval pottery were also recovered from this layer. It is likely that this deposit represents bedding for the cobbled sets **212** above this layer. Approximately 1.85m of overburden **200** and **201**, made up the remaining depth of the trench, and consisted entirely of demolition rubble (see Figure 7; Plate 11).

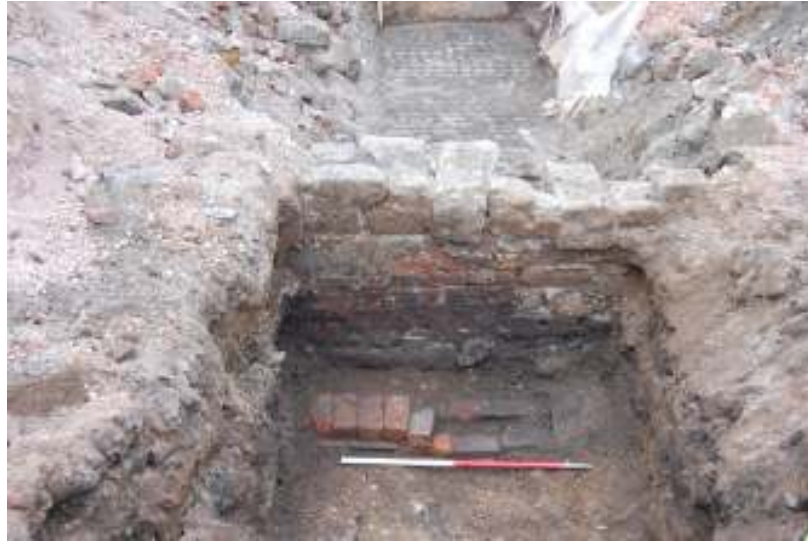
**Plate 12:** Wall *204* and drain *208*, facing east

- 5.3.5 **Section 2(b):** this section measured 4.90m from the western extent of the trench to wall **204**. The natural **213**, was exposed at a maximum depth of 2.50m below modern ground level. Observed cutting this layer was a small north south-aligned brick drain **208**, which was constructed from red handmade bricks, measuring 0.25m by 0.12 by 0.10m and bonded with lime mortar. Overlaying this layer was context **207**, consisting of dark greyish brown gritty silty clay up to 0.37m deep and may represent the original ground surface. The remaining depth of the trench (*c*.1.66m) was made up of various demolition and or construction episodes. Layers **201**, **202**, **205** and **206** were loose, mid grey to brown in colour and contained a large amount of building debris and rubble as well as mortar fragments.

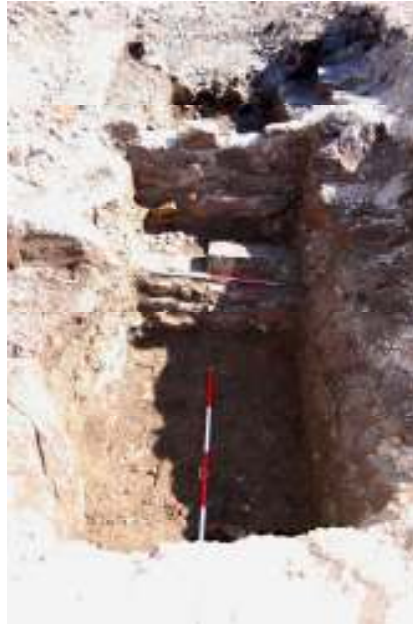
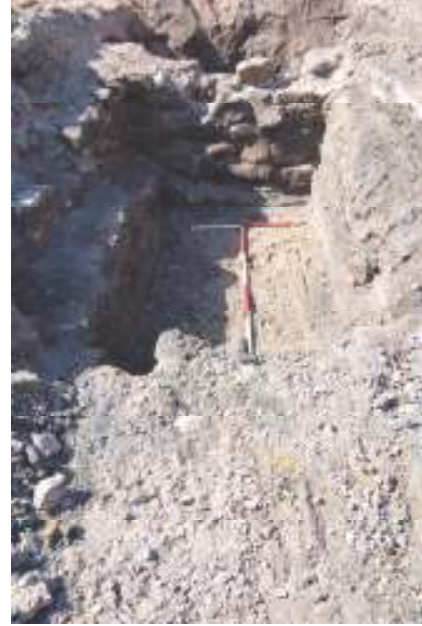
**Plate 13:** Trench 3, facing east**Plate 14:** Trench 3, facing west

- 5.4.1 Trench 3 was located within the middle sector of the development site and was aligned east west (see Figure 8; Plates 13 and 14). The trench was 10m long, however the discovery of a substantial cellar necessitated the movement of the trench approximately 3m eastwards. The machining involved the removal of remnant sections of concrete and rubble associated with the demolished building: these layers are described as overburden *300* and *309*. The removal of the overburden uncovered two cross-walls, which effectively sub-divided the trench into two sections. These sections, 2(a) and 2(b), will be discussed separately for ease of clarification.

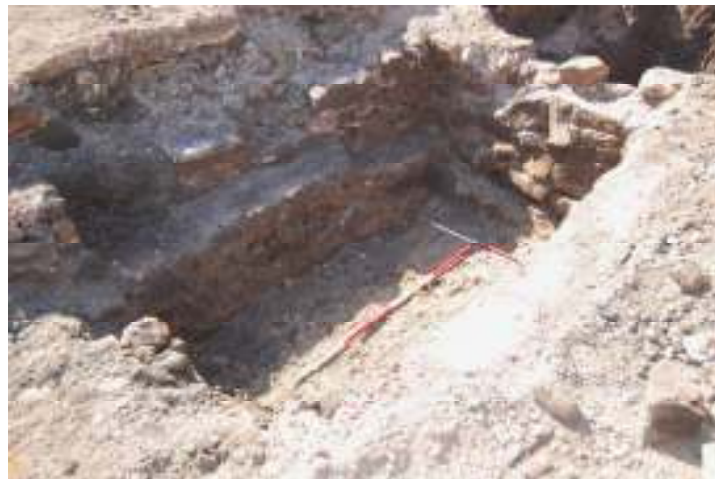
**Plate 15:** Walls **307** and **314**, facing southwest

- 5.4.3 A short section of walling *314* incorporating a doorway or entrance was noted running parallel with the north facing section of the trench. The wall butts *307*, however it is not keyed into this structure and may represent a later addition. The wall is approximately 2.30m long by 0.55m wide, its depth is unknown as the section was unstable and left unexcavated (see Figure 8; Plate 15).

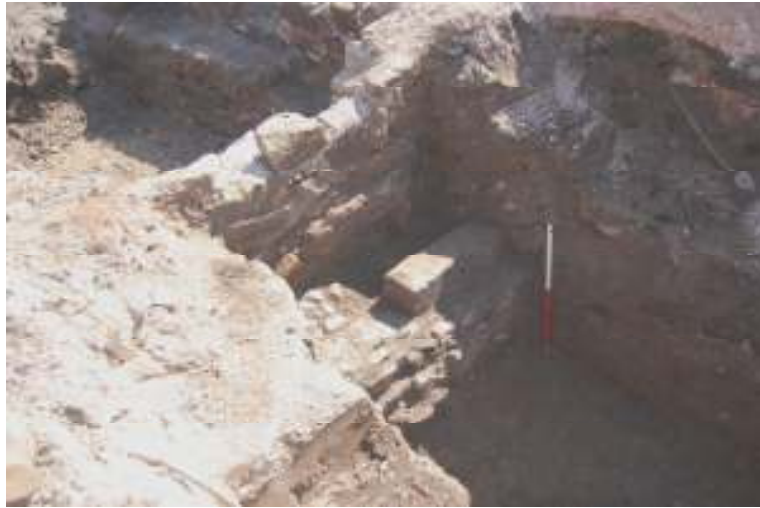
**Plate 16:** Walls **307**, **313** and cobbled surface **312**, facing southeast

- 5.4.4 **Section 3(b):** this section measured 4.55m from the western extent of the trench to wall **307**. The natural **310**, was exposed at a maximum depth of 2.13m below the modern ground surface. The earliest archaeological horizon exposed overlying the natural was context **308**, which consisted of crushed lime mortar and red brick fragments. Three Delft Ware pottery sherds were recovered from this layer. Running parallel with wall **307** was a well-dressed kerbstone **313** and associated

cobbled surface **312**, which had been truncated when wall **307** was built (see Figure 3; Plates 16). It is probable that both features relate to the large linear building noted on Hutchinsons Map in 1790 and may represent a boundary wall and yard/garden area. Abutting the kerbstone was a **306**, consisting of compacted greyish brown silty sand up to 0.24m deep, which has been identified as a levelling deposit. Layers **305**, **304**, **303** and **302** consist of loose demolition rubble. Concrete layer **301**, abutting wall **307** possibly represents the floor level of the building.
