NORTH PENNINES ARCHAEOLOGY LTD

Project Designs and Client Reports No. CP/701/08

19 June 2008

North Pennines Archaeology Ltd were commissioned by Mr Will Browne-Swinburne to undertake an archaeological watching brief on repairs and alterations during the redevelopment of the eastern wing of Capheaton Hall, Northumberland (NGR NZ 0390 8055).

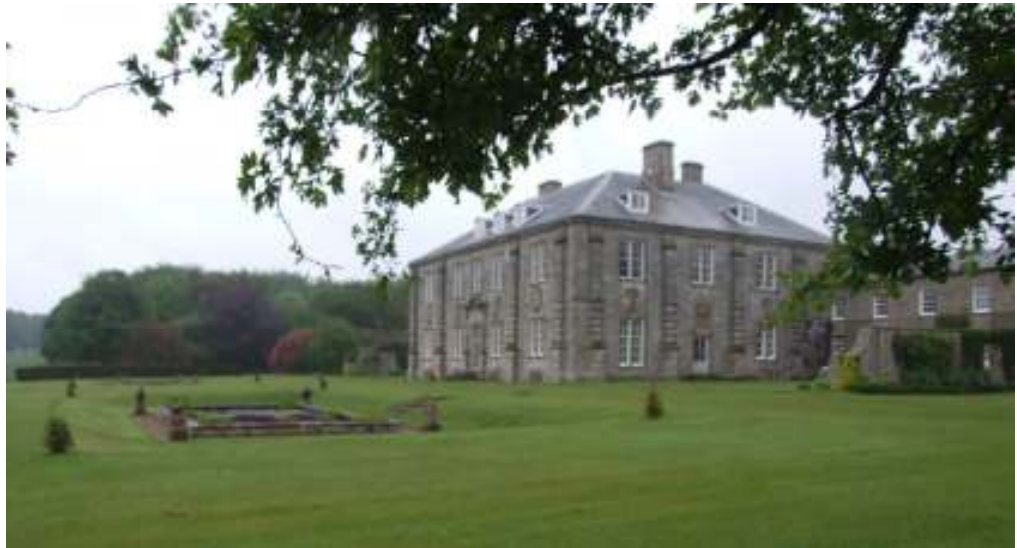
Plate 1: South-facing elevation of Capheaton Hall, from south-east (17th century part)

- 3.2.4 Much of the original 17th century detail survives (Plate 1), although the north side of the building has since been altered, and the two wings are mid 18th century additions. The watching brief monitored works undertaken within the eastern wing (Plate 2).

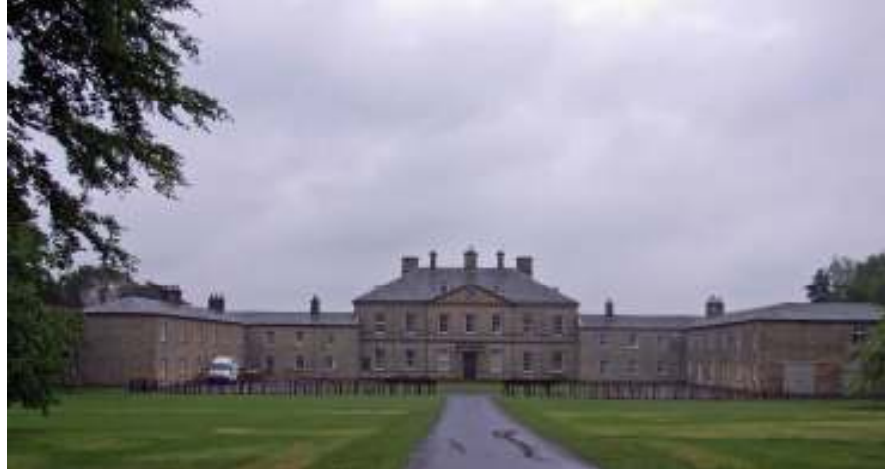
Plate 2: North-facing elevation of Capheaton Hall (eastern wing shown on left)

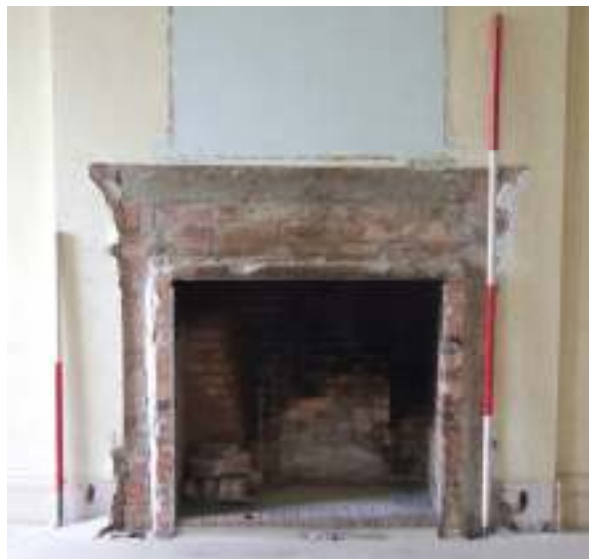
- 4.2.1 Several features, revealed during unmonitored initial developments within the eastern wing of Capheaton Hall, were recorded. This included a fireplace, which was exposed prior to later relocation, revealing some of the brickwork and fabric of the western wall within the present drawing room (Plate 3). Not much of the brickwork either side of the fireplace was exposed, but the height of the lintel, as well as the appearance of modern stretcher bricking between it and the present fireplace space, suggests a previously larger fireplace than was revealed at present.

Plate 3: Fireplace in western wall of present drawing room, facing west

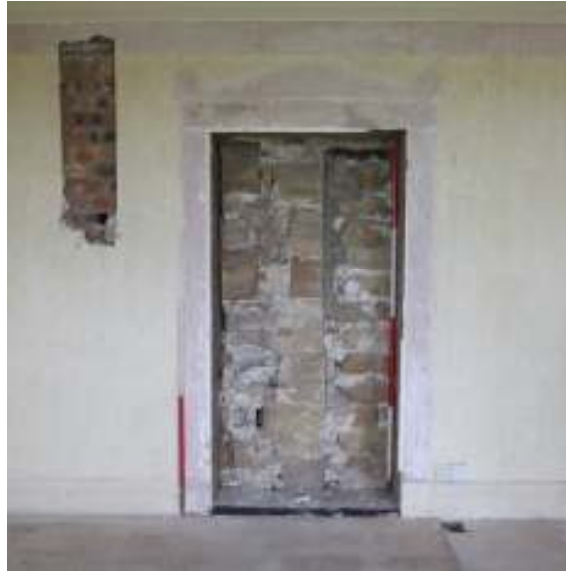
- 4.2.2 A blocked north-facing window within the northern wall of the drawing room had also been revealed, prior to reinstatement (Plate 4). This highlighted the difference between the blocking material of the window, which was lumps of sandstone with a pale cream mortar, and the fabric of the wall, revealed by a small exposed part of the wall to the west, which was brickwork.

Plate 4: Blocked window in north wall of present drawing room, facing north

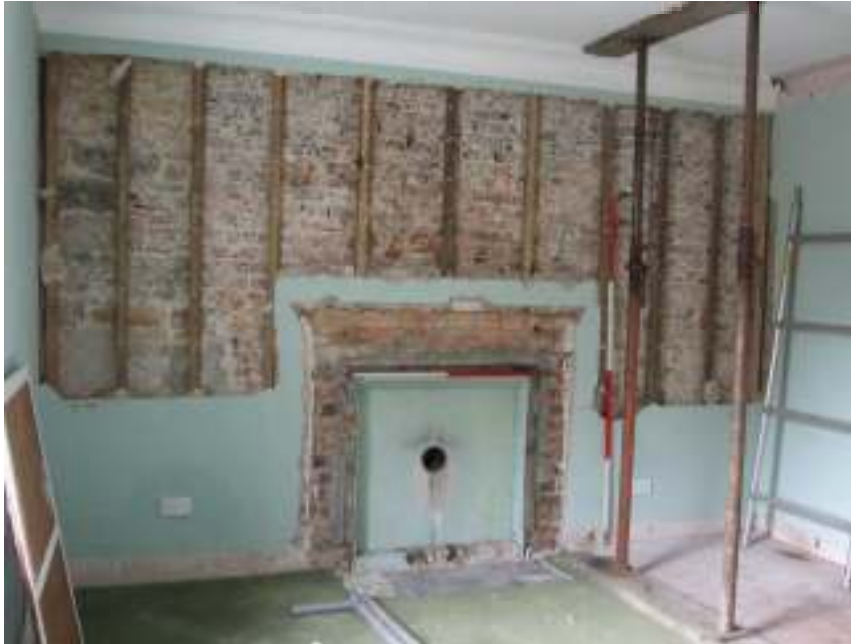
- 4.2.3 Also noted during the archaeological monitoring was a large part of the northern wall of the present sitting room, prior to the relocation of the fireplace once the internal walls have been removed (Plate 5). The fireplace, similar to that revealed in the drawing room, must once have been larger, indicated by the height of the lintel and the modern bricking below it. The bricks, revealed once the plasterboard had been removed, were of a pale pinkish hue with cream coloured mortar. They were set in English Garden Wall bond one and five. At the western edge of the elevation, sandstone blocks, seen on the outer elevations of the building, were revealed, indicating that this internal wall was part of the original plan of the building.

Plate 5: Northern wall of present sitting room, facing north

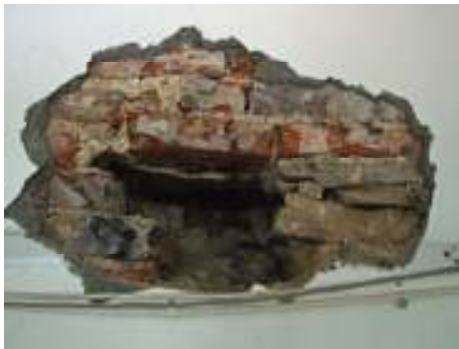
- 4.2.4 Developments within the eastern wing, monitored during Phase I of the watching brief condition, included the insertion of a hole, 0.2m by 0.2m, 2m above the floor level, in the west wall of the small room to the north of the lobby, due to be the doorway between a gentlemen's toilet and a gun room (Figure 2). This was for a new lintel to be put in for the new doorway relating to the new breezeblock wall being created to form these two rooms. The creation of this hole required the exposure of a section of the wall fabric, 0.55m wide by 0.38m high (Plate 6). It revealed a small section of haphazard brickwork and some small fragments.

Plate 6: Hole inserted in west wall of small room north of the lobby

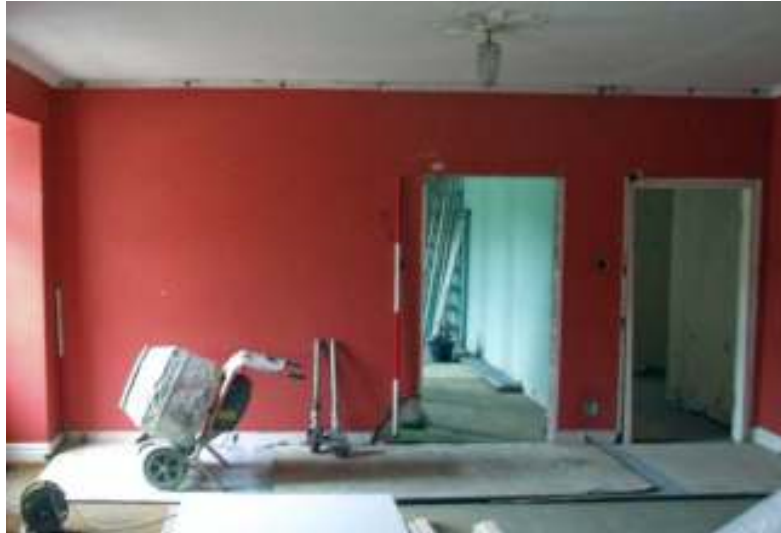
- 4.2.5 The main component of the monitoring involved the observation of the demolition of two internal walls, dividing the present sitting room from the present hall, to create a large hall space. The walls themselves are thought to have been constructed in 1965 by the father of the present owner, but their demolition had the potential to reveal architectural features, particularly where the walls meet the adjoining earlier walls (Plate 7).

Plate 7: Wall 1 (foreground) and Wall 2 (adjoining, centre) prior to demolition

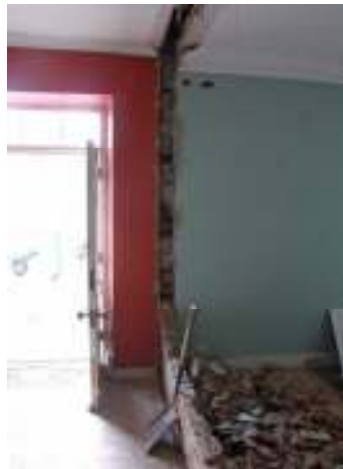
- 4.2.6 Walls 1 and 2 formed an L-Shaped dividing wall, creating a sitting room within the original larger hall room, due to be reinstated. The walls were removed by hand, using hand drills and mallets. They consisted of modern stretcher bricking, 0.22m in length, 0.075m in height and 0.11m in depth, each with a frog, inscribed 'Wylam'. No features were revealed within the walls themselves, although a 0.11m width of the west elevation of the main wall was revealed where it once met Wall 1 (Plate 8). A timber beam was observed at the top of this narrow area.

Plate 8: Section of western hall wall revealed after demolition of Wall 1

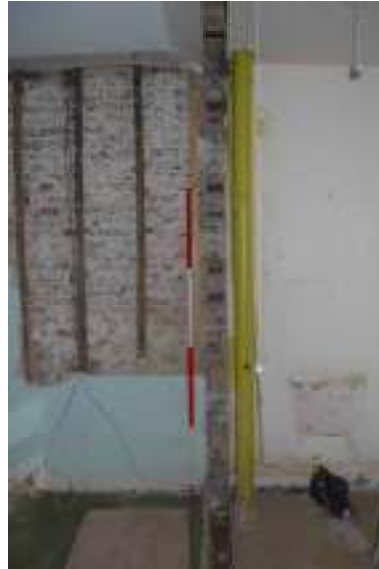
- 4.2.7 Similarly, after the removal of Wall 2, a strip of wall was revealed to the height of the room, and a width of 0.11m. This revealed a wall-structure made of brick (Plate 9). No discernable architectural features were observed.

Plate 9: Section of northern hall wall revealed after demolition of Wall 2

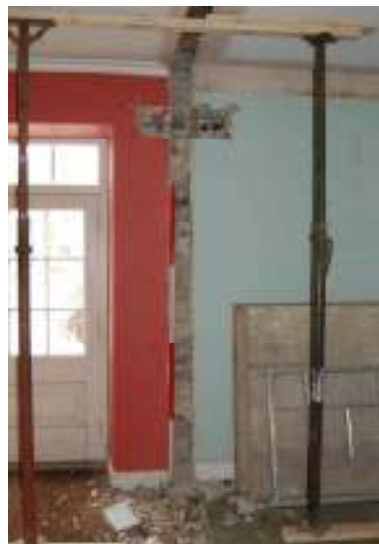
- 4.3.1 Phase II of the watching brief involved the monitoring of the insertion of two holes within the walls of the newly created hall space, previously the hall and sitting room, and the observation and recording of the creation of an alcove in the former fireplace in the kitchen. One hole was created in the western wall, where the former internal wall 1 met the external wall (Figure 3). The hole was 2.25m above floor level, of a width of 0.5m and a height of 0.33m. It revealed some of the brick structure of the wall (Plate 10).

Plate 10: Hole inserted in western hall wall

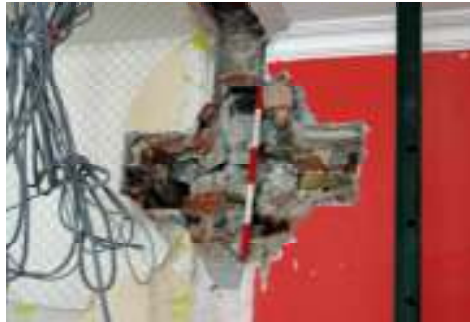
- 4.3.2 A second hole was inserted on the opposite hall wall, to create a space for a supporting steel girder to run the width of the enlarged hall space and to support the ceiling above. This second hole, was again created 2.25m above floor level, directly

opposite the first (Figure 3). It measured 0.5m in width, and in height and exposed the sandstone rubble structure of the wall (Plate 11).

Plate 11: Hole inserted in eastern hall wall

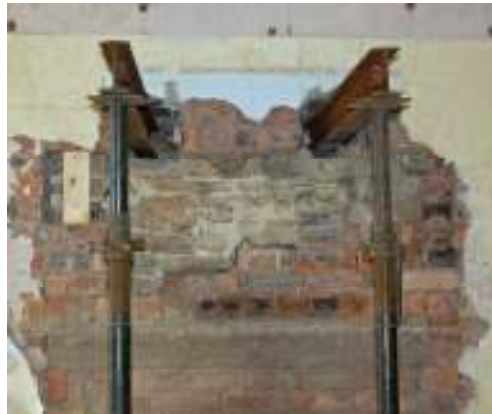
4.3.3 The last archaeological monitoring that was undertaken during the works at Capheaton Hall was the removal of bricks above the existing fireplace in the kitchen (Figure 3). This constituted the removal of the facing bricks to a depth of 0.48m to create an alcove as a setting for a modern aga to be part of the new kitchen. The existing bricks of the fireplace below are to be retained, and the space created, to be filled up with more bricks, to create a brick-faced alcove for aesthetic purposes. The removal of the bricks exposed sandstone rubble behind the bricks, forming the structure of the wall. Some courses of brick were revealed behind the facing bricks, above the concrete lintel of the existing fireplace, further indicating, as seen during the Phase I recording that alterations had been made to this fireplace area since the initial construction of the wall (Plate 12).

Plate 12: Mixture of brick and rubble revealed above fireplace in kitchen

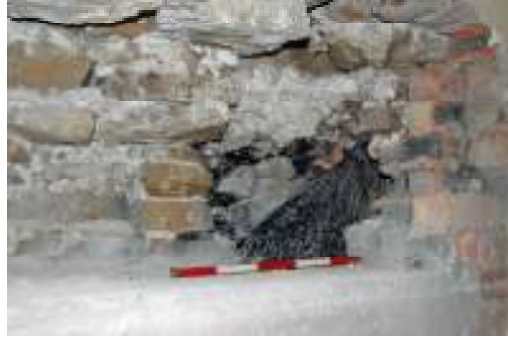
4.3.4 Further removal works revealed a slate-lined angled flue leading from the fireplace (Plates 13 and 14).

Plate 13: Slate-lined flue

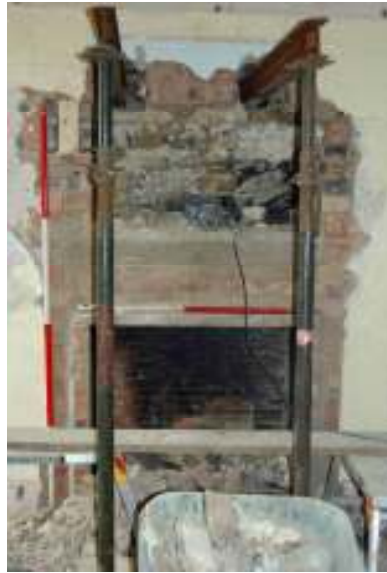
Plate 14: Finished fireplace

- 4.3.5 The works formally ended on 17th June 2008. The only further work due to be completed on the fireplace is the removal of the concrete lintel, after which the newly created alcove will be brick-faced.
