NORTH PENNINES ARCHAEOLOGY LTD

Project Designs and Client Reports No. CP 726/08

**FOR
JOMAST DEVELOPMENTS**

30th July 2008

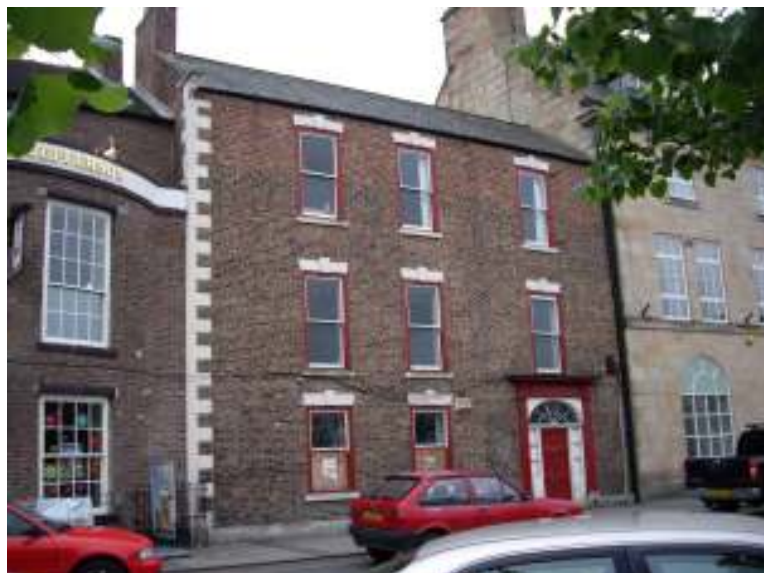
Plate 1: Northern elevation of No. 4 Market Place

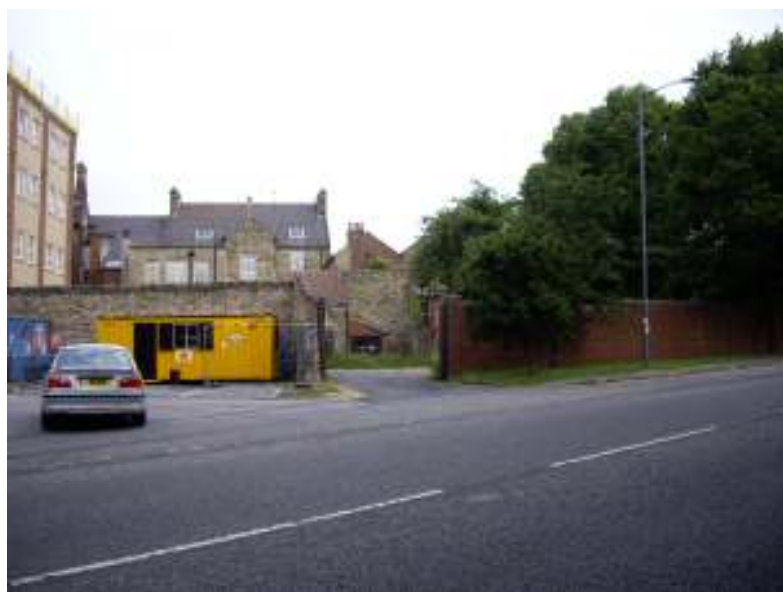
- 4.6.2 **Description:** the plot was accessed from Kingsway, a route installed sometime after the publication of the Fourth Edition Ordnance Survey Mapping of 1939 (Figure 7). This would explain the difference between the western boundary wall of the site, which is made of stone, and the southern boundary wall of the site, which is of modern red-brick construction (Plate 2). The access from Kingsway provides access into the far south-western corner of the proposed development site.

Plate 2: Entrance to land behind No. 4 Market Place, from the south

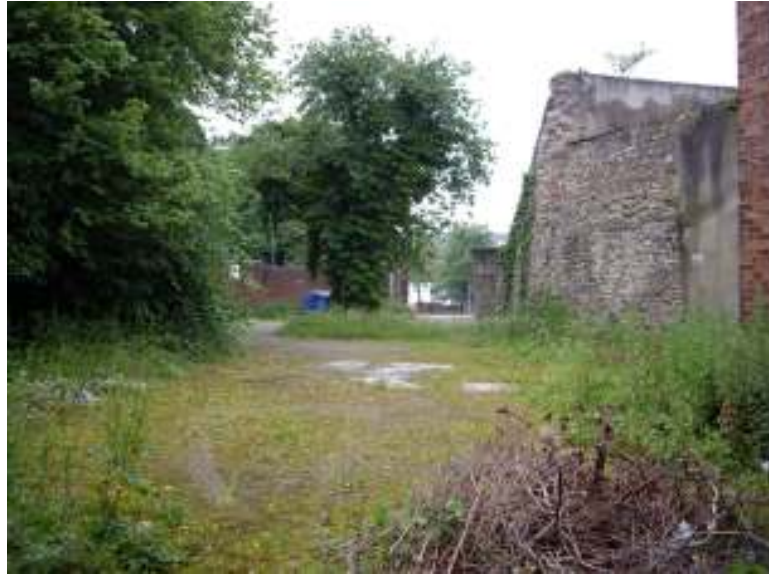
- 4.6.3 The majority of the land behind No. 4 Market Place consisted of tarmac surface, used previously for car parking, and gravelled areas, with overgrown shrubbery towards the north. Larger bushes and trees lined the eastern boundary, with a wall behind (Plate 3).

Plate 3: Tarmac and graveled area from the north

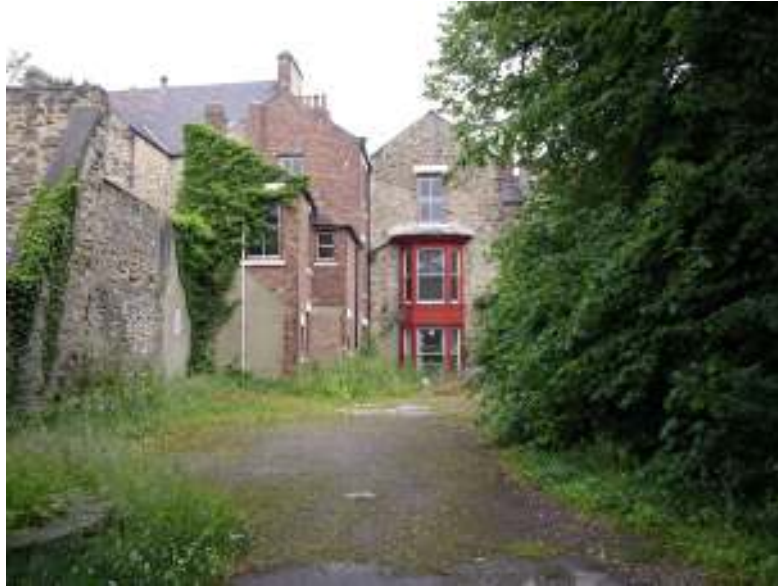
- 4.6.4 The back of the buildings fronting the Market Place showed evidence for a series of architectural alterations over the years, presumably relating to the desires of the different inhabitants throughout the building's 250 year lifespan (Plate 4). The eastern part of the building was stone-faced, with an extending two storey red-painted bay window. A diagonal line in the stonework towards the top of the building could indicate an extension of height, and this can be traced in the brickwork of the northern elevation (Plate 1). Listed Building information indicates that the building was raised in the mid 19th century. To the west of this was a series of two and three storey red-brick built structures, adjoining the stone-faced façade, and perhaps of a later date than the earlier mid-18th century construction, although their layout matches the building layouts shown on the First Edition Ordnance Survey Mapping of 1856 (Figure 4), showing that even the extensions are at least 150 years old. A blocked doorway on one of these structures shows the different alterations made in access over time. A roof-line revealed by a cement pattern on the southern elevation of the southernmost red-brick built structure, was evidence for a further structure, once in existence adjoining these structures, and may represent the small square shaped building shown on earlier Ordnance Survey Mapping (Figures 4-7) which show that this existed in 1939, so was demolished within the last 70 years.

Plate 4: Southern elevation of No. 4 Market Place

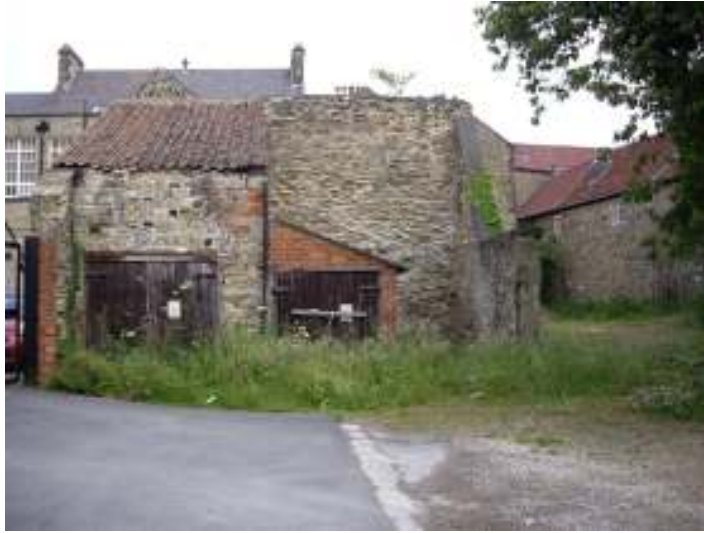
- 4.6.5 Beside the western boundary wall of the site, and close to the access into the adjacent property to the west, were outbuildings, due to be demolished by the proposed scheme. The stone-faced rectangular building on the west, with a south-facing sloping roof of red tiles is of an earlier construction, and its back wall matches that of the boundary wall in this part of the site (Plate 5). An extending section of stone wall, southwards to the same length as the western outbuilding is further suggestion, that the outbuilding was once twice the length as it is currently, and that the eastern half of the building has previously been demolished. Red-brick repair work on the outbuilding further evidences this potential, as does early Ordnance Survey Mapping, which indicates a change from a rectangular building at this location from at least 1856 (Figure 4) and 1919 (Figure 6), shortened into a square outbuilding by 1939 (Figure 7). The adjoining smaller red-brick outhouse on the east is of more recent construction. The fact that the western outbuilding matches the height of the boundary wall, and is of the same fabric, which also appears to be of matching fabric to the eastern part of the southern elevation of No. 4 Market Place, might be indicative of a similar date, which could mean it is of mid-18th century construction.

Plate 5: Outbuildings at western boundary of site

- 4.7.2 The existing outbuildings, described in *Paragraph 4.6.5* and shown in Plate 5 are due to be demolished. In their place, and extending eastwards and northwards to meet the brick-built structures of No. 4 three new dwellings are proposed. This would require the excavation of foundation trenches, which have the potential to impact upon sub-surface features within this part of the site. It is known from early Ordnance Survey Mapping (Figures 5-7) that a further rectangular outbuilding once existed within the proposed development site, in the area due to be affected by the new dwellings, on a roughly north-south alignment, so traces of this building may still survive sub-surface. In addition, other, as-yet unknown, features may survive in the area.

- 5.2.1 A building recording may be required for the outbuilding and boundary wall, due to be adversely affected by the development. Further recording of this type may show that these structures relate to the Grade II mid 18th century No. 4 Market Place house.
- 5.2.2 As foundation trenches and services are due to be excavated within the site as part of the proposed development, it is further recommended that a scheme of trial trenching is undertaken, in the areas due to be affected, to test the potential for medieval deposits relating to the early history of Bishop Auckland, and also to
