NORTH PENNINES ARCHAEOLOGY LTD

Client Report No. CP/604/08

REPORT ON AN
ARCHAEOLOGICAL
BUILDING RECORDING
PROJECT AT
THE WAGON AND
HORSES,
ST GEORGE'S QUAY,
LANCASTER

FOR
Manning Elliott and Frederic
Robinson Ltd

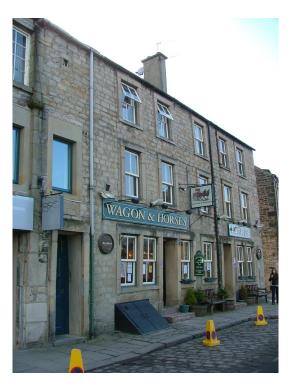
Plate 8 – View of north-east elevation facing St George Quay, the doorway to left of photograph does not provide access into any part of the Wagon and Horses; however it clearly formed part of the original building as shown by the stonework

- On the main north-east elevation which faces the River Lune is was observed that there is a doorway to the left of the Wagon and Horses which does not provide access into the property, however it was clearly constructed at the same time as there is no evidence for a vertical construction break. This doorway with window above appears to provide access to the warehouse to the rear, however as this does not form part of the present survey this could not be substantiated. The property to the left of this doorway (presumably No.26) is set back from the main elevation of the Wagon and Horses suggesting that it may have been constructed at a different time (Plate 67).

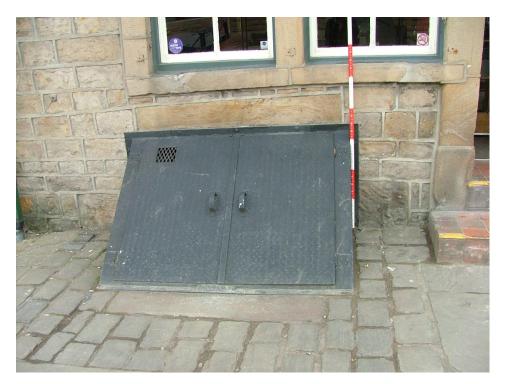
Plate 12 – Barrel-drop, north-east elevation (Scale is in 20cm graduations)

- 5.2.3 In the main north-east facing elevation there are two doorways, accessed up one step, set in plain, projecting stone surrounds, along with two sets of paired windows at ground level with plain mullions (Plate 8 and Figure 11). In between the two doorways are a further two single windows, one of which appears to have formerly been a doorway (Plate 10), however, there was no internal evidence for where this doorway may have led, it is possible it was for a -ginnelø or lane between the two original houses, although the maps consulted during the rapid desk-based assessment do not appear to show such features. At first and second floor level there are five windows in plain, projecting surrounds. All the windows are top-hung casements imitating 4-pane sashes (Plate 11). At ground level there is a modern, metal door which allows barrels to be transferred to the cellar; this is presumably in the same location as an earlier example of barrel-drop (Plate 12). To the right of the second doorway into the pub (northernmost), is a small wooden door which presumably allowed for the transference of coal or other commodities into the cellar (Plate 13).

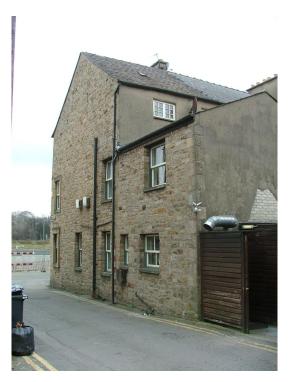
Plate 14 – View looking east of the north-west elevation of the Wagon and Horses which faces Reynolds Street (Scale = 2m)

- 5.2.4 The northowest elevation of the Wagon and Horses faces onto Reynolds Street. This elevation consists of the 3-storey gable of the main building, and a 2-storey extension to the rear (Plate 14 and Figure 12). There are three ground-floor windows in the main gable, and two first floor windows, whilst in the extension there are two smaller windows at ground level, and one at first-floor level (Plate 14). It is interesting to note that only two of the windows in this elevation have the projecting surrounds already noted on the north-east elevation, this may be either because the other windows are later insertions, or there was no need to have, what is essentially an architectural feature, around windows which could not easily been seen from the main road. There was no vertical construction break observed between the main gable and the extension suggesting that either the extension is contemporary with the main building, of this whole wall has been rebuilt. The evidence for some rebuilding can be observed in the south-west elevation of the extension as some of the render has fallen off to expose modern grey brick (Plate 14). From this evidence it would therefore appear that the whole of the north-west wall has been rebuilt.

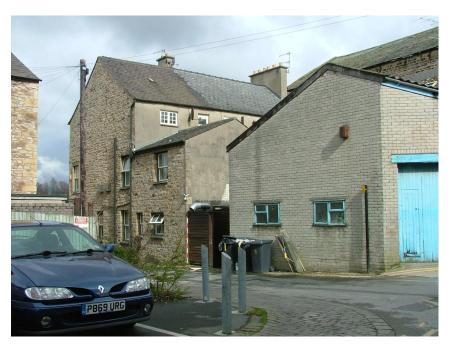
Plate 15 – View looking east of the north-west and south-west elevations. The garage/workshop to right of photograph was demolished as part of the renovation work (Scale = 2m)

- 5.2.5 The rear (south-west) elevation of the Wagon and Horses was difficult to photograph due to the presence of a modern brick-built garage/workshop, which has been demolished as part of the renovation work (Plate 15). Against the south-west elevation of the main 3-storey building is a single-storey extension with flat roof which houses the toilets (this has also since been demolished). From what could be observed of the south-west elevation, it was noted that there are three modern windows at first floor level (one of which is hidden by the fire escape stairs), and at second floor level there are four windows of varying sizes, all with modern frames, and a modern fire escape door (Plates 16 and 17 and Figure 13). Due to the presence of render it was not possible to note any possible earlier windows which may have been blocked.

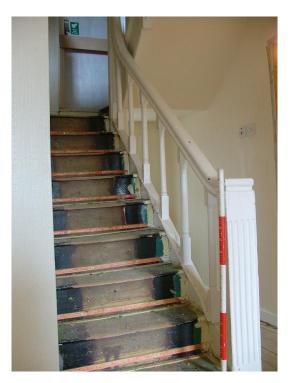
Plate 26 – Detail of 18th century staircase with turned balusters and decorative newel post (Scale is in 20cm graduations)

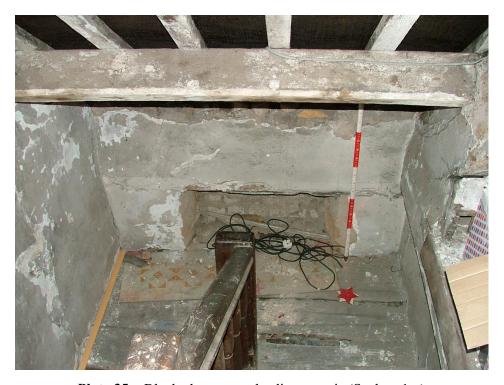
Plate 35 – Blocked aperture, landing to attic (Scale = 1m)

- 5.2.11 At the top of the landing to the attic, where the dog-leg of the staircase turns, there is a blocked aperture located level with the floor (Plate 35). This was presumably a small window which lit the staircase to the attic, although it could not be observed externally due to modern render. The attic space is divided into three bays by two timber-framed walls with wattle and daub infill (Plate 36). The wattle of this infill could be observed in the eaves (Plate 37). The northernmost of the cross-walls has two brick-built chimney stacks against its south side, providing evidence for the location of fireplaces on the floors below (Plate 38). It is clear from the presence of a chimney stack on the southwest side of the wall that fireplaces are missing from the rooms below: where the bathroom is located in the managerøs flat, where the communal bathroom is located on the first floor, and in the bar area on the ground floor. The two chimney stacks are effectively free-standing as they do not appear to have been bonded to the wattle and

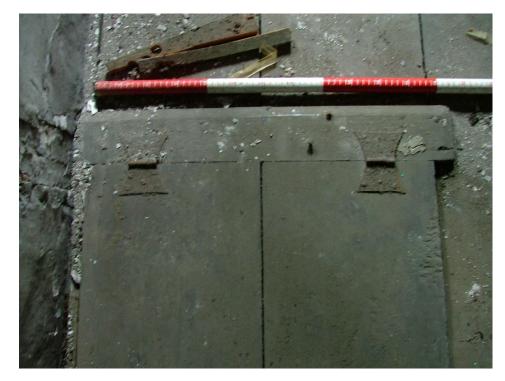
Plate 40 – Detail of the butterfly hinges, wooden hatch in attic floor (Scale is in 20cm graduations)

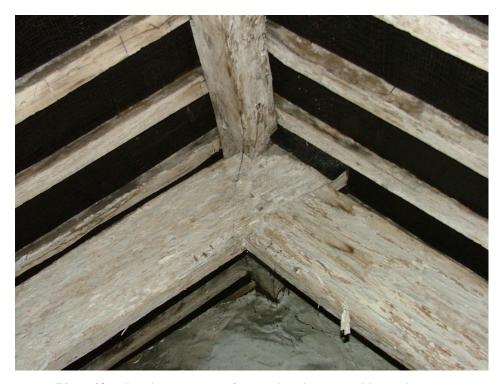
Plate 43 – Southernmost roof truss showing assembly marks $\pm III \phi$

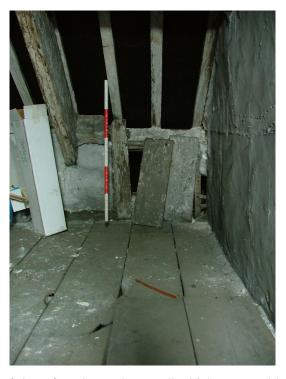
Plate 44 - The base of the rafters has a short wall which presumably preventing the wind blowing into the attic (Scale = 1 m)

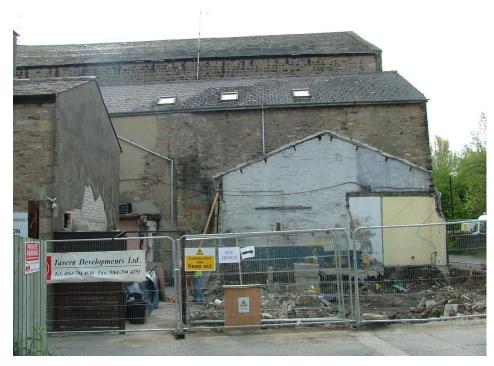
Plate 46 – View looking south-east of the rear of the Wagon and Horses after the demolition of the modern garage/workshop showing the scarring of the gable against the adjoining former warehouse

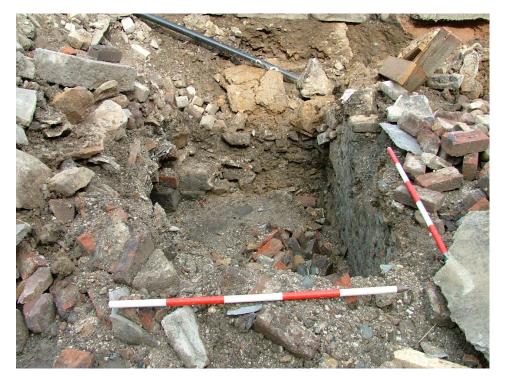
Plate 47 – Excavated area to the rear of the Wagon and Horses revealed cobbled surface and brick walls, possibly relating to a cellar of earlier building (Scales = 1m each)

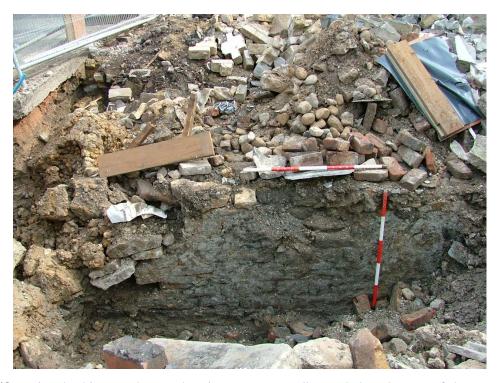
Plate $48 - \text{View looking north-east showing masonry wall revealed to the rear of the Wagon and Horses (Scales = 1m)$

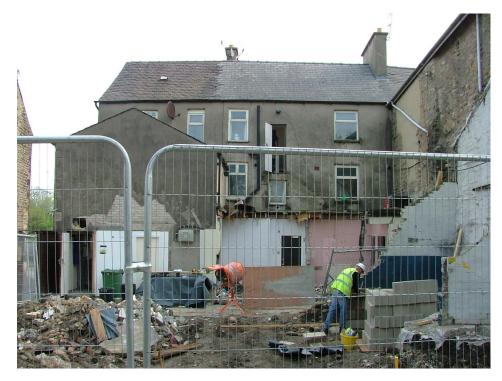
Plate 49 – View looking north-east of the rear of the Wagon and Horses after the removal of the garage/workshop and the single-storey extension

- 5.3.3 Most of the single-storey extension which housed the ladies and gentos toilets was demolished, although the corridor to the cellar remained, consequently the works did not allow for the original back wall of the property to be examined for blocked windows or doorways (Plate 49).

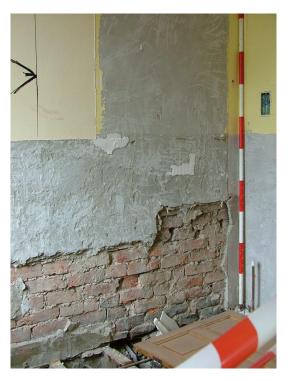
Plate 50 – Brick wall which separated the communal bathroom and the corridor, first floor (Scale is in 20cm graduations)

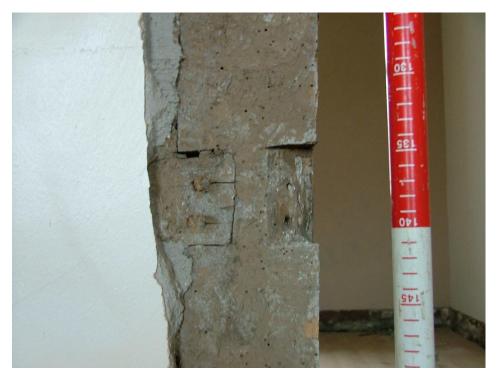
Plate 51 – Notch in left-hand timber of door surround, Bedroom 1, second floor (Scale is in 1cm graduations)

- 5.3.6 It was noted that the doorway in the wall which separates Bedrooms 1 and 2 on the second floor does not appear to be in its original position (Figure 17). This is shown by a redundant notch in the left-hand timber which would originally have held a horizontal timber (Plate 51). It would appear that the original door into this room was opposite the stairs to the attic, this is suggested by the presence of a lathe and plaster infill of wall in this location (Plate 52).

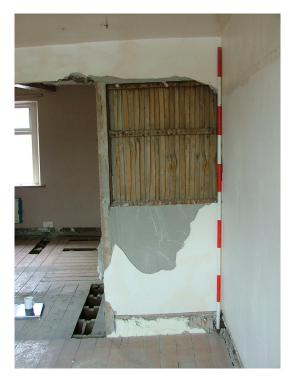
Plate 52 – Lathe and plaster section of wall between Bedroom 1 and the hall, second floor, this appears to have been inserted in the original location of the door into the room (Scale = 2m)

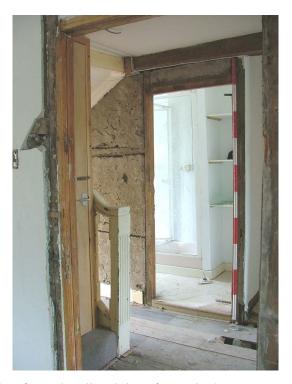
Plate 53 – Original timber-framed wall and door frame, bathroom on second floor (Scale = 2m)

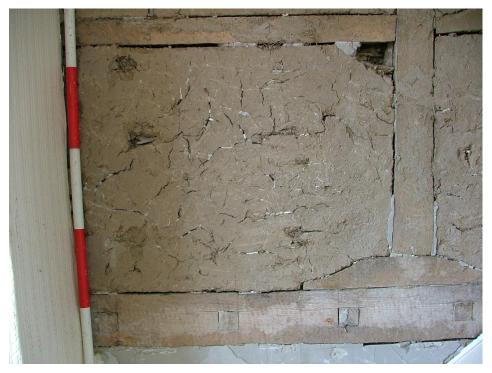
Plate 55- Base of timber-framed wall showing detail of construction (Scale is in 20cm graduations)

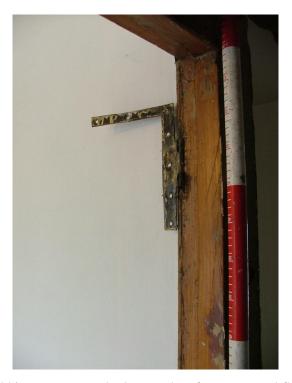
Plate 56 – L-shaped hinge *in-situ* on bathroom doorframe, second floor (Scale is in 1cm graduations)

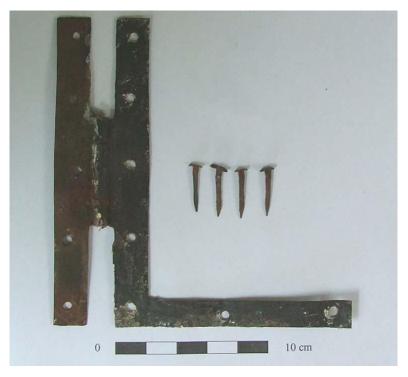
Plate 57 – One of the L-shaped hinges and associated nails removed from the bathroom door, second floor

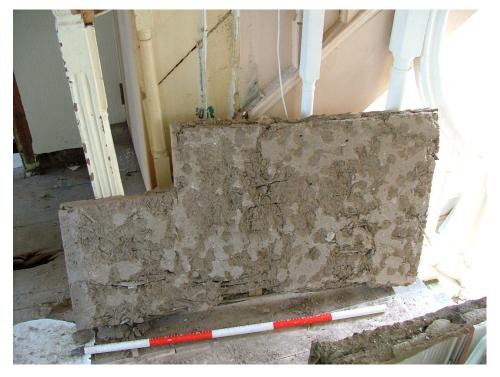
Plate 58 – The removed wattle and daub panel, the corner was removed to allow for analysis of construction method (Scale = 1m)

- One of the wattle and daub panels was removed whilst the attendant archaeologist was on site so information could be gleaned as to how the wall was constructed. The panel that was removed measured c.118cm in length, 60cm wide and 7cm thick (Plate 58). The horizontal timber on which this panel was supported was also removed, and it was found that the bottom side of this timber had four holes which held vertical wooden staves that were located within the wattle and daub panel below. The top of this timber section had a groove into which the vertical stakes of the panel above rested (Plates 59 and 60). To either side of the wattle and daub panel, one fixed to the door frame and the other to the vertical timber to the left, were curved pieces of wood which presumably prevented the wattle and daub panel from moving.

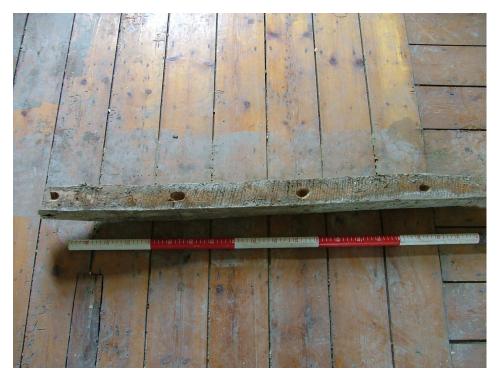
Plate 59 – Underside of one of the horizontal timbers removed from the timber-framed wall, second floor (Scale = 1m)

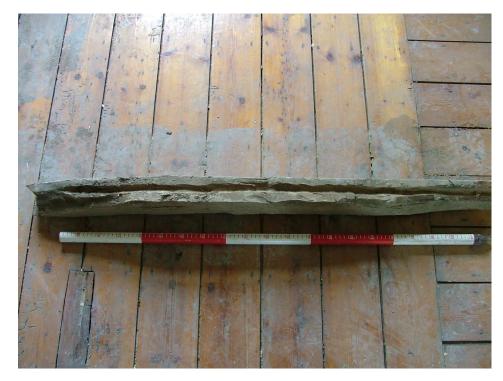
Plate 60 – Top side (showing shallow groove) of horizontal timber removed from timber-framed wall, second floor (Scale = 1m)

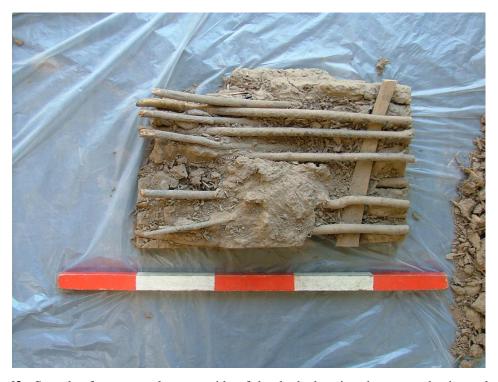
Plate 63 – Sample after removal on one side of the daub showing the woven horizontal sticks around one of the vertical staves (Scale = 50cm)

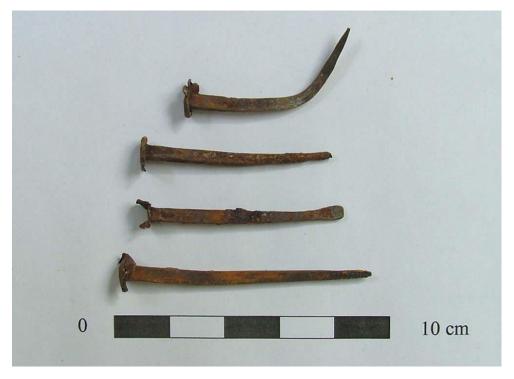
Plate 64 – Four nails retrieved from the timber-framed wall (Context 103), second floor

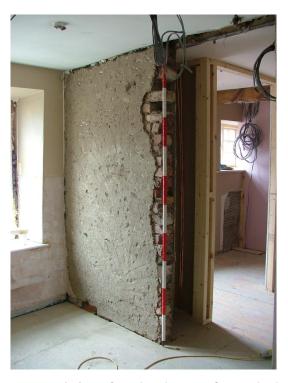
Plate 65 − Layer of ÷plasterøconsisting of mud and straw, former bathroom wall, second floor (Scale = 2m)

- 5.3.12 Following the removal of tiles from the former bathroom wall on the second floor, a layer of ÷plasterø was revealed on the brick wall consisting of mud and straw (Context 104). This was quite different from any other coverings observed elsewhere in the property (Plate 65). It is interesting to note that this ÷plasterø was located immediately behind the modern tiling with little evidence of it having had several phases of tiles or wall coverings adhered to it. This layer of plaster covers one side of an internal wall which consists of bricks measuring *c*.11cm in width, 8cm thick and 22cm in length.

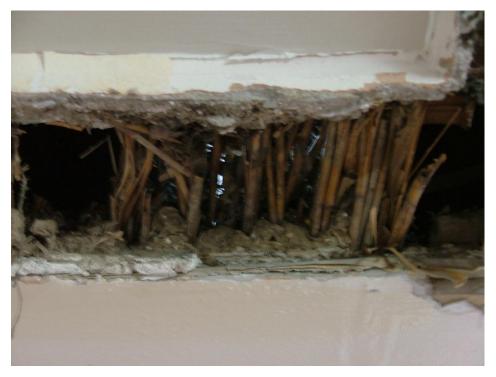
Plate 66 – Layer of dried reed stalks within ceiling between Bedroom 1 and the hall on the second floor

- 5.3.13 Where the door frame between Bedroom 1 and the hall on the second floor had been removed, it was noted that within the cavity between the ceiling and the floor of the attic, there was a layer of what appeared to be dried reed stalks (Context 105) (Plate 66). This possibly acted as a form of insulation, although it is not known if this was an original feature. The use of common reed (*phragmites australis*) in building has been noted elsewhere, for example in the Doncaster area where it has been recorded in a range of high and low status buildings dating from the 16th to the 19th century, commonly as a keying agent for internal plaster walls, plaster ceilings and screed (gypsum) floors, probably as an alternative to wooden laths. The thermal insulation properties of the hollow steams, however, may also have been appreciated²⁰. A sample of the reed was retained for analysis, the results of which will be included within an addendum to this report.

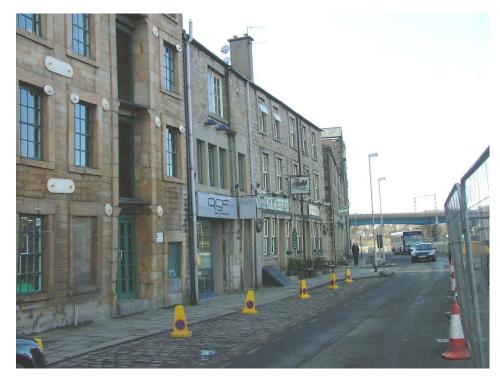
Plate 67 – View looking north-west along St Georgeøs Quay. The property with the signage -qsfø is set back slightly from the Wagon and Horses. The doorway with window above, located between -qsfø and the Wagon and Horses, presumably provided access to the warehouse to the rear
