# **NORTH PENNINES ARCHAEOLOGY LTD**

**Client Report No. CP 774/08**

**REPORT ON AN  
ARCHAEOLOGICAL  
EVALUATION AT  
EAST HOUSE, MAIN  
STREET,  
CORBRIDGE,  
NORTHUMBERLAND

**NGR NY 9908 6435**

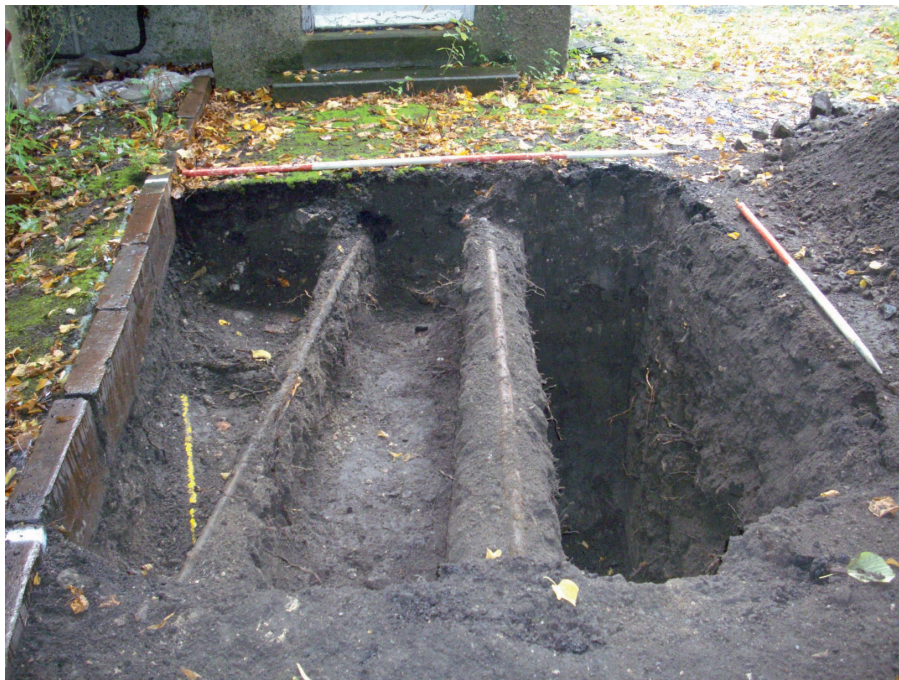
*Plate 1: trench 1 looking west towards the modern porch.*

- 4.2.1 Trench 1, measuring 2m by 2m, was located 0.86m to the north of East House, 1.44m east of the modern porch extension. The trench was located in this area to evaluate the potential archaeological remains within the proposed new residential extension. The precise location of the trench can be seen on Figure 3, and on Plate 1.
- 4.2.2 A section of Trench 1 can be seen on Figure 4, demonstrating the deep stratigraphy north of East House, as well as the depths of services, both live and dead in this area.
- 4.2.3 The excavation of the trench revealed the natural substrate to be sand (**101**), which was located at 38.29m OD, 1.43m below the current ground surface. Above the natural

substrate was a layer of dark brown friable sandy clay subsoil (**105**), measuring an average of 0.68m thick. Over this was a c.0.67m thick deposit of dark brown sandy clay topsoil (**104**) with heavy root activity which also contained a small amount of post-medieval pottery (see Section 5) as well as a number of services with no visible cut (see 4.2.4). The modern tarmac surface (**100**) covered this topsoil strata across the extent of the trench to a varying depth averaging at 0.08m thick.

- 4.2.4 Excavation through topsoil (**104**) and extensive CAT scanning revealed the location of a live mains electricity cable and three potentially live gas pipes. The location and orientation of these services are illustrated in Figure 4. The old gas pipes (**102**) lay at c.39.63m OD (0.22m below the current surface) and the modern PVC gas pipe (**103**) at 39.43m OD (0.45m below the current surface). The electricity cable was roughly located in plan, but as it was just outside the trenched area, the depth remains unknown. Due to health and safety issues, the trench was not excavated beneath the service pipes and cables.
- 4.2.5 The trench did not reveal any archaeological features or deposits within the extents of the excavation.

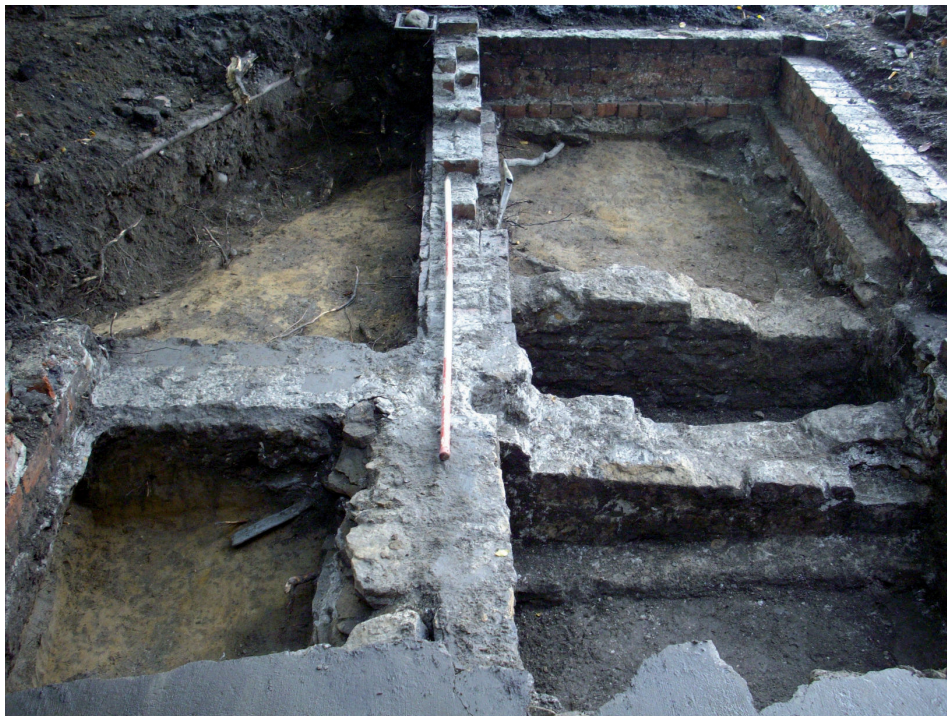
*Plate 2: trench 2 looking east.*

- 4.3.1 Trench 2, measuring 4m by 4m, was located 1.86m to the east of East House. The trench was located in this area to evaluate the potential archaeological remains within the proposed new garage extension. The precise location of the trench can be seen on Figure 3.
- 4.3.2 Before the trench could be excavated, the concrete footing for a modern building had to be removed by the mechanical excavator. This concrete footing (**100**) was up to

0.20m thick and was bounded by tarmac. This marked a potentially recent demolition within the area to be evaluated: mapping data provided by the client compared to data present in NPA archives from 2007 showed the presence of three outbuildings within the proposed extension area, presumably demolished prior to the current client gaining ownership of the property. The location of the outbuildings can be seen in Figure 6.

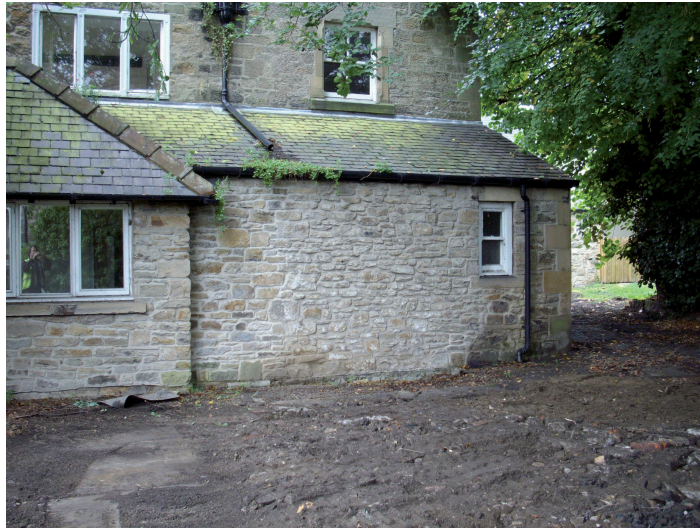
*Plate 3: east-facing wall of East House, showing repairs to sandstone wall after demolition of modern outbuildings.*

- 4.3.3 The outbuildings also left their mark on the stonework of the east-facing wall of East House, as seen in Plate 3 below. The brick foundations of the outer walls of these outbuildings can clearly still be seen butting up against the base of the wall.

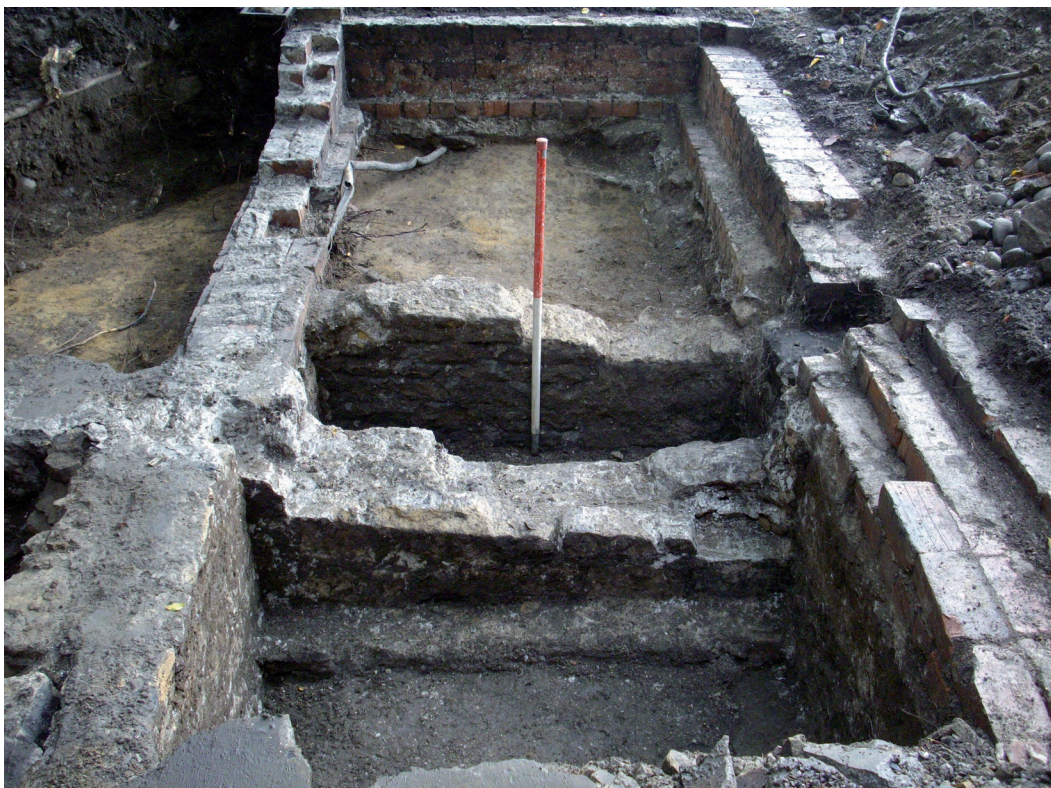
*Plate 5: graded scale on wall (110), looking east.*

- 4.3.5 Natural sand (**101**) lay at 39.07m OD, c.0.74m below the current ground surface at its highest point.
- 4.3.6 The south-eastern segment of the trench was bounded by a modern brick foundation (wall (**107/121/122**) up to four courses high (highest point at 39.62m OD), two running east-west and one north-south. These can be interpreted as the base of the modern foundations to the outbuildings seen in the mapping data from 2007 (Figure 6). These walls were built on a thin brick and stone rubble deposit (**120**) which was visible beneath the east and south walls. The southern-bounding brick wall (**116**) continued west along the extent of the trench, disappearing into the east-facing section though surface trace could plot the wall to butting against East House. A lead water pipe was also located running beneath this structure, running from beneath wall (**122**) north-west beneath wall (**107**). This is visible in Plate 5.

- 4.3.8 A roughly dressed and mortared sandstone wall (**110**), orientated north-south divided the trench roughly mid-way and stood to at least 0.54m and 0.36m in width, with its full depth on its western face not being encountered during the course of the evaluation. Between wall (**110**) and wall (**111**) (detailed above in 4.3.7) was a narrow slot, 0.27m in width and 1.44m in length, filled with sandy brown soil and a heavy concentration of river cobbles (**109**). This can be interpreted as a potential drain to take water away from the eastern edge of the potential cellared area. Plate 5 demonstrates the relationship between the potential cellar and the slot (**109**).
