NORTH PENNINES ARCHAEOLOGY LTD

Client Report No. CP/742/08

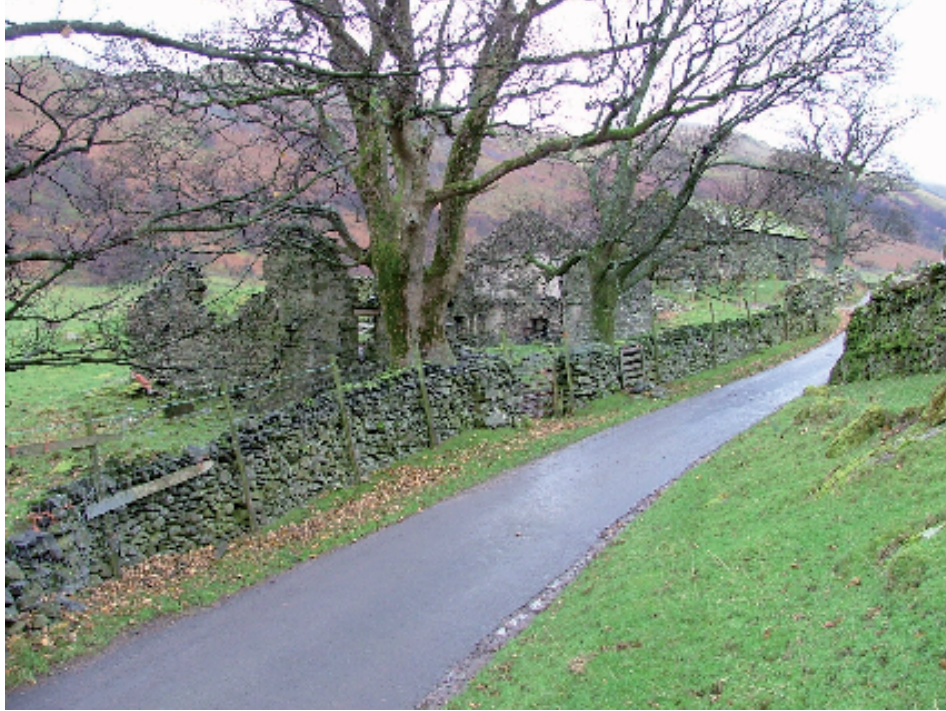
Plate 1 – View looking south showing the ruined house at Hen Howe with the barn in the background

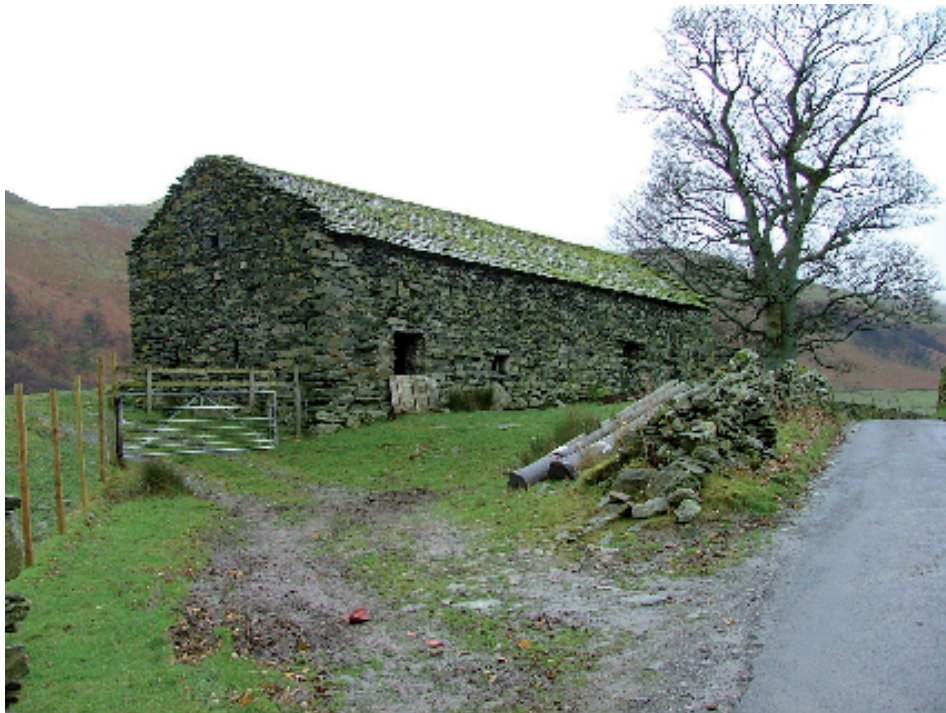
Plate 2 – View looking south showing the barn at Hen Howe

- 5.2.1 Hen Howe is a partly ruined house located on the east side of the single-track road which runs from Howtown to the north, towards Dale Head to the south (Plate 1). To the south of the ruined house is a barn which is in a good state of repair and is still utilised for agricultural purposes (Plate 2). The ground to the east of the property is undulating grassland towards the Howe Grain (Plate 3), whilst to the west on the opposite side of the road, the ground level rises steeply towards Raven Crag. It was possible to observe in the field on the opposite side of the road to Hen Howe, shallow linear earthworks characteristic of ridge and furrow (as already noted on modern satellite mapping) (Plate 4).

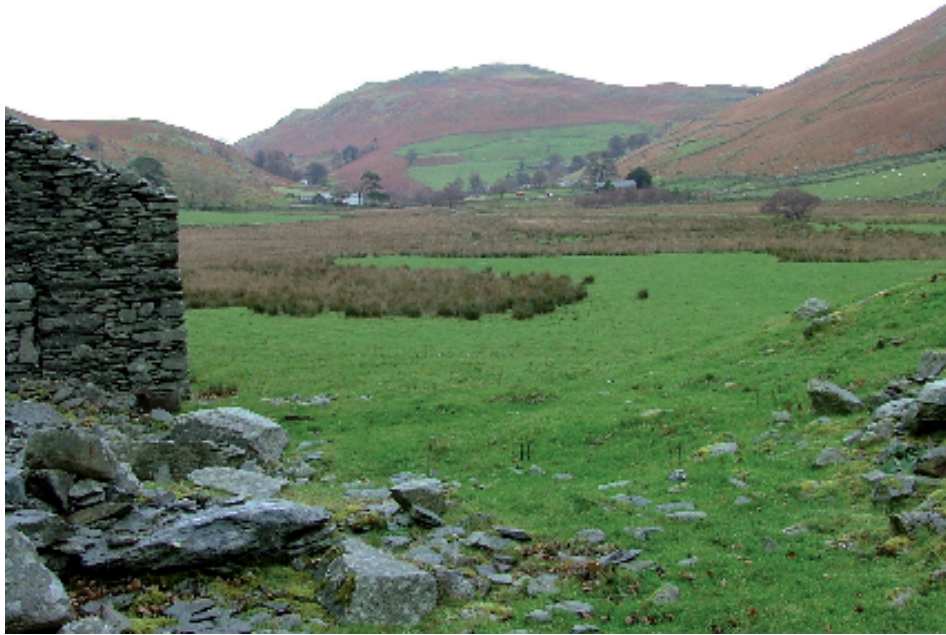
Plate 3 – View looking north showing the grassland to the east of Hen Howe

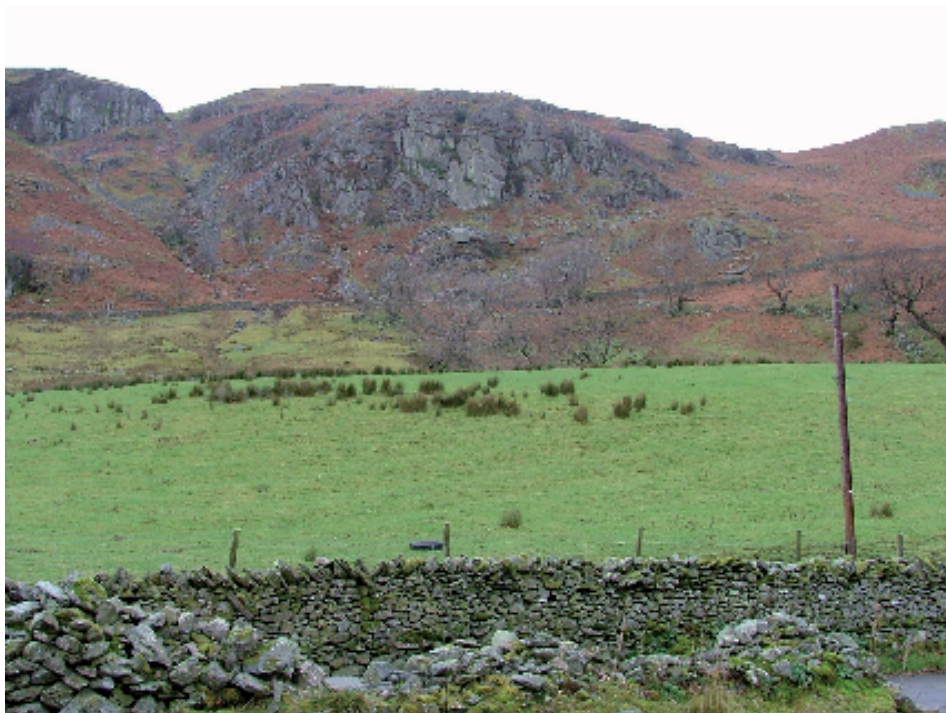
Plate 4 – The field opposite Hen Howe with Raven Crag in the background. Note the shallow earthworks of ridge and furrow in the foreground

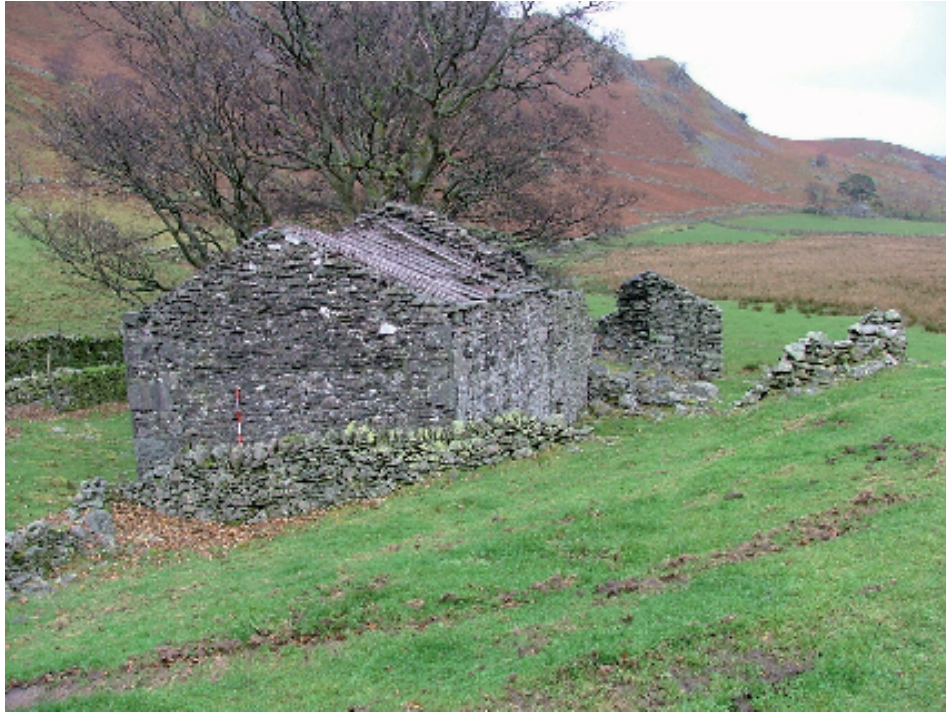
Plate 5 – View looking north showing the intact byre/stable at south end of Hen Howe

- 5.2.2 The former house at Hen Howe is constructed of rubble masonry, is two-storeys in height and single-pile in plan (i.e. one room deep). At the south end of the building a byre or stable survives relatively intact, although it has lost its roof (Plates 5 and 6). It is suggested that this was a byre or stable (or even a loose box) due to the lack of windows, the presence of a ventilation slit in the east wall, the pitching door at first floor level over the main entrance for transferring hay to the loft and the niche in the internal west wall, close to the doorway, which would have held a candle or oil light. The central portion of the property is now largely gone apart from a section of the rear (east) wall which has a window or low doorway at ground level and a small blocked window at first floor level (Plate 7).

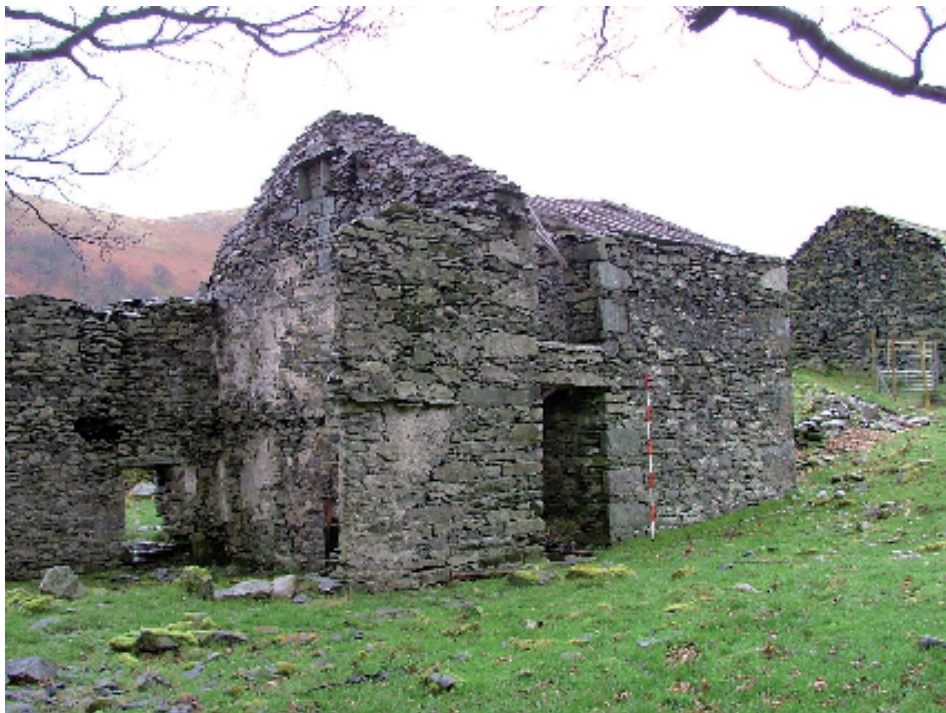
Plate 6 – View looking south-east showing the intact byre/stable at south end of the ruined house (Scale = 2m)

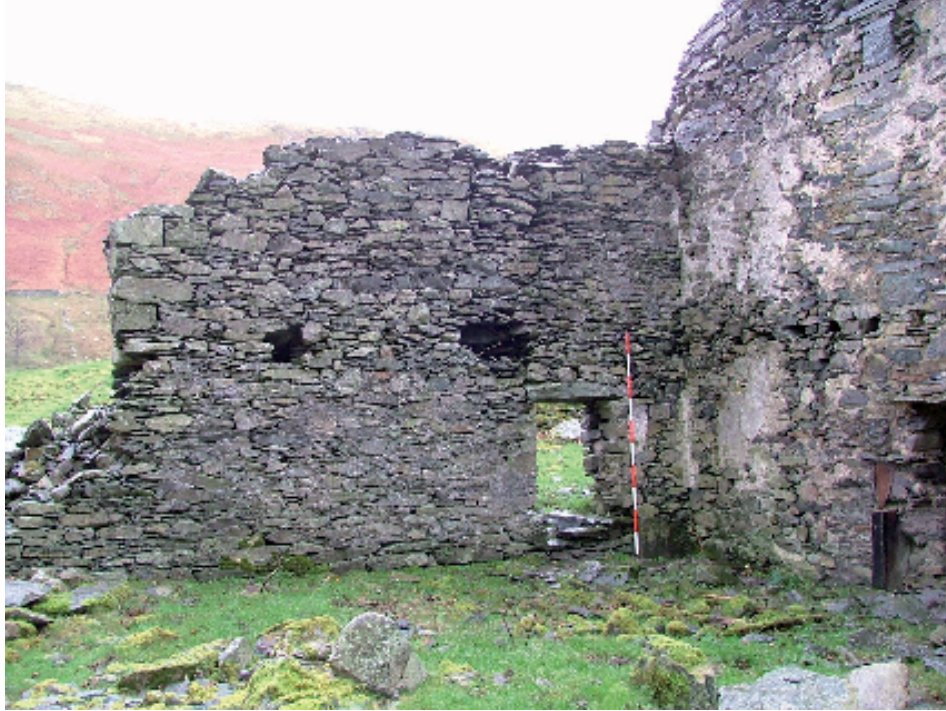
Plate 7 – View looking east of surviving section of house wall with window/low door, blocked first floor window and two large holes for former beams (Scale = 2m)

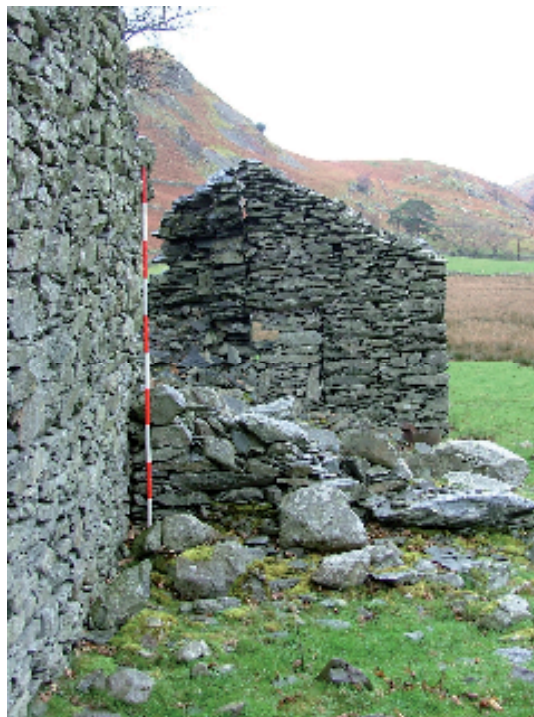
Plate 8 – View looking north showing the possible remains of a semi-circular outshut to rear (east) side to house staircase (Scale = 2m)

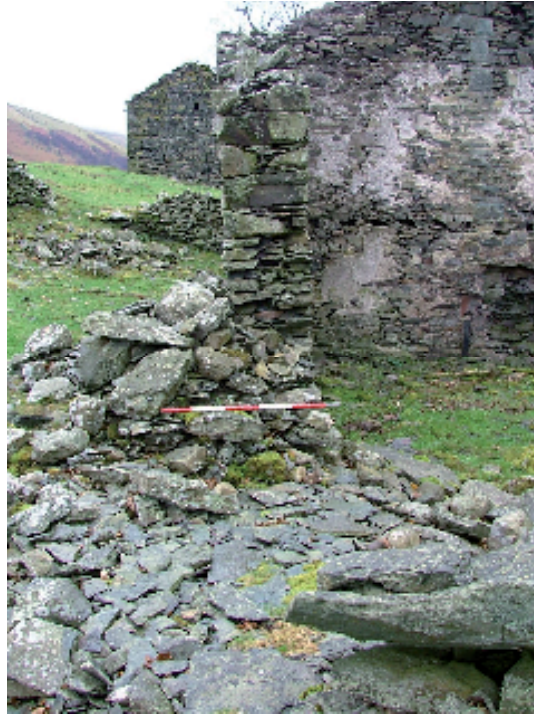
Plate 9 – View looking south showing possible location of former staircase and detail of drystone wall construction (Scale = 1m)

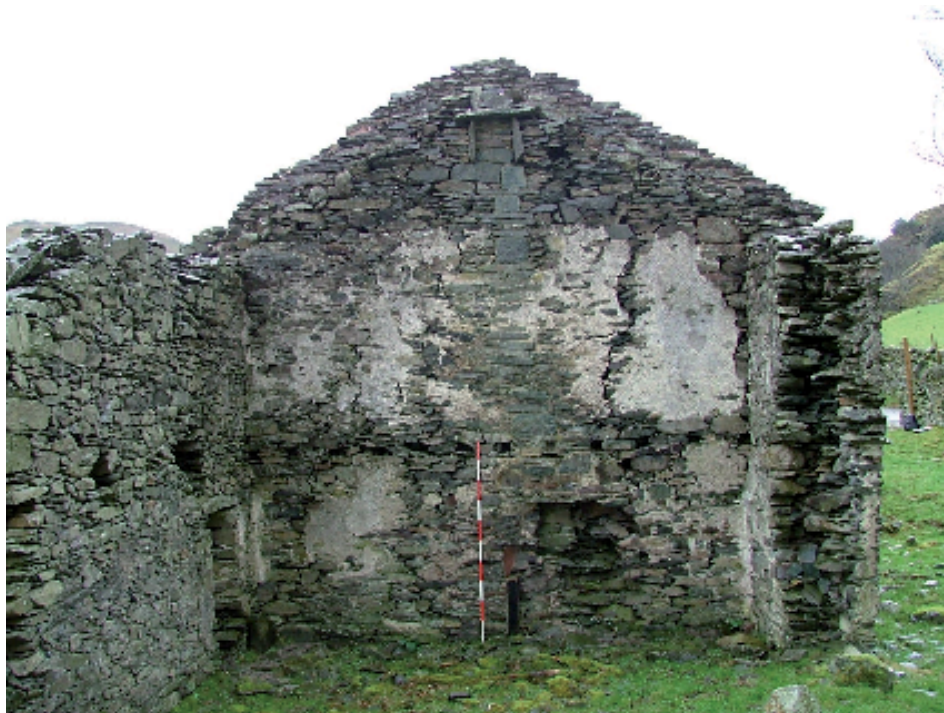
Plate 10 – View looking south of the south gable of house showing remains of fireplace at ground level, joist holes for former first floor, areas of mortared wall and support for the chimney at apex of gable (Scale = 2m)

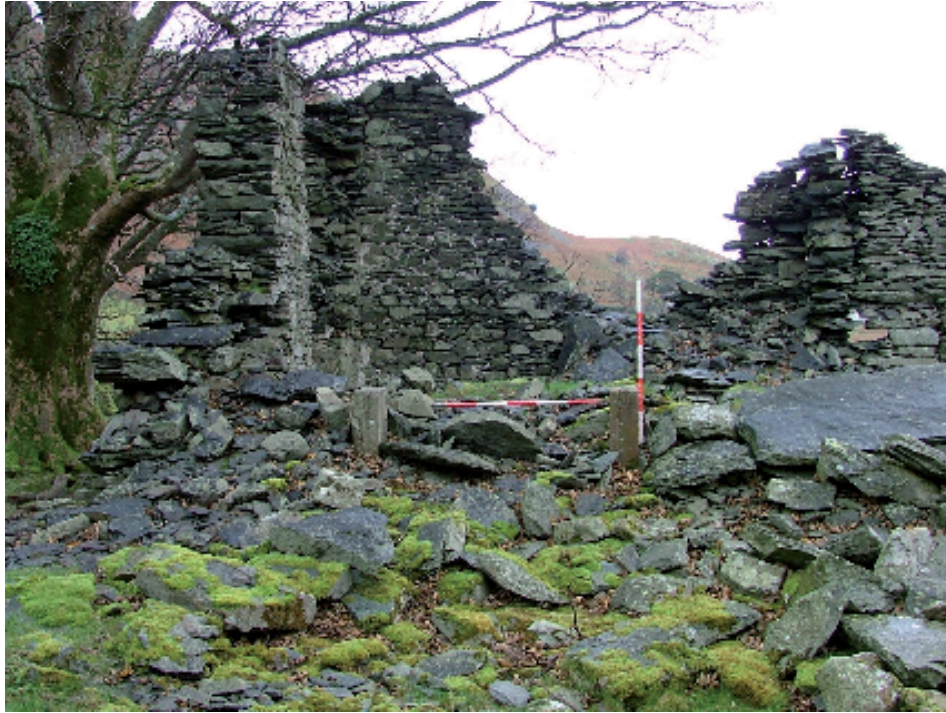
Plate 11 – Remains of fire surround, north side of house showing the possible downhouse or pantry and parlour beyond (Scales = 1m each)

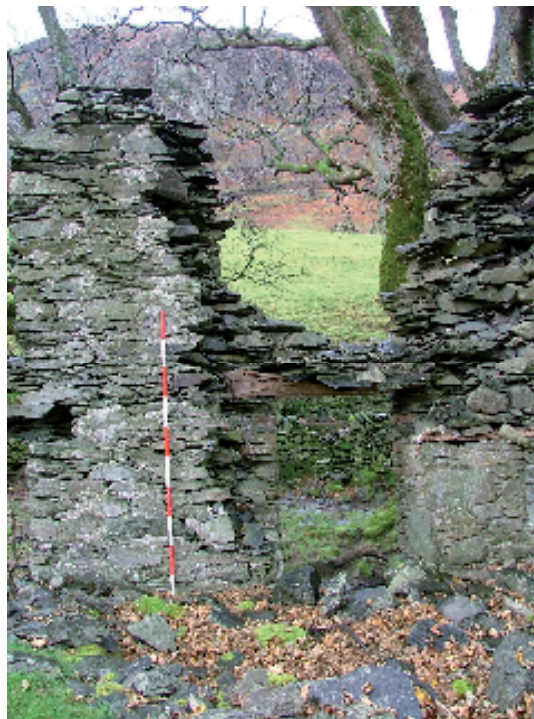
Plate 12 – View looking west from house interior showing surviving lintels of doorway and window, west wall, north end of house (Scale = 2m)

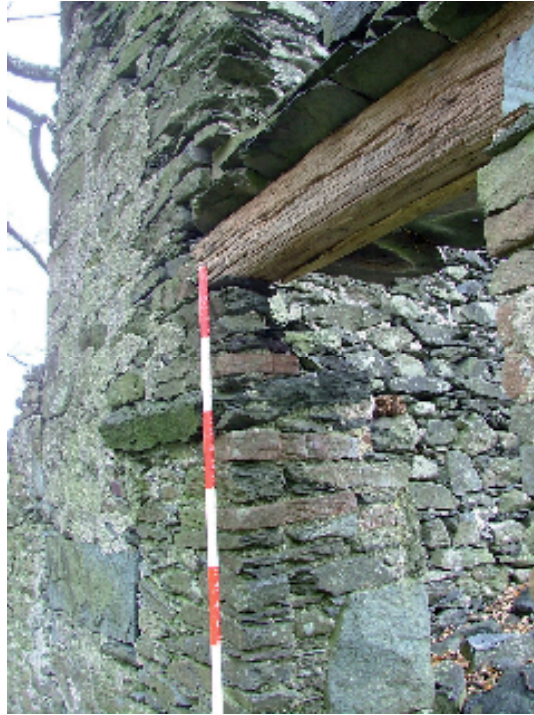
Plate 13 – View of doorway at north end of west wall showing extant wooden lintel, and rebated jambs constructed from a mix of slate and red sandstone. Note the slates over the lintel which kept rainwater from the doorway

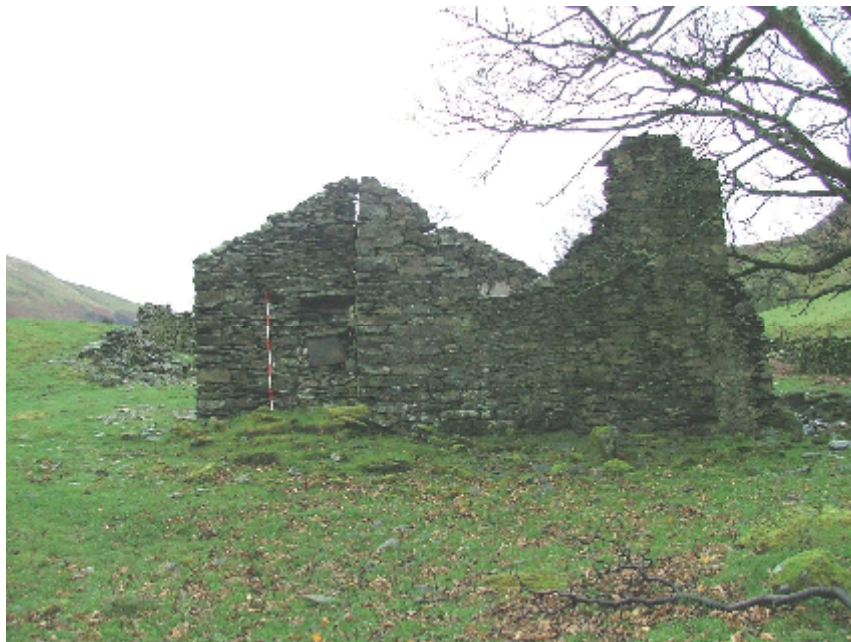
Plate 14 – View looking south of north end of house showing vertical line between main building and extension to the east, as well as the remains of a further extension against the north wall (possible privy/store/pig sty) (Scale = 2m)

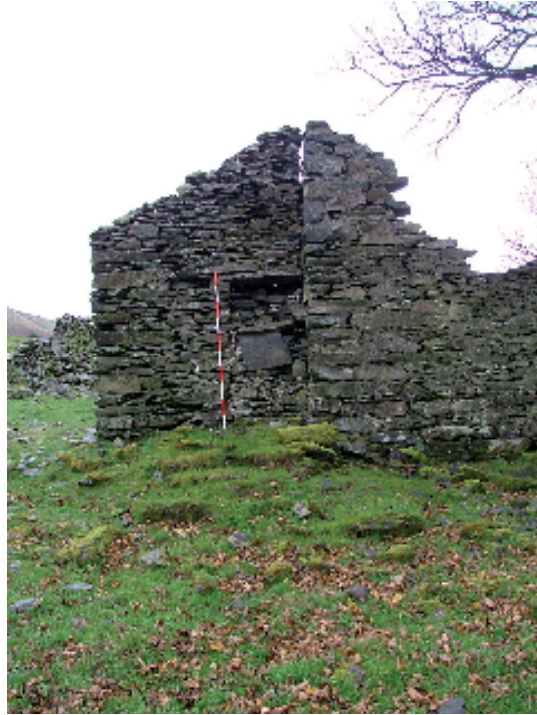
Plate 15 – View looking south showing the vertical line of a construction break between main house and outshut which contains a blocked doorway (Scale = 2m)

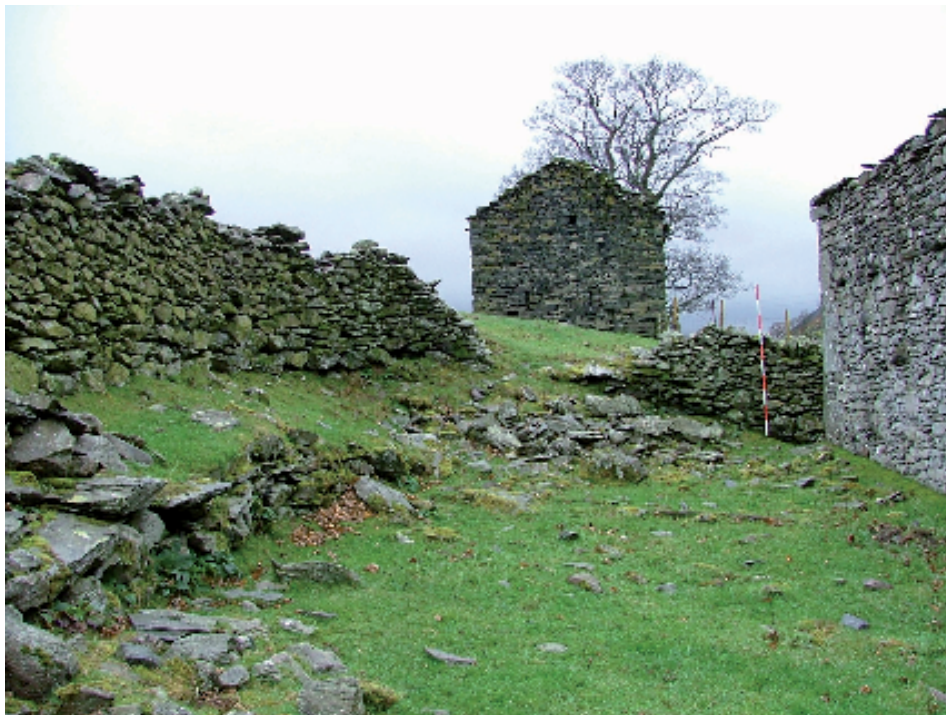
Plate 16 – View looking south down east side of house showing drystone wall and 'ledge', with north gable of the barn in background (Scale = 2m)

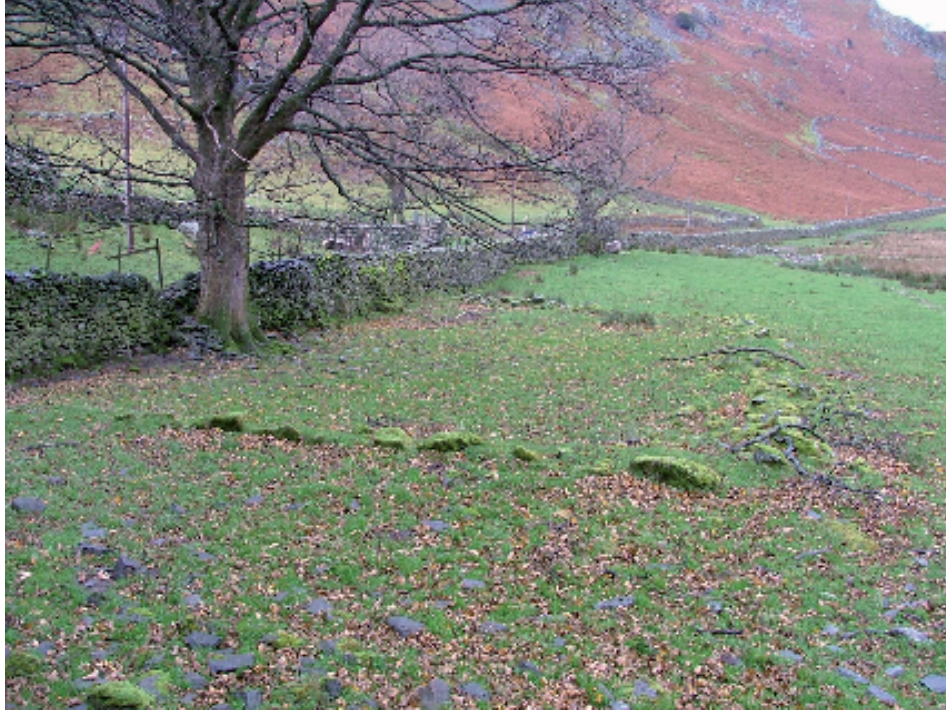
- 5.2.8 To the north of the ruined house of Hen Howe are the stone footings for a large rectangular feature clearly visible against the wall which separates the field from the road (Plates 17 and 18). This feature measures *c.*14.40 metres in width, *c.*29.5 metres long and *c.*0.70 metres thick. Historical mapping indicates that this was a separate enclosure certainly in the 1860s as shown by the First Edition Ordnance Survey map (Figure 7), where it is shown as tree-lined. It is possible that this was a walled garden for Hen Howe, and it has been suggested locally that this was the case (*pers.comm.* Mr Robinson).

Plate 17 – View of the stone-built rectangular feature located to the north of the ruined house of Hen Howe, Martindale

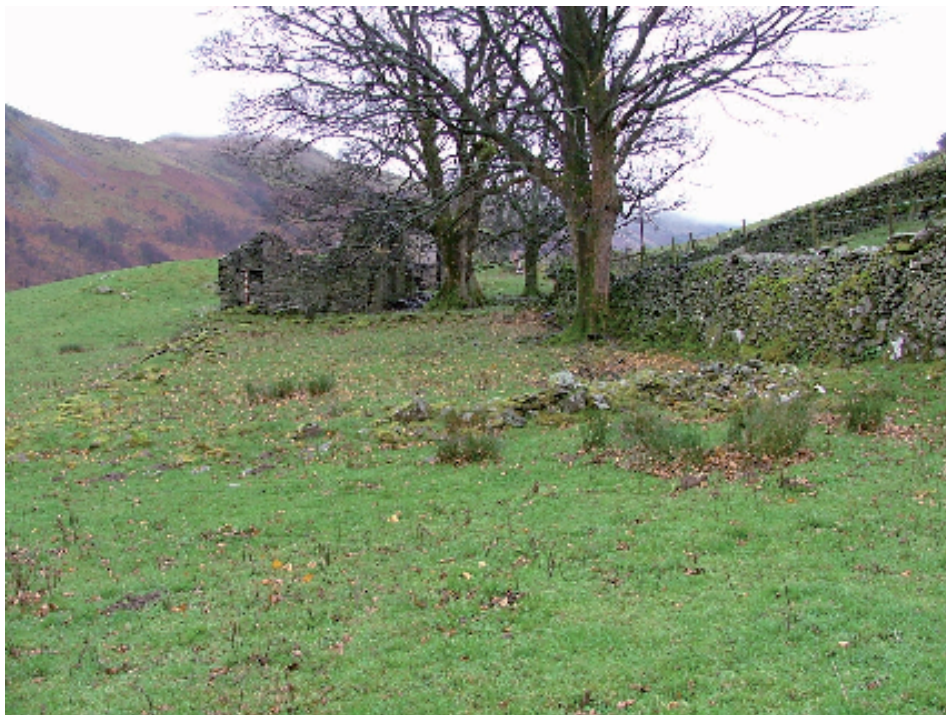
Plate 18 – View looking south of the rectangular feature on the north side of Hen Howe

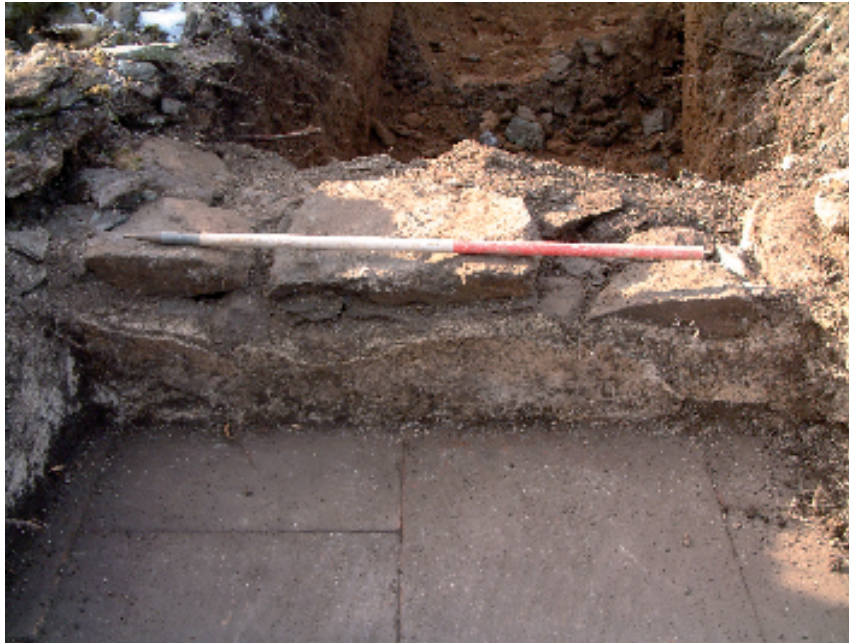
6.2.2 The foundations of the western wall of the farmhouse were located c.3.5m west of the eastern limit of Trench 1 (Figure 11). The foundation wall (**103**) was aligned north-northeast to south-southwest and measured c.0.75m in width and c.0.4m in height. This comprised 2-3 courses of irregular shaped stone of local volcanic type. Although there was no evidence of mortar bonding, the remains of wall plaster were still present, adhered to the eastern elevation of the wall (**103**) (Plate 19). The cut of the wall foundation trench for the wall (**103**) was also noted within the north facing section of the trench, immediately west of the wall (**103**). The cut [**108**] measured c.0.6m in width and c.0.4m in depth, and was filled by c.95% sub-rounded/angular stones interleaved with c.5% topsoil (**106**) (Plate 20).

Plate 19 – East facing elevation of wall (103) showing wall plaster

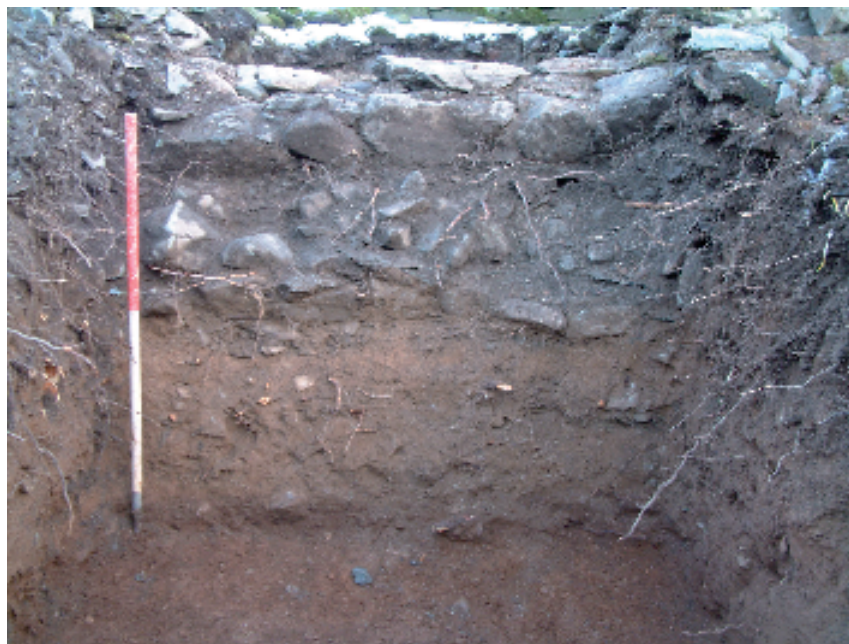
Plate 20 – Trench 1 looking east-southeast showing backfill (106) of wall cut [108]

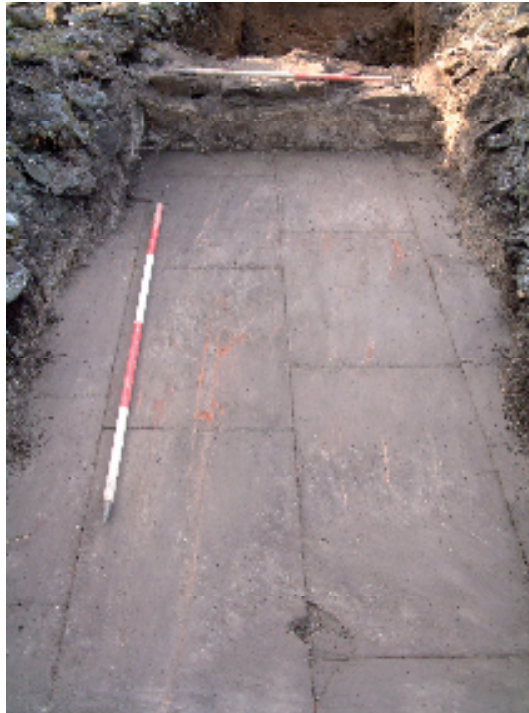
6.2.3 Within the easternmost c.3.5m of the trench, situated east of the wall (**103**), the well-preserved floor surface of the firehouse was located below a c.0.25m thick demolition layer (**102**), which was below c.0.1m of topsoil (**100**) (Plate 21). The floor surface (**104**) was comprised of regular, rectangular red sandstone slabs, which averaged c.1m in length x 0.6m in width (Figure 11). The flagged surface (**104**) displayed very little wear or damage suggesting that it may have only been laid down shortly before the building went out of use. It is also highly likely that the entire floor surface of the firehouse remains *in-situ*.

Plate 21 – Trench 1 looking west-northwest showing floor surface (104)

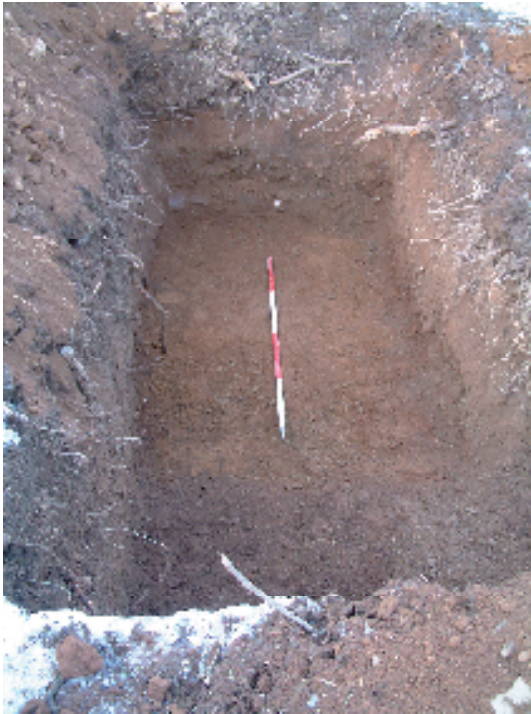
- 6.2.4 The western section of Trench 1, which extended outside of the building was excavated to a depth of *c.*1.3m at which point the natural substrate (101) was reached (Plate 22). The natural orange clayey silt (101) was below a *c.*0.8m thick deposit of mid-brown/orange sandy clay hill wash material (105), which was in turn below *c.*0.3m of topsoil (100) (Plate 23). Immediately west of the wall cut [108], a north-south aligned modern ceramic drain was noted within the hill wash material (105), *c.*0.5m below the surface. However, no archaeological features were noted within Trench 1 outside of the building.

Plate 22 – Trench 1 looking north-northeast showing natural substrate (101)

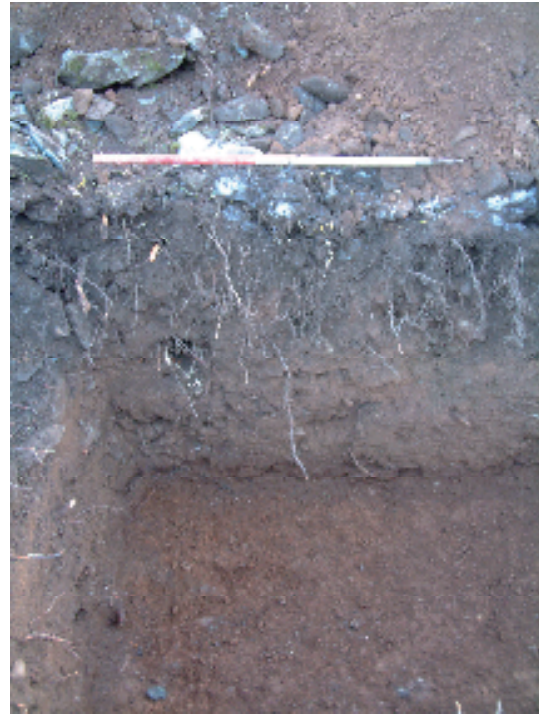
Plate 23 – North facing section of Trench 1 showing hill wash material (105)

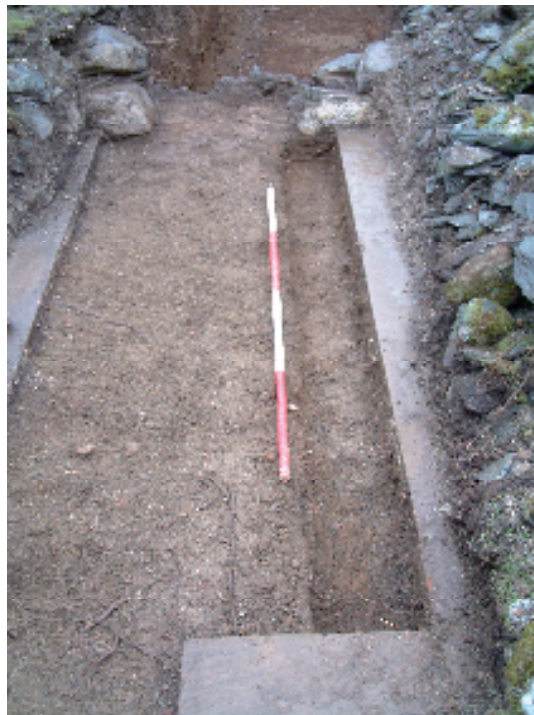
- 6.2.5 Further work in Trench 1 included the removal of several sandstone flags within the firehouse which revealed that the floor surface (104) had been laid directly above a *c.*0.02m thick bedding layer, comprised of fine river gravel (107) (Plate 24). A slot was excavated through the river gravel (107) to a depth of *c.*0.18m to expose the hill wash material (105) noted within the western half of the trench. A section of the foundation wall (103) was also removed down to this deposit (105) (Plate 24). No archaeology was observed below the floor surface (104) or wall (103).

Plate 24 – Trench 1 looking west after removal of floor surface (104) showing gravel bedding (107) and investigation slot

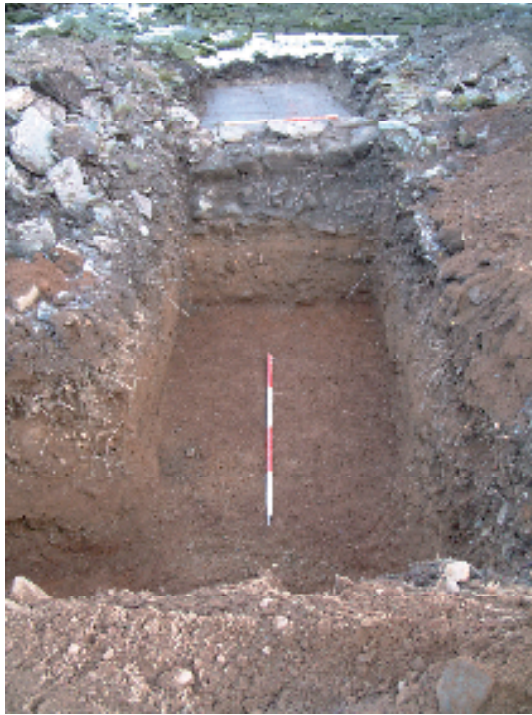
Plate 25 – Trench 1 looking east-southeast showing natural substrate (**101**)

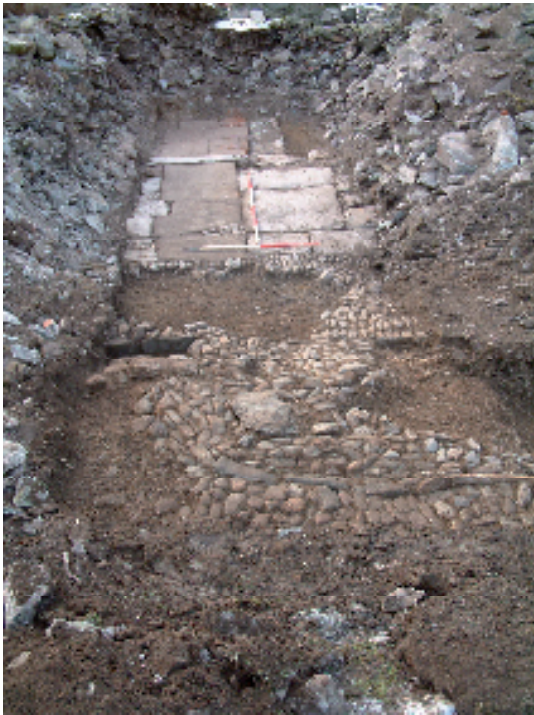
- 6.2.7 After the rubble (**210**) was cleared, Trench 2 exposed a section of the east wall foundation of the main building. The wall foundation (**207**) measured *c.*0.9m in width and was comprised of blue/grey irregular shaped local volcanic stone (Plate 28, Figure 12). No mortar bonding was present. Trench 2 also exposed a floor surface immediately southwest of the main wall foundation (**207**). The floor surface (**203**) measured *c.*2.1m in length and *c.*1m in width and was comprised of rectangular red sandstone flags (Plate 27, Figure 12). However, unlike the well-preserved flagged surface (**104**) observed in Trench 1, the floor surface (**203**) in Trench 2 was much more irregular and worn.

Plate 26 – Trench 2 looking west-northwest

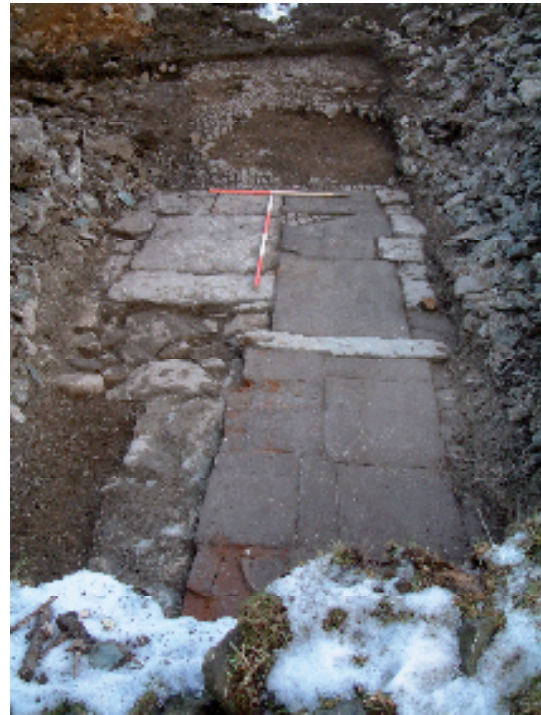
Plate 27 – Trench 2 looking east-southeast

- 6.2.8 The floor surface (203) was flanked to the north by the foundations of a wall, which abutted the southwest corner of the main wall foundations (207) (Plate 27, Figure 12). The wall foundations (204) measured *c.*1.7m in length and *c.*0.4m in width, and were comprised of sub-rounded and angular stones bonded by lime mortar. The floor surface (203) was also flanked to the south by a further east-southeast – west-northwest aligned wall separating this area from the firehouse to the south. However, this wall was beyond the southern limit of the trench and could not be accurately recorded. The eastern limit of the floor surface (203) was demarcated by a stone threshold formed from a single piece of blue/grey stone (206) which measured *c.*1.2m in length and *c.*0.22m in width. The stone threshold (206) was slotted at either end to facilitate a doorframe (Plate 29, Figure 12).

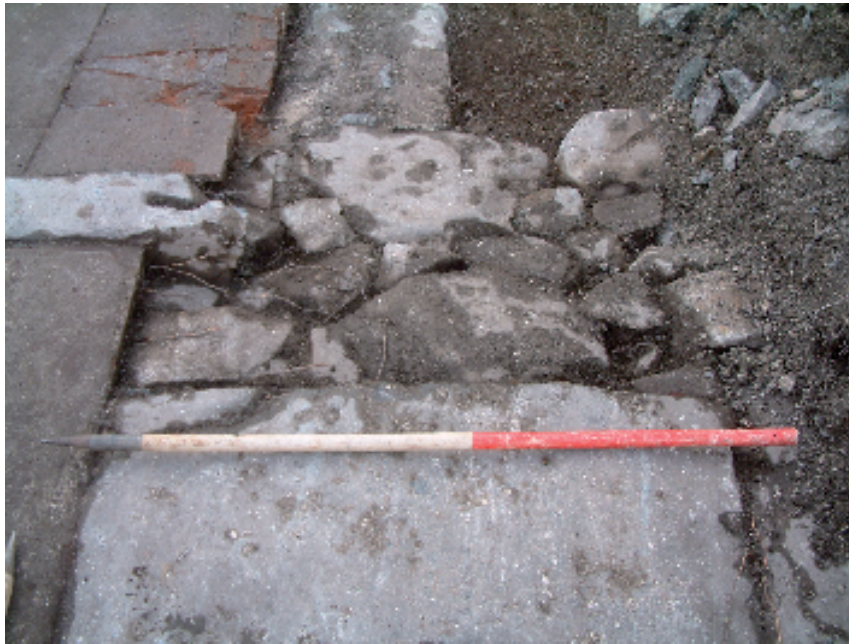
Plate 28 – Trench 2 looking west-northwest
across wall foundations (207)

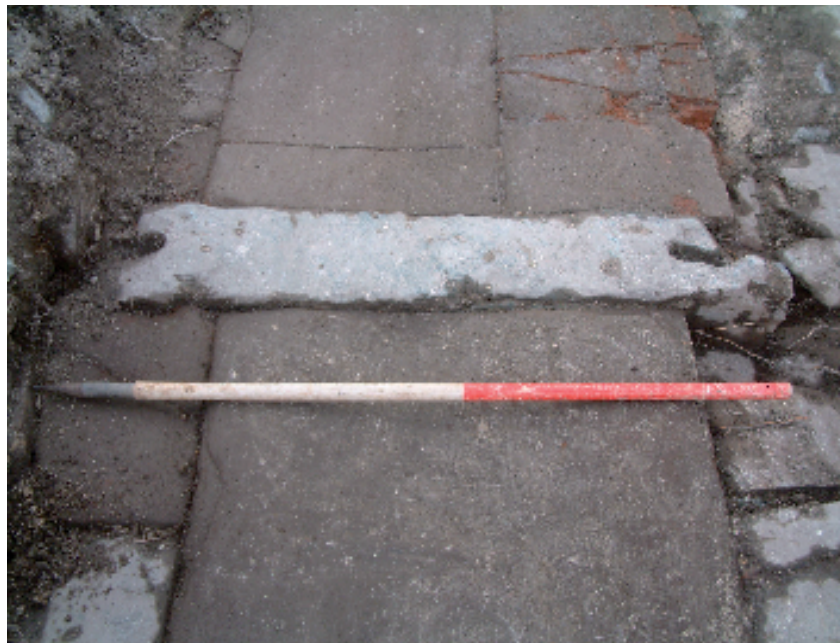
Plate 29 – Trench 2 looking west-northwest
across door threshold (206)

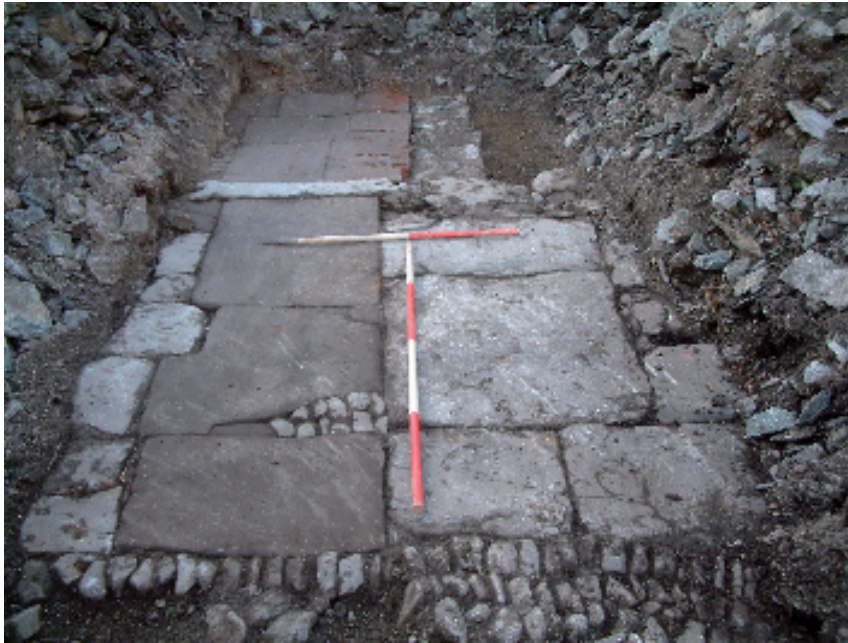
Plate 30 – Trench 2 looking west-northwest across lean-to surface (208) with wall (207), door threshold (206), and cross-passage (203), (204) further west

- 6.2.11 A further floor was exposed within Trench 2 immediately east of the main foundation wall (207) and cross-passage which would have formed the surface of the lean-to adjoining the northeast corner of the main building (Figure 12). The floor surface (208) measured *c.*2.8m in length and *c.*2m in width, and was comprised of irregular red sandstone slabs which continued along the same alignment as the cross-passage with blue/grey rectangular stone slabs, probably of local volcanic type, to the north and south (Plate 30). The floor (208) also retained a small area of cobble patching. It would appear that the lean-to was left ‘open’ on its eastern side as no wall foundations were observed. It is possible that the structure had additional timber supports which have not survived, although no evidence of this was observed during the evaluation.

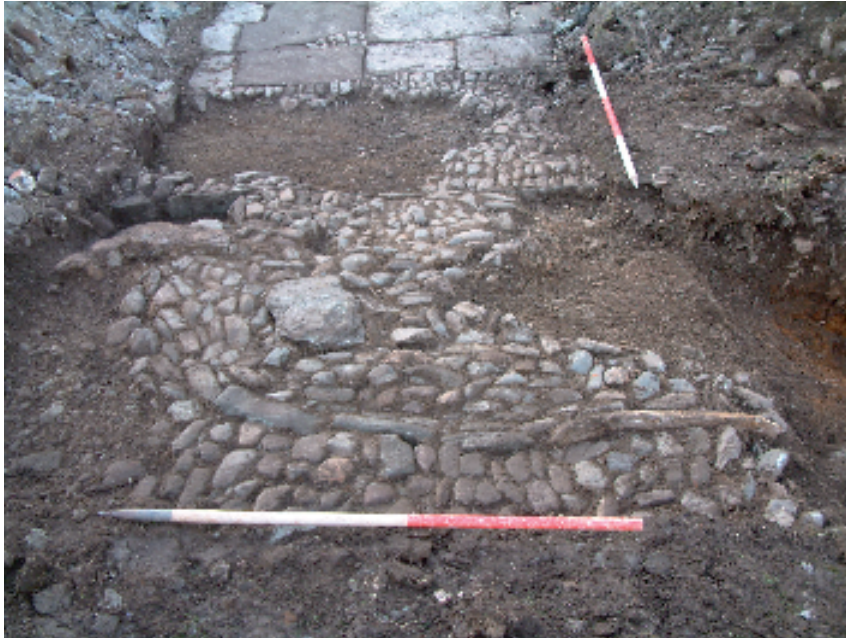
- 6.2.12 The lean-to floor surface (208) was bound by a *c.*4.2m x *c.*2.2m external cobbled yard to the east which was partially destroyed during excavation (Plate 31, Figure 12). The cobbled surface (209) was below *c.*0.3m of topsoil (200) and was comprised of *c.*95% rounded river cobbles set in a *c.*0.03m thick deposit of fine river gravel (211). Several larger stones had also been set on their edge forming divisions within the cobbled area. Interestingly, the cobbled yard (209) followed the natural sloping geology westwards towards the lean-to, which would have carried rainwater into the structure (Plate 31, Figure 12).

Plate 31 – Trench 2 looking west-northwest across cobbled yard (209)

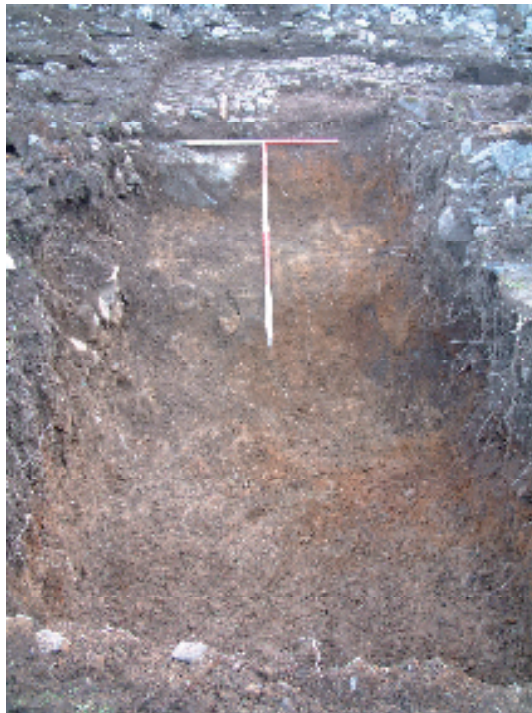
The north-northeast to south-southwest aligned section of Trench 2 was excavated to a maximum depth of c.0.9m exposing c.0.6m of natural light-brown/orange sandy gravel (201) (Plate 32, Figure 12) below c.0.3m of topsoil (200). No archaeological features or deposits were observed within this section of Trench 2.

Plate 32 – Trench 2 looking south-southwest across natural substrate (201)

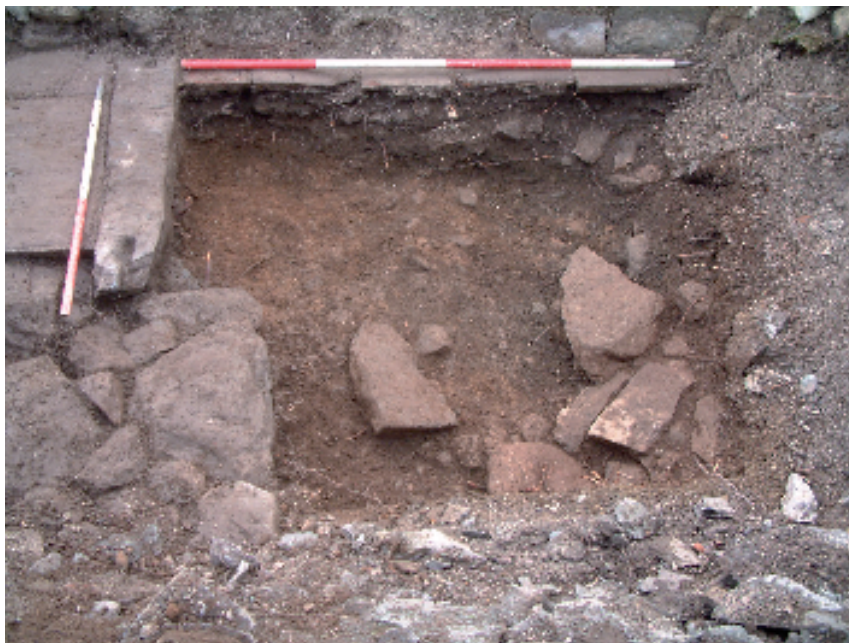
- 6.2.14 Two test-pits were hand excavated in Trench 2 in order to locate evidence for earlier archaeological activity. The first test-pit (Test-pit A) was located at the western end of the trench and involved the removal of the floor surface (203) and north partition wall (204) of the cross-passage, and the partial removal of the gravel-bedding layer (205) (Plate 33). Test-pit A measured *c.*1.8m x *c.*1.7m, and was excavated to a depth of *c.*0.5m exposing the natural substrate (201) below a *c.*0.25m deposit of brown sandy silt containing large irregular stones (213), which probably represented backfill material (Plate 33). At the southern edge of Test-pit A, the backfill deposit (213) was replaced by a *c.*0.18m thick stoney deposit (214), possibly marking the location of the foundation trench for the south wall of the cross-passage (Plate 33). Both of the backfill deposits (213) and (214) were below a *c.*0.11m thick bedding layer comprised of dark-brown/black silt (212) which was directly below the cross-passage floor surface (203).

Plate 33 – View south-southwest across Test-pit A showing backfill (213) (northwest corner) and backfill (214) (southwest corner)

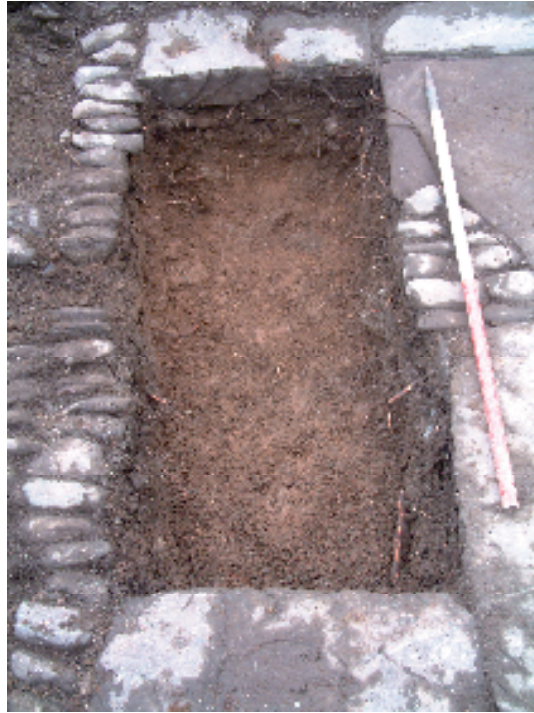
- 6.2.15 Test-pit B was located at the eastern extent of the lean-to structure and involved the removal of several floor slabs (Plate 34). Test-pit B measured *c.*1.3m x *c.*0.6m, and was excavated to a depth of *c.*0.3m exposing the natural substrate (201) below a *c.*0.2m layer of the backfill deposit (213) which was directly below the lean-to floor surface (208) (Plate 34). No earlier archaeological features or deposits were observed in either Test-pit A or B.

Plate 34 – View south-southwest across Test-pit B showing natural substrate (201)

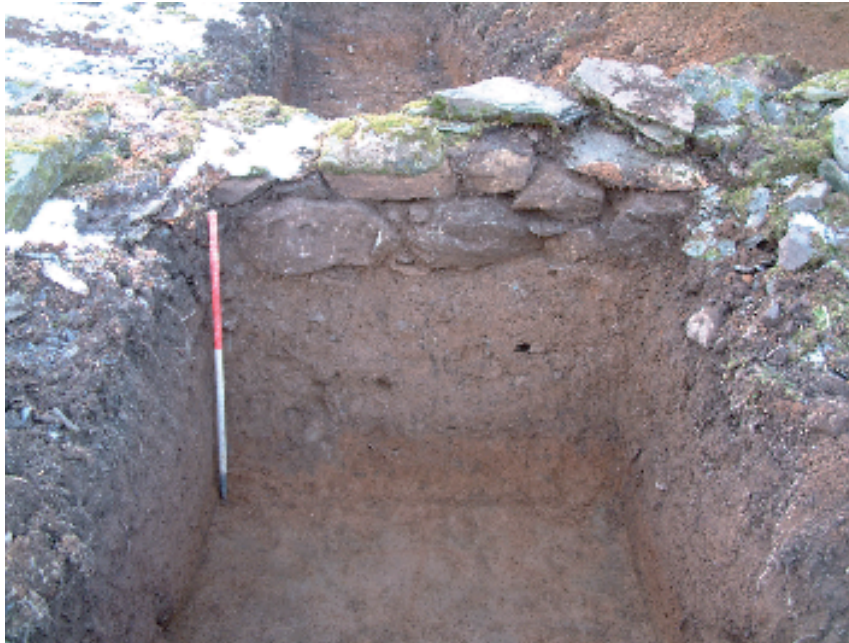
Plate 35 – View west across Trench 3 showing wall (304)

- 6.2.18 No archaeological features were noted within Trench 3 or Trench 4 (excluding the east wall **(304)** of the rectangular enclosure).

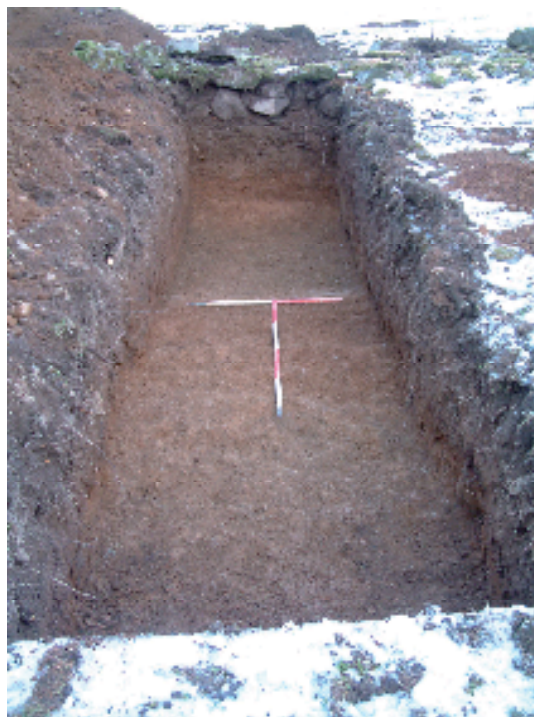
6.2.16 **Trench 3:** Trench 3 was located within the southern end of the rectangular walled enclosure north of the farmhouse (Figure 10). The trench measured *c.*1.1m in length and *c.*1.5m in width, and was aligned east – west partially exposing the north – south aligned eastern wall of the rectangular structure. The wall (304) was comprised of two courses of un-mortared large irregular stone of local volcanic type (Plate 35). Trench 3 was excavated to a maximum depth of *c.*1.3m exposing the compact orange/grey natural silty gravel (301) below a *c.*0.4m deposit of orange silty sand (303), which was further below a *c.*0.6m deposit of light-brown silt (302) and *c.*0.3m of dark brown topsoil (300) (Plate 36, Figure 13).

Plate 36 – View east across Trench 3
