NORTH PENNINES ARCHAEOLOGY LTD

Client Report No. CP/742/08

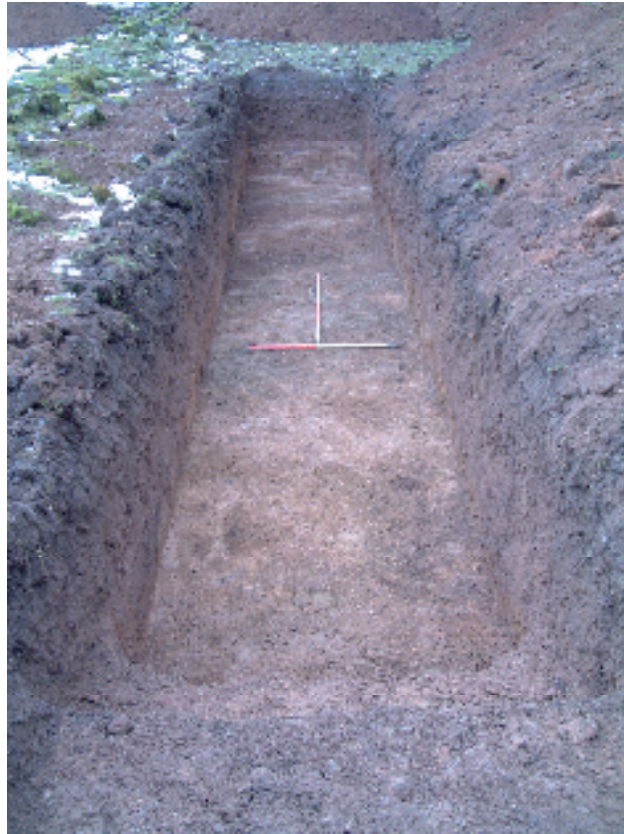
6.2.17 **Trench 4:** Trench 4 was located within the walled enclosure north of Trench 3. Trench 4 was aligned north – south and extended from the northeast corner of the enclosure parallel with the enclosure's east wall (Figure 10). The trench measured *c.*1.3m in length and *c.*1.5m in width, and was excavated to a maximum depth of *c.*1.3m exposing a very compact natural orange/grey silty gravel (401) below a *c.*0.4m deposit of orange silty sand (403), which was further below a *c.*0.6m deposit of light-brown silt (402) and *c.*0.3m of dark brown topsoil (400)³ (Plate 37, Figure 14).

Plate 37 – View south across Trench 4
