NORTH PENNINES ARCHAEOLOGY LTD

Client Report No. CP/850/08

In December 2008, North Pennines Archaeology Limited were commissioned by Tims Morris Ltd to undertake an archaeological building recording project of Armstrong Cottages, Rothbury, Northumberland (NZ 061 018) prior to the renovation of the buildings following flood damage incurred in 2008. Armstrong Cottages are Grade II listed buildings, sited to the north of a low stone wall with central entrance gate, which are also Grade II listed. The properties are located at the eastern end of Rothbury Conservation Area.

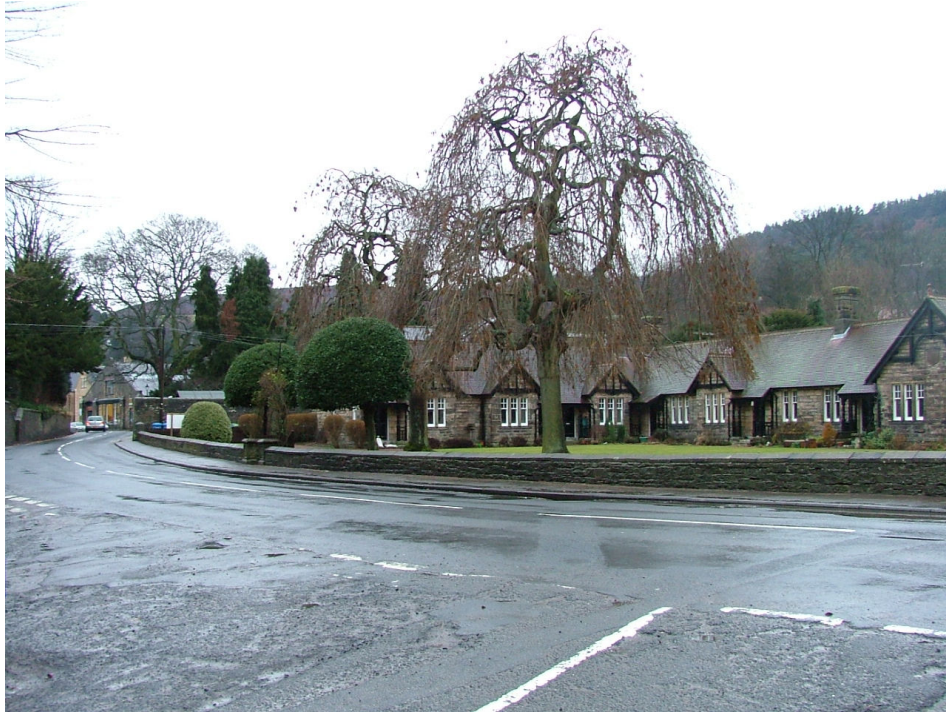
Plate 1 – View looking north-west showing Armstrong Cottages as seen from the east of Walby's Hill

- 4.1.2 The land to the front of the properties consists of a large area of lawn intersected by gravel paths laid symmetrically into the grass (Plate 1). From the main road the cottages are accessed via a small gate set in a low wall placed centrally with the long range of the buildings. The low wall is constructed of roughly-squared masonry topped with chamfered coping stones which have regularly-spaced holes along the top indicating that formerly there were railings. The gateway is defined by two short panelled piers with moulded flat tops. A decorative cast iron archway over the gateway is intertwined with foliage. Trees have been planted symmetrically either side of the gateway within the lawned area (Plate 2).

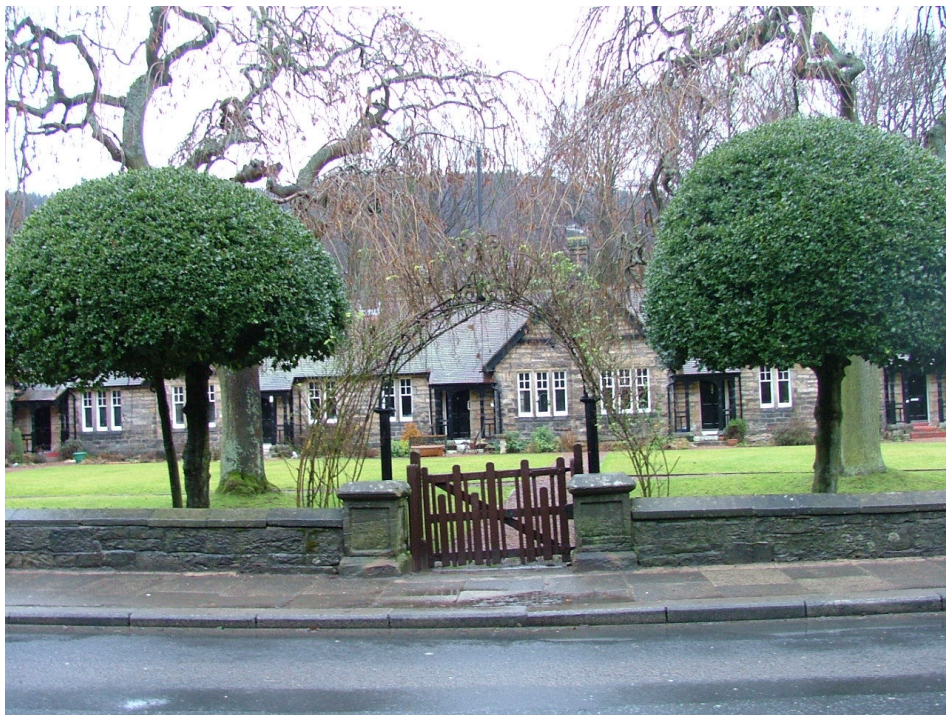
Plate 2 – View looking north showing the low wall, central gate and symmetrically placed trees with Armstrong Cottages behind

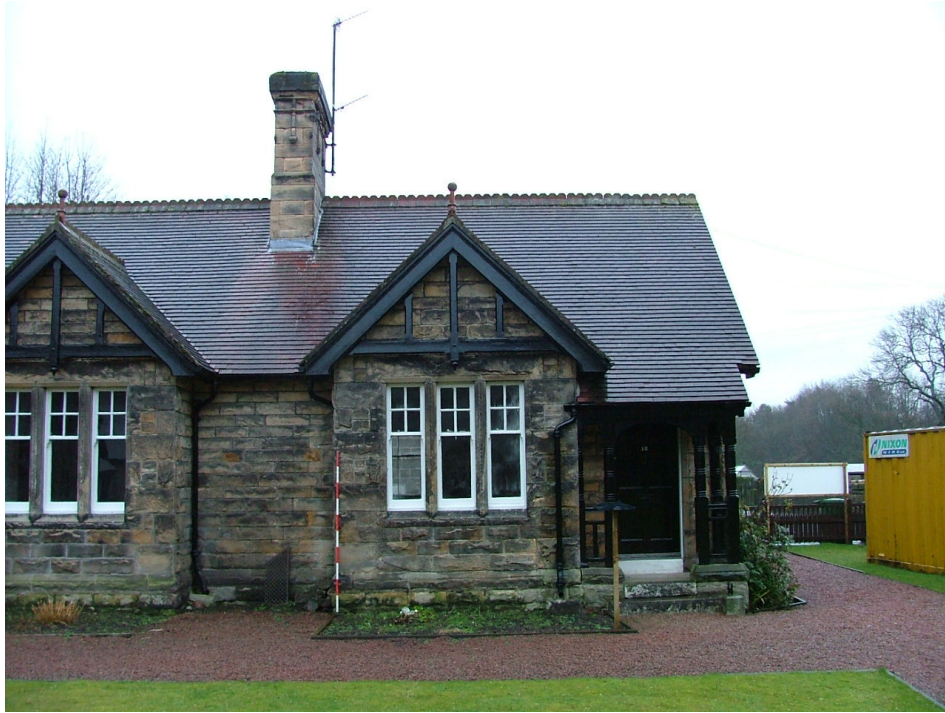
Plate 3 – West elevation of No.12 Armstrong Cottages showing ‘rock-faced’ masonry, red tiled roof, chimney stack and projecting gable (Scale = 2m)

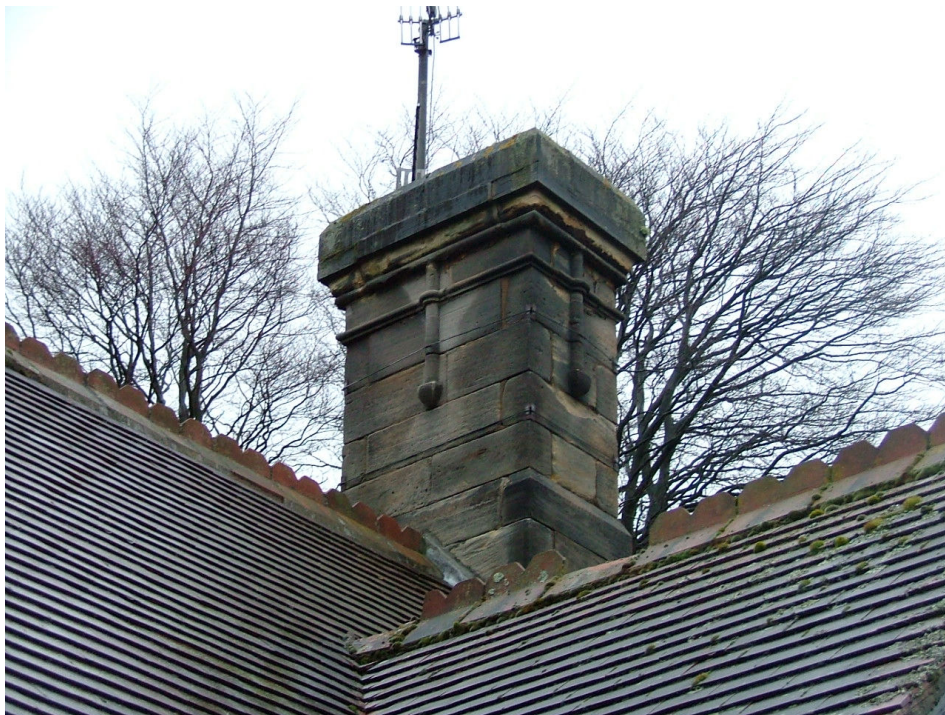
Plate 4 – Detail of one of the chimney stacks

- 4.2.1 Externally, the cottages are constructed of coursed 'rock-faced' stone, sometimes referred to as '*rustication*' or '*cyclopean*', this type of masonry is used to give a rich and bold texture to an exterior wall¹³. At the base of the walls is a projecting plinth which contains iron air vents along its length. Air vents, or airbricks, were used to reduce moisture as they allowed air to circulate in the void beneath the internal floorboards¹⁴. The roofs are laid in red clay tiles with decorative tile ridge cresting, and located astride the ridge are regularly-spaced substantial masonry chimney stacks (Plate 3). The chimney stacks are constructed of ashlar masonry, with two thin half-round decorative string courses encompassing half-round vertical pilasters on each side, and topped with a cornice (Plate 4).

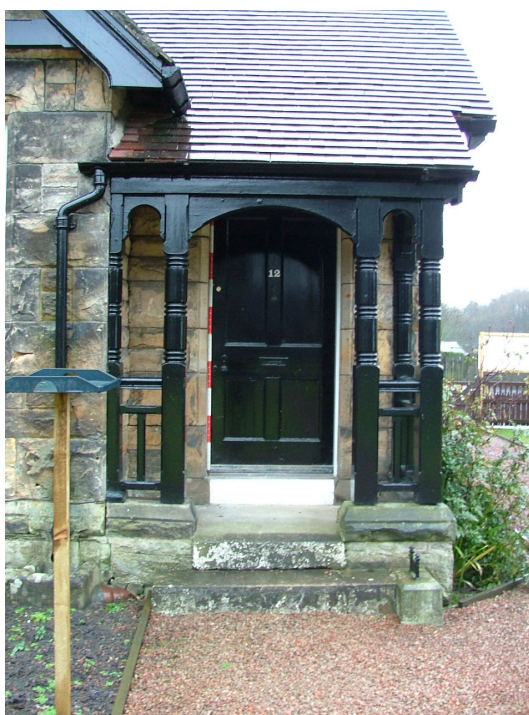
Plate 6 – Detail of porch way to No.12 Armstrong Cottages (Scale = 2m)

- 4.2.3 The main doorways to each of the cottages in the elevations facing the lawned area are all accessed up two steps. Each doorway is protected from the elements by a porch constructed from decorative timber with a central segmental arch. The porches are covered by a continuation of the main roof. The main doors are of 4-panels with a centrally-placed letterbox. No.12 Armstrong Cottages has an interesting door knocker in the form of a stags head with what appears to be a fox below. Similar door knockers were not noted on any other of the doors so it is not known if this is an original feature relating to the Cragside Estate, or a personal feature of one of the former occupants (Plate 7). Each cottage has an iron boot scraper located at the base of the steps to the porch (Plates 6 and 8).

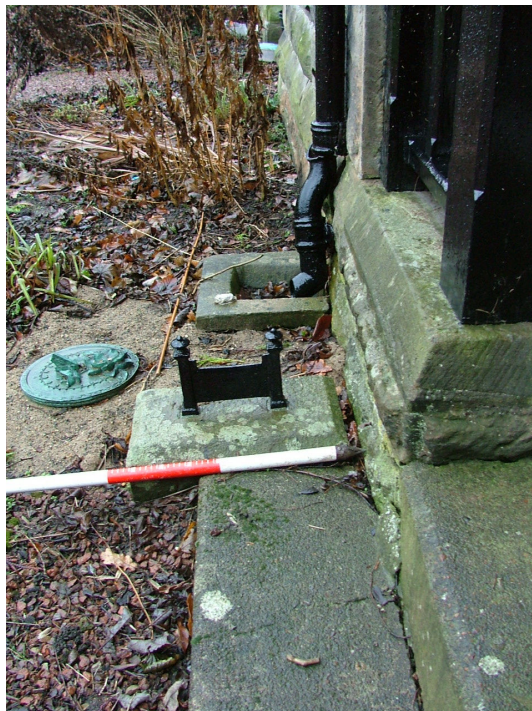
Plate 8 – Detail of boot scraper outside No.2 Armstrong Cottages

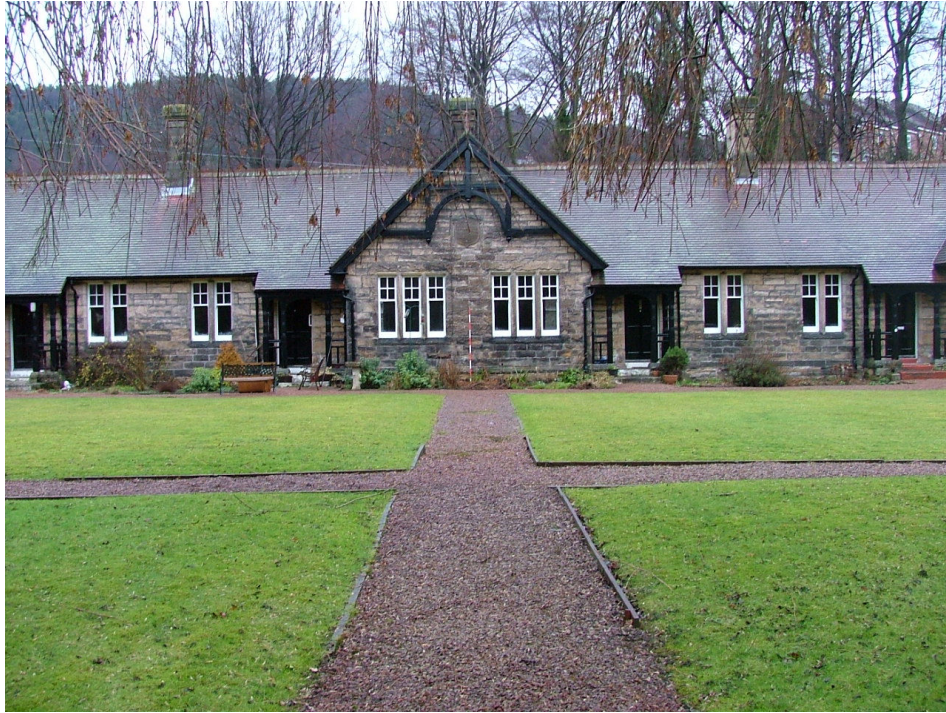
Plate 9 – View looking north of the central gabled projection which contains the date stone
(Scale = 2m)

- 4.2.4 The long range which faces south and contains six of the cottages has a central gabled projection which is much larger than those already noted (Plate 9). This section of the cottages is in line with the gateway from the road and is consequently the main focus. Located within this gable (and noticeably in direct sight of the main gateway) is an inscribed shield-shaped tablet which reads (Plate 10):

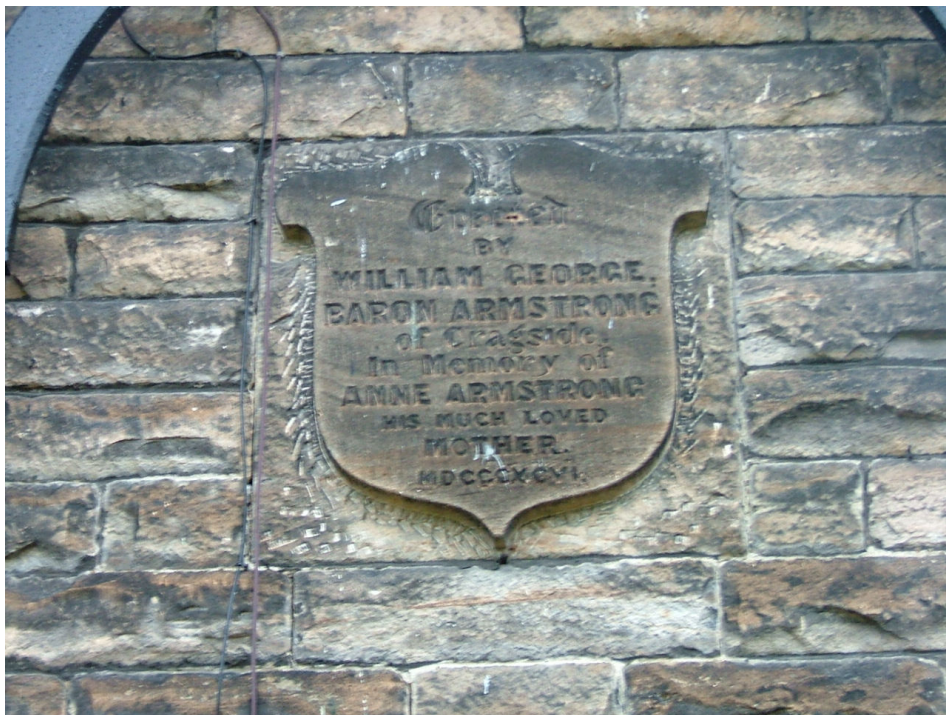
Plate 10 – Detail of the inscribed tablet in central gable of long range

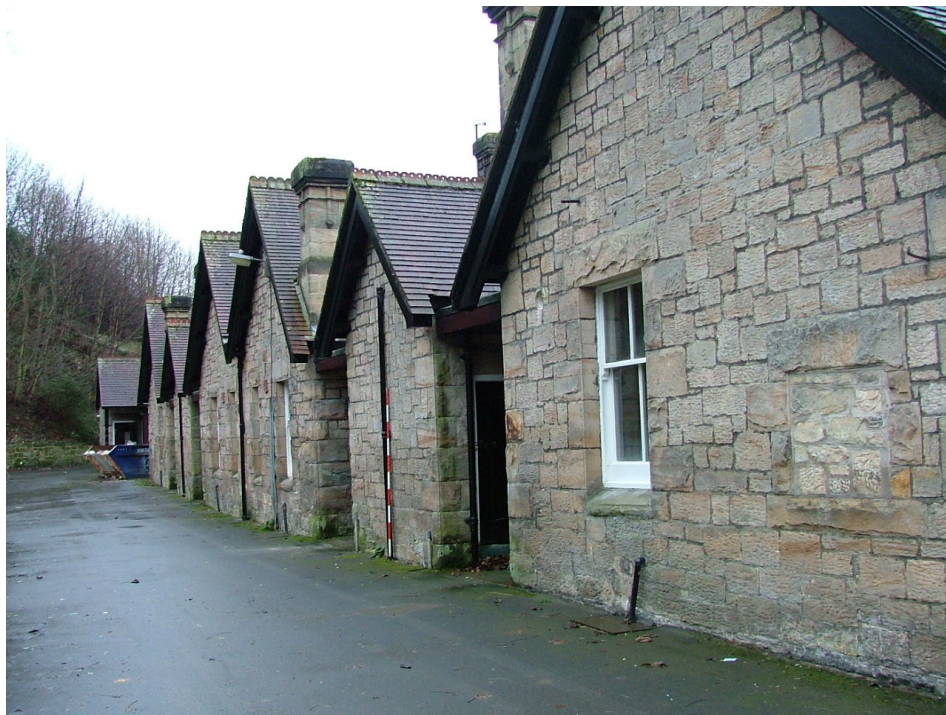
Plate 18 – View looking east showing the north elevation of the long range. Note the blocked
'window' to No.5 (Scale =2m)

- 4.2.9 There are small blocked 'windows' in the north elevation of No's 5 and 8 Armstrong Cottages; similar 'windows' were *not* noted in any of the other cottages (Plates 18 and 20). The blocked 'window' to No.8 retains two iron spindles externally, presumably for a wooden door. These features are reminiscent of coal holes for transferring fuel into a property; however this would have meant fuel being moved into one of the main rooms in the cottage. It is curious that these should only be present in two of the properties.

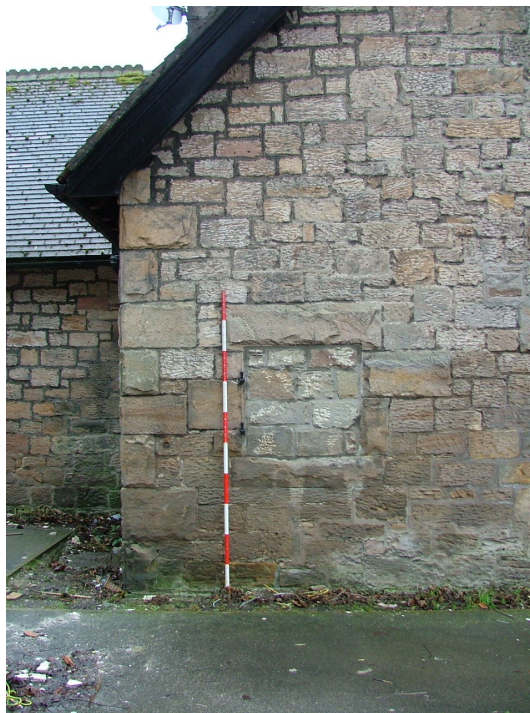
Plate 20 – Blocked 'window' to No.8 with iron spindles for a former external door (Scale = 2m)

- 4.3.11 The possible 'coal hole' noted in 4.2.9 above and shown on Plate 20 was clearly visible from within the interior of No.8 (Plate 42). Its presence leading into a room such as this is curious as it suggests that fuel was being transferred into the interior of the cottage here, rather than into an external store. The fact that two of the cottages, symmetrically placed in the layout of the buildings, each have these features is also difficult to interpret. It is possible that these cottages were designed to house a particular function which required more heat. Both No's 5 and 8, which have these square blocked holes in the north elevation, also have an additional chimney set in the gabled projection, however No's 6 and 7 also have this extra chimney but have no evidence for a blocked 'coal hole'. Interestingly, there is also no evidence in any of the cottages which have the extra chimney in the gabled projections to the north, of a fireplace or set-pot which these chimneys may have served. It is possible that these chimney stacks to the rear of the cottages were decorative, however they are not visible to those passing the main façade.

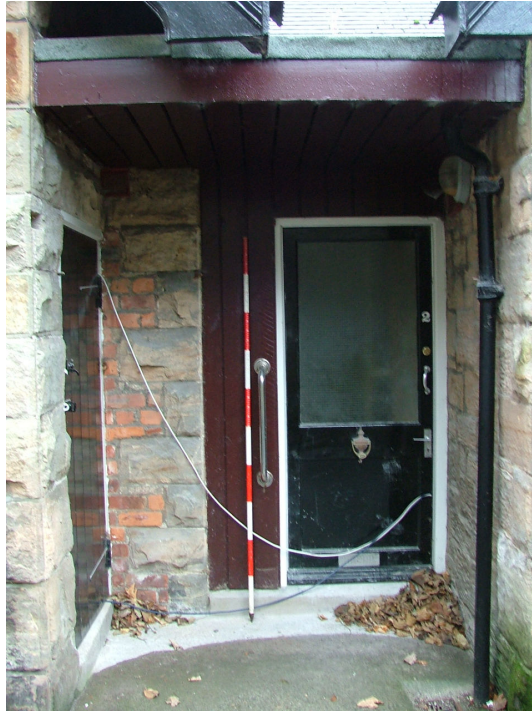
Plate 21 – Back door to No.2 Armstrong Cottages showing flat roof over and door set in a panelled surround (Scale = 2m)

- 4.2.10 The flat-roofed extensions to the rear of the properties appear to generally have been used as protection for the back entrances (Plate 21). With No's 1 and 12, however, the flat roofs also cover a small room which may originally have been a privy or a fuel store, which have more recently been used for housing meters or as utility rooms (Plate 22). All the other cottages have a similar small room, but these are housed within the gabled projections. Writing in relation to water closets (WC's), Yorke notes that by the 1890s improvements in drainage and building regulations meant that some middle class homes were able to have a small room indoors, but usually separate from the bathroom. In new build houses for the working classes, however, the water closet was usually on the ground floor within a rear extension often accessed only from outside¹⁵. Given that the cottages were constructed as almshouses (and therefore for those of a lower class) it is likely that the small rooms to the rear of the properties, all accessed from outside with no internal link with the cottage, may have been used as WC's.

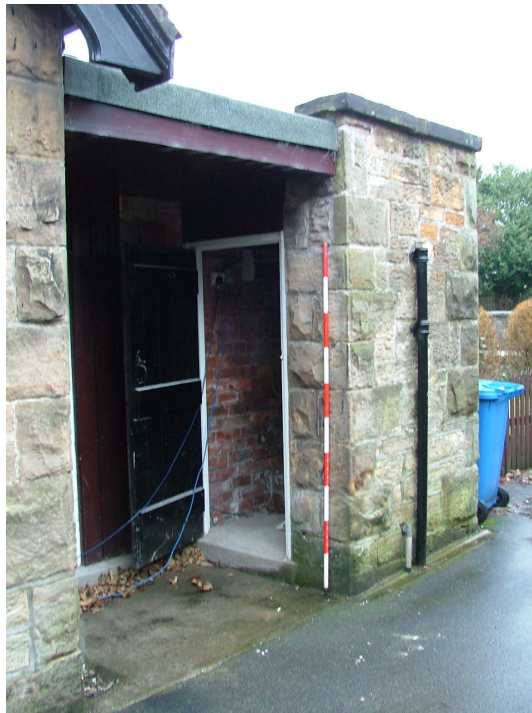
Plate 22 – Flat roofed extension to No.1 Armstrong Cottages also houses a former privy or fuel store. Note the brick internal wall of the small room (Scale = 2m)

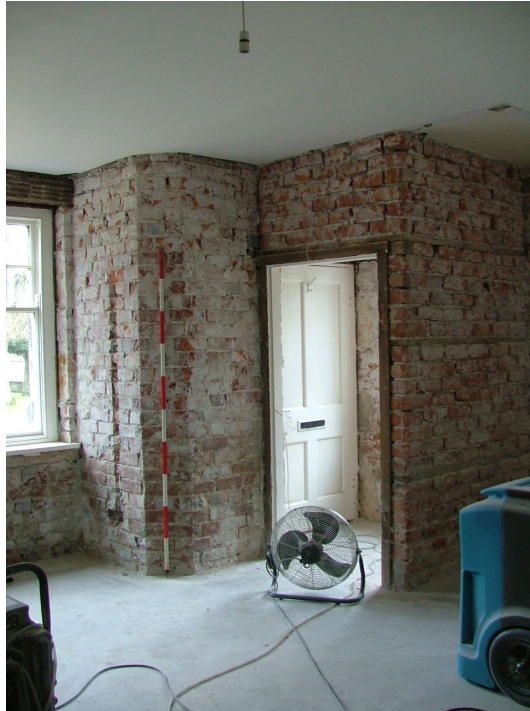
Plate 23 – Brick-built lobby in No.1 Armstrong Cottages (Scale = 2m)

is masonry (Plate 23). This was also noted on some of the walls which separated the living area from the utility/bathrooms to the rear, although this was not seen in all the cottages (Plate 26 and Figure 8).

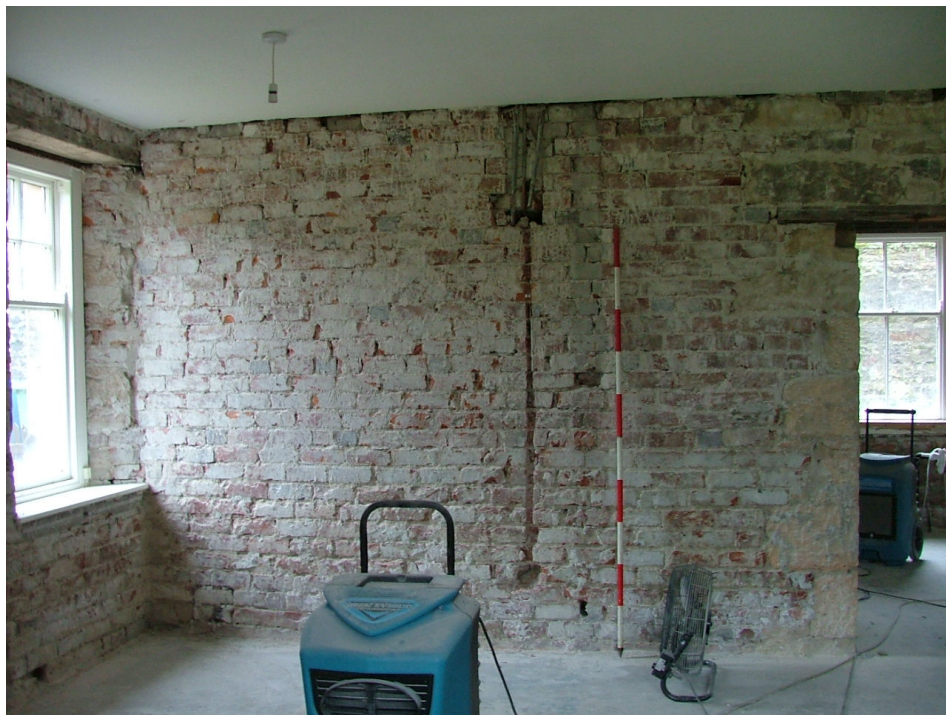
Plate 26 – Internal cross-wall showing bricks laid in stretcher bond, No.1 Armstrong Cottages.
Note the masonry quoins of the door jamb (Scale = 2m)

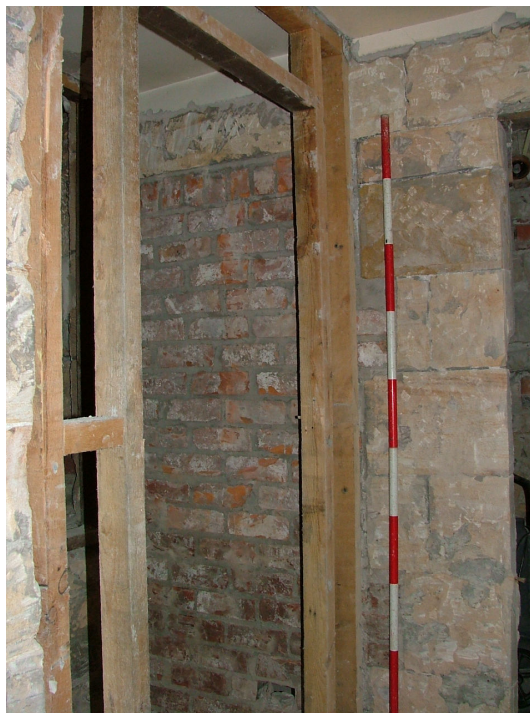
Plate 28 – Bricked-up doorway in masonry wall between former bathroom and rear lobby, No.3 Armstrong Cottages. Note the later studwork of a cupboard (Scale = 2m)

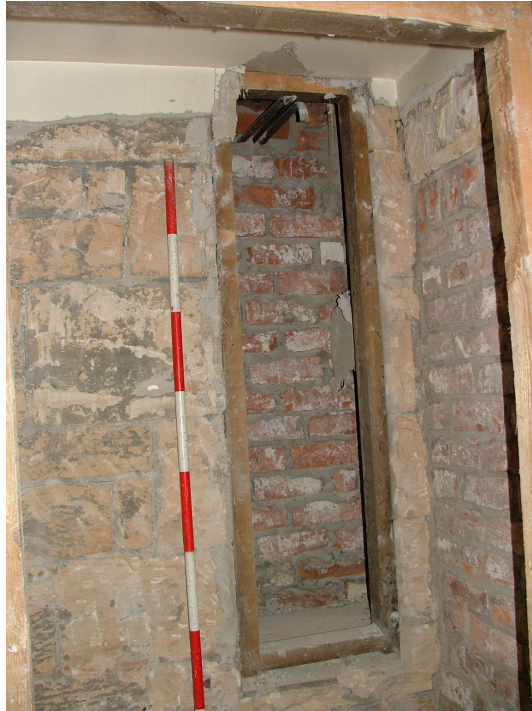
Plate 29 – Inserted hole in wall between main living room and rear of cottage possibly for a boiler, as shown by the water pipes *in-situ* at the top of the aperture (Scale = 2m)

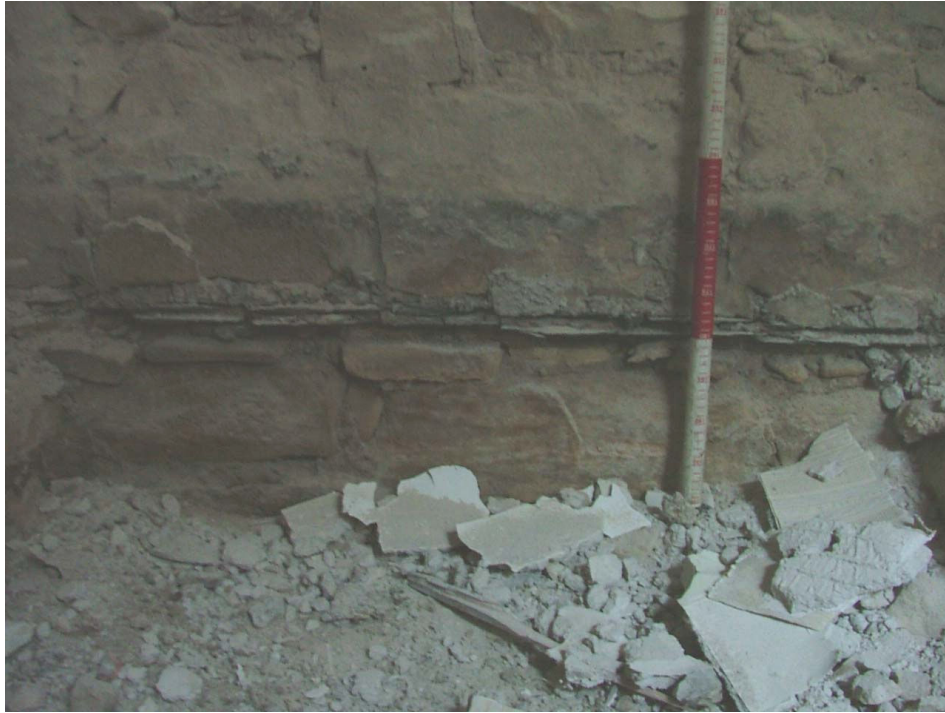
Plate 33 – Detail of slate course below masonry, No.4 Armstrong Cottages

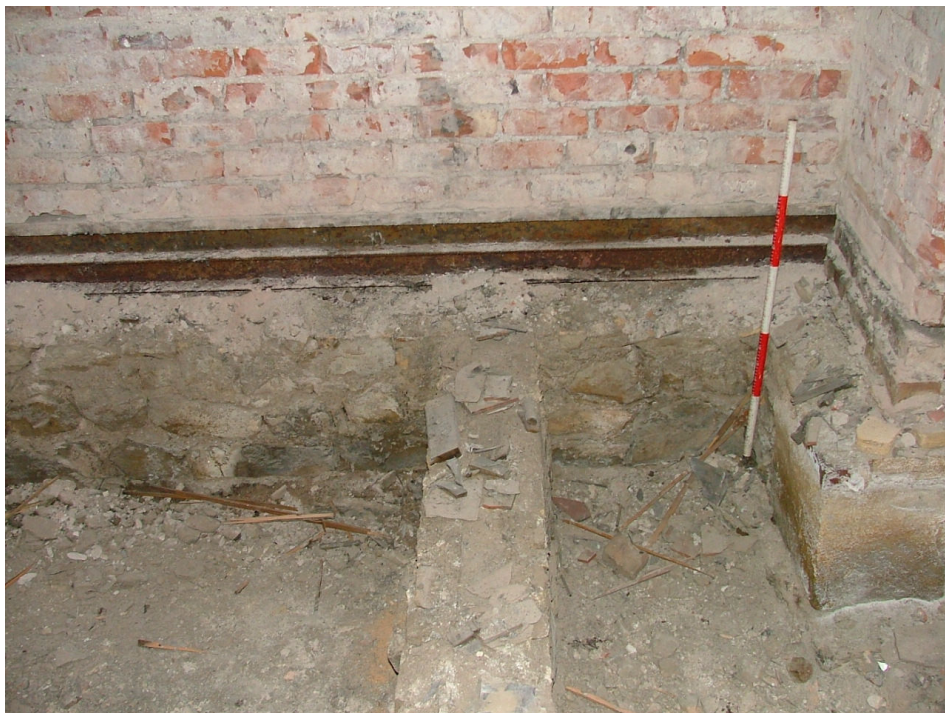
Plate 34 – Base of wall in No.8 showing two iron girders below the brickwork (Scale = 1m)

- 4.3.6 The six cottages in the long range (No's 4 to 9) are all larger than those in the sort ranges, having an extra room and fireplace (Figure 8). The fireplace in the extra room is slightly smaller than that in the main living space (Plate 31), and several retain their fire backs (Plate 32). The floor of No.4 has been removed in the western room to a depth of c.30cm to expose a masonry plinth around the edges of the roof and across the width which would have supported the original floor boards. In the walls it was noted that a layer of slate had been inserted within the brickwork and the masonry, just above the top of the height of the original floorboards (Plate 33). This layer of slate appears to have acted as a damp proof course; from the late 1800s into the early 20th century damp proof courses were common and were generally located around 1ft above ground level. The damp proof course layer was constructed of either a mixture of tar and sand, sheets of lead-cored felt or a line of slates¹⁸. In a room in No.8, where the floor has been removed, two thin horizontal iron girders are set into the wall at the base of the brickwork; it is unlikely that these acted as a damp course due to the material from which they are made, consequently they may have been used to provide support for this wall although this feature was noted in any other room where the floor surface had been removed (Plate 34).

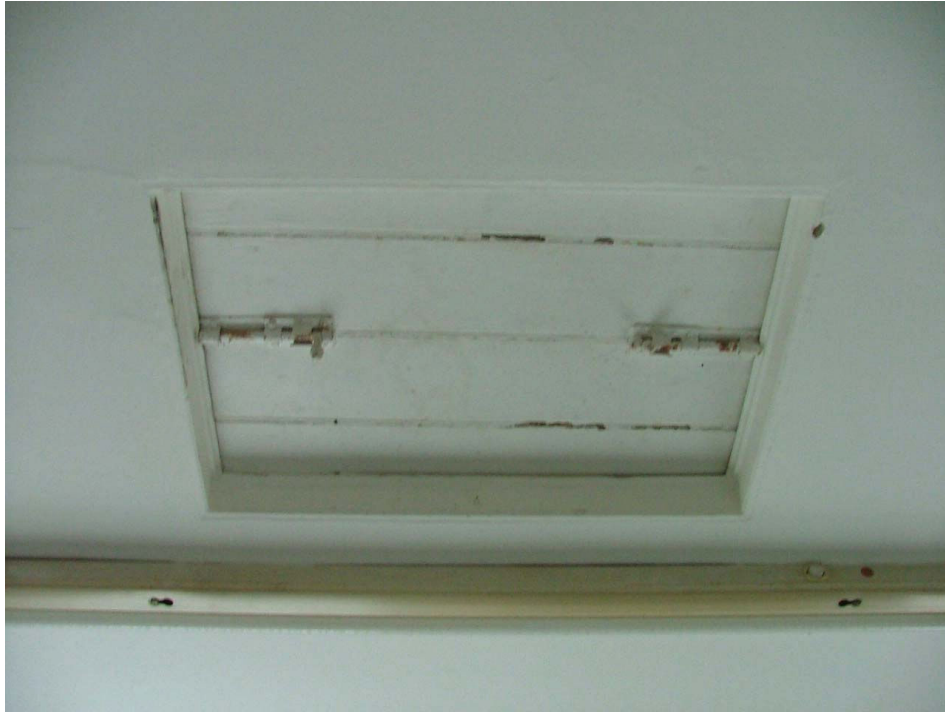
Plate 35 – Hatch with two bolts in ceiling of No.6 Armstrong Cottages

- 4.3.7 In the ceilings of what may have been the former kitchens of No's 4 to 8 (located to the north side of the cottages), hatches were observed which would have provided access to the roof space (Plate 35). The windows in the north elevations of several of the cottages in the long range were noted to have internal reveals which were constructed of a mixture of masonry blocks and brickwork (Plate 36).

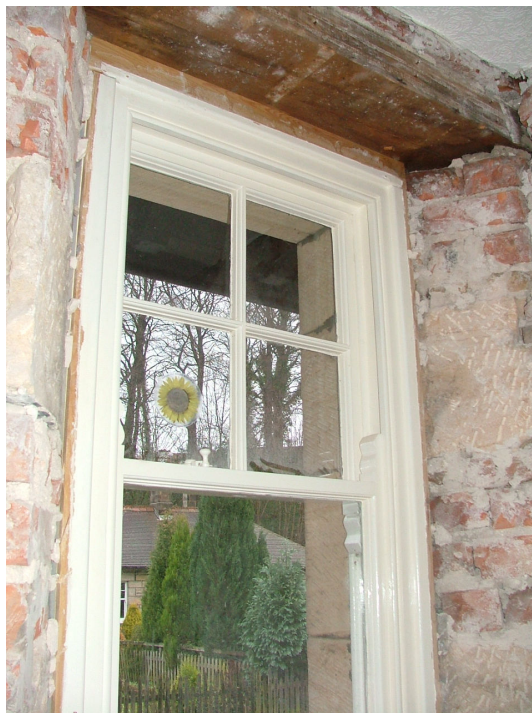
Plate 36 – Detail of kitchen window, No.4 Armstrong Cottages, showing upper 4-pane sash and reveals constructed of both masonry and brick

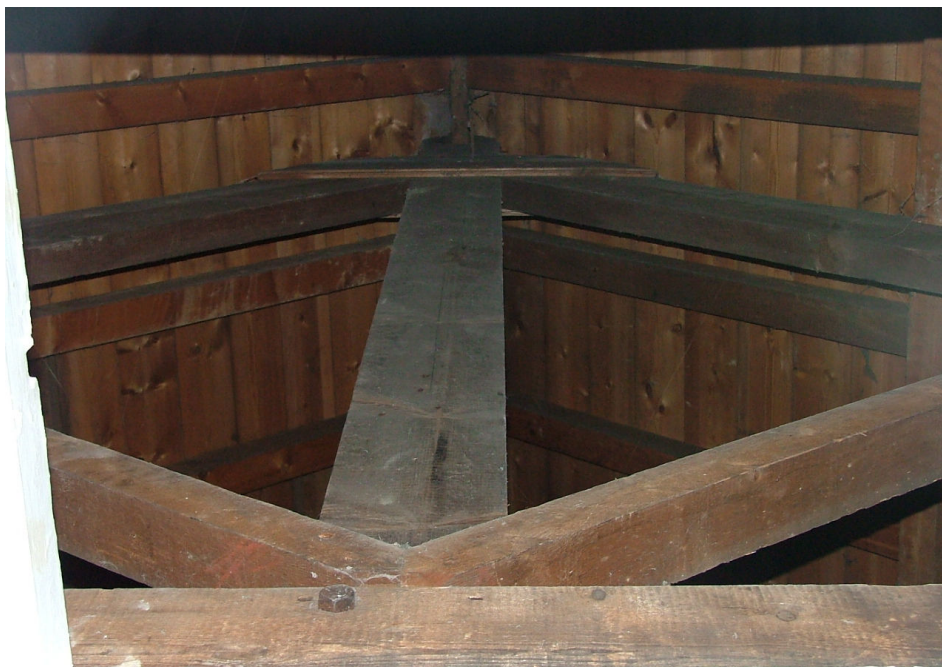
Plate 37 – Roof structure of one of the gabled projections as seen from a ceiling within No.5 Armstrong Cottages

- 4.3.8 The only area where any of the roof structure could be noted was through the hatch above the kitchen in No.5, which showed that the roof of the gabled projections was

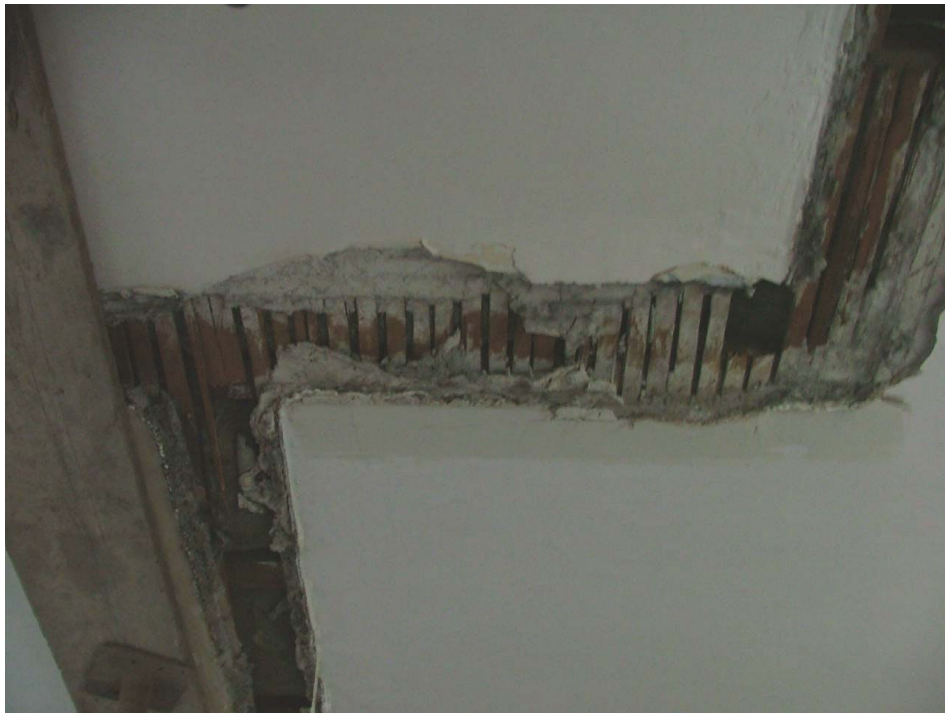
Plate 40 – Scarring in ceiling of No.7 showing line of former brick partition wall

- 4.3.9 Where the floor level has been removed in several of the cottages, it was possible to note a small aperture at the base of the internal brickwork of the main elevations (facing the lawned area) which allowed air into the building and circulate under the floorboards (Plate 38). In No.7 the former concrete floor has been removed in one room to expose a depth of c.1.20 metres below present floor level. The foundations of the building are clearly visible as being constructed from coursed masonry and the cross-wall in line with the fireplace would have supported the wooden joists for the floor boarding (Plate 39). The brick partition wall has been removed in this cottage, and in the ceiling the scarring for the former wall shows that the ceiling is constructed of wooden laths which have been plastered (Plate 40).

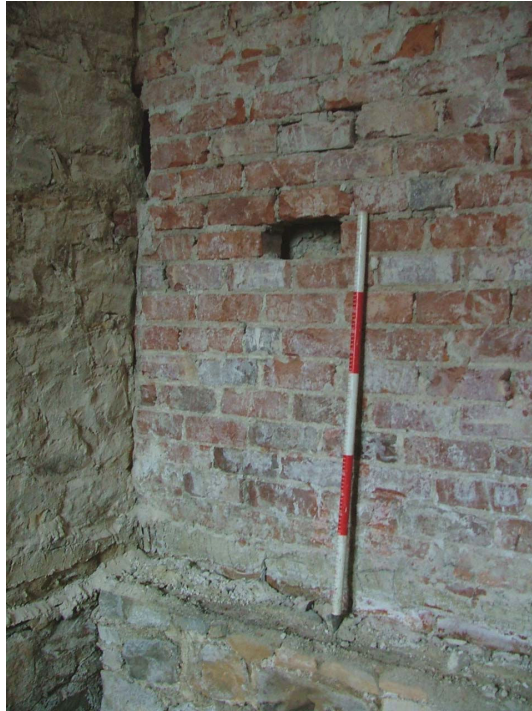
Plate 41 – Missing brick in north wall of bedroom of No.8 shows a cavity between the brickwork and the masonry wall behind (Scale = 1m)

- 4.3.10 It has already been noted that some walls in the cottages are constructed of two separate 'leaves', one of brick (always internal) and one of masonry, and it was suggested that these acted as cavity walls to allow the walls to remain dry. In No.8 Armstrong Cottages a single missing brick in the north wall of the possible former bedroom shows that there is indeed a cavity between the two different construction materials (Plate 41).

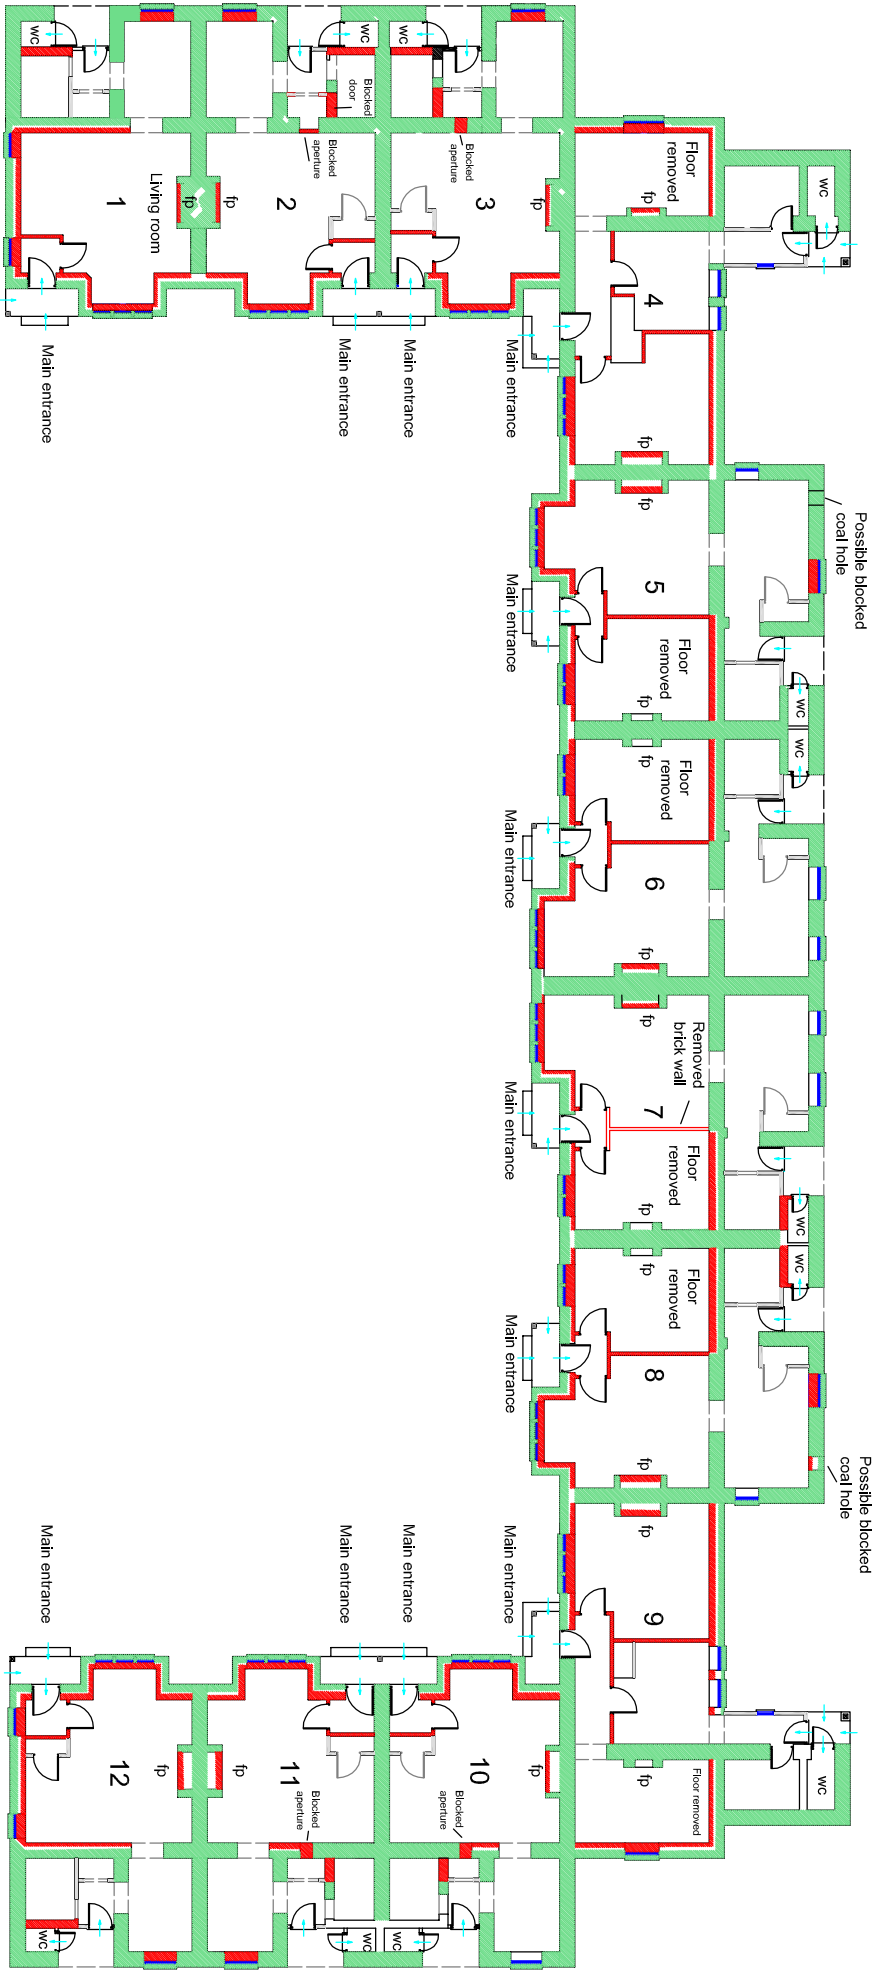
Figure 8 : Ground Plan of Armstrong Cottages

- 4.1.3 Figure 8 shows the type of construction material, where observed, of the exterior and interior walls of the cottages.
