Client Report No. 232/05

**REPORT ON AN
ARCHAEOLOGICAL
BUILDING RECORDING
PROJECT AT
ISLEKIRK HALL,
WESTWARD,
WIGTON,
CUMBRIA**

NY 2595 4455

12th January 2006

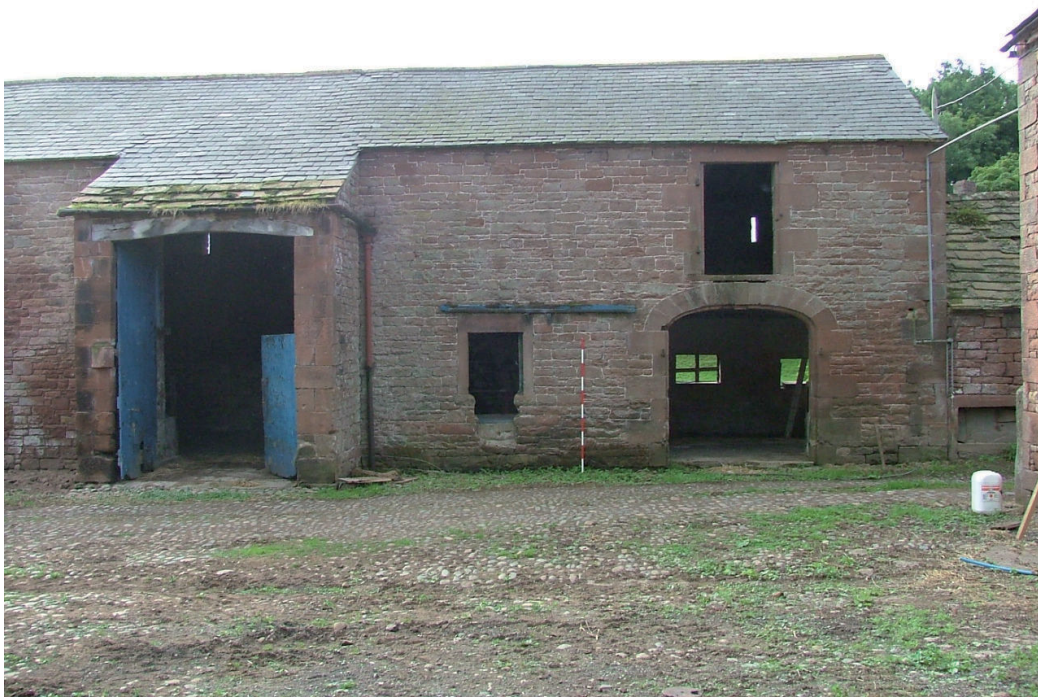
Plate 2 – North facing elevation of the large barn ‘A’

6.3.2 The northern elevation, which faces into the courtyard, has a fairly central large double doorway with projecting porch, with a re-used timber as a lintel (figure 10). The door jambs of this entrance are rebated internally, therefore the double doors opened inwards. To either side of this porched entrance there is a further cart doorway with alternating block jambs and arched heads of dressed voussoirs. Both of these cart doorways are rebated externally, therefore the doors could only open outwards. To the east of the large, almost central, doorway is a stable door again with alternating blocks of masonry making up the jambs. A single rectangular piece of sandstone has been used for the lintel, with a further dressed block two courses above (plate 3). Ryder refers to this as a ‘supra-lintel’ (i.e. an elongate block)²², although what the function of this piece of stonework is remains unclear. Also along this elevation are two windows, one to the stable or loose box, and the other to the west of the large doorway (figure 10). The surrounds of these windows are of four dressed pieces of sandstone. The sill of the western ground floor window has been partly cut away.

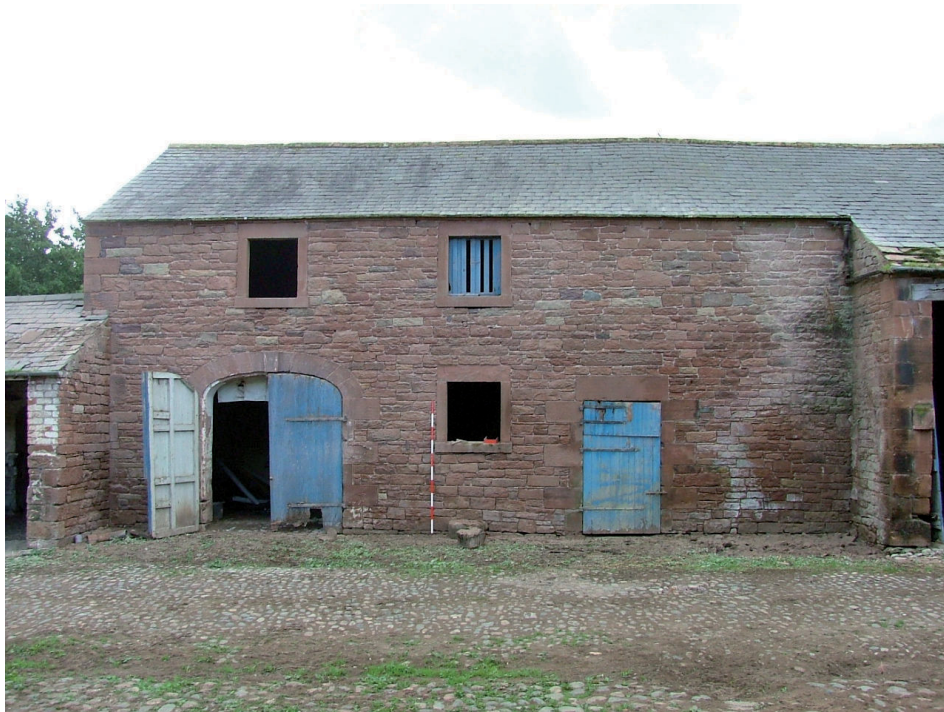
Plate 3 – Eastern end of the large barn ‘A’, northern elevation

- 6.3.3 At first floor level along the northern elevation there is a pitching doorway at the western end, used for transferring hay, straw or grain to the first floor loft (plate 3). To the eastern end of the elevation there are two further windows which provide light for a room above the stable and cart shed.

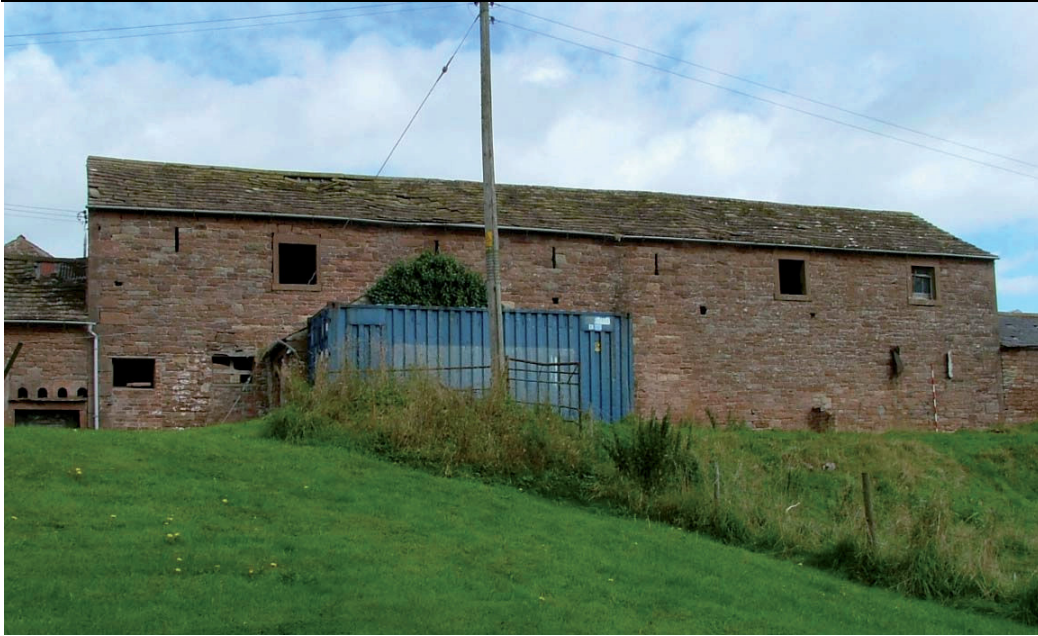
Plate 4 – South facing elevation of the large barn ‘A’ showing roof of sandstone tiles

- 6.3.4 The southern elevation of ‘A’ (plate 4 and Figure 11) has two original doorways towards its western end that have subsequently been partly bricked-up to create windows (plate 5). At the eastern end of this elevation, at ground floor level, are two ventilation slits. At first floor level, there are two windows, corresponding to those on the northern elevation providing light for the possible granary, and a further window at the western end, as well as four ventilation slits (figure 11). Parallel to this elevation is a double-channelled sheep dip, which will be referred to below (figure 9).

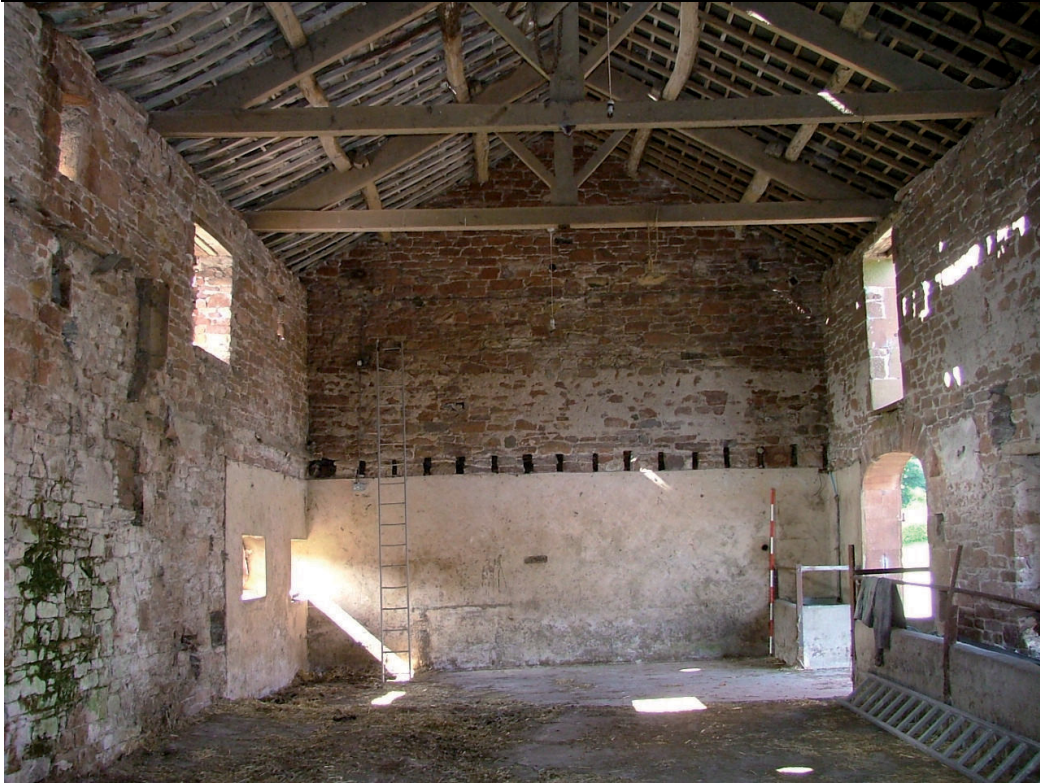
Plate 7 – Interior of 'A' looking west

- 6.4.2 At the western end of the threshing barn, there has obviously been a timber partition at some time, which originally created a separate cart shed with loft above. The cement lines and joist holes for this room are visible on Plate 7.

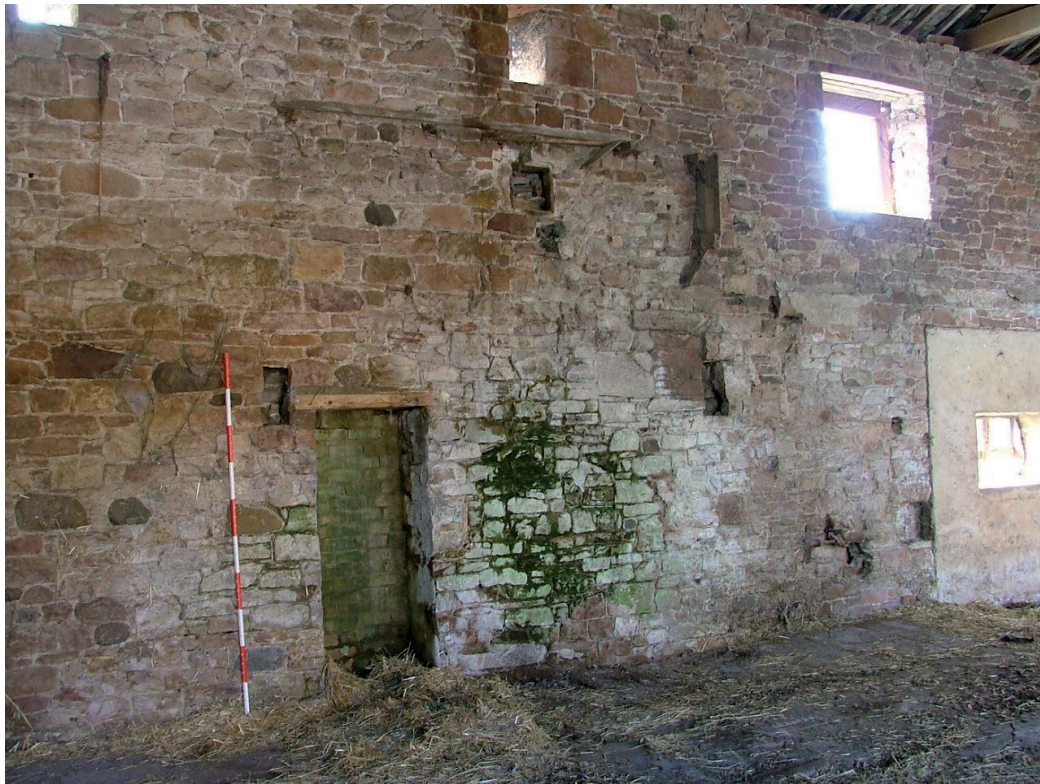
Plate 8 – Southern interior wall of 'A' showing features related to threshing cereals

- 6.4.5 Along the southern interior wall there are a series of features which are presumably related to a threshing machine (plate 8). There is a blocked aperture measuring *c.*45cm square at a height of *c.*1.70 metres from ground level (plate 9). This aperture is very similar to that observed at Hembles Gate, Brampton²⁷, where water-power was utilised for threshing cereals. It is certainly located at the same height from the ground, and the dimensions of the blocked-up hole are the same.

- 6.4.9 There is a bricked-up doorway in the southern wall, roughly opposing the large doorway into the barn (plate 8 and figure 12). It is much smaller than the other doorways observed on the farm, measuring *c.*0.60 metres wide and *c.*1.70 metres high. The other side of this doorway was observed within the interior of the building on the southern elevation of the barn.

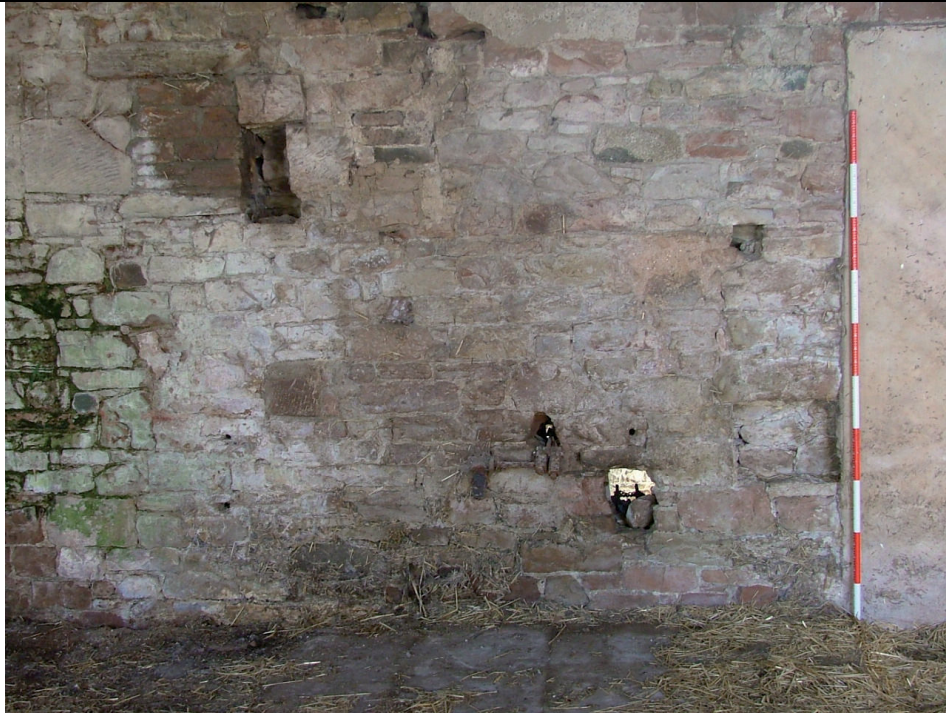
- 6.4.8 A further aperture, complete with iron housing, was observed at a lower level to that described above (plate 9). The housing within the aperture would appear to have held, at one time, a horizontal axle, which may have been driven by an oil or diesel engine located within the gabled structure behind the barn.

Plate 9 – Blocked aperture (left hand side) and lower hole for drive shaft?

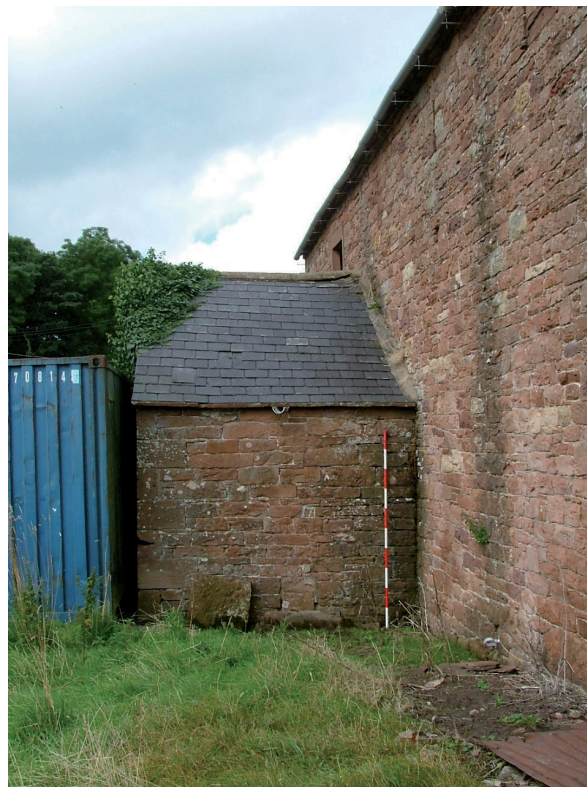
- 6.4.7 The presence of a water-wheel cannot, however, be totally discounted. A change in power source could have taken place some time prior to the publishing of the First Edition OS map (figure 1) of 1867. Portable steam-engines were available from around the mid-19th century²⁸, allowing contractors to travel from farm to farm to undertake the threshing process. Secondly, it is possible that the sheep dips (purpose-built sheep dips were introduced towards the end of the 19th century) utilised a pre-existing channel. A culvert was observed running underneath the gabled structure on the southern elevation of ‘A’; this may also have been related to a mill race (plate 10).

Plate 10 – Eastern elevation of building on S elevation of 'A', a culvert was observed running beneath this structure, parallel to the wall of the barn

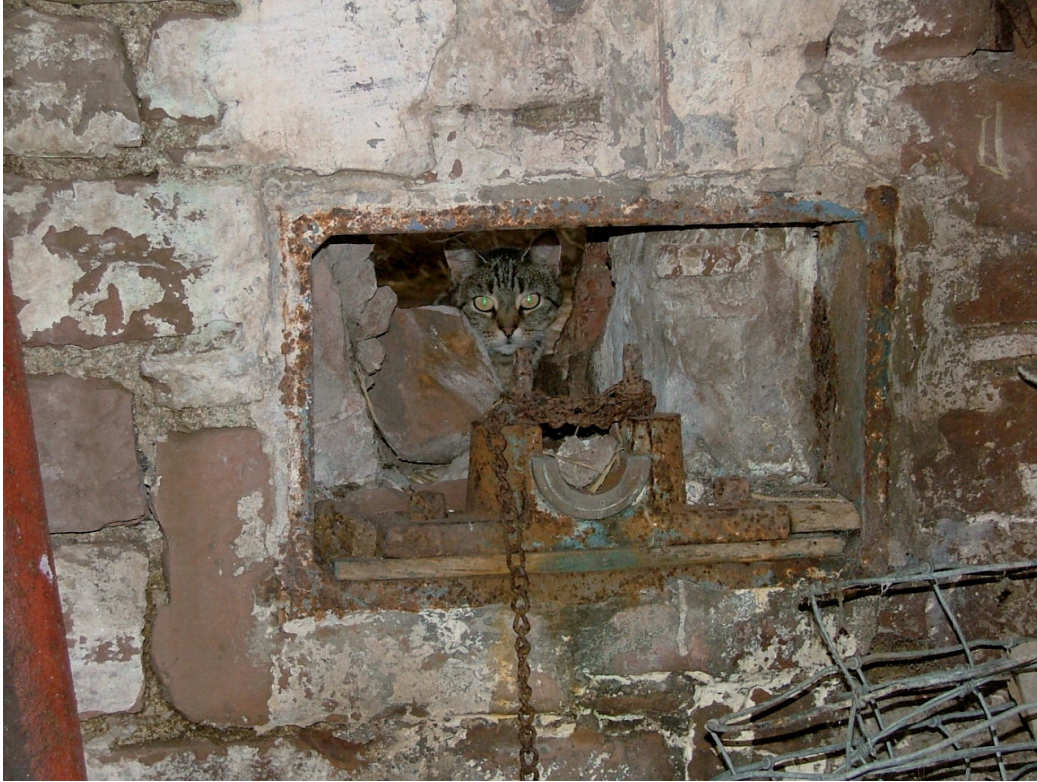
Plate 11 – Housing for a drive shaft for an oil or diesel engine used to power thresher? (Cat included for scale), as seen from the gable structure behind ‘A’

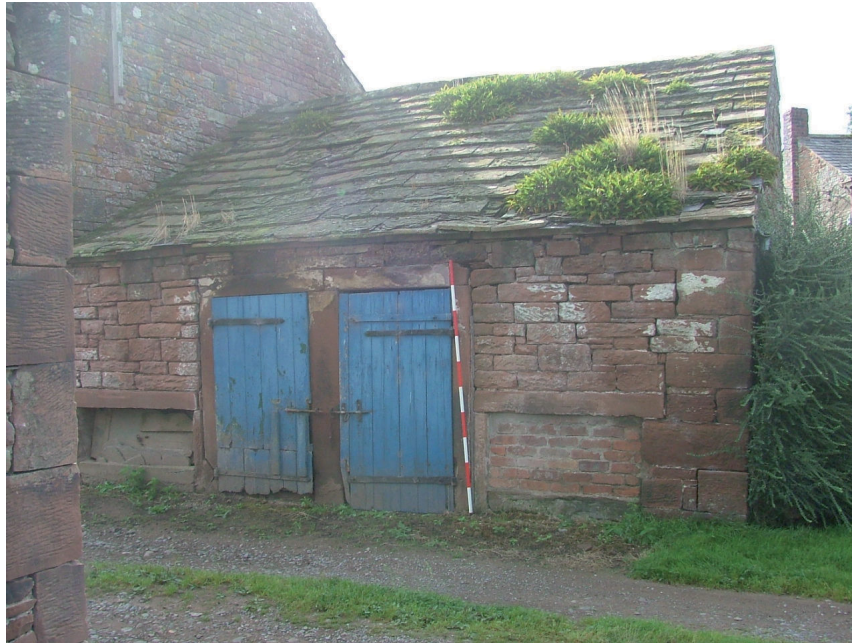
Plate 12 – Northern elevation of pigsties ‘B’

this elevation there are four round-arched nesting boxes which have been cut into large sandstone blocks with a projecting sill. Above each of the doorways on this elevation are rectangular openings at eaves level. These openings and the arched apertures would have been for poultry, and it is a common feature to find accommodation for pigs and poultry together.

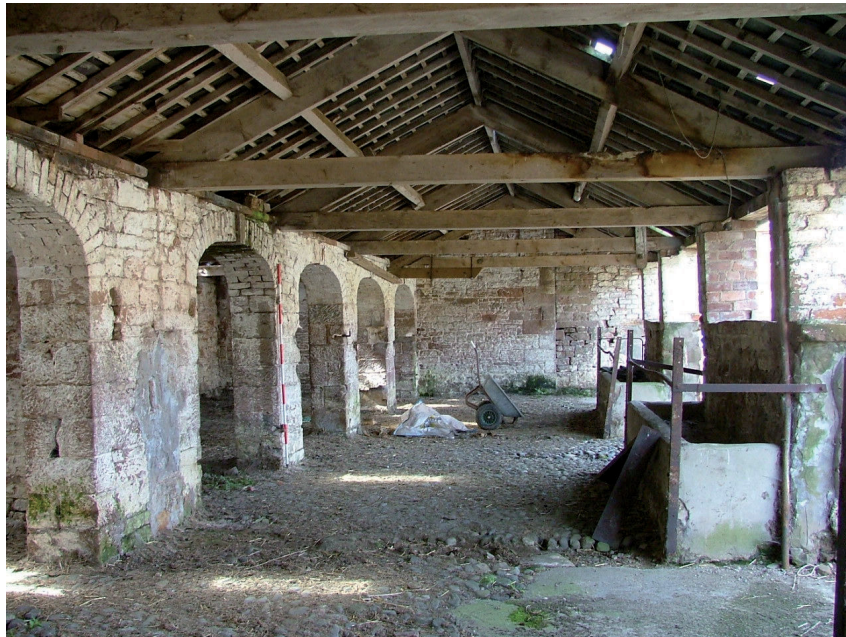
Plate 14 – View looking west showing arched doorways to cart sheds of ‘C’

6.6.1 The single-storey shelter shed is attached to the eastern end of the barn and consists of two construction phases. The earlier build measures *c.*19.40 metres in length by *c.*4.40 metres in width and is constructed of coursed, roughly squared masonry with a Welsh slate roof. This original structure consisted of four open bays, a further enclosed bay (separated from the other four bays by a masonry transverse wall) to the east and a small room at the eastern end (figure 13). The five ‘cart sheds’ are fronted to the north by a masonry arcade of five elliptical arches constructed of brick with a masonry keystone (plate 14).

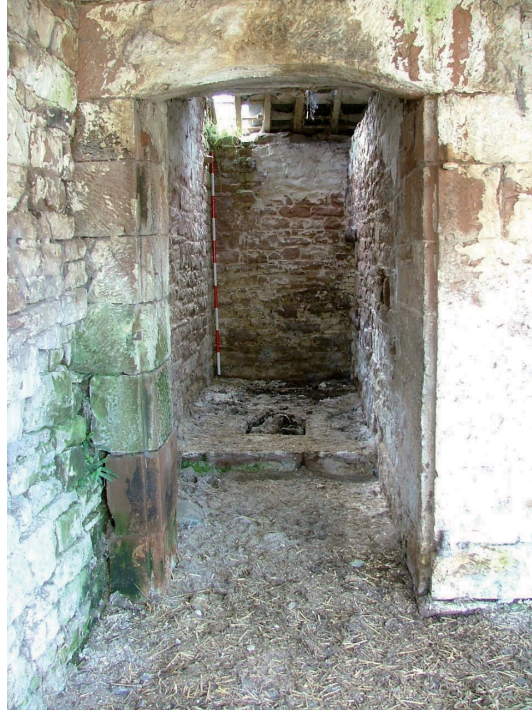
Plate 15 – Doorway and raised platform with recesses, eastern end of ‘C’

6.6.2 The small room at the eastern end of this range is accessed through a doorway with a nicely carved, slightly arched and chamfered, door lintel and door jambs that are rebated externally (plate 15). The interior of this room is unusual as there is a raised platform with two recesses, the central of which measures *c.*4.5m square (figure 13). The function of this room is unclear, Mr Skelton mentioned that he was told that it was for the collection of bull’s urine, but so far it has not been possible to confirm this in the literature. There are two holes in the wall that separate this room from the cart shed. The roof trusses of machine sawn timber consist of principal rafters and tie beams, with through purlins. There are assembly marks in Roman numerals visible on several of the trusses. The southern elevation of this range is featureless.

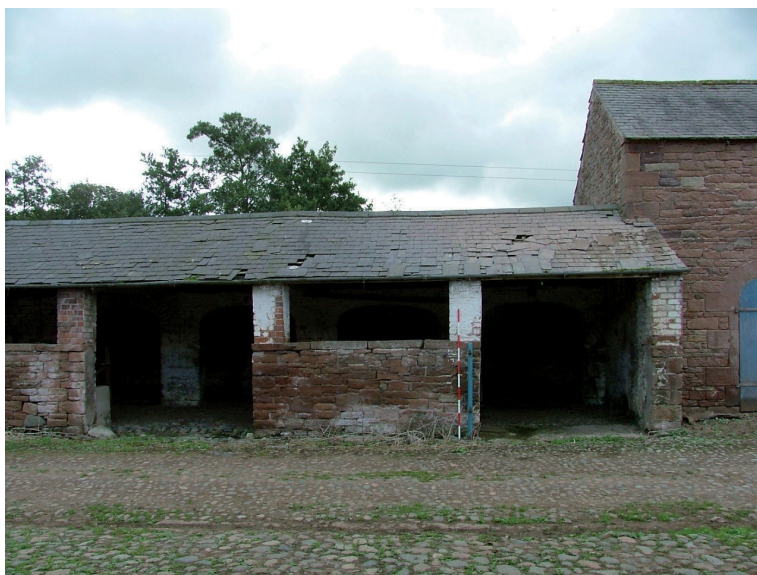
Plate 16 – Shelter shed added to northern elevation, ‘C’

- 6.6.3 The second phase of construction was the addition of a masonry wall with brick piers to support a further gabled roof; this created a shelter shed for cattle (figure 14 and plate 16). Like the earlier range, this addition has a Welsh slate roof with ceramic ridge tiles, and in fact, the two roofs appear to be contemporary and therefore the roof of the earlier range may have been re-done when the shelter shed was added. The top of the masonry wall facing the courtyard has flat slab sandstone coping on which the brick piers have been constructed.

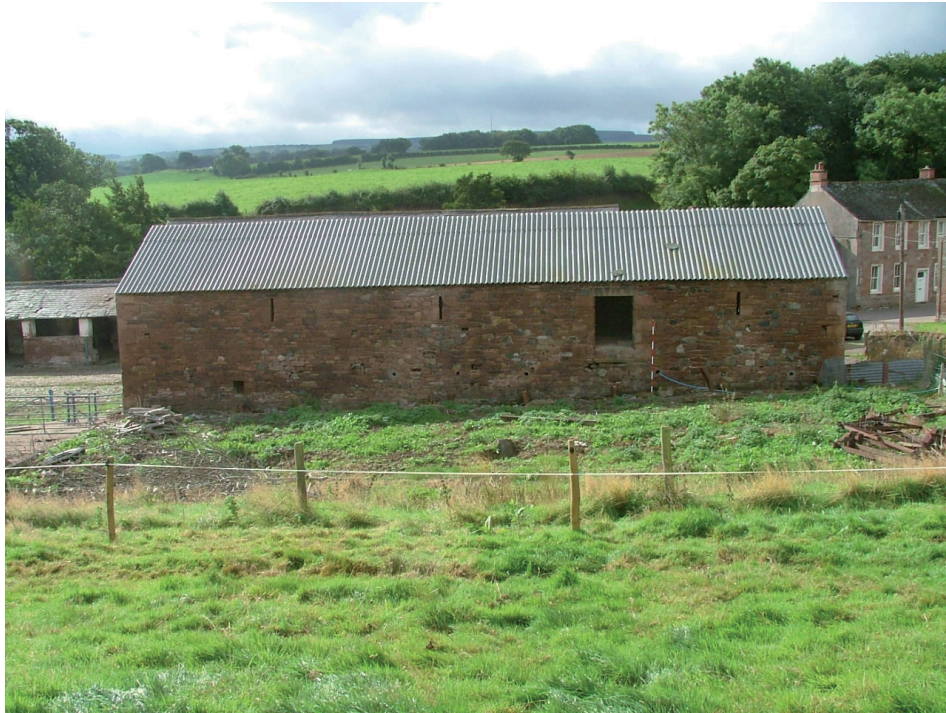
Plate 23 – Northern elevation of ‘E’

- 6.9.3 The northern elevation of Building E has a pitching door, with jambs that are rebated externally, and three ventilation slits, all at first floor level (plate 23). Towards the eastern end of this elevation there is a small aperture which is blocked internally.

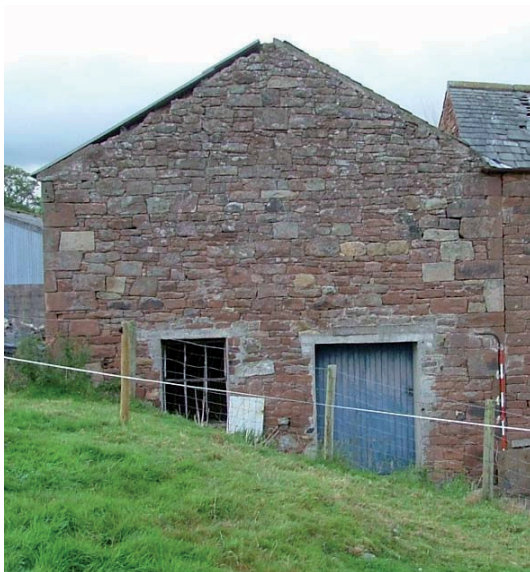
Plate 24 – Western gable end of ‘E’

- 6.9.4 Both the eastern and western gable ends have had modern doorways inserted that have obliterated any earlier entrances or windows. The western gable end has a door and window at ground level, both with concrete lintels (plate 24). The eastern gable end has had a large doorway with sliding door inserted, with a possible blocked window to the right; there are two ventilation slits at first floor level (plate 25).

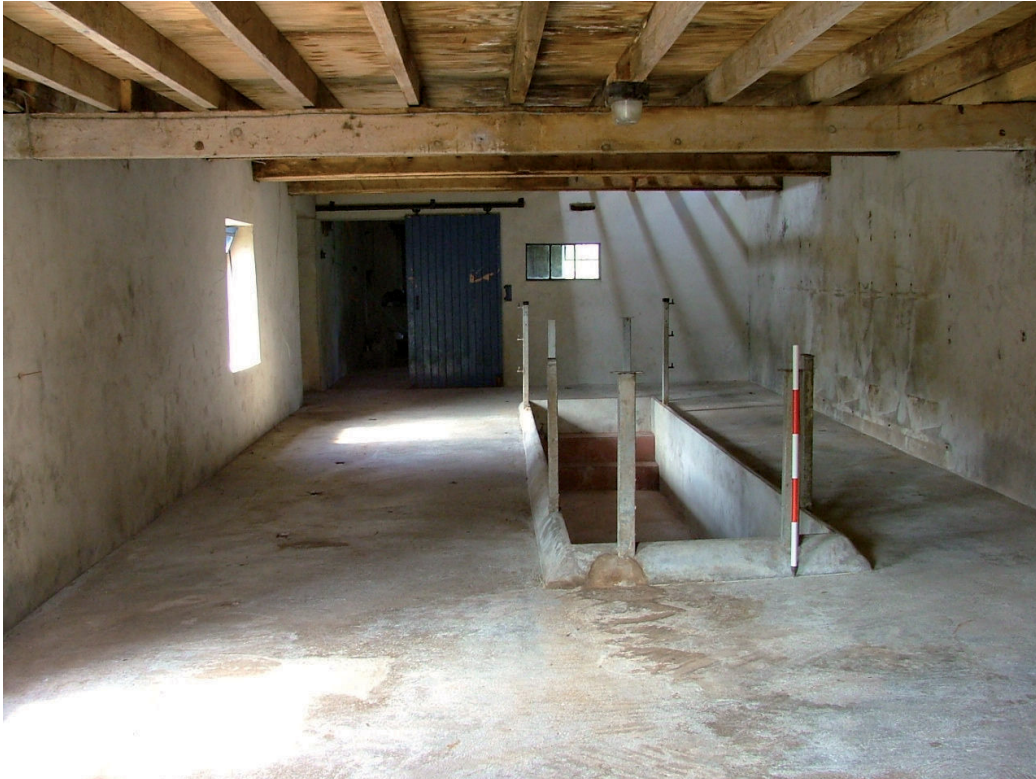
- 6.10.1 Internally this building has been completely modernised to accommodate a milking parlour complete with pit, and a concrete block partition wall, presumably providing accommodation for the dairy at the western end. The walls at ground floor level have been heavily rendered and the floor and pit is of concrete (plate 26). The ceiling timbers are machine sawn and modern, and it appears that the floor level has been raised when the parlour was modernised.

Plate 26 – Interior of ‘E’, showing pit for milking parlour and modern ceiling

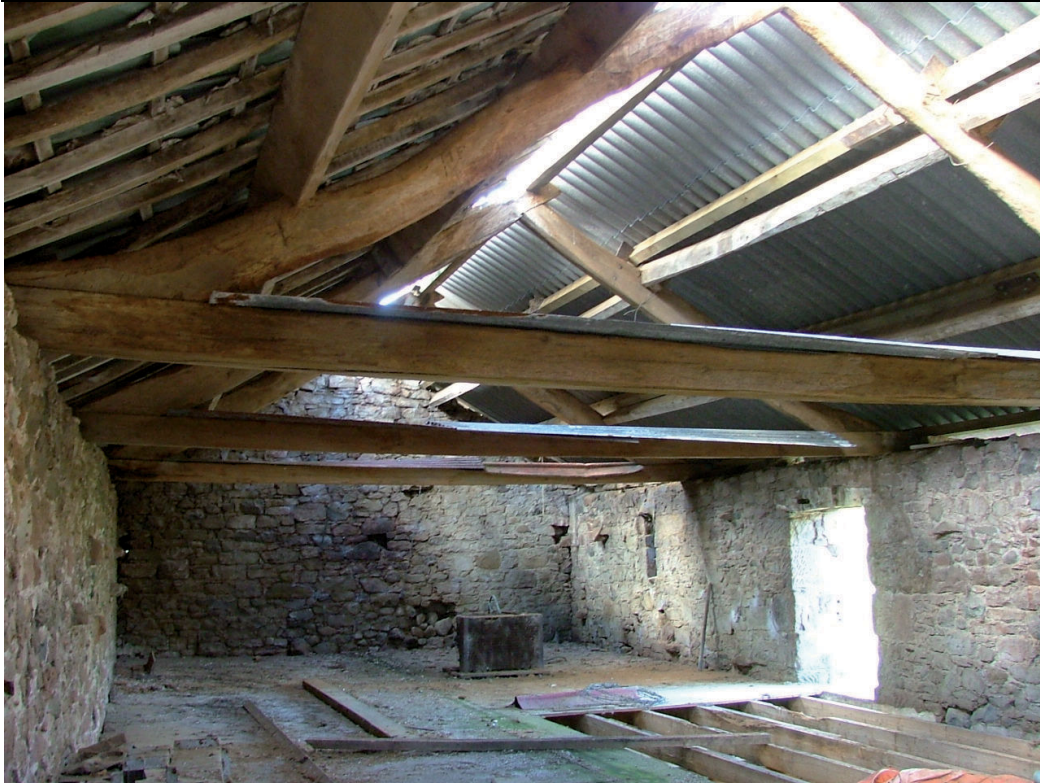
- 6.10.2 The upper floor of Building E is undivided and was presumably used as a storage loft for hay or straw. There are five principal rafter and tie-beam roof trusses, creating six bays. The timbers for the roof are generally of a poorer quality than those observed in the other farm buildings, some appear to have been hand cut rather than machine sawn, and therefore may be older, or the timbers have been re-used from an earlier building (plate 27). There are two rows of purlins to either side.

Plate 27 – Roof detail, Building ‘E’

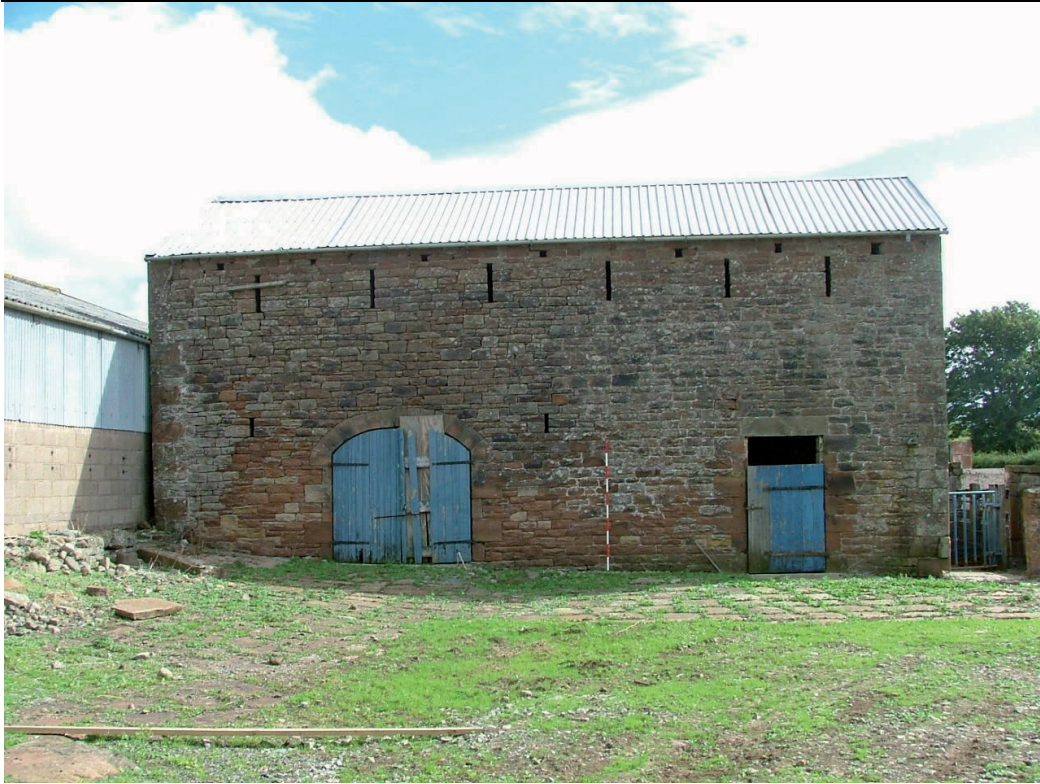
Plate 28 – Western elevation of ‘F’

- 6.11.1 This two-storey structure measures *c.*12.70 metres by *c.*4.70 metres externally and is constructed of roughly coursed and squared sandstone masonry with tooled quoins. The roof is of modern metal profile sheeting (plate 28). It is located at the north-eastern side of the courtyard and unlike the rest of the cobbled ground surface, there is paving to the front of the western elevation. Along the western elevation (figure 17), facing the courtyard, there is an elliptical-arched cart entrance (plate 28); the head being made up of 13 voussoirs including the keystone. Either side of this entrance are two small ventilation slits. To the southern end of this elevation there is a doorway with alternating blocks making up the jambs. Both doorways on this elevation are rebated externally, indicating that the doors opened outwards. At first floor level there are six ventilation slits and, just below eaves level, a series of seven smaller holes. A small brick-built pen is not shown on the architects drawing of this elevation (figure 17), although it is visible on Plate 29.

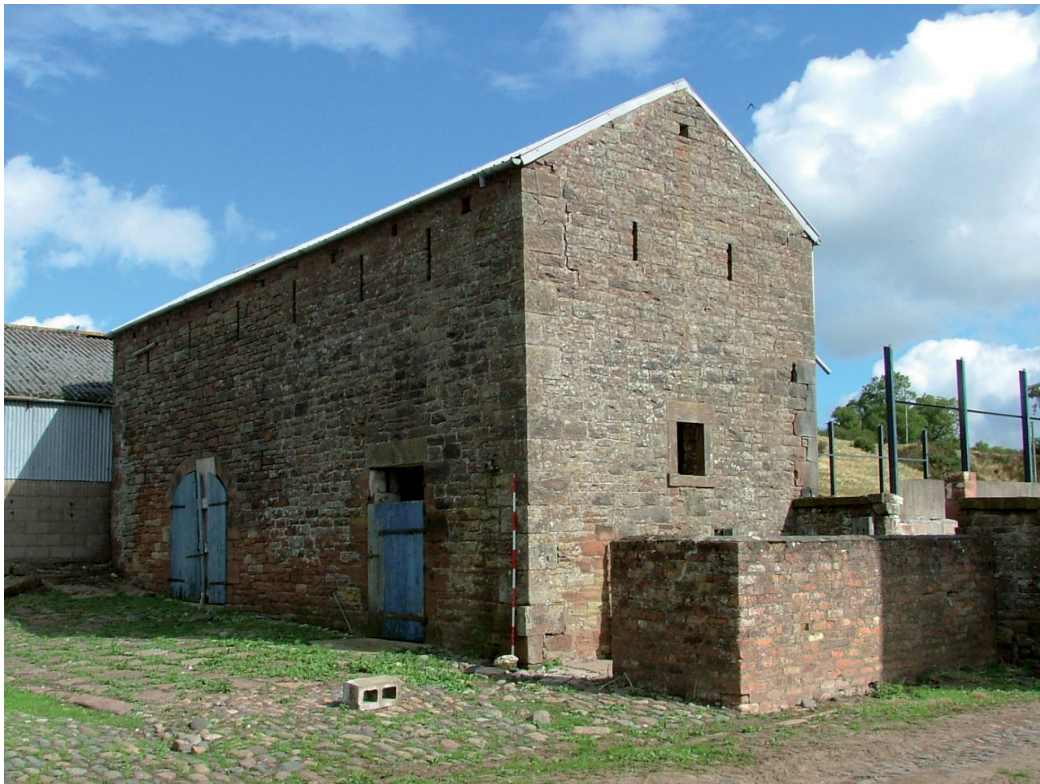
- 6.11.2 The southern elevation of Building F has a window at ground floor level, with stone surround, two ventilation slits at the upper level and a small hole, similar to those observed below eaves level on the western elevation, near the apex of the gable end; this appears too small to be an owl hole (plate 29).

Plate 29 – Southern elevation of ‘F’

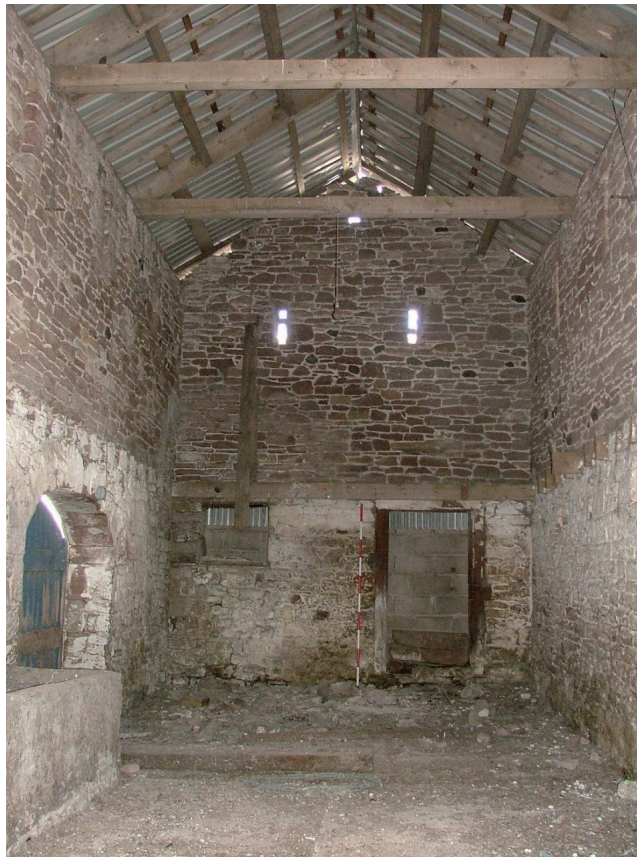
Plate 31 – Interior of ‘F’, looking north

- 6.12.1 Internally, Building ‘F’ has had a floor for an upper storey and a transverse ground floor wall removed, therefore the entire length and height of the building was open with no divisions (plate 31). The walls of the ground level have been lime-washed suggesting that animals were housed in at least part of this building. Lime-wash was a common wall coating on Cumbrian vernacular buildings including farmsteads, both externally and internally; it acted as a disinfectant as well as absorbing moisture, but it allowed the walls, whether stone or clay, to breathe³¹.

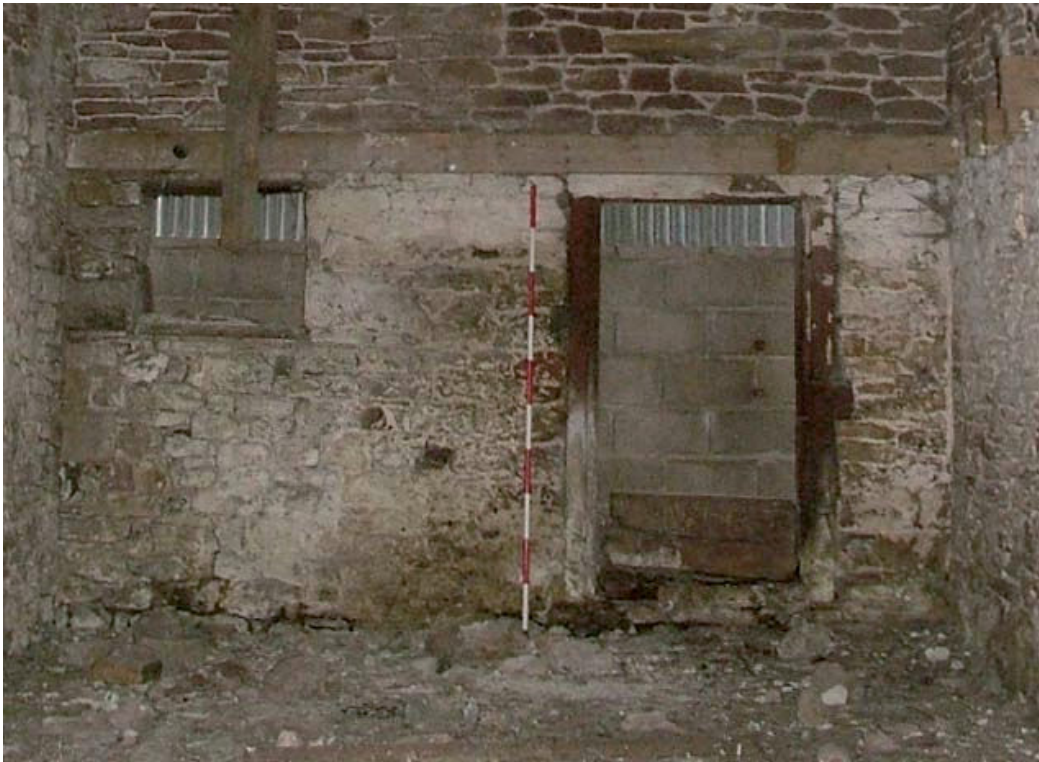
- 6.12.3 At the northern end of this building is the doorway and window referred to in 6.11.4. The door jambs are constructed of a single upright piece of sandstone on the western side and two upright pieces to the eastern. The jambs are rebated internally, although if this is a surviving doorway from an earlier building, then the door may have originally opened outwards. The First Edition Ordnance Survey map does not show Building F (figure 1), however there is a range, which has obviously now gone, aligned roughly east-west to the north of (and at a right angle to) Building F. This doorway (and possibly the window) may be surviving features of this earlier range. There is a step at the base of this doorway.

Plate 32 – Doorway and window in northern gable end of Building ‘F’

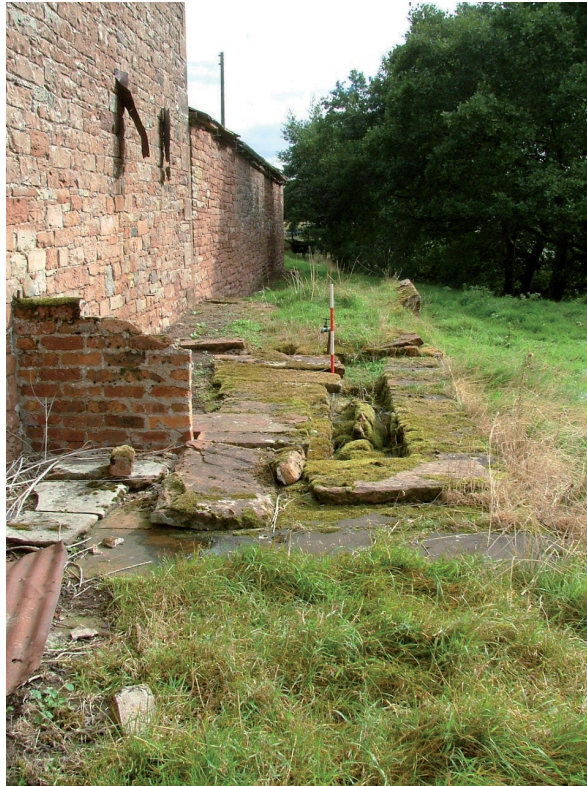
Plate 33 – The sheep dip located to the rear of Building ‘A’ (view looking east), showing one of the two channels, the other is capped in sandstone slabs

- 6.13.1 The sheep dip is situated at the rear (southern elevation) of Building A (figure 9). It consists of two parallel channels lined with red sandstone slabs, each channel measuring *c.*0.50 metres in width by *c.*4.50 metres in length (figure 18 and plate 33). At the eastern end of the sheep dip is a tap and a circular hole cut into a piece of sandstone (plate 34); the stop tap for the water supply was observed in the base of a metal milk churn that had been placed within the ground just to the south-east of the dip. Steps into the channels were also observed at the eastern end of the sheep dip, possibly suggesting that the sheep were placed into the dip at the western end and could exit the dip up the steps at the eastern end.

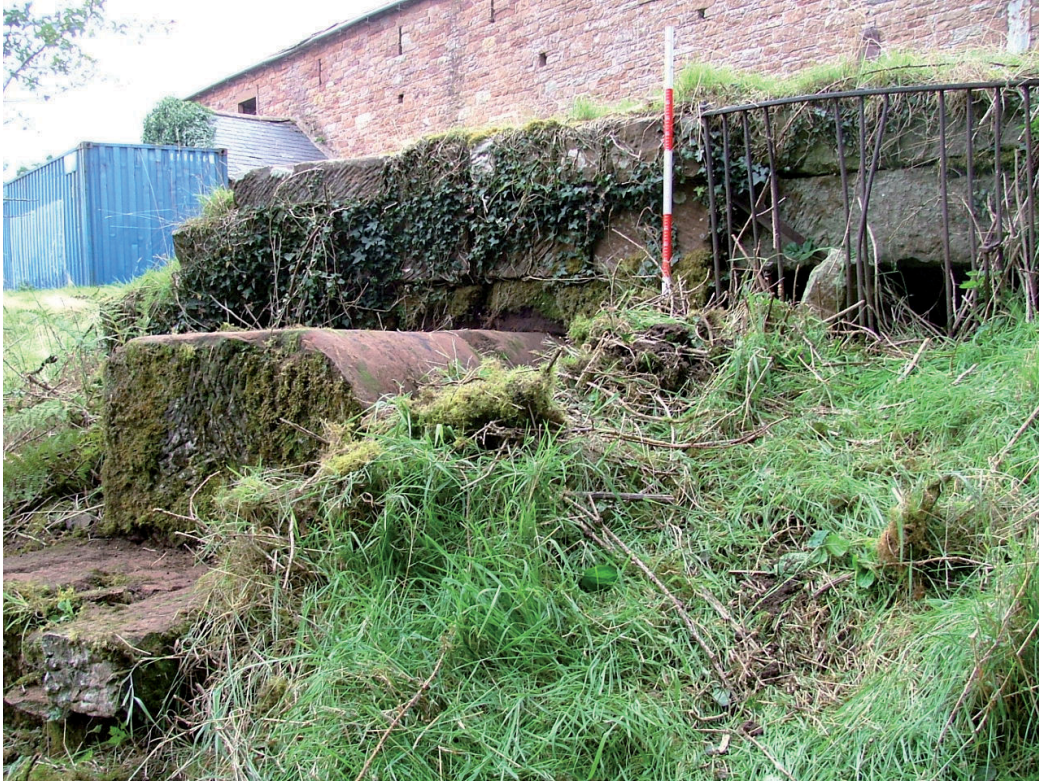
Plate 35 – Culvert with iron grill (to the right of ranging pole) and remains of the weir for the sheep dip

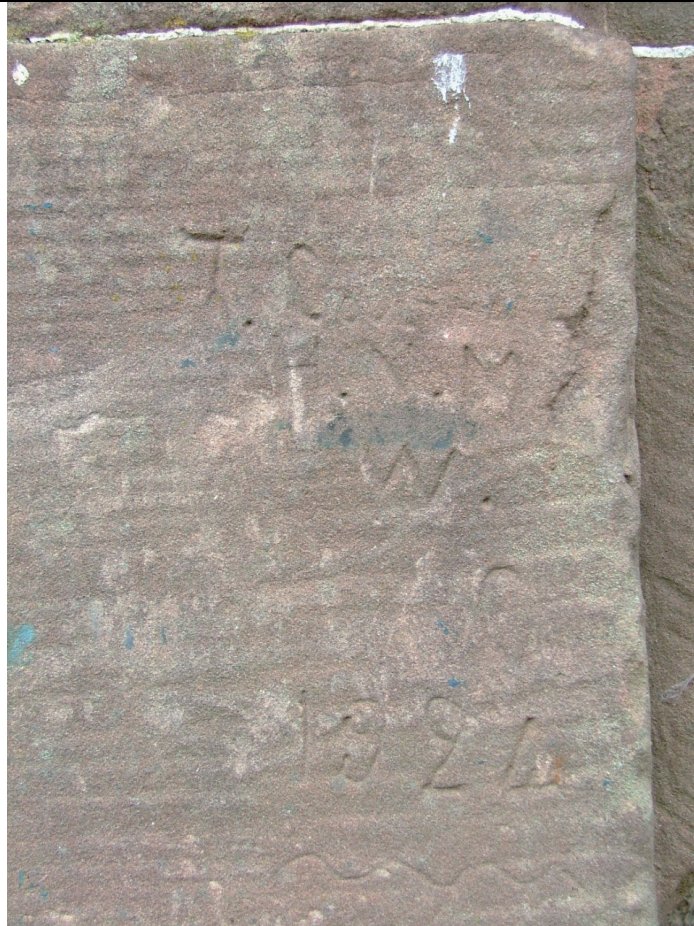
Plate 36 – Graffito in doorjamb of cart shed doorway, ‘A’

- 6.14.1 Like many farmsteads, there were several pieces of graffiti observed at Islekirk Hall inscribed into door jambs. Carved into one of the blocks making up the door jambs for the western cart shed doorway of Building A were the initials and date (plate 36): -

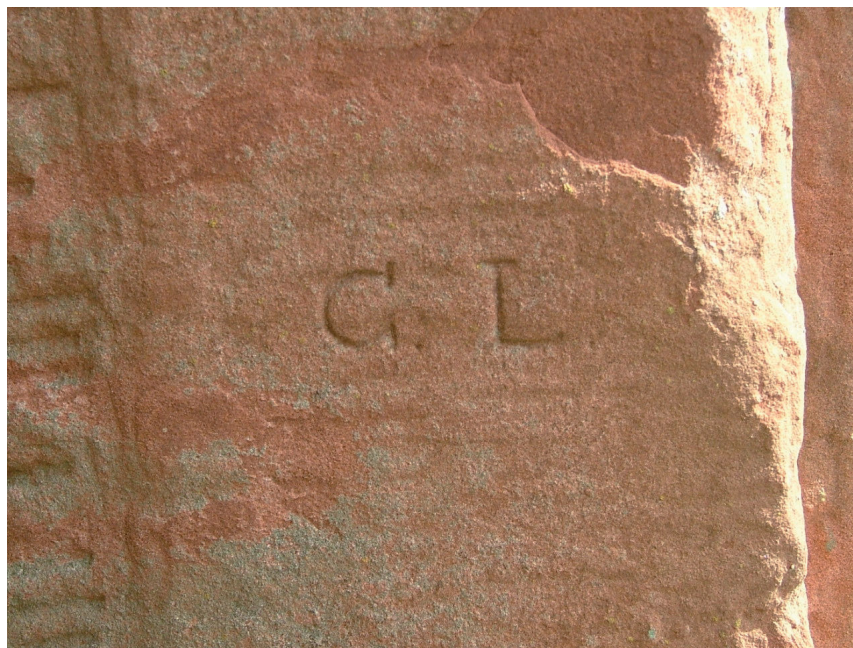
Plate 37 – Graffito in door jamb of southern pitching door, ‘E’

And carved into the door jamb of the southern pitching door of Building E, were the initials (plate 37): -

C. L

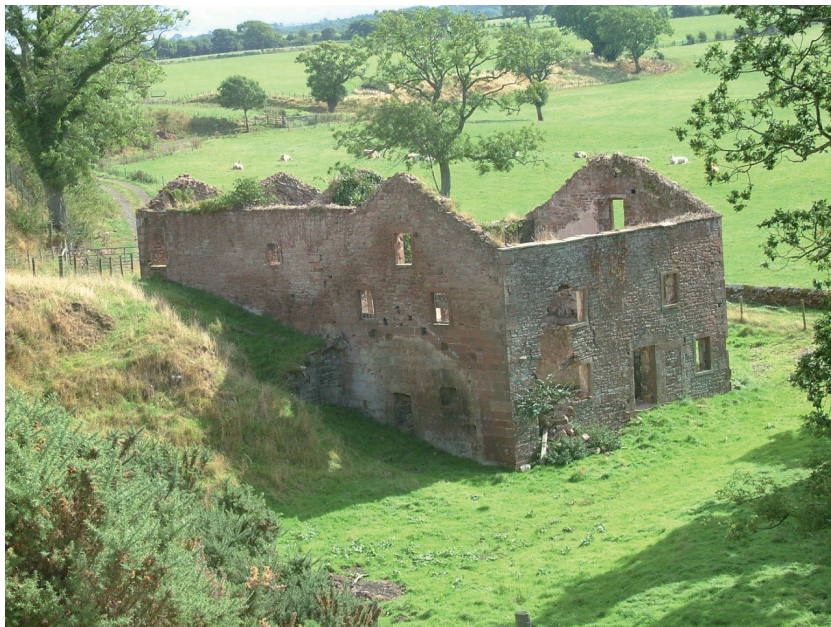
Plate 38 – Islekirk Mill as seen from the north-west

- 6.15.1 The remains of Islekirk Corn Mill are situated approximately 160 metres to the north-east of the farm buildings, on the same side of the river (the north side), although the access road to the mill from the farm crosses the Packhorse Bridge and then crosses the river again at the Mill Bridge (figure 4). At the time of Peter Ryder's assessment in 2002, the mill was covered in ivy and there were mature trees growing within the mill interior³², however at the time of the present survey, the mill had been completely cleaned out internally and the exterior walls had been stripped of any foliage by Mr Skelton. During the storms in January 2005, the western elevation of the mill had suffered some damage, with a section of wall between a first floor and a ground floor window having collapsed (plate 38).

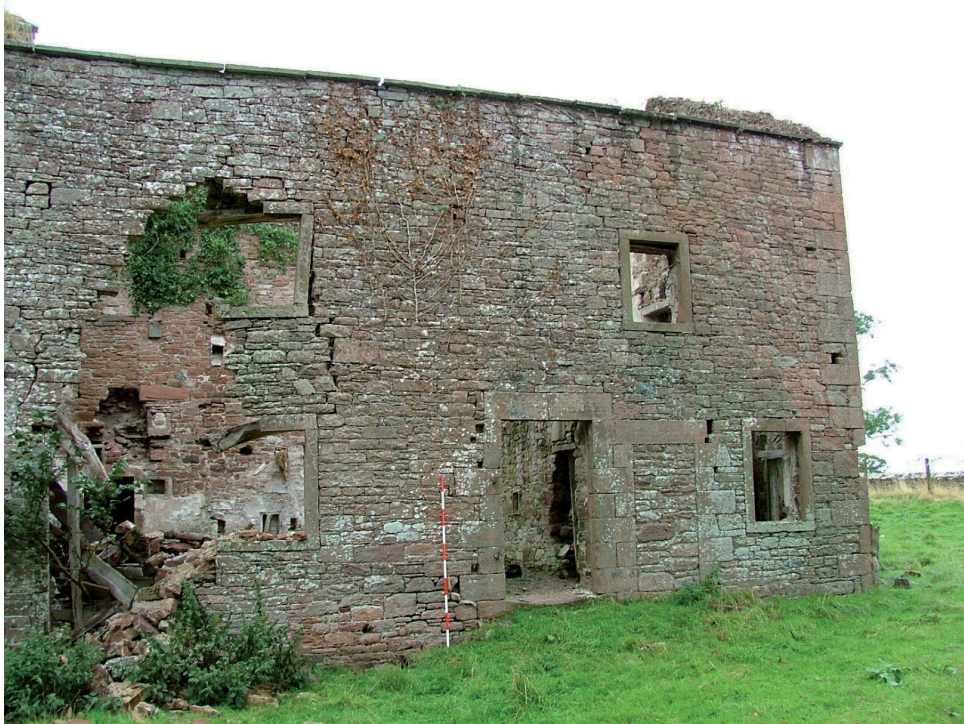
- 6.15.2 The main rectangular block of the mill building is of two storeys (plate 39), although like most corn mills, the roof space appears to have been utilised as shown by the windows close to the roof apex's in the north and south gable ends. According to Brunskill, the topmost level of water-powered corn mills was used for storage, for example of the grain to be ground³³. The western elevation, which faces the River Waver, has a central doorway, with a shorter and thinner doorway (now blocked) immediately to the right (plate 40 and figure 22). These two doorways appear to be contemporary as shown by the lintel of the smaller door forming the uppermost jamb of the larger doorway. The sandstone step of the larger doorway is heavily worn. Up until January 2005, there was a further doorway towards the northern end of this elevation; however storm damage has caused a section of the wall to collapse and only the straight line of the door frame can be seen to the left of the damaged window surround on Plate 39. Peter Ryder's observations of this aperture in 2002 were *'At the north end is a rather strange [word missing], its left jamb is of neatly-cut blocks coursed in and surely contemporary with the adjacent angle quoins, but the right [jamb] is simply roughly cut into the wall masonry; the lintel is timber, a patch of infill above'*³⁴ There are two windows at ground floor and first floor levels, all have stone surrounds of red sandstone. The sandstone wall plate is also visible on Plate 39.

Plate 39 – Western elevation of the mill

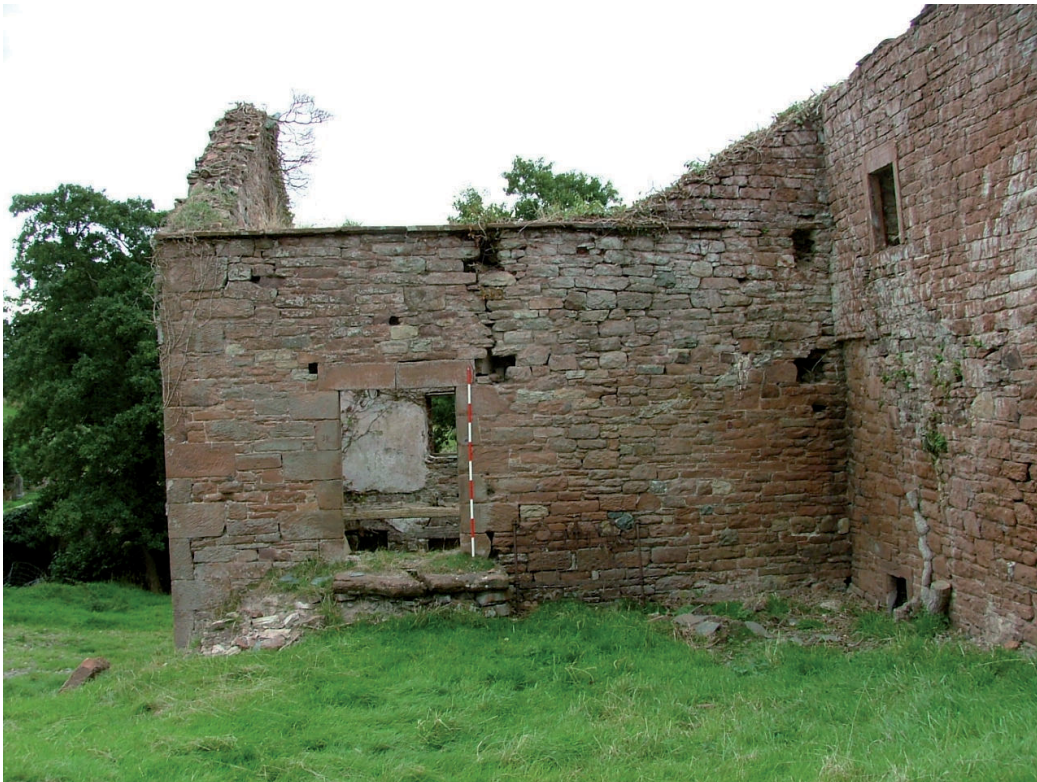
- 6.15.5 The eastern elevation (plate 42 and figure 24) of the main section of the mill can only be observed externally at the southern end of the building as the remainder is hidden behind the later addition that runs at a right angle to the main structure. Towards the southern end is a doorway with alternating blocks making up the jambs and a large sandstone lintel, now cracked in two. This doorway would have given access to the first floor of the mill as the building has been constructed into a bank.

Plate 42 – Eastern elevation of main mill building, with the additional building to the right of photograph
