Client Report No. 232/05

**REPORT ON AN
ARCHAEOLOGICAL
BUILDING RECORDING
PROJECT AT
ISLEKIRK HALL,
WESTWARD,
WIGTON,
CUMBRIA**

NY 2595 4455

12th January 2006

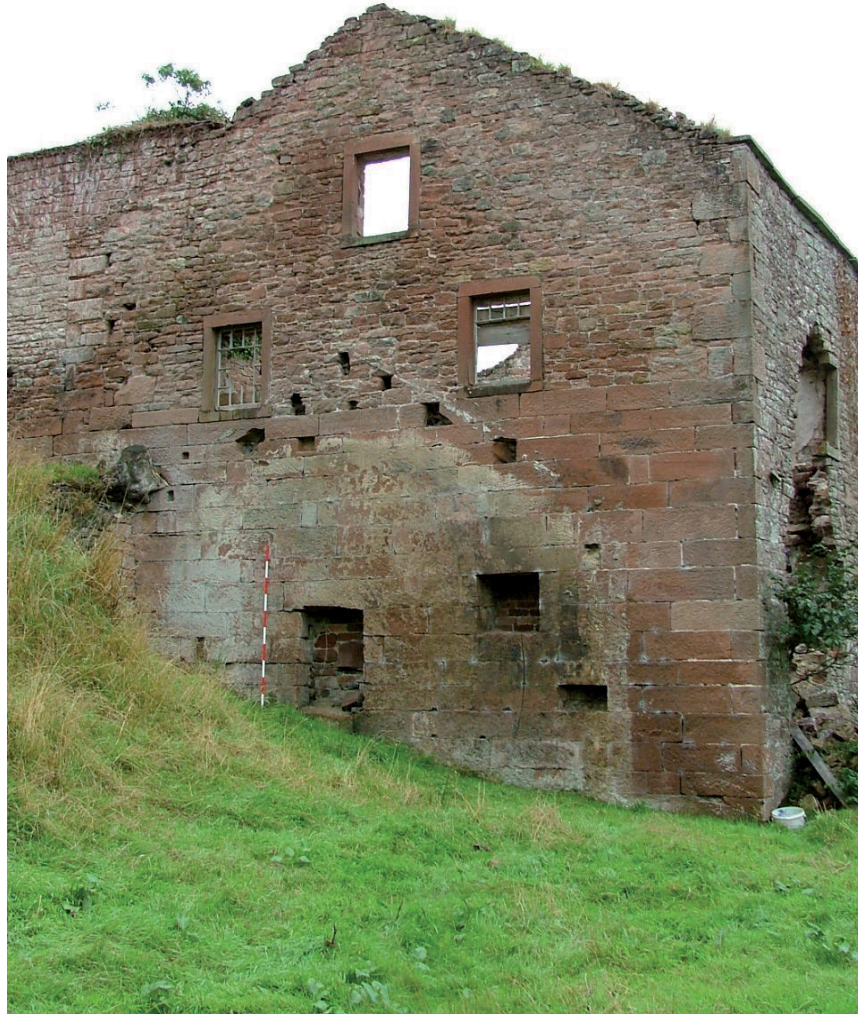
evidence for the former wheel-house that would have protected the water-wheel from frost, prevented the wheel from warping and allowed grease to remain on the bearings longer³⁵ (plate 43). The axle hole for the water wheel remains, partly blocked (plate 44), and now almost at ground level, highlighting that there appears to have been a programme of land-moving undertaken in this area, as well as the complete removal of the wheel-pit and structures to the north of the mill that are shown on both the First and Second Edition Ordnance Survey maps (figures 1 and 2).

Plate 43 – Northern elevation showing the location of the former wheel-house

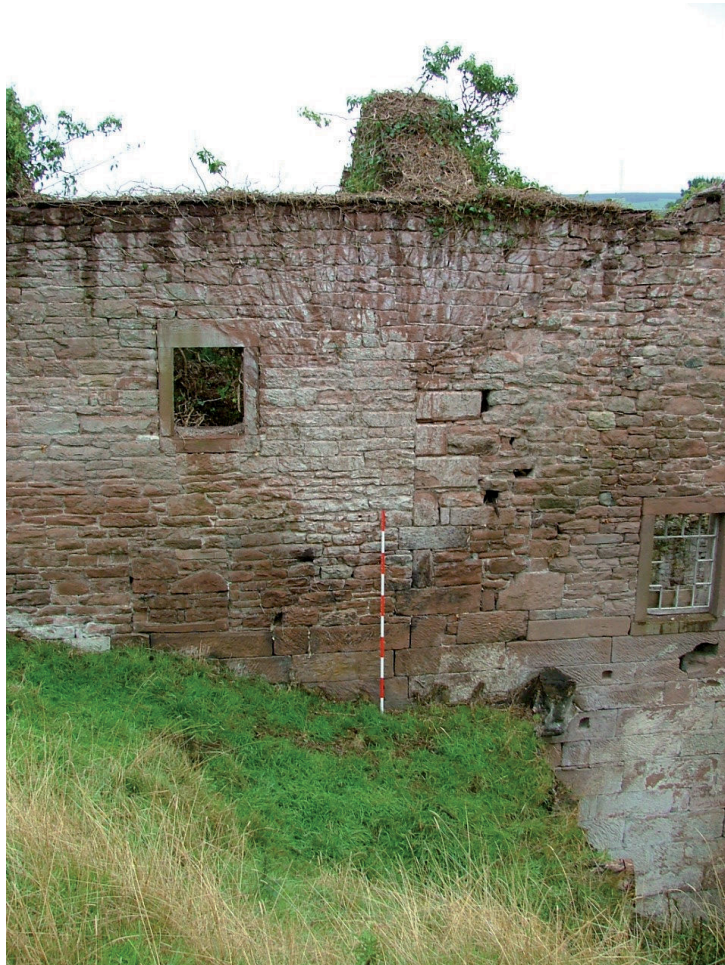
6.15.7 The evidence for the different construction phases between the main mill building and the gabled addition at the north-eastern side can be clearly seen from the north-west (plate 47 and figure 27). Here, the stonework of the addition can clearly be seen abutting the quoins of the larger section of the mill, as well as built onto part of the gable end. This addition to the main mill building is rectangular in plan but because the mill has been built into a steep bank, the ground level (which only consists of the base of the corn dryer) and the upper levels differ in length. Along the northern elevation of this building is a doorway which, due to the steep bank, would have originally given access to the upper floor, there is a window with stone surround, and a further window (now blocked) just above the course of ashlar which continues from the main mill building (plate 48). The gabled eastern elevation of this wing is featureless (plate 49).

Plate 47 – Northern elevation of mill showing construction break between the main mill and the addition

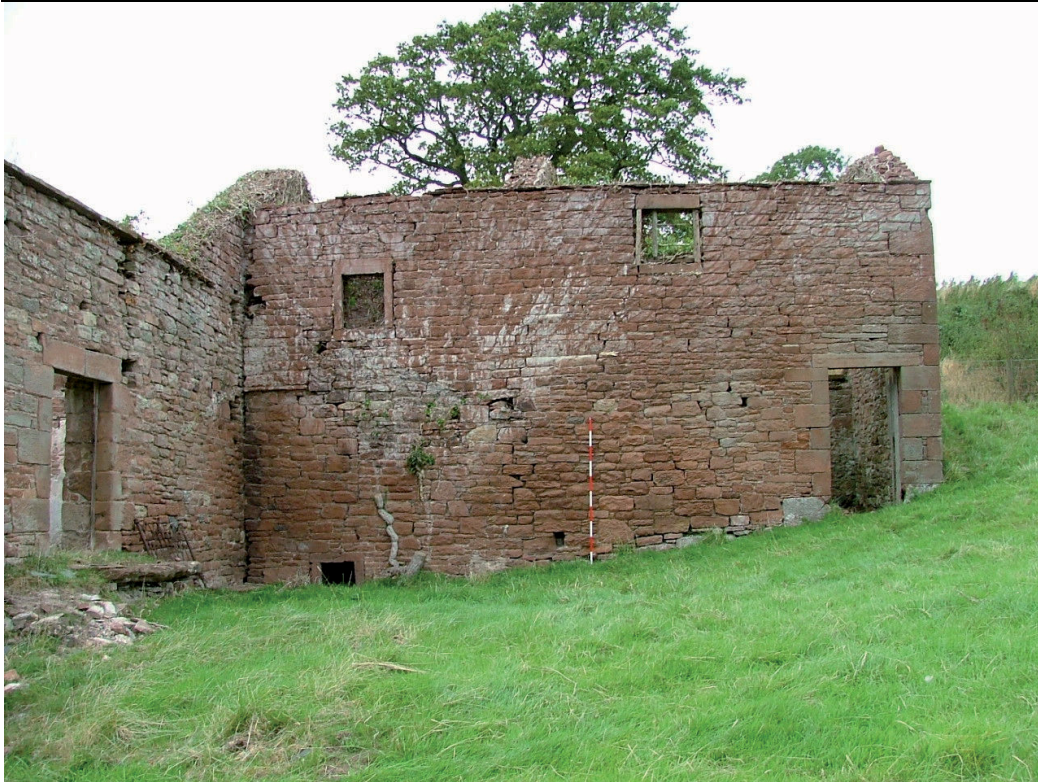
- 6.15.10 What is slightly curious about the addition of the rear wing is, firstly, the western gable end of this structure which was built onto the eastern wall of the main mill building (plate 50). The gable end is wider than the rear wing itself, leaving a fairly shallow pitch for the roof. And secondly, the blocked windows on the southern and northern elevations (plates 50 and 47), and the blocked doorway which was observed in the eastern interior wall of the main mill building (plate 54). It seems as though during construction it was realised that the windows and door were in the wrong positions in relation to the corn-dryer and were consequently blocked-up and inserted at a higher level.

Plate 50 – South facing elevation of rear wing (eastern side) of mill

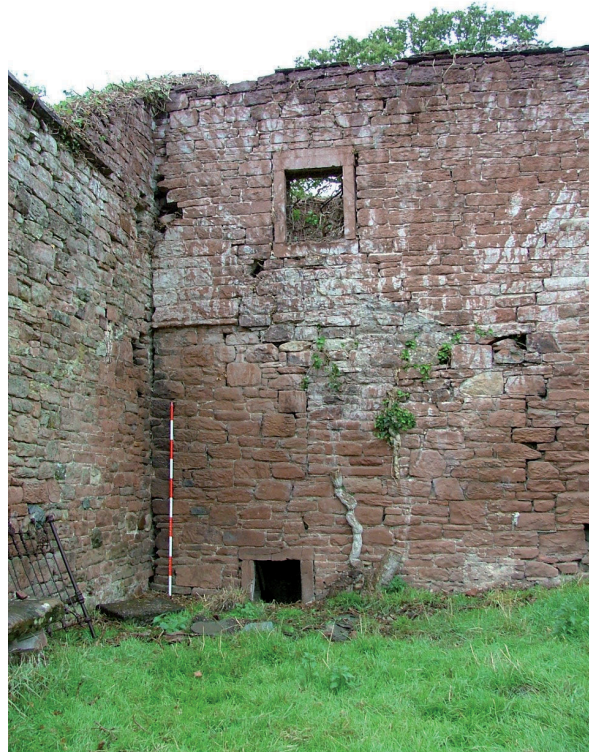
Plate 51 – Western end of south facing elevation of rear wing showing window to corn dryer, blocked and upper windows and difference in stonework

- 6.15.8 The south facing elevation of the rear wing has a variety of features (figure 28). At the base of the elevation, at the western end, there is a small window which provided light for the base of the corn dryer (plate 50). Just to the east, and slightly above this window, is a blocked window which still retains its sill but the jambs and lintel has now gone. To the eastern end of this elevation is a doorway with dressed blocks of sandstone making up the jambs and lintel, into one of these blocks are the initials 'TM' and 'IE', these will be referred to below.

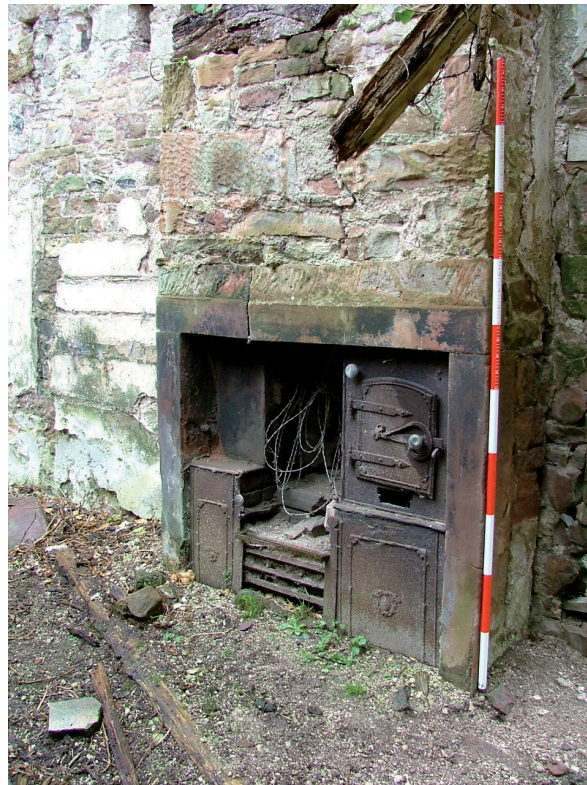
Plate 52 – Range and scarring for shelves, ground floor interior of mill

- 6.16.1 The interior of the main mill building could be accessed via the doorways in the southern or western elevations. At ground level, the main body of the mill is divided into two sections (figure 19). The southern end contains a range with a nicely dressed sandstone surround, a blocked cupboard and scarring on the wall where shelving was once present (plate 52). There is a doorway in the partition wall, however, as it only measures *c.*0.50 metres wide, it is not the usual width for a standard doorway (which appear to measure around one metre), and therefore may not be an original feature.

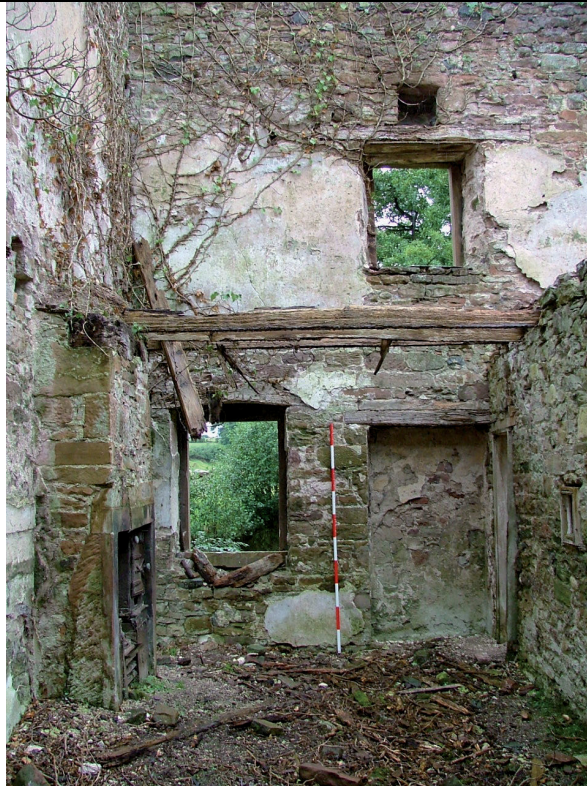
Plate 53 – Blocked doorway and window, western wall of main mill building

- 6.16.2 The blocked external doorway, which was observed on the western elevation, still retains its timber lintel (plate 53). Within the partition wall is a square aperture with a wooden lining that measures *c.*30cm square. The northern end of the ground floor is where the machinery and gearing for grinding the corn would have been located. There were various features in the northern and eastern walls observed which presumably related to some of the machinery. Along the eastern wall is a doorway which provided access to the base of the corn dryer and several wooden lined apertures in the wall. At first floor level there is a blocked doorway, with a further doorway above which would have given access to the drying floor of the kiln (plate 54).

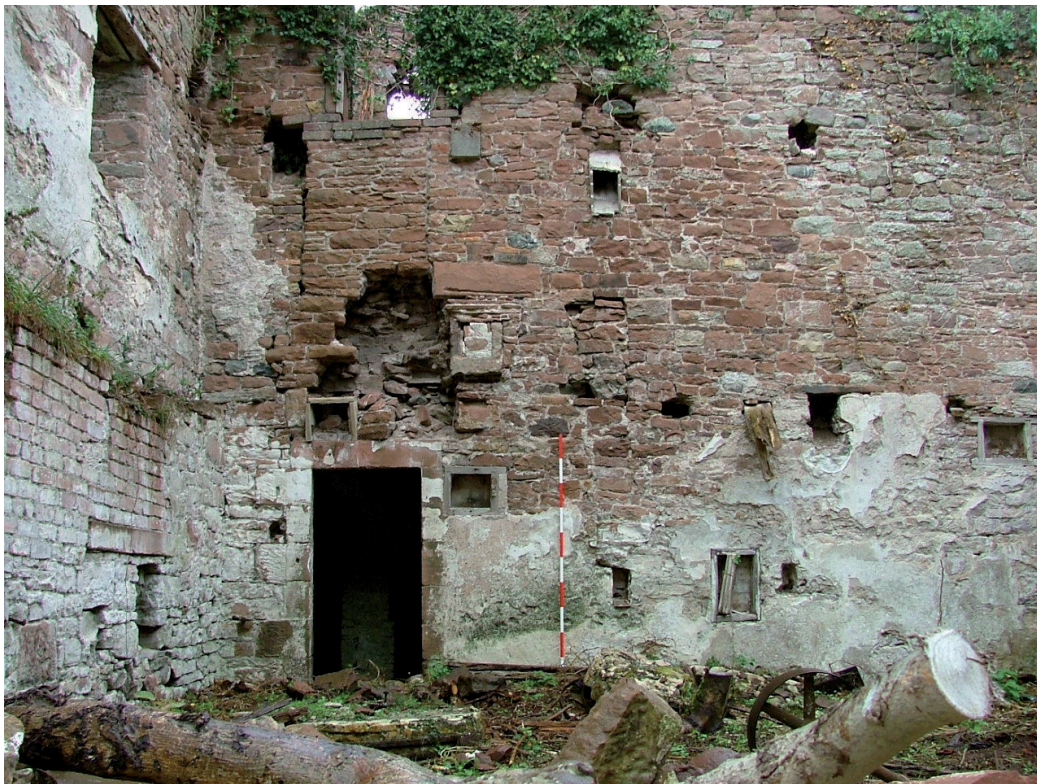
Plate 54 – Eastern wall of main mill building showing various features

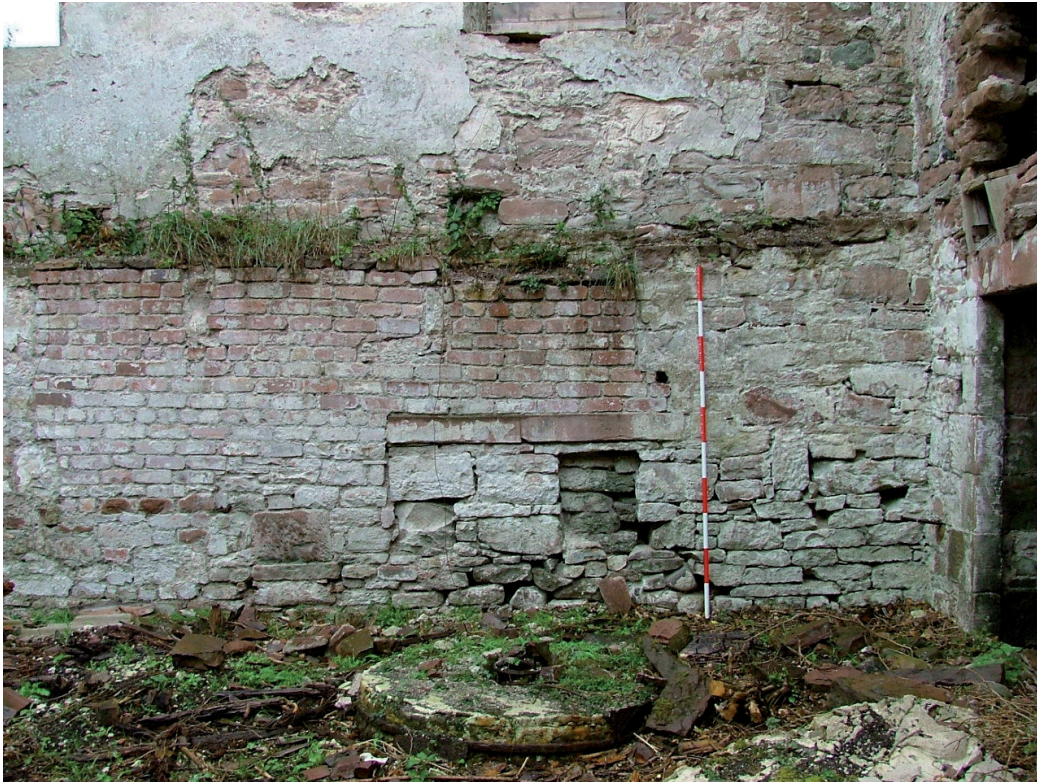
- 6.16.3 Along the northern interior wall there is a section of wall which has been rebuilt in brick; the axle hole for the water-wheel would be located behind this section of wall, although its exact position was not discernible. The lower part of this wall projects slightly, this would have provided some support for the first floor. As there was no evidence for a staircase, it is likely that access to the first floor from within the mill interior would have been via ladder, as well as via the external doorway on the eastern wall of the main mill building. Holes within the walls at second floor level provide evidence for a further floor in the loft space (plate 57). Lying on the ground in this section of the mill were two French Burr millstones and various other fixtures, these will be referred to below.

Plate 55 – Northern interior wall of main mill building

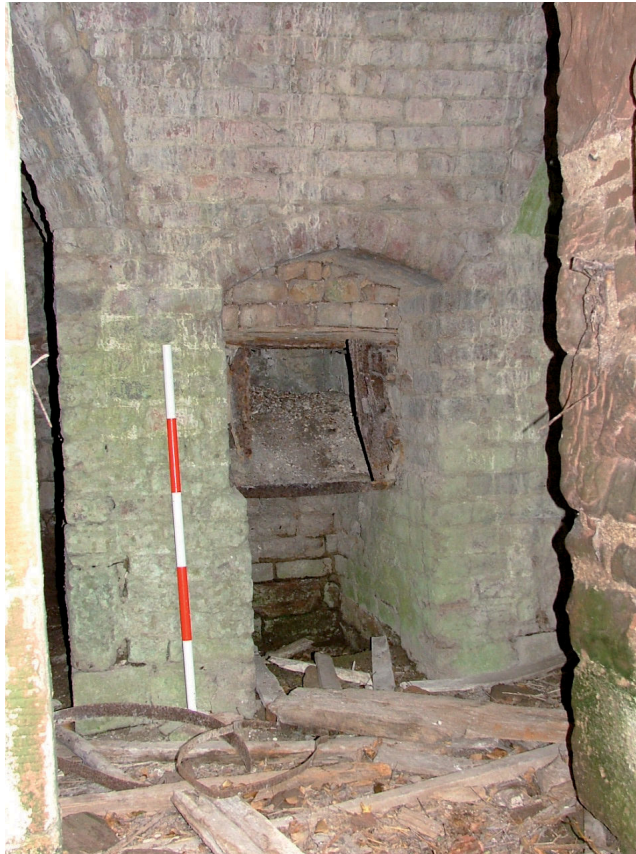
Plate 57 – Base of corn-drying kiln as seen from the main mill building

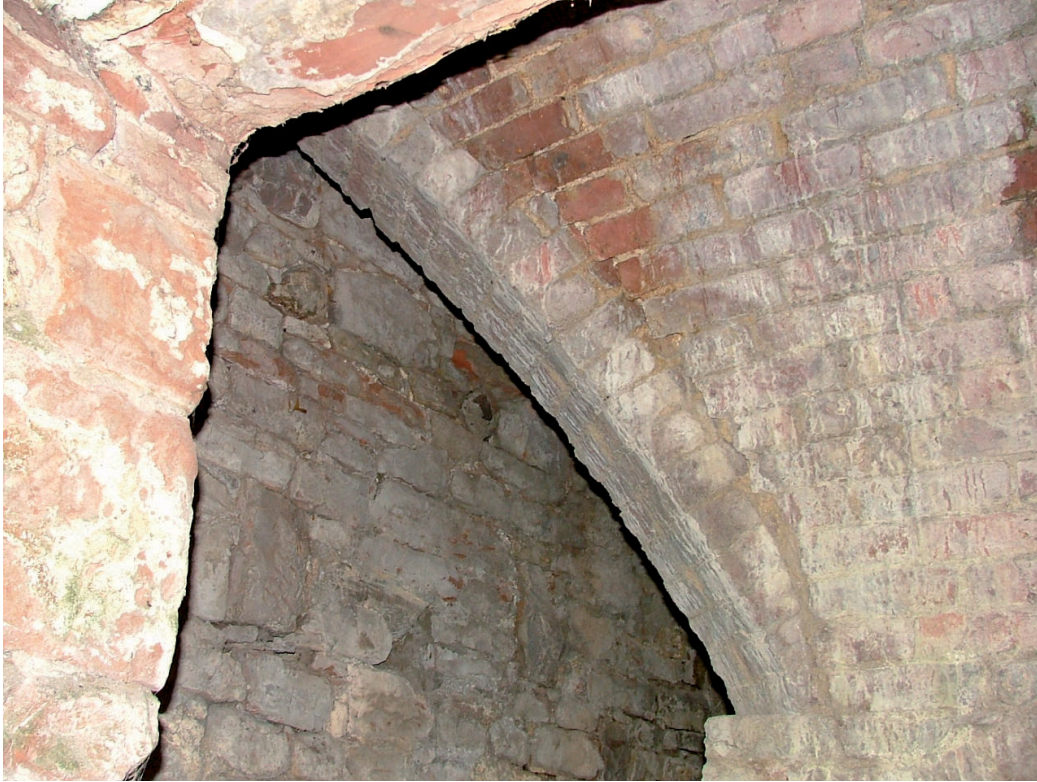
6.17.3 The drying floor of the kiln could not be properly observed due to the precarious state of the gable walls between the main mill and the dividing gable wall within the rear wing. Through a crack in the eastern wall of the kiln it was, however, possible to observe the iron bars that made up the drying kiln floor on which slate or iron plates would have been laid, on top of which the grain would have been spread. One iron plate was observed within the mill interior, a photograph of which is included on the CD-Rom.

Plate 58 – Detail of the brick heat-spreading half arches of drying kiln

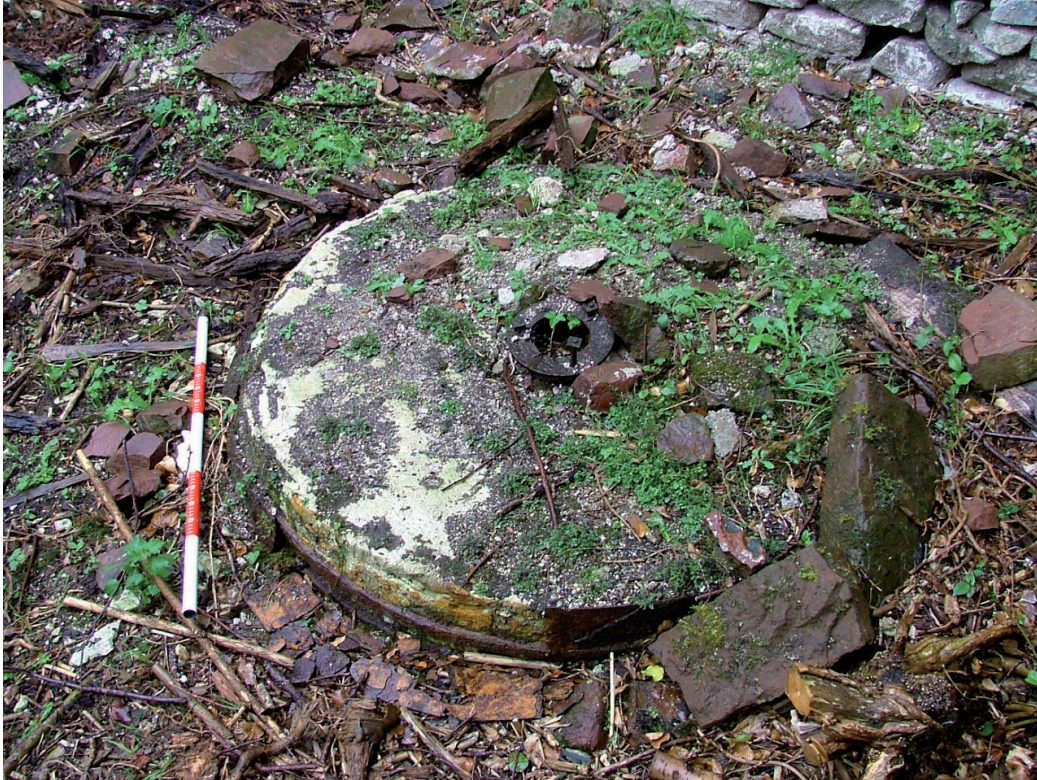
- 6.19.1 Within the mill interior there were two French Burr millstones lying on the ground close to the entrance to the corn-dryer (plate 59). French Burr is a quartz-like stone that is found in the Paris basin, and it was regarded as being the best stone for wheat milling and white flour production⁴⁴. As the stone was not found large enough to cut a single piece, segmental blocks were cut and stuck together with cement; these were held together with heated wrought-iron bands around the circumference⁴⁵.

Plate 59 – One of the two French Burr millstones at Islekirk Hall

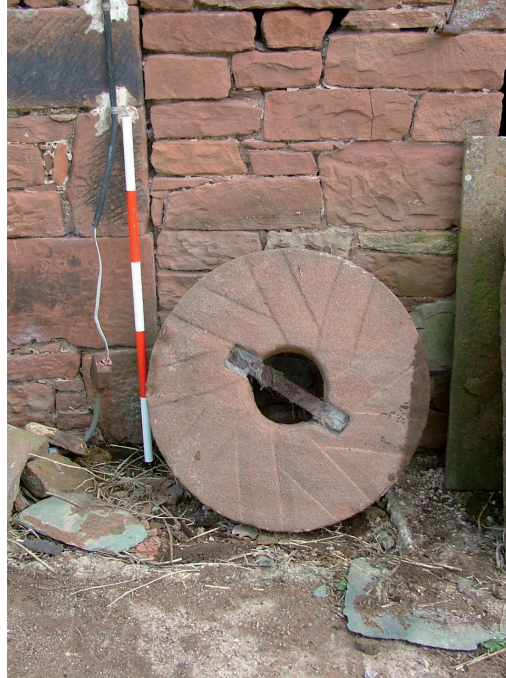
Plate 60 – Masonry runner-stone

- 6.19.2 A red sandstone millstone was located beside Building D of the farm buildings (plate 60).

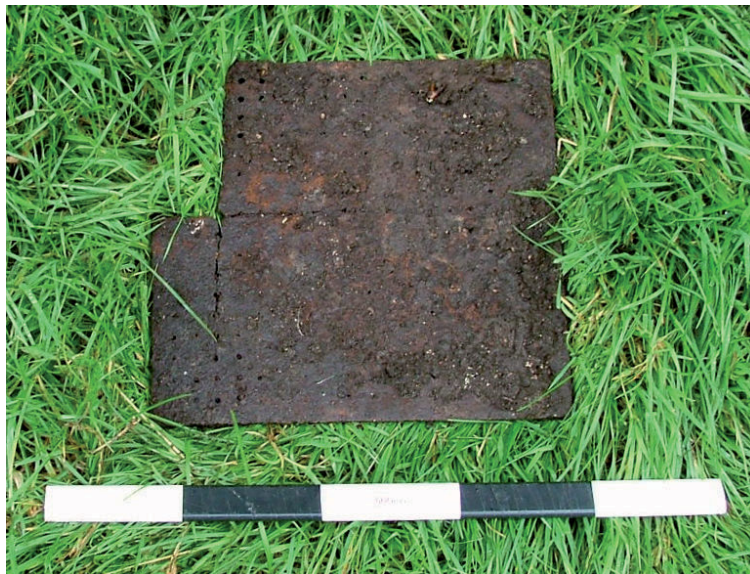
- 6.20.1 There were several pieces of fixtures and fittings observed within the mill interior and these have been included on the CD-Rom. Of particular interest was a single iron plate which presumably was one of many that made up the kiln drying floor (plate 61).

Plate 61 – Iron plate from the mill interior (Scale measures 500mm)

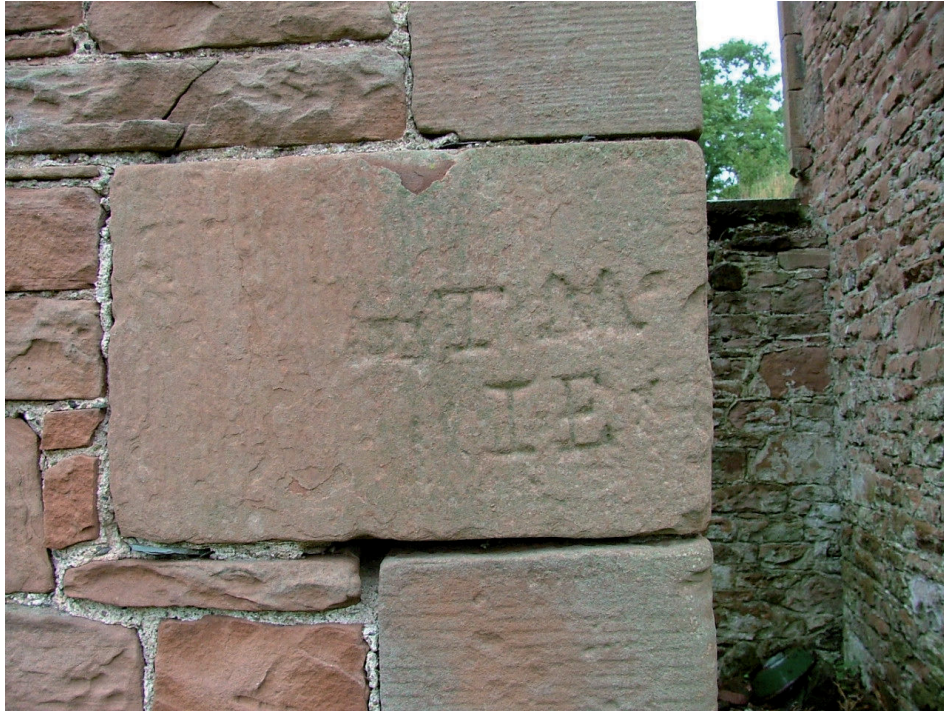
Plate 62 – South facing elevation of the rear wing – initials ‘TM’ and ‘IE’

- 6.21.1 Like the farm buildings, there were several sets of initials observed that had been carved into door jambs. Perhaps the clearest was the two sets on initials on one of the door jambs in the south facing elevation of the rear wing (plate 62).

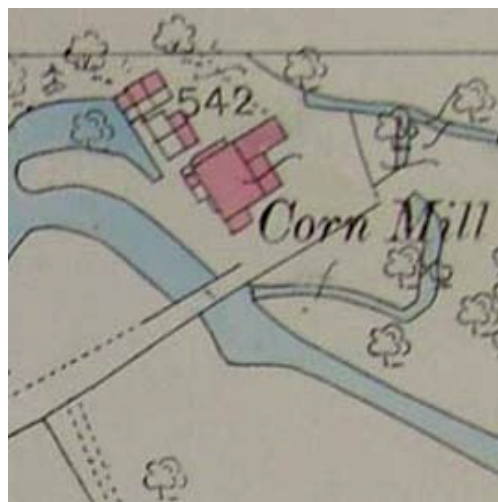
Figure 29 – First Edition OS map of 1867 showing buildings to the north-west of the mill

- 6.22.1 Both the First and Second Edition Ordnance Survey maps of 1867 and 1900 (figures 1, 2 and 29) show several small structures to the north-west of the main mill building. These buildings and associated pens or yards have been totally obliterated by land-moving works, as have any sign of the pool into which the tail race flowed. These buildings may have housed a small amount of animals which were kept by the miller, for example, a couple of cows, pigs and poultry. They may then relate to periods when the miller was not also the farmer, such as in 1824 when John Barnfather was the farmer at Islekirk Hall, while John Matthews was the miller (See table in Appendix).

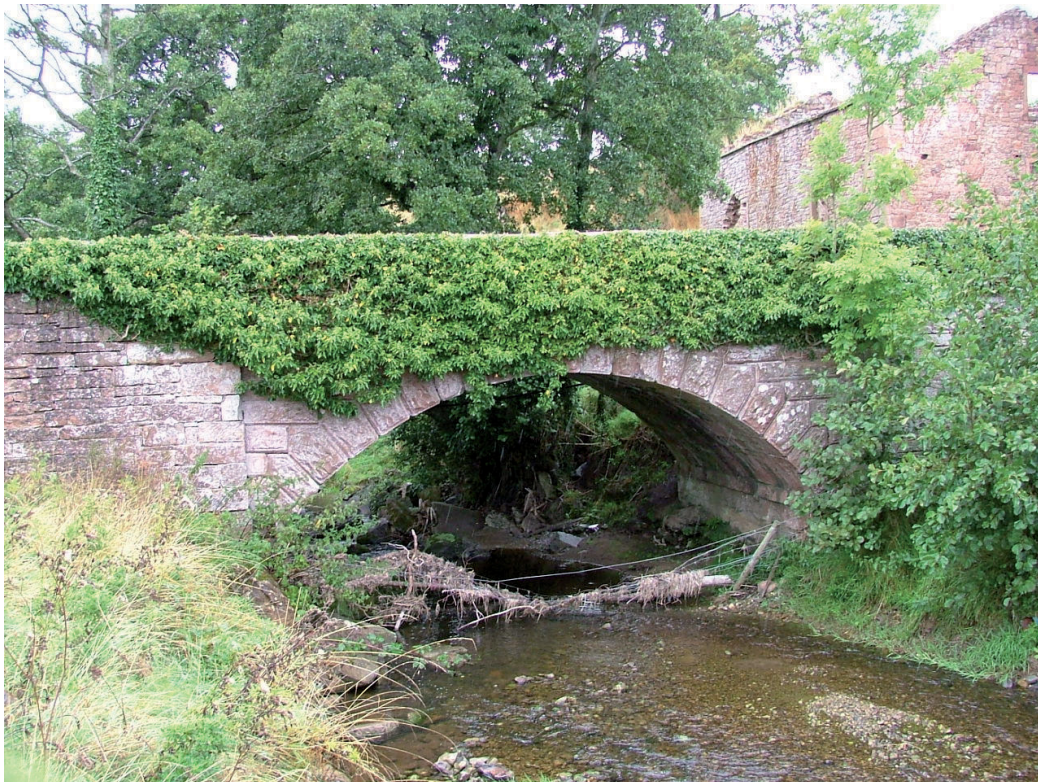
'The Mill Bridge – This has a segmental arch, with a keystone, springing from an impost band, with the voussoirs and the masonry in the spandrels of the arch having a rusticated and rock-faced finish. The abutments have retaining walls of battered section, of squared and coursed sandstone, the courses varying in height; the parapets have a heavy coping, chamfered on its upper angles, and end in large steeply-inclined ashlar blocks. The soffit of the arch and the faces of the abutments have masonry with a fairly rough tooling'.

Plate 66 – The Mill Bridge looking north, with the mill to the right of photograph

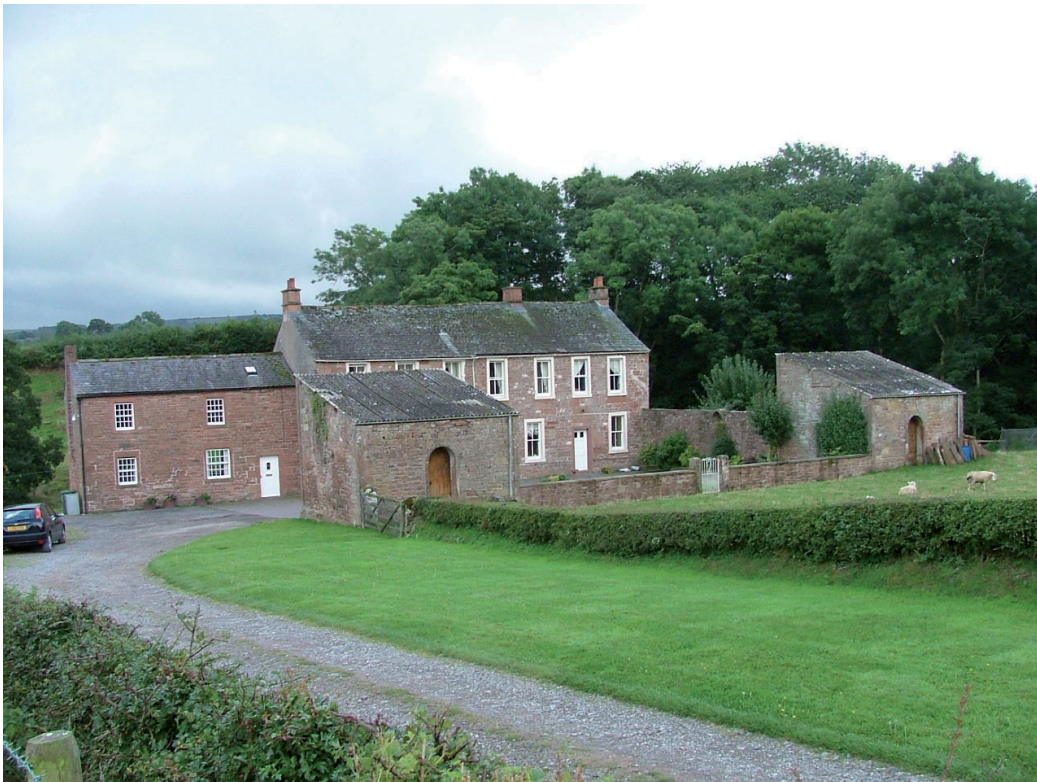
Plate 67 – Islekirk Hall as seen from northern approach road

- 6.24.2 To the front of the house (northern side) are, what Ryder describes as *'two pavilions-cum-dovecotes'*⁴⁷ (plate 67). Originally, these structures had hipped roofs as shown in a poor-quality photograph of c.1928 (plate 70), however by 1985, these roofs has been replaced by the monopitch roofs seen today (plate 71).
