**FARM BUILDINGS TO
THE EAST OF
MIDTOWN FARM,
STANTON,
PENRITH,
CUMBRIA**

DOCUMENT TITLE: Farm Buildings to the east of Midtown Farm, Stainton, Penrith, Cumbria

DOCUMENT TYPE: Building Recording Report

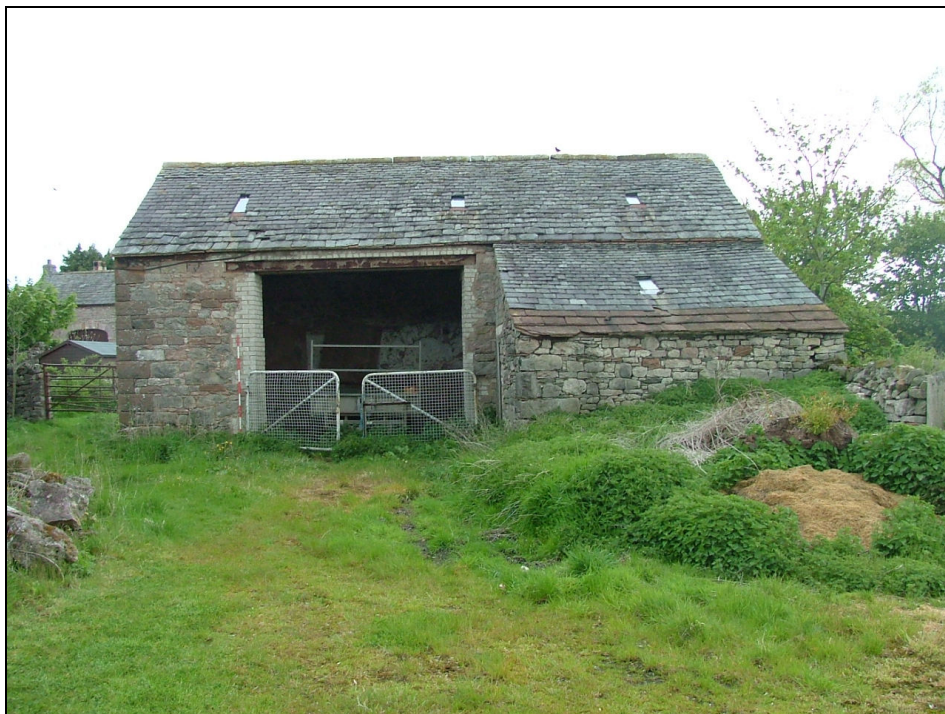
Plate 1 – South-east facing elevation of Building 1 showing the outshut to the eastern side

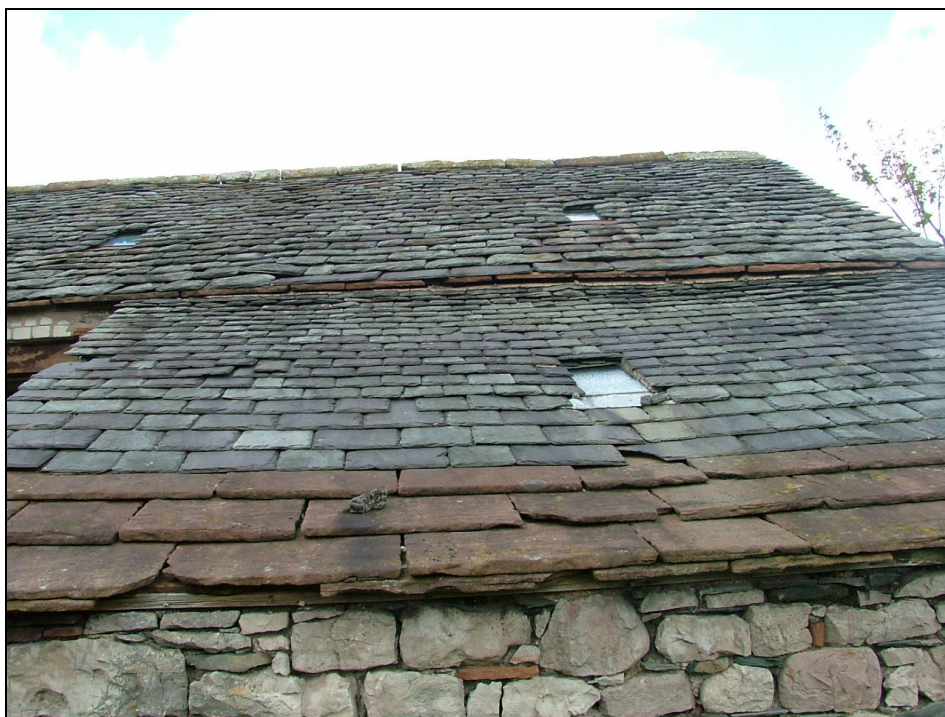
Plate 2 – Detail of the south facing roofs of Building 1 and the outshut

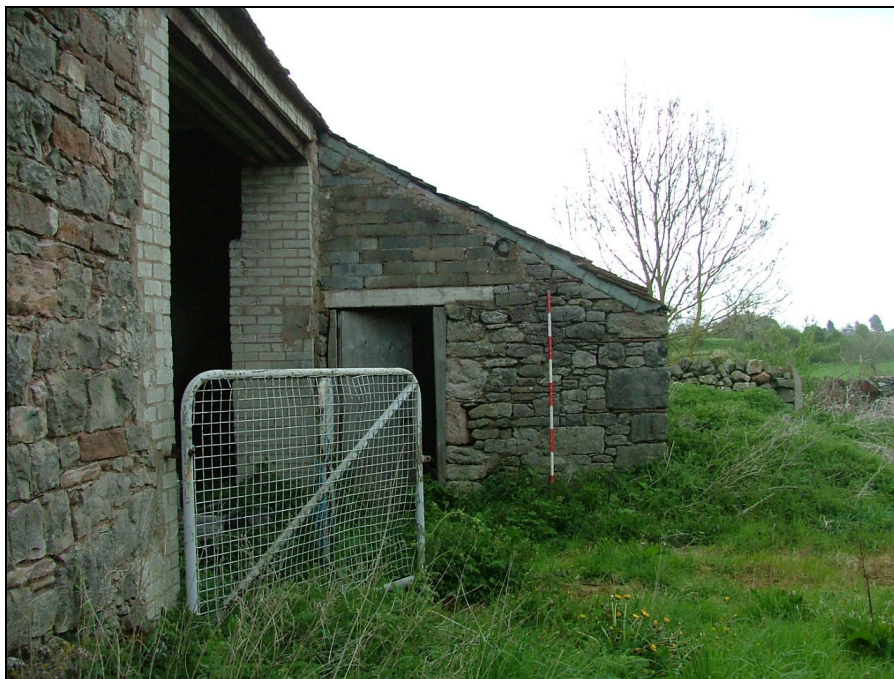
Plate 3 – South-west elevation of outshut against Building 1 showing possible inserted door (Scale = 2m)

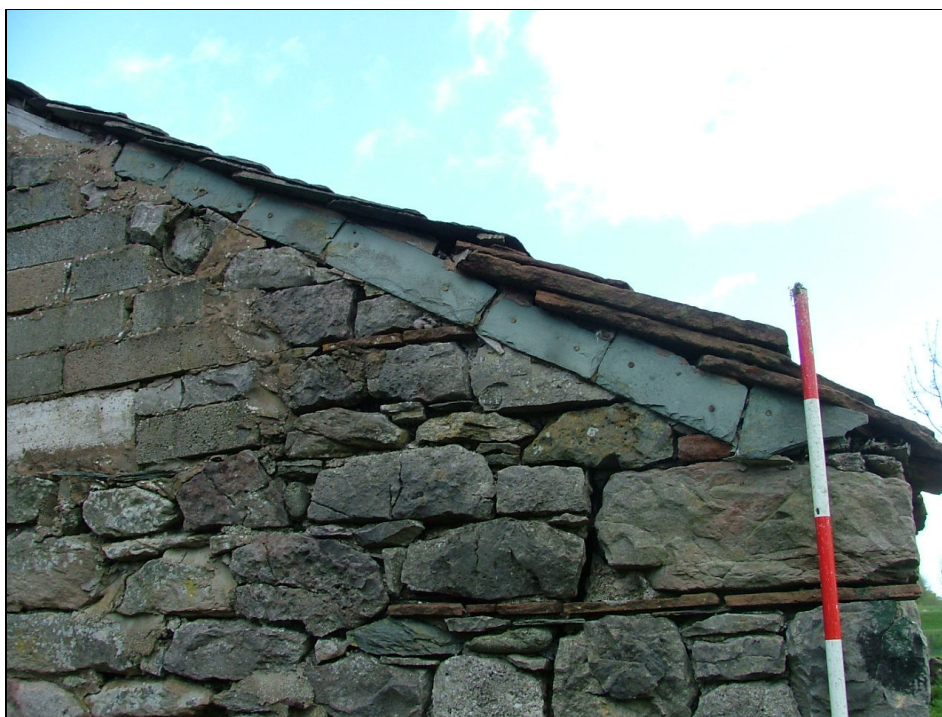
Plate 4 – Detail of slate nailed to timber below roof, outshut against Building 1

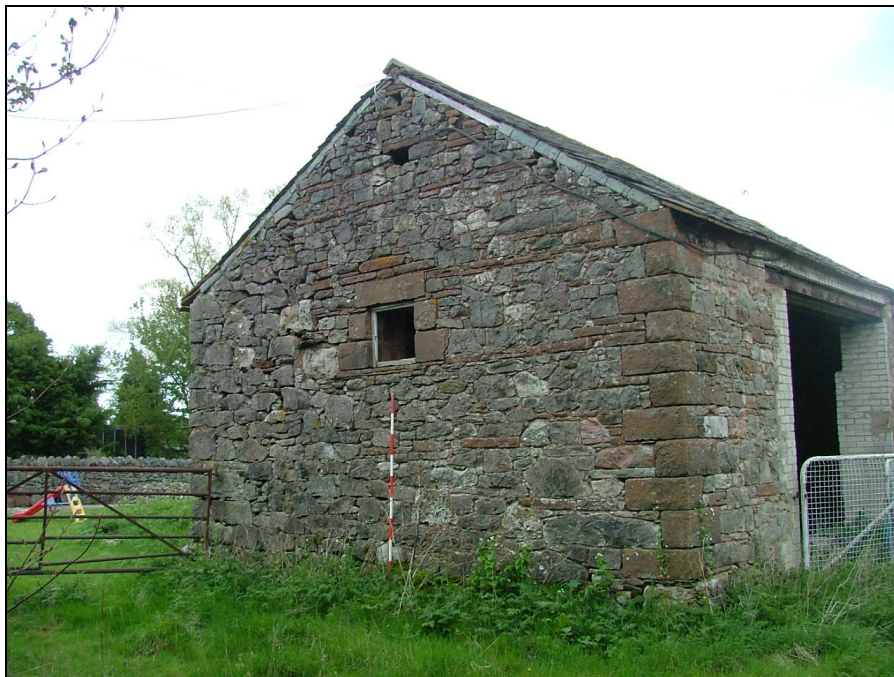
Plate 5 – South-west elevation of Building 1 (Scale = 2m)

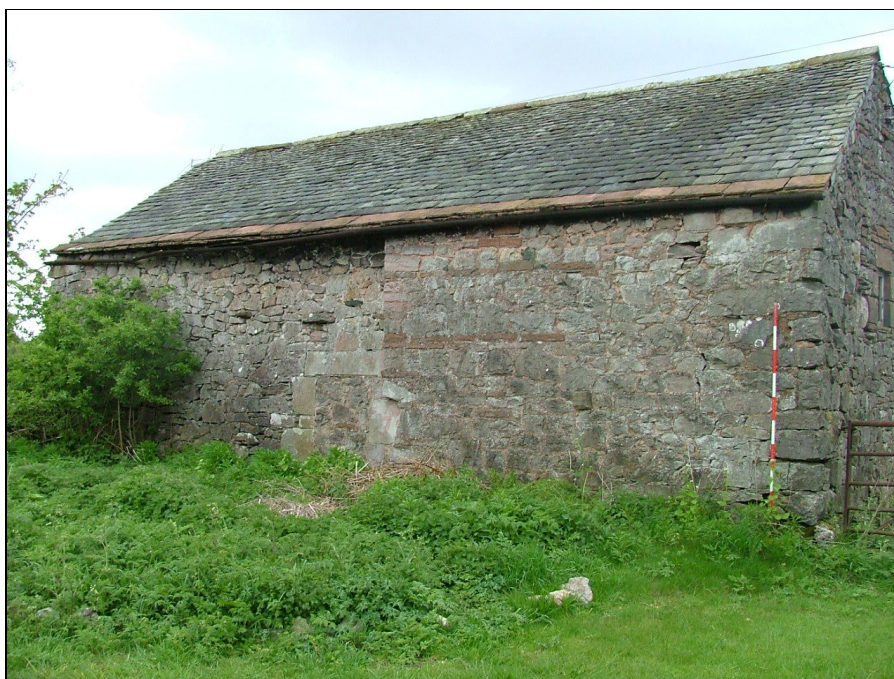
Plate 6 – North-west elevation of Building 1 showing blocked doorway and vertical construction break (Scale = 2m)

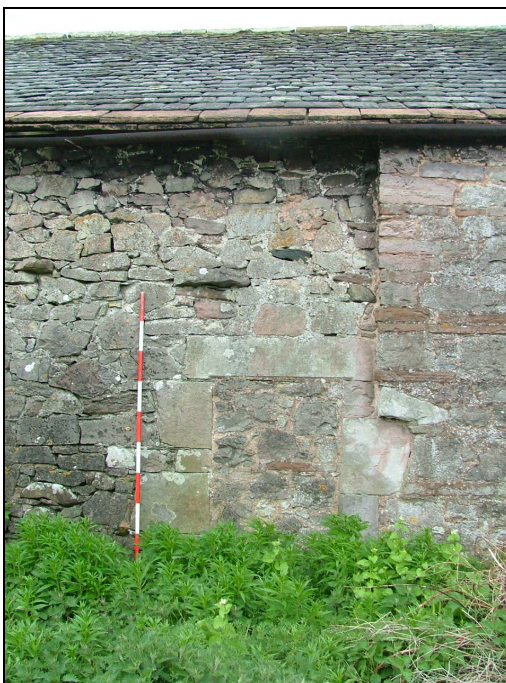
Plate 7 – Blocked doorway, north-west elevation of Building 1 (Scale = 2m)

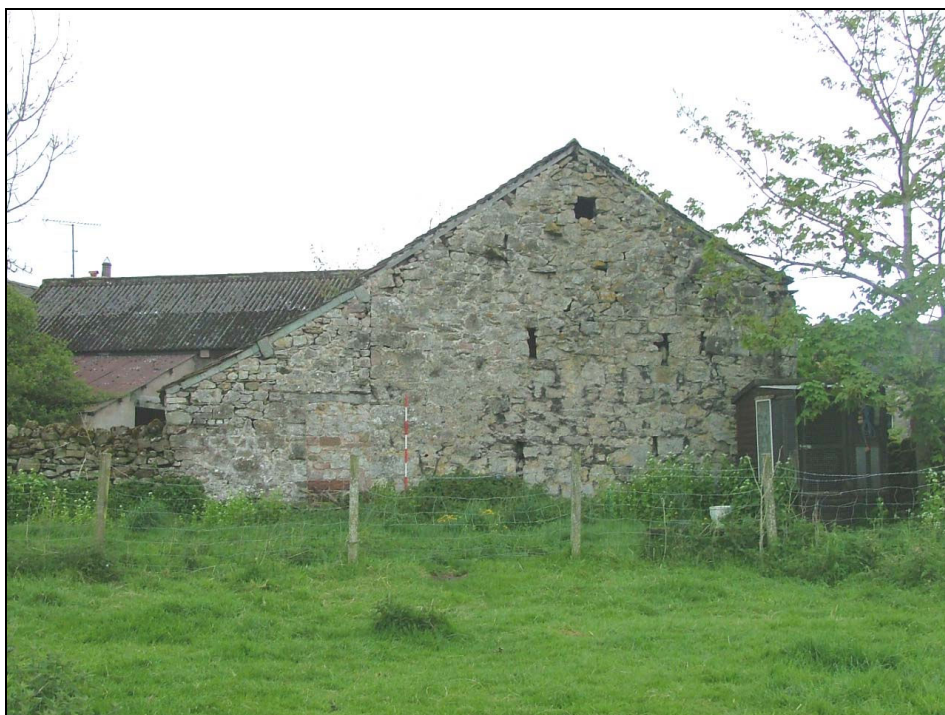
4.2.5 The north-east elevation of Building 1 has four ventilation slits, two at a lower level and two above, each measuring approximately 10cm in width by 60cm high. Close to the apex of the gable is a square owl hole. Several through-stones were noted in this elevation; these are a common feature of traditional buildings constructed from limestone²⁰, and were presumably used to provide some stability to the walls. The north-east elevation of the outshut has a blocked doorway (Plate 8).

Plate 8 – North-east elevation of Building 1 and the outshut (Scale = 2m)

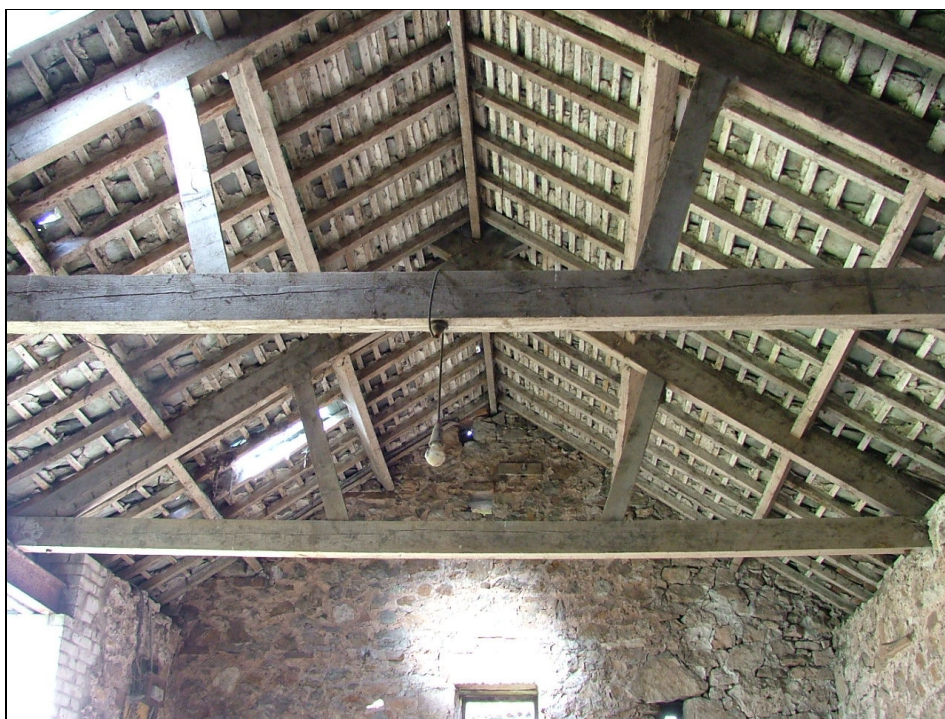
- 4.3.1 The interior of Building 1 was accessed via the large doorway in the south-east elevation, where it was noted that the walls were c.56cm thick. This building contained no internal divisions and was open to the roof. The roof structure consisted of three trusses of machine-sawn timber, with struts creating four bays (Plate 9). The ends of the principal rafters cross at the apex to provide support for the ridge beam (Plate 10).

Plate 9 – Detail of roof structure, Building 1

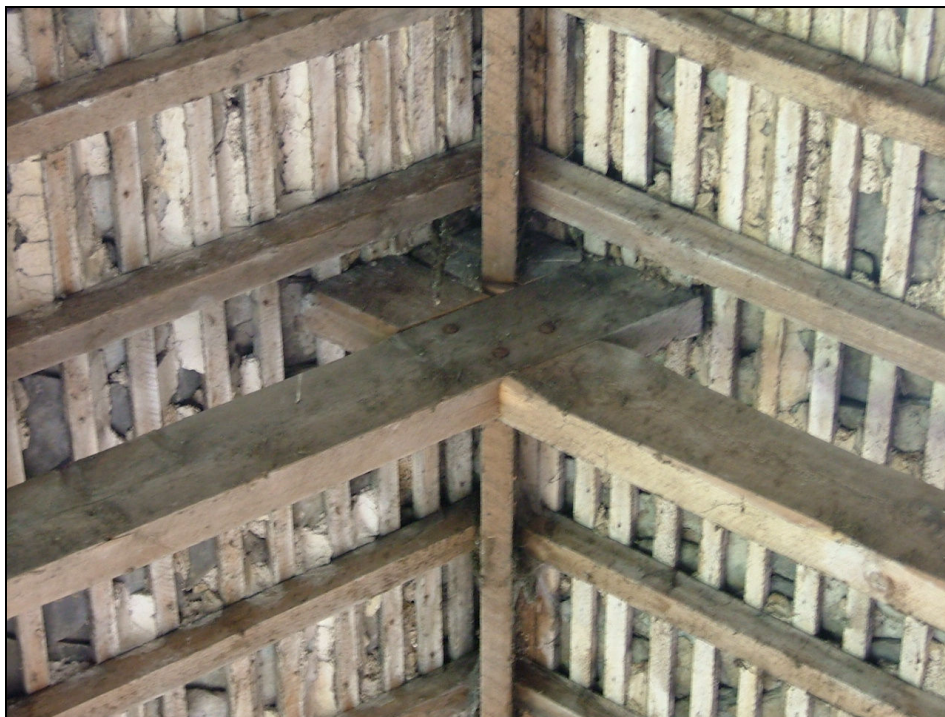
Plate 10 – Detail of apex of principal rafter, Building 1

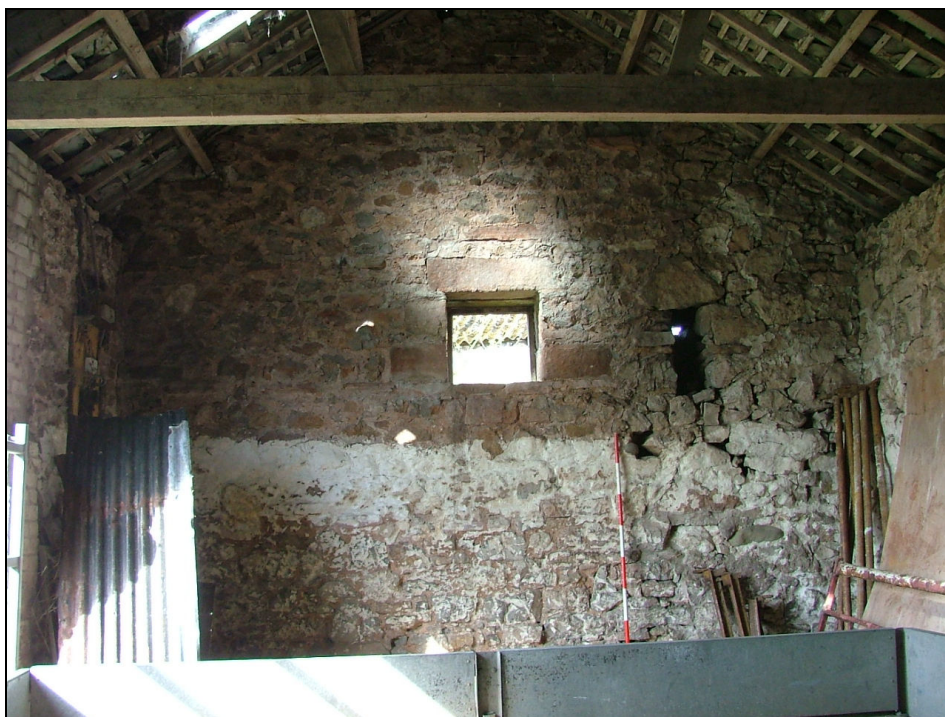
- 4.3.2 The lower half of the internal walls of this building have been limewashed indicating that at some point animals were housed, as limewash is a common wall coating on Cumbrian farmsteads which acted as a disinfectant and allowed the walls to breathe (Plate 11). There was no evidence noted at the time of survey for any joist holes which may have indicated the former presence of a first floor.

Plate 11 – South-west internal wall of Building 1 showing part limewashed walls and window (Scale = 2m)

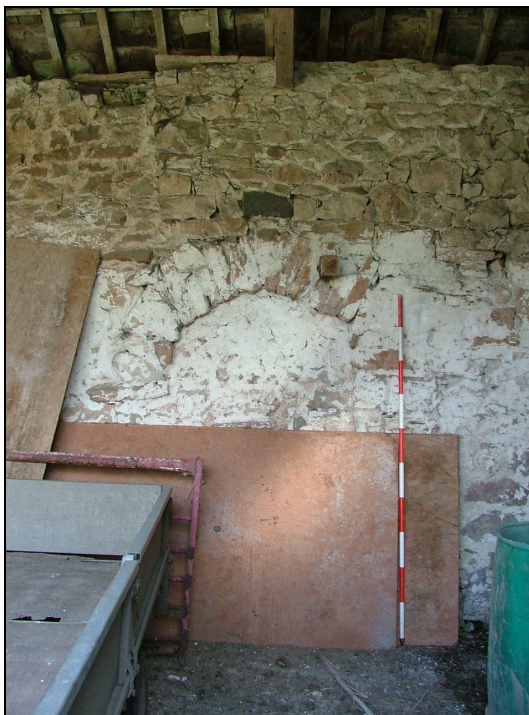
- 4.3.3 In the north-west elevation of Building 1, the blocked doorway already noted externally was clearly visible. Internally, however, the head of this doorway is quite different from the exterior, being arched with rough voussoirs (Plate 12). It is interesting to note that it would presumably have been easier to use a single piece of masonry for the lintel when the building was constructed; the use of rough voussoirs may suggest some form of architectural detail. At Westlands Farm, Crosby, Maryport, a doorway with a similar head was noted during an archaeological survey in 2005²¹. The bank barn in which this doorway was located is associated with the farmhouse which has a date stone of 1743, which may imply a mid-18th century date for the barn there. It is of course not possible to accurately assess if a similarity in door heads can provide some indication of date, especially as there is no dateable architectural detail.

Plate 12 – Blocked doorway with arched head, north-west internal elevation of Building 1 (Scale = 2m)

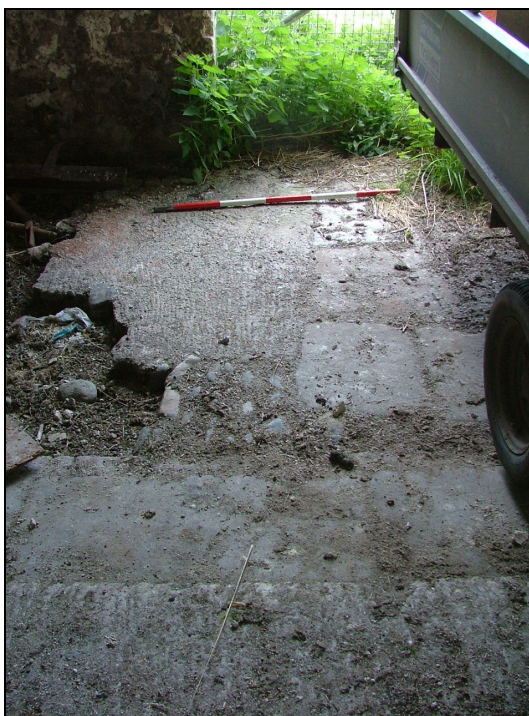
- 4.3.4 The floor surface of Building 1 was noted to consist of stone flags to the central section, and cobbled to either side (Plates 13 and 14). The occurrence of a central threshing floor made from stone flags with cobbled surfaces to either side, has also been noted at Brackenthwaite Farmhouse, near Wigton²² and at School House, Raughton Head near Carlisle²³. The presence of a stone flagged floor, in line with a large central doorway and possible opposing winnowing door, is characteristic of a threshing barn where the process of beating crops to separate the grain from the stalk was undertaken. The stone floor would have been required to provide a hard clean surface for threshing using a hand-flail; the large doorway provided plenty of light, space and height as well as controllable ventilation, and the opposing small door (now

Plate 13 – Remains of the stone flagged floor, central section of Building 1 (Scale = 1m)

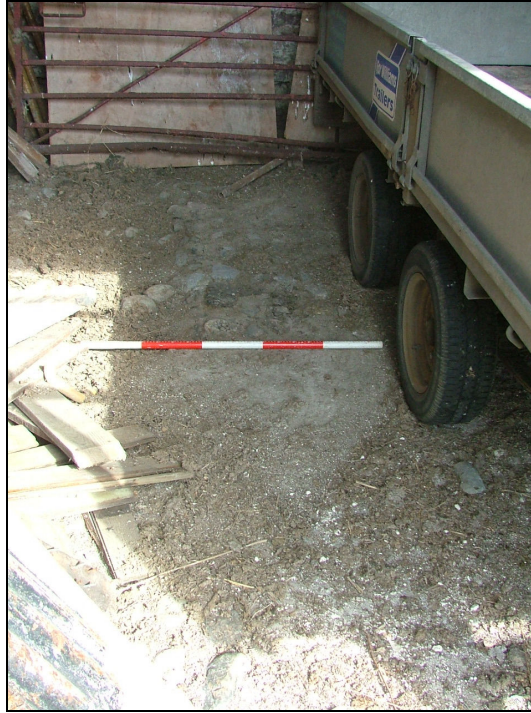
Plate 14 – Remains of cobbled floor to the west side of Building 1 (Scale = 1m)

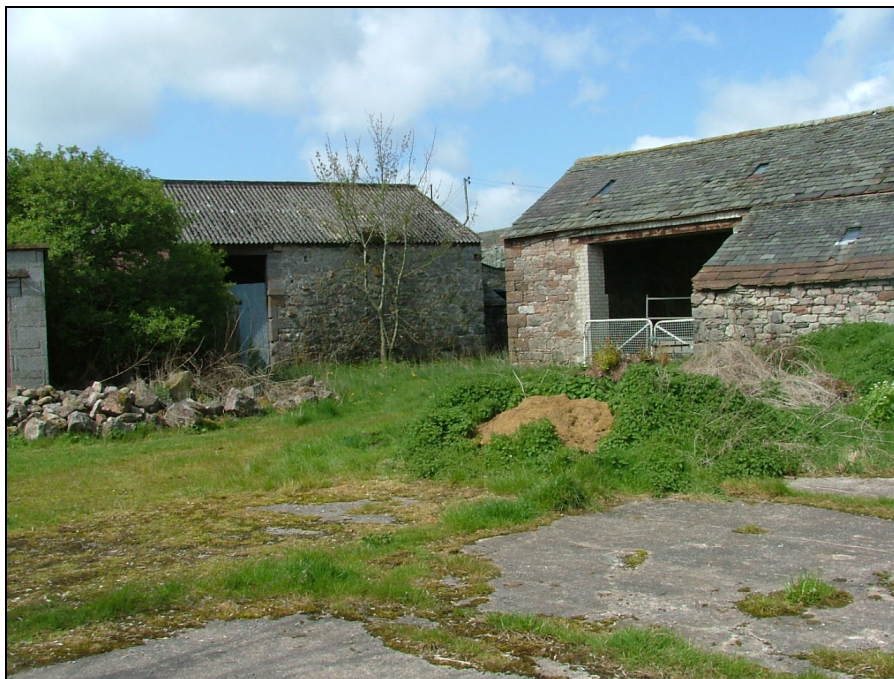
- 4.4.1 Building 2 is located to the west of Building 1, and is orientated north-south (Figure 3 and Plate 15). This building is constructed of uncoursed rubble masonry and measures c.7.5m wide and c.15m in length. The roof is laid in corrugated sheeting, a material which replaced the traditional roof covering of slate or sandstone tiles in the 20th century, and which gave an industrial character to the farmstead.

Plate 15 – View looking north-west showing Building 1 to the right of photograph and Building 2 to the left

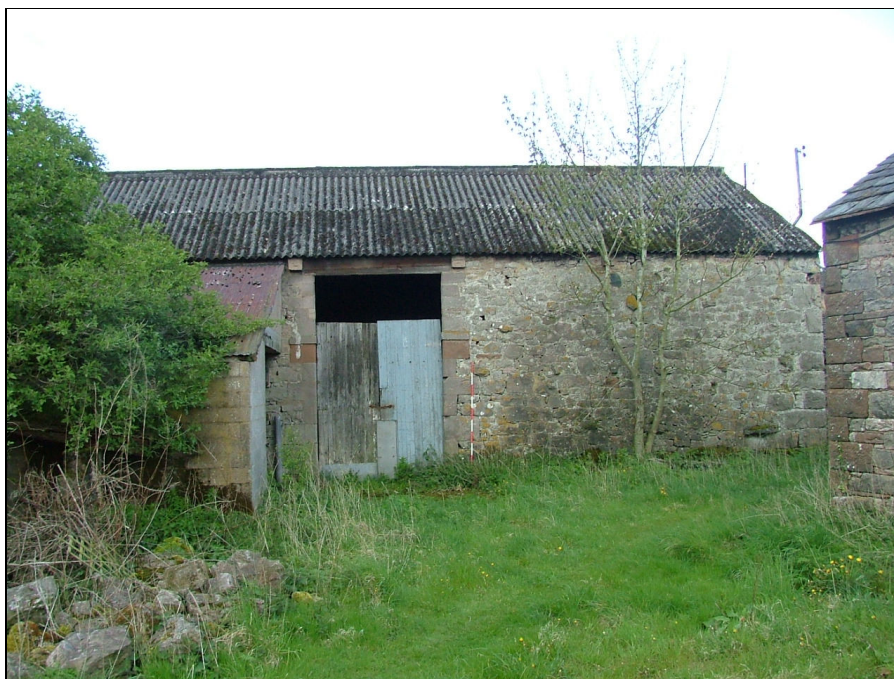
Plate 16 – East elevation of Building 2 (Scale = 2m)

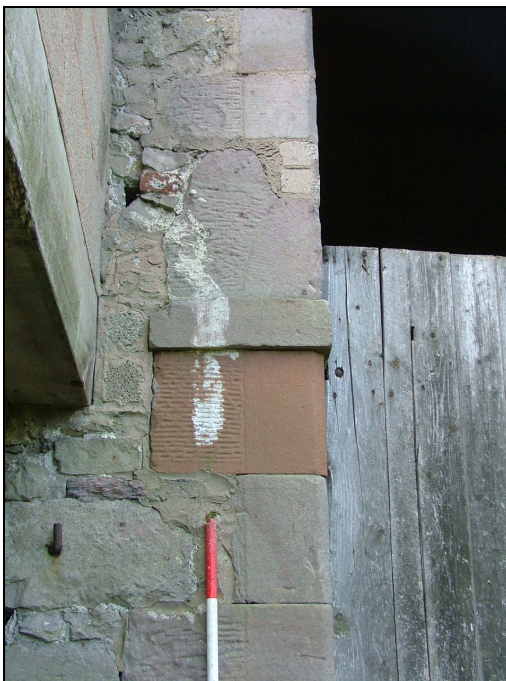
Plate 17 – Detail of the masonry blocks which make up part of the left-hand jamb with one block showing evidence for a former arched head, Building 2

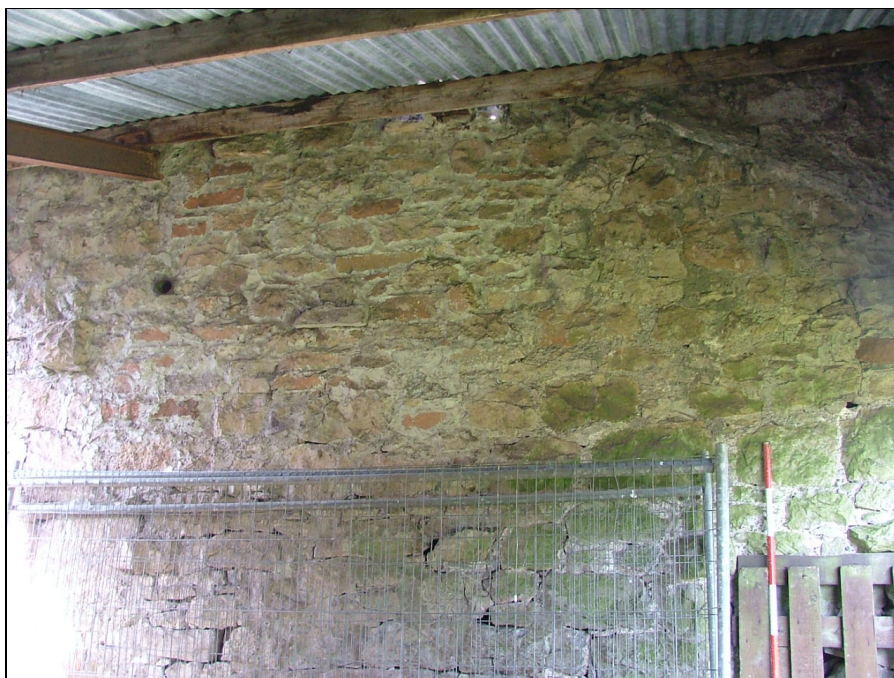
Plate 18 – Diagonal line of a former roof against the east elevation of Building 2

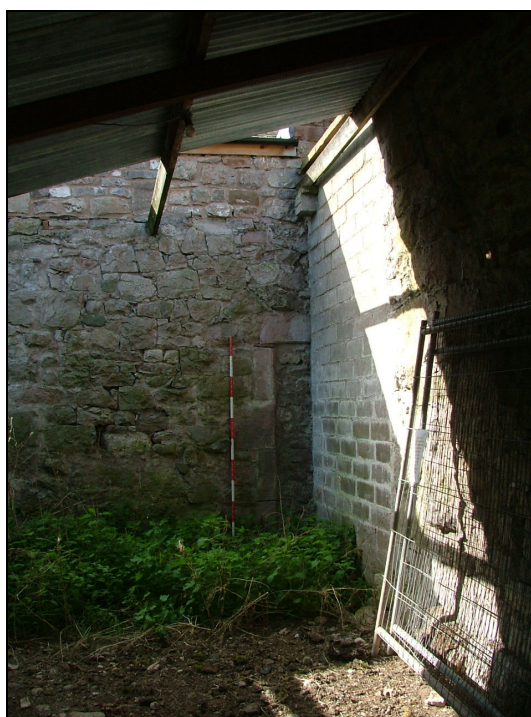
- 4.4.4 At the south end of the east elevation of Building 2 is a section of modern block work wall, which partly obscures a blocked doorway which belongs to the former agricultural building adjoining the property known as The Mains (Plate 20). It has already been noted that a local resident has mentioned that the redundant farm buildings related to Midtown Farm and not The Mains, however the presence of a doorway in the north wall of farm building at The Mains suggests that access from that property to the land to the north was obviously possible at one time.

Plate 20 – Blocked doorway in the north wall of The Mains as seen from the east elevation of Building 2 (Scale = 2m)

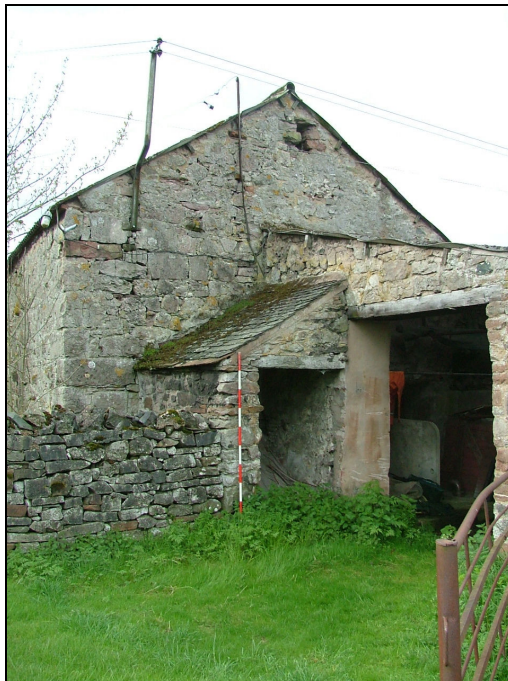
- 4.4.5 The north elevation of Building 2 is partly obscured by a privy and the east end of Building 3, however it was possible to note an owl hole close to the apex of the gable (Plate 21). The privy is located in a small outshut with pitched roof. The sandstone support for the seat is still visible although the holes have been filled in (Plate 22). The length of the privy seat suggests that this may have had two holes, indicating that using the privy was not regarded as a totally private activity. A two-seater was recently noted at Greystone House, Skelton²⁵, with both holes of the same size cut into a wooden seat. A two-seater with a child and adults size hole was also recently recorded at Mill Farm, Corbridge²⁶. A hole for clearing out the privy was noted at the base of the east elevation (Plate 23).

Plate 21 – North elevation of Building 2 partly obscured by a privy and the east end of Building 3 (Scale = 2m)

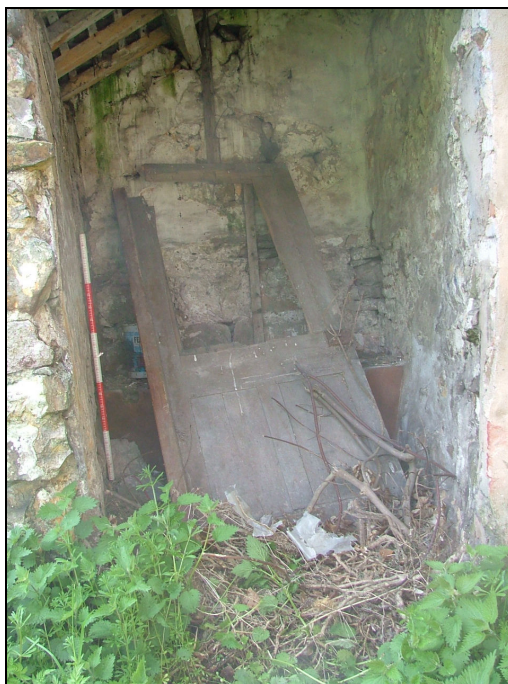
Plate 22 – View into the privy showing the sandstone support for the seat partly hidden by the door, and the limewashed walls (Scale = 1m)

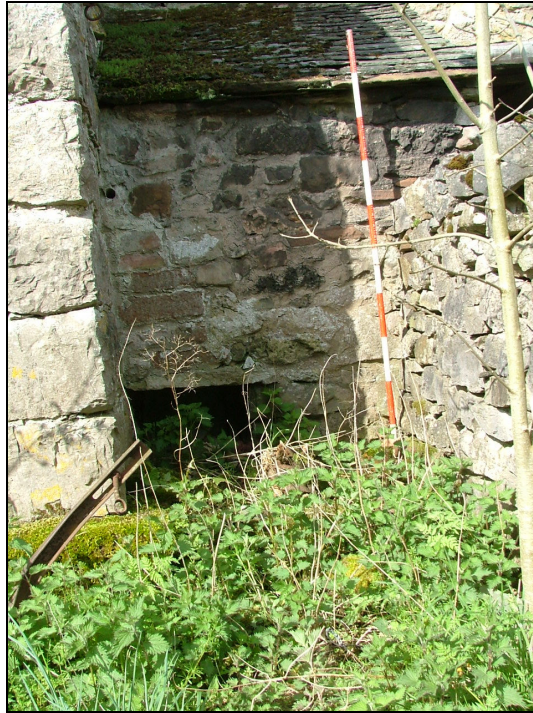
Plate 23 – Hole at the base of the privy wall (Scale = 2m)

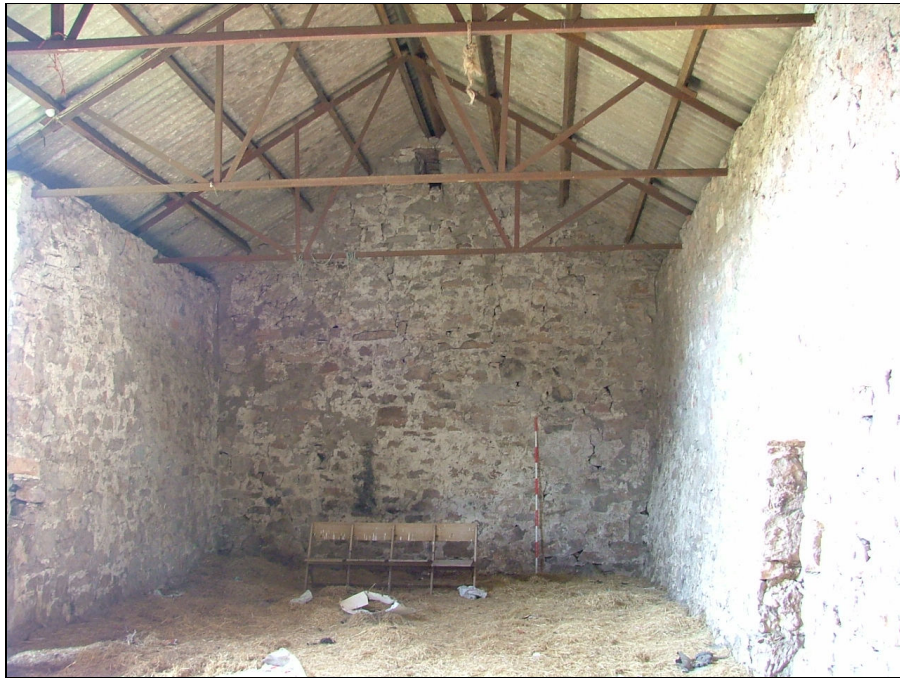
Plate 24 – View looking south of the interior of Building 2 showing the modern roof structure (Scale = 2m)

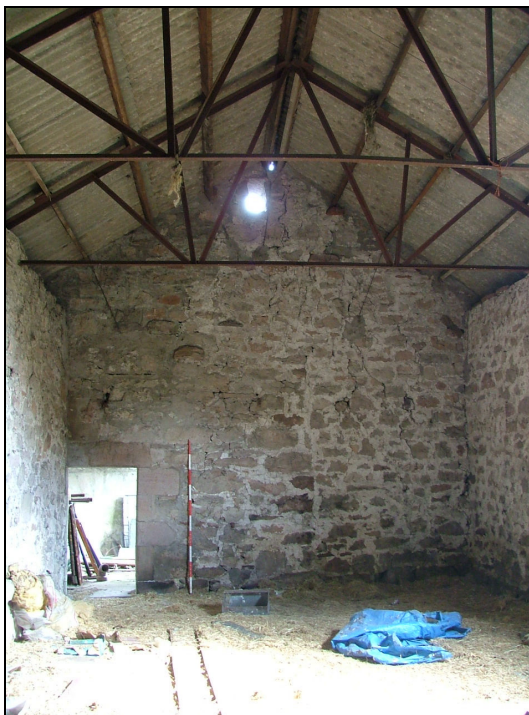
- 4.5.3 The north gable of Building 2 has a doorway to the western side which now provides access to Building 3 (Plate 25). The jambs and lintel of this doorway are constructed from squared blocks of masonry, the inner edge of which are chamfered, and the left-hand jamb is obscured by the west wall of Building 2 (Plate 26). This suggests that the wall in which this doorway is located (i.e. the south wall of Building 3) was in existence prior to the construction of Building 2. The author has noted on other farmsteads that a chamfered edge to a doorway, such as that noted here, is generally on the external side which suggests that Building 3 had no buildings against this part of the wall when it was constructed. That Building 3 was in existence

prior to Building 2 can also be suggested by a vertical construction break visible in the masonry of the north elevation (Plate 25).

Plate 25 – View looking north of the interior of Building 2 showing a doorway to Building 3 and a vertical construction break in the north gable (Scale= 2m)

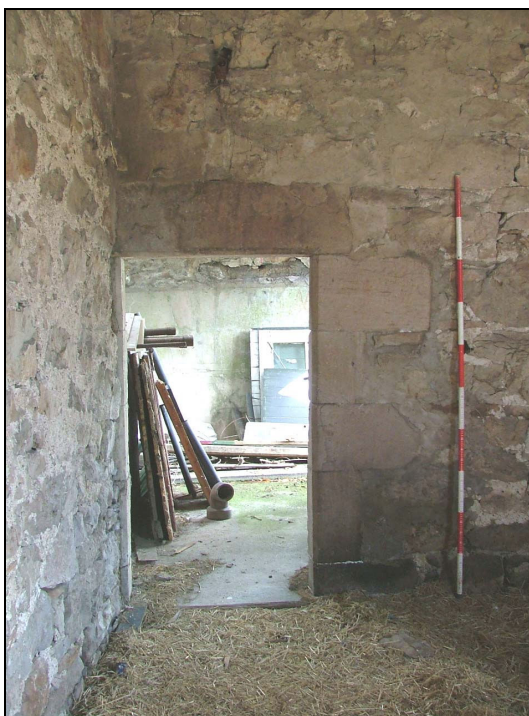
Plate 26 – Doorway in north gable of Building 2 which has chamfered edges to the jambs and lintel suggesting Building 3 was in existence prior to Building 2 (Scale = 2m)

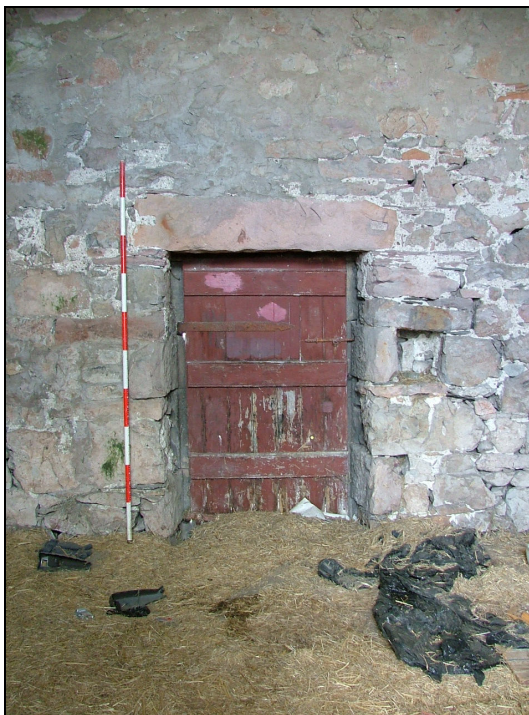
- 4.5.4 In the centre of the west internal elevation of Building 2 is a doorway, which is in line with the large double doorway in the east elevation, indicative of a winnowing door, as already noted in Building 1. To the right-hand side of this doorway is a niche which may have been used to house a candle or oil light (Plate 27). A further niche was noted to the right-hand side of the large doorway in the east elevation (Plate 28).
- 4.5.5 The floor of Building 2 was covered in straw and debris at the time of survey, however it was possible to note that the surface in line with the large double doors was covered in stone flags (Plate 29). This evidence, along with the possible winnowing door in the west elevation, the open space to the roof and the large double doors, suggests that this building was also used for threshing crops, possibly replacing the smaller Building 2.

Plate 27 – Doorway in west elevation of Building 2, with a niche for a candle or oil lamp to the right-hand side (Scale = 2m)

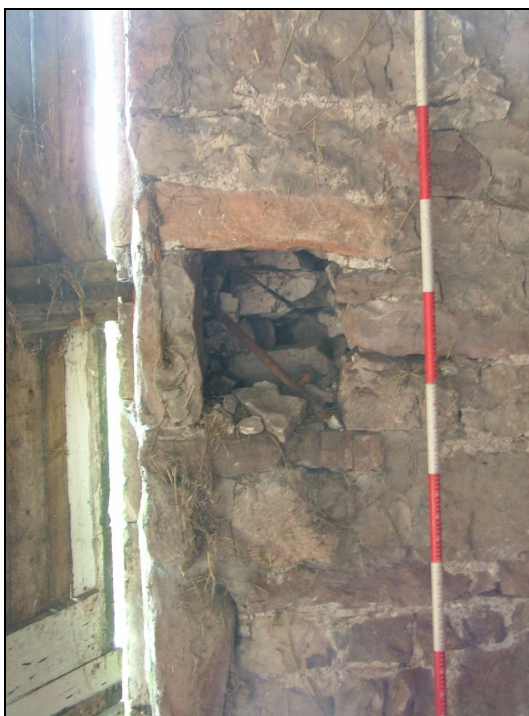
Plate 28 – Niche in east wall, Building 2 (Scale is in 20cm graduations)

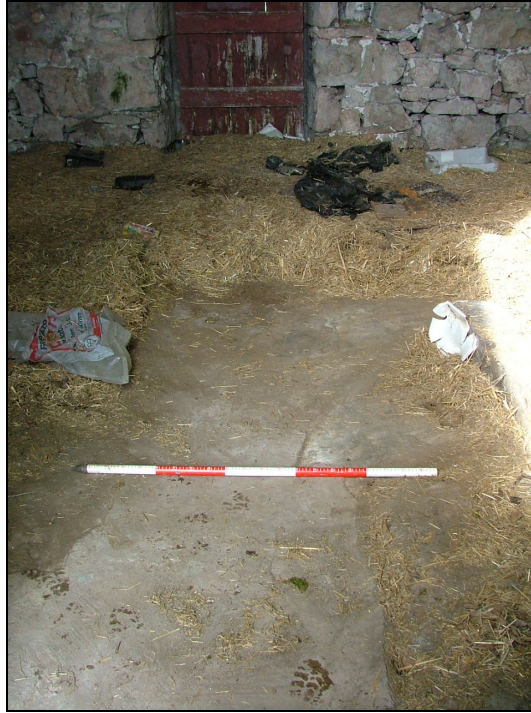
Plate 29 – Detail of part of the stone flagged floor in Building 2 (Scale = 1m)

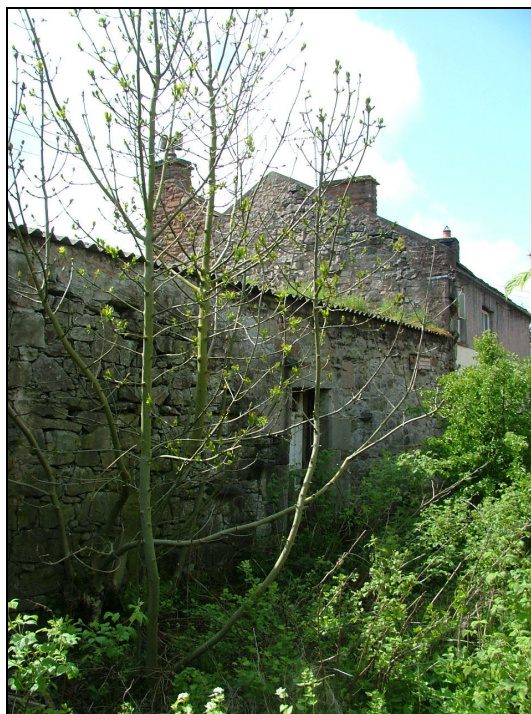
Plate 30 – View looking west along the north elevation of Building 3 towards Barn Harrow

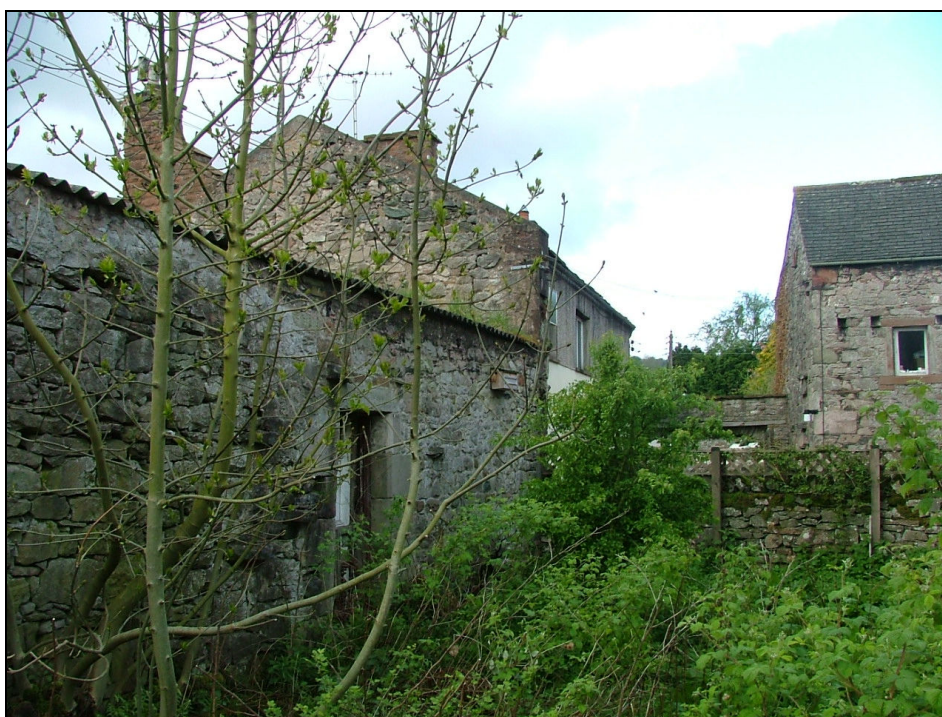
Plate 31 – View looking west along the north elevation of Building 3

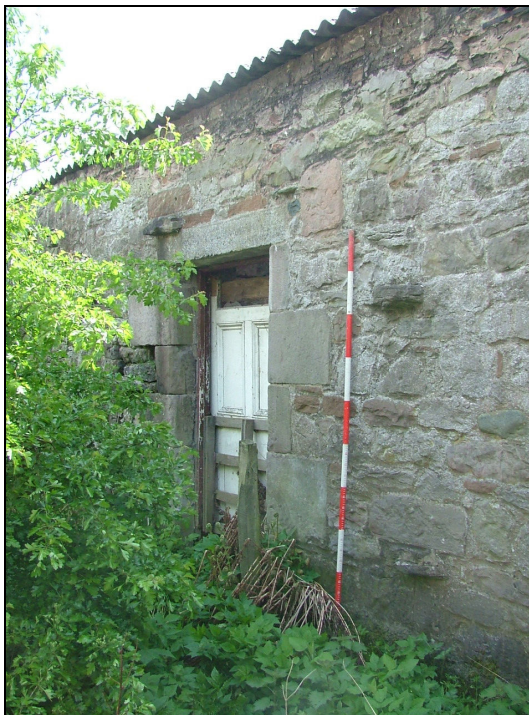
- 4.6.2 In the north elevation, which is largely obscured by foliage, it was possible to note one doorway and a blocked doorway (Plates 32 and 33). The inner edges of the jambs of both these doorways are chamfered similar to the doorway noted in the south elevation and shown on Plate 26.

Plate 32 – Doorway in north elevation of Building 3 (Scale = 2m)

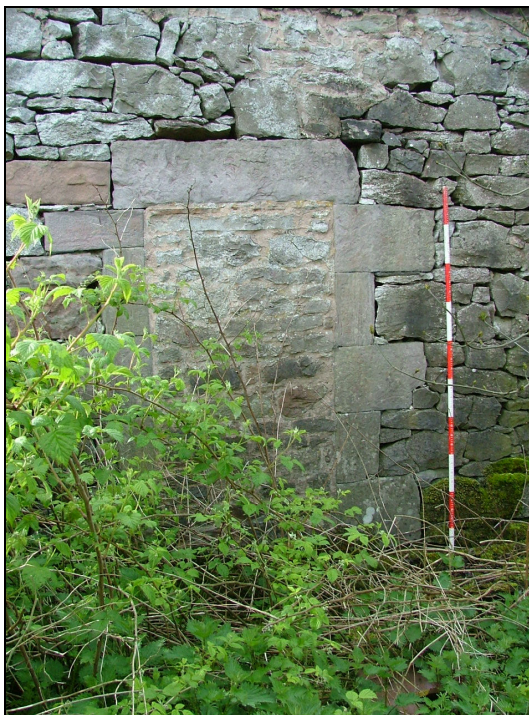
Plate 33 – Blocked doorway in north elevation of Building 3 (Scale = 2m)

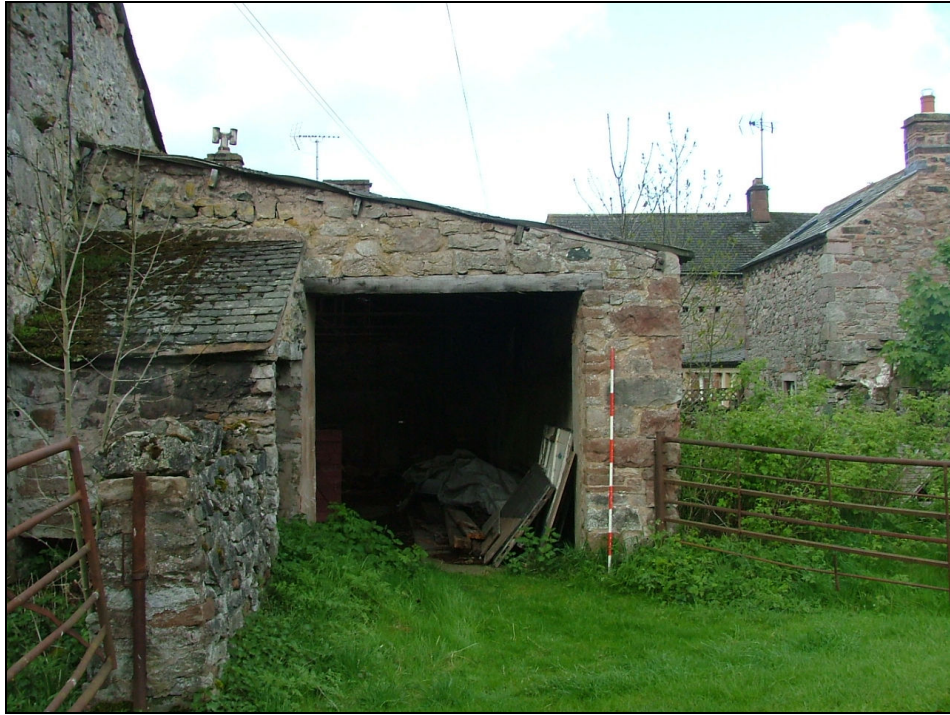
- 4.6.3 The east elevation of Building 3 has a large aperture, which is possibly a relatively modern insertion (Plate 34). The south elevation could not be observed due to the area to the south being in separate ownership and no access was possible at the time of survey.

Plate 34 – East elevation of Building 3 (Scale = 2m)

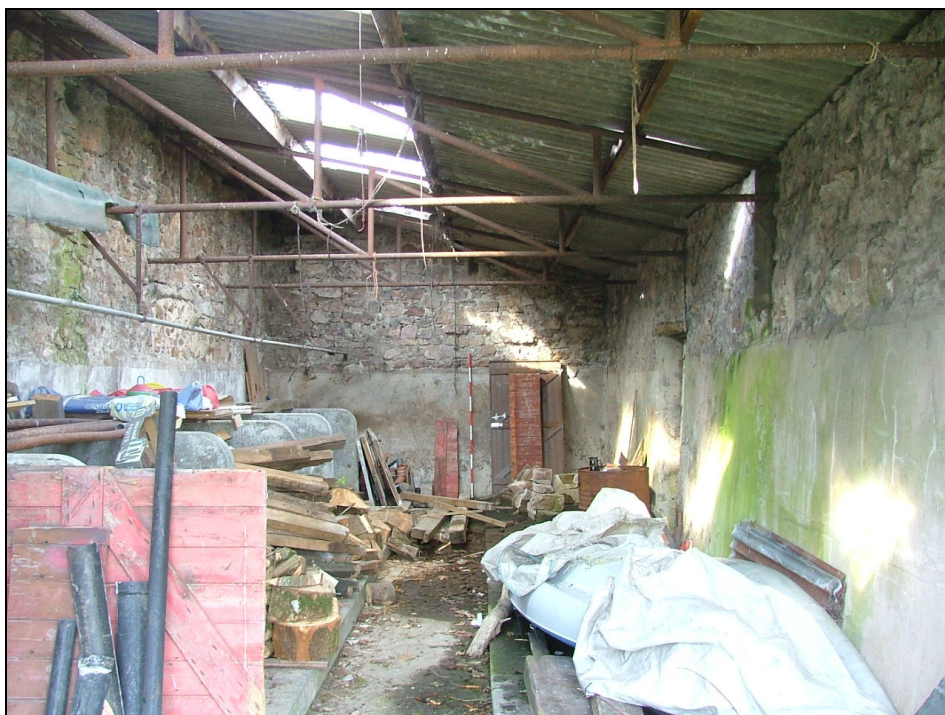
Plate 35 – View looking west of the interior of Building 3 (Scale = 2m)

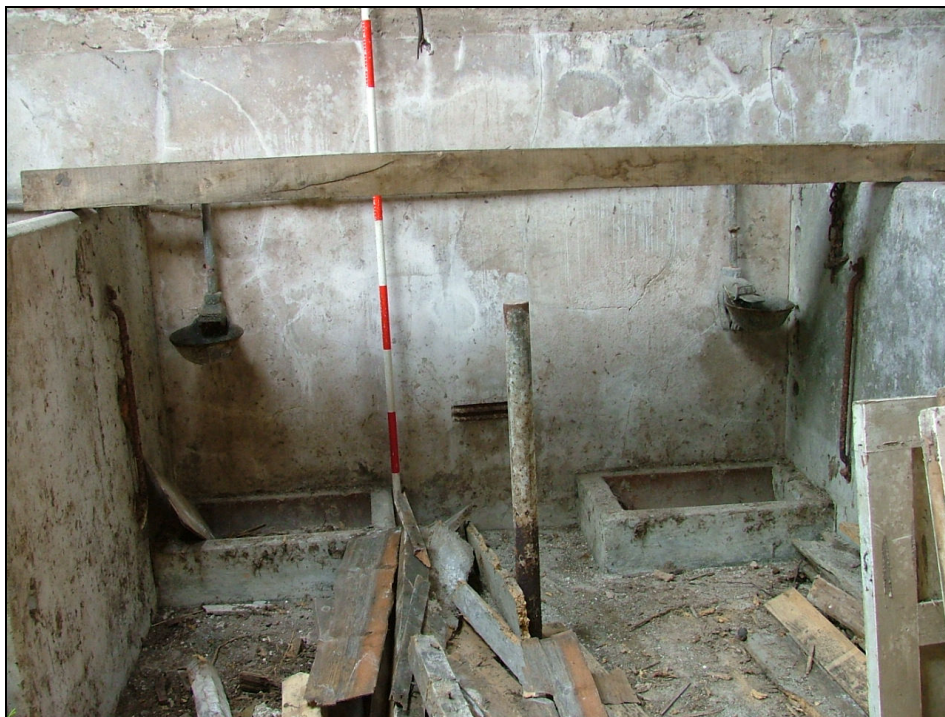
Plate 36 – Detail of one of the double stalls showing metal stanchion, water troughs and feeding troughs (Scale is in 20cm graduations)

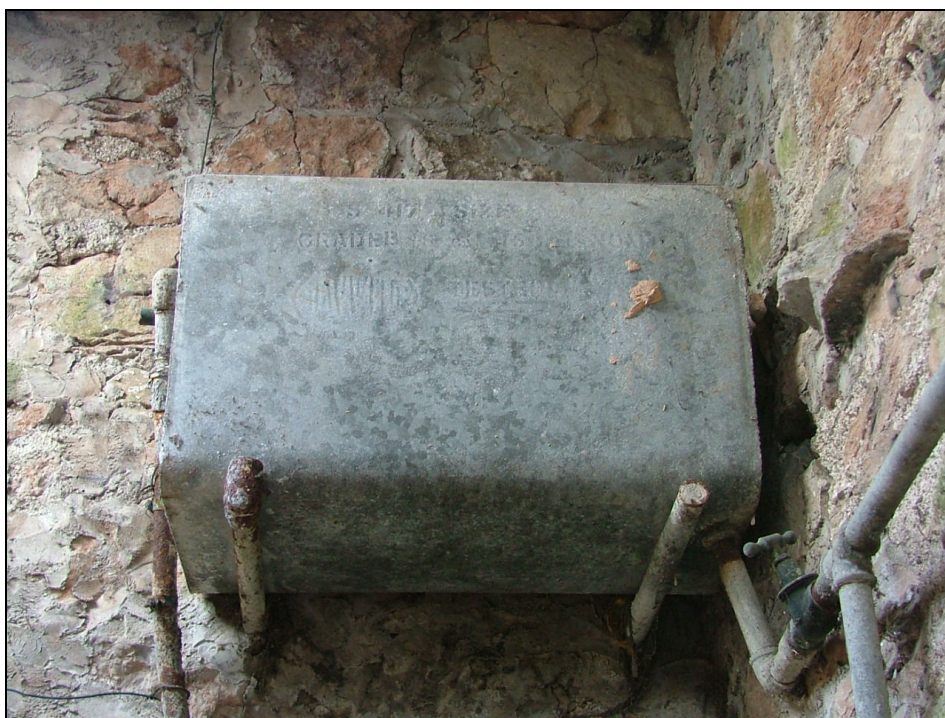
Plate 37 – Water tank on the east wall of the byre, Building 3

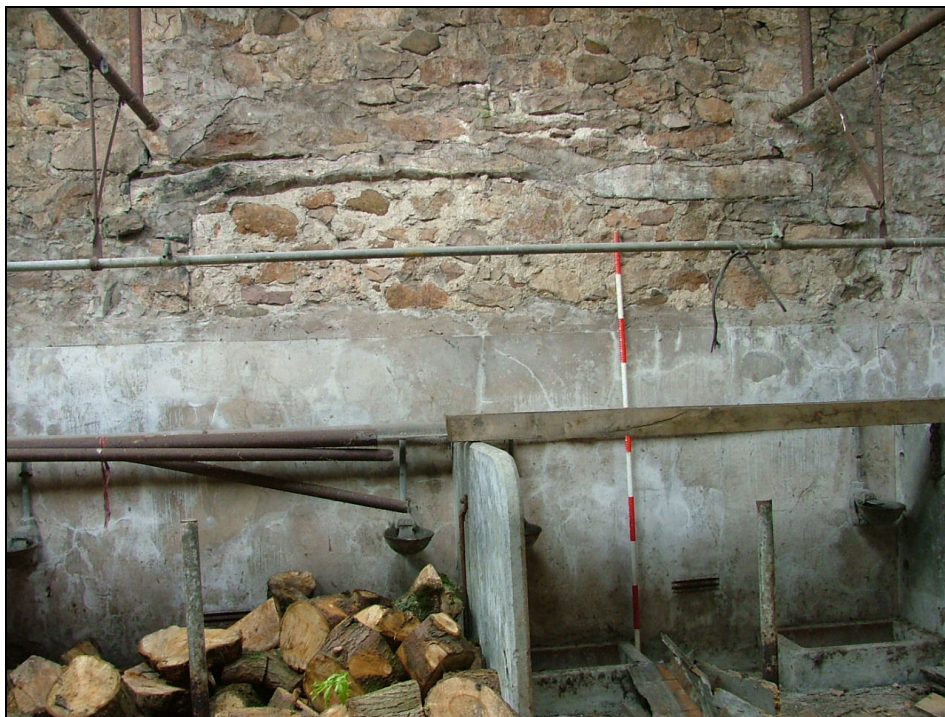
- 4.7.3 In the south wall of the byre are two possible former doorways or windows as shown by lintels which are visible above the plaster (Plate 38). These blocked features could not be noted externally due to lack of access. The

presence of these blocked features does suggest that the ground floor of this building, as it was originally, may not have been used as a byre in the way it is presently with the stalls against the south wall. Along the top of the south wall are a series of square apertures with sections of circular pipe set in the wall, presumably to provide ventilation (Plate 39).

Plate 38 – South internal wall of Building 3 showing the lintels of a former doorway/window (Scale = 2m)
