**FARM BUILDINGS TO
THE EAST OF
MIDTOWN FARM,
STANTON,
PENRITH,
CUMBRIA**

DOCUMENT TITLE: Farm Buildings to the east of Midtown Farm, Stainton, Penrith, Cumbria

DOCUMENT TYPE: Building Recording Report

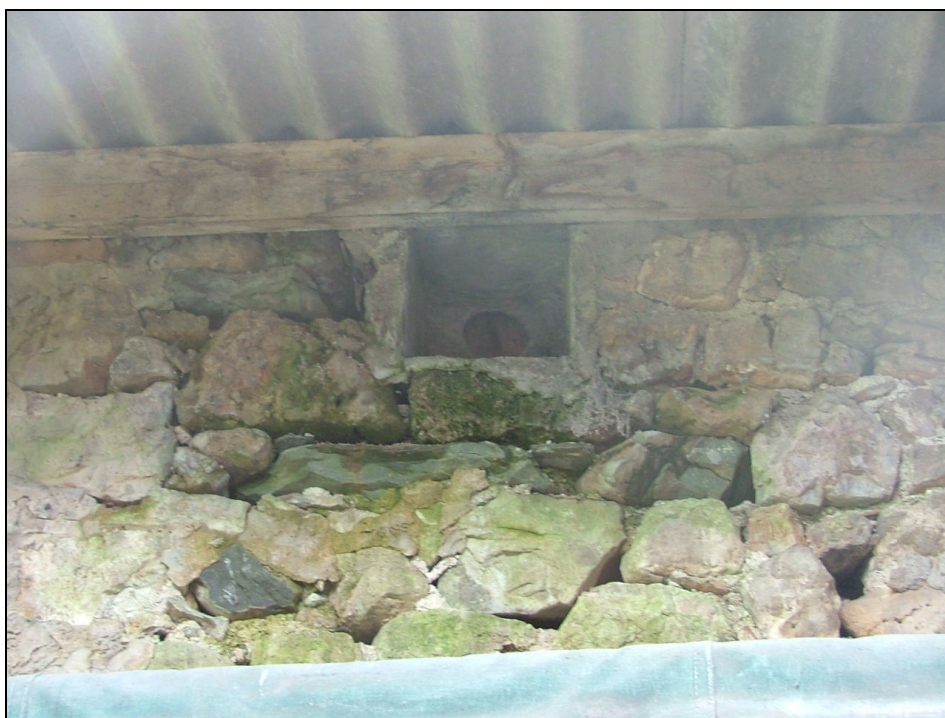
presence of these blocked features does suggest that the ground floor of this building, as it was originally, may not have been used as a byre in the way it is presently with the stalls against the south wall. Along the top of the south wall are a series of square apertures with sections of circular pipe set in the wall, presumably to provide ventilation (Plate 39).

Plate 39 – Detail of one of the ventilation holes along the top of the south elevation, Building 3

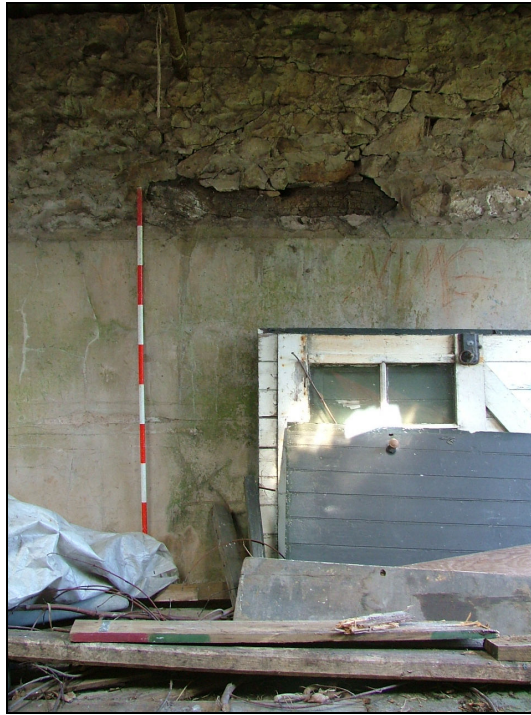
- 4.7.4 The blocked doorway already noted in the north wall (see Plate 33) was only visible internally as a wooden lintel (Plate 40).

*Plate 40 – Wooden lintel of the blocked doorway in the north elevation, Building 3
(Scale = 2m)*

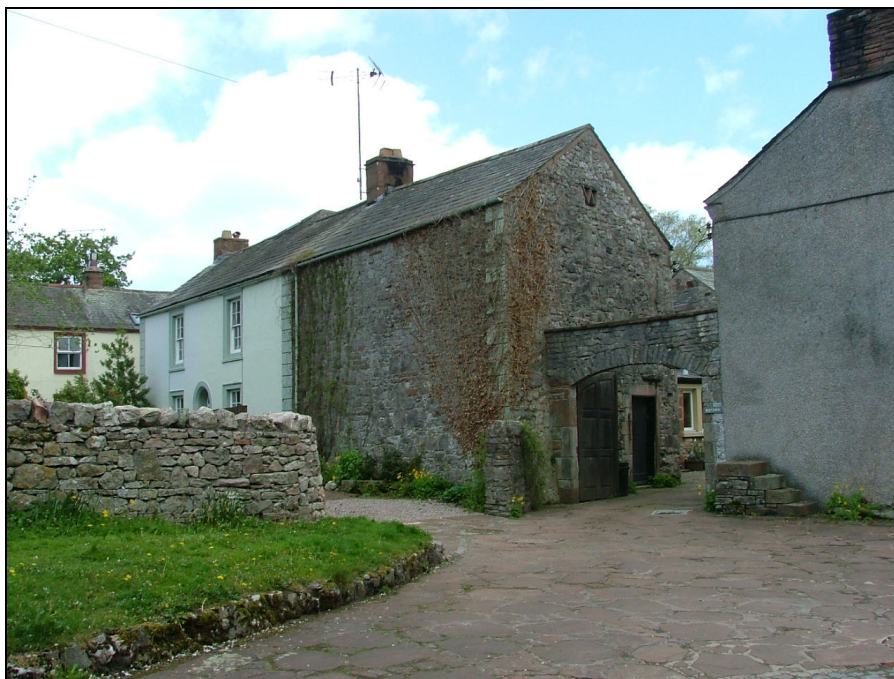
- 4.8.3 The main elevation of Midtown faces the road, with the west elevation of the adjoining barn featureless (Plate 41). The property now known as Barn Harrow appears to be shown on historical mapping and it is assumed that

Plate 41 – West elevation of Midtown and adjoining barn

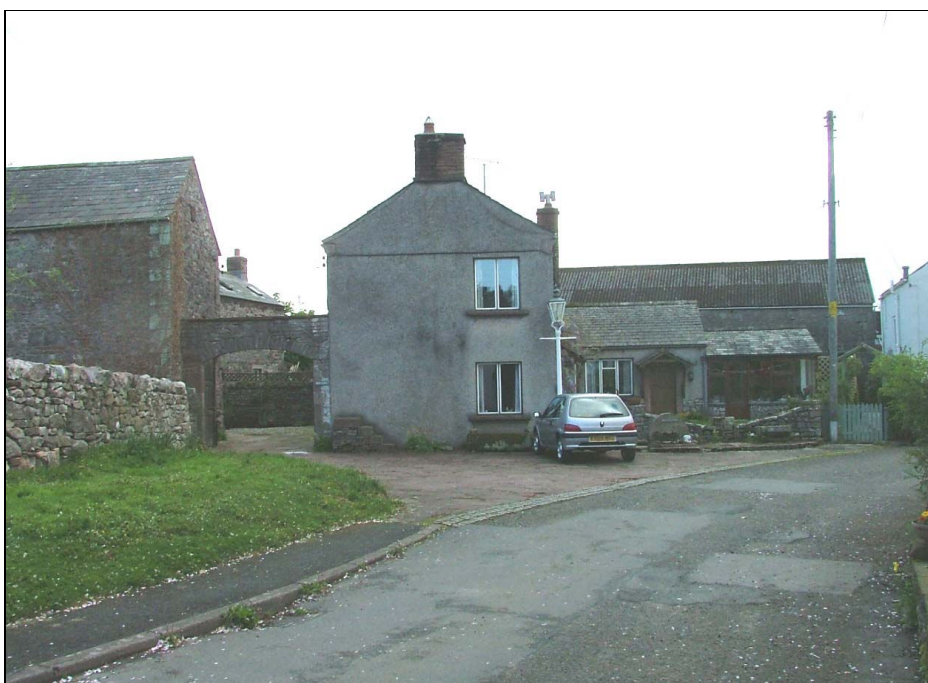
this building also formed part of Midtown Farm in the 19th century, although its conversion to a dwelling and the external render does not allow for an accurate interpretation as to what this building was used for (Plate 42).

Plate 42 – View looking east showing the gable of Barn Harrow, Midtown is to the left of the archway and the corrugated roof in the background belongs to Building 2

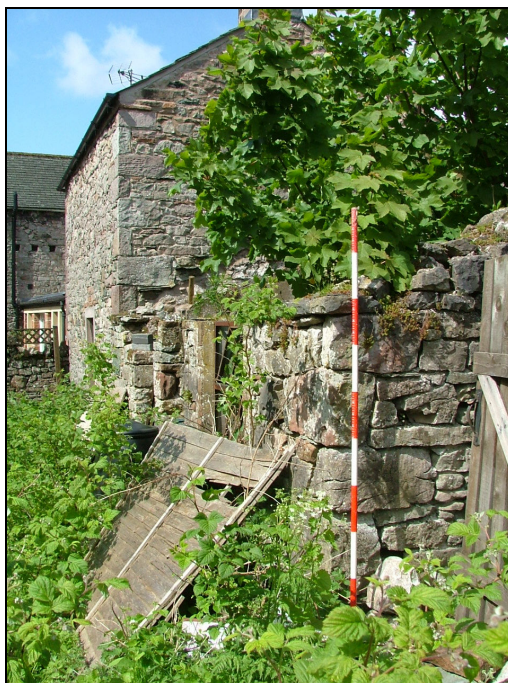
- 4.8.4 To the east side of Midtown is a two-storey building which may also have formed part of the farm historically, but now appears to form part of the house known as Midtown. To the east side of this building is the remains of a single-storey range which consisted of two rooms (Plates 43 and 44). From the north side of Building 3, looking west, it was possible to note that the east elevation of the barn adjoining the house at Midtown (see Plate 41) has what appears to be a row of square apertures at the upper level; these may have been nesting boxes. The barn appears to now be in use as residential.

Plate 43 – View looking west showing a two-storey building, which may now form part of Midtown, and the remains of a single-storey range, all located to the north of Building 3 (Scale = 2m)

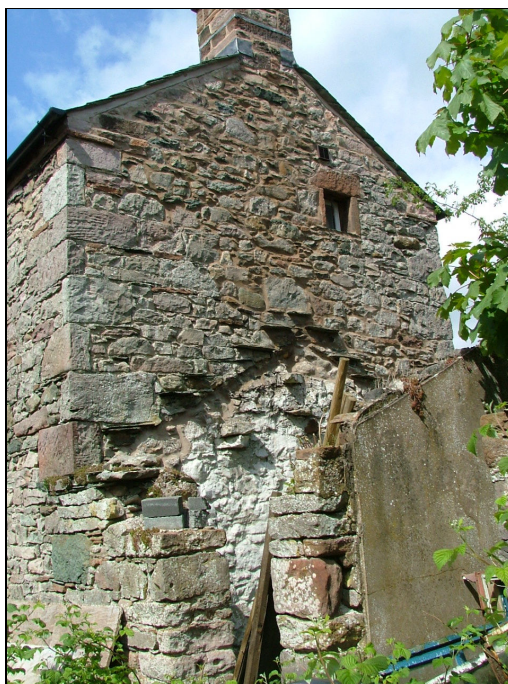
Plate 44 – East gable of two-storey building to the east of Midtown and the scarring of the roofline of the single-storey range

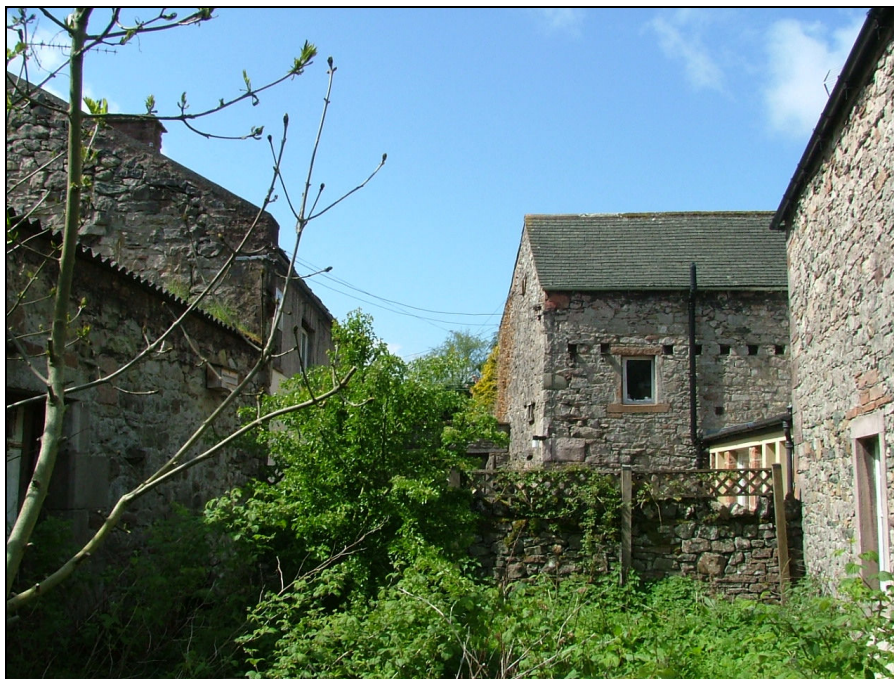
Plate 45 – View looking west to the north of Building 3 showing the former barn adjoining Midtown, with the upper floor containing a row of possible nesting boxes for birds

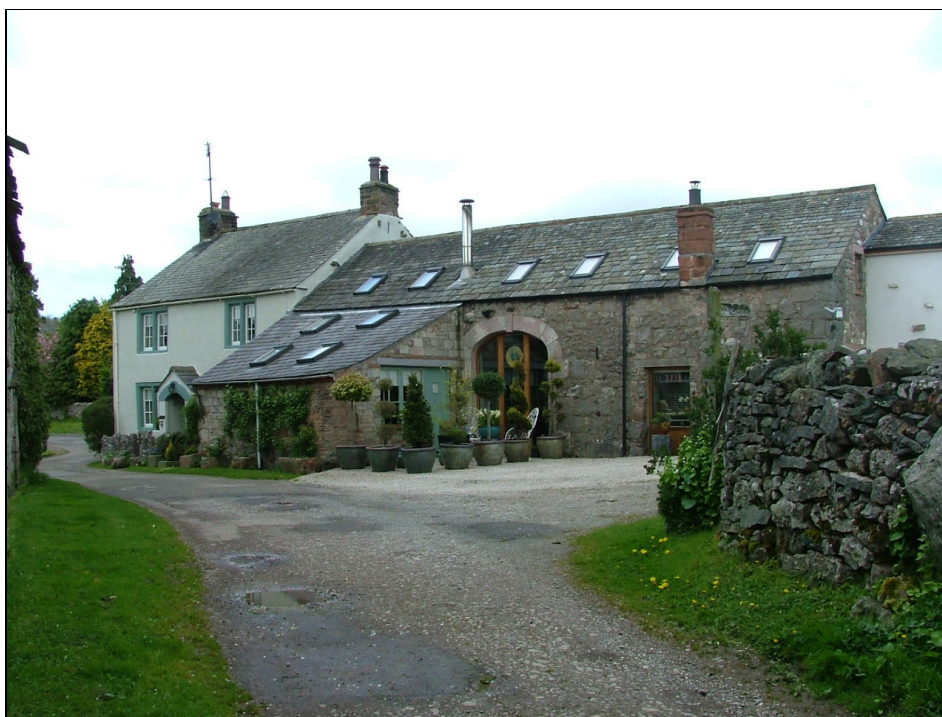
Plate 46 – View looking north of The Mains

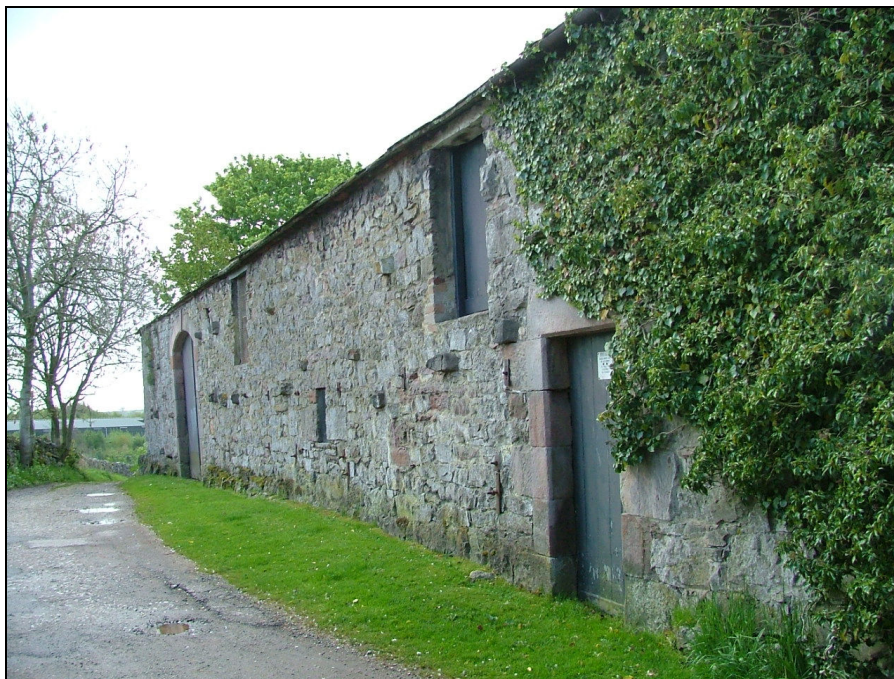
Plate 47 – View looking east showing the detached farm building on the south side of the track opposite The Mains

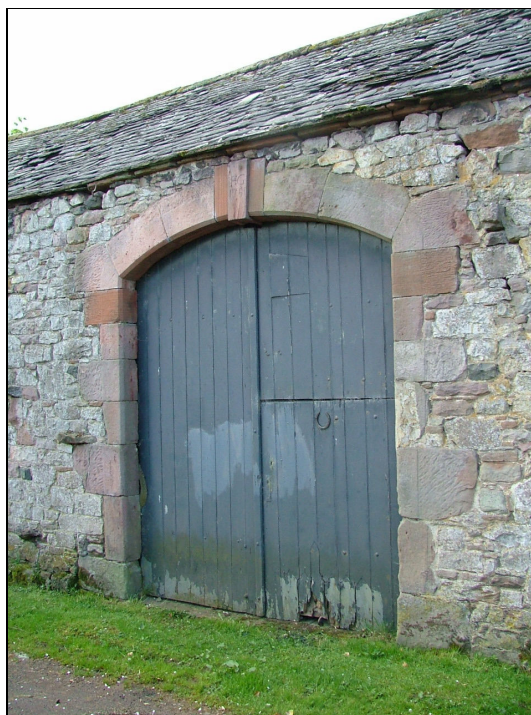
- 4.9.1 The Mains is located to the south side of the redundant farm buildings and the building which make-up the property are noted here due to their close proximity to the survey site. The property is now two dwellings, one of which is apparently a holiday let. The house is to the western end and the former barn is to the east (Plate 46). Local tradition says that the barn at The Mains was where animals were brought to be slaughtered at one point in its history.
- 4.9.2 Located on the south side of the track which provides access to the redundant farm buildings that are the subject of the present survey, is a detached farm building which is also redundant. Above the main double arched doorway in the north facing elevation of this building is the inscription 'P G 1751' carved into the keystone (Plates 47 and 48).

Plate 48 – Doorway with keystone containing the inscription 'P G 1751', redundant farm building opposite The Mains

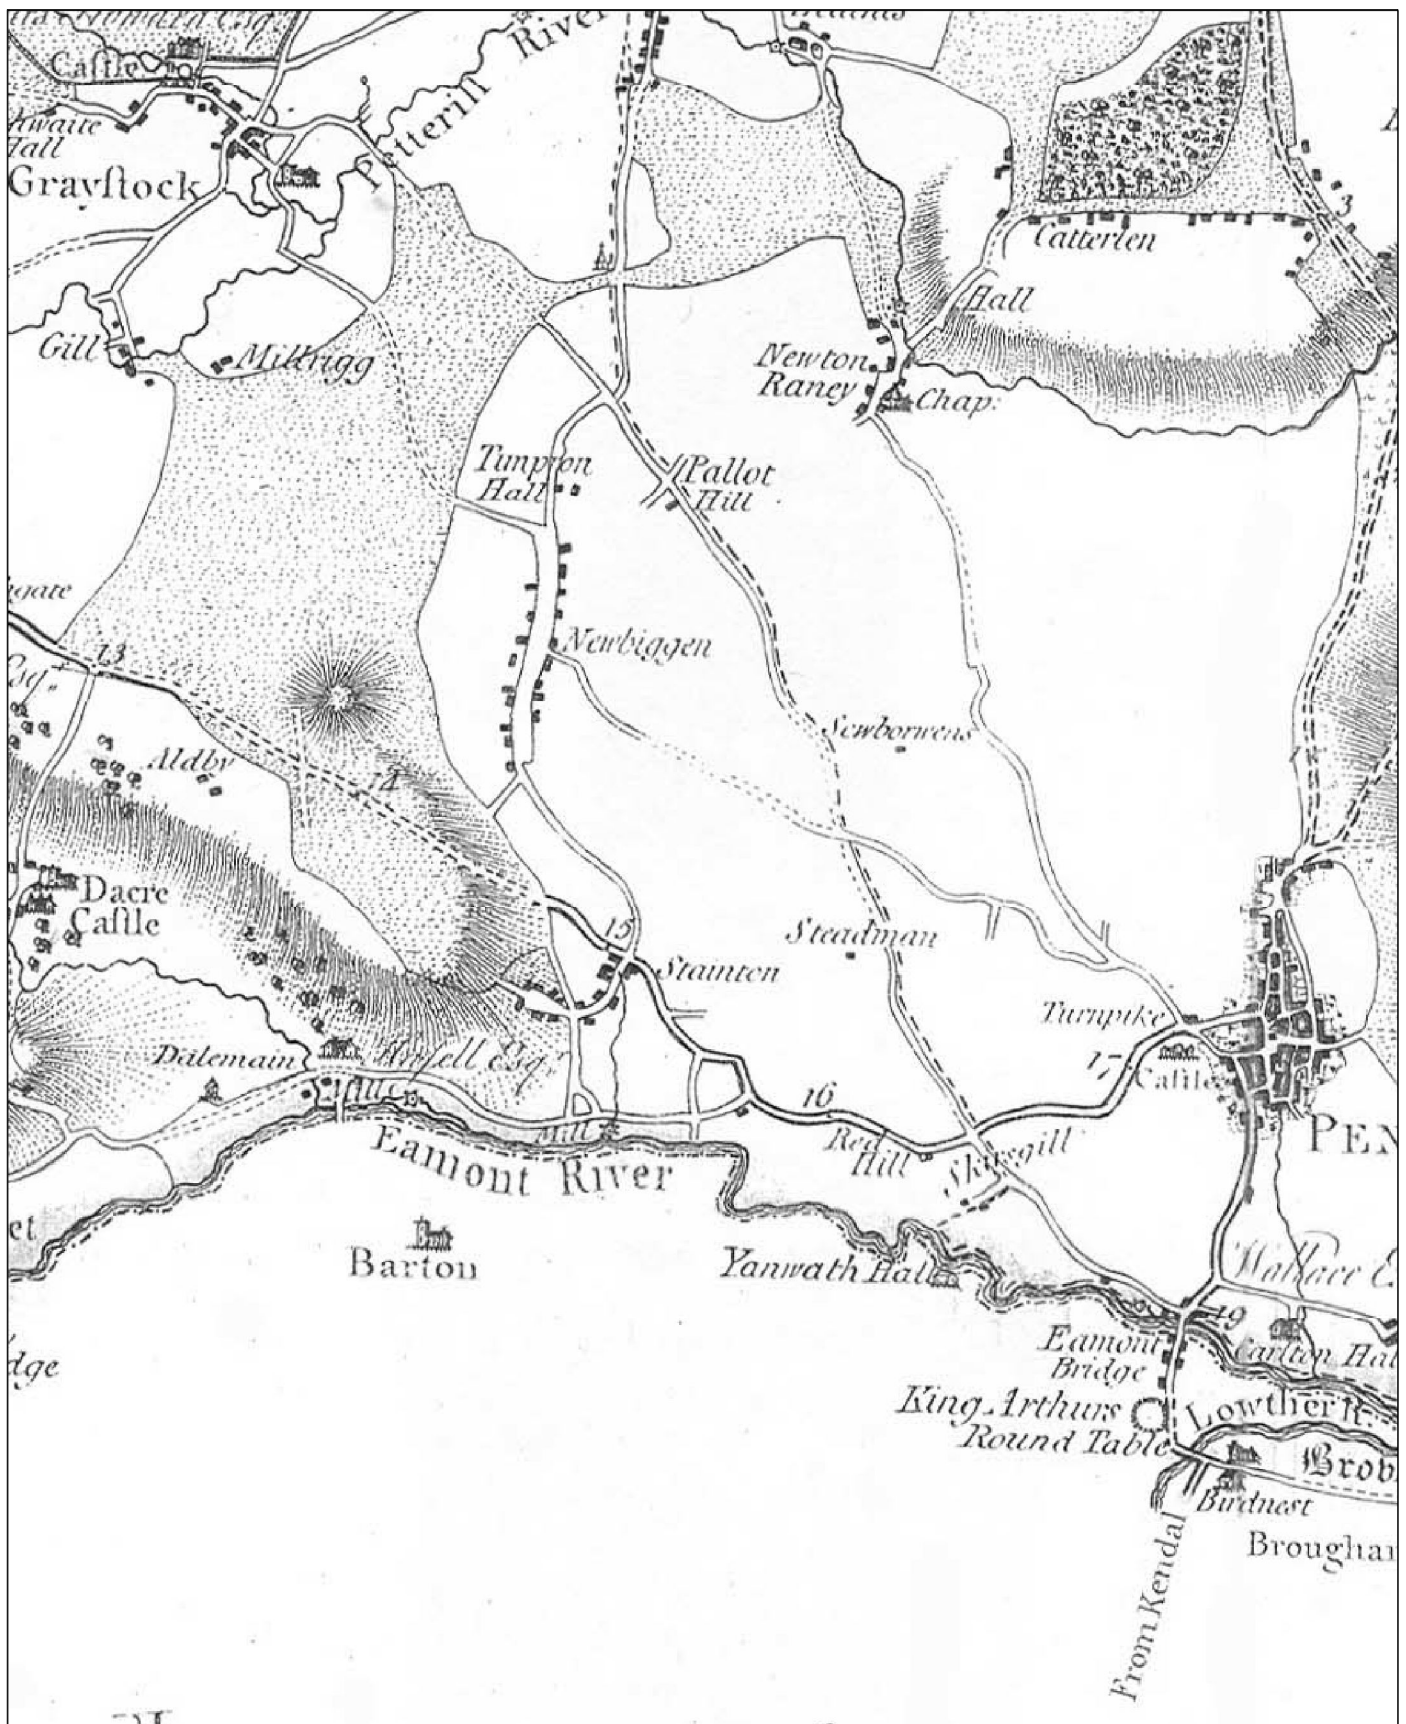
Figure 3 : Site Plan

west of the buildings, whilst to the east fields enclosed with drystone walls slope gently down towards the Kirk Sike (Figure 3).

4.1.1 The present building survey is concerned with three redundant agricultural buildings located to the north of The Mains and to the east of Midtown Farm. For ease of reference the three structures will be referred to as Building 1, Building 2 and Building 3, as shown on Figure 3.
