NORTH PENNINES ARCHAEOLOGY LTD

Client Report No. CP966/09

EXECUTIVE SUMMARY

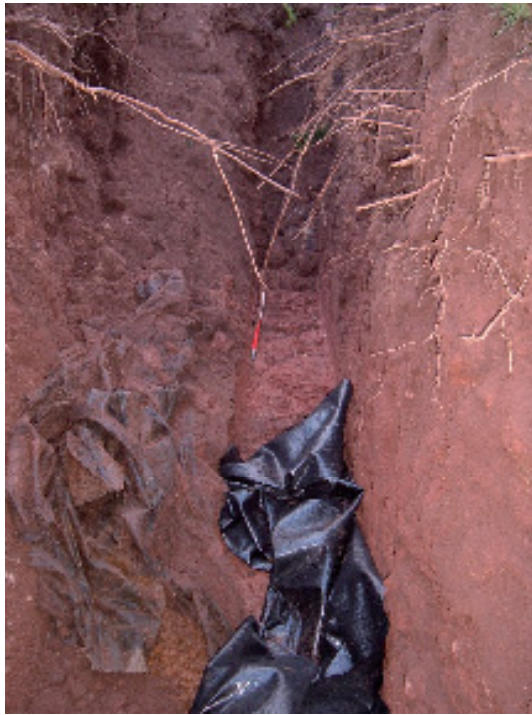
Plate 3: Undisturbed ground parallel to Old pipe trench, looking south

the following day continued alongside (immediately to the west) of the earlier pipe and the trench cut appeared to be in previously undisturbed ground (Plate 3). It comprised mid pinkish-red sandy clay with occasional stone inclusions. From the ground surface the average depth of the trench in this section was 1.70m (Plate 4), to maintain the correct gradient of slope for the pipe. By the end of the second day approximately 30m of the trench had been excavated. The third day's excavation continued alongside the eastern side of the castle towards Point B. The topsoil maintained an average thickness of 0.25m, and was mid brownish-grey sandy silt which overlaid an apparently untouched moderately compacted, dark grey smooth silty clay with occasional inclusions of medium to large sized stones (some of which may have been fallen masonry). Along the eastern side of the castle the ground excavated remained consistent. Towards Point B the ground became more sodden causing trench section slips, which then had to be re-excavated.

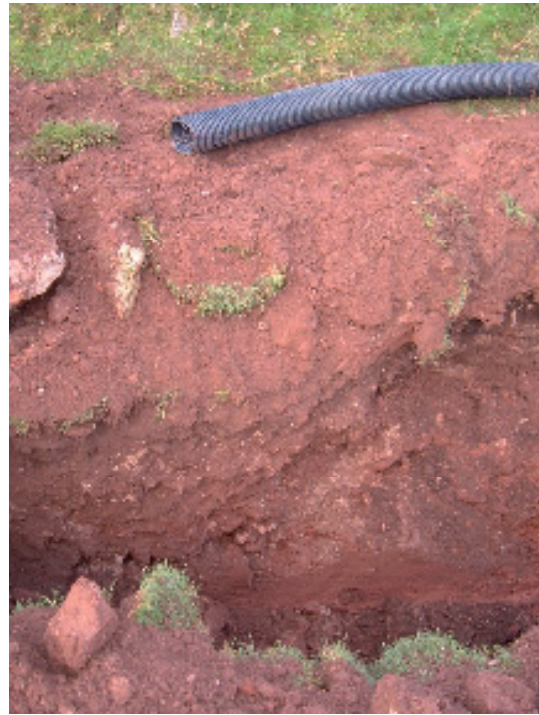
Plate 4: East facing section of trench between points C and B

- 4.1.3 The initial 7m of the trench never reached a depth greater than 1.50m. Beneath the mid-grey sandy silt topsoil was up to 1.20m of re-deposited sub-soil with which the 1993 drain pipe had been covered after its insertion (ADS website). This comprised dark reddish-brown clay/sand/silt mix that carried frequent small to large sized stone inclusions (one stone possibly being a piece of roughly hewn masonry, fallen from the castle in antiquity). In the first 12m section of trench virgin ground was never encountered, as the trench followed the route of the 1993 pipe. The next section dug on

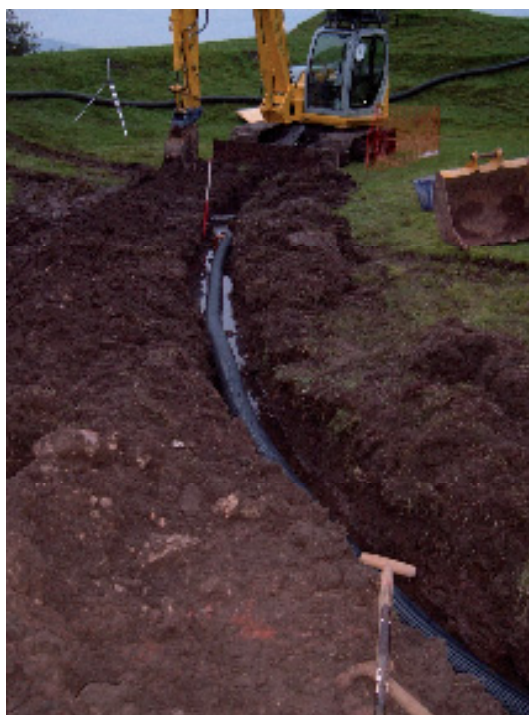
- 4.1.4 **Point 'B':** At this point the trench was only required to be approximately 0.40m deep (Plates 7 and 9), because of the low lying level of the ground surface that was the major cause for the ponding of water at this point. A rodding eye trench was excavated (Plate 8) at an angle from the main drain trench for a length of 1.50m. The main trench continued to curve to the west following the turn of the moat and headed towards the access for the castle. The ground surface began to rise and in consequence the depth of the trench began to get deeper again. Continuing west on the south side of the castle structure the trench remained almost consistent at a depth of approximately 0.40m, utilizing the natural slope of the ground in this area. The topsoil measured

Plate 7: Turning around southeast corner of castle looking southwest

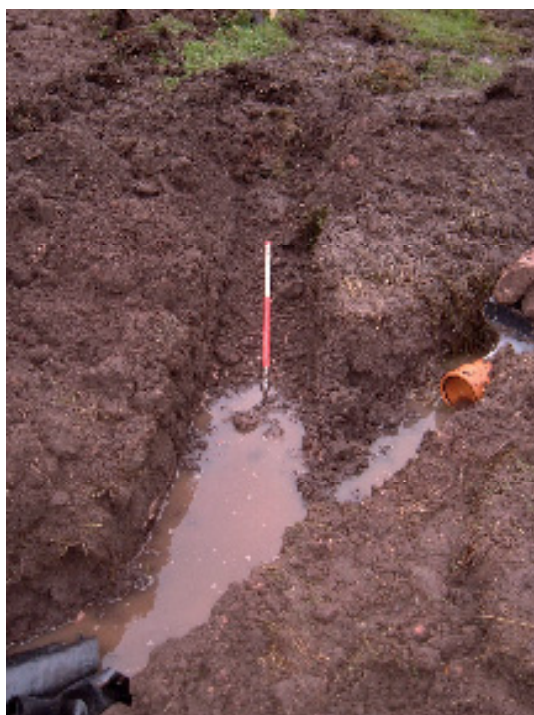
Plate 8: Rodding eye trench at point B, looking north

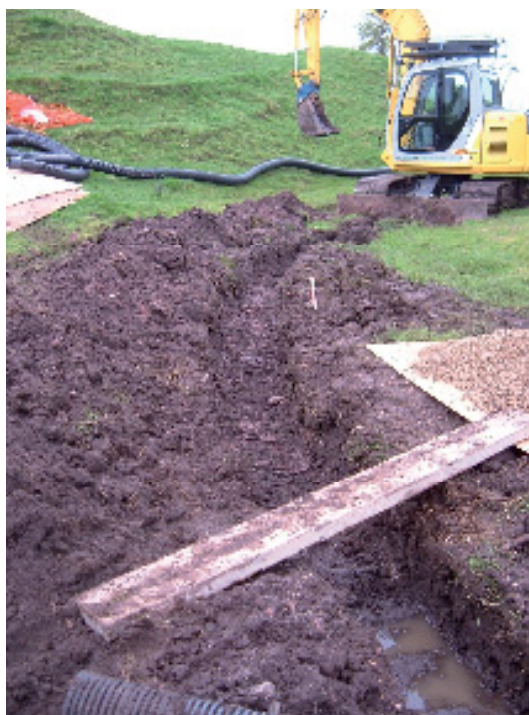
Plate 9: Point B where water was ponding in the moat

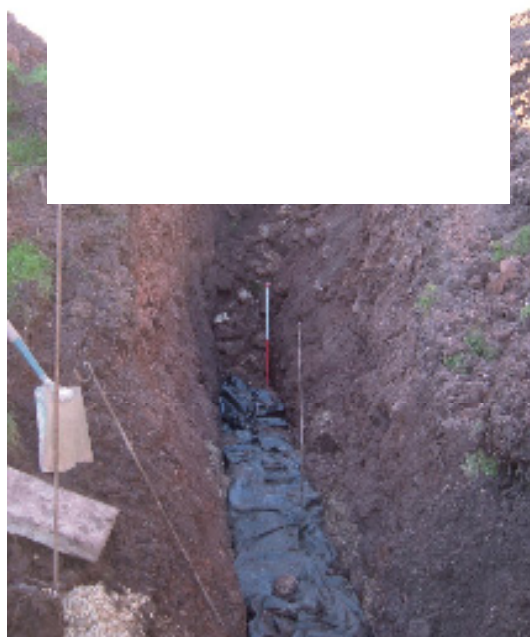
Plate 13: View along the trench at the same point

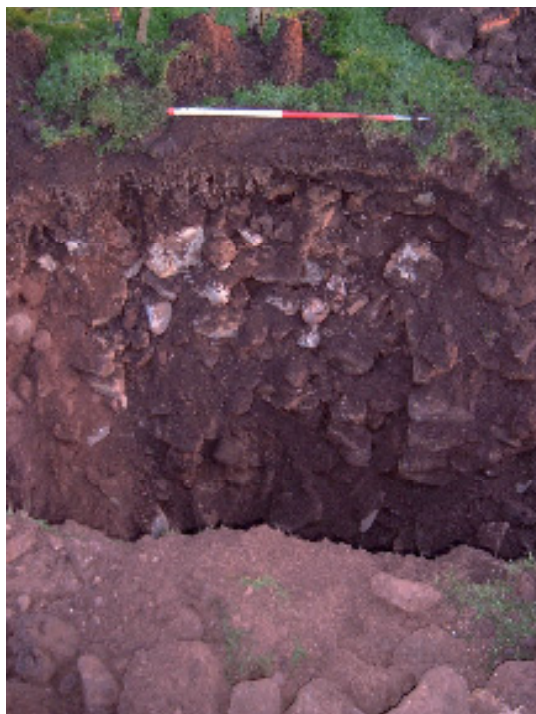
Plate 14: Unknown wall feature in south-facing section just west of point D

- 4.1.5 The structure appeared to be either a wide stone wall with facing stones on either side and a rubble core or possibly a stone built archway for an entrance into the castle or even an abutment (Plate 14 Appendix 2). It measured up to 2.50m in height and approximately 1.40m in width. Its position was immediately to the east of the present cobbled entrance into the castle, and if it extended north under the unexcavated ground would run parallel to the main castle entrance. The outer faces of the structure showed a possible leaning in towards each other, though whether it was designed in that manner or if disturbance over time has led it to look that way is unknown. No datable artefacts were recovered from the vicinity of the feature to aid with either interpretation of its date or primary purpose.

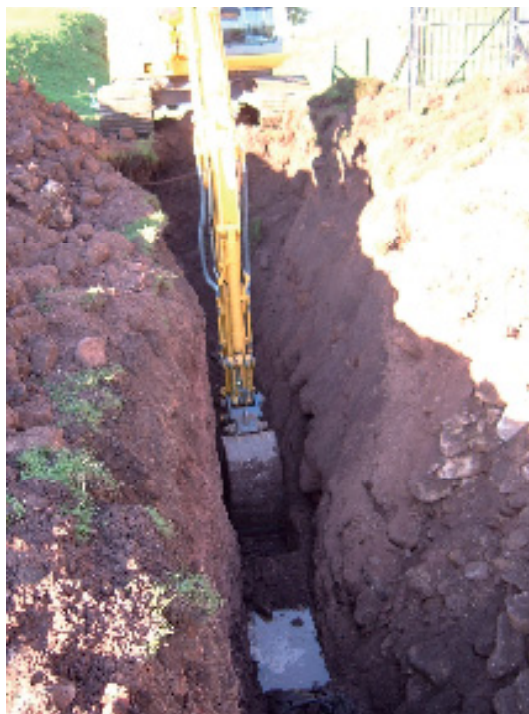
Plate 15: Trench reaching maximum depth through castle entrance way

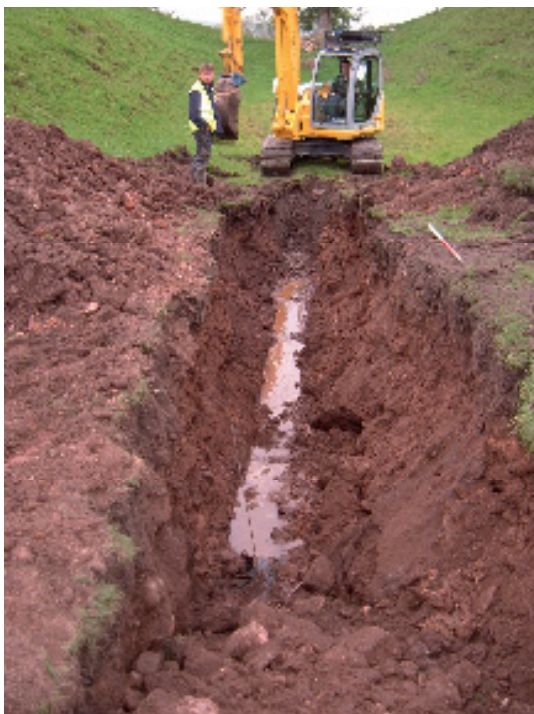
- 4.1.6 **Point 'A':** Towards Point A (Plates 18 and 19 Appendix 2), the end of the trench, the depth returned to approximately 0.40m as it went beyond the castle entranceway and continued for a distance of approximately 20m, with both the topsoil remaining consistent and the subsoil comprising dark red sandy silt. No other artefacts or features of interest were recorded within the trench.

Plate 18: Looking west towards point A

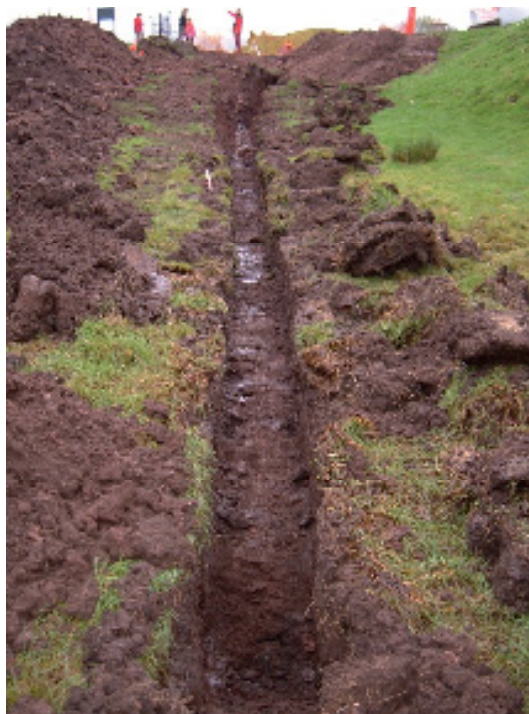
Plate 19: Looking east from point A
towards backfilled entrance way

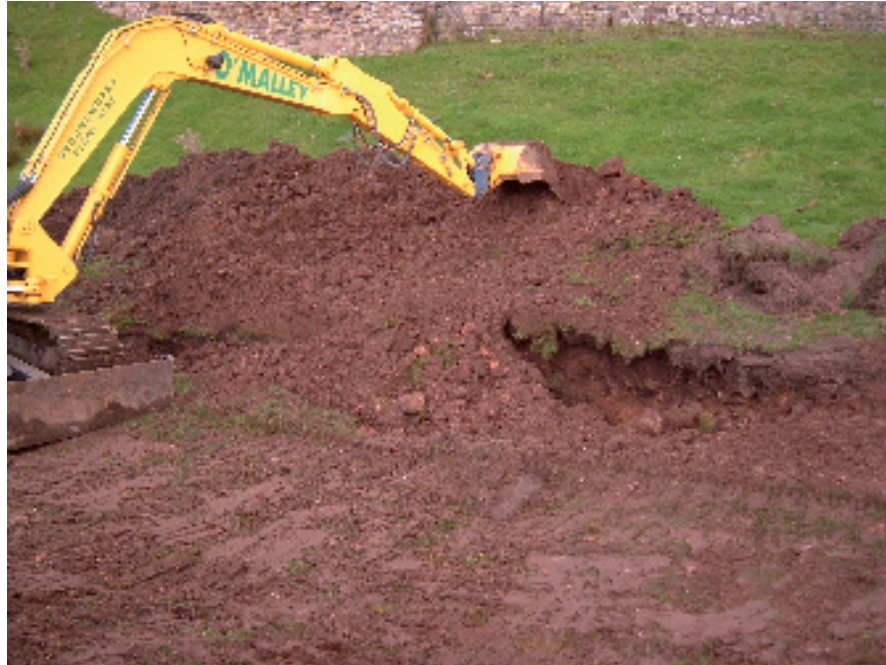
Plate 22: End of trench at point A being backfilled

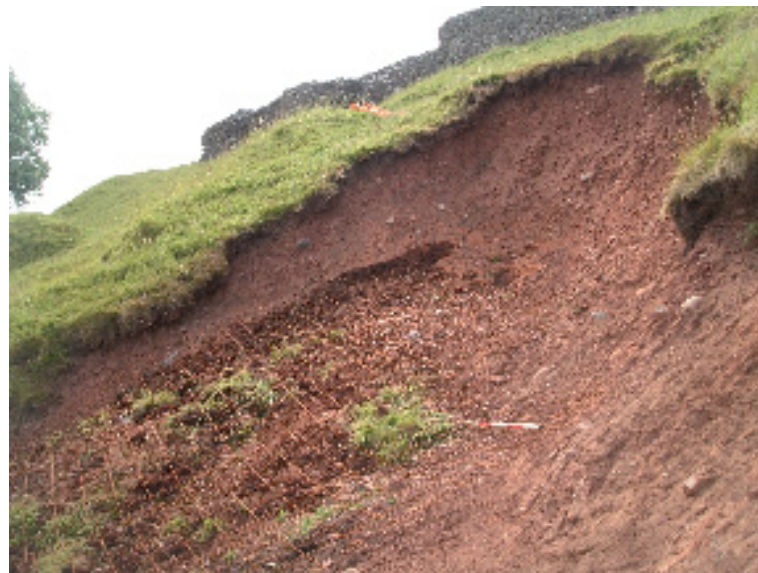
Plate 23: Looking southeast, showing the remedial work on the bank slip.

- 4.2.2 On the 29th of June the area of subsidence was addressed. This was located close to the top of the bank that runs from the north side of the castle down to the Swindale Beck. The area of the slip was levelled out and a wire mesh placed on it, before backfill material from the drain works was tipped on it.

- 4.2.3 Three clear layers were visible in the material surrounding the bank erosion. The topsoil was reddy pinkish brown, overlaid with thick turf. There were some grey stone inclusions, and the condition of the soil was loose and crumbly. This layer was between 0.25m and 0.40m in thickness. Beneath this layer was a layer of subsoil, also reddy pinkish brown in colour, but paler than the topsoil. It also had some grey stone inclusions and was made up of firmly compacted silty clay. The depth was hard to gauge because of the nature of the slip but appeared to average 0.40m in depth. In some places below the subsoil on the slip, the natural was visible. This was also firmly compacted and consisted of red clay with some grey angular stone inclusions.

- 4.2.4 The area of the erosion measured approximately 5m across by 7m. All the work was carried out by hand under dry conditions and no archaeological deposits or features were uncovered in this phase of the works.

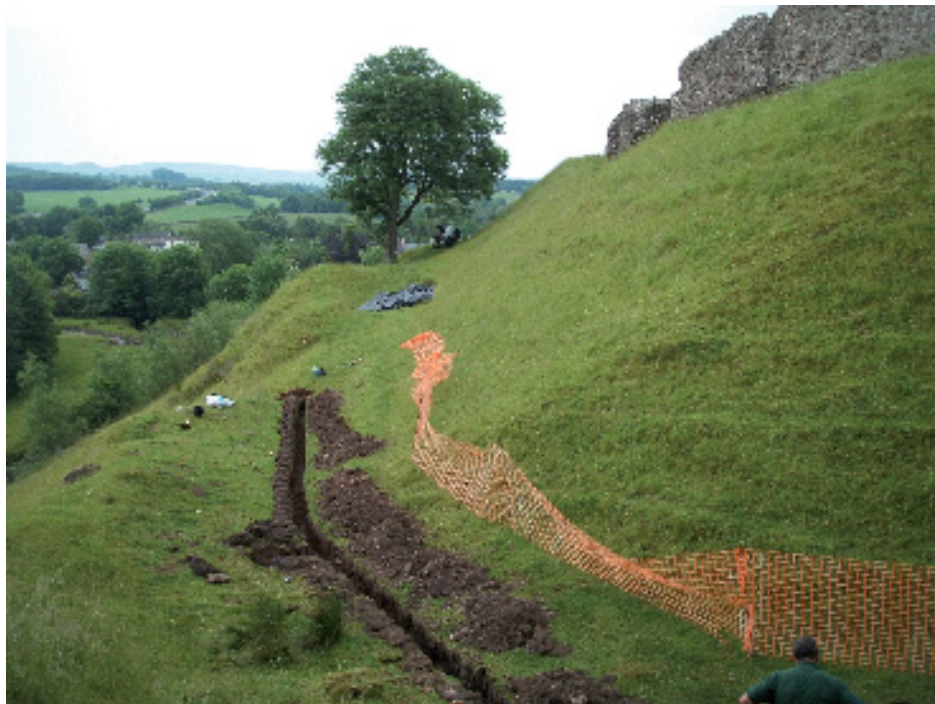
- 4.2.5 The drainage trench began from a point in the moat to the west of the castle (Point 1), in line with the north west corner of the castle. The trench ran in the centre of the moat northwards (Point 2), then followed the moat in an easterly direction, until it reached an interruption in the bank surrounding the castle (Point 3). From this point it turned north and headed through the gap in the bank and down the hill towards the stream (Figure 2).

Plate 24: Looking east along the moat, with the interruption to the bank.

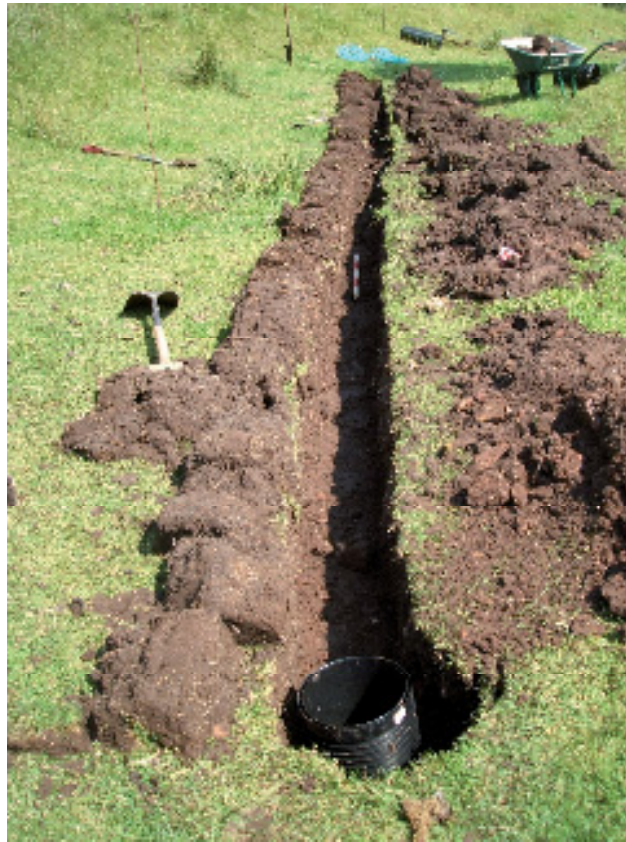
Plate 25: Looking north, showing Point 1 and the first section of the drain trench in the moat.

- 4.2.6 The drain trench cut through soil that was a silty sandy material, of a dark brown colour and covered by a thin layer of turf. The trench was excavated to a depth of 0.40m, with a width of 0.33m. This layer appeared to continue beyond the extents of the trench. Many pieces of reddish sand stone were uncovered from this layer; some were square cut. It is presumed that these are tumble from the castle walls. These stones were kept to one side in case of future restoration works on the castle. The majority of these came from the western end of the east-west section of the drain trench. Some smaller pieces of both red and yellow were recovered from throughout the trench, these averaged between 0.10m and 0.30m thick.

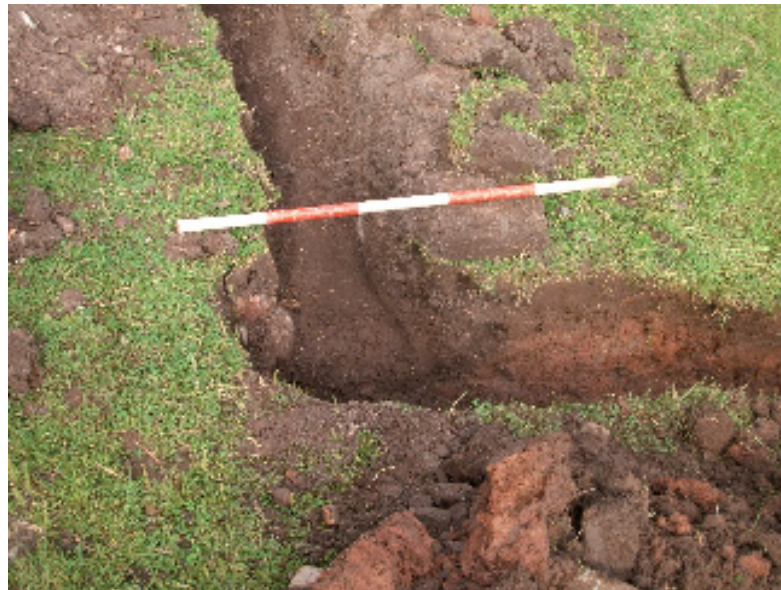
Plate 28: Looking West, at Manhole 3 where a change in soil is shown.

- 4.2.9 At the point where the drain trench changed direction at Manhole 3, a clear change in soils was observed. The darker soil of the moat area gave way to the previously observed soil of the bank slip; a much redder topsoil. The depth of this trench continued to be 0.40m. The topsoil was observed to a depth of 0.20m and the top of the bank, however this deepened at 12m from the top of the bank as the trench progressed down and continued to vary beyond that. The topsoil continued to overlay the subsoil and the trench was not deep enough to reveal the natural. At 35m down the hill from Manhole 3, the trench ended in a soak away which was 0.60m deep with a diameter of 0.50m. The ground changed at this depth, below the topsoil was a layer of gritty mid brown sand and alluvial cobbles.

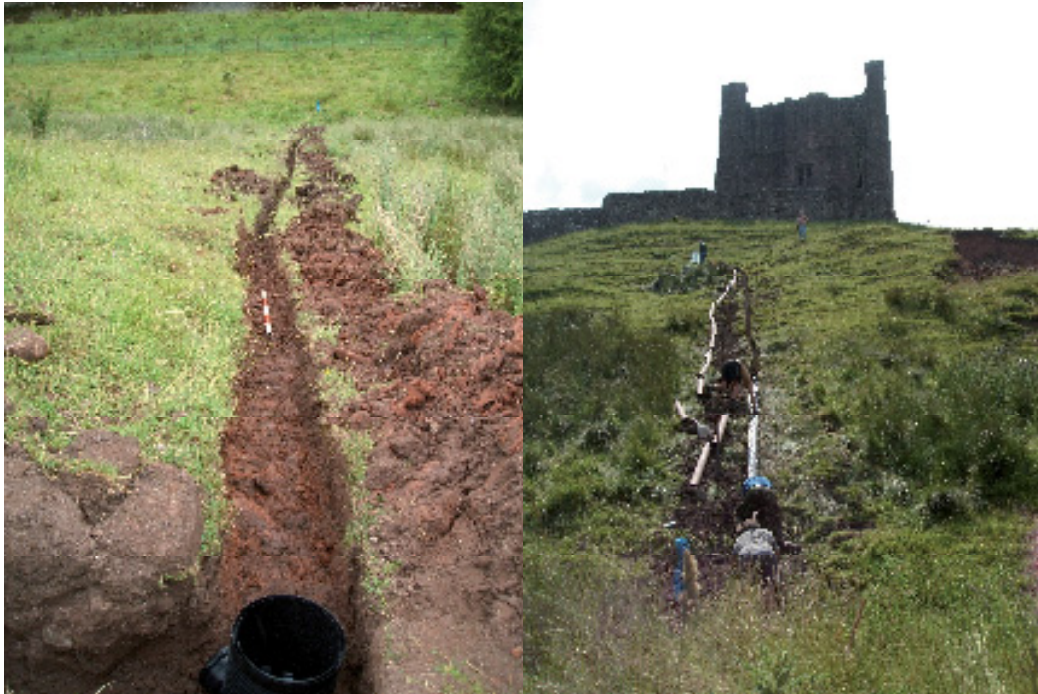
- 4.2.10 The work was all carried out by hand, and although no archaeological features were exposed, a quantity of bone and pottery was uncovered. The first piece of pottery was a piece of Roman Mortaria and this was revealed at 14m down the bank; the majority of the rest of the bone and all the pottery came from below this point (see Section 6).

Plates 29 and 30: Showing the trench north-south down the bank.

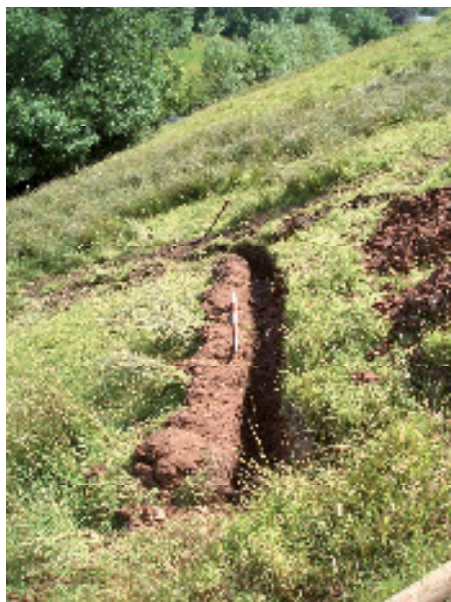
- 4.2.11 A further trench was excavated across the bank, from 13m down the hill, west towards a point just below the area of the bank slip. This trench was also 0.40m in depth and extended for 12m. Some bone and some Roman pottery were also uncovered from this trench. The finds came from the eastern end of the trench, near the point where it joined the trench running the length of the bank. There was a slight variation in the soil here; it was more clay like but looser in consistency and of a darker hue.

Plate 31: Looking East showing the east-west drain trench running across the bank.

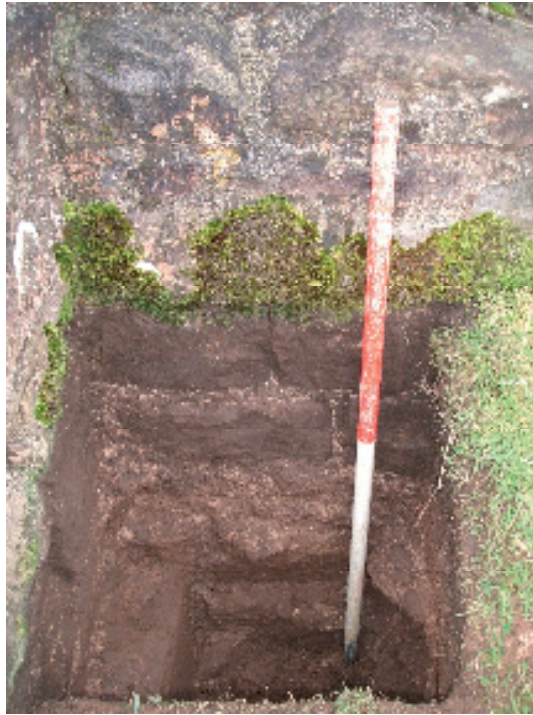
Plate 32: North facing section of curtain wall foundations within Trench 1.

- 5.2.2 The earliest deposit observed, was encountered at a depth of approximately 0.40m from ground level. It consisted of loosely compacted orange-brown sandy silt, **(102)**. This deposit had frequent inclusions of large rounded to sub-angular stones, which represented the bedding layer for the foundations.

- 5.2.3 The foundations of the wall **{106}** were observed to a depth of 0.95m below the current ground level, and were positioned on top of deposit **(102)**. Five courses were observed within the trial trench, and consisted of evenly coursed rectangular blocks of red sandstone, approximately 0.3m in length and 0.15m in width, which were bonded with a lime based mortar.

- 5.2.4 In the eastern section face of Trench 1, an offset belonging to a buttress was observed. This offset and the construction of the buttress is likely to be part of a 13th century renovation of the wall, and it is possible that this buttress was constructed to provide support for an already fragile northern limit.

- 5.2.5 Overlying the earliest deposit **(102)**, and enclosing the foundations, deposit **(101)** was observed to a depth of 0.3m from the current ground level. This consisted of loosely compacted reddish-brown sandy silt with some inclusions of sub-rounded stones and pebbles, which represents tumble and displacement of the stones from within the foundations.

- 5.2.6 Above this deposit, the topsoil **(100)**, consisted of loosely compacted dark brown silty-clay. This was observed to be up to 0.2m in depth and had frequent inclusions of roots and sub-angular stones, which represent tumble that fell from the top of the curtain wall.

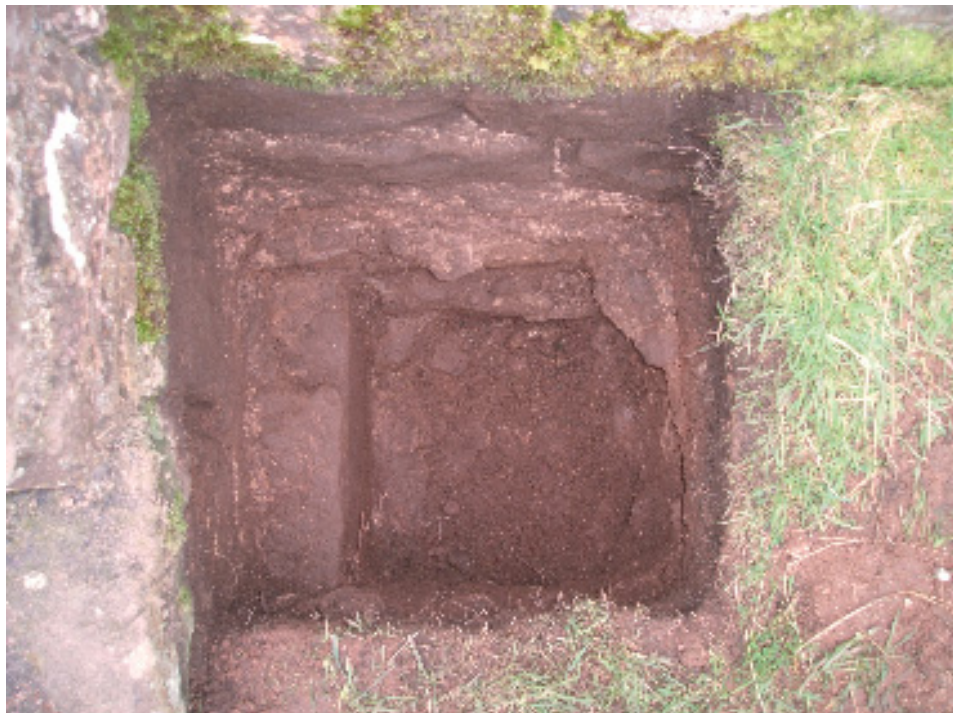
Plate 33: North curtain wall foundations within Trench 1, from above.

- 5.2.1 Trench 1 was positioned to abut the north curtain wall, located next to a buttress, on a slight downhill slope. Trench 1 measured 0.5m in length and 0.5m in width and was excavated to a depth of 1.20m. No discrete archaeological features were encountered, although the foundations were observed within the section (see Plates 32 and 33).

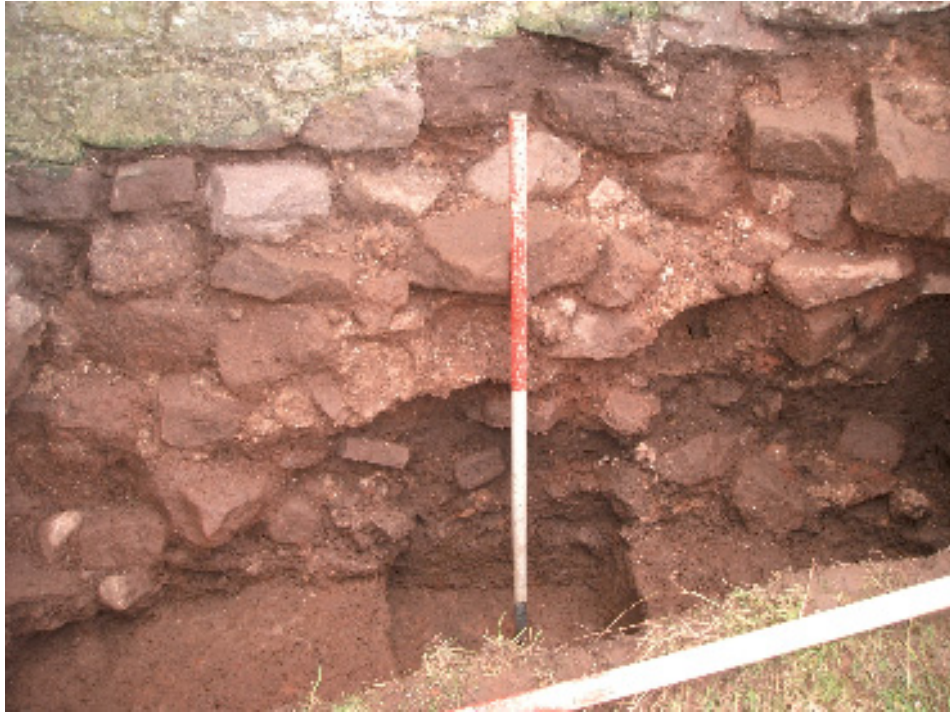
Plate 34: North facing section of curtain wall foundations within Trench 2.

- 5.3.2 The earliest deposit observed (**105**), consisted of loosely compacted blackish-brown, silty sand and was encountered 0.7m below ground level. This had inclusions of sub-angular stones and fragments of lime mortar, and was the bedding for the foundations.

- 5.3.3 The foundations of the north curtain wall **{106}**, were observed just above deposit (**105**), and were observed to a depth of approximately 0.55m below the current ground level. Four courses were observed within this trench and consisted of evenly coursed rectangular blocks of red sandstone, approximately 0.3m in length by 0.15m in width, bonded with a lime based mortar.

- 5.3.4 Observed within the central section of the trench, the foundation coursing appears to become uneven and disrupted, suggesting that some form of collapse, and a phase of subsequent rebuilding occurred.

- 5.3.5 No offset for the foundations was observed in Trench 2, which was placed next to the latrines. These were a late addition in the 17th century and led to the destruction of approximately 11m of the north curtain wall. It is possible the 13th century renovations had occurred on this part of the wall too, as seen within Trench 1, but that these were entirely destroyed during the 17th century works.

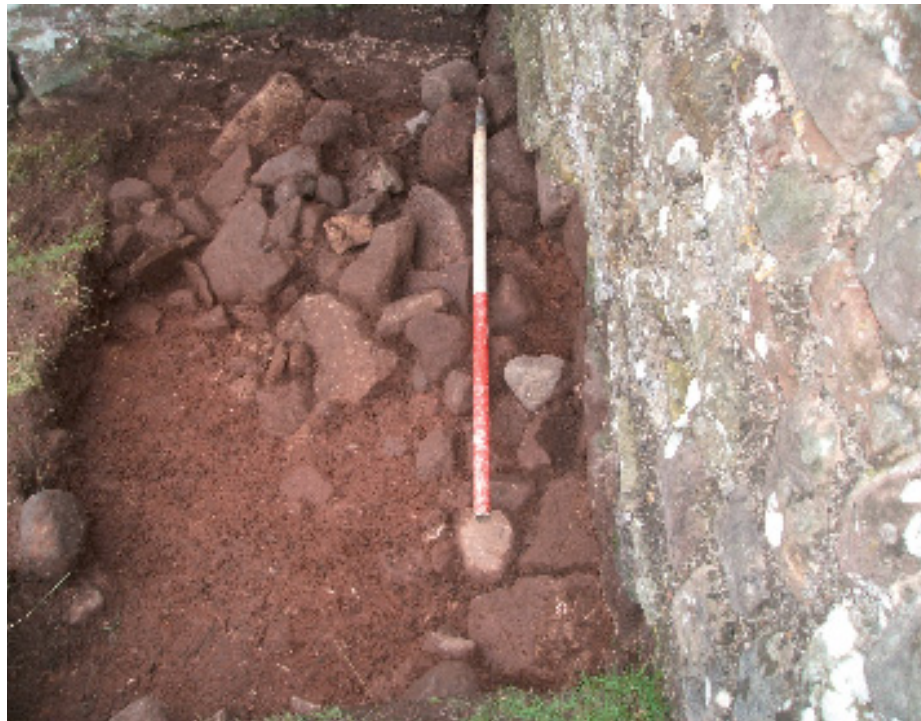
Plate 35: Tumble within upper horizons of (104), within Trench 2, (facing east)

- 5.3.6 Overlying deposit (**105**) and sealing the foundations, deposit (**104**) was observed to a depth of 0.55m. This comprised loosely compacted light orange-red silty sand. Observed within the upper horizon of this deposit, tumbled stones were recorded in plan (see Plate 4), one of which was observed to have decorative moulding on both sides, and appeared to be a voussoir.
