GILSLAND VICARAGE, GILSLAND, CUMBRIA.

WATCHING BRIEF REPORT

CP. No: 898/09

DOCUMENT TITLE: An Archaeological Watching Brief at Gilsland
Vicarage, Gilsland, Cumbria.

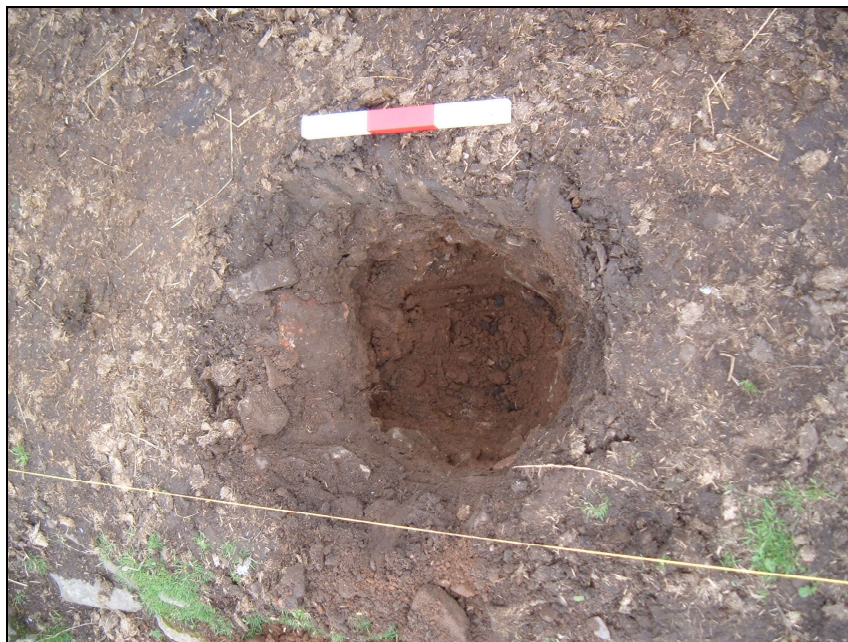
Plate 1: West facing section of posthole to the south of Hadrian's Wall

4.2.3 Work began on the south side of Hadrian's Wall, at the western end of the proposed fence line. On the first day of work (14th July) 27 postholes were dug, from the west to the east. These were located between 1m and 1.30m south of Hadrian's Wall. The postholes were dug to a depth of between 0.60m and 0.80m, and were spaced evenly apart, with a distance of 1.80m from centre to centre. The diameter of these postholes was 0.50m. On the second day of work (16th July), a further 16 postholes were excavated along the same alignment. The final and most eastern posthole abutted the boundary wall running north-east/south-west. There was a change in the appearance of the ground at the fifth posthole from the west. Here the ground was pastureland and the topsoil was deeper and a richer brown shade. The deepest topsoil observed was 0.70m in this area.

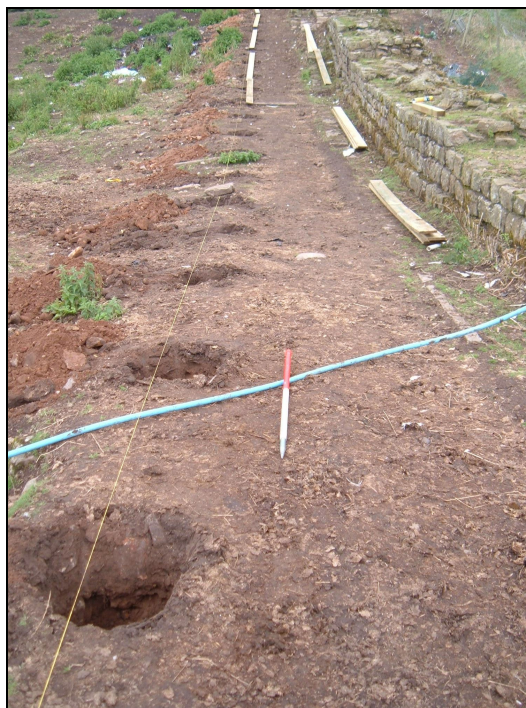
Plate 2: Looking west along the postholes excavated on the 14th July on the south side of the Wall

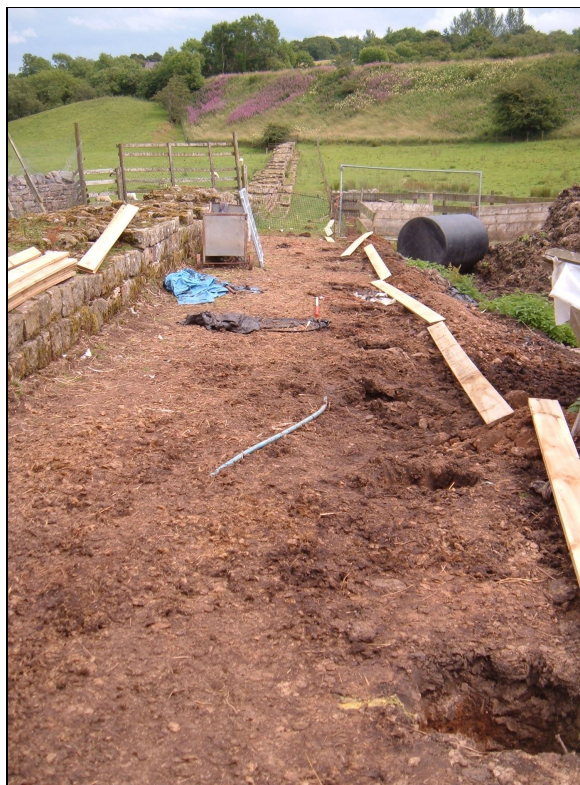
Plate 3: Looking east along the line of the postholes on the south side of the Wall excavated on the 16th July

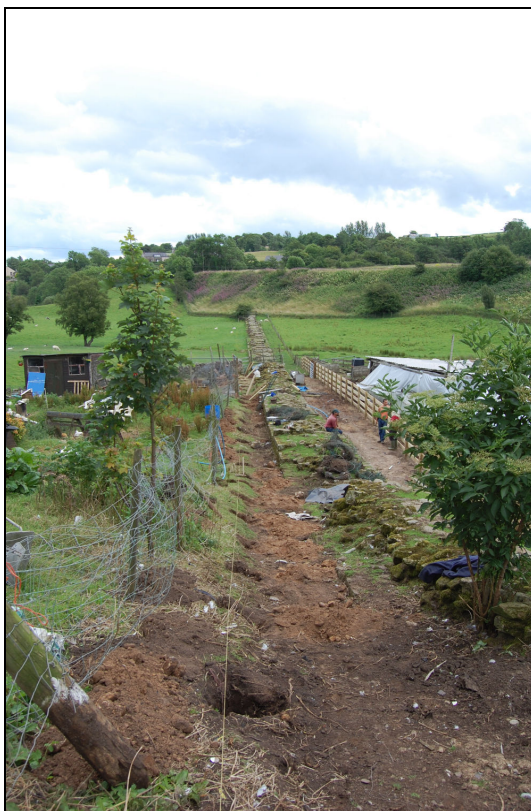
Plate 4: Postholes excavated to the north of Hadrian's Wall on July 23rd, 2009, looking east

- 4.2.5 On the 23rd July a further 32 postholes were dug. The postholes were dug west to east and were a continuation of the work from 16th July. In total 30 postholes were dug to the north of the wall and two postholes to the south (Plates 4-5). Dressed stones were found in four of these postholes. These stones were presumably tumble from the wall as these stones were isolated occurrences that had no structure and were found in the subsoil (Plates 6-8).

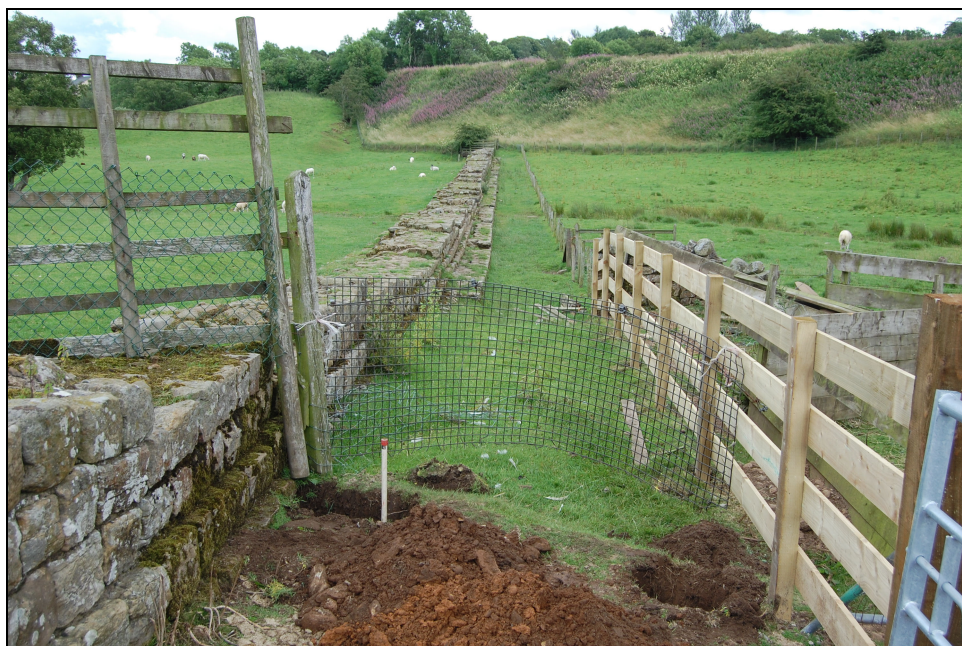
Plate 5: Two postholes to the south of the wall excavated on July 23rd, looking east

- 4.2.6 There were two postholes excavated to the southern side of the wall on 23rd of July. One of these postholes was located 0.05m from the Wall. To the east and west of this area was part of the wall that was expected to be encountered in this area as well (Plate 10). However, the wall did not extend into this area. Here Hadrian's Wall appeared to rest directly in the ground with a thin layer of modern cement between the ground and the first layer of stones. This cement appeared to be modern and it was thought that this area of the wall had been robbed out and possibly rebuilt on top of a layer of cement in order to prevent subsiding (Plate 11). No archaeological features or artifacts were encountered on July 23rd.

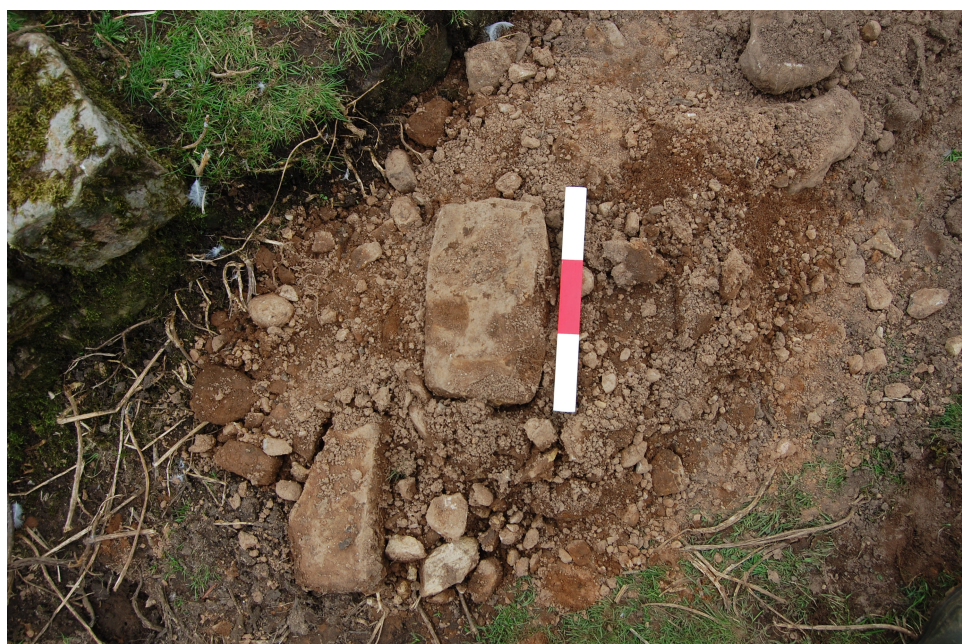
Plate 6: Dressed stone found in one of the postholes on the northern side of the wall, excavated on July 23rd.

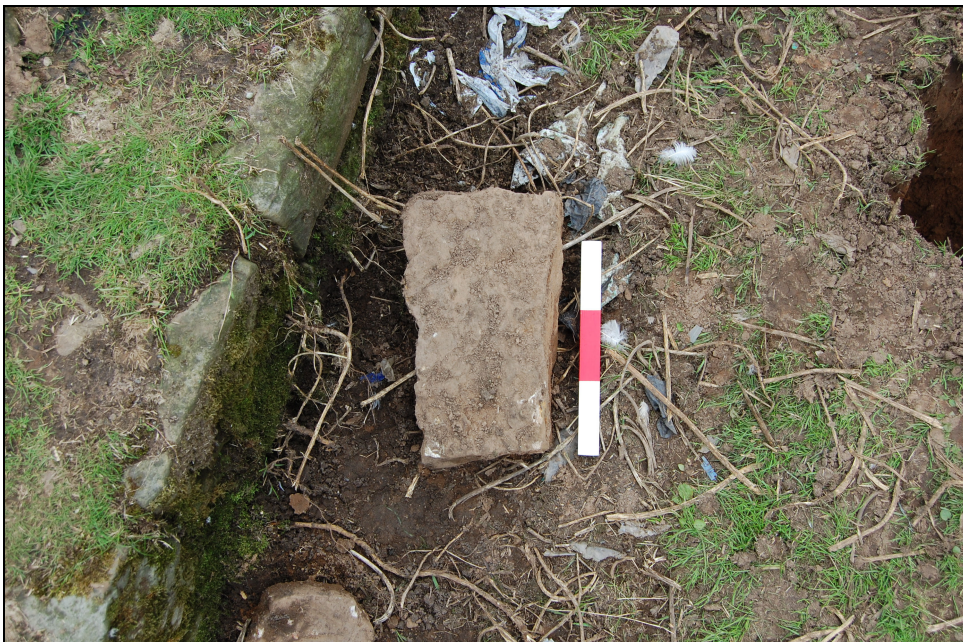
Plate 7: Dressed stone found further east than the previous photograph, on the northern side of the wall

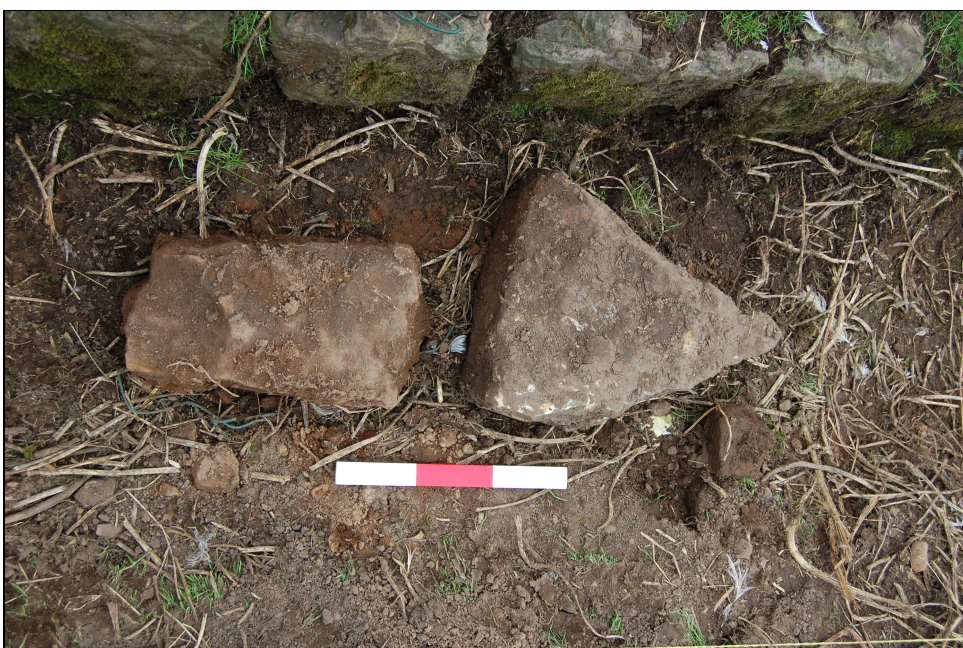
Plate 8: Two further dressed stones found in postholes to the north of Hadrian's wall, excavated on July 23rd

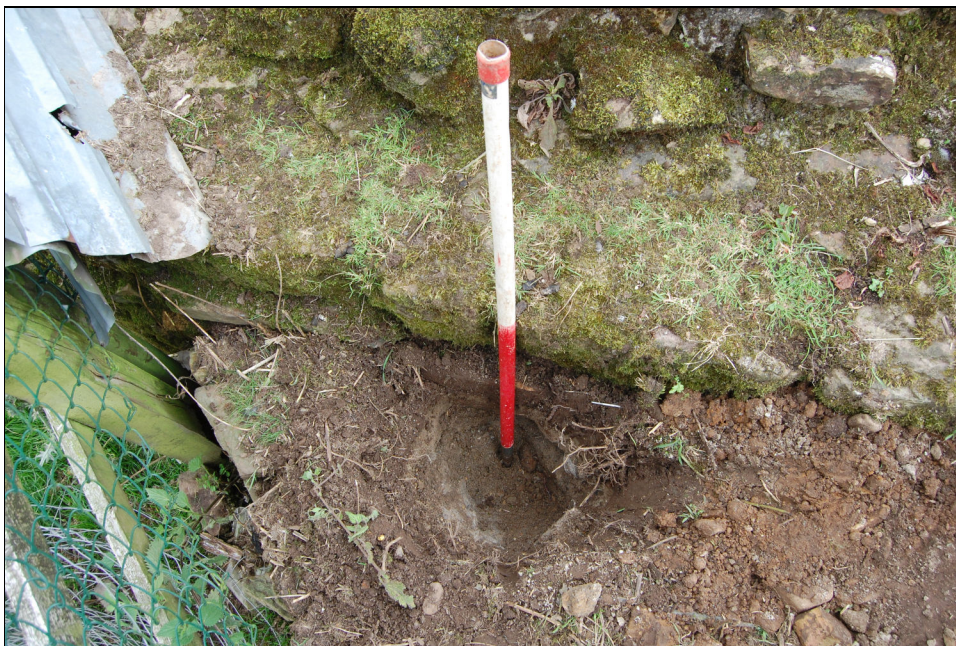
The posthole closest to the wall on the northern side encountered stones from a modern boundary wall constructed because of the raised nature of the ground (Plate 9).

Plate 9: Stones from a boundary wall encountered at a depth of 0.40m abutting the wall to the north

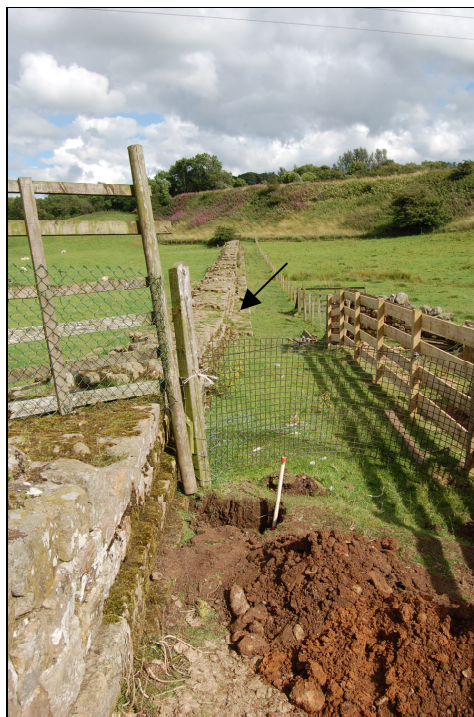
Plate 10: Posthole on the southern side of the wall. Arrow points to a lower part of the wall that should have been present in the area of the posthole

- 4.2.7 The postholes for the remaining sections of fence line were excavated on the 17th September 2009 from the area where the Wall disappears heading in a westerly direction towards the boundary wall with the road. It was noted that the line of the Wall from the point where it disappears, was defined by a line of kerb stones on each side, with concrete noted along each length, possibly relating to works undertaken by the Ministry of Works. A large tree has until recently been located within a section of the wall line.

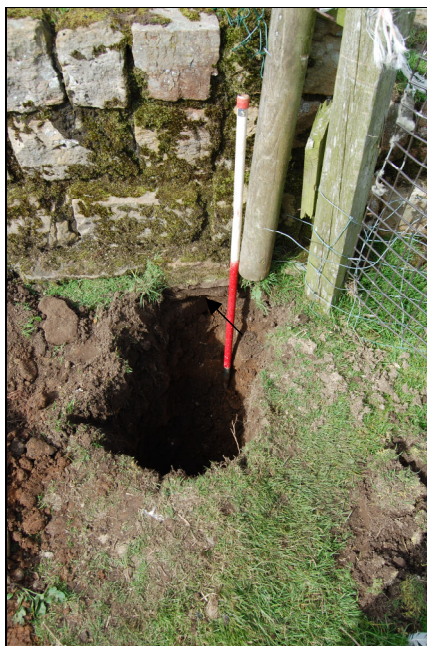
Plate 11: South facing section of posthole to the south of Hadrian's Wall. Arrow is pointing to the thin layer of concrete found at the base of the wall

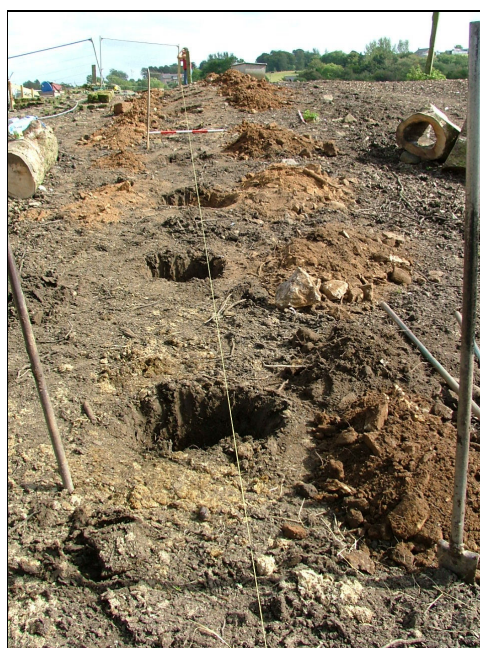
Plate 12: View looking east showing the postholes excavated to the south side of the wall immediately opposite The Vicarage

located approximately 1.65m from the outer face of the Wall, and c.1.80m apart centre to centre. The excavated material from the south side of the wall consisted of topsoil (100) which varied in depth due to the gradient of the slope northwards. Beneath the topsoil, the excavated material consisted of a loose, red gravelly layer which included rounded and angular stones (102), some of which may have been tumble from the Wall, although none appeared to have been from the outer faces (Plates 12 ,13 and 14).

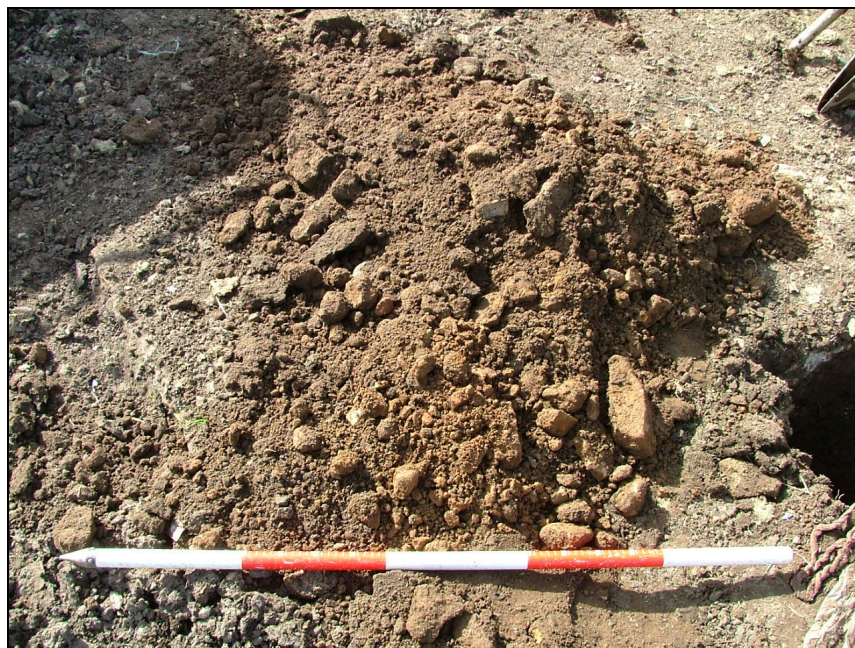
Plate 13: Detail of excavated material from one of the postholes on the south side of the wall (Scale = 1m)

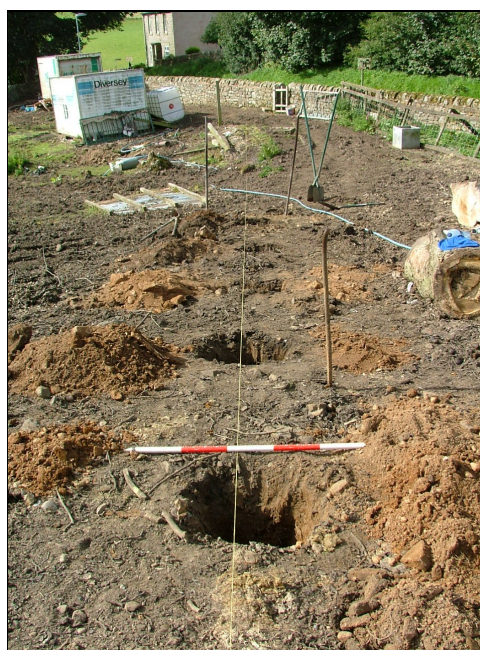
Plate 14: View looking west showing excavated postholes to the south side of Hadrian's Wall (Scale = 1m)

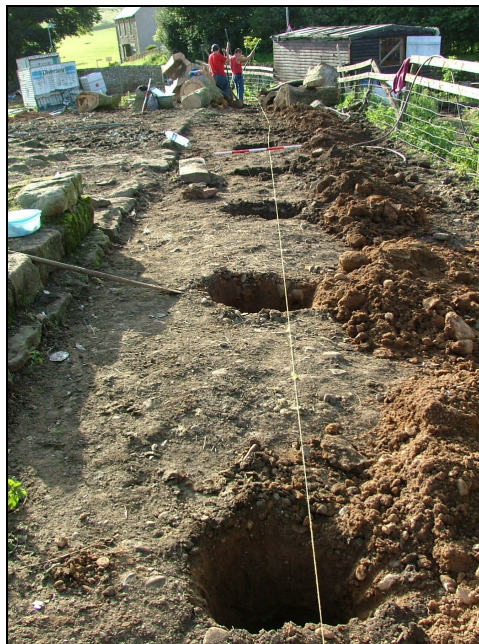
Plate 15: View looking west showing excavated postholes on the north side of the Wall (Scale = 1m)

- 4.2.9 Along the northern side of the Wall, a total of 18 postholes were excavated each of similar dimensions to those already referred to. The excavated material from these postholes was similar to those on the south side. Towards the western end of the fence line, the topsoil was much deeper presumably as this area forms part of the present garden. Located in one of the postholes close to the garden fence a small diameter metal pipe was exposed, aligned roughly north-east to south-west (see Figure 3). It is possible that a trench may have been excavated at some point through the area where the Wall is no longer visible, to allow for the laying of this pipe (Plate 16).

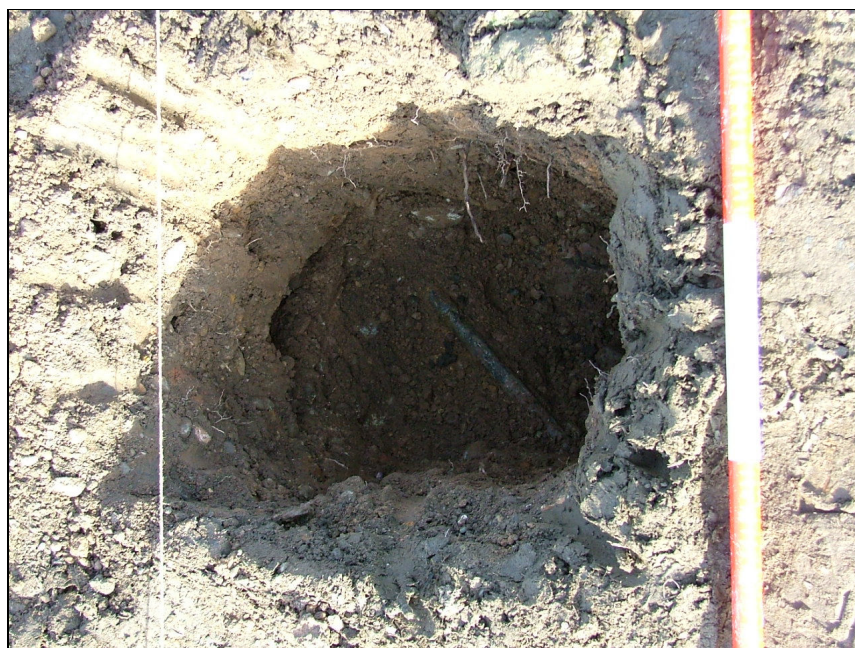
Plate 16: Detail of metal water pipe exposed in posthole to north side of Hadrian's Wall

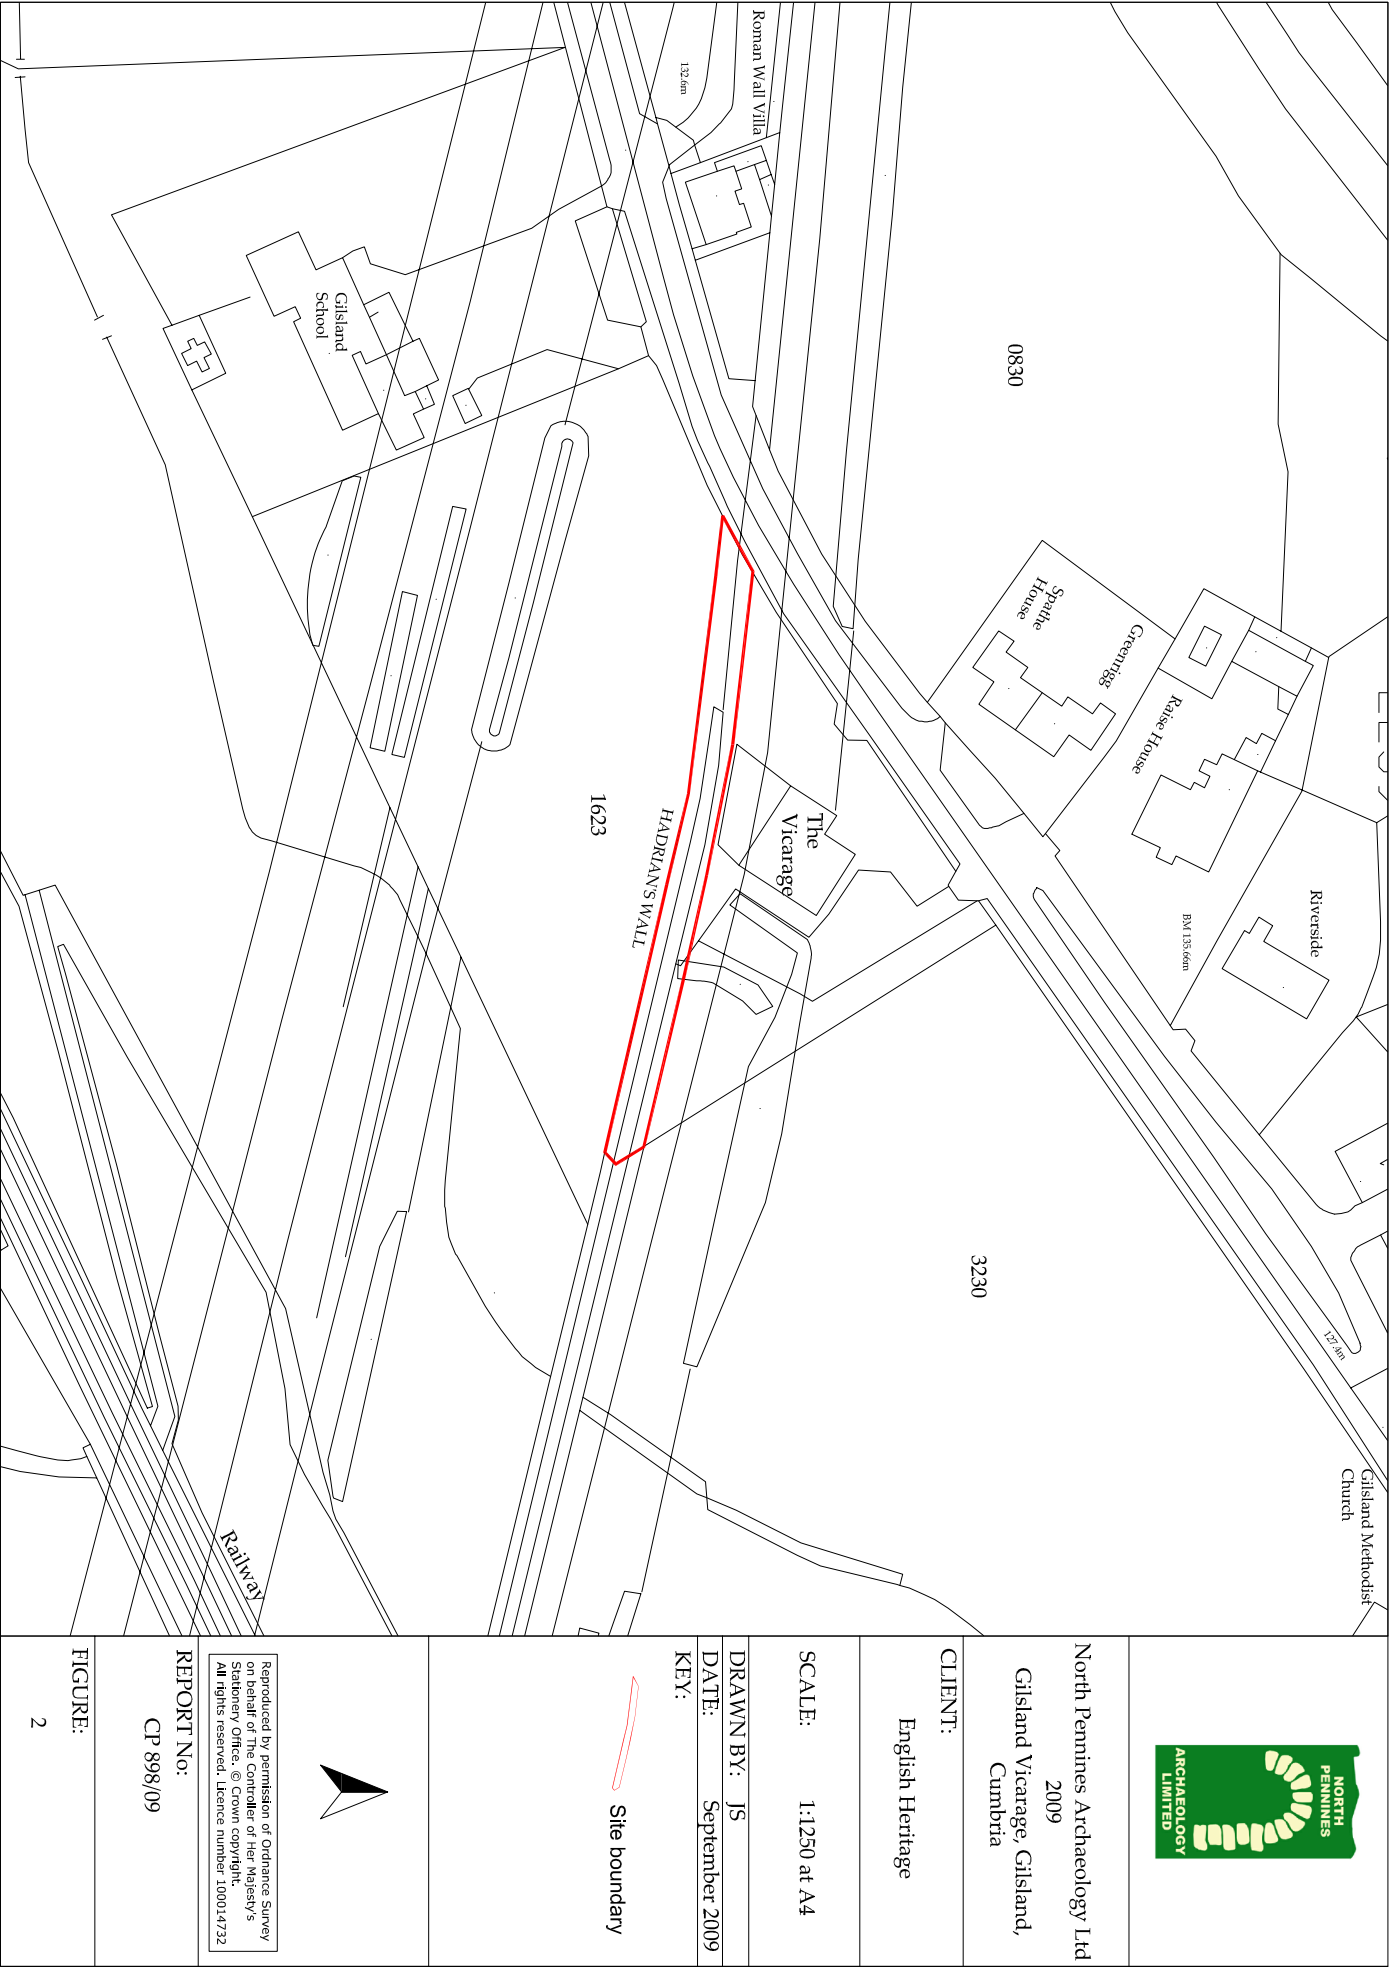
Figure 2: Location of watching brief at Gilsland Vicarage, Gilsland, Cumbria

- 3.1.1 Gilsland Vicarage lies within the village of Gilsland, which spans the two counties of Northumberland and Cumbria. The Vicarage is situated in close proximity to Hadrian's Wall, and the Newcastle to Carlisle railway line. The countryside is undulating farm land, mostly used for sheep grazing. The village of Gilsland lies approximately 18 miles east of Carlisle and 42 miles west of the city of Newcastle at a height of between 120 to 130m AOD. The River Irthing flows westwards to the north the village (Countryside Commission 1998). The area is shown in Figure 2.
