# **NORTH PENNINES ARCHAEOLOGY LTD**

**Client Report No. CP/744/09**

In July 2009, North Pennines Archaeology Ltd were invited by Bruce Pilling of United Utilities to undertake an archaeological evaluation along the projected line of Hadrian's Wall near Glasson, Cumbria (NGR NY 325814 5602451). The archaeological work was undertaken in advance of the proposed instalment of a new electricity cable at a depth of 0.6m. At this depth, any archaeological remains within the vicinity would be severely impacted upon. As the proposed works are within an area of high archaeological potential close to the projected course of Hadrian's Wall (SM 28472), which is classified as a World Heritage Site, Mike Collins of English Heritage (Hadrian's Wall Archaeologist) recommended that a programme of archaeological work be undertaken in advance of the proposed electricity scheme.

PROJECT: Glasson Pumping Station

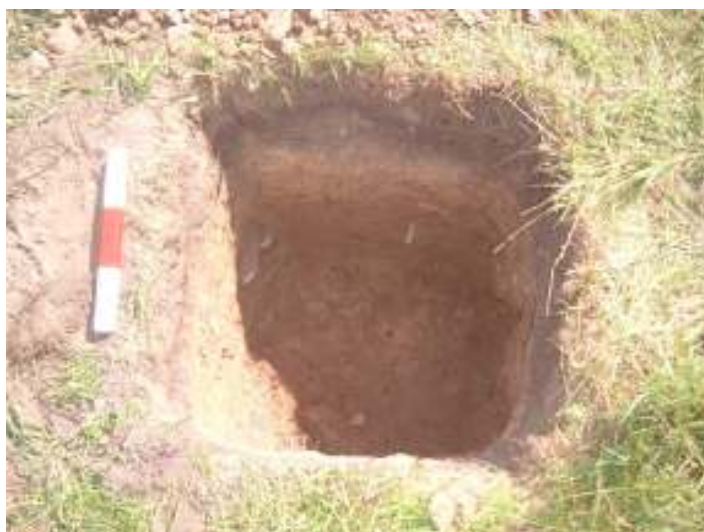
Plate 1: West-southwest facing section of Test-pit 1

- 4.2.1 **Test-pit 1:** Test-pit 1 was located at the northern end of the study area, c.4.5m south of the junction between the main road and an access track to the east (Figure 3). The test-pit was excavated to a maximum depth of 0.7m and revealed a deposit of orange/light brown clayey sand subsoil (**102**) which measured over 0.47m in depth. Occasional inclusions of fragmented tarmac and crushed brick were noted within the clayey sand (**102**), highlighting the relatively modern nature of this deposit. The clayey sand subsoil (**102**) was sealed by a deposit of dark brown sandy silt topsoil (**100**), which measured c.0.23m in depth (Plate 1).

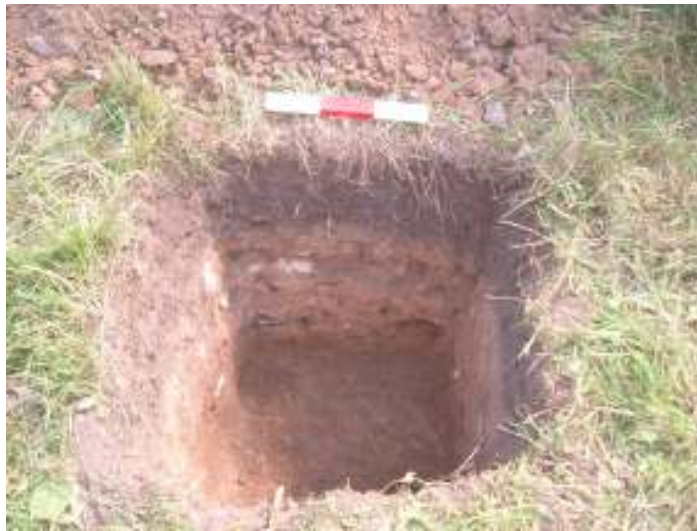
Plate 2: *West-southwest facing section of Test-pit 2*

- 4.2.2 **Test-pit 2:** Test-pit 2 was located c.9.3m south of Test-pit 1 (Figure 3). The test-pit was excavated to a maximum depth of 0.7m and revealed c.0.45m of the orange/light brown clayey sand subsoil (**102**) below c.0.25m of dark brown sandy silt topsoil (**100**) (Plate 2). Further fragments of tarmac were noted throughout the clayey sand deposit (**102**) to a depth of 0.7m.

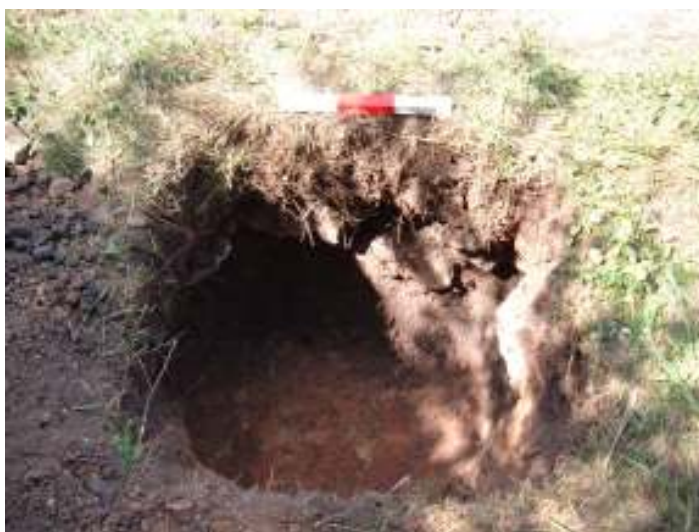
Plate 3: *East-northeast facing section of Test-pit 3*

- 4.2.3 **Test-pit 3:** Test-pit 3 was located *c.*6m south of Test-pit 2 (Figure 3) and was excavated to a maximum depth of 0.7m, exposing a firm deposit of red clayey sand with occasional small stone inclusions (105), which measured over 0.1m in depth. Within the eastern most *c.*0.4m of Test-pit 3, the red clayey sand deposit (105) was below *c.*0.4m of the orange/light brown clayey sand subsoil (102). Within the western most *c.*0.2m of Test-Pit 3, the firm red clayey deposit (105) was below a *c.*0.15m deposit of black/grey ash material with occasional fragments of clinker inclusions (104). The ash deposit (104) was below a *c.*0.35m deposit of large fragmented angular stones (103) (Plate 3). The stones were possibly comprised of limestone or greywacke, and had been randomly deposited to form the footings of the modern road surface. The deposits (102) and (103) were sealed by *c.*0.2m of topsoil (100). Although the exact nature of the ash deposit (104) is unknown, it is unlikely to be of any significant age as the deposit (104) appeared to overlay the relatively modern clayey sand subsoil (102) (Figure 3).

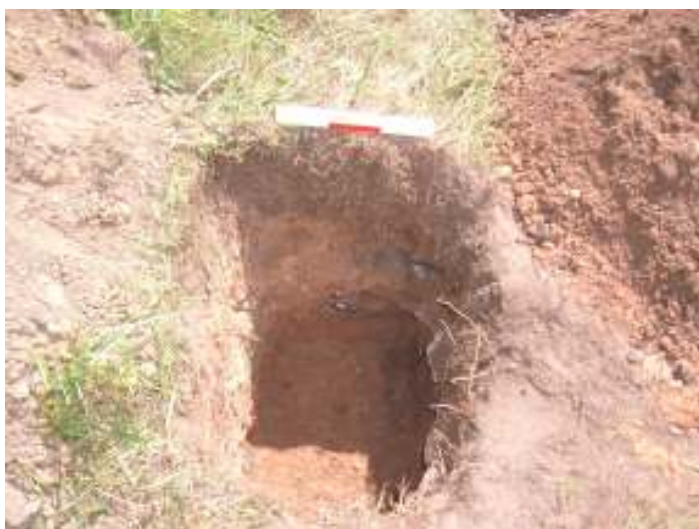
Plate 4: *North-northwest facing section of Test-pit 4*

- 4.2.4 **Test-pit 4:** Test-pit 4 was located *c.*6.4m south of Test-pit 3 (Figure 3). The test-pit was excavated to a maximum depth of *c.*0.85m at its eastern edge due to the sloping gradient of the grass verge at this point. Test-pit 4 largely exposed *c.*0.2m of the firm red clayey sand deposit (105) below *c.*0.43m of the orange/light brown clayey sand subsoil (102), which was sealed by *c.*0.22m of dark brown topsoil (100). However, the road footings (103) and dispersed ashy material could be seen in the northeast facing section of the test-pit (Plate 4).

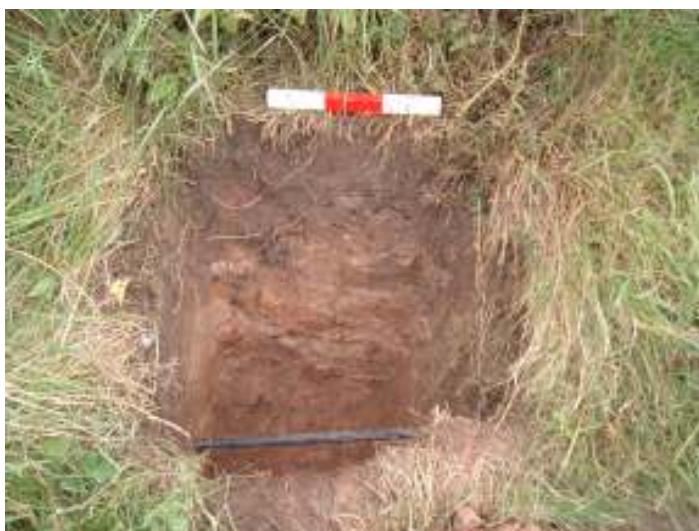
Plate 5: *West-southwest facing section Test-pit 5*

- 4.2.5 **Test-pit 5:** Test-pit 5 was located at the southern end of the evaluation area, *c.*4.3m south of Test-pit 4 (Figure 3). The test-pit was excavated to a maximum depth of 0.8m and revealed *c.*0.17m of the red clayey sand deposit (105) below *c.*0.4m of the orange/light brown clayey sand subsoil (102). The orange/light brown clayey sand subsoil (102) was below *c.*0.23m of the dark brown sandy silt topsoil (100). A small water pipe was also noted within Test-pit 5, directly below the topsoil (100) (Plate 5).

- 5.2.1 The purpose of this archaeological evaluation was to establish the nature and extent of below ground remains associated with Hadrian's Wall within the proposed development area. No evidence of Hadrian's wall was recorded at a depth of 0.8m, therefore if the proposed cable trench is excavated along this evaluated route and goes no deeper than 0.7m there should be no impact on any significant archaeological remains. However, given the location of the development area, it is recommended that any future invasive work in the vicinity of the site be subject to a programme of archaeological monitoring.
