**BELMONT ROW GLASSWORKS,
BELMONT ROW,
EASTSIDE,
BIRMINGHAM,
WEST MIDLANDS**

ARCHAEOLOGICAL EXCAVATION REPORT

CP. No: 778/09

DOCUMENT TITLE: Belmont Row Glassworks, Belmont Row,
Birmingham, West Midlands

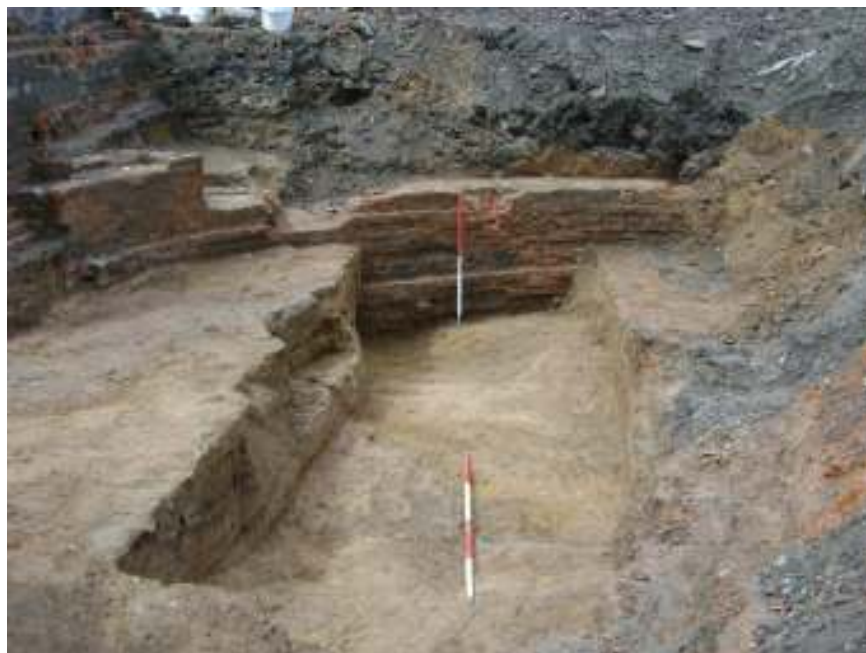
Plate 1: Structure 1107, Foundation 1059. Facing North.

4.2.2 <1107> consisted of three distinct sections of wall foundations, <1059>, <1094> and <1097>, the upstanding portion of the structure having been demolished down to foundation level. All three foundations were constructed of moulded, unfroged red bricks that measured 230mm x 110mm x 80mm in size, arranged in alternate courses of headers and stretchers.

4.2.3 The depth of the foundations varied considerably. <1094> was nine courses deep, whilst <1097> was estimated to have been seven courses deep. Three courses of <1097> remained in-situ, the four upper courses having been robbed out and the cut [1085] backfilled with rubble (1086). The southern end of <1059> was again eight courses deep, whilst the central portion was fourteen courses deep. The transition from the shallow to the deeper foundation was identified 2.10m from the southern end of <1059>, there being a clear vertical edge marking the limit of the deeper foundation courses (Plate 2).

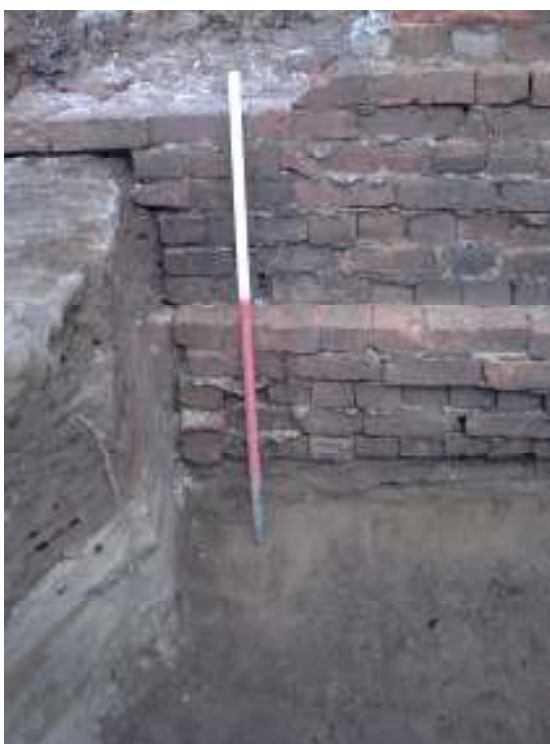
Plate 2: Detail of Foundation 1059, showing stepped brickwork. Facing North.

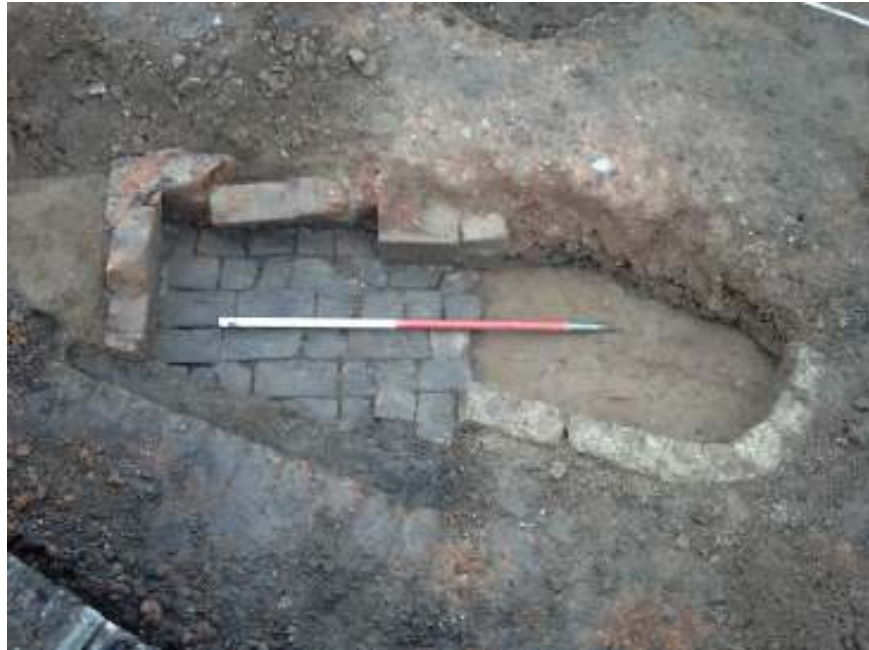
Plate 3: Structure 1080. Facing North-east.

- 4.2.8 Situated immediately to the south of <1094> were the remains of a small brick-built structure <1080>. <1080> was 2.0m long, 0.80m wide and had a keyhole-shaped plan. It survived to a maximum of three courses in height and was constructed of unfrosted red bricks that measured 230mm x 80mm x 110mm. A brick floor <1081> survived in the northern part of <1080> and was overlaid by a thin deposit of ash (1083). <1080> butted <1107> and may represent a small glass-annealing furnace (Plate 3).

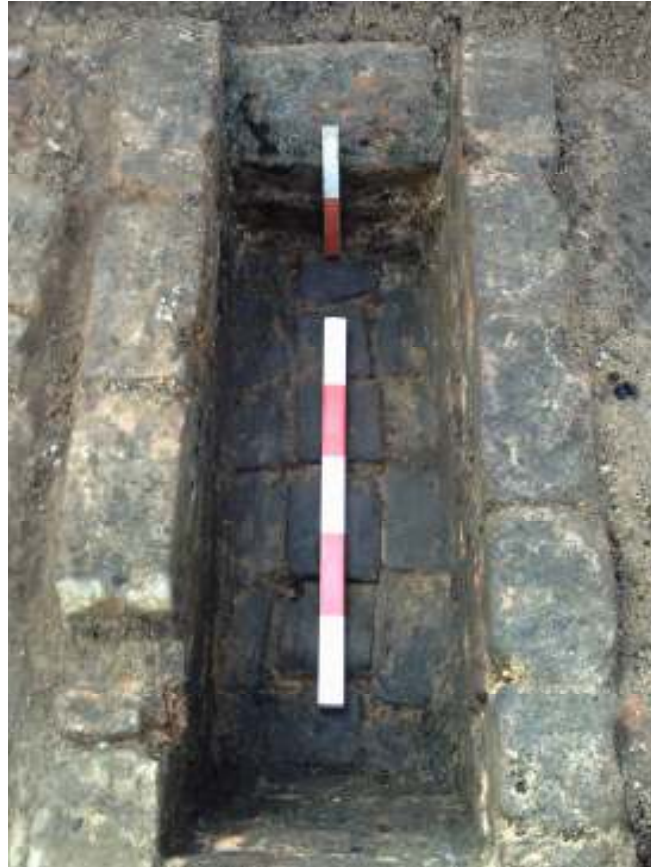
Plate 4: Structure 1057. Facing West.

- 4.3.2 <1060> was cut to the north by a brick-built trough-like feature, <1057> that also cut through Foundation <1059>. <1057> was 1.04m long, 0.50m wide and had a brick base (Plate 4). The base of the structure appeared to be heat-affected, whilst the interior was filled by an ashy deposit (1058).

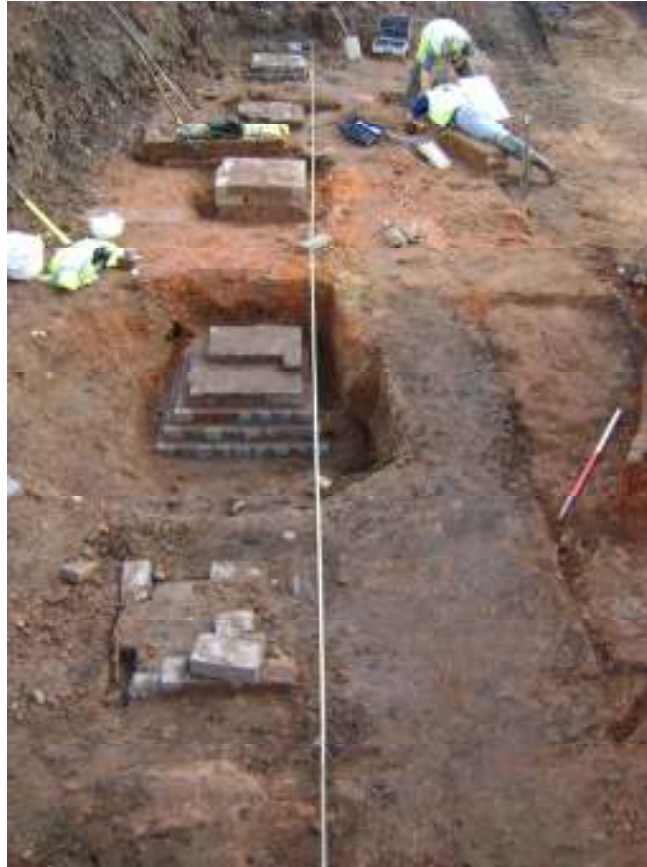
Plate 5: Site working shot showing Stanchions 1063, 1064, 1071, 1076 and 1079. Facing South.

- 4.3.6 <1051> and <1050> were succeeded by a later structure, the archaeological evidence for which consisted of five massive brick-built stanchions:- <1063>, <1064>, <1071>, <1076> and <1079>. Each stanchion was constructed upon a 0.30m deep concrete bedding layer and was set into an individual rectangular foundation cut:- [1103], [1105], [1065], [1074] and [1077] that were cut through (1068) into the underlying natural sands. The stanchions were rectangular in plan, with the courses of bricks being stepped, the base of each stanchion being 1m square, whilst the surviving upper part measured 0.75m x 0.75m (Plate 5). The bricks themselves were large blue/black machine-moulded froged and unfroged bricks that measured 230mm x 110mm x 80mm. One example, a froged brick from <1076>, was marked "B B". No other bricks of this type or size were noted in any of the other excavated or recorded structures.

- 4.3.7 The linear arrangement of the stanchions suggests that they may have acted as pile foundations for a substantial east to west aligned wall. However, no trace of this structure survived, suggesting that it had subsequently been demolished down to ground level. The likely date range of this structure is from circa 1855 to 1880, there being no evidence of a building at this location on the 1889 Ordnance Survey Map.

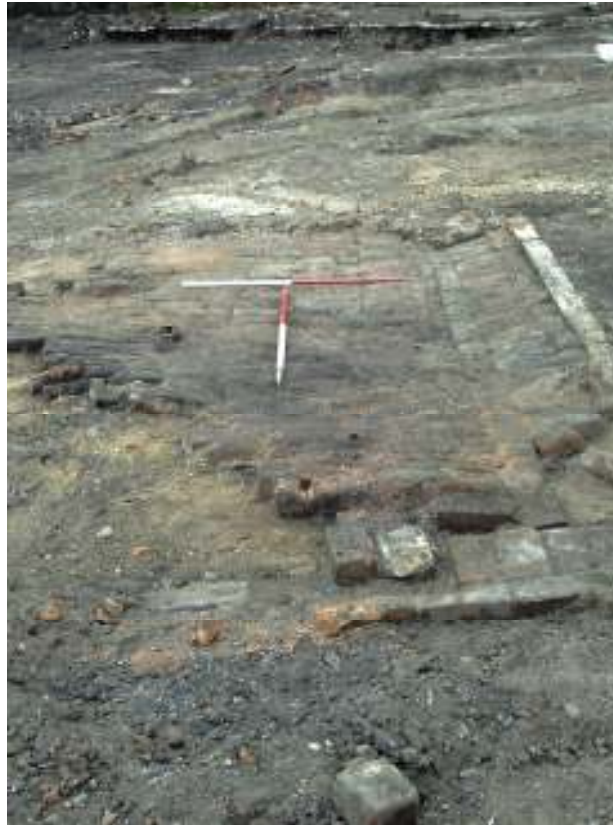
Plate 6: Floor 1033. Facing West.

- 4.4.6 A 4.2m x 5.10m fragment of brick flooring <1033> was situated 0.88m to the north of <1043>. <1033> was constructed of worn, edge-laid unfrosted hand-moulded bricks that measured 230mm x 60mm x 100mm (Plate 6). The floor was divided from east to west by a single course of bricks <1034> that appeared to represent the remains of a partition wall. Both the floor and dividing wall were covered by a deposit of ash and clinker (1046).

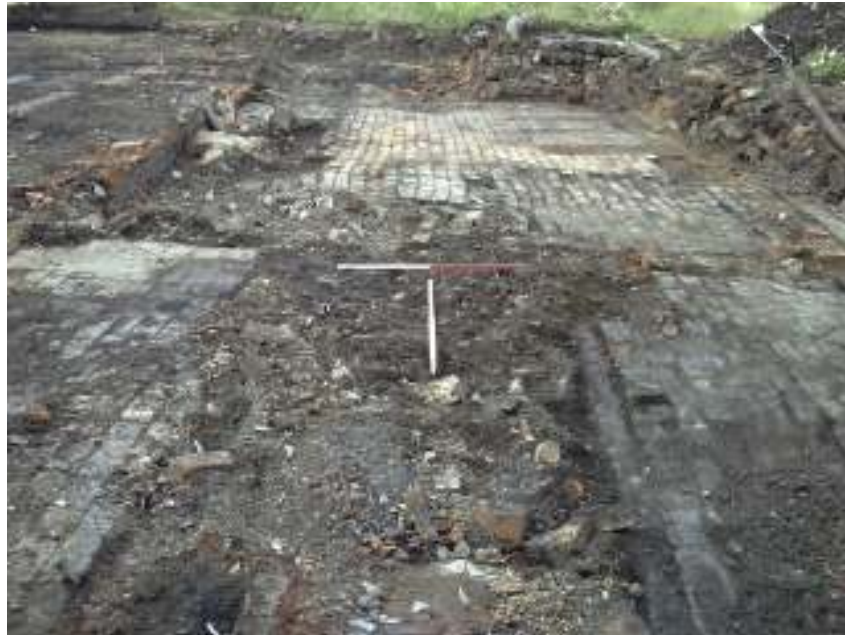
Plate 7: Floor 1005. Facing North.

- 4.5.4 The cartographic evidence indicates that the factory building was remodelled during the period 1918-1946. <1001=1002>, <1004> and <1031> represent the exterior walls of this latter structure. Four large concrete stanchions:- <1022>, <1023>, <1024> and <1025> represent supports for the roof of the later building, whilst the floor was formed by a concrete slab <1030> that sealed <1005> and the foundations of <1017>.

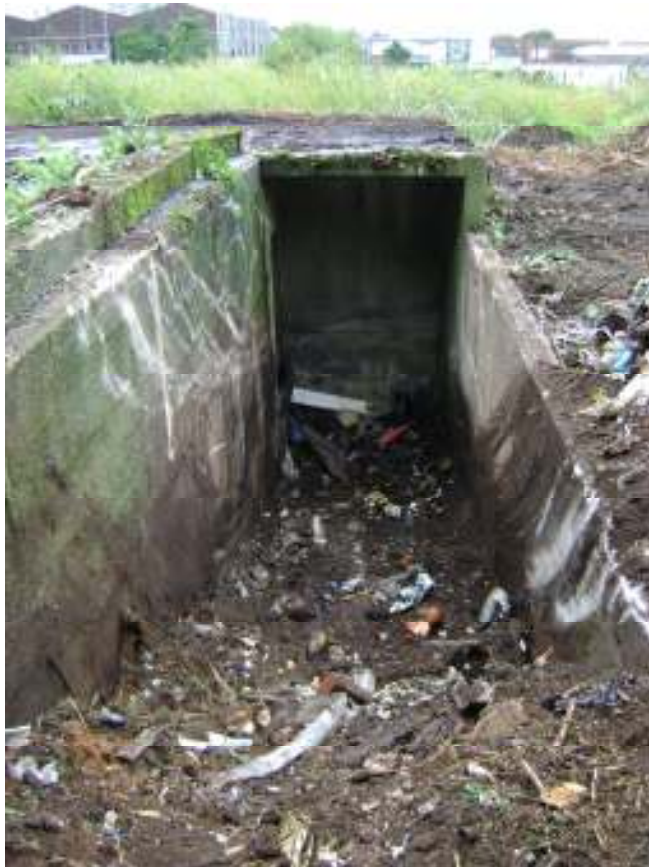
Plate 8: Entrance to Air Raid Shelter 1000. Facing East.

- 4.5.5 The final phase of development consisted of the demolition of the L-shaped building to the north represented by <1020> and <1021> and the construction of a large, semi-sunken air raid shelter <1000> during World War II. Shelter <1000> (Fig. 13) measured 17.20m x 10.40m and was constructed of 0.32m thick steel reinforced concrete, the reinforcing bars being 10mm and 20mm thick. It was set into a large vertical-sided construction cut [1098] that was clearly visible running along the southern edge of the structure. The eastern edge of the foundation cut was defined by <1032>, the concrete of the eastern wall of the shelter being poured directly against the upstanding brickwork of <1032>. The imprints of timber planks were visible on all the other concrete faces of the shelter, indicating that the concrete had poured into a system of timber shuttering. The foundation cut itself was estimated to be circa 3m deep.
