NORTH PENNINES ARCHAEOLOGY LTD

Client Reports No. CP/1002/09

In September 2009, North Pennines Archaeology Ltd were invited by United Utilities to undertake an archaeological investigation at Peel Place, Lanthwaite, within the Lake District National Park (NGR NY 160 212). It was believed that the excavation of a United Utilities exploratory trench could have impacted upon archaeological remains at the site. As a result, The National Trust, in agreement with United Utilities, requested a programme of archaeological excavation and investigation, in order to obtain further information on the presence and state of preservation of any archaeological deposits within the vicinity. The archaeological work comprised a topographic survey, the archaeological recording of the previously excavated United Utilities trench and a trial trench evaluation. The work was conducted by North Pennines Archaeology Ltd, with the assistance of volunteers from the Lorton and Derwent Fells Local History Society.

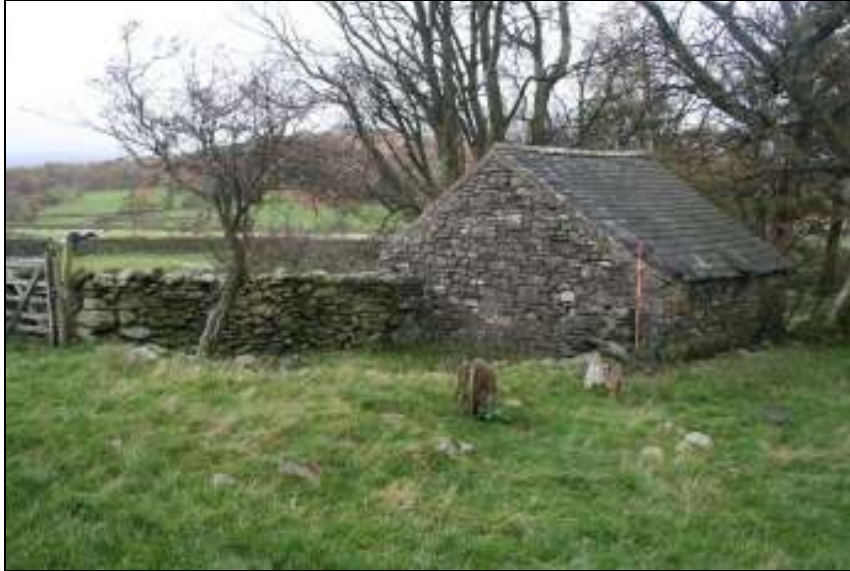
- 4.2.2 The foundations of a former stone wall were identified on the western side of the study area (a), adjacent to an existing stone shed (Plate 2). The wall defined an area measuring c.6m long and c.5m wide, interpreted as a former pen or small building. The remains of the wall measured 0.8m high and 0.6m wide at the north end, where it abutted the shed, indicating it was a relatively recent structure. However, another wall foundation was identified immediately to the southwest of this structure, measuring 1.8m long and 1.2m wide, which may relate to an even earlier building. A number of buildings are shown in this location on the Brackenthwaite Tithe Map of c.1840 (Plate 1) and the Plan of Peile Place and Lanthwaite Green Farms (Plate 1), suggesting that this may be a remnant of a 19th century or earlier structure.

Plate 2: *Foundations of a possible ruined building and existing shed on the west side of the site, looking northwest*

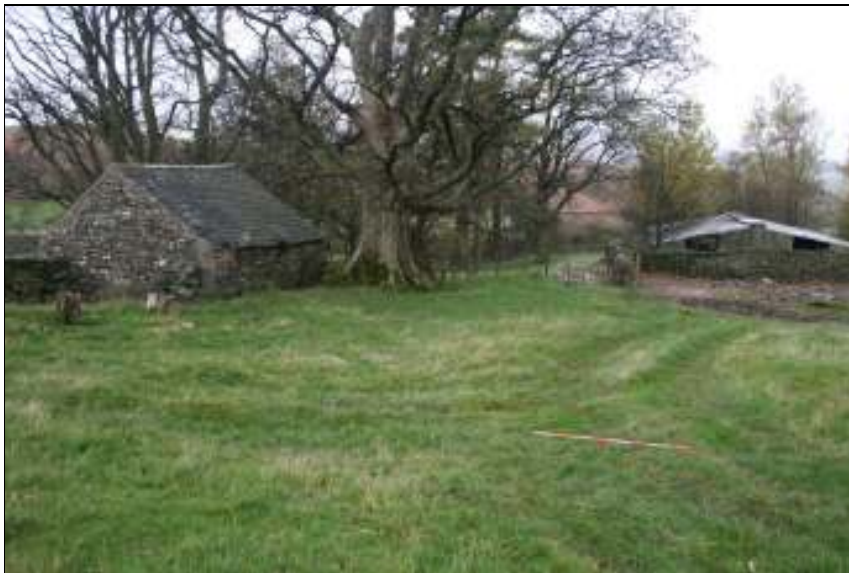
Plate 3: *A platform of land and track ways (right) on the west side of the site, which housed buildings in the 19th century, looking northwest*

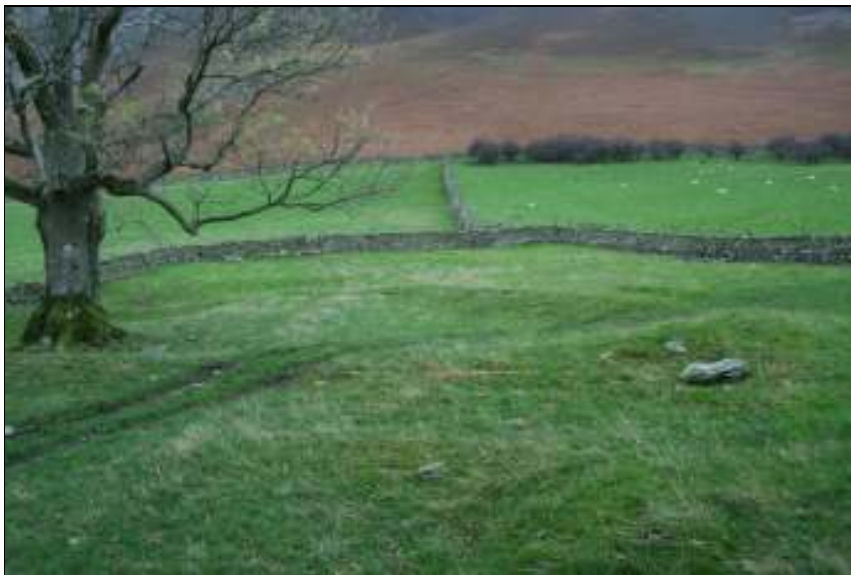
- 4.2.6 The most notable earthwork identified during the survey was a stone and earth bank at the centre of the study area (Plate 4), which defined an irregular polygonal enclosure measuring *c.*24m long and *c.*13m wide, aligned approximately northeast to southwest (g). The banks were set into the natural hillside, with steeper northwest sides, being up to *c.*1m high. The foundations of a stone wall measuring *c.*0.8m wide were visible on the top of the bank, particularly on the west side of the enclosure, where a definite wall edge was visible. This enclosure is clearly marked on the Brackenthwaite Tithe Map of *c.*1840 and the Plan of Peile Place and Lanthwaite Green Farms, but is not illustrated on the 1st Edition Ordnance Survey map of *c.*1865. It is likely that this was a former stock enclosure. A mature ash tree occupied the north side of the enclosure at the time of the survey.

Plate 4: *The banks of the former enclosure, looking east*

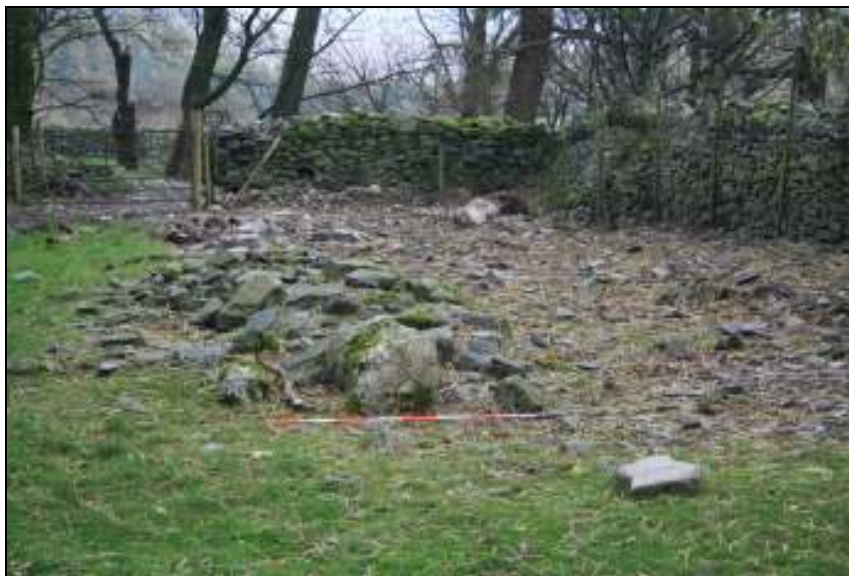
- 4.2.10 On the north side of the study area the foundation wall of a former rectangular building was visible. This was covered in places by stone rubble forming a 2.6m-wide bank (l). The wall was visible for a distance of *c.*7m, being *c.*1.3m wide and 0.4m high, aligned northeast to southwest (Plate 5). A large boulder marked the east corner of this building, with further stones protruding out of the dry stone wall to the northwest (Plate 6). A low bank was visible under this dry stone wall, which was believed to be the location of the northern wall of the former building. The southern corner of the building was not identified, however a line of stones marking a possible internal wall were targeted in the subsequent trial trench evaluation. A building is shown in this location on the Brackenthwaite Tithe Map of *c.*1840 and the Plan of Peile Place and Lanthwaite Green Farms, but is only marked as an enclosure on modern Ordnance Survey maps.

Plate 5: *Foundation wall of a rectangular building on the north side of the site, the subject of the trial trench evaluation (looking west)*

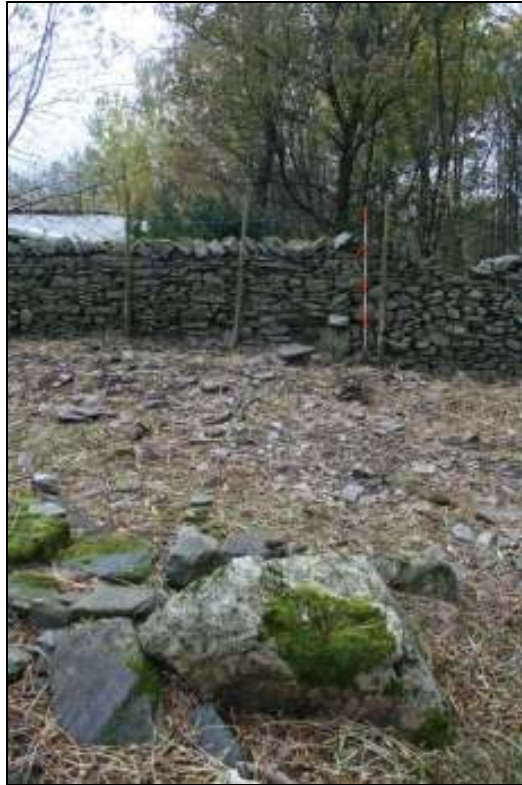
Plate 6: *Possible return of the building within the existing dry stone wall (looking northwest)*

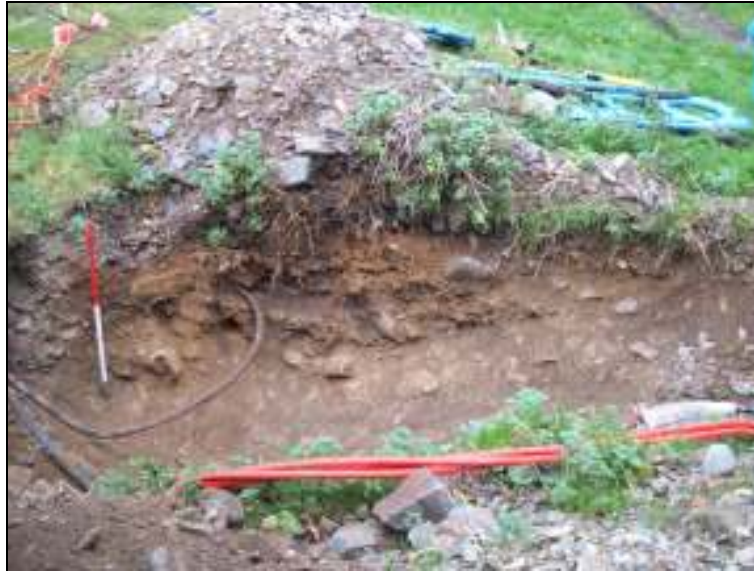
- 4.3.2 **Trench 1:** Trench 1 was located within the northwest corner of the evaluation area and measured *c.*5.9m in length and *c.*2.3m in width (Figure 3). The northwest to southeast aligned trench was excavated by mechanical excavator in order to locate existing underground utilities. Trench 1 was excavated to a maximum depth of 1.1m revealing *c.*0.32m of firm yellow sandy clay and gravel (**104**) below *c.*0.4m of loose grey fluvial gravel (**102**) and *c.*0.06m of loose mid-brown silty gravel topsoil (**100**). The northeast corner of Trench 1 was largely comprised of over 1m of gravel backfill (**103**) below topsoil (**100**), associated with existing services (Plate 7).

Plate 7: *West facing section of Trench 1 (utility trench)*

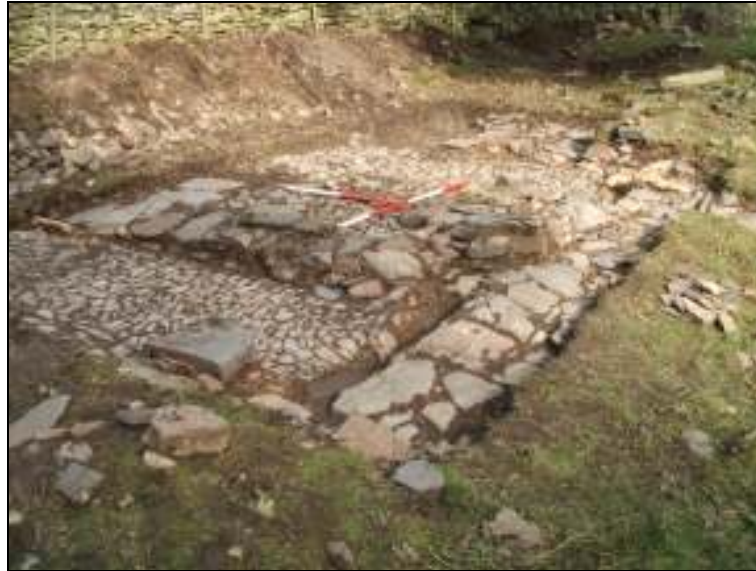
Plate 8: *View north of Trench 2 with wall (113) and cobbled yard (112) in foreground*

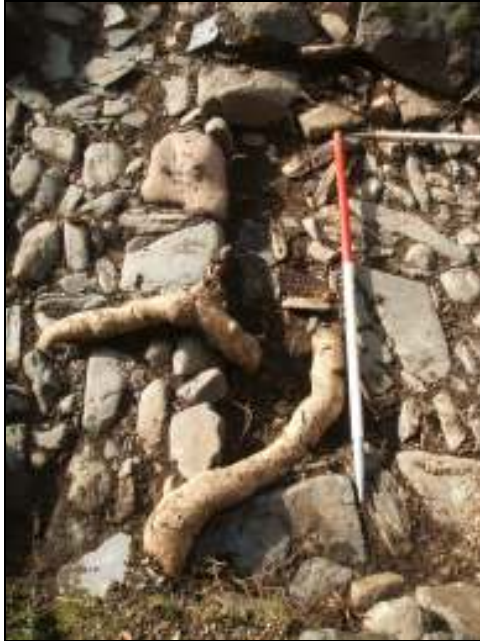
Plate 9: Entrance (**109**) looking southwest

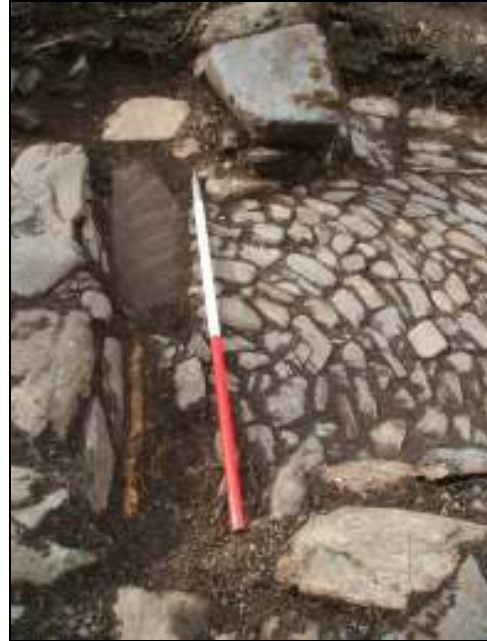
Plate 10: Entrance (**115**) looking southwest

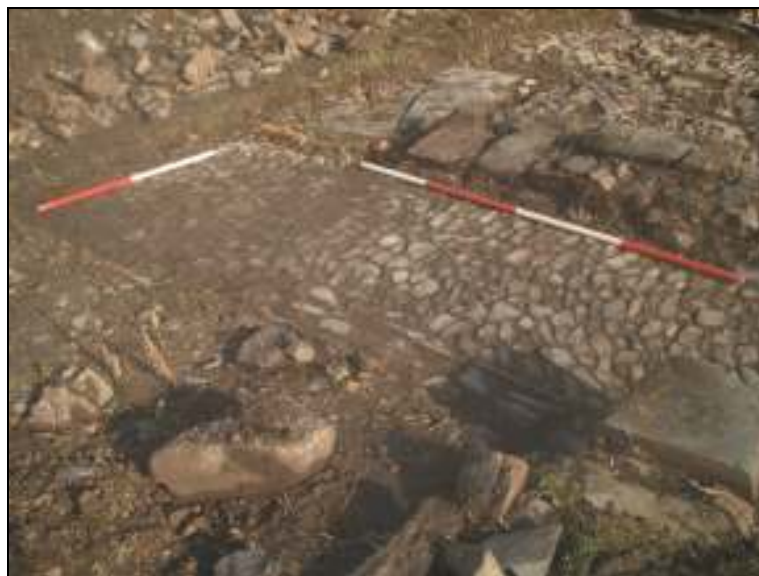
- 4.3.6 The interior of the building was divided into two sections by a dividing wall. The dividing wall (**108**) was aligned northwest to southeast and abutted the eastern corner of the entrance (**115**) (Figure 5). The dividing wall measured over 3m in length, *c.*0.6m in width and survived to a height of 0.4m. The wall was comprised of large sub-angular stone of quartz, slate and local volcanic stone (Plate 11). It is possible that the

Plate 11: View north of cobbled surface (**107**) and internal wall (**108**)

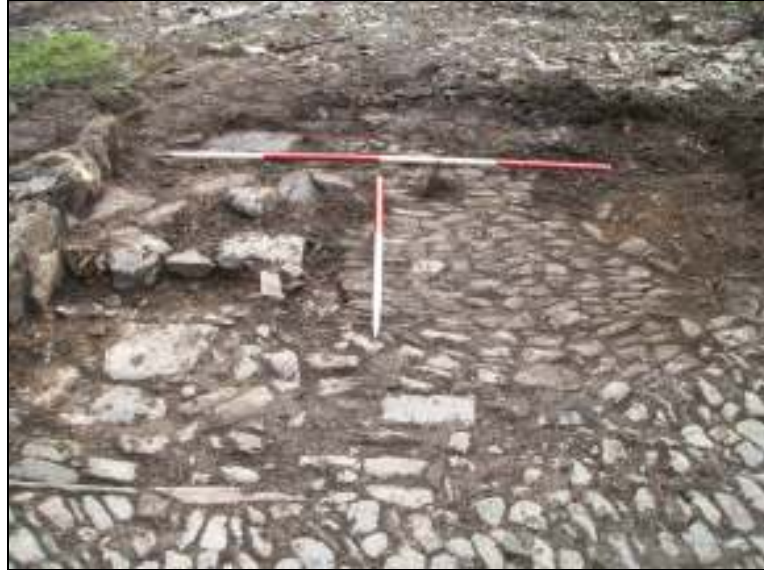
Plate 12: *View southwest of cobbled surface (107) and rough surface (124)*

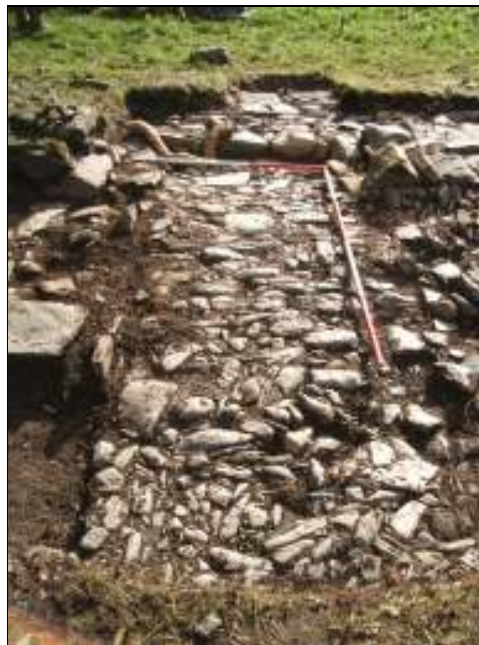
Plate 13: *View southeast of central aisle (105)
leading out to the exterior yard (112)*

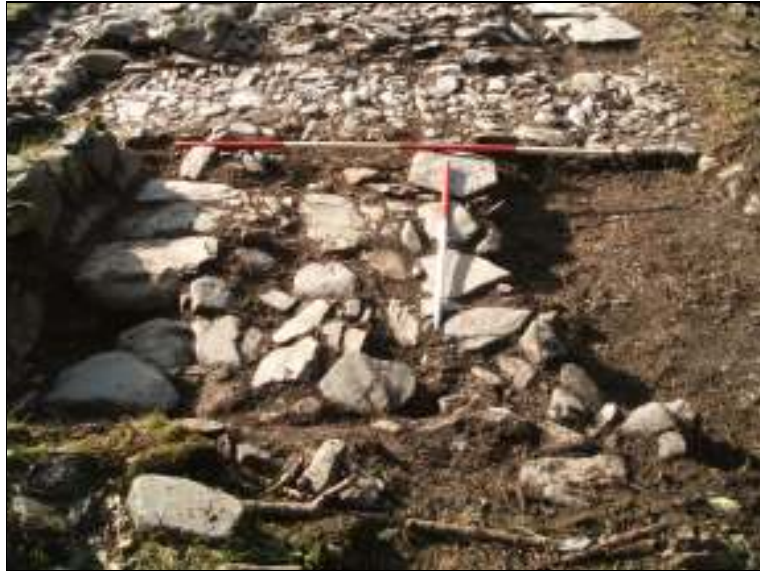
Plate 14: *View southwest of flagged surface (117)*

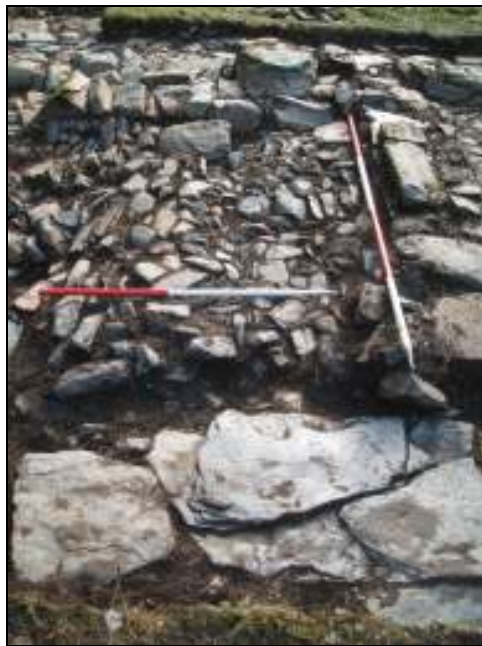
- 4.3.8 Immediately east of the internal dividing wall (108), an area was revealed which measured over 5.2m x 3m (Figure 5). The area was comprised of several different floor surfaces, including a central aisle (105) which measured over 3m in length and c.1m in width. The central aisle was comprised of roughly laid small-large river worn cobbles (Plate 13). The aisle was flanked to the east by an area of large flags of local volcanic stone (117). The flagged surface (117) measured c.2m x 1.4m, although it is unclear whether the surface continued further northwest, or whether the area once comprised a separate surface, as this area was completely damaged (Plate 14). The flagged surface had been laid on a bed of fine river gravel (118), which measured over 0.2m in depth. The central aisle (105) was also flanked to the west by a raised area of roughly laid cobbles (116). The raised cobbled surface (116) measured c.1.9m x 1.7m, and was flanked to the northwest by an area of slate flooring (106) (Plate 15). The slate flooring

Plate 15: *View southeast of raised cobbled surface (116) and slate surface (106)*

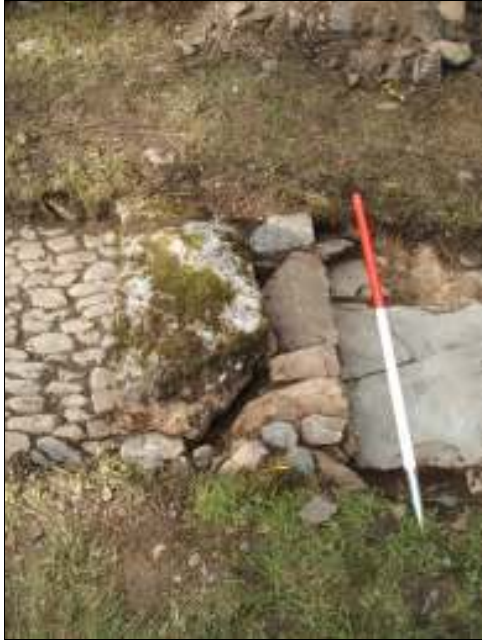
- 4.3.9 Additional investigations within Trench 2 included the removal of a *c.*1m section of the interior partition wall (108) in order to investigate the possibility of earlier activity on the site. Although no evidence of earlier activity was found, the additional investigation did reveal that the partition wall was probably a later addition to the structure as it was situated directly above the slate flooring (106). However, the fine cobbled surface (107) appeared to respect the partition wall (108) suggesting that this was contemporary with the wall (Plates 16 and 17).

Plate 16: *View northwest prior to the removal of wall (108)*

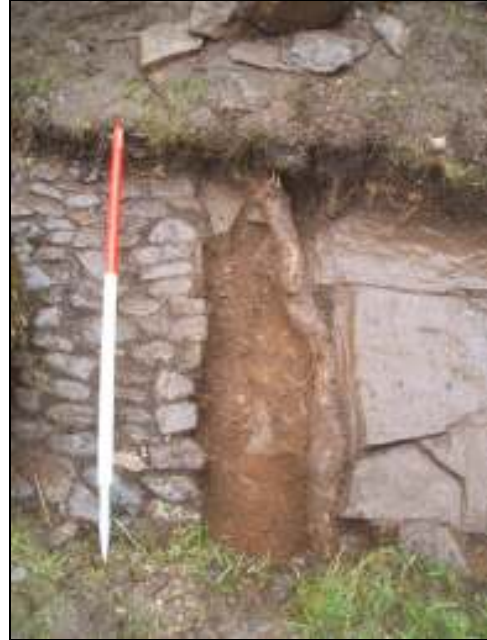
Plate 17: *View northwest after the removal of wall (108)*

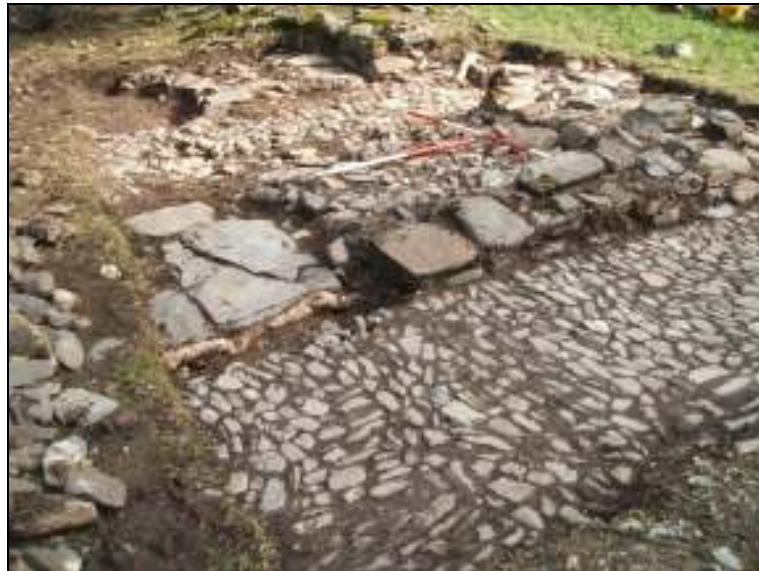
Plate 18: *View east of Trench 2*

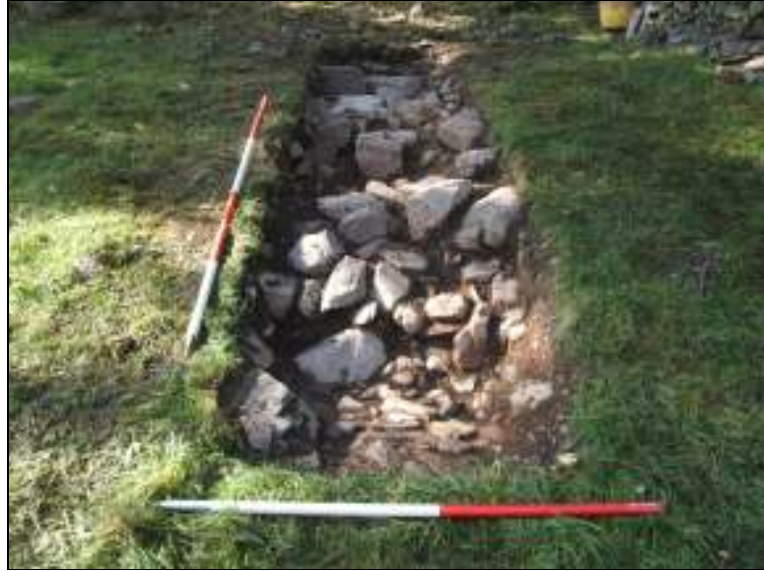
4.3.10 **Trench 3:** Trench 3 was located *c.*5m northeast of Trench 2, and *c.*2m south of the northern boundary wall (Figure 3). The trench was located in order to investigate a prominent earthwork believed to relate to the east wall of the rectangular structure. Trench 3 measured *c.*8.4m in length and *c.*1m in width. After the removal of *c.*0.12m of fluvial gravel (102) and *c.*0.1m of topsoil (100), a deposit of wall tumble (110) was revealed which covered the entire trench. The wall tumble measured *c.*0.45m in depth and was comprised of small-large sub-angular stones (Plate 19, Figure 6).

Plate 19: *View southwest of Trench 3 showing wall tumble (110)*

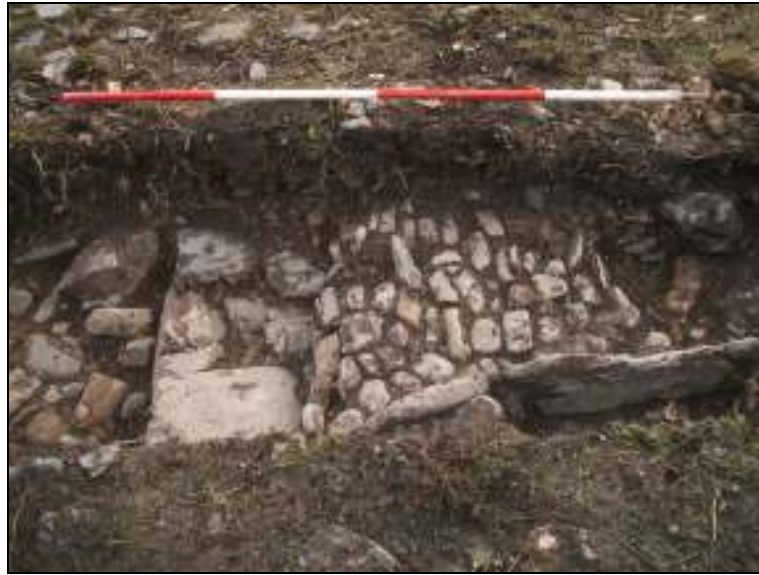
- 4.3.11 Following the removal of the wall tumble, several archaeological features were revealed within Trench 3, including the foundations of the east wall of the rectangular building. The wall foundations (**121**) measured over 1m in length, *c.*0.5m in width and survived to height of over 0.1m (Plate 20, Figure 6). The northwest to southeast aligned wall foundations were comprised of green slate and large angular stones, and appeared to correspond with the eastern extent of the earthwork marking the south wall of the building (**113**), and with stones protruding out of the northern boundary wall of the evaluation area to the northwest. However, the wall foundations (**121**) did not correspond with the earthwork which was the original focus of Trench 3, suggesting that this earthwork may have resulted from the wall tumble (**110**) which may have been largely redeposited within this area. Immediately west of the wall foundations (**121**), Trench 3 revealed a heavily disturbed cobbled surface (**119**) abutting the east wall. The cobbled surface measured *c.*0.8m x 0.8m, and was comprised of roughly laid river worn cobbles (Plate 20). The cobbled surface was flanked to the north by an area of raised cobbling (**120**), which was separated from the cobbled surface (**119**) by a slate division. The raised cobbled surface measured over 0.3m in length and over 0.2m in width, and was comprised of roughly laid river worn cobbles and slate (Figure 6).

Plate 20: *View southeast of Trench 3 showing wall foundations (121) and cobbled surface (119)*

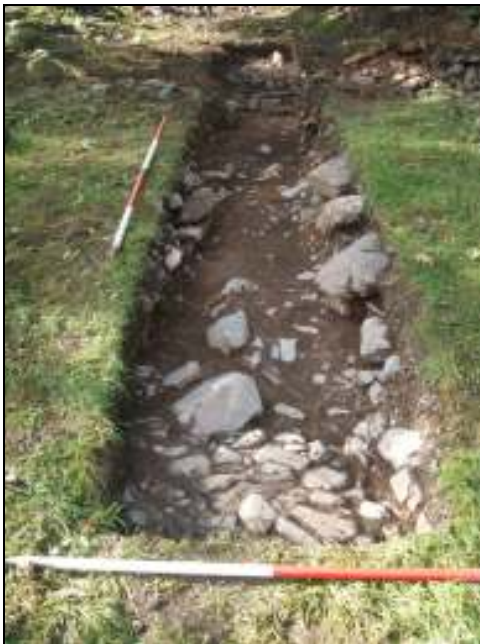
Plate 21: *View southwest of Trench 3*

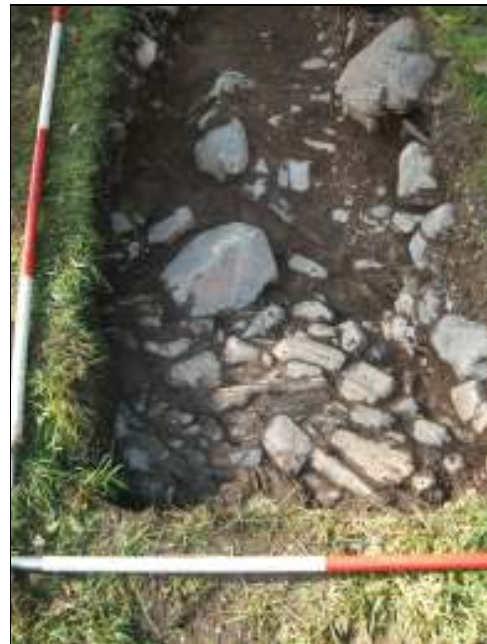
- 4.3.13 Further archaeological features were revealed within the northeast end of Trench 3. These features comprised a stone-lined drain (**122**), flanked by a roughly laid cobbled surface (**111**) to the east. The cobbled surface measured over 1m x 1m, and was comprised of moderately sized river worn cobbles. The stone-lined drain was aligned north to south, and measured over 1m in length, *c.*0.24m in width, and *c.*0.15m in depth (Plate 22, Figure 6). The drain had been cut into the natural substrate (**101**), and was comprised of mid-sized rounded stones and small angular stones, forming the base and sides. It is also possible that the drain was originally covered, as a single piece of

slate was observed within the southeast facing section of the trench, directly above the drain. The drain was filled by a c.0.15m deep deposit of mid-brown silt and small rounded pebbles (123).

Plate 22: *View southwest of cobbled surface (111) and drain (122)*
