**KENDAL COLLEGE,
BEEZON ROAD,
KENDAL,
CUMBRIA**

**ARCHAEOLOGICAL
EVALUATION REPORT**

CP. No: 1110/10

DOCUMENT TITLE: Kendal College, Beezon Road, Kendal, Cumbria
DOCUMENT TYPE: Archaeological Evaluation Report
CLIENT: Kendal College
CP NUMBER: 1110/10
SITE CODE: KCK-A
PLANNING APP. NO: 5/09/0955
OASIS REFERENCE: northpen3-72742
PRINT DATE: 25/02/2010
GRID REFERENCE: SD 5190 9310

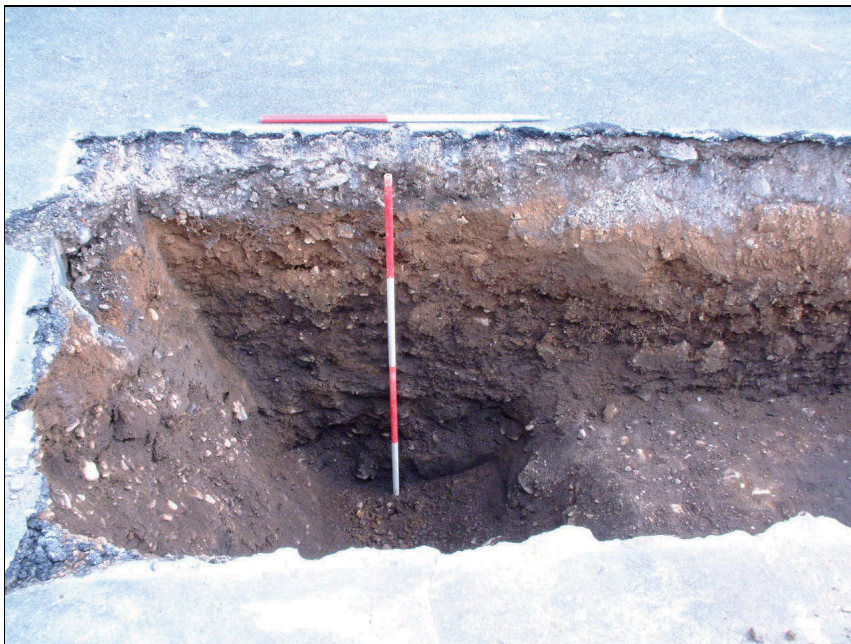
Plate 1: Southwest facing section of trench showing fluvial deposits (101)

- 4.2.1 The evaluation trench was located within a small recess of the car park, parallel with an existing college building to the east and several storage sheds to the west (Figure 2). The northwest to southeast aligned trench was excavated to a maximum depth of 2m at its northwestern extremity revealing a series of natural fluvial gravels and silts **(101)**, which measured over 1.35m in depth and varied in colour from grey to black. The fluvial deposits **(101)** were sealed by a deposit of orange sandy gravel **(103)**, which reached a maximum depth of 0.9m. The orange sandy gravel **(103)** was sealed by a c.0.26m deposit of mid-brown silty gravel sub-base **(102)** and c.0.06m of black asphalt surface **(100)** (Plate 1, Figure 3). In several areas along the eastern edge of the trench, the sandy gravel **(103)** and the sub-base **(102)** were separated by areas of c.0.15m thick deposits of concrete **(111)**, which probably formed the footings for a modern out-building which has since been demolished. This sequence of deposits remained consistent throughout the northwestern most c.4.5m of the evaluation trench.

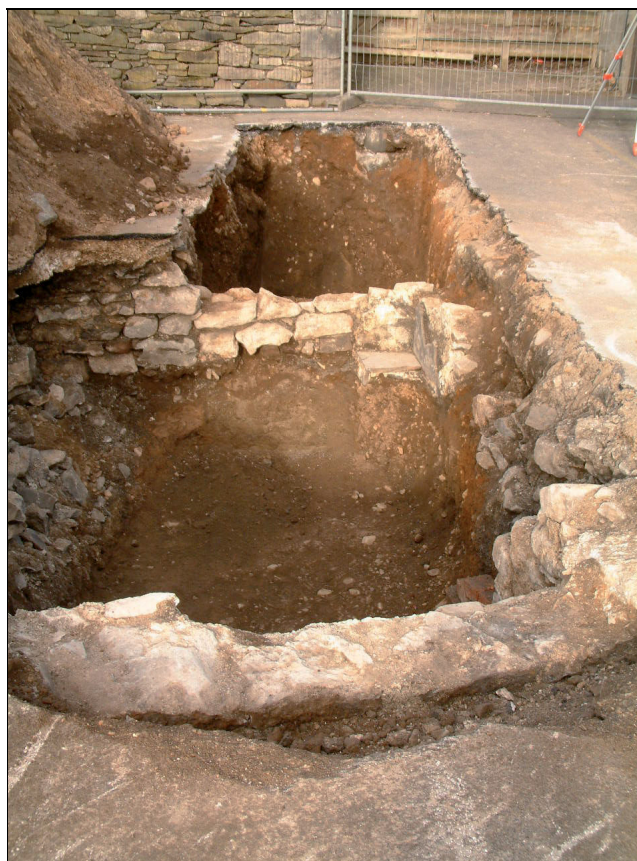
Plate 2: View northwest showing square structure within trench

- 4.2.2 At a distance of c.4.5m from the southeast end of the trench, the remains of a square structure were revealed (Plate 2, Figure 3), the northern end of which had been constructed directly above the natural fluvial deposits **(101)**, the southern end having been constructed above the orange sandy gravel **(103)**. The structure had also been backfilled with a c.0.65m deposit of demolition rubble **(104)**, which was comprised of undressed angular stones. The building rubble **(104)** was sealed by a c.0.1m deposit of silty gravel sub-base **(102)** and c.0.06m of black asphalt surface **(100)** (Plate 3).

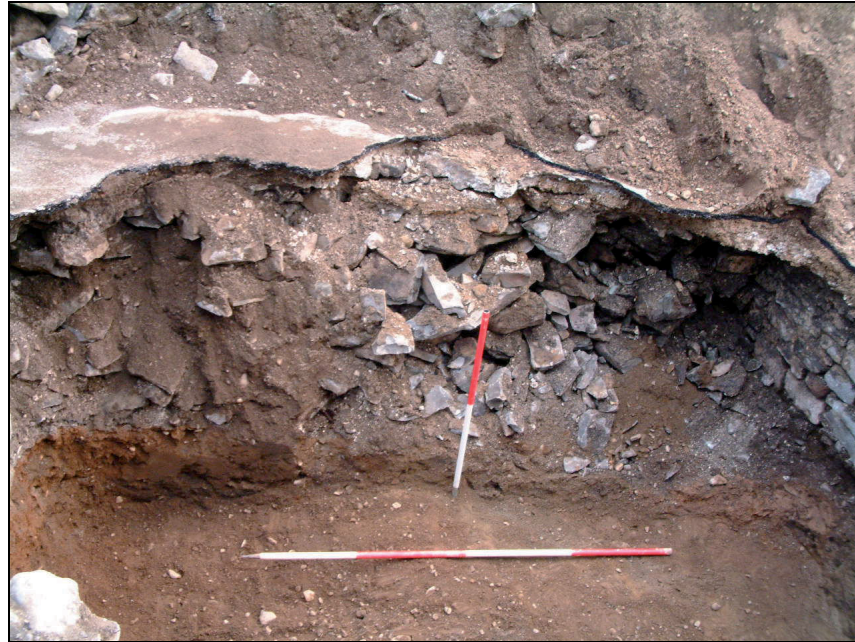
Plate 3: Northeast facing section of trench showing rubble backfill (104)

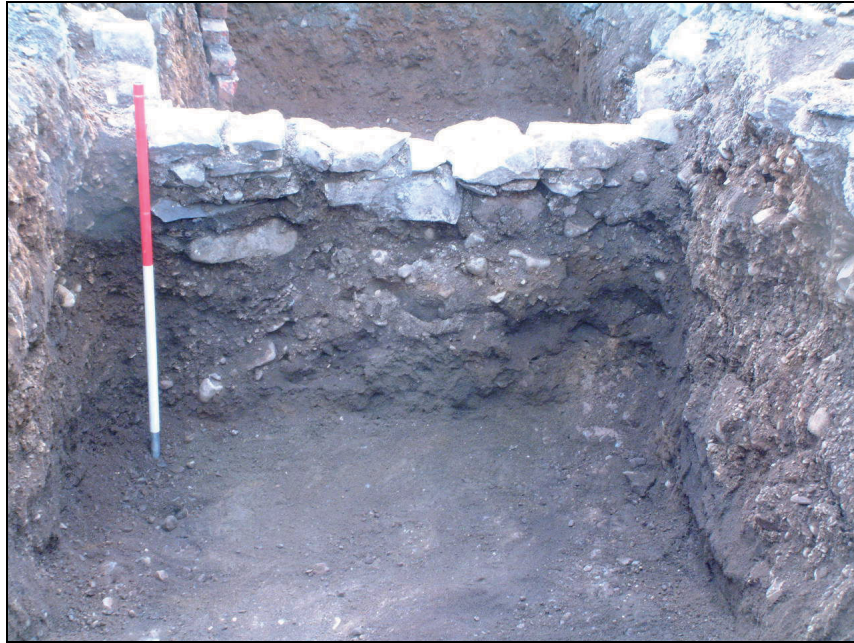
Plate 4: View southeast of wall (108)

- 4.2.3 The square structure was comprised of three walls. The north wall of the structure **(108)** was aligned northeast to southwest and was comprised of irregular, moderately sized stone which retained some lime mortar bonding. The wall **(108)** measured over 1.7m in length, 0.4m in width and 0.36m in height. The north wall of the structure was poorly constructed, being only one course thick for most of the exposed section (Plate 4, Figure 3). This suggests that this wall was possibly a later addition, or that it did not serve a load-bearing capacity within the building.

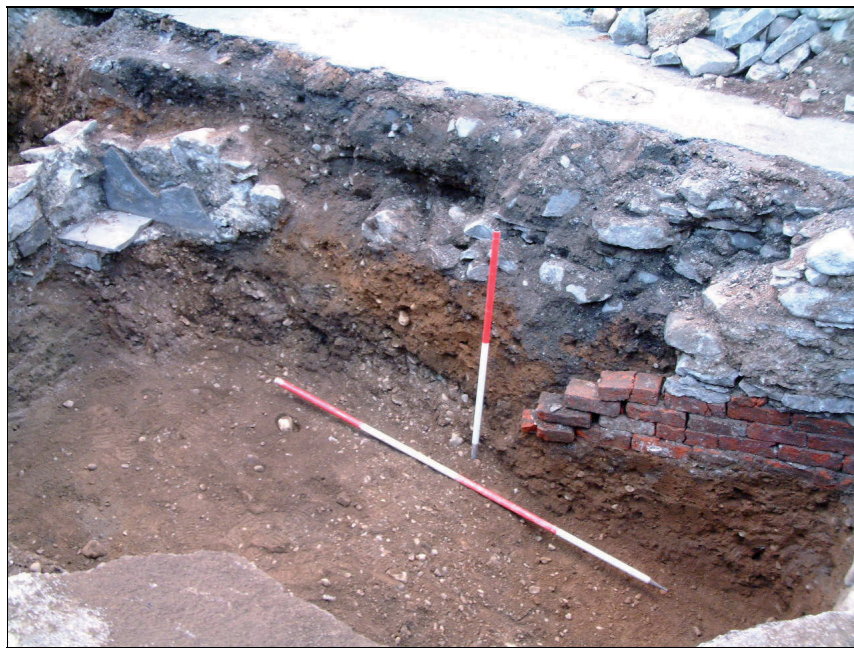
Plate 5: View northeast of wall (106)

- 4.2.4 The northeastern corner of the north wall **(108)** was adjoining the northwest corner of the northwest to southeast-aligned east wall of the structure. The east wall **(106)** was severely damaged, the central c.1.6m section having been completely destroyed (Plate 5, Figure 3). The two surviving sections of the wall **(106)** measured c.0.3m in width and survived to a maximum height of 0.67m. The wall was comprised of rounded and angular stones which were bonded with lime mortar. Interestingly, although the northwestern c.1.1m section of the wall **(106)** had been constructed above the natural fluvial gravels **(101)**, the southeastern c.1m section had been constructed on top of several courses of red brick (Plate 6, Figure 3). The red brick wall **(105)** measured c.1.35m in length, c.0.11m in width, and c.0.35m in height, and was comprised of four courses of un-bonded red brick which were probably hand-made. The exact purpose of the underlying brick wall **(105)** remains unclear at present, although it possibly represents an attempt to underpin a

failing eastern wall. If so, then it may be significant that the southern half of the structure had been constructed on top of the sandy gravel (103), as opposed to the natural fluvial deposits (101) that had been used as a base for the northern half of the structure.

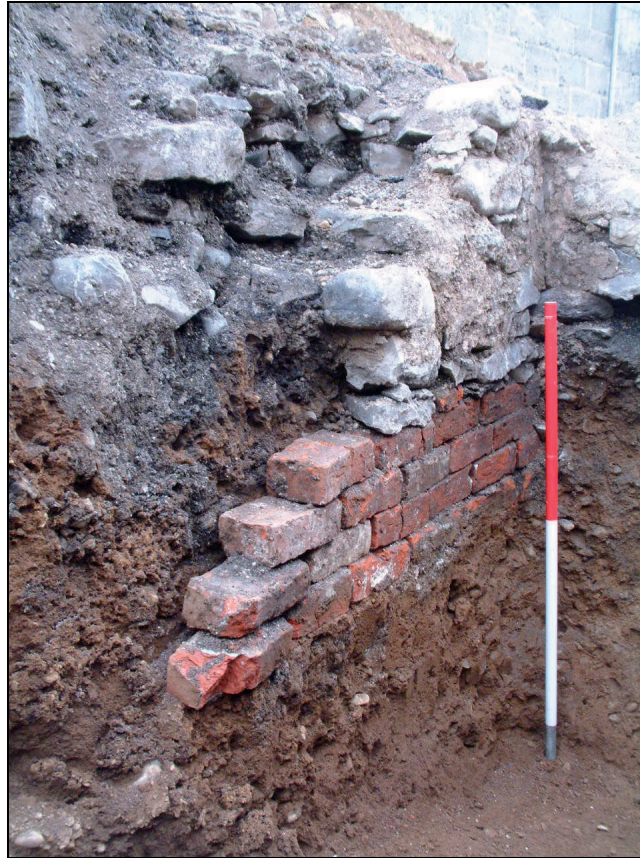
Plate 6: View southeast of wall (106) above brick wall (105)

- 4.2.5 The southeastern corner of the east wall **(106)** and the underlying brick wall **(105)** were adjoining the northeast corner of the south wall of the structure. The south wall **(107)** was aligned northeast to southwest, and was comprised of rounded and angular stones which were bonded with lime mortar. The south wall **(107)** measured over 1.6m in length, c.0.5m in width, and c.0.72m in height, and had been well constructed suggesting that this wall was a key element in the structural integrity of the building. The south wall **(107)** also retained a c.0.7m wide x c.0.25m deep recess which extended to the lowest foundation course of the wall (Plate 7, Figure 4). However, the exact function of the recess remains unknown at present.

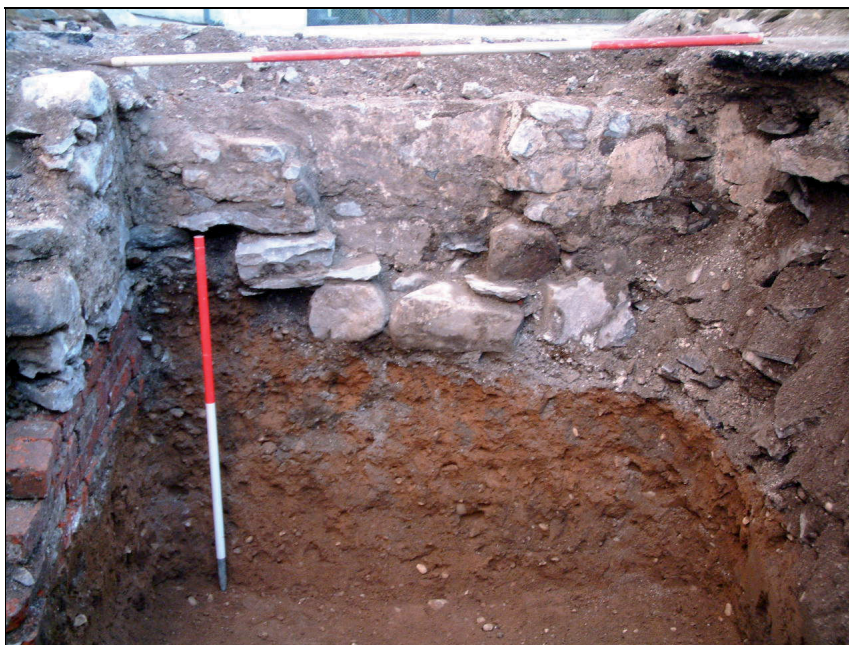
Plate 7: Northwest elevation of wall (107) above deposit (103)

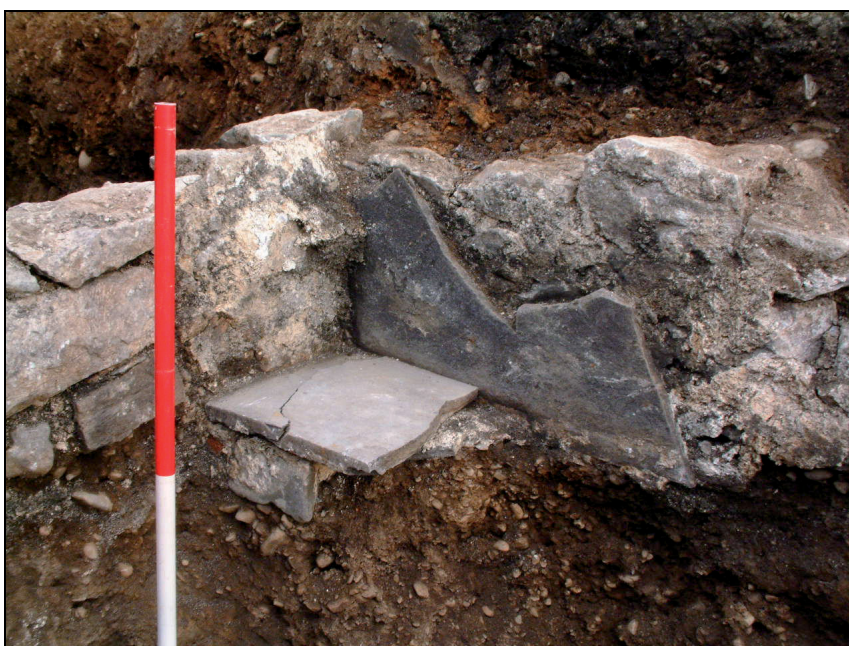
Plate 8: View northeast of flagstone (109) and stone slab (110)

- 4.2.6 Unfortunately, the internal elements of the structure had largely been destroyed, although several features were preserved within the extreme northern corner of the building. These features included a single grey fine-grained flagstone **(109)** set on lime mortar, and a further grey fine-grained slab **(110)** which had been mortared to the east wall of the building, perpendicular to the flagstone **(109)** (Plate 8, Figure 3). It was originally believed that the flagstone **(109)** represented the remnants of the structure's

original floor surface. However, given the flagstone's position in relation to the wall slab (110), it is possible that the two features are the remains of a certain type of storage tank, although this must remain speculative without further evidence.

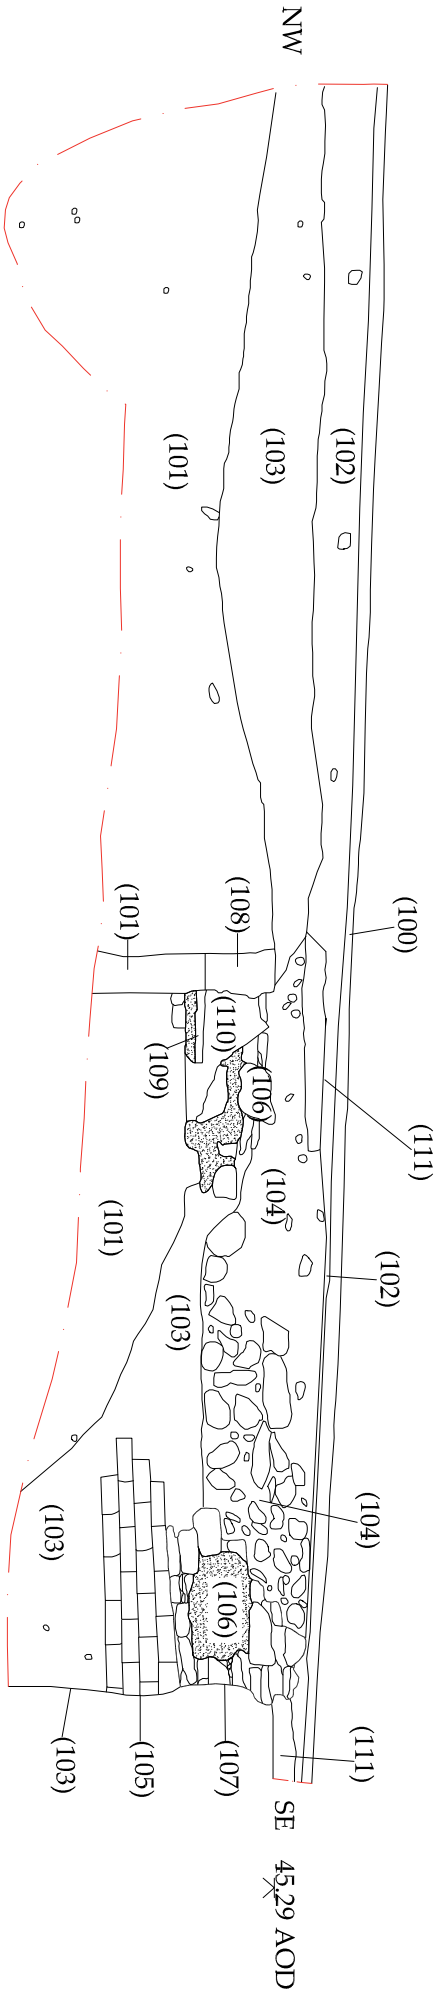
Plan of Trench

Southwest Facing Section

Figure 3: Plan and southwest facing section of evaluation trench
