**CHURCH STREET
STANWIX,
CARLISLE,
CUMBRIA**

WATCHING BRIEF REPORT

CP. No: 993/09

DOCUMENT TITLE: Church Street, Stanwix, Carlisle, Cumbria
DOCUMENT TYPE: Watching Brief Report
CLIENT: United Utilities
CP NUMBER: 993/09
SITE CODE: CHS-A
PLANNING APP. NO: -
OASIS REFERENCE: northpen3-73485
PRINT DATE: 08/03/2010
GRID REFERENCE: NY 4041 5710

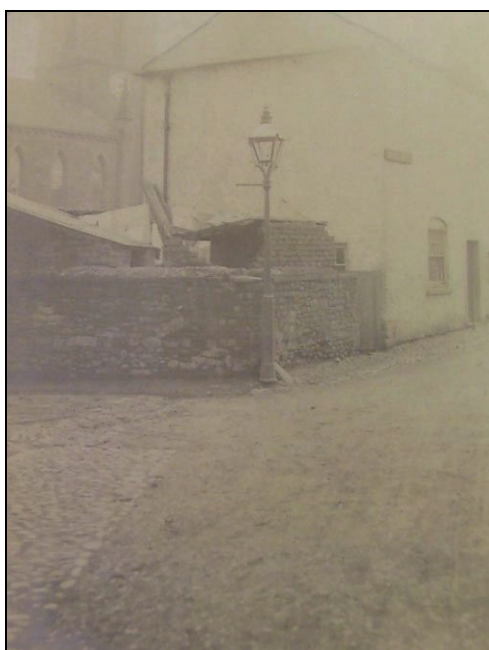
Plate 3: View looking south-west along south side of Church Street showing one of the cottages formerly located to the north-west of the church (just visible in background), c1904 (CRO Ref: CaH/9 Box 1, Photograph No. 10)

- 4.2.4 At the north end of Church Lane, on the western side, sandstone foundations of a former building or wall were revealed c0.25m below the tarmac. These foundations comprised of large irregular boulders and several smaller dressed stones. This 'wall' (103) appeared to be orientated east to west, although only a small section was uncovered within the trench (Plate 6). One sherd of post-medieval pottery and one sherd of post-medieval glass were recovered from the lime mortar in the stonework. It would appear that this 'wall' was related to a sandstone boundary wall which was located in this vicinity up until the 1950s (see Figure 6 for example, and Plate 3).

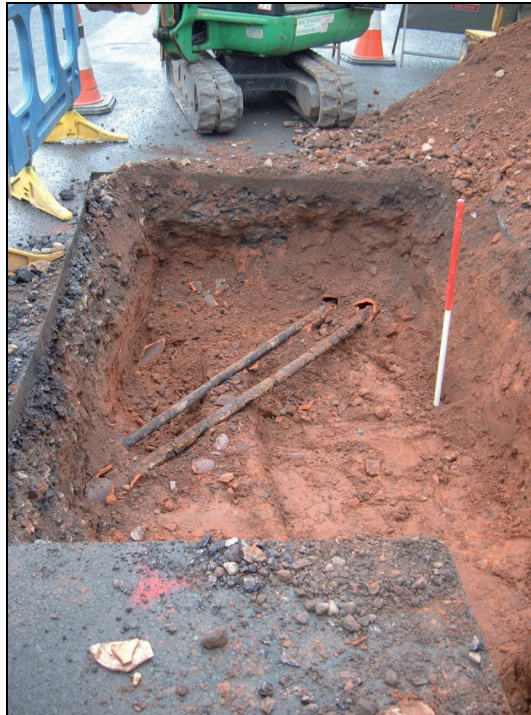
Plate 4: View looking north- east showing the jointing box at the eastern end of the service trench, located at the junction of Church Street and Knowe Terrace (Scale = 1m)

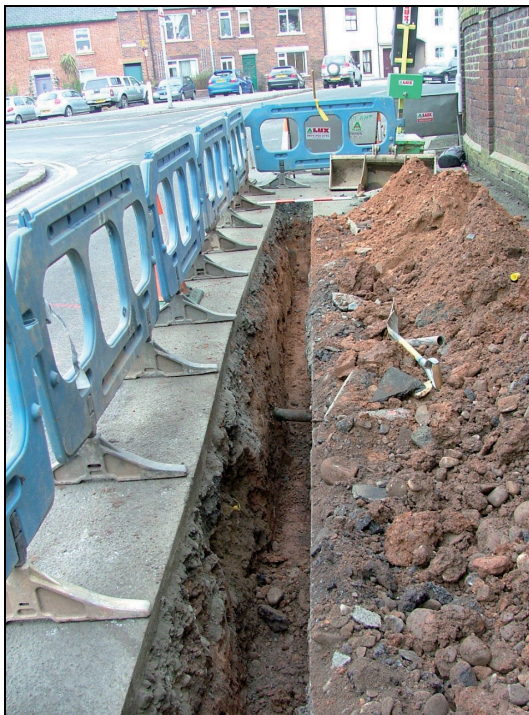
Plate 5: View looking north-east showing the width of the service trench and the excavated material

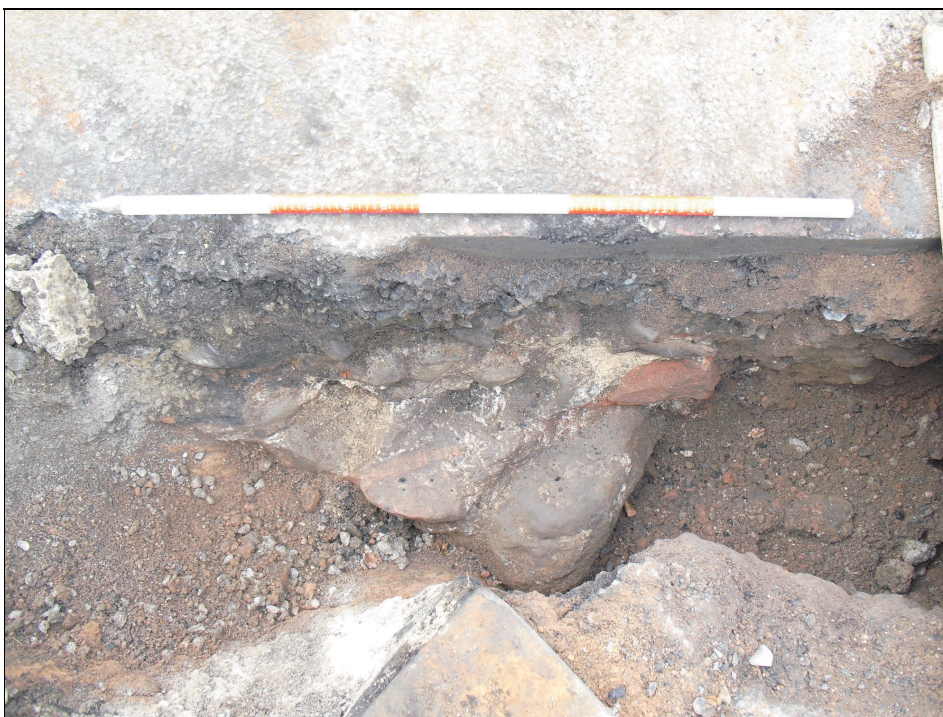
Plate 6: Detail of sandstone foundation noted within the trench at the junction of Church Lane and Church Street (Scale = 1m)

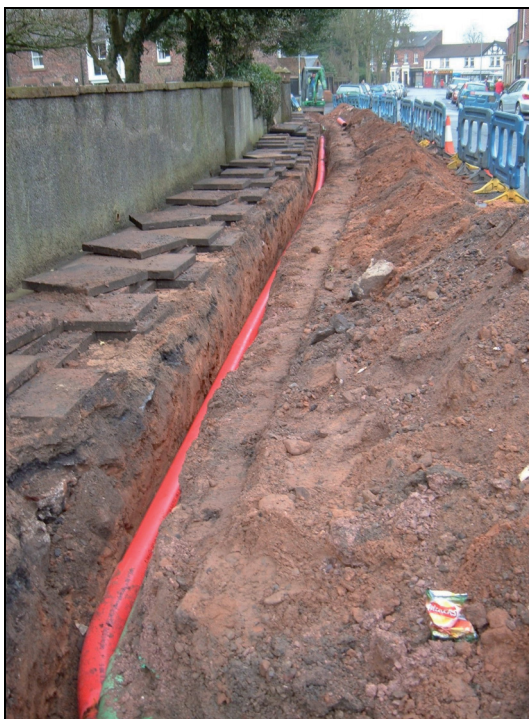
Plate 7: View looking west showing the location of the service trench to the north side of the churchyard wall

- 4.2.5 Located approximately 5m west of the foundation (103) revealed at the junction of Church Lane and Church Street, further sandstone foundations were noted (105). As the trench progressed along the pavement, close to the present church boundary wall on the south side of Church Street (Plate 7), evidence of a further five walls, all of brick rather than sandstone, were noted all orientated north to south. The brickwork survived to a height of six courses where they could be observed. It would appear that these walls relate to the row of cottages which formerly stood along the north-west side of the church from at least the middle of the 19th century to the 1950s (see Figures 4, 5 and 6). Finds from within this section of the trench included post-medieval pottery, glass, metal and clay pipe fragments. A large sandstone door threshold was also recovered, displaying a worn-away middle section from the many years of feet walking in and out of one of the properties.

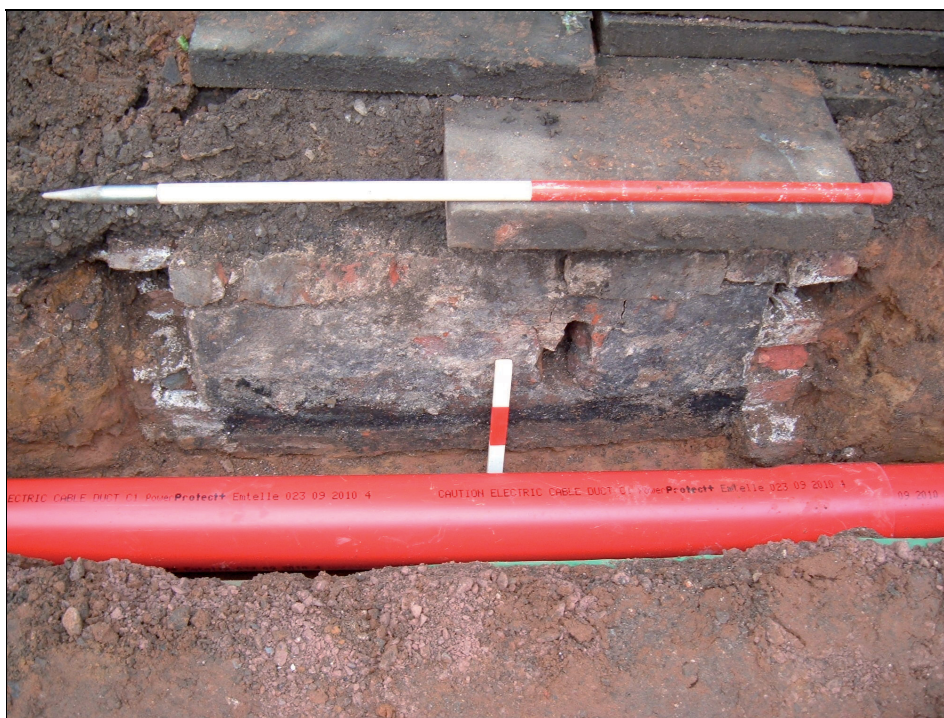
Plate 8: View looking south showing the remains of brick wall foundations in the north facing section of the service trench

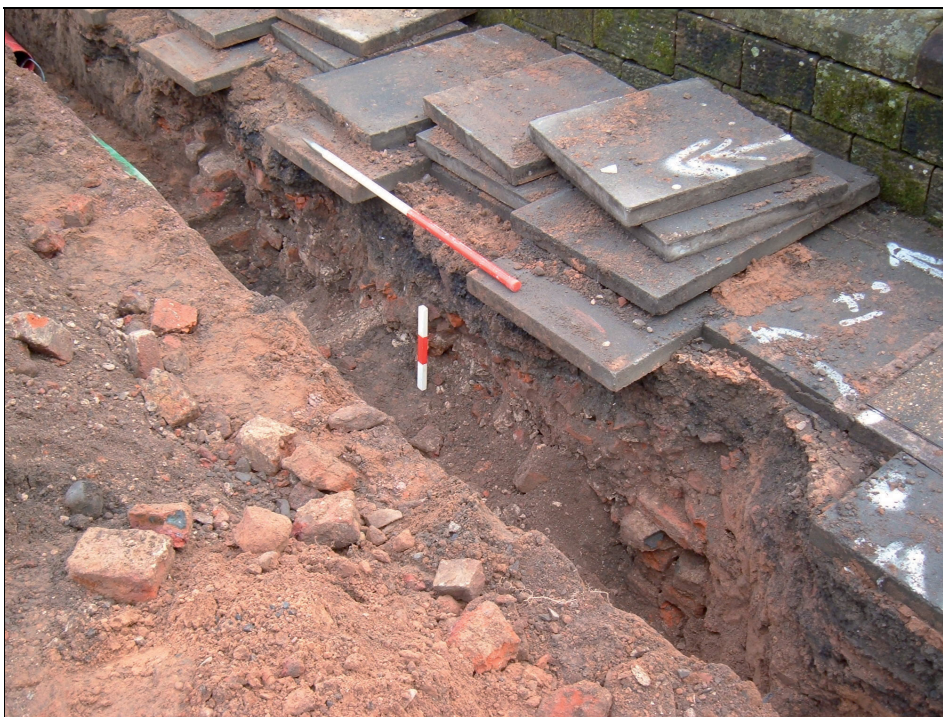
Plate 9: View looking east showing the brickwork in the north facing section of the service trench immediately north of the churchyard wall

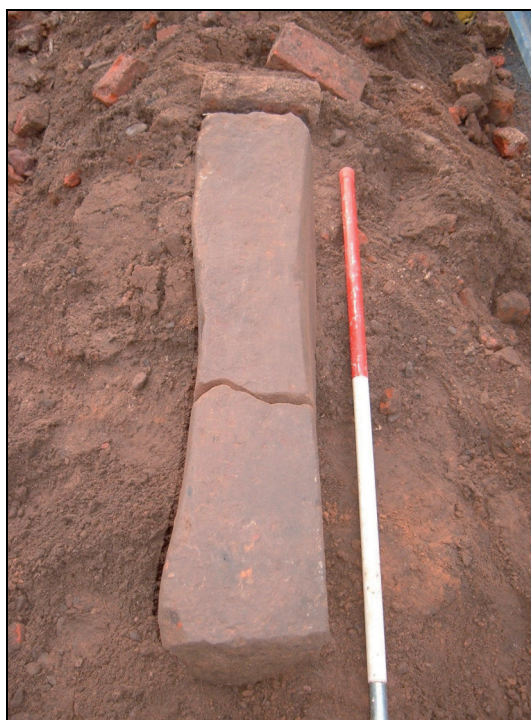
Plate 10: Detail of a sandstone door threshold retrieved from the trench immediately north of the churchyard wall on the south side of Church Street (Scale = 1m)

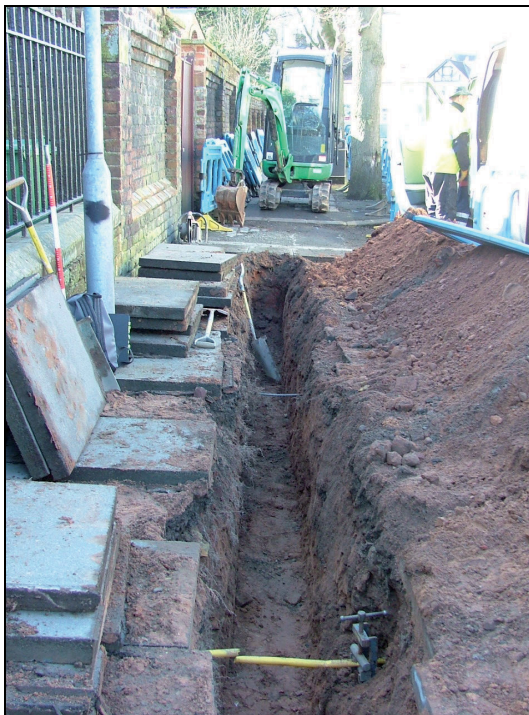
Plate 11: View looking south-west showing the section of trench north of the church hall showing existing services orientated north to south across the trench

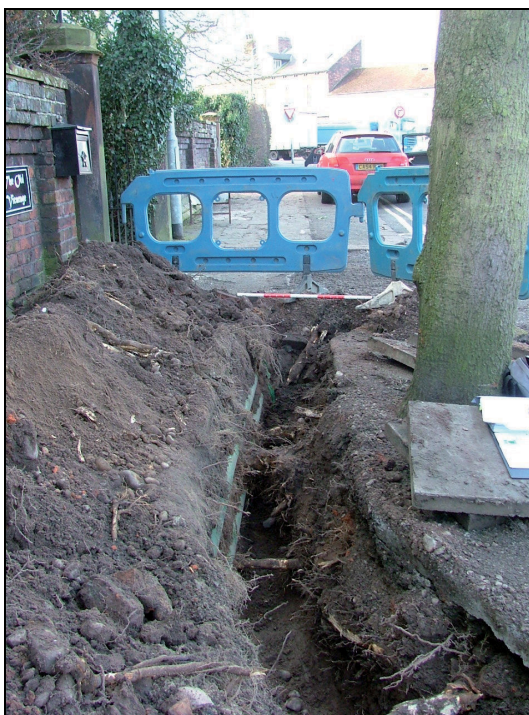
Plate 12: View looking south-west close to the entrance to The Old Rectory showing existing services in the south side of the trench and the tree roots (Scale = 1m)

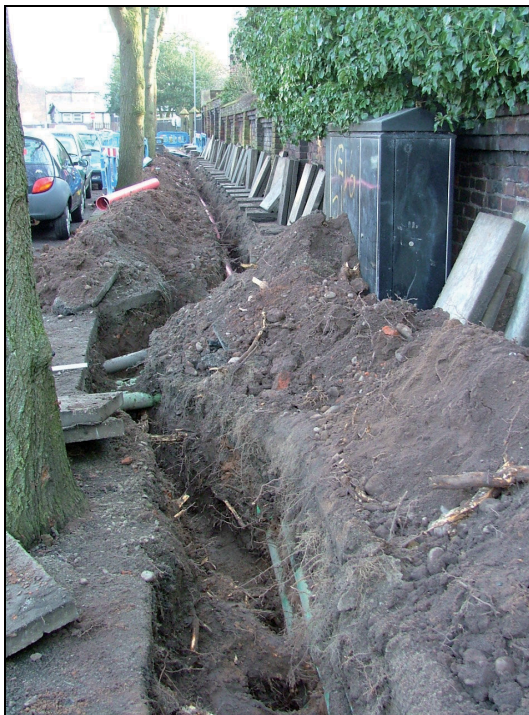
Plate 13: View looking north-east showing the excavated trench along the north side of The Old Rectory boundary wall

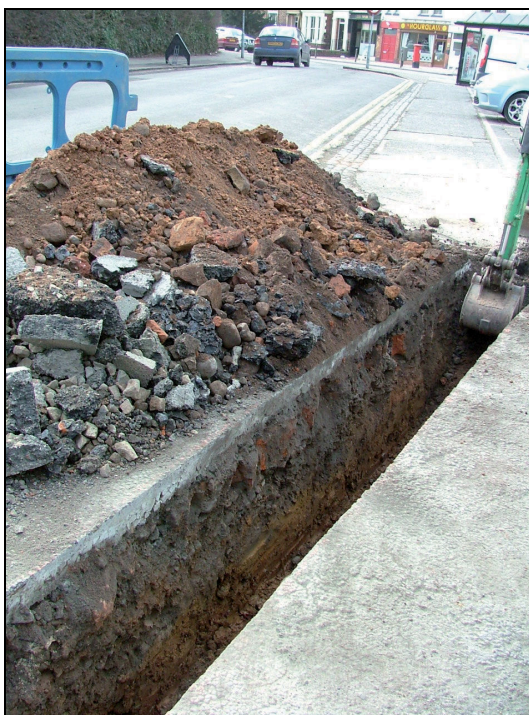
Plate 14: View looking west showing the excavated material from the western end of the service trench at the car park
