THE COCK & DOLPHIN 2 MILNTHORPE ROAD KENDAL, CUMBRIA

ARCHAEOLOGICAL
DESK-BASED ASSESSMENT
AND EVALUATION
CP. No1133/10
11/05/2010

DOCUMENT TITLE: The Cock & Dolphin, 2 Milnthorpe Road, Kendal
DOCUMENT TYPE: Archaeological Desk-Based Assessment and Evaluation Report
CLIENT: Russell Armer Ltd
CP NUMBER: 1133/10
SITE CODE: CDK-A
PLANNING APP. NO: SL/09/1143
OASIS REFERENCE: northpen3-76950
PRINT DATE: 11/05/2010
GRID REFERENCE: SD 5162 9193

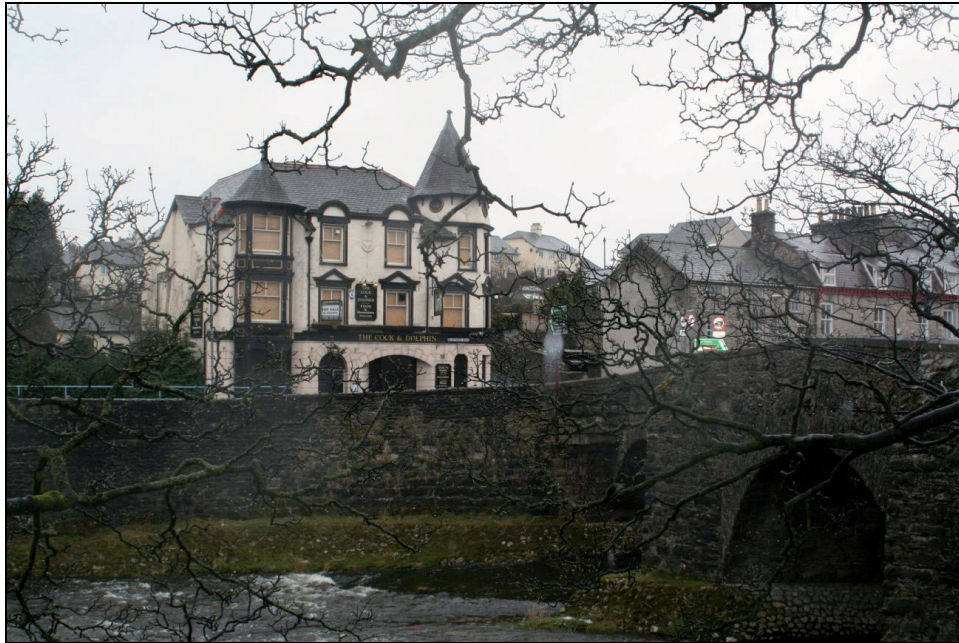
Plate 2: The Cock & Dolphin Public House and Nether Bridge, looking northwest

- 4.4.2 The Cock & Dolphin Public House stands opposite Nether Bridge on the edge of Milnthorpe Road, a busy thoroughfare into Kendal town centre (Plate 2). The pub was vacant at the time of the site visit and the interior was not inspected. The main elevation of the Cock and Dolphin Public House faces towards Nether Bridge, and onto Milnthorpe Road (Plate 3). This is a prominent position within this part of Kendal and consequently the main façade is the most elaborate in terms of architectural detail. The building is of three storeys, and has a hipped roof to the east side of the building, laid in slate with red ceramic ridge tiles which contrast markedly with the grey Welsh slate. At ground level, the main façade is covered in render to create a

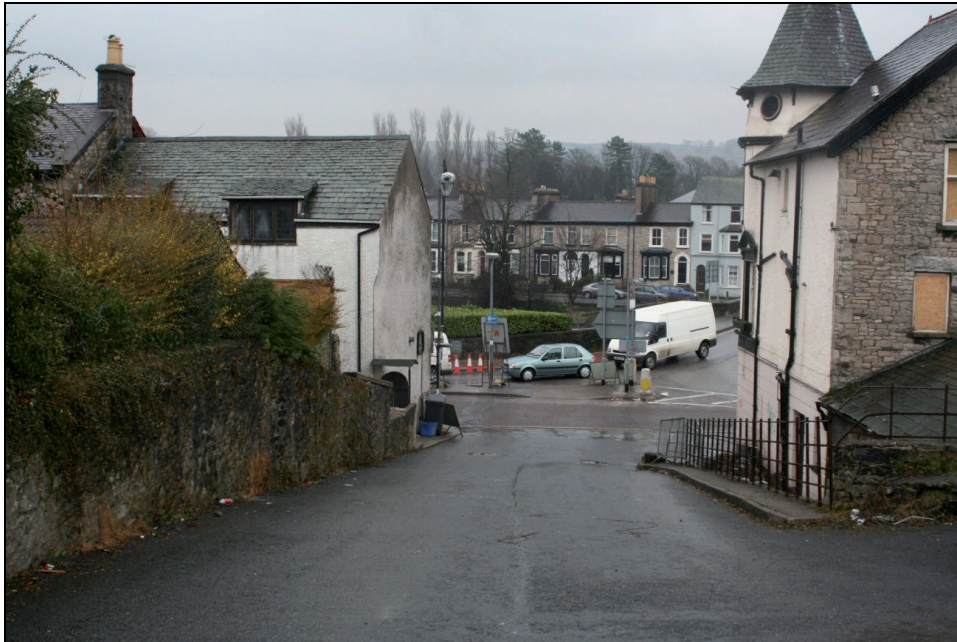
Plate 4: Drive on the north side of the proposed development area, looking east

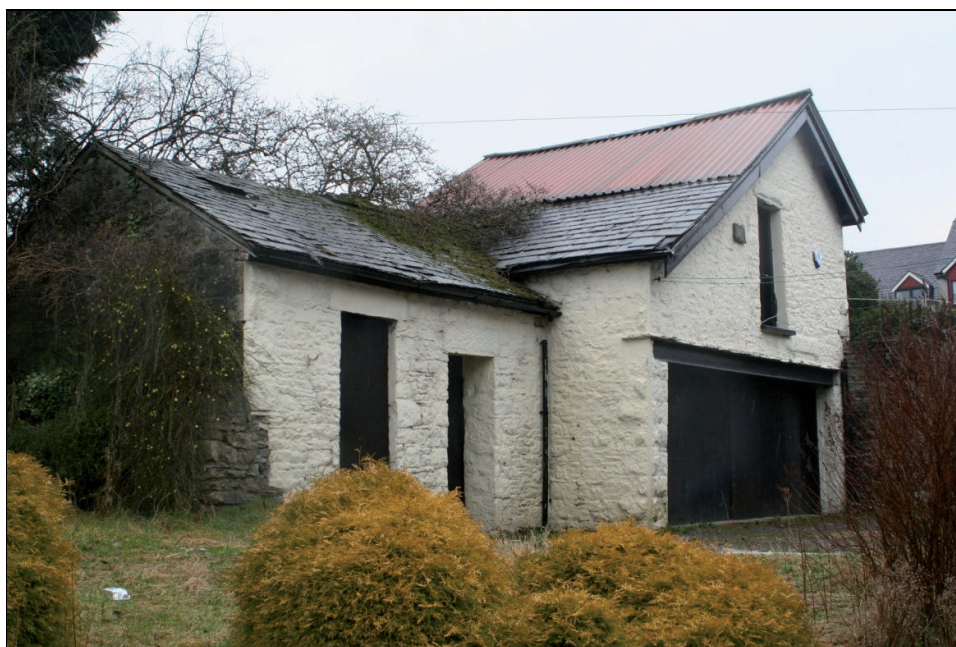
Plate 9: Garage and wash house to the rear of the Cock & Dolphin, looking northeast

- 4.4.6 To the rear of the Cock & Dolphin are the garage and wash house (Plate 9). The northern 8m by 6m building is a two-storey garage with sliding doors on the east and west elevations. This building was formerly a stable, converted into two garages in the early 20th century. The former stables are constructed of rubble masonry with dressed quoins. The roof, which is asymmetrical, is laid in a mixture of slate and corrugated sheeting. In the east elevation facing the public house, there is a large opening at ground level, presumably inserted when the building was modified to a garage, which truncates an earlier opening as shown by the surviving lintel. At first floor level there is a pitching door, which was presumably used for the transference of hay or straw into the first floor loft. There appears to have been a lean-to structure adjacent to this building, evidence for which is visible where the stonework is exposed on the north side (Plate 10).

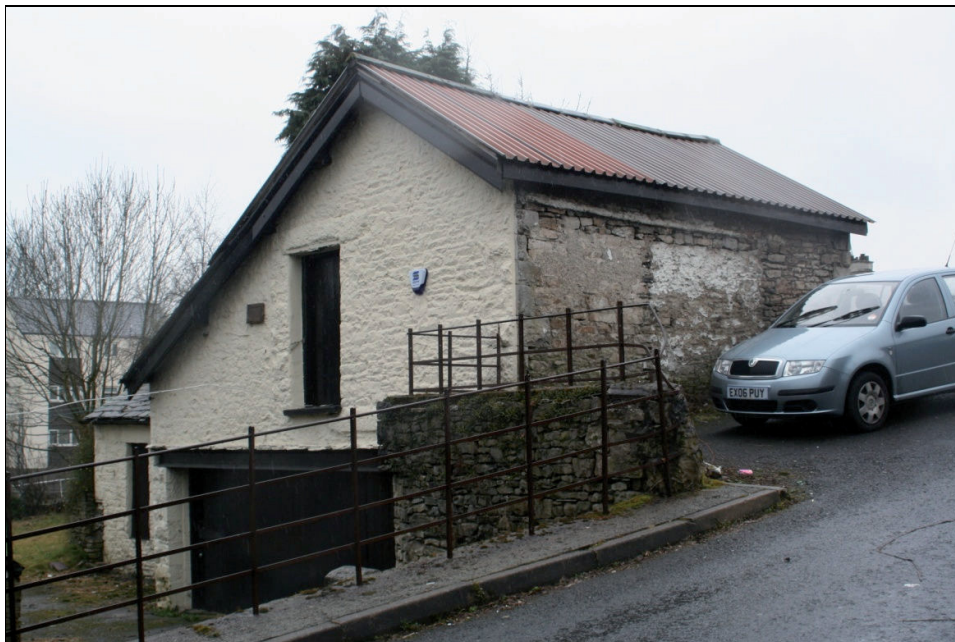
Plate 10: The former stable building (now a garage), looking southwest

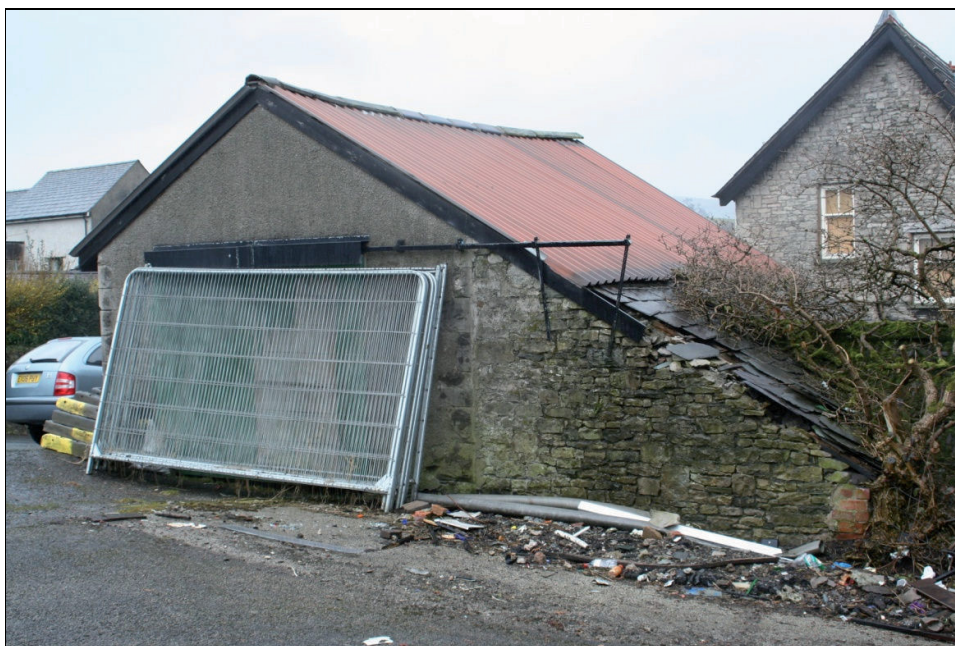
Plate 11: Rear of the former stable building and wash house, looking northeast

- 4.4.7 The wash house building to the south is a 4.5m by 5.5m structure with a slate roof (Plate 11), constructed into the natural hillside so that access is only possible from two doors on the east side. The building has been used both as a wash house and coal store. The interiors of these buildings were not inspected.

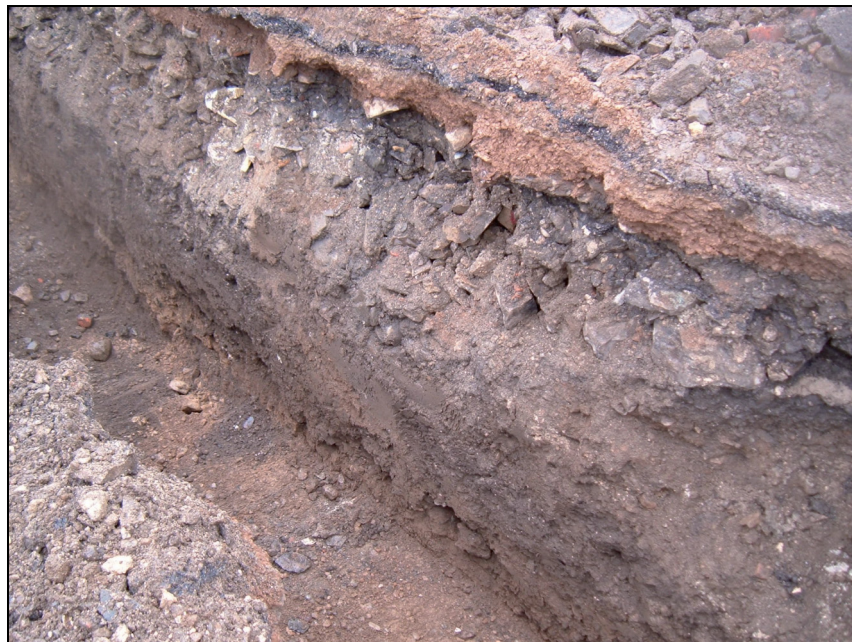
Plate 12: East facing section of Trench 1

- 5.2.1 *Trench 1:* Trench 1 was located within the PH car park, along the western boundary of the proposed development area (Figure 2). The trench was aligned north to south and measured 25m in length and 1.6m in width, and was excavated to a maximum depth of 2.6m revealing the natural substrate **(101)**, which was comprised of light brown/yellow fluvial sands and gravels. The natural substrate **(101)** was sealed by a c.0.5m deposit of light brown/yellow sandy silt **(105)**. This was further below a deposit of dark brown sandy silt made-up ground **(104)**, which measured c.0.9m in depth and contained frequent amounts of 19th century pottery. The made-up ground **(104)** was sealed by a c.0.9m deposit of building rubble **(103)**, which possibly relates to the demolition of the properties to the north and south of the Cock & Dolphin PH in the mid-20th century. The demolition layer **(103)** was sealed by a 0.3m deposit of hardcore packing **(102)** and 0.08m of asphalt surface **(100)** (Plate 12).

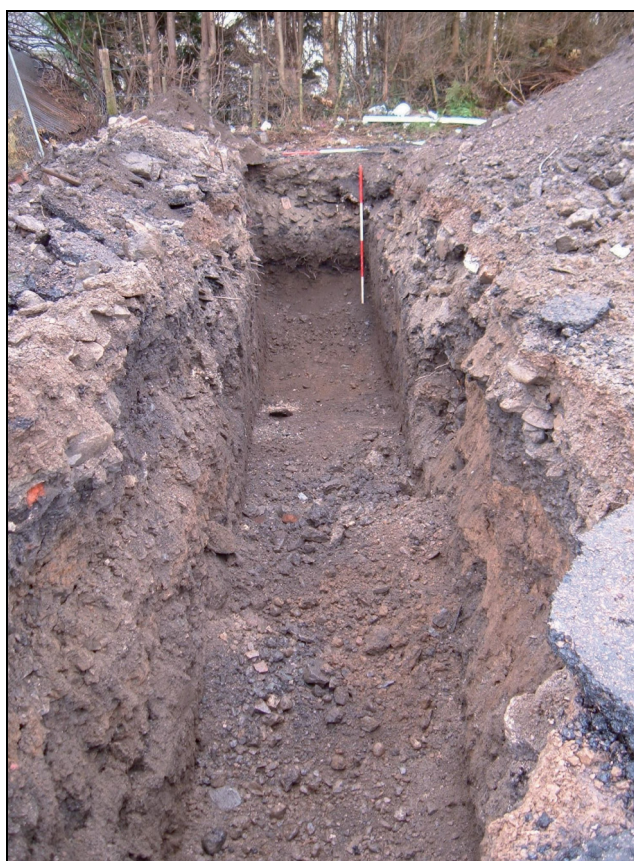
Plate 13: View south of Trench 3

- 5.2.3 **Trench 3:** Trench 3 was located toward the eastern edge of the car park, approximately 3m west of the former stable building (Figure 2). The trench was aligned north to south and measured 12m in length and 1.6m in width (Plate 13). Trench 3 was excavated to a maximum depth of 2.7m revealing the same sequence of deposits observed within Trenches 1 and 2.

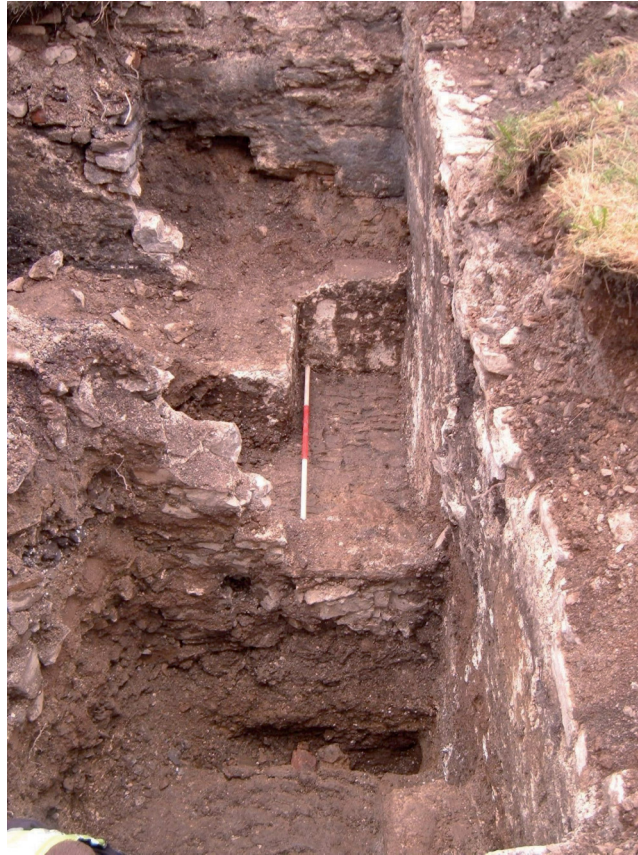
Plate 15: View south of cobbled surface (131), Phase 2 wall (125) (centre), Phase 1 abutment (129) and walls (127) and (132) showing step-line (background)

5.2.8 The surface of the early cellar had been lined with river-worn cobbles (131) which had been relatively well-set within the northern half of the room (Plates 15 & 16, Figure 10). A 1.1m x 0.38m slot was excavated through the cobbled surface (131) in order to investigate the possibility of earlier building phases. The slot was excavated to a depth of 0.5m revealing the natural orange sandy clay (116) below c.0.3m of natural fluvial gravel (101). The fluvial gravel (101) was sealed by a c.0.1m deposit of mid-brown/orange sandy clay (137), which was probably laid down as a bedding layer for the cobbled surface (131). No earlier features were noted below the cobbles (131), although two sherds of late 18th century Midlands Ware pottery were retrieved from the sandy clay bedding layer (137).

- 5.2.10 **Phase 2:** The second phase of construction comprised an east to west aligned internal wall which effectively separated the cellar into two rooms. The wall (125) was located within the centre of Trench 4 and was incorporated into the opening within the west wall (110) of the cellar prior to it being blocked-up. The wall (125) measured approximately 2.8m in length, 0.28m in width and c.1m in height, and was constructed from sub-angular limestone blocks bonded with lime mortar (Plates 15 & 16, Figure 11).

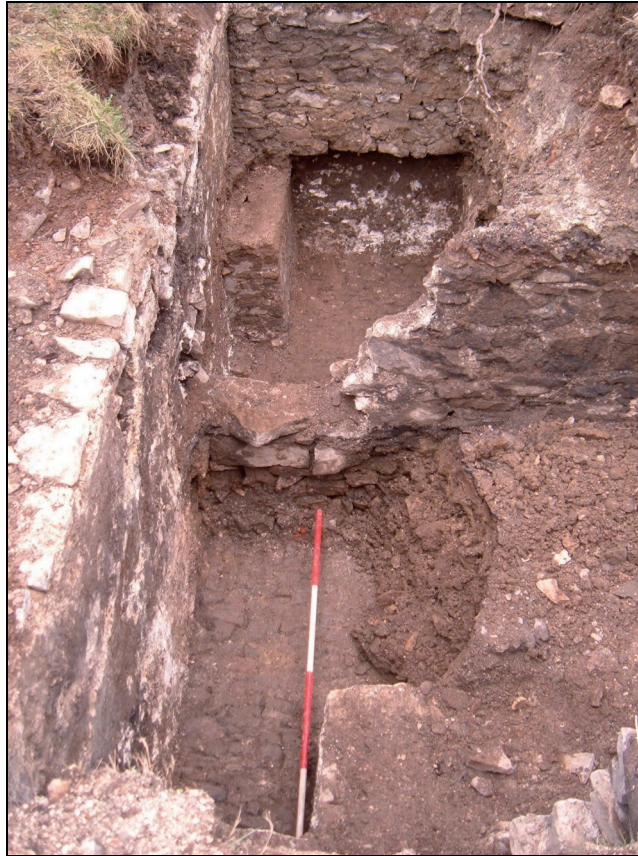
Plate 16: View north of cobbled surface (131), Phase 2 wall (125) (centre), Phase 1 wall (134) and abutment (135) below Phase 3 wall (133) (background)

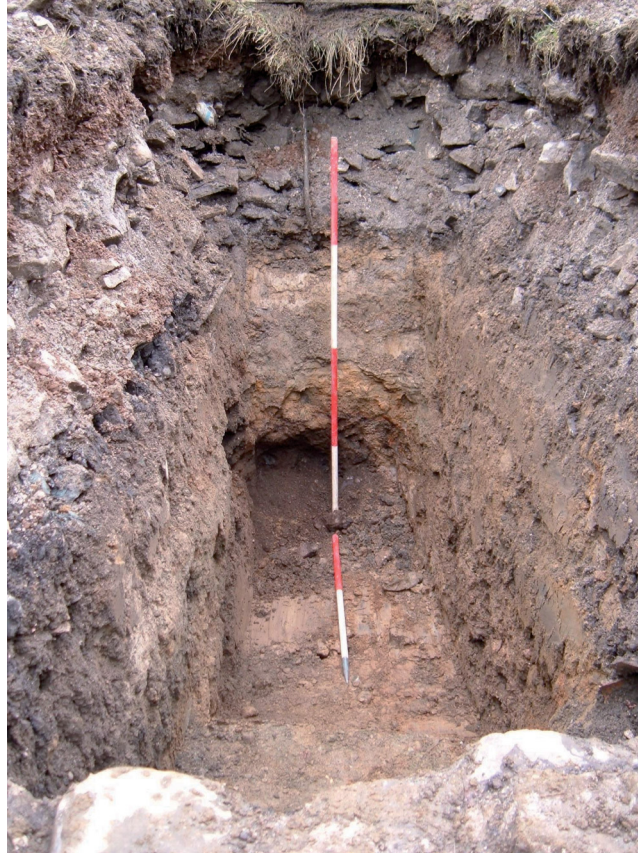
Plate 17: View west of deposits below cobbled surface (106)

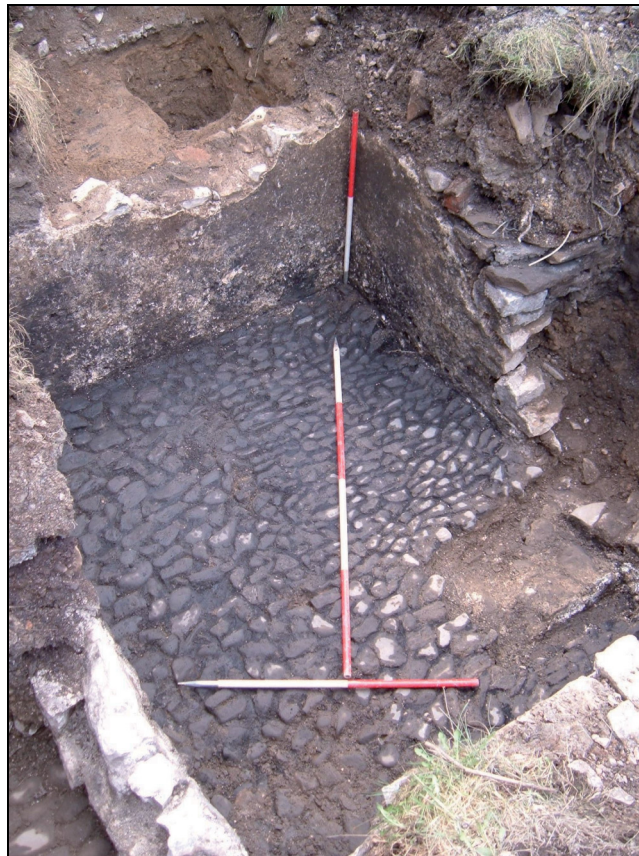
Plate 18: View southeast of cobbled surface (122) and Phase 1 walls (127) and (128). Phase 1 abutment (129) can be seen below the cobbled surface (right)

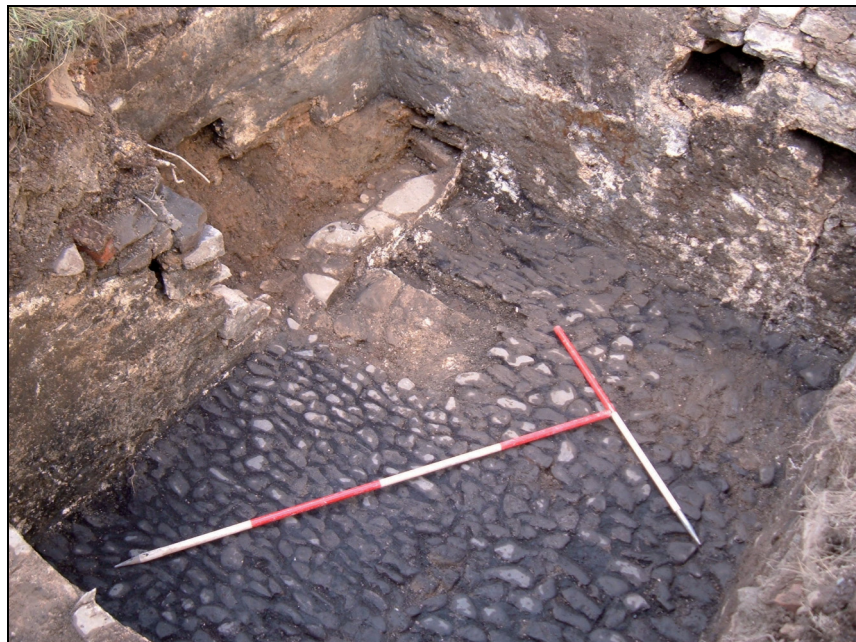
Plate 19: View southwest of cobbled surface (122) and Phase 1 walls (110), (127) and (132). Phase 1 abutment (129) can be seen below the cobbled surface (centre)

located approximately 0.7m east of the wall (110), and measured 0.66m in length, 0.5m in width and 0.55m in height (Plates 15 & 19). At the eastern extremity of the east to west aligned wall (127), a north to south aligned return wall (128) was noted, which measured over 2.1m in length, 0.47m in width, and 1.1m in height, and was comprised of angular limestone and sandstone blocks bonded and rendered with lime mortar.

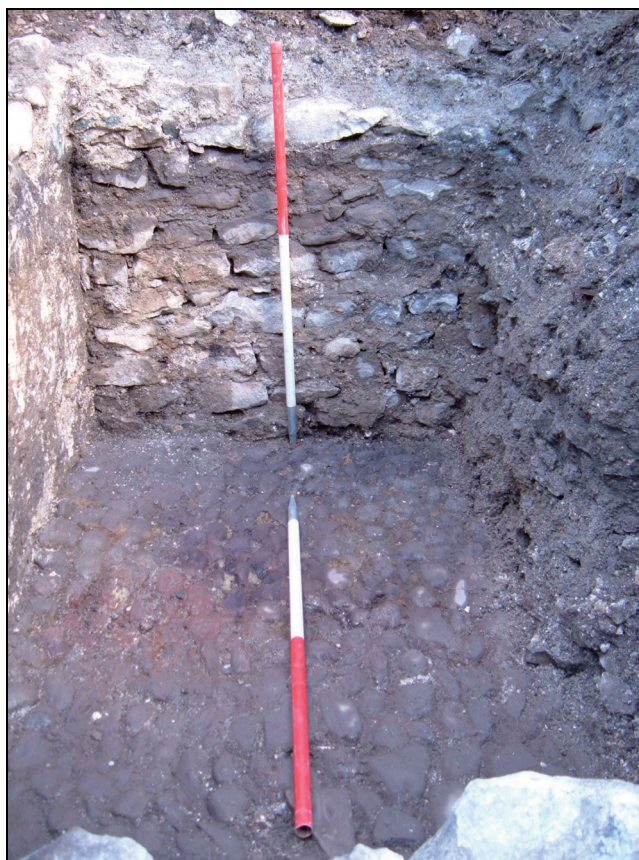
Plate 20: View north of cobbled surface (113) and wall (133)

5.2.11 **Phase 3:** The third phase of building construction appears to have incorporated a single wall and several floor surfaces into the existing footprint of the cellar. Prior to the construction of these features, the original cellar was backfilled with a mid/dark brown silty clay/gravel in order to raise the ground level. The backfill deposit (124) to the south of the Phase 2 partition wall (125) measured c.0.7m in depth, and the backfill deposit (126) to the north of the partition wall (125) measured c.1m in depth (Figure 13). Both of these deposits contained frequent amounts of late 18th/early 19th century finds. Following the deposition of the silty clay/gravel backfill, an east to west aligned wall (133) was constructed at the northern extent of Trench 4, abutting the northern end of the western cellar wall (110). The east to west aligned wall (133) measured over 1.5m in length, over 0.27m in width and c.1m in height, and was comprised of sub-angular limestone blocks bonded with lime mortar. Interestingly, the wall (133) was constructed immediately south of the earlier north wall (134) rather than incorporating it into the later building design (Plates 16 & 20).

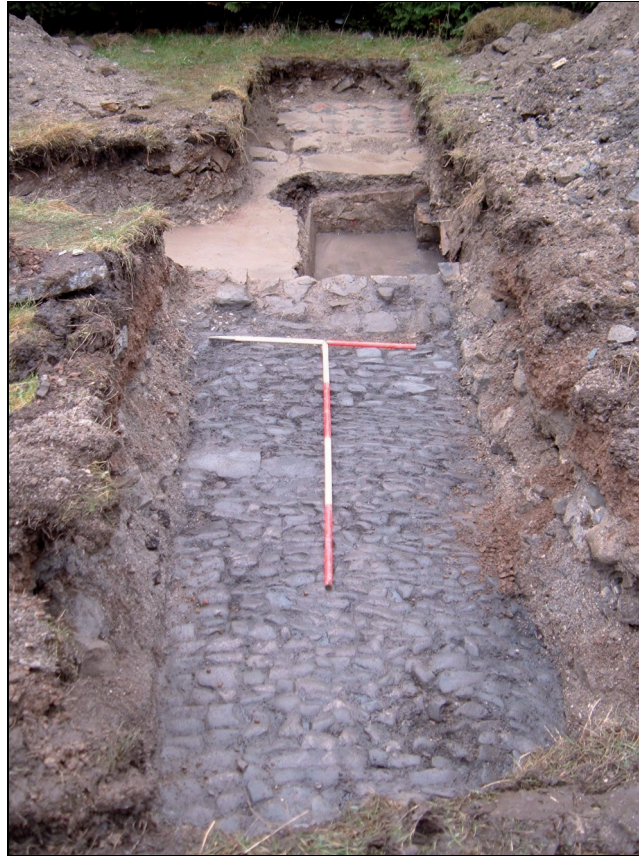
Plate 21: View east of cobbled surface (106)

- 5.2.13 It is probable that it was during the second phase of construction that the cobbled yard (106) to the west of the cellar was deposited. The cobbled yard (106) measured over 3.7m in length and over 1.6m in width, and was again comprised of randomly laid river worn cobbles (Plate 21, Figure 11).

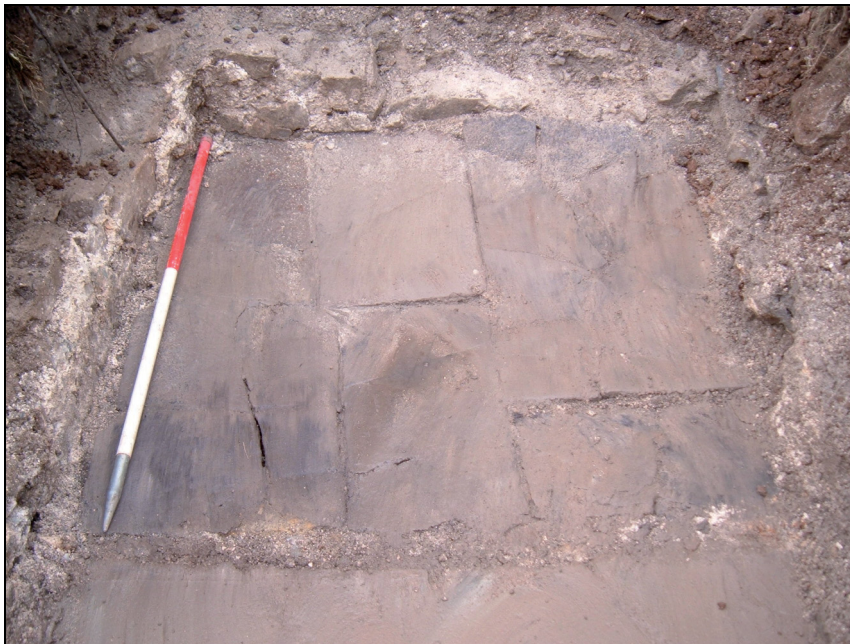
Plate 22: View north of sandstone surface (111)

5.2.15 **Phase 5 & Phase 6:** Several different floor surfaces were also noted within Trench 4, forming Phase 5 and Phase 6 of the building. The northernmost 1.3m of the excavated area exposed a flagged floor (111) (Phase 5) which was comprised of excessively worn yellow sandstone slabs (Plate 22, Figure 12). The sandstone floor (111) measured over 1.5m in width and 1.3m in length, and had been replaced by a 0.09m thick concrete surface (112) at a later date (Phase 6). The concrete surface (112) measured c.3m x 3m and had been extensively damaged. A modern pit (118) had also been constructed within the southwest corner of the concrete surface (112), which measured c.2m in

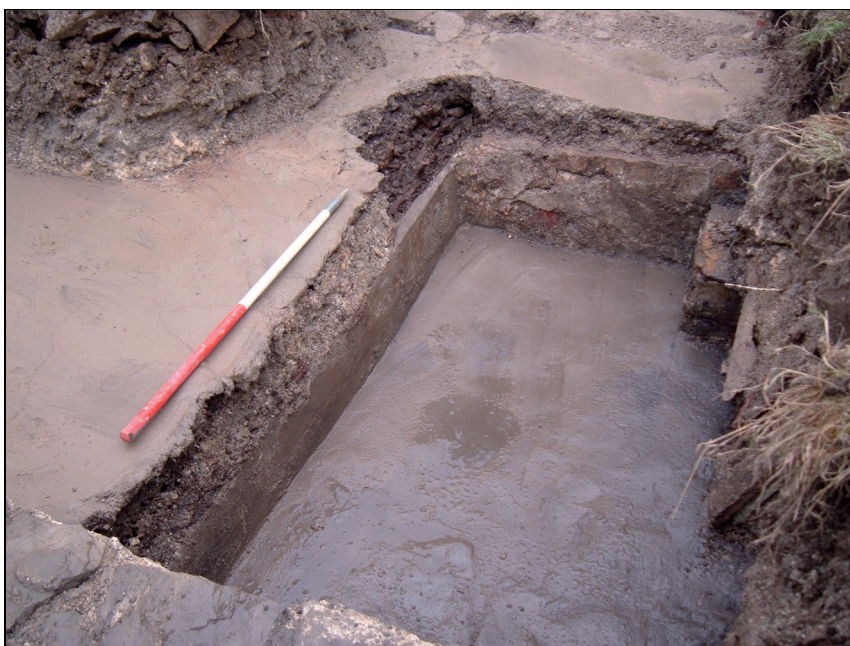
Plate 23: View northeast of concrete surface (112) and pit (118)

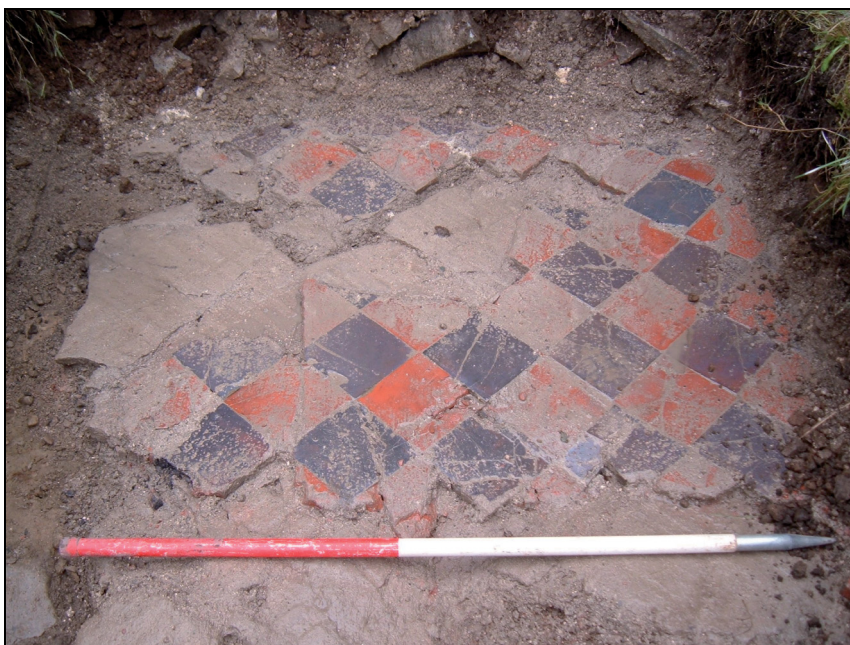
Plate 24: View east of tiled surface (113)

5.2.16 Immediately east of the concrete surface (112), a further floor surface (113) was revealed which was probably more closely associated with the sandstone floor (111) (Phase 5) rather than the concrete surface (Phase 6). The easternmost surface (113) measured c.1.2m in length and c.1.3m in width, and was comprised of terracotta and purple diamond shaped tiles (Plate 24, Figure 12). It is probable that the tiled floor (113) was associated with a vestibule dating to the Victorian period. The tiled floor was set upon a bed of 0.05m thick concrete (114).

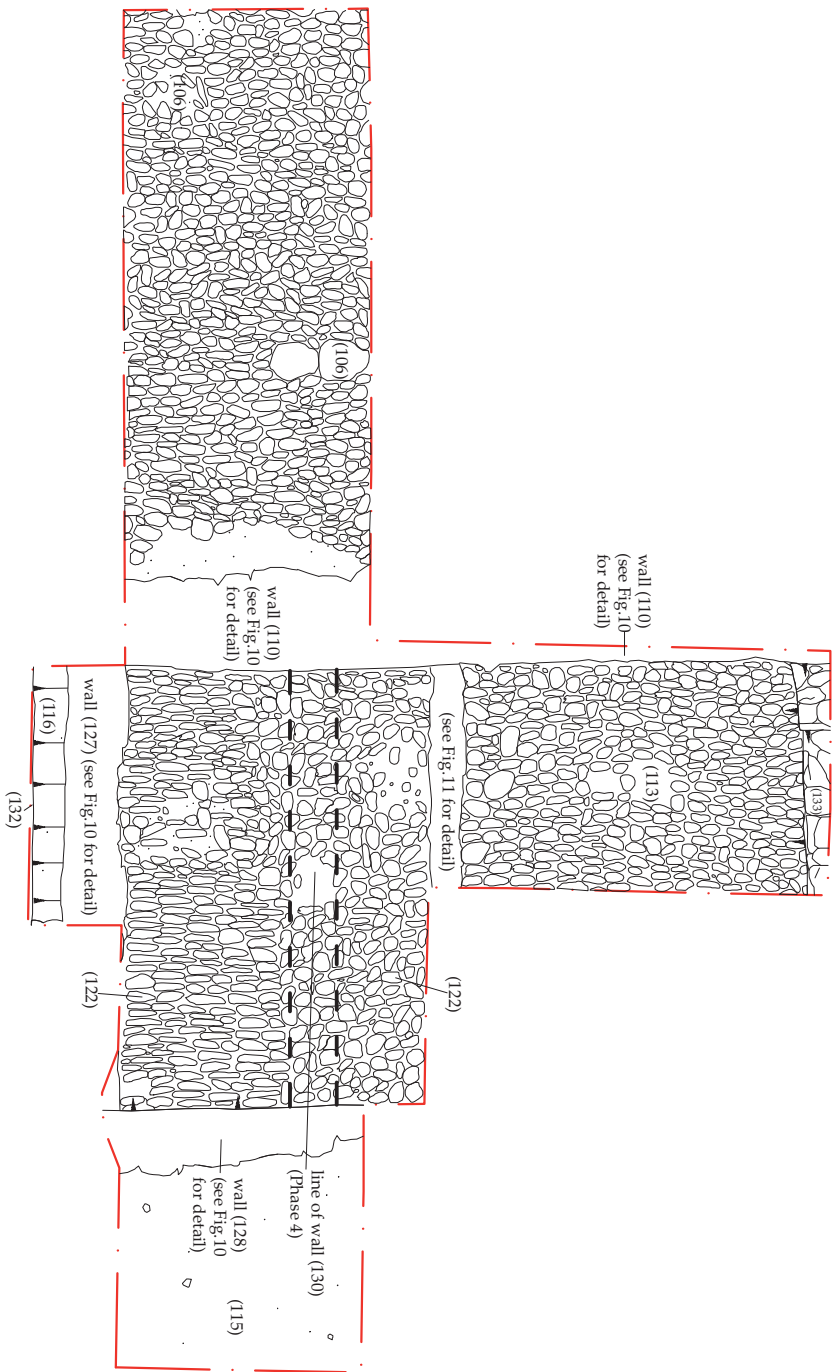
Figure 11: Plan of Trench 4 (Phase 3 & Phase 4)

- 5.2.12 Two separate cobbled surfaces were also laid down during this phase, both to the north and south of the central partition wall (125) (Figure 11). The southernmost cobbled surface (122) was comprised of river worn cobbles which had been regularly set within the southern half of the area, but appeared more random in the northern half (Plates 18 & 19). The cobbled surface (113) to the north of the partition wall (125) was very similar in appearance to the northern half of the southernmost cobbled surface (122) (Plate 20), although the latter was constructed at a height of c.0.3m below the northernmost surface (113).

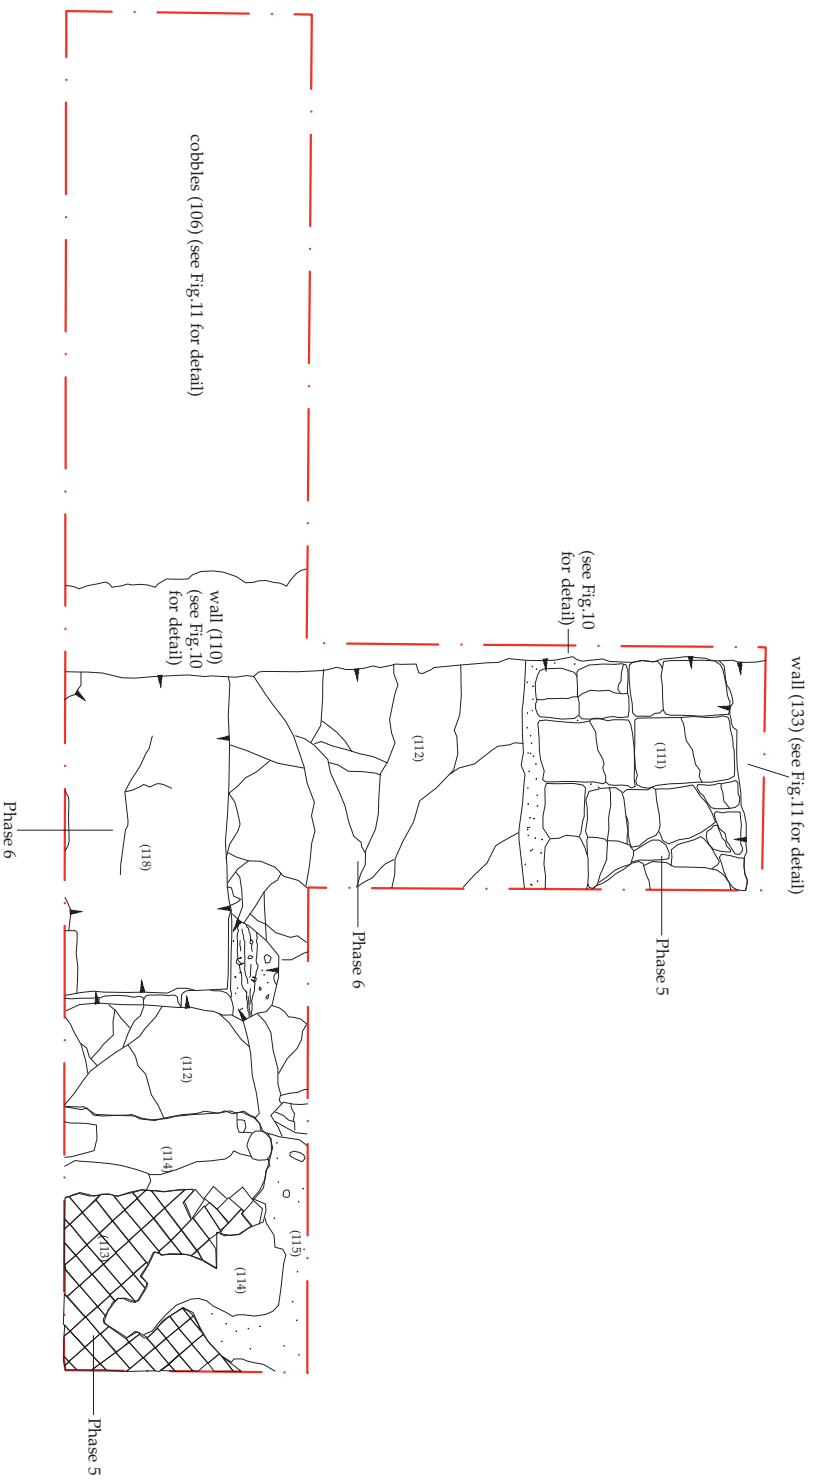
Figure 12: Plan of Trench 4 (Phase 5 & Phase 6)
