**FORMER TARMAC
WORKS,
CHORLEY,
LANCASHIRE**

**ARCHAEOLOGICAL
EVALUATION REPORT**

DOCUMENT TITLE: Former Tarmac Works, Sandy Lane, Clayton Le Woods, Chorley, Lancashire

DOCUMENT TYPE: Archaeological Evaluation Report

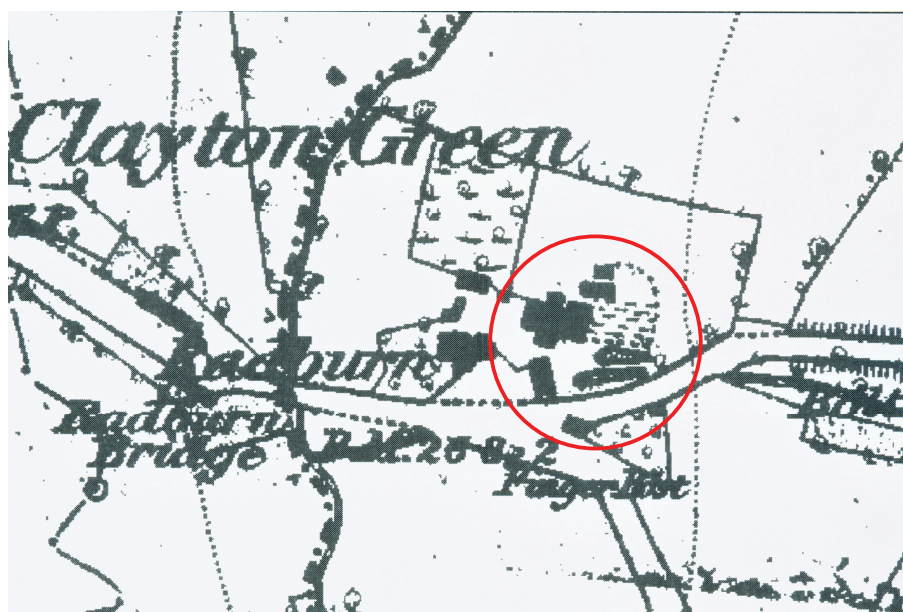
Plate 2: First Edition Ordnance Survey Map 1: 10,560 1848

- 3.2.2 *1848 First Edition Ordnance Survey Map*: the First Edition map (Plate 2) clearly shows a large building and three smaller buildings within the development site. There are also two ponds visible by the road side, the buildings are suggestive of an industrial complex.

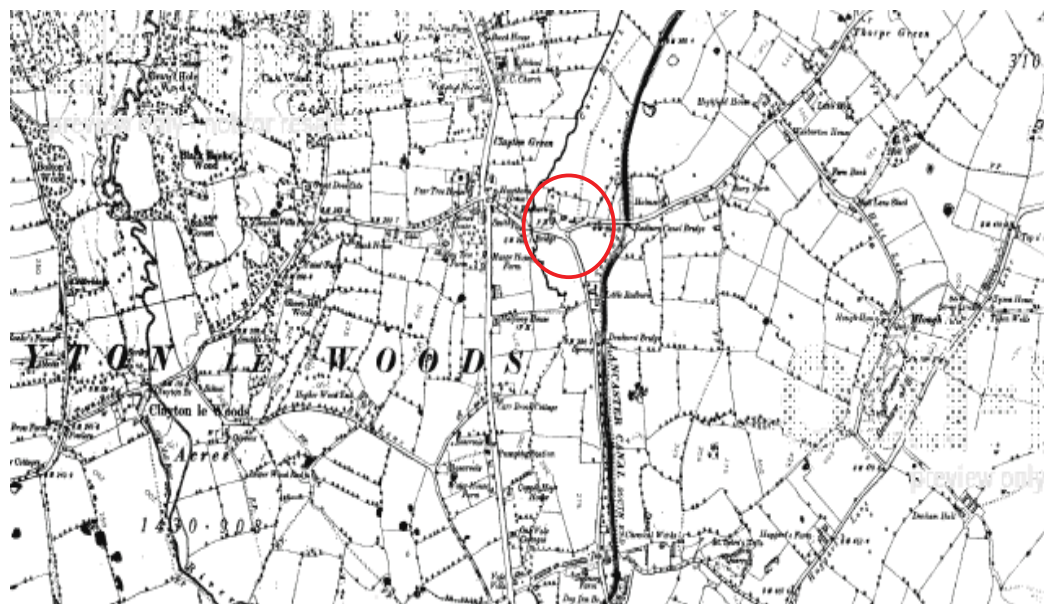
Plate 3: Second Edition Ordnance Survey Map 1:10,560 1893-94

- 3.2.3 *1893 Second Edition Ordnance Survey Map*: the Second Edition map (Plate 3) shows the Lord Nelson public house to the west of the site and the largest of the three buildings still remaining.

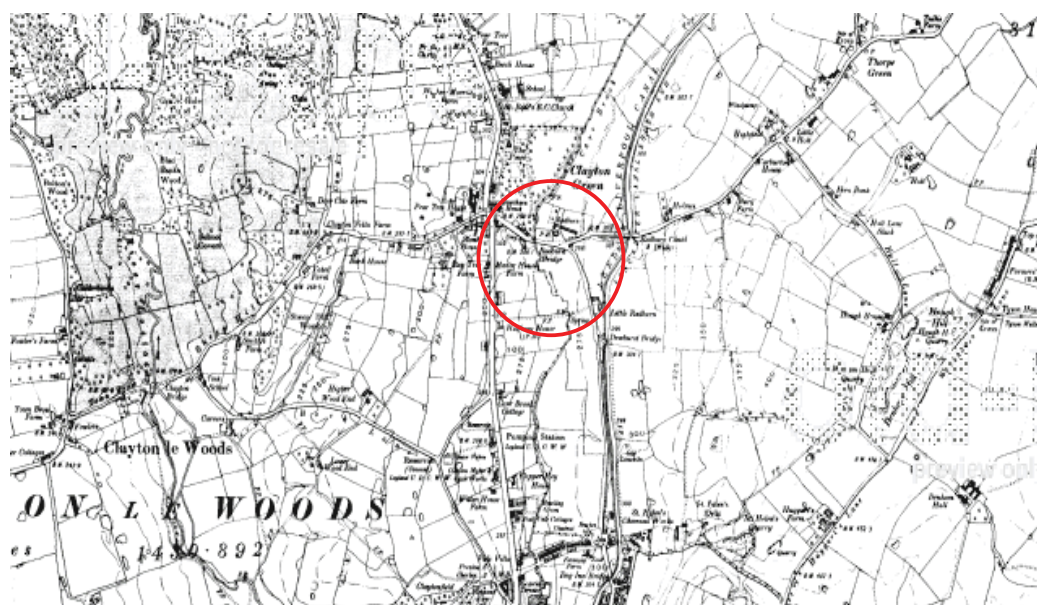
Plate 4: 1912 Ordnance Survey Map 1:10,560

- 3.2.4 *1912 Ordnance Survey Map*: the 1912 map (Plate 4) shows that the original buildings shown within the site have now gone, and a single long north-west south-east aligned building is now shown on the site.

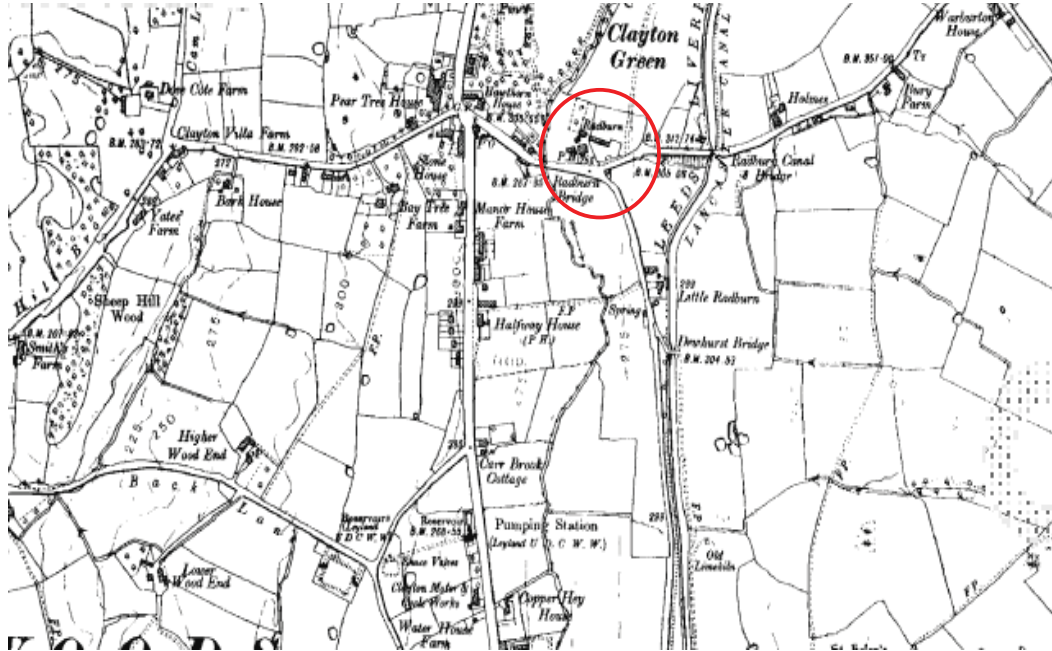
Plate 5: 1931 Lancashire and Furness OS Map 1:10,560

- 3.2.5 *1931 Lancashire and Furness Ordnance Survey Map 1:10,560*: the latest map (Plate 5) still shows the long rectangular building shown on the 1912 map. There are still no indications of the use of this building.

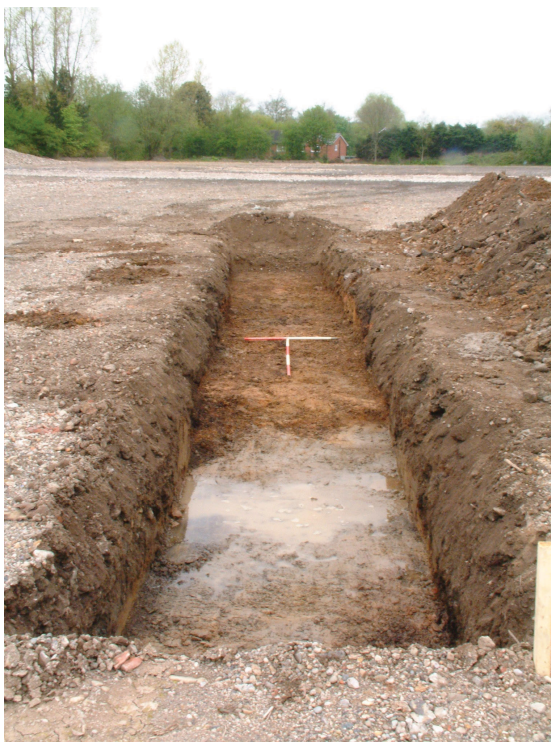
Plate 6: Trench 1 general view

4.2.1 **Trench 1:** the trench was excavated to a maximum depth of 0.71m revealing sands and gravels mixed with clay (108) below c.0.71 of mixed modern crushed building material comprised of brick, concrete, metal rebar and dark grey brown silty sand (Plate 6).

4.2.2 There were no archaeological remains within Trench 1.

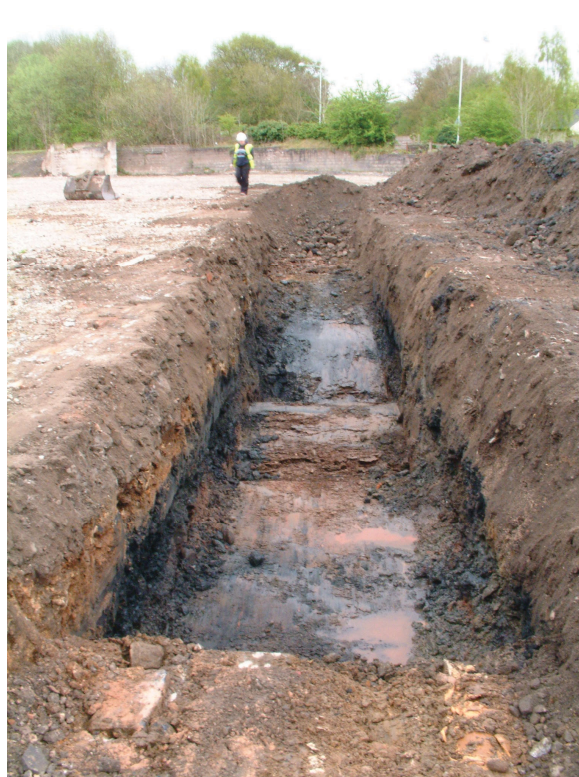
Plate 7: Trench 2 showing area of organic deposit and deeper excavation

4.2.3 **Trench 2:** the trench was excavated to a maximum depth of 1.83m revealing red marl clay (108) below c.0.52m of mixed dark grey brown sands and gravels (104). The gravels were overlain by a layer of very dark blue black sandy clays between 0.10 and 0.45m depth (103). Organic layer (103) may have leached into the deposits below changing their colour. An east-west aligned wall was found in the west half of Trench 2 (106), built on top of the organic layer. The trench was sealed by a 0.38m to 0.60m-depth layer of modern crushed building material (101) (Plate 7 and 8). There were no finds within Trench 2.

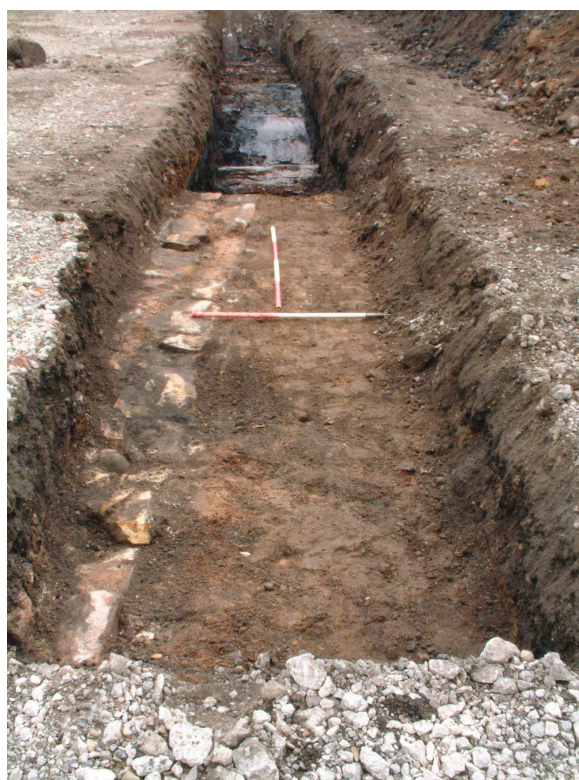
Plate 9: Wall (106) within Trench 2, showing deeper excavation to the north

4.2.4 Wall (106) measured 7.6m in length and comprised a single course of fairly degraded sandstone, aligned east-west across the north edge of the trench. It was rough hewn with a line of square cobbles just visible to the north of the wall at the trench edge (Plate 9, Figure 3). It was truncated to the east by the cut for a sewer pipe. The overlying modern crushed material (101) also deepens to the east perhaps indicating an area of deeper excavation. There were no finds within Trench 3

- 5.1.2 Trenches 1 and 3 were devoid of any archaeological features or deposits, whilst Trench 2 contained the foundations of a wall. The modern deposition of material seen within each trench is most likely the result of levelling activity following the demolition of the Tarmac Works. It is possible that prior to the any building works on site the topsoil had been removed and other surfaces laid down removing the natural stratigraphy within the development area. As no finds were recovered from the trial evaluation is it difficult to ascertain the date of the stone wall, however the alignment suggests that it may be the remains of the building seen on the 1912 and 1931 Ordnance Survey Maps.

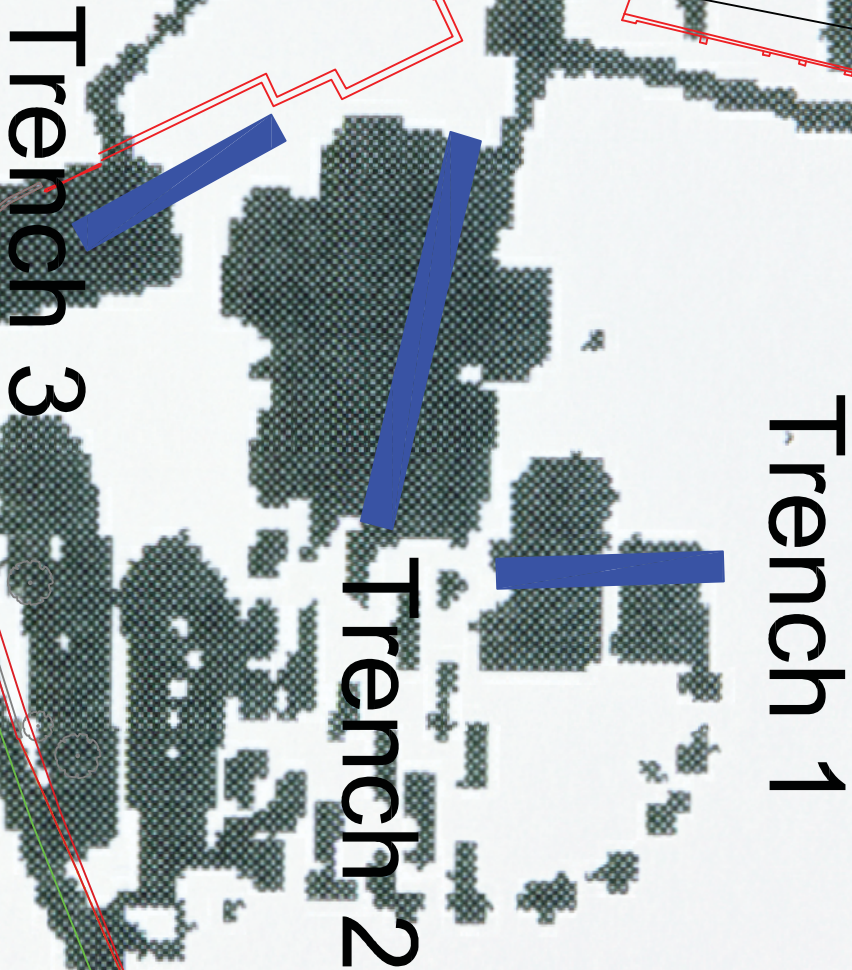
4.1.1 The evaluation was undertaken in one phase, between 5th to 7th May 2010 (Figure 2). Each trench was excavated using a JCB 3 CX with a flat ditching bucket under archaeological supervision. The three trenches were targeted over the assumed position of the buildings shown on the 1848 First Edition Ordnance Survey Map. Trench 1 was aligned north-west south-east and aimed to locate the smaller building located to the north of the road. Trench 2 was located east-west across the largest of the buildings. Trench 3 was aligned north-south over the two smaller buildings to the north of the largest building (Figure 2). The location of trench 3 was moved to the north due to the presence of a high voltage electricity cable.

Figure 2: Trench location plan overlaid 1848 First Edition Ordnance Survey Map
