LAND AT BARFORTH CHAPEL, GAINFORD, CO. DURHAM

EARTHWORK SURVEY CP. No: 1097/10 DATE: 28/07/2010

DOCUMENT TITLE: Land at Barforth Chapel, Gainford, County Durham

DOCUMENT TYPE: Earthwork Survey

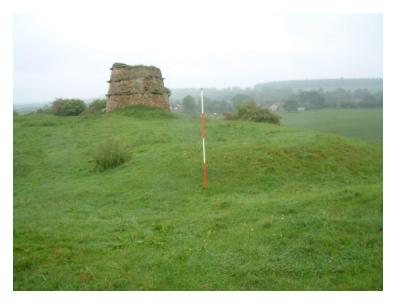
Plate 1: Overall view of Site B looking north

Site B | Rectilinear Earthwork: this feature is a large rectilinear earthwork to the immediate south of the Dovecote. The banks of the earthwork consist of turf and earth, with many large stones visible. At the centre of the earthwork is a large rectilinear depression. The long axis of the earthwork is aligned north-south, and short axis aligned east-west. The dovecote and its associated earthwork obscure the north and western edge of the earthwork. The earthwork runs along the edge of the natural contour of the promontory. This feature stands to a maximum height of 2.0m, but on average measures between 0.50-1.0m in height, and is 24.0m in length by and 12.0m in width. This earthwork may represent a late medieval or post medieval building platform associated with the Dovecote.

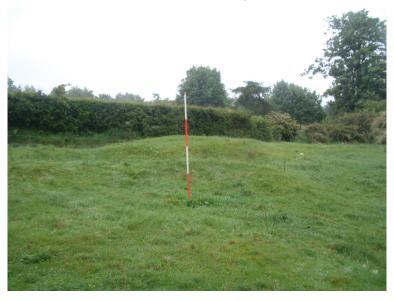
Plate 2: Overall view of Site M looking south

Site M | *Earthworks*: two low earthworks situated east of the chapel. The southernmost earthwork is sub-rectangular in shape, stands to c.0.14m in height and measures c.16m in length and c.5m in width. The northernmost earthwork is more linear in form, and measures c.10m in length by c.2m in width and to a height of c.0.15m. These earthworks may represent the southern extent of a boundary, possibly continuing north represented by Sites Q and R. The possible date of this boundary is either late medieval or post-medieval.

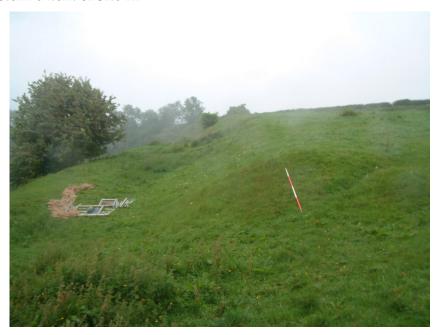
Plate 3: Overall view of Site T looking east

Site T | *Natural Break of Slope*: the natural break of slope is used to make a channel or route between itself and the eastern end of Boundary Site A.

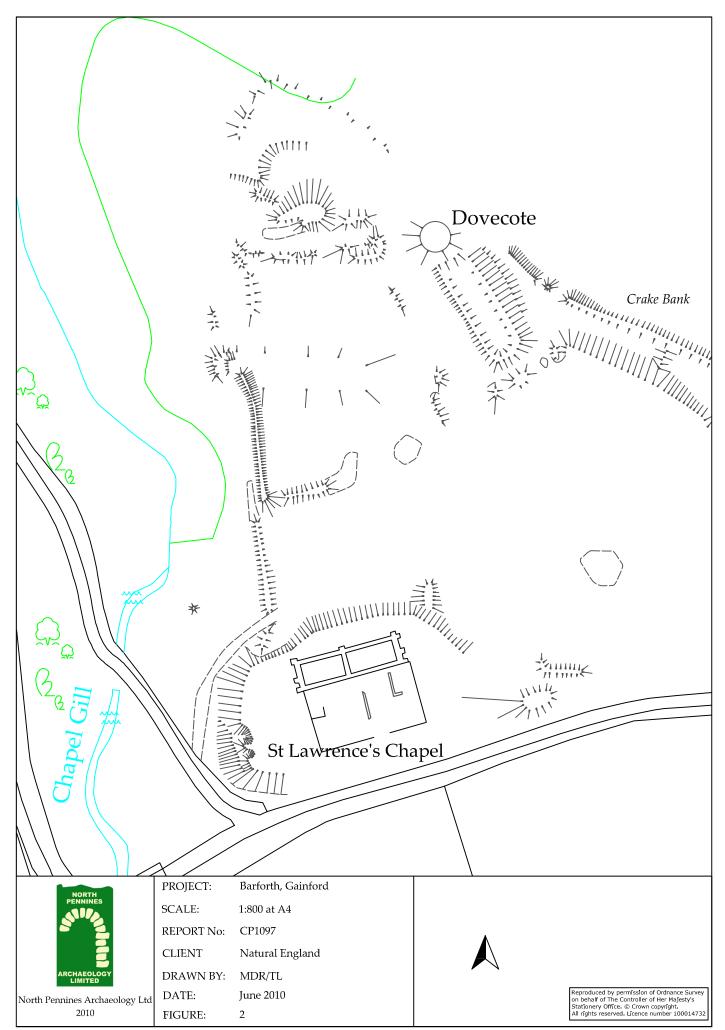
Figure 2: Overall Plan of Survey Results

- 4.2.1 The earthwork survey identified 20 site elements of interest (Figure 2) within the survey area, all associated with either the chapel or dovecote, and with potential other buildings within the parcel of land between the two standing monuments. A full gazetteer of the site elements identified can be found in Appendix 1, and is shown on Figure 3.

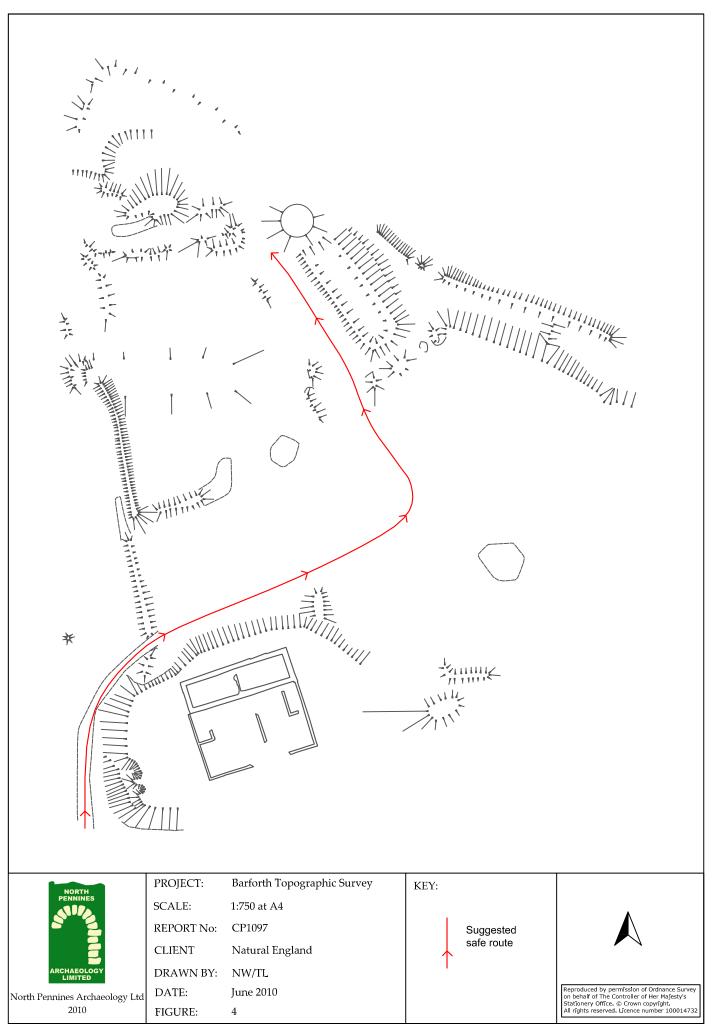
Figure 4: Suggested safe route through earthworks for consolidation contractors.

- 5.1.5 A 'safe route' was identified through the earthworks to allow consolidation contractors to safely transport materials and tools through the complex to the dovecote to allow work on the structure to begin.

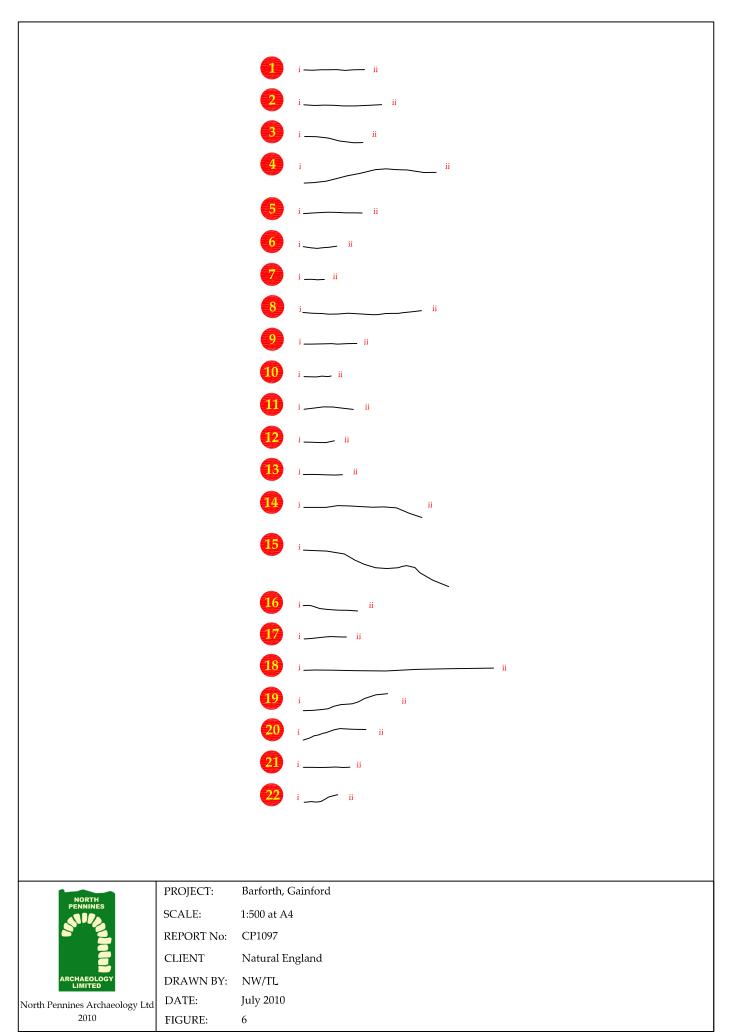
Figure 6: Earthwork Profiles (see Figure 5 for location)

- 5.1.6 Detailed earthwork plans, including feature profiles, can be seen in Figures 2-6.
- 5.1.7 Overall, the field survey showed that the landscape contained a series of linear earthworks, the potential remains of four large buildings or enclosures, as well as a small animal enclosure. Though it can be assumed that the earthworks are associated with the medieval and post-medieval extant features at Barforth, it must also be noted that no solid dating evidence could be identified, due to the nature of the earthworks.
