TRINITY STREET, STALYBRIDGE, TAMESIDE

RAPID DESK-BASED ASSESSMENT AND WATCHING BRIEF REPORT

CP. No: 1161/10

11/03/2011

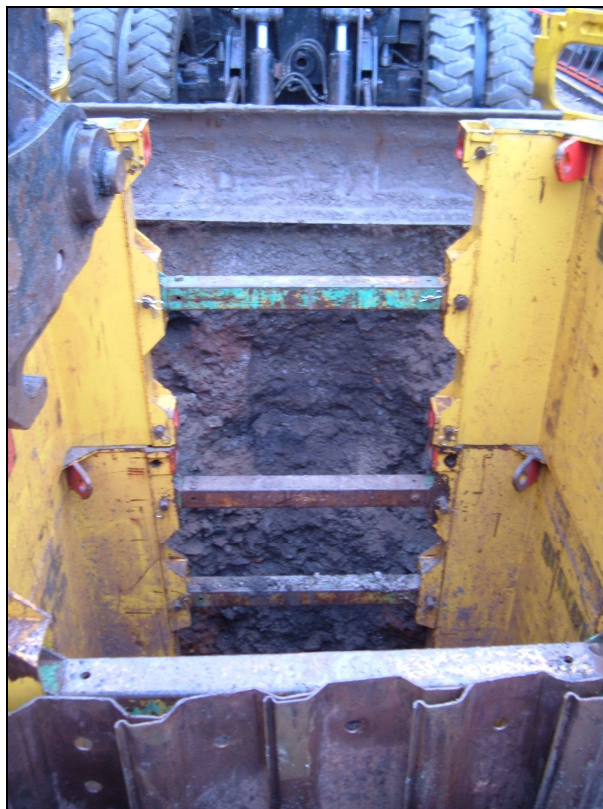
Plate 3: East facing section through deposits in Trench 1.

- 4.2.2 Several deposits were noted within this trench, although none appeared to be archaeological in nature. At the base of the trench, the targeted east-west aligned mains pipe (**111**) was observed and measured 0.20m in diameter.

- 4.2.3 The natural substrate was not encountered within this trench. However, backfill deposits were observed to a depth of 4.40m and comprised loose orange-red sand which had frequent inclusions of red brick and river cobbles (**109**).

- 4.2.4 This deposit (**109**) was truncated by the cut for a later sewage pipe [**110**], which had a U shaped profile, with gently sloping sides and a concave base. This measured 1.0m in width and was observed at 2m from the street level.

- 4.2.5 Above deposit (**109**), a 0.15m deep deposit composed of moderately compacted black silty sand (**108**) contained inclusions of crushed red brick and ceramic pipe.

- 4.2.6 A layer of compacted white dolomite was present to a depth of 0.39m above deposit **(108)**, which in turn was overlain by orange-yellow sand **(106)** to a depth of 0.05m. These layers comprised the leveling and bedding layers respectively, which make up modern day Dean Street. Above these deposits **(108)** and **(106)**, concrete paving slabs created the road surface of Dean Street.

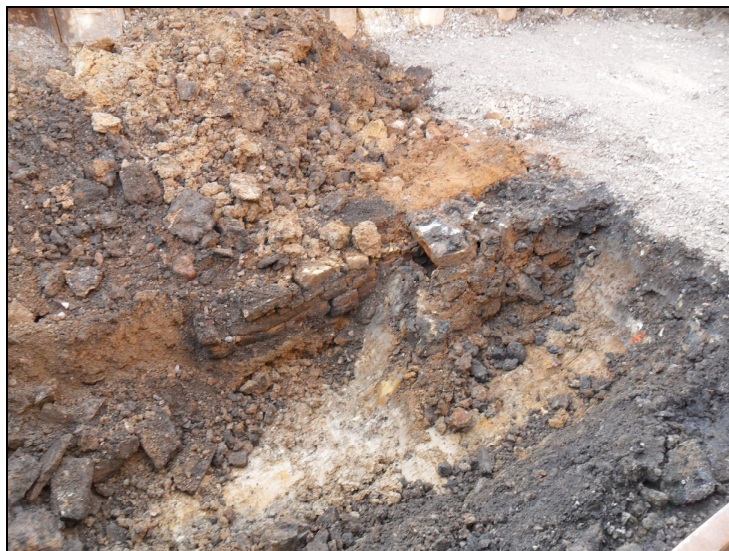
Plate 4: Sandstone culvert located within Trench 1

- 4.2.7 On February 18th, 2011 Trench 1 was extended eastward. At a depth of 2.0m a yellow sandstone covered culvert was uncovered, aligned east/west (Plate 4). The exposed aspect of the culvert was *c.* 1m in length and had a depth of 0.5m. The culvert did not appear to extend any further east. The deposits on either side of the culvert consisted of red and black sand intermixed with red brick, river cobbles and segments of metal pipe **(109)**. Due to health and safety issues the culvert was only recorded photographically before it was removed

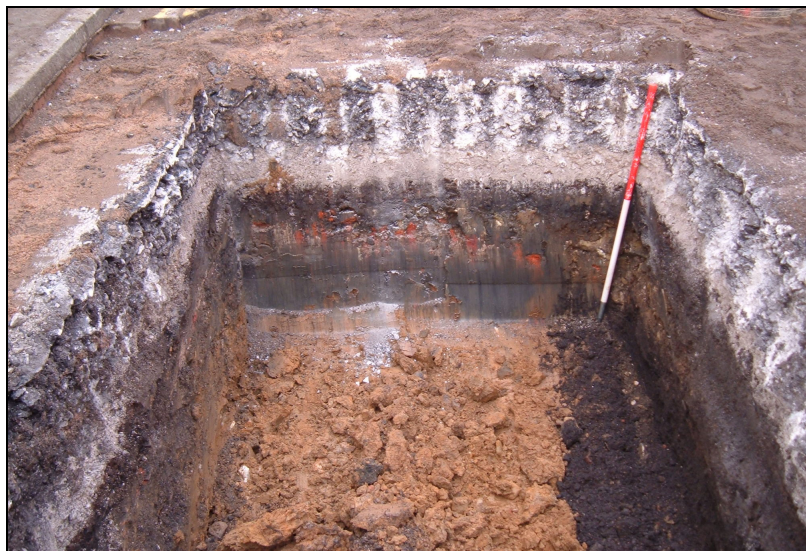
Plate 5: South facing section of deposits within upper strata of Trench 2, showing service cut [207].

- 4.3.2 The natural substrate (205), which was composed of reddish-brown silty gravels was encountered at a depth of 0.85m below street level. This was truncated at the eastern extent by a service cut [207] which was observed for a width of 1.20m, and filled to a depth of 3.3m with loosely compacted black silty clays (206) which contained red brick fragments (Plate 5).

- 4.3.3 This service cut [207] had sharp sloping sides and appeared to be V-shaped in profile, but with a flattened base. At the base of the trench, and at 4.20m below the street level, a red brick culvert [209] aligned north-south was observed within this cut [207], thought to be post-medieval in date.

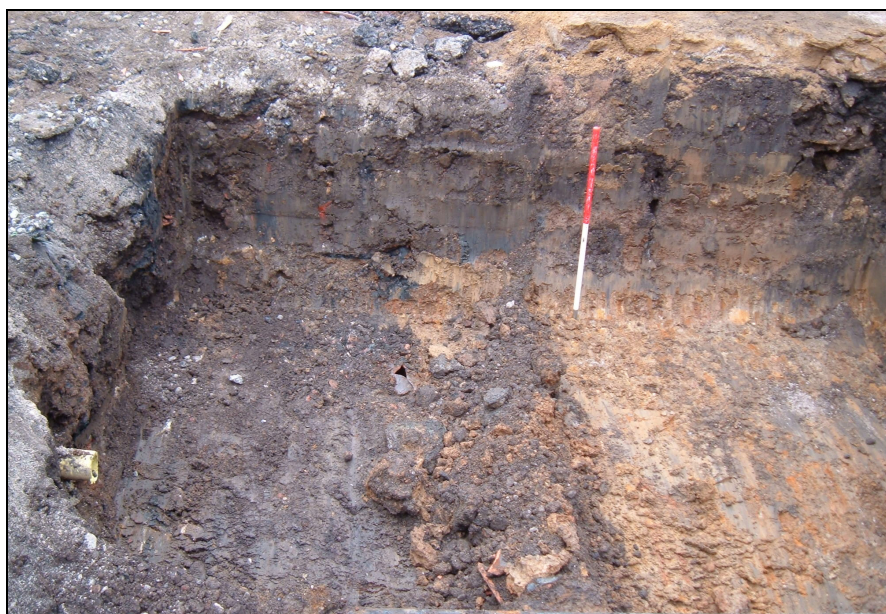
Plate 6: East facing section of deposits within Trench 3.

- 4.4.3 Truncating the natural substrate, a large service cut [303] was observed aligned in an east-west direction (Plates 6 and 7). This measured 2m in width and was filled to a depth of at least 0.50m by loosely compacted brownish-grey silty clay (304). This service cut [303] appeared to have steeply sloping sides, as observed within section (Plate 7). It is probable that this feature represents another red brick constructed culvert.

- 4.4.4 This service cut [303] was truncated by a later service trench [306]. This was a shallow feature, 0.30m in width and filled to a depth of 0.25m by moderately compacted greyish-brown silty clays (307) which contained a yellow plastic gas pipe within its deposit. This service trench [306] truncated the earlier feature [303] for the full extent of the trench.

- 4.4.5 A 0.2m deep layer composed of crushed dolomite (302) was observed above these deposits, within which a number of modern services were observed. To the west, electric, water and gas pipes were all observed, aligned in a north-south orientation, and measured a maximum of 0.10m in diameter. Within the central area of the trench a north-south aligned active water pipe was also observed, measuring 0.12m in diameter.
- 4.4.6 A thick layer of concrete (301) 0.2m in depth was observed to seal all the above deposits. Above this was loose orange-red bedding sand (300) into which the concrete paving of the modern road was set.

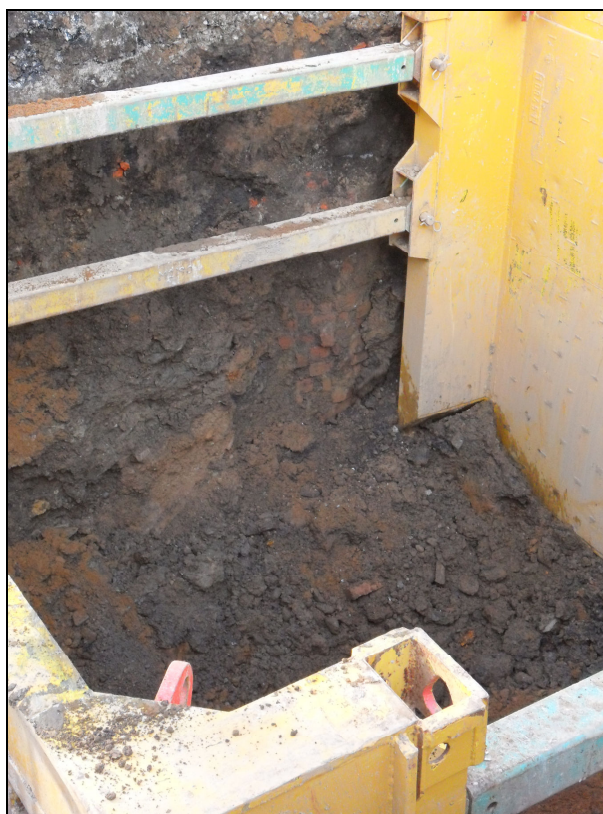
Plate 8: South facing section of Trench 4, showing coursed brick from manhole (403)

- 4.5.2 Observed to a depth of 0.15m was a layer of crushed dolomite (401). Beneath this was a deposit of brown/black sand with infrequent inclusions of red brick, river cobbles, timber fragments, sandstone blocks and ceramic pipe (402).

- 4.5.3 The south facing section of the trench revealed a coursed brick feature (403) that was part of the wall for the manhole located directly north of the Trench (Plate 8). The inclusions located within this trench may have been from the earlier construction of this manhole with subsequent backfilling of the area.
