THE HEMMEL, OLD CASSOP, Co. DURHAM

WATCHING BRIEF REPORT

CP. No: 1334/10

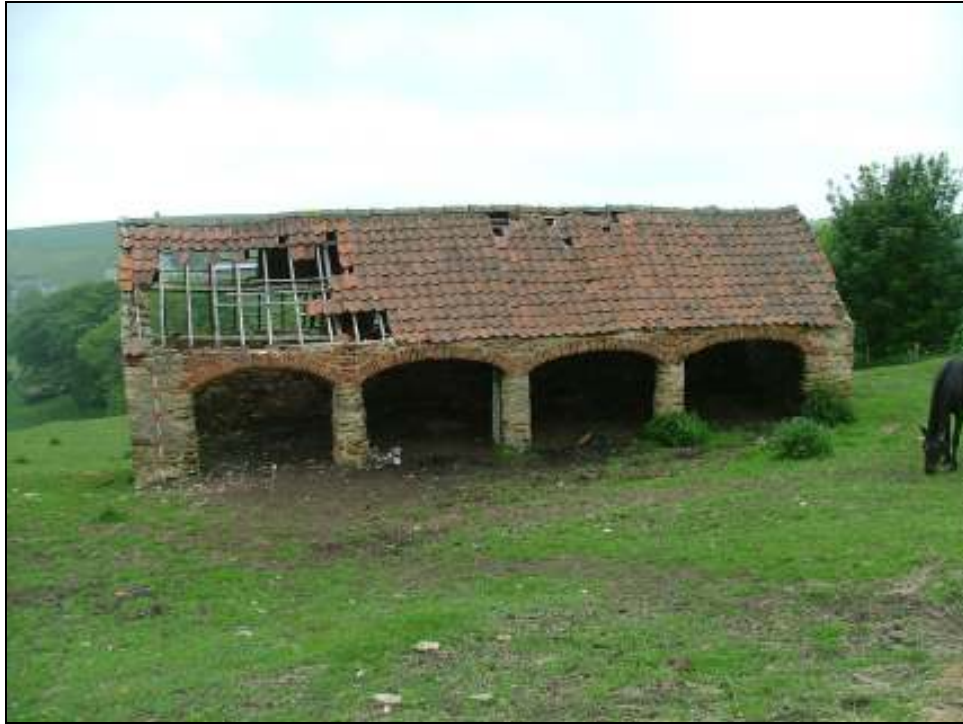
Plate 1: South elevation of The Hemmel showing the three piers as they existed in June 2010 prior to restoration work

4.2.1 The three holes were excavated by hand in the location of the three former piers, which have been removed as part of the restoration works, prior to reconstruction (Plate 1). Figure 3 shows the locations of the excavated holes, referred to as Hole 1, Hole 2 and Hole 3. Plate 2 shows The Hemmel under restoration in November 2010, and Plate 3 shows the hand excavation of the three foundation holes.

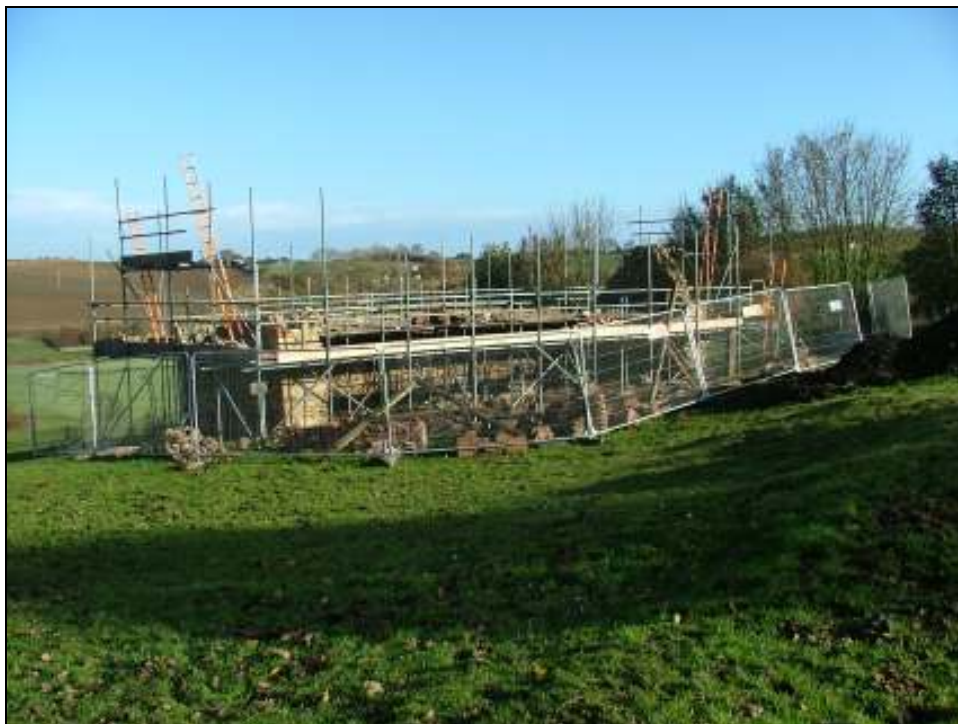
Plate 2: The Hemmel as seen in November 2010, south elevation

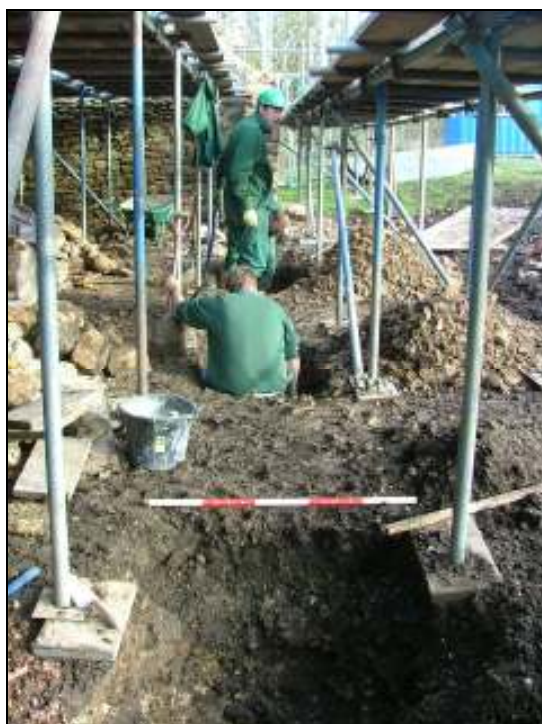
Plate 3: View looking east showing the excavation of the three foundation holes along the line of the south elevation of The Hemmel (November 2010)

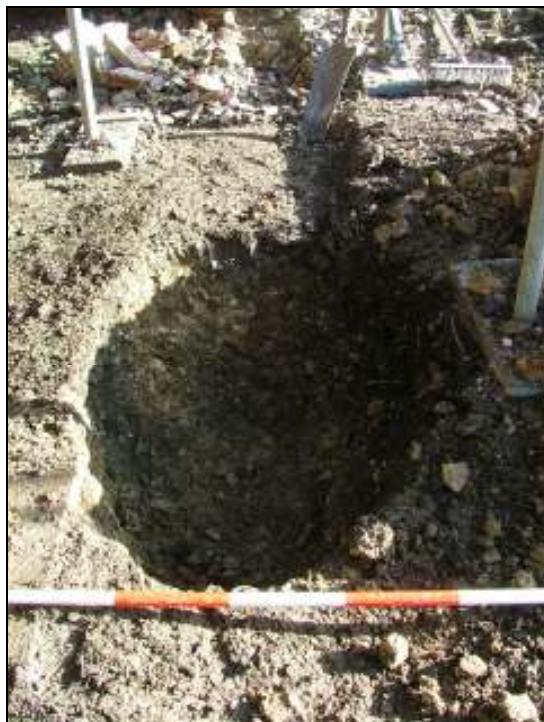
4.2.2 **Hole 1:** was located to the eastern side of the building. This hole measured approximately 1.2m long, 0.80m wide and 0.60m in depth (Plate 4). The excavated material consisted of the topsoil (100) and sub-soil (101), below which was yellow, stony clay, which was interpreted as the natural (102). No features or artefacts of archaeological interest were revealed within this hole apart from a single sherd of 20th century domestic pottery from the topsoil.

Plate 4: View looking east showing Hole 1

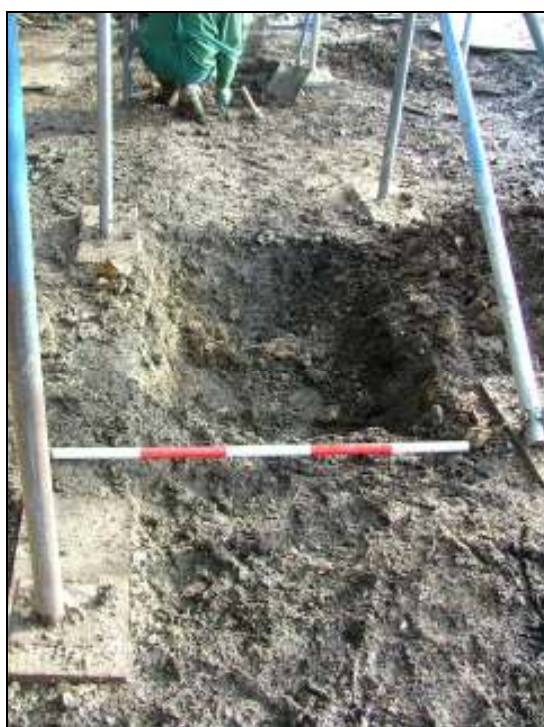
4.2.3 **Hole 2:** was located in the centre of the line of the south elevation of The Hemmel, as with Hole 1, this excavated area measured approximately 1.2m long, 0.80m wide and 0.60m deep (Plate 5). The excavated material from this hole also consisted of the topsoil (100), sub-soil (101) and the natural (102). A single sherd of 20th century domestic pottery was retrieved from the topsoil. No archaeological features were noted within this excavated area.

Plate 5: View looking east showing Hole 2

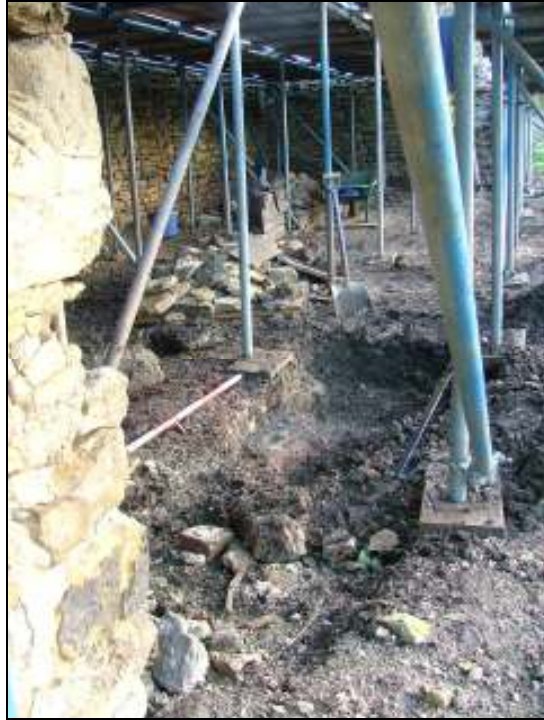
4.2.4 **Hole 3:** was located to the west end of the line of the south elevation of The Hemmel (Figure 3). This hole was approximately 1.80m long, 0.80m wide, and was excavated to a depth of 0.60m. Upon removal of the more recent foundation stones for the western pier, a semi-circular feature, interpreted as a 'well' (103), was revealed consisting of bricks bedded with mortar (Plate 6). Upon removal of two courses of the brickwork, it was revealed that this feature was constructed of masonry. No artefactual evidence was revealed in this hole to provide some information on the date of this well; however it clearly pre-dates The Hemmel, which has been suggested to be early 19th century in date (Wooler and Noakes 2010, 10). Part of the masonry of this

Plate 6: View looking east showing the location of Hole 3

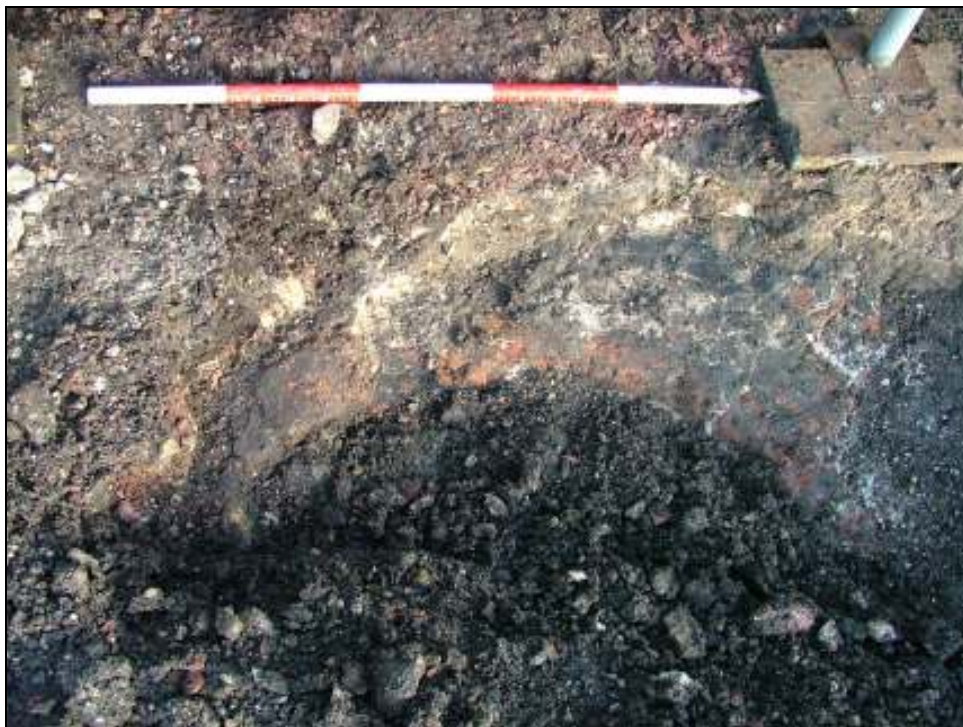
well had to be removed to obtain the required depth for the foundation of the pier in this location, however the majority of the radius of the structure will be undisturbed by the present restoration works, and will survive sub-surface.

Plate 7: Detail of the semi-circular 'well' revealed in Hole 3 (Scale = 1m)

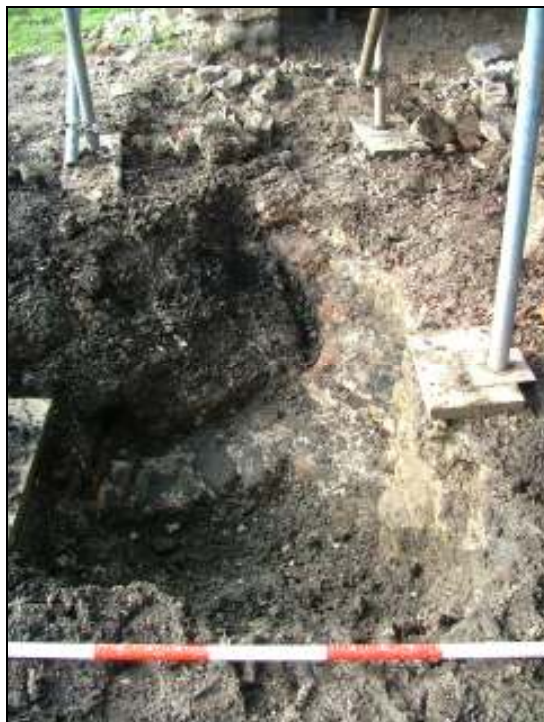
Plate 8: View looking west showing the 'well' following the removal of the upper courses of brick
