# THROCKLEY, WALBOTTLE AND DENTON BURN, NEWCASTLE UPON TYNE, TYNE AND WEAR

**WATCHING BRIEF REPORT**  
**CP. NOS: 955/09 & 956/09**  
**12/11/2010**

**DOCUMENT TYPE:** Watching Brief Report

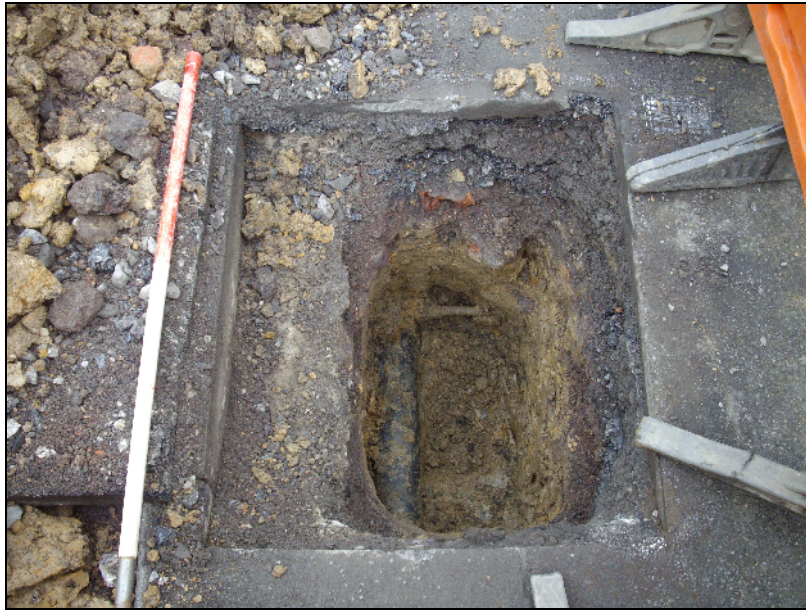
*Plate 1: Trial-hole within Woodside Avenue, Throckley, looking south*

- 4.2.1 **Throckley:** a total of 68 trenches and trial-holes were monitored during the groundworks within Throckley, which were spread across Hexham Road and several adjoining roads including Hadrian Place, Newburn Road, Vallum Road, Callerton Road, Portland Road, and Woodside Avenue. All of the monitored excavations were within the Hadrian's Wall buffer zone, some of which being located within the immediate vicinity of the projected line of Hadrian's Wall and the Vallum (Figures 2 and 3). However, as the excavations were located within the vicinity of existing water mains, all of the monitored trenches and trial-holes were largely comprised of made-ground and backfill deposits below ground level (Plates 1 and 2). The only notable observation was the discovery of a substantial limestone block (**124**), located within the north corner of a northwest to southeast-aligned trench, which was located approximately 4m south of No. 16 Hexham Road (Figure 3, Plate 3). The squared limestone block (**124**) measured over 0.62m in height, 0.51m in length and over 0.23m in width, and was observed at a depth of c.1m below ground level. However, although the bottom of the block was not visually observed, further exploration was unable to locate any additional blocks. Furthermore, the limestone block (**124**) had been encased within a mixed clay backfill deposit (**123**), which contained sherds of modern pottery (Figure 8, Plate 4). Whilst the block (**124**) was in the right location and was of the correct form to be associated with Hadrian's Wall, the excessive disturbance within the immediate vicinity suggests that it was not *in-situ*. No further archaeological features or deposits were observed during the watching brief within Throckley.

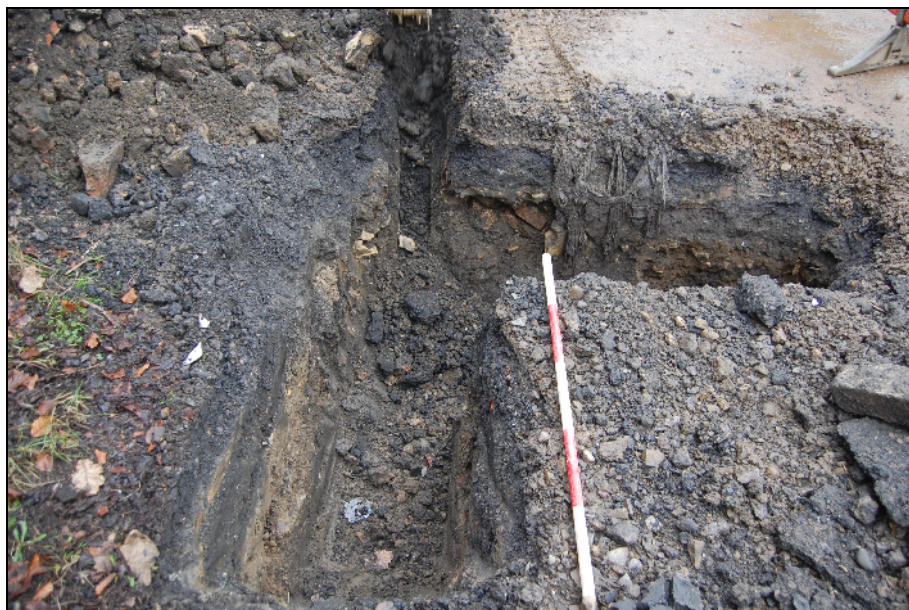
*Plate 2: Trench to the rear of Hexham Road, Throckley, looking east*

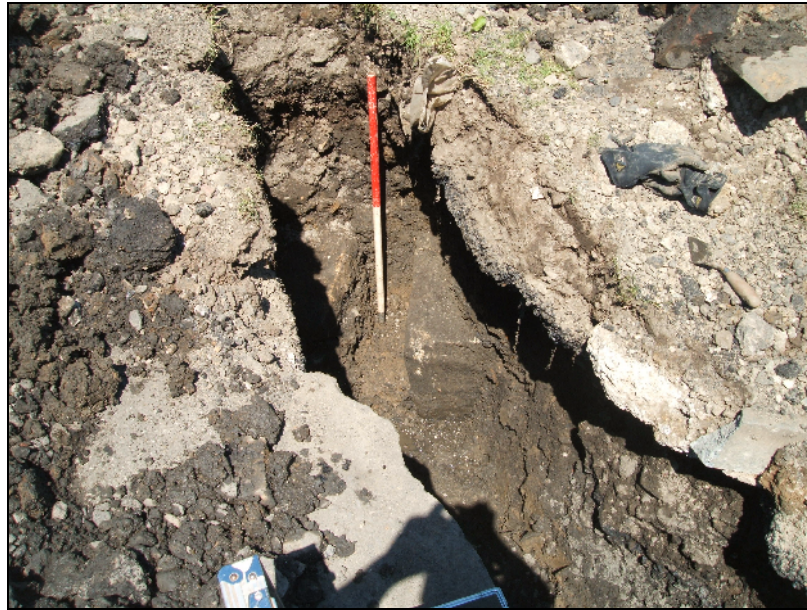
*Plate 3: View of limestone block (124), Hexham Road, Throckley, looking north*

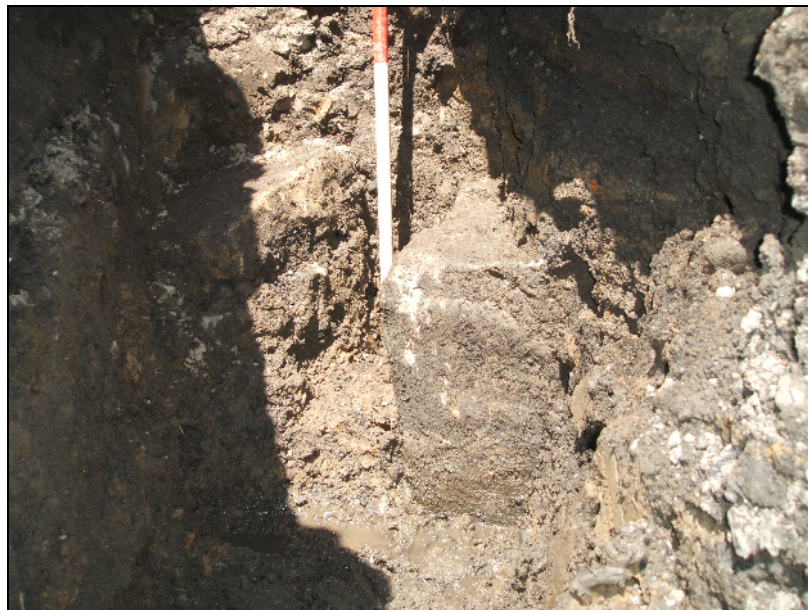
*Plate 4: View of limestone block (124) within disturbed ground, Hexham Road, Throckley, looking north*

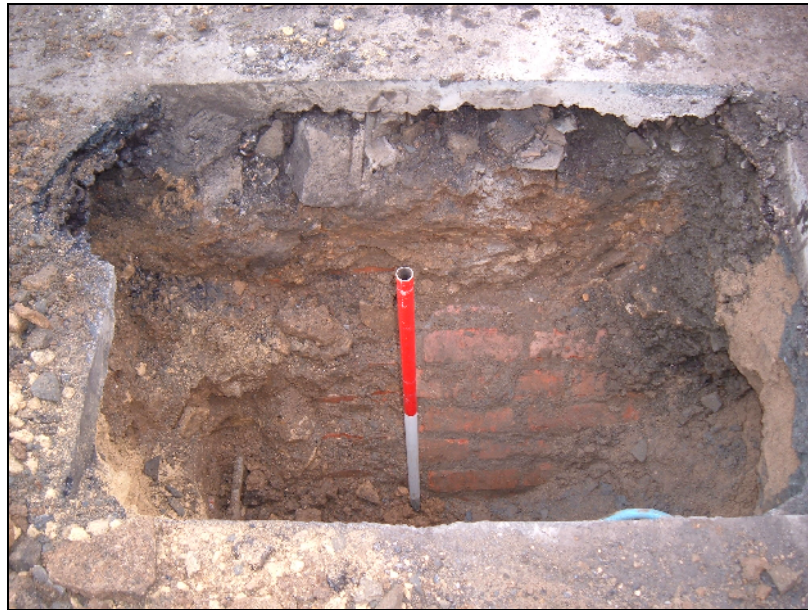
*Plate 5: Trial-hole showing culvert (136) between Burt and Beverley Terraces, Walbottle, looking south*

4.2.2 **Walbottle:** a total of 20 trial-holes were monitored during the groundworks within Walbottle, which were located between Beverley Terrace and Burt Terrace. A single trial-hole was located within the immediate vicinity of the projected line of Hadrian's Wall, whilst the remaining trial-holes were located immediately to the north (Figure 4). All of the trial-holes were excavated to a maximum depth of 1m at which point an existing water main

was reached. The trial-holes were largely comprised of firm yellow sand (138) below black industrial waste (137) and silty sand backfill (135). This was further below hardcore (134) and tarmac (100). A redbrick culvert (136) was also noted within the central most trial-hole at a depth of c.0.6m (Plate 5). No significant archaeological features or deposits were noted during the watching brief within Walbottle.

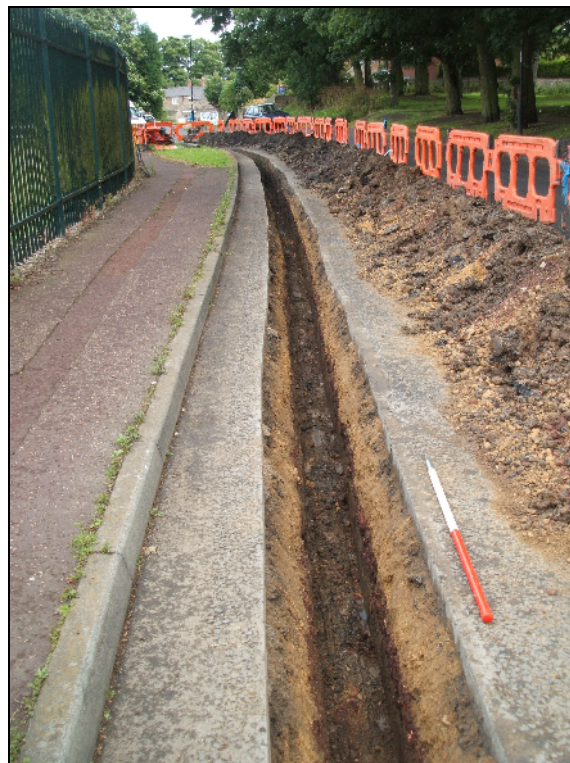
*Plate 6: Trench within West Denton Road, Denton Burn, looking east*

4.2.3 **Denton Burn:** a total of 122 trenches and trial-holes were monitored during the groundworks within Denton Burn, which were largely centered between the projected lines of Hadrian's Wall and the Vallum and included excavations within South View, The Ramparts, Southway, Wallington Drive, Northlea, St. Vincent's Close, Falstone Avenue, Avalon Drive, Claremont Avenue, West Denton Road, West Denton Close, Norwood Road, Sandringham Road, and Roman Way (Figures 5-7). The monitored excavations were largely comprised of made-ground and backfill deposits below ground level (Plate 6). However, excavations between the northern half of Avalon Drive and the A69 revealed sandstone foundations, which were possibly related to the Hadrian's Wall complex (Plates 7 and 8). The crudely worked yellow sandstone foundations (115) were revealed below topsoil (104) at a depth of c.0.3m within four separate trenches, which were excavated along an east-southeast to west-northwest aligned grass verge immediately south of the A69 carriageway (Figure 6). The foundations measured over 0.4m in width and, based upon the distance between the four

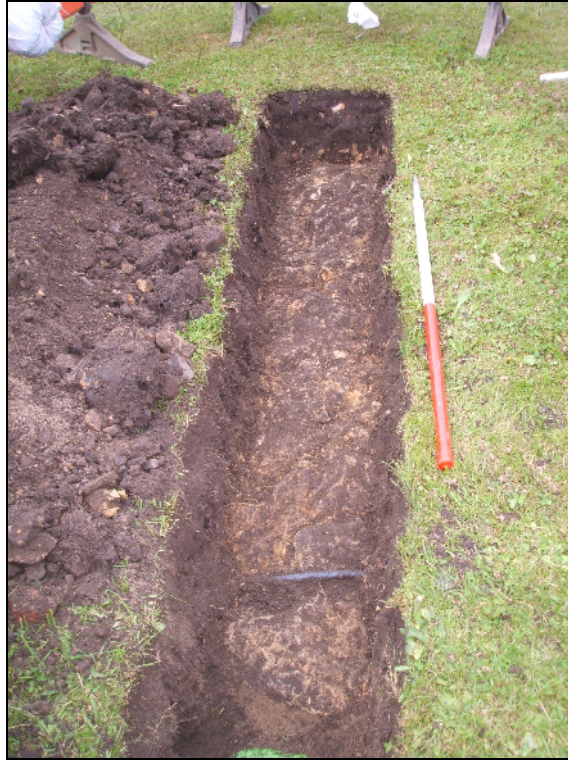
*Plate 7: Foundations (115) within centre of excavated area, Avalon Drive, Denton Burn, looking east-southeast*

trenches, extended to over 85m in length. However, whilst these remains could be related to Hadrian's Wall, the projected line of which is approximately 16m further north, or Milecastle 8, which has previously been located within the immediate vicinity, this could not be confirmed due to the lack of dating evidence and limited excavation. Further yellow sandstone blocks were also noted within a small test-pit within the north face of an earthen bank, approximately 2m further south of the foundations (115). Three courses of the crudely worked sandstone blocks were revealed, measuring 0.54m in height and sloping southwards toward the top (Plate 9). However, whilst these blocks could have been related to the Hadrian's Wall complex, it is more probable that they were re-used to provide additional support to the earthen bank within which they were encased. Based upon the discovery of the sandstone foundations (115), all further excavations within the area were located approximately 5m further south. No further archaeological features or deposits were noted within the Denton Burn section of the watching brief.

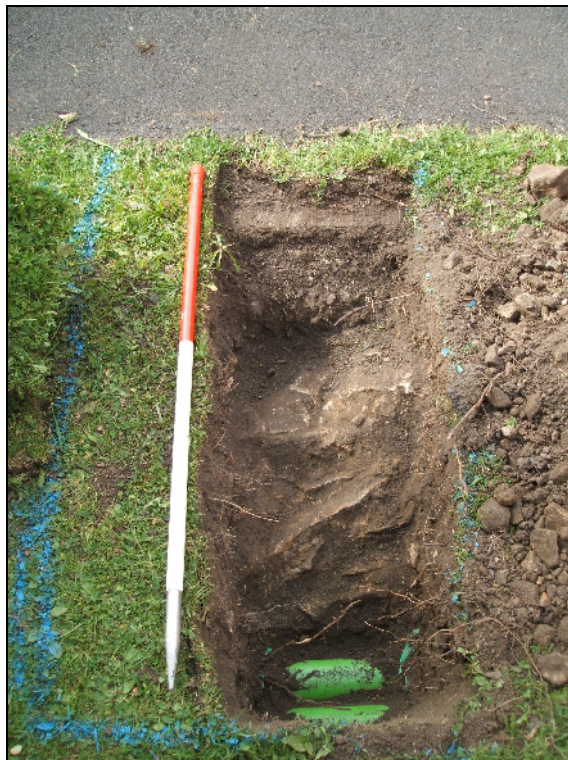
*Plate 8: Foundations (115) to the west of excavated area, Avalon Drive, Denton Burn, looking southwest*

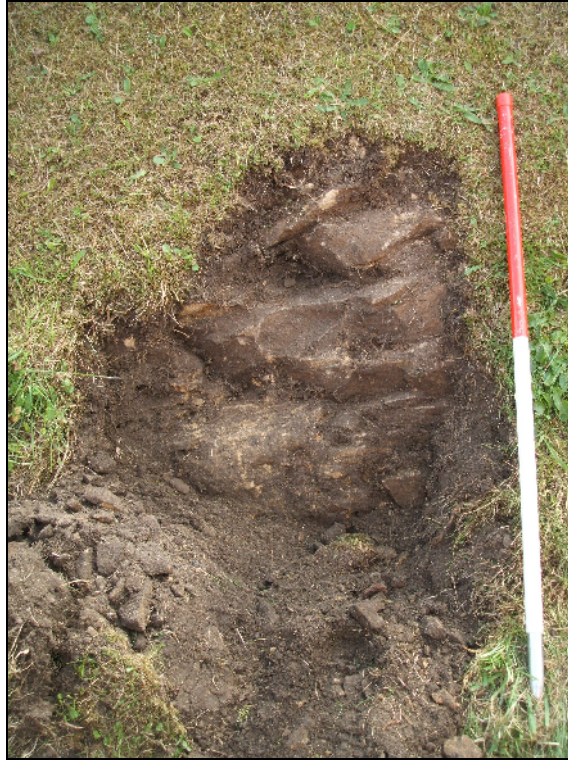
*Plate 9: View southwest of possible re-used Roman stone within earthen bank, Avalon Drive, Denton Burn*

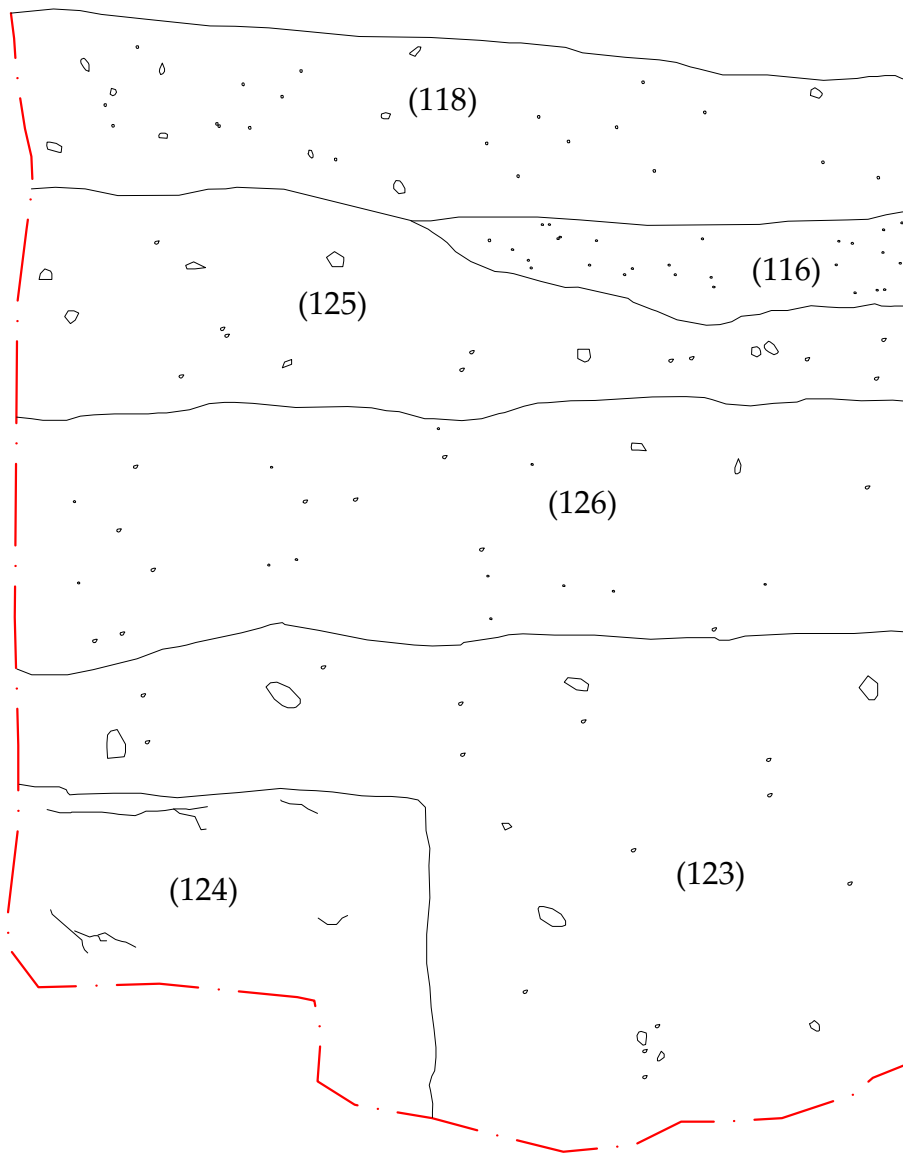
**PROJECT:** Throckley, Walbottle and Denton Burn, Newcastle upon Tyne  
**SCALE:** 1:10 at A4  
**REPORT No:** CP955/09 & CP 956/09  
**CLIENT** Northumbrian Water  
**DRAWN BY:** DJ  
**DATE:** November 2010  
**FIGURE:** 8

FIGURE 8: SOUTHWEST FACING SECTION OF SERVICE TRENCH SHOWING LIMESTONE BLOCK (124)
