**LANGLEY CASTLE,
LANGLEY-ON-TYNE,
NORTHUMBERLAND**

**ARCHAEOLOGICAL WATCHING
BRIEF REPORT
CP. No: 1184/10
16/12/2010**

DOCUMENT TITLE: Langley Castle, Langley-on-Tyne, Northumberland
DOCUMENT TYPE: Archaeological Watching Brief Report
CLIENT: Langley Castle Hotel
CP NUMBER: 1184/10
SITE CODE: LCH-A
PLANNING APP. NO: 20100059 & 20100060
OASIS REFERENCE: northpen3-87241
PRINT DATE: 16/12/2010
GRID REFERENCE: NY 8341 6242

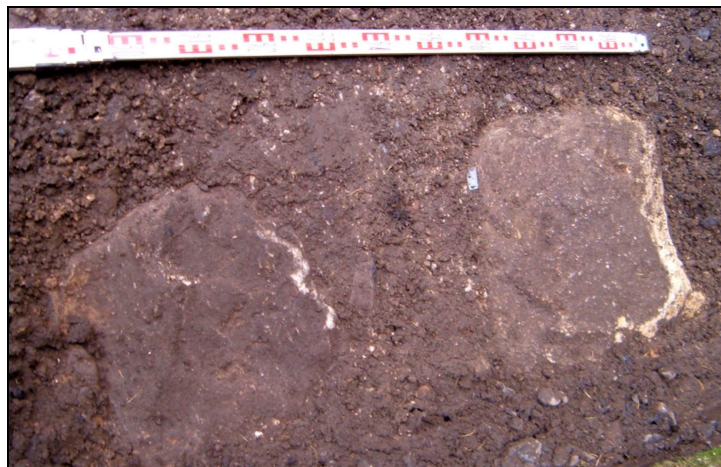
Plate 1: Plan view of stones 101

4.2.2 Several features were encountered within the eastern part of the pavilion area adjacent to the castle walls which may have been medieval in origin and associated with the construction of the castle (Figure 3). Two large flagged sandstones (101) were exposed at a depth of 165.77m OD located adjacent to the north wall of the south west tower of the castle. They measured 500mm by 400mm and 480mm by 500mm. The stones may have been a remnant of a former flagged surface (Plate 1).

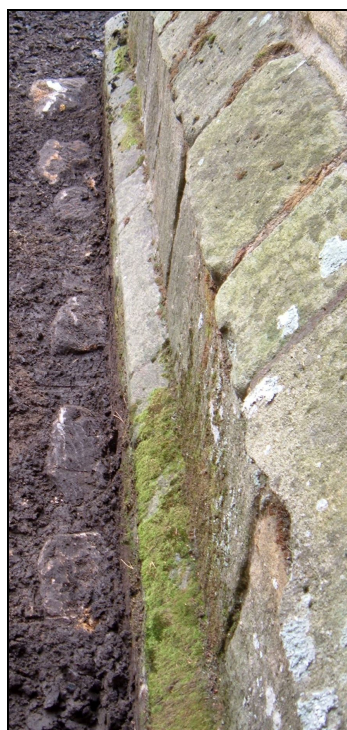
Plate 2: North facing view of foundation stones 102

- 4.2.3 A line of stones (102) was exposed alongside the west wall of the central hall of the castle these were assumed to be part of the castle foundations and were exposed at a depth of 165.79m OD (Figure 3) (Plate 2). They consisted of roughly shaped sandstone blocks which measured between 430mm by 210mm and 120mm and 210mm in size. They were observed extending beneath the castle wall and measured 1.10m long and projected for 0.3m from the castle wall.

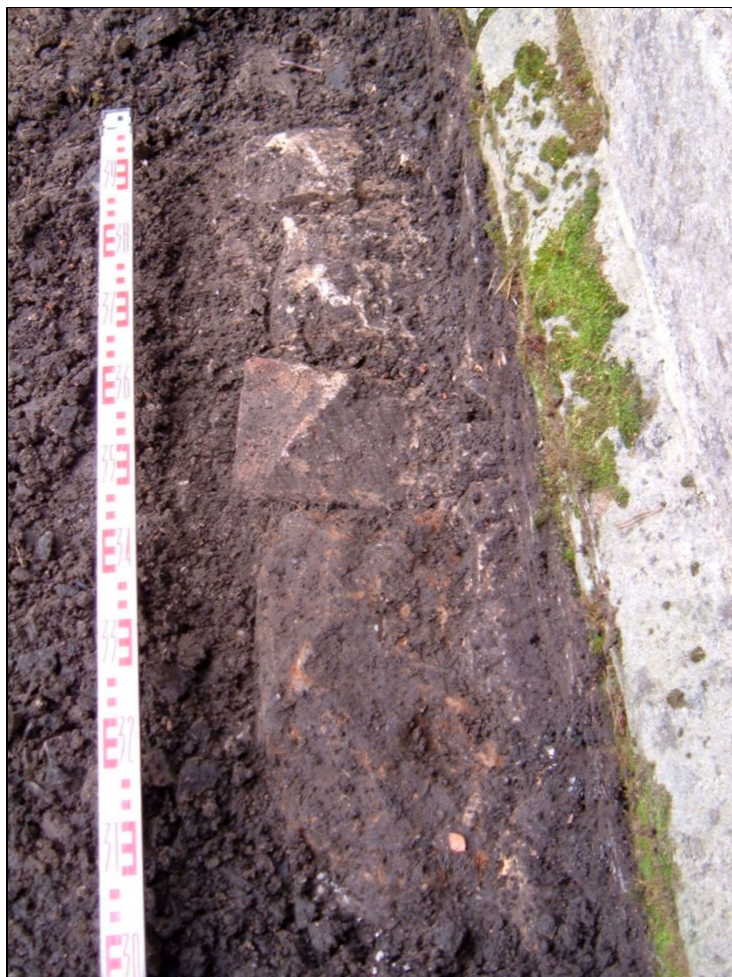
Plate 3: West facing view of foundation stones 103

4.2.4 A further line of stone was exposed along the south wall of the north west tower of the castle (103) (Figure 3 and 4) (Plate 3). These were between 520mm by 300mm to 300mm by 200mm in size and projected for 0.30m from the castle wall and were observed for a total of 1.4m along the castle wall. A service trench exposed at least two courses of these stones which were directly underneath the walls of the castle.

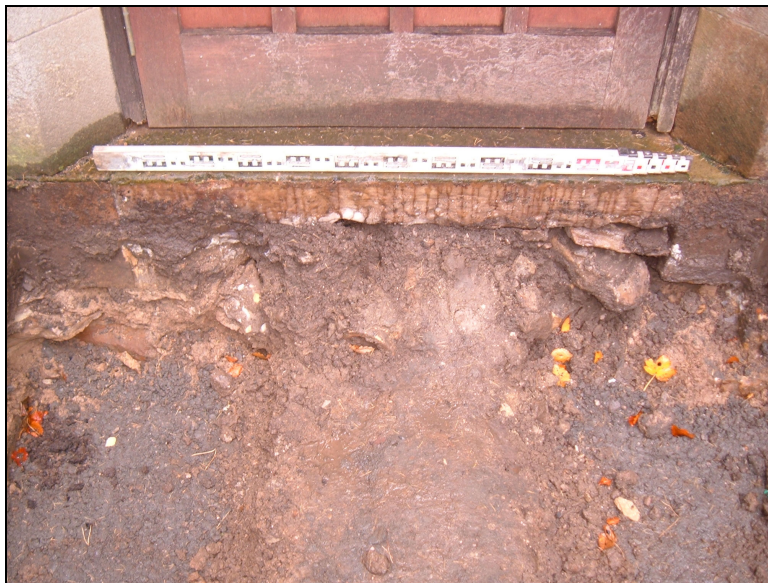
Plate 4: West facing view of castle foundations beneath doorway

4.2.5 During the groundworks the deposits beneath the western castle doorway were exposed enabling observation and recording. The earliest deposit exposed was stone rubble and mortar (122) which was exposed for some 0.30m in depth. Above this was the ashlar sandstone doorstep and door frame (120) (Plate 4) (Figure 4).

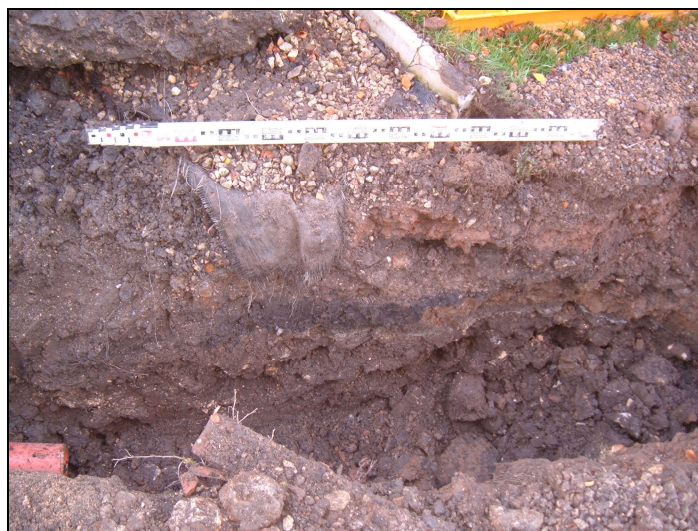
Plate 5: East facing view of section of trench across access road showing cuts 131 and 136

- 4.2.10 The trench which was excavated across the hotel kitchen access road to the north of the pavilion area contained several features. A layer of subsoil was exposed (123/133) which was composed of mid brown silty clay which was up to 0.6m in depth. It was given a separate number in the north side of the trench (133) to in the south (123) though the deposit was the same. It was cut by a steep sided cut [136] which measured 1.5m long. The primary fill was a deposit of river cobbles (126) which were on average 70mm by 50mm by 20mm. and were 0.15m in thickness. A deposit of squared masonry blocks overlay the cobbles (125) these were sandstone and measured 400mm x 300mm x 280mm in size and the deposit was 0.25m in depth. A thin layer of mortar (130) overlay the cut it was 0.03m thick and was light grey. Above the mortar was a deposit of loose reddish brown mixed sand and clay (135). It was cut by a small wide U-shaped cut [131] which was 0.7m wide, 0.28m deep and had a flat base. It was filled with a deposit of (131) dark brown clayey silt. Above this was a layer of loose greyish mortar which was 0.2m thick. Sealing this layer was a bedding sand layer (129) for the modern garden gravel (128) and kerbing (134), which bordered the access road surface (127).

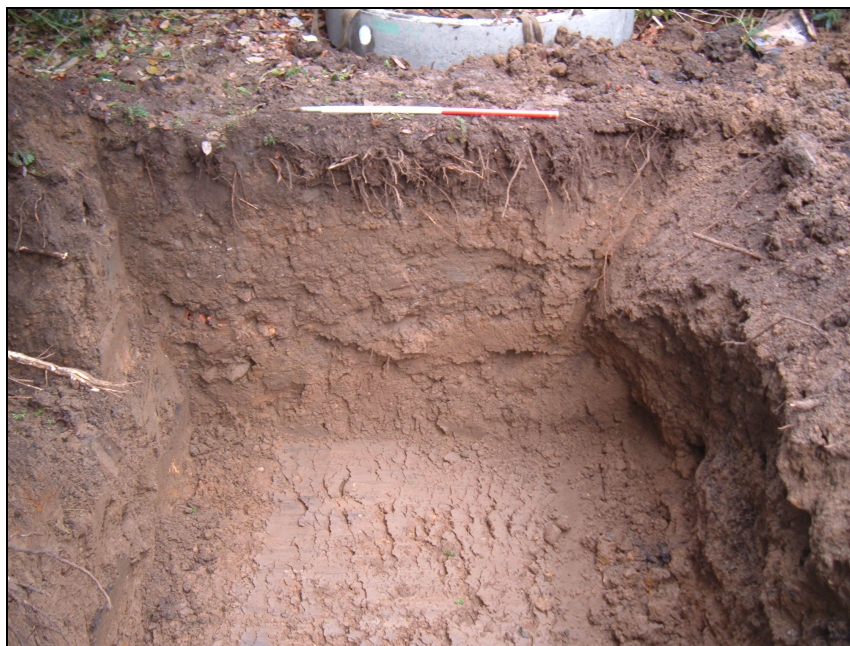
Plate 6: South facing section showing deposits within sewage tank trench.

4.2.10 The service trench extended further north where a large trench for a sewage tank was excavated. The trench measured 3m north to south 2.5m east to west and was 2m in depth and a small overflow trench was excavated to the west of it. Natural brownish yellow clay subsoil (137) was exposed at a depth of approximately 0.90m below the ground level. It was overlain by garden soil (133) that was up to 0.6m in thickness and this in turn was sealed by the topsoil (104) which was up to 0.30m in thickness in this area.

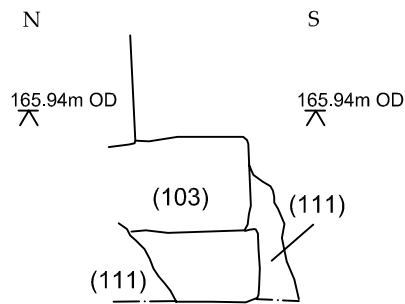
West facing section (a) of castle wall foundations 103

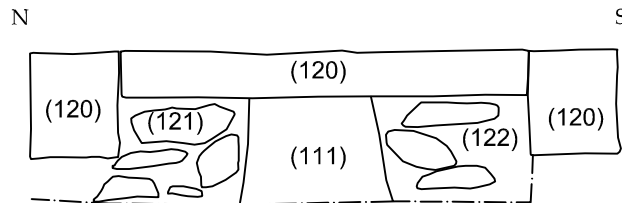
West facing section (b) of deposits beneath castle doorway

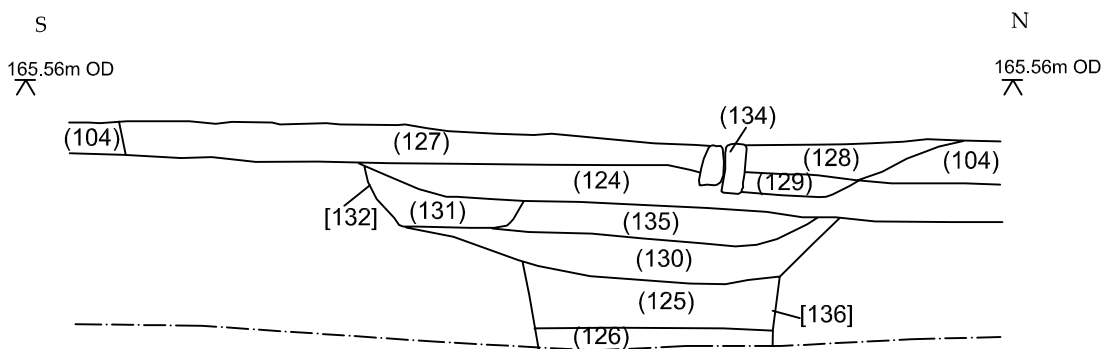
East facing section (c) of deposits within service trench
