**LAND AT SEGHILL
CARAVAN PARK,
SEGHILL,
CRAMLINGTON,
NORTHUMBERLAND**

**ARCHAEOLOGICAL
EVALUATION REPORT
CP. No: 1340/10
15/12/2010**

DOCUMENT TYPE: Archaeological Evaluation Report

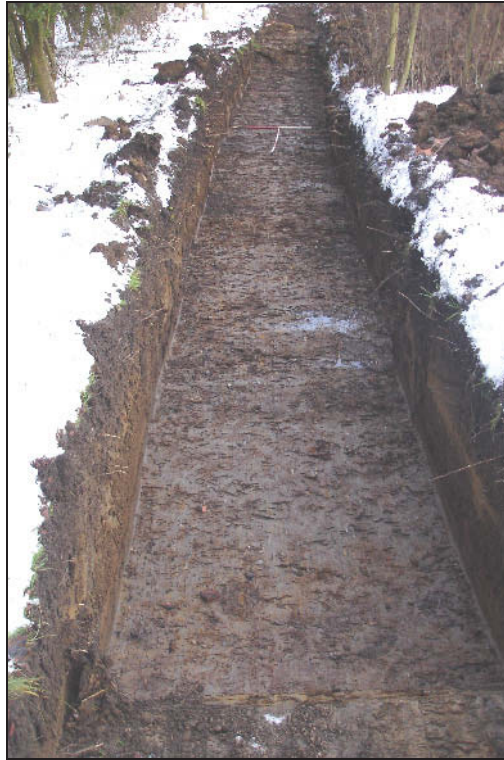
Plate 1: Trench 1 looking east

- 4.2.1 **Trench 1:** Trench 1 was located toward the northern boundary of the proposed development area and was aligned east to west (Figure 2). The trench measured 30m in length and 2m in width, and was excavated to a maximum depth of 0.9m revealing natural grey/orange mixed sand and clay (101) (Plate 1). The natural substrate (101) was sealed by a deposit of grey/brown mixed silty clay subsoil (105), which measured c.0.7m in depth. This was further sealed by a c.0.2m deposit of mid-grey/brown silty clay topsoil (100) (Plate 2).

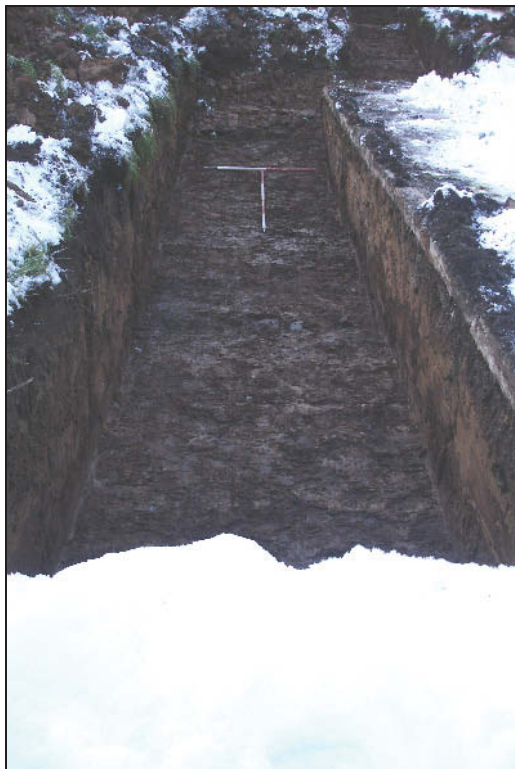
Plate 3: Trench 2 looking west

- 4.2.2 **Trench 2:** Trench 2 was located toward the northern boundary of the site, approximately 16m east of Trench 1 (Figure 2). The east to west aligned trench measured 30m in length and 2m in width, and was excavated to a maximum depth of 1m revealing natural grey/orange mixed sand and clay (101) (Plate 3), below a c.0.7m deposit of grey/brown mixed silty clay subsoil (105) and a c.0.3m deposit of mid-grey/brown silty clay topsoil (100).

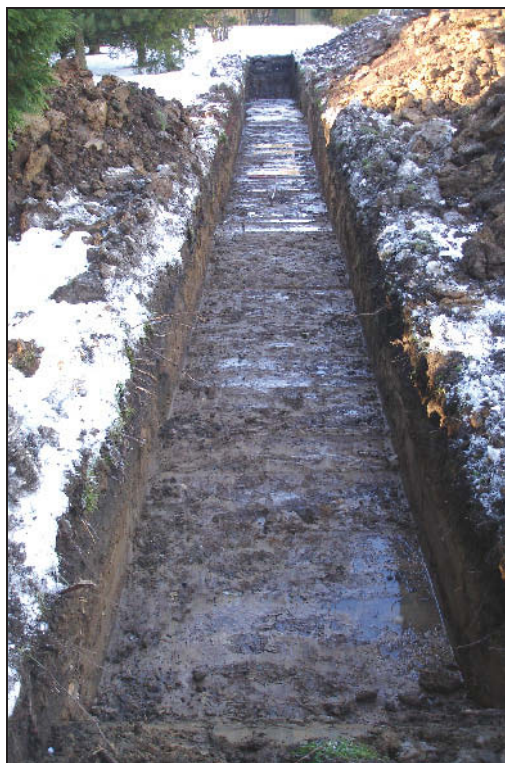
Plate 4: Trench 3 looking west

- 4.2.3 **Trench 3:** Trench 3 was a T-shaped trench, located toward the northern end of the development area, approximately 24m south of Trench 1 (Figure 2). The trench measured 30m in length east to west and 15m in length north to

south. Trench 3 was excavated to a maximum depth of 1.6m revealing natural grey/orange mixed sand and clay (101), which measured over 0.4m in depth (Plate 4). The natural substrate was sealed by a c.1m deposit of grey/brown mixed silty clay subsoil (105) and a c.0.2m deposit of mid-grey/brown silty clay topsoil (100).

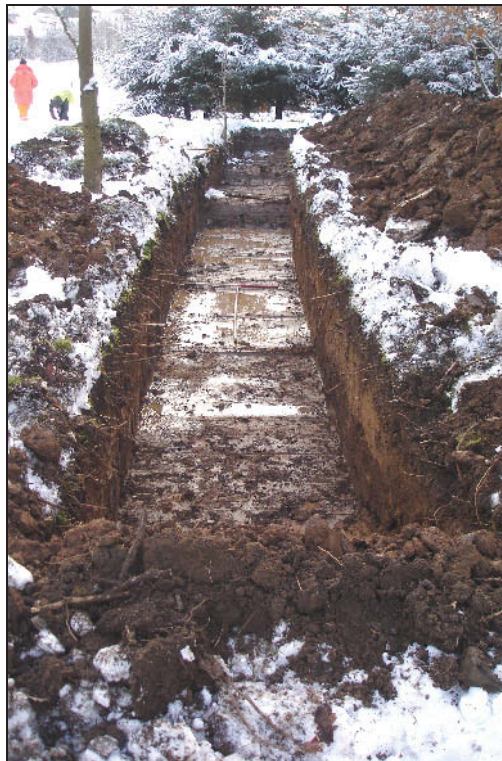
Plate 5: Trench 4 looking south

- 4.2.4 **Trench 4:** Trench 4 was located toward the northeastern boundary of the development area, approximately 32m east of Trench 3 (Figure 2). The north to south aligned trench measured 20m in length and 2m in width, and was excavated to a maximum depth of 0.9m revealing natural grey/orange mixed sand and clay (101) (Plate 5), below a c.0.5m deposit of grey/brown mixed silty clay subsoil (105) and a c.0.4m deposit of mid-grey/brown silty clay topsoil (100).

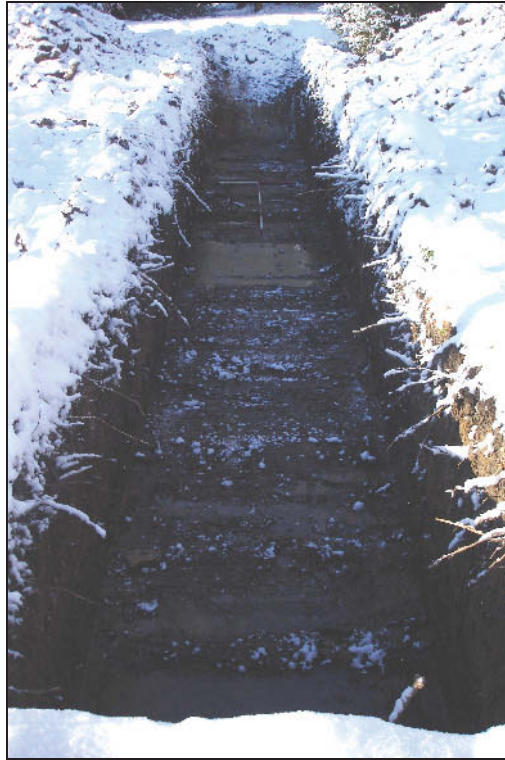
Plate 6: Trench 5 looking west-southwest

- 4.2.5 **Trench 5:** Trench 5 was located approximately 15m southwest of Trench 4 and was aligned east-northeast to west-southwest (Figure 2). The trench was excavated to a maximum depth of 1.5m revealing natural grey/orange mixed sand and clay (101) (Plate 6), which measured over 0.7m in depth. The natural substrate was sealed by a c.0.4m deposit of grey/brown mixed silty clay subsoil (105) and a c.0.3m deposit of mid-grey/brown silty clay topsoil (100).

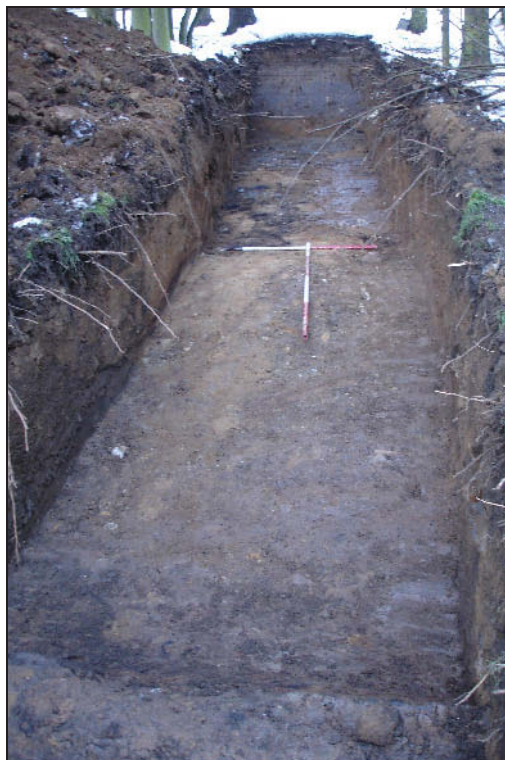
Plate 7: Trench 6 looking north-northwest

- 4.2.6 **Trench 6:** Trench 6 was located within the centre of the proposed development area, approximately 17m west of Trench 5 (Figure 2). The north-northeast to south-southwest aligned trench measured 30m in length and 2m in width, and was excavated to a maximum depth of 1.2m revealing natural grey/orange mixed sand and clay (101), which measured over 0.5m in depth. The natural substrate was sealed by a c.0.4m deposit of grey/brown mixed silty clay subsoil (105) and a c.0.3m deposit of mid-grey/brown silty clay topsoil (100) (Plate 7).

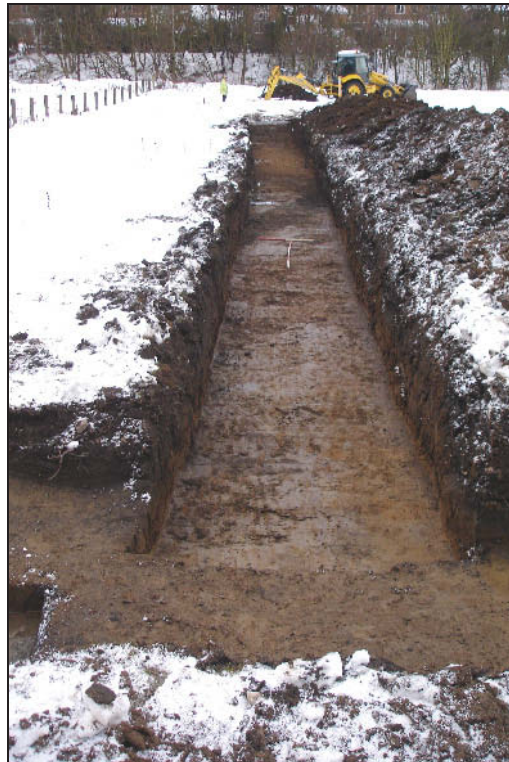
Plate 8: Trench 8 looking southeast

4.2.7 **Trench 8:** Trench 8 was a T-shaped trench, located along the eastern edge of the proposed development site, approximately 15m southeast of Trench 6 (Figure 2). Trench 8 measured 20m in length by 2m in width northeast to southwest, and 30m in length by 2m in width northwest to southeast. The trench was excavated to a maximum depth of 1m revealing natural grey/orange mixed sand and clay (**101**), which measured over 0.25m in depth (Plate 8). The natural substrate was sealed by a 0.15m deposit of orange/grey brown sandy clay (**104**). This was further sealed by a c.0.2m deposit of black hardcore and rubble (**103**) and a c.0.3m deposit of mid-grey/brown silty clay mixed with rubble (**102**). The deposit of silty clay (**102**) was sealed by a c.0.1m deposit of mid-grey/brown silty clay topsoil (**100**) (Plate 9).

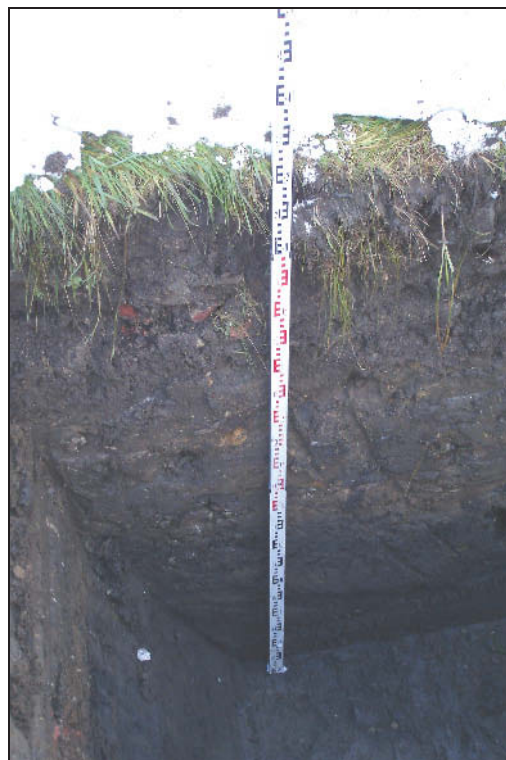
Plate 10: Northwest facing section of Trench 9

4.2.8 **Trench 9:** Trench 9 was located toward the southeast corner of the proposed development area, approximately 16m southeast of Trench 8 (Figure 2). The northeast to southwest aligned trench measured 9m in length and 2m in width, and was excavated to a maximum depth of 2.5m revealing a deposit of dark brown/grey silty clay made ground (**107**), which measured over 2m in depth. The made ground (**107**) was sealed by a c.0.2m deposit of mid-grey/brown silty clay mixed with rubble (**102**) and a c.0.3m deposit of mid-grey/brown silty clay topsoil (**100**) (Plate 10).

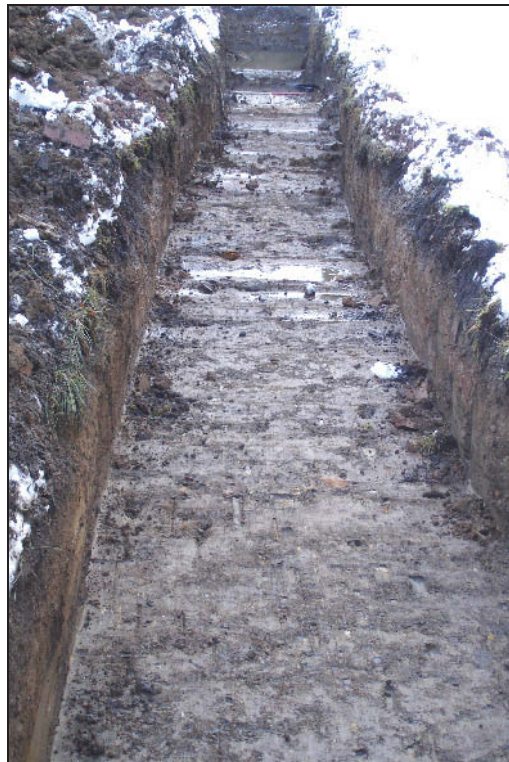
Plate 11: Trench 10 looking southeast

4.2.9 **Trench 10:** Trench 10 was aligned northwest to southeast and was located toward the western development area, approximately 35m west of Trench 8 (Figure 2). Trench 10 measured 30m in length and 2m in width, and was excavated to a maximum depth of 1.3m revealing natural grey/orange mixed sand and clay (**101**), which measured over 0.1m in depth (Plate 11). The natural substrate (**101**) was sealed by a 0.15m deposit of orange/grey brown sandy clay (**104**) and a c.0.5m deposit of dark brown/grey silty clay made ground (**107**). This was further sealed by a c.0.2m deposit of mid-grey/brown silty clay mixed with rubble (**102**) and a c.0.3m deposit of mid-grey/brown silty clay topsoil (**100**).

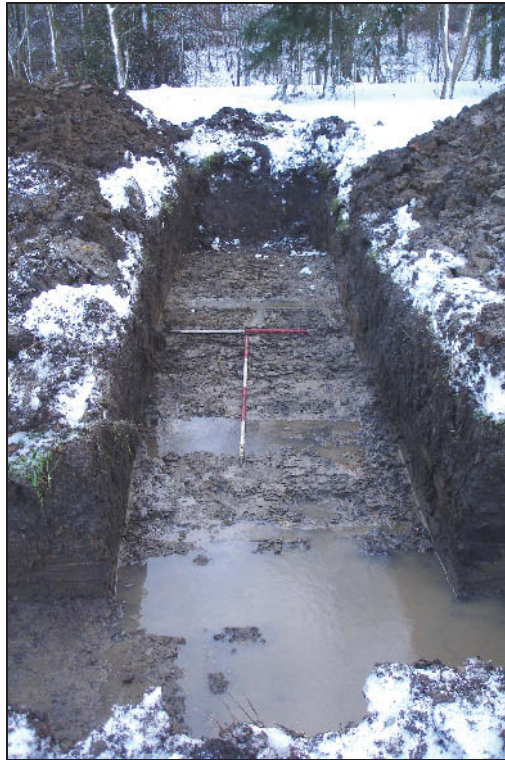
Plate 12: Trench 11 looking southwest

4.2.10 **Trench 11:** Trench 11 was a T-shaped trench, located along the western boundary of the development area, approximately 12m west of Trench 10 (Figure 2). Trench 11 measured 15m in length by 2m in width northwest to southeast and 10m in length by 2m in width northeast to southwest. The trench was excavated to a maximum depth of 1.2m revealing natural grey/orange mixed sand and clay (**101**), below a 0.15m deposit of orange/grey brown sandy clay (**104**). The sandy clay (**104**) was sealed by a c.0.5m deposit of dark brown/grey silty clay made ground (**107**) and a c.0.2m deposit of mid-grey/brown silty clay mixed with rubble (**102**). This was further sealed by a c.0.3m deposit of mid-grey/brown silty clay topsoil (**100**) (Plate 12).

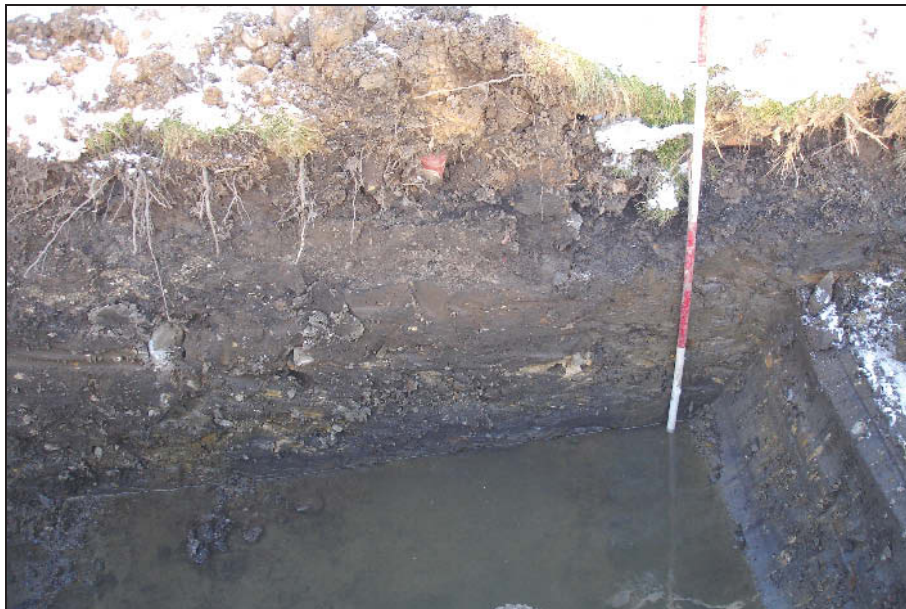
Plate 13: Northwest facing section of Trench 12

4.2.11 **Trench 12:** Trench 12 was located toward the southwest corner of the proposed development area, approximately 22m south of Trench 11 (Figure 2). Trench 12 measured 17m in length by 2m in width northeast to southwest and 5.5m in length by 2m in width northwest to southeast. The trench was excavated to a maximum depth of 2m revealing a deposit of dark brown/grey silty clay made ground (**107**), which measured over 1.5m in depth. The made ground (**107**) was sealed by a c.0.2m deposit of mid-grey/brown silty clay mixed with rubble (**102**) and a c.0.3m deposit of mid-grey/brown silty clay topsoil (**100**) (Plate 13).
