**ST ANDREW'S
CHURCH,
DACRE,
PENRITH,
CUMBRIA**

WATCHING BRIEF REPORT

CP. No: 1360/10

09/02/2011

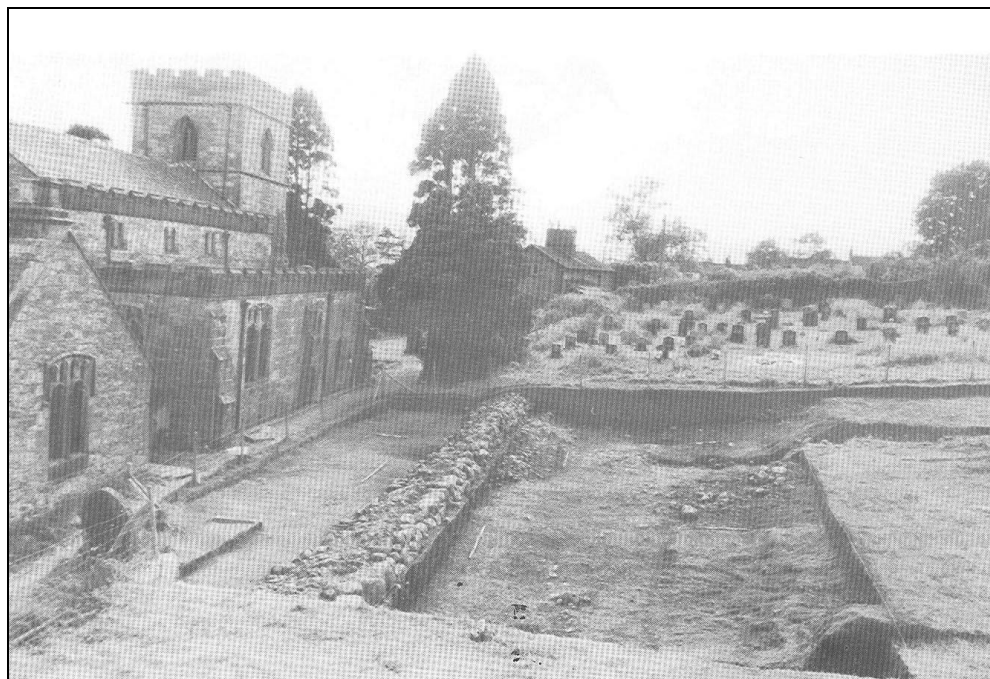
Plate 3: View looking west of north side of church showing the original medieval churchyard wall revealed during the excavations (Source: Smith and Newman, undated)

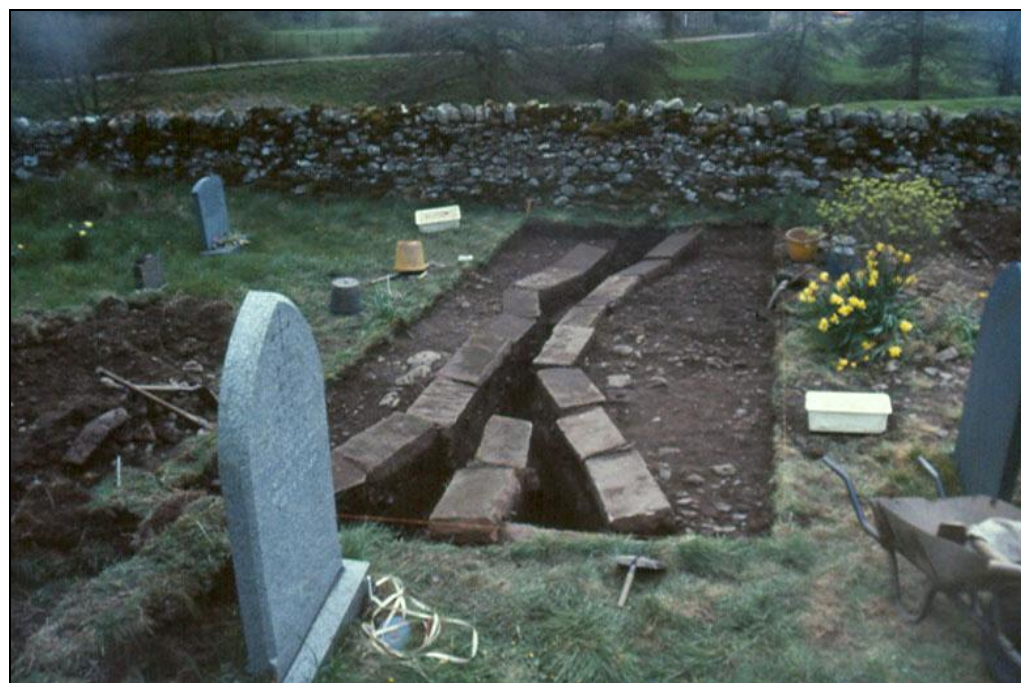
Plate 4: View looking south of the re-excavated drain in the 1980s (Courtesy of Alan James)

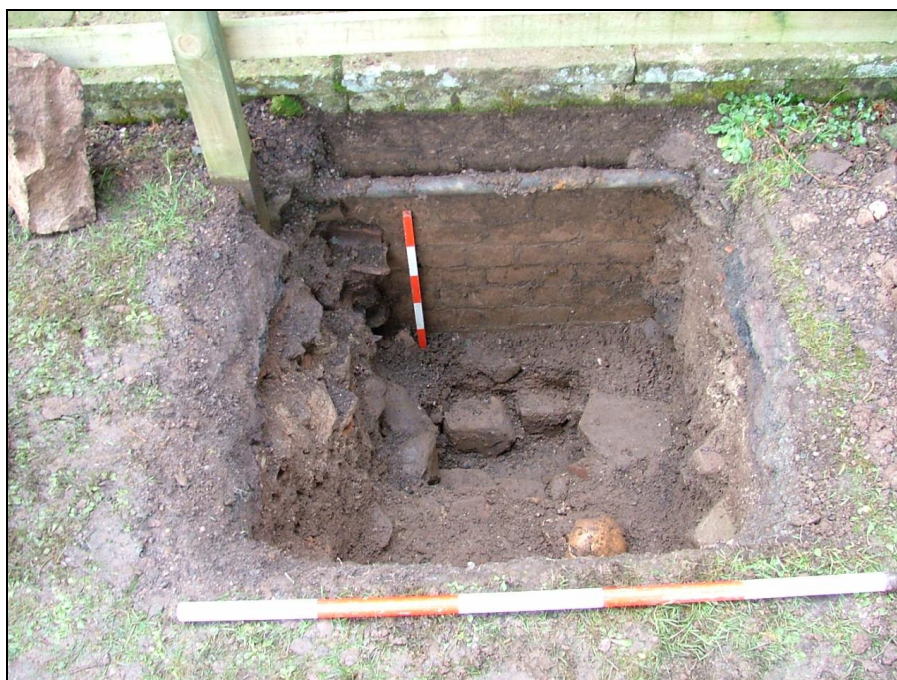
Plate 5: View looking south showing the evaluation trench. The skull of the burial is visible with the stone drain to the rear

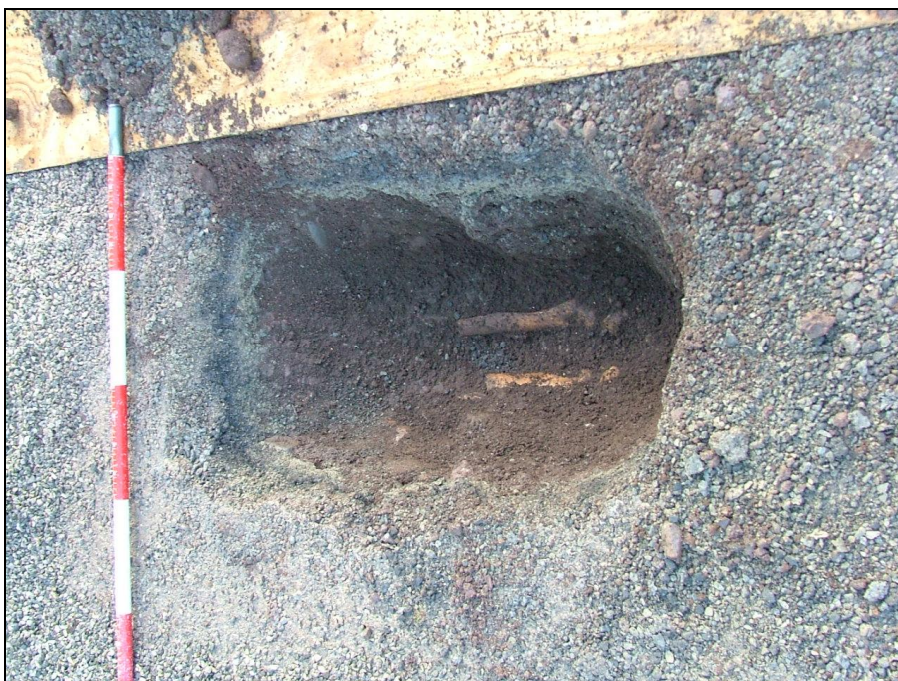
Plate 6: An in-situ burial noted with Test Pit No. 1, aligned east to west below the present gravel path

- 5.2.2 The first test pit to be excavated was located approximately 4.25m to the west of the main door to the church, in the west tower (Figure 2). Test Pit No. 1 was noted to contain an *in-situ* burial, exposed as two leg bones aligned east to west, at a depth of 0.40m below the present level of the gravel path (Plates 6 and 7). Due to the presence of this burial, it was decided to alter the route of the service trench, consequently further test pits were excavated to the north of the path, and west from the location of the pump chamber. Test Pit No's 3, 4 and 5 were all excavated along the line of the present gravel path to the west of the church (Plates 8 and 9). The excavated material consisted of 0.10m of gravel and sub-base (**101**), below which was red, loose sandy gravel (**102**). Some disarticulated human bone was noted

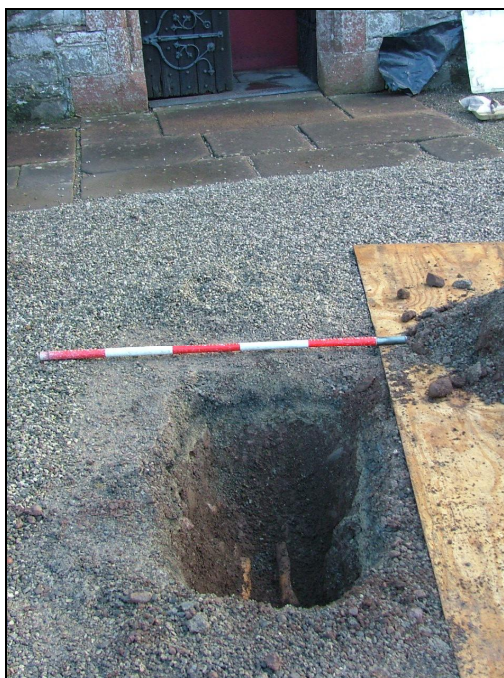
Plate 7: View looking east towards the church door showing the exposed section of in-situ burial within Test Pit No. 1 (Scale = 1m)

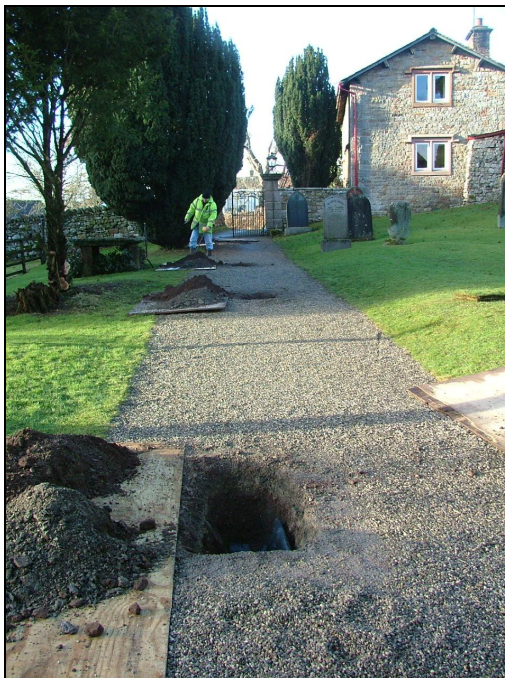
Plate 9: View from the church tower looking west showing the locations of the test pits along the churchyard path

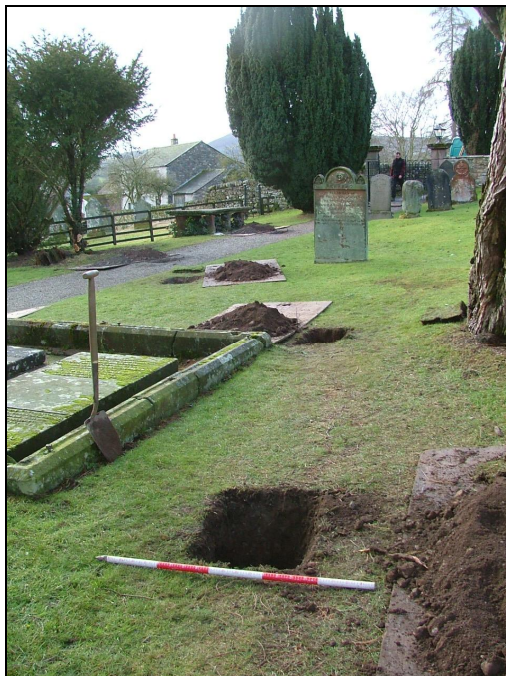
Plate 10: View looking west showing the locations of Test Pit No's 6, 7 and 8 (Scale = 1m)

- 5.2.3 Although Test Pit No's 6 – 10 were all located within the present churchyard, no further *in-situ* burials were noted during these excavations, although there were fragments of disarticulated human bone found (Plates 10 and 11). These fragments were bagged and reburied within the test pit from which they were retrieved.

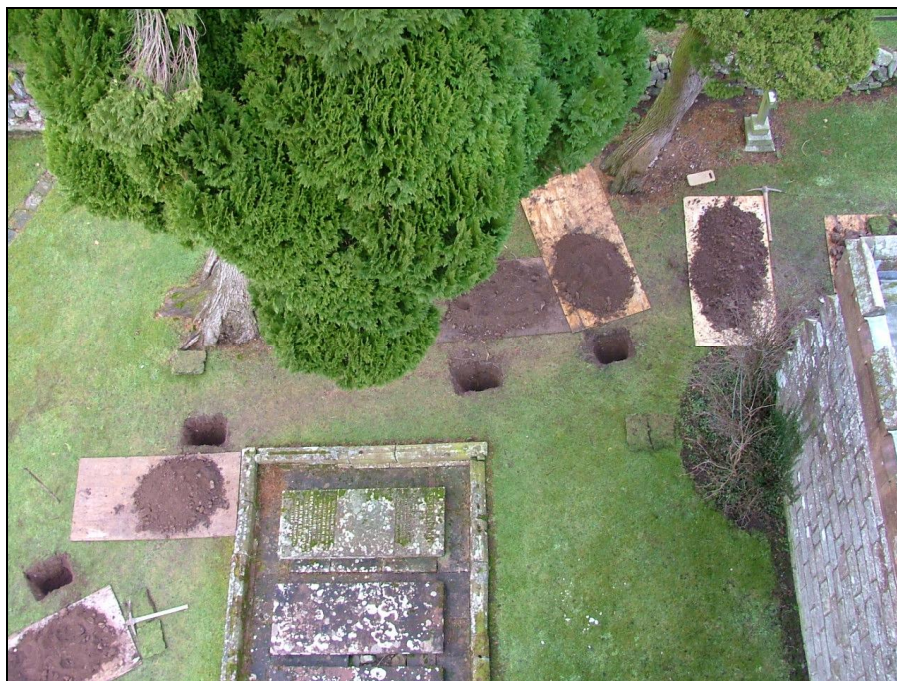
Plate 11: View from the top of the church tower showing the locations of Test Pit No's 7-10

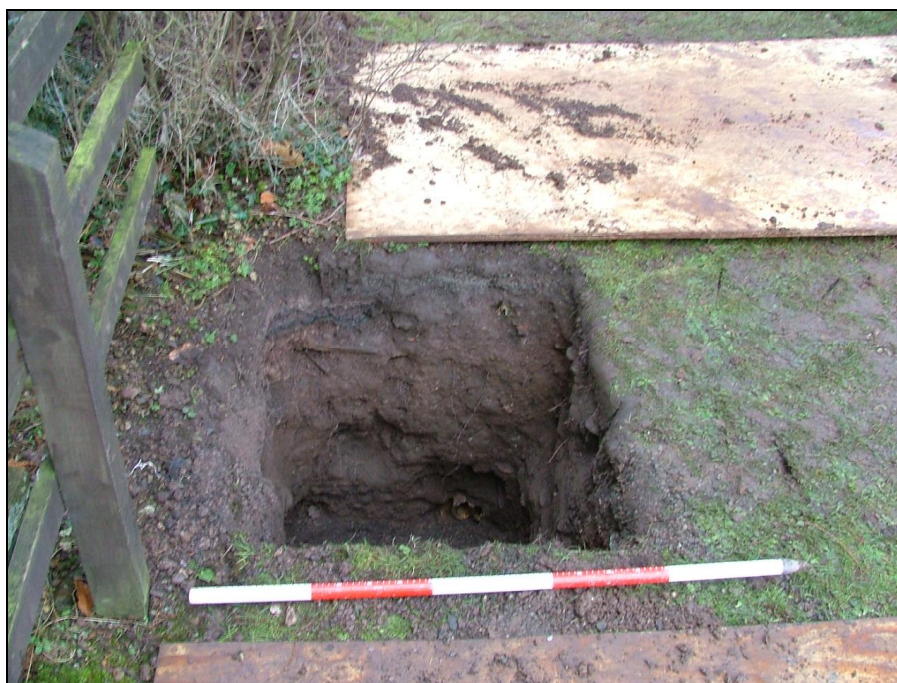
Plate 13: View looking west in the hole for the pump chamber showing the skull of a burial at the base of the trench (Scale =1m)

- 6.2 The remainder of the test pits did not reveal any further *in-situ* burials apart from the trench for the pump chamber, where a burial was noted at c.1.0m below present ground surface. The route of the test pits therefore provided a suitable route for the excavation by machine of the service trench.

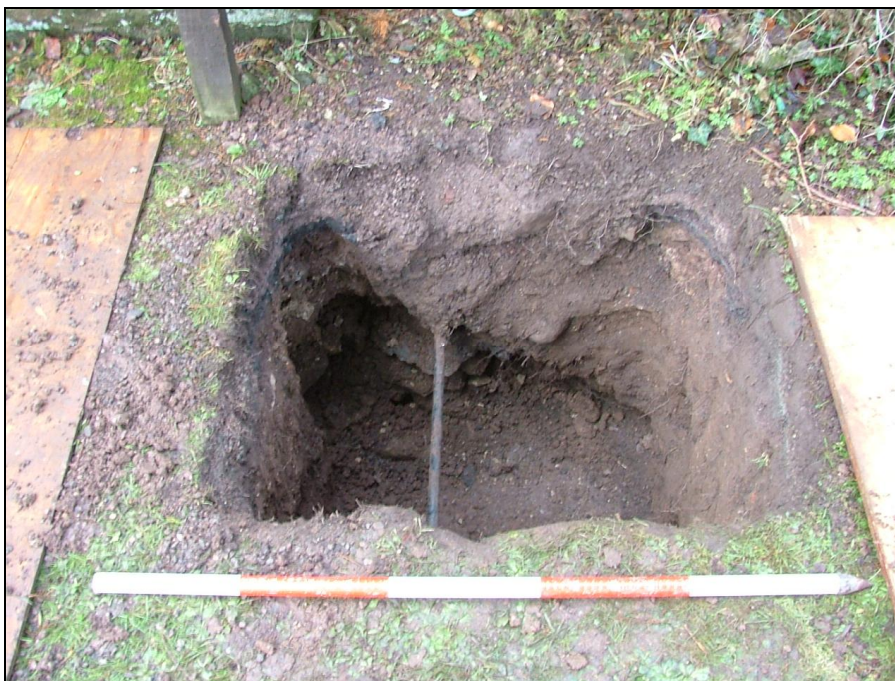
*Plate 14: View looking south showing a water pipe within the pump chamber hole
(Scale = 1m)*

- 5.2.4 The hole for the pump chamber (Test Pit 11) was located just to the west of the point where the evaluation had been undertaken in 2007 (see 4.5.5 above and Plate 5), and just to the north of the north-west corner of the church, and immediately to the north of a brick retaining wall (Plate 12). This was the deepest of the hand excavated holes, taken to a depth of 1.00m, although ultimately it would accommodate a 2m high plastic pump chamber. An *in-situ* burial in the form of an adult skull was revealed in the east facing section of this hole at a depth of c.1.0m below present ground level, consequently the test pit was excavated in an easterly direction to allow the burial to remain undisturbed (Plate 13). It is interesting to consider the presence of a burial immediately north of the church itself, as historically the unconsecrated north side of the churchyard was generally reserved for the '*mortal remains of transgressors*', usually those who had taken their own life or the life of another³³. It is not known how long this practice continued at Dacre. A water pipe was revealed running across the trench, aligned north to south, indicating that this area had already been partially disturbed (Plate 14).

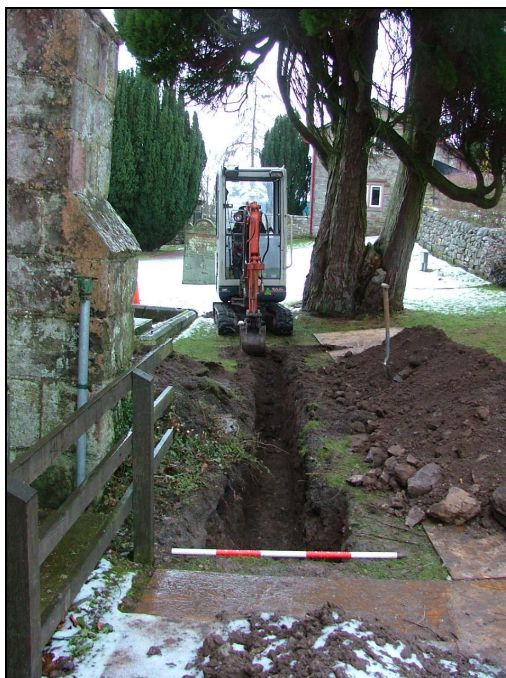
Plate 15: View looking west showing the excavation of the service trench from the north-west corner of the church in a westerly direction (Scale = 1m)

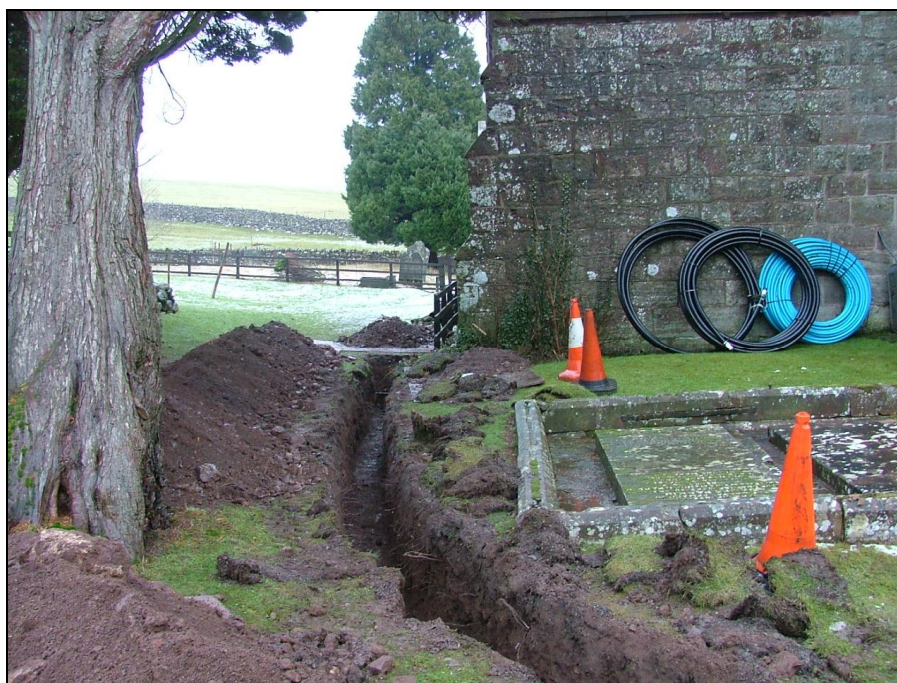
Plate 16: View looking east showing the excavated service trench from the north-west corner of the church and the square stone burial plot set to right of photograph

to the west of the church, a cluster of skull and other bone fragments were all found together along with two silver shroud pins (**SF No.2**), and the remains of wood still attached to iron coffin nails. This mixture of finds was clearly a redeposited feature due to the different bone types and other finds found in a small area. The human bone fragments were retained together for deposition back into the trench prior to the insertion of the service pipes and backfill.

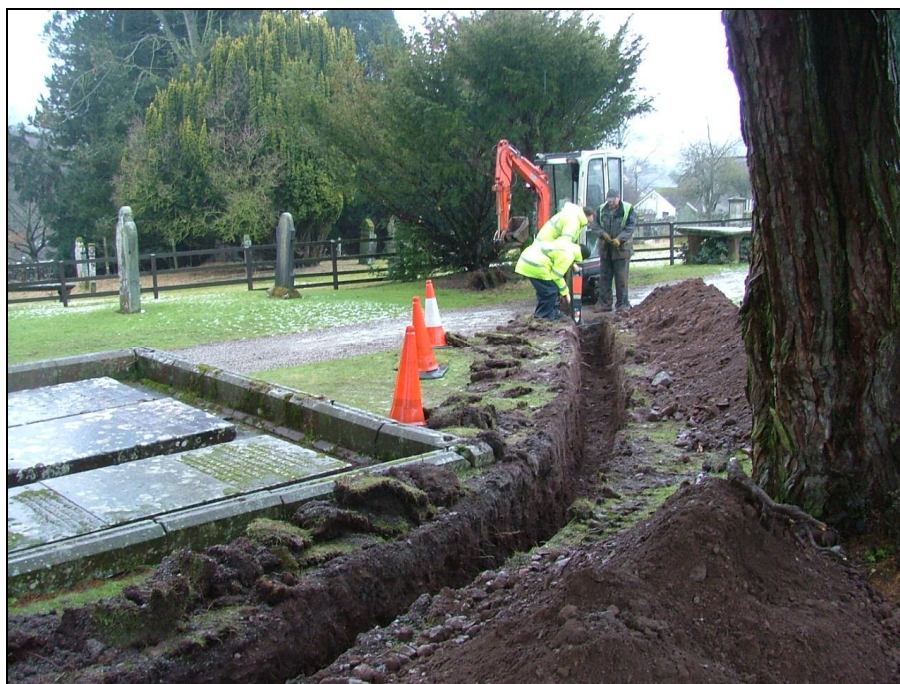
Plate 17: View looking south-west showing the route of the service trench up to the pathway to the west of the church

- 5.3.4 As the trench progressed in a south-westerly direction, at least two *in-situ* burials were noted within the trench sections; these burials were left untouched. Plate 17 shows the route of the trench prior to it reaching the north side of the gravel churchyard path.

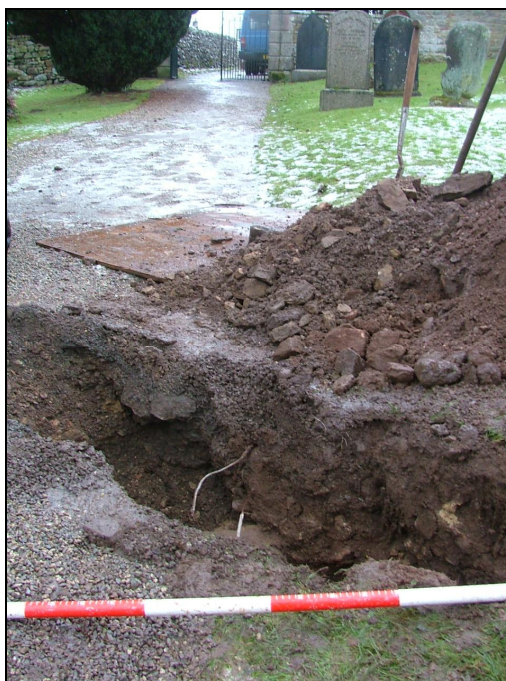
Plate 18: View looking west showing the point where the trench reaches the gravel path. The remains of a stone wall or culvert were noted in the trench

- 5.3.5 At the point where the trench reached the north edge of the present gravel path, which leads from the churchyard gates to the main door of the church, large masonry blocks were noted, possibly the remains of a wall or culvert (**103**) (Plate 18). An modern electricity cable was noted to run along the edge of the path towards the church gates. The remains of an *in-situ* burial were noted to have been partially truncated by this wall or culvert, with a section of a pelvis and spine clearly visible right up against the north facing side of the masonry (Plate 19). Two service pipes aligned east to west were noted within the trench indicating that this area has already been partially disturbed.

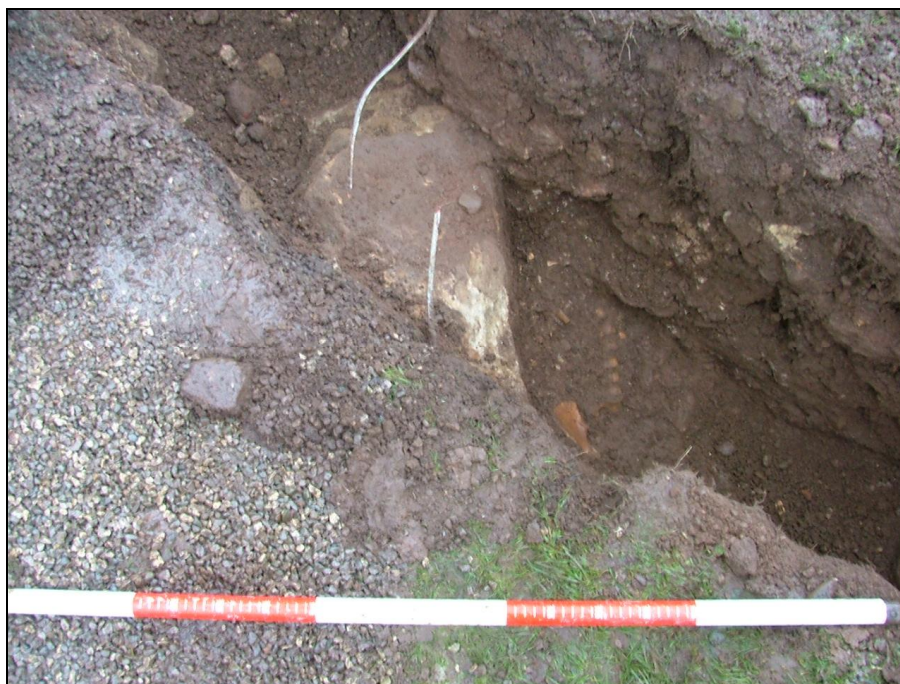
Plate 19: Part of a stone wall or culvert with the remains of an in-situ burial to its right-hand side

- 6.3 **Phase 2:** the service trench was excavated by machine and was monitored at all times by the attendant archaeologist. Features of note revealed during these groundworks was the discovery of a stone culvert or wall located at the point where the present turf of the graveyard and the north side of the gravel path meet. This feature was noted to have truncated a burial.

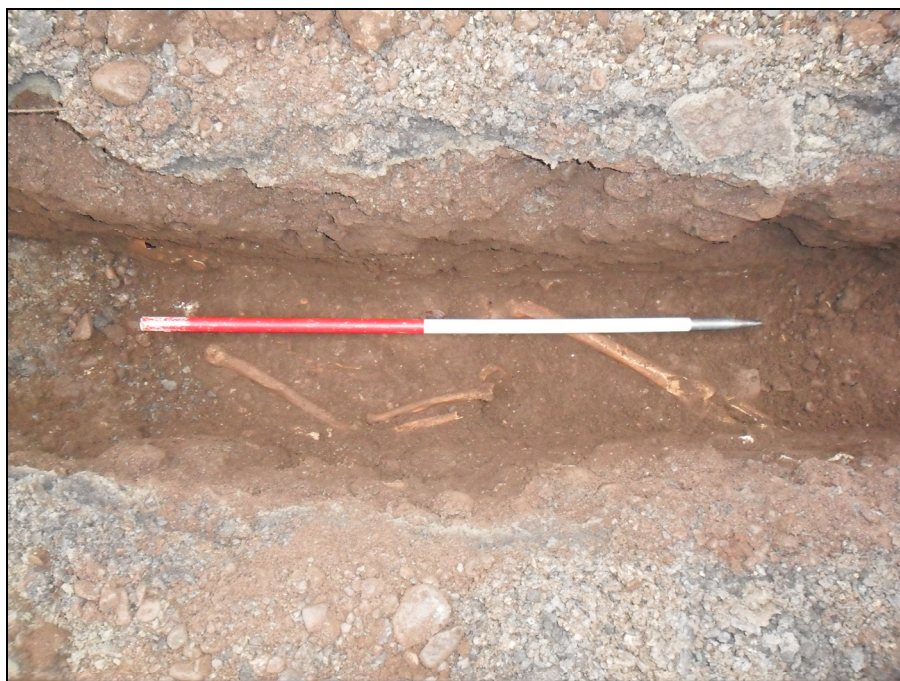
Plate 20: An in-situ burial revealed during the course of excavations within the gravel path to the west of the church

- 5.3.6 Located approximately 13m from the churchyard gates, an *in-situ* burial (**104**) aligned roughly east to west was noted within the line of the present gravel path into the church (Plate 20). This burial was believed to have been that of an adult female based on pelvis fragments. As this burial lay at a level higher than the require depth for the trench, the remains were recorded, lifted and then redeposited within this section of the trench following the excavation of the ground to a depth of 0.60m.

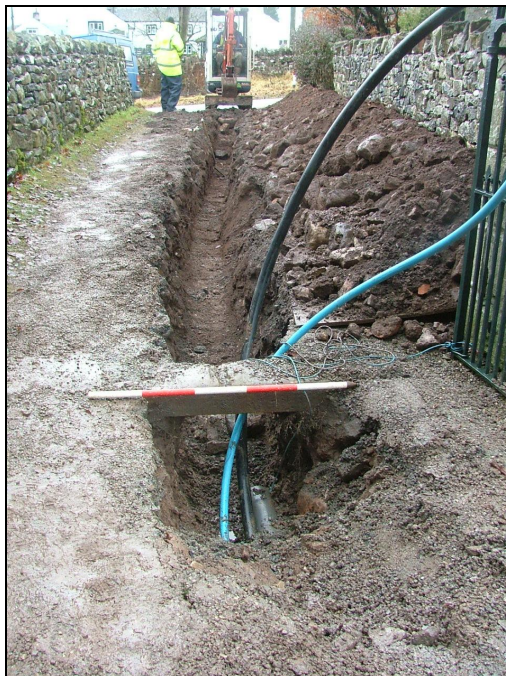
Plate 21: View looking west showing the excavation of the trench from the church gates towards the road (Scale = 1m)

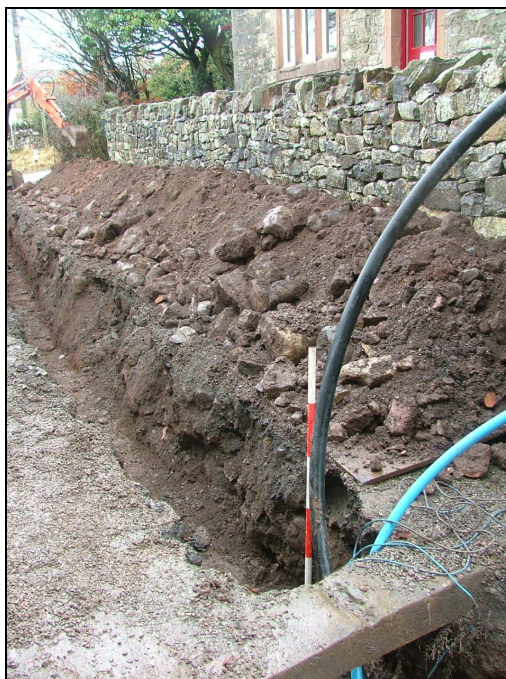
Plate 22: View looking west showing the excavated material from the section between the church gates and the road (Scale = 1m)

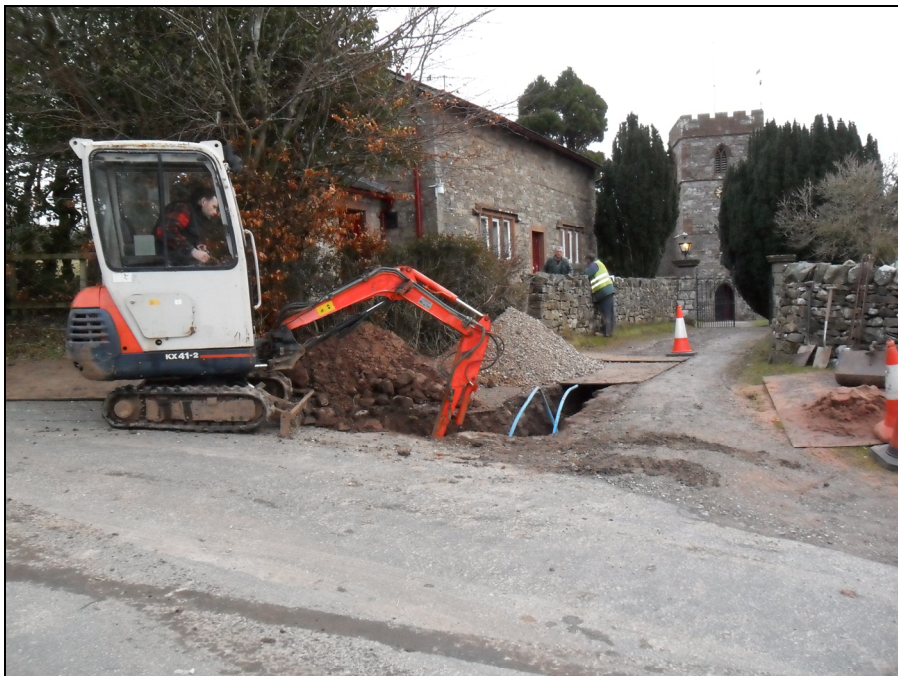
Plate 23: View looking east showing the excavation of trenches to the west of the church

irregular shaped stones. It was possible to note a line of cobbles, possibly part of a former road surface, in section (Plates 23 and 24).

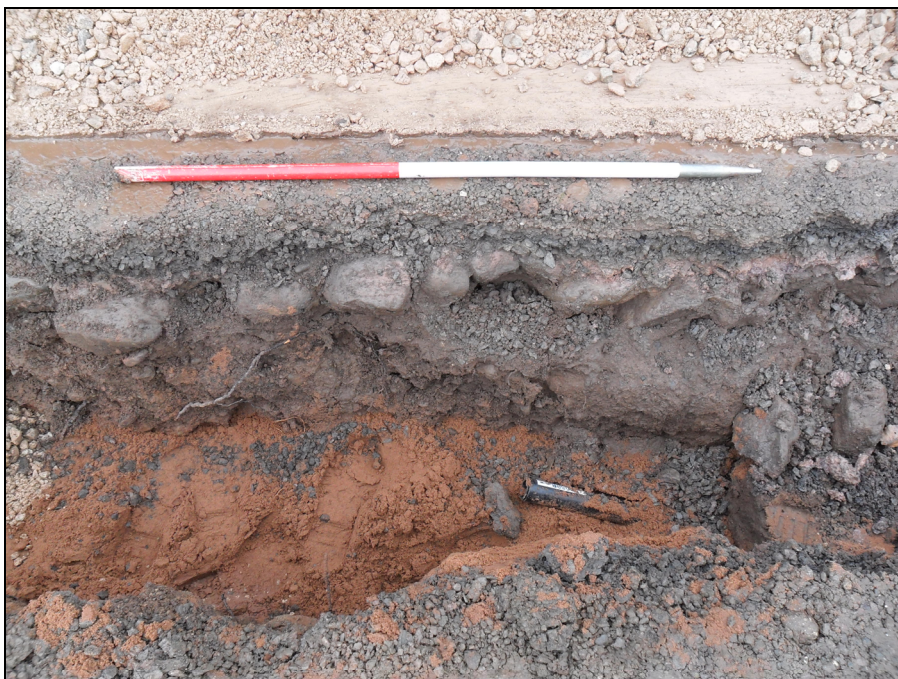
Plate 24: Detailed of possible cobbled surface located beneath the modern road to the west of the church

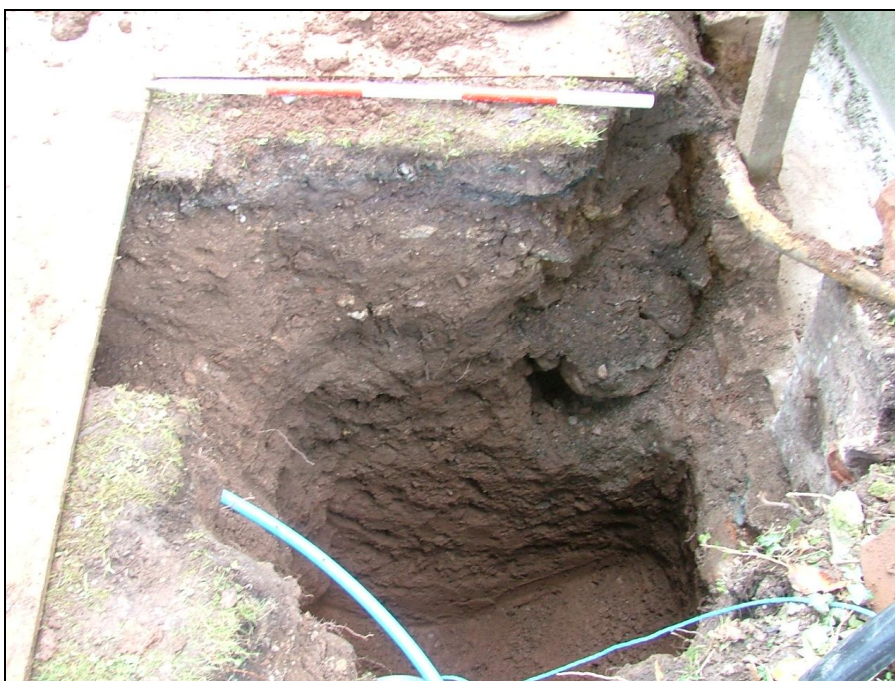
Plate 25: View looking east showing the trench for the pump chamber. The collapsed remains of a stone culvert are visible to right of photograph (Scale = 1m)

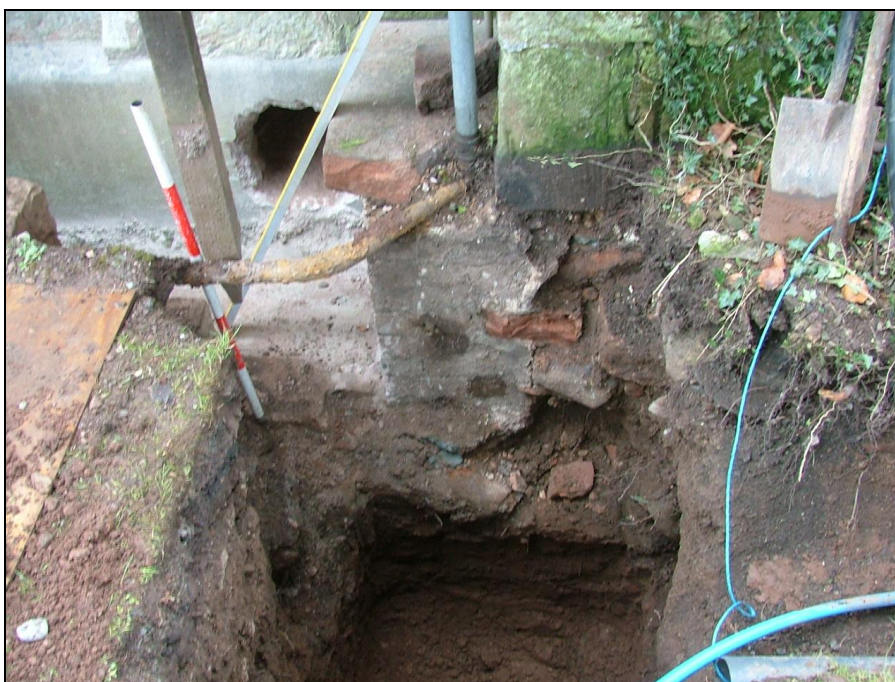
Plate 26: View looking south showing the trench for the 2m high pump chamber (Scale = 1m)

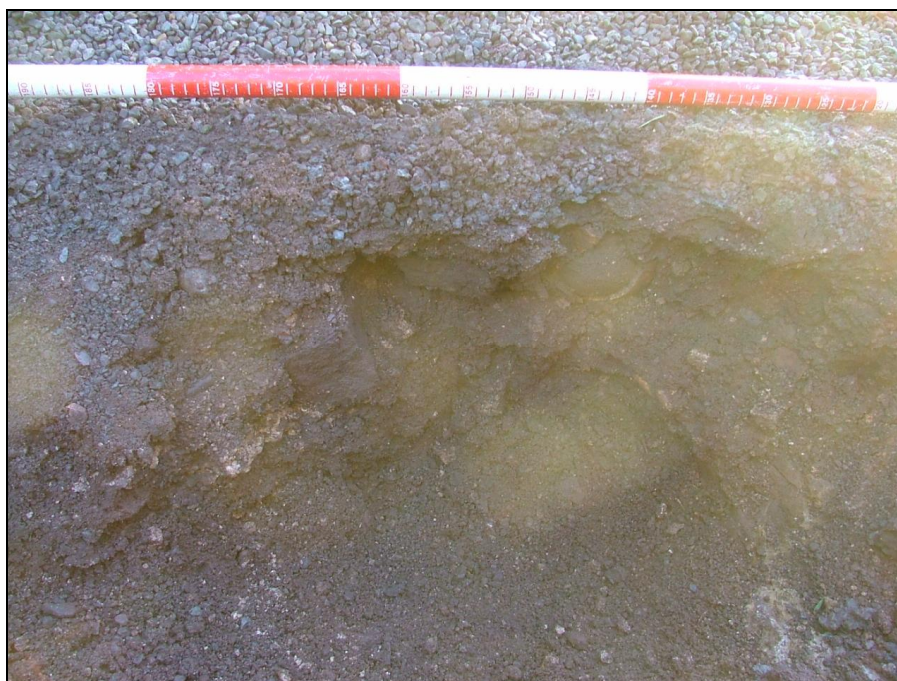
Plate 27: West facing section of drainage trench showing a partially exposed skull at a shallow depth of only 0.10m below present ground surface

- 5.4.1 To allow for standing water to drain away from the paving stones outside the main entrance to the church, a short section of trench was excavated by mini digger with toothless bucket from the south-west corner of the church tower in a southerly direction, for a length of approximately 5.50m. An *in-situ burial* was noted within the section of this trench at a very shallow depth below present ground surface of only 0.10m (from top of skull to top of gravel path) (Plate 27).

- 6.6 Also of significance was the shallow depth of an *in-situ* burial revealed during the excavation of this drainage trench, being only 0.10m below present ground surface. This should be considered during any future ground works within the churchyard.

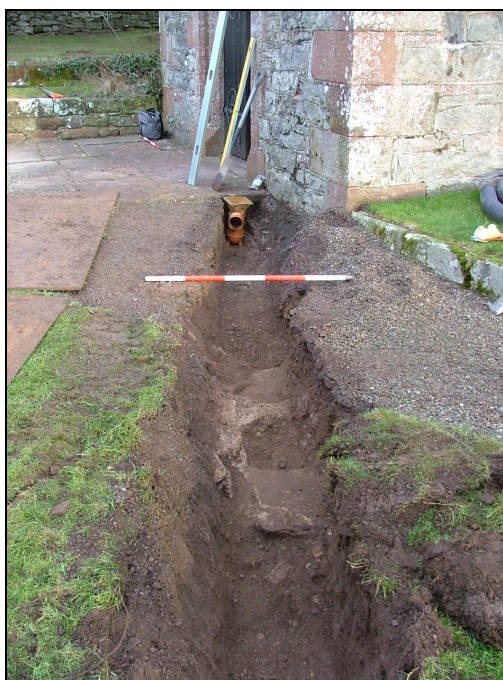
Plate 28: View looking north showing the drainage trench leading off from the south-west corner of the church tower, with the remains of a wall visible within the trench (Scale = 1m)

- 5.4.2 Of particular interest within this trench was the exposure of the remains of a substantial masonry wall located at a depth of only 0.35m below the present ground surface. This wall measured c.1.40m in width and consisted of masonry facing stones to the north and south sides, and was infilled with rubble. The wall was noted to be aligned east to west (Plates 28-30). As this trench was only being filled with gravel to allow water to soak away, the wall exposed in this trench was left untouched.

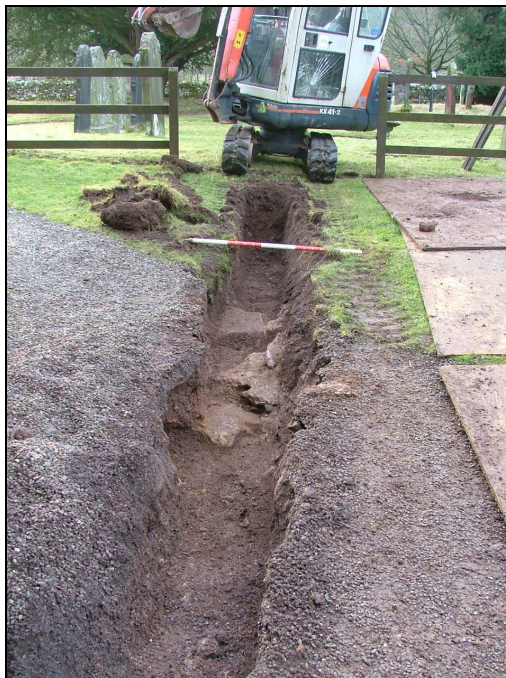
Plate 29: View looking south showing the remains of a wall (112) within the drainage trench (Scale = 1m)

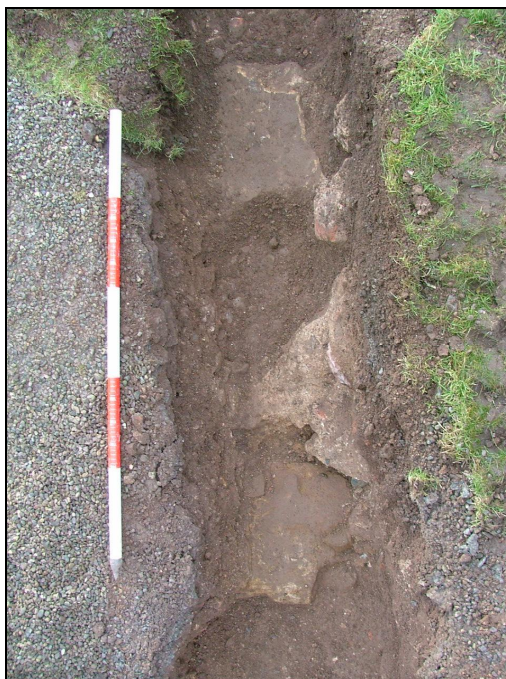
Plate 30: Detail of the stone wall (112) within the drainage trench (Scale = 1m)

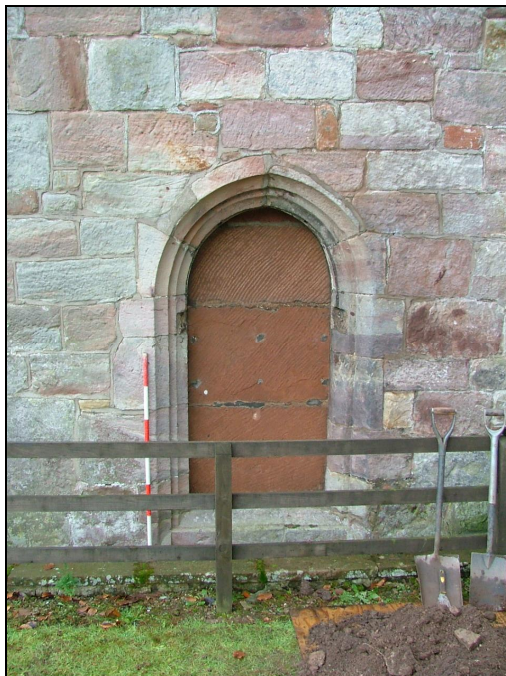
Plate 31: Blocked doorway in the north wall of the church

- 5.5.1 Prior to the insertion of service pipes through the north wall of the church, to serve the kitchen and toilet, and the insertion of an extractor fan in the blocked doorway, photographs were taken of the exterior and interior areas of wall that were to be affected (Plates 31-34).

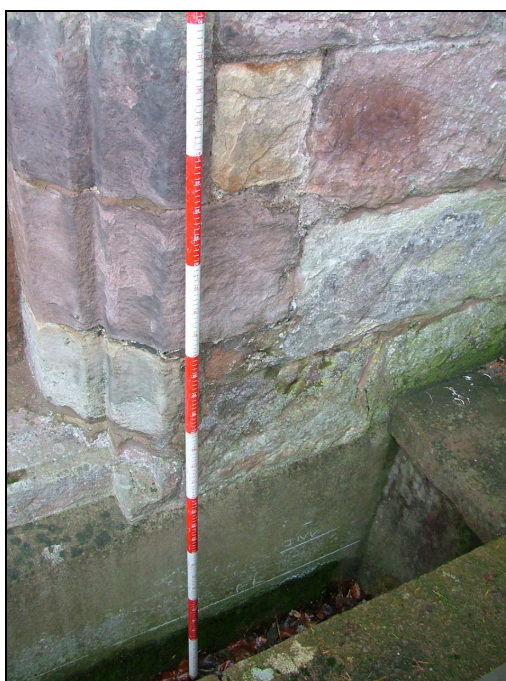
Plate 32: Detail of the area to be affected by the insertion of service pipes, north wall of the church

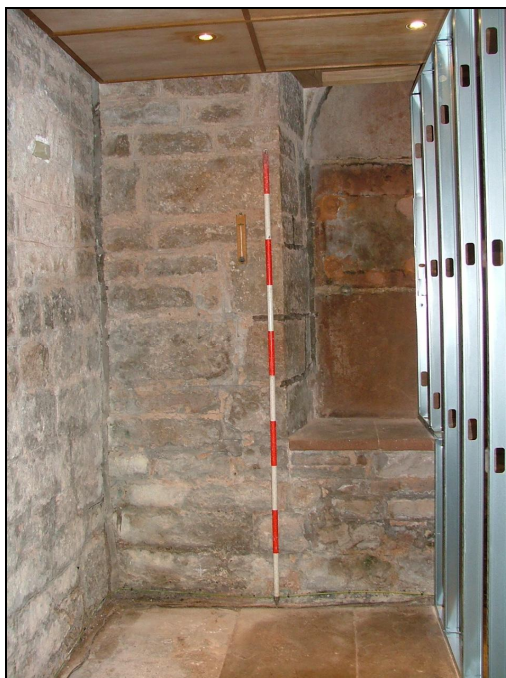
Plate 33: Interior of the north wall where the toilet is to be located (Scale = 2m)

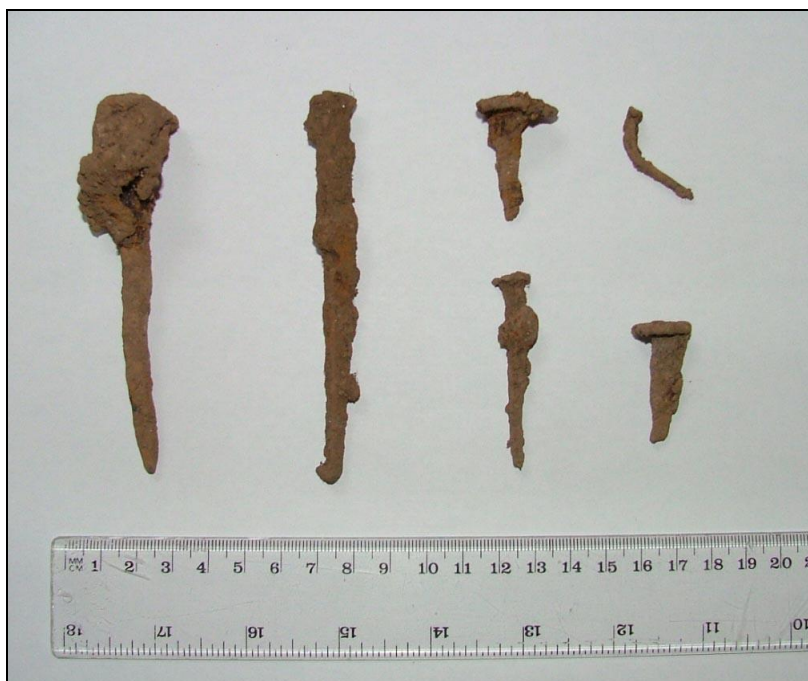
Plate 35: Detail of some of the iron coffin nails retrieved during the watching brief

- 5.1 The finds retrieved during the course of the watching brief were mainly derived through metal detecting of the excavated material. Unsurprisingly, the bulk of the finds were iron coffin nails of carrying sizes and condition (Plate 35).

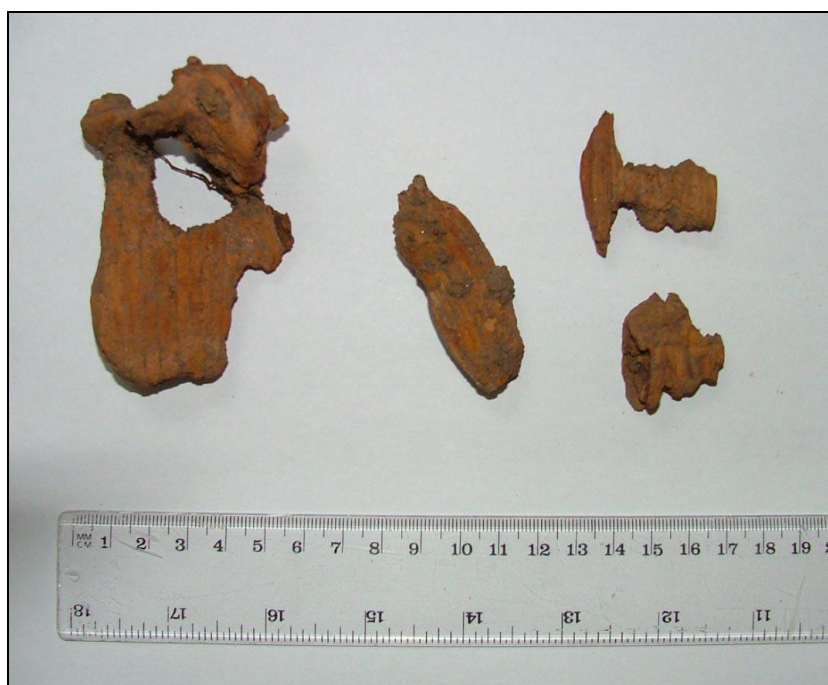
Plate 36: Detail of some of the wooden fragments attached to iron nails found during the watching brief

- 5.2 As already noted above, a cluster of human bone was revealed during the excavation of the service trench close to the point where the trench passed the defined stone burial area close to the west side of the church. These bones were found in association with fragments of wood which had survived due to them surrounding iron nails (Plate 36).

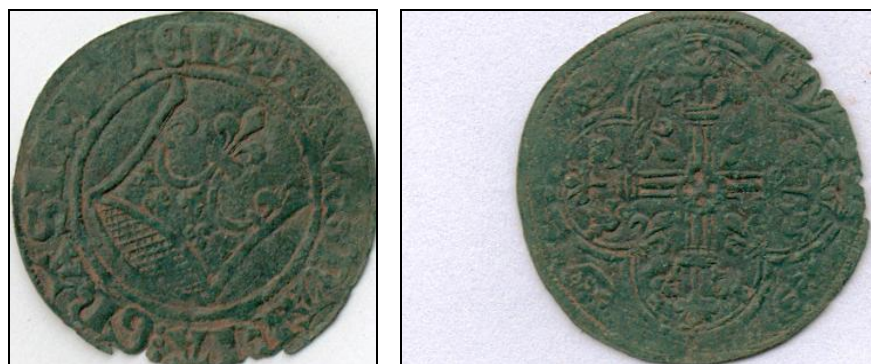
Plate 38: Front and reverse of the possible French jeton

- 5.4 During the excavation of the test pits along the line of the gravel path leading towards the main church door in the west tower, a copper (cu) alloy token or 'jeton' was found by metal detector. The inscription on this jeton appears to read 'AVE MARIA GRACIA PLENA' meaning 'HAIL MARY TRUE GRACE'. Similar examples of this style of jeton are listed on the UK Finds Database³⁶ as being French and dating from the late 14th or early 15th century. The front of the jeton displays the royal crown with central *fleur-de-lis* and two lateral *lis* and three rosettes across the body. The reverse has a triple stranded straight cross fleuretty within 4-arched tressure (Plate 38).
