NORTH PENNINES ARCHAEOLOGY LTD

Project Designs and Client Reports No. CP/65/03

**REPORT ON
AN ARCHAEOLOGICAL
DESK-BASED ASSESSMENT
AND FIELD SURVEY OF
ABBAY FARM,
LANERCOST,
BRAMPTON,
CUMBRIA**

**FOR
NAWORTH CASTLE ESTATE**

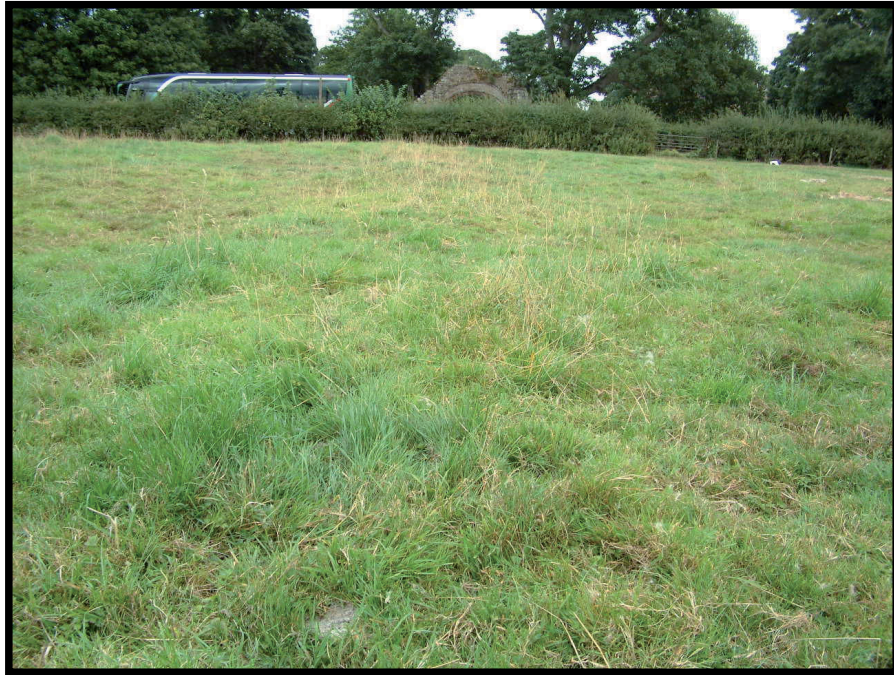
PLATE 2: Earthwork in Bull Pen Field

Twelve stone and earth mounds were observed and recorded during the identification survey (see plate 2 and figure 7). These consist of two rows of six, evenly spaced (though not parallel) mounds containing stone overlain by turf. The precise interpretation of these is uncertain but one possible interpretation is that these form the basis for a rectangular aisled building that had been demolished prior to the first edition OS map of 1864.

- 7.2 Proposals for the Bull-Pen field involve a 'no-dig' specification design for the car park. This will involve the laying of terram geo-textile matting on the present ground surface and the building up of levels with Type 1 sub-base, graded with fine dust and should cause minimal impact on any potential archaeological remains. One small area, approximately 5 m x 2 m will be excavated to allow access to the car park from the road. In this area it is recommended a full archaeological watching brief be maintained during the course of all these groundworks.

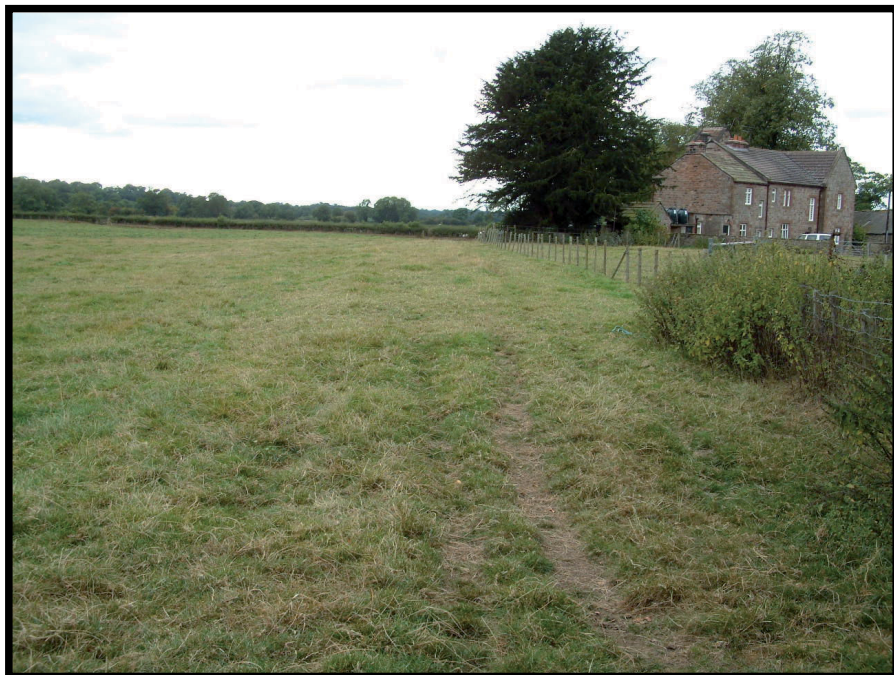
PLATE 3: Earthwork in South Field

A low positive lynchet was observed during identification survey, forming a terrace or platform at the north end of the south field (see figure 6 and plate 3).

- 7.5 In the field to the south of the Farm complex it is recommended that a series of evaluation trenches be excavated prior to the final decision on the location for the septic tank and associated pipe work as the area is likely to contain sensitive archaeological deposits.
