NORTH PENNINES ARCHAEOLOGY LTD

**REPORT ON
AN ARCHAEOLOGICAL
WATCHING BRIEF
AT BLENCARN
PENRITH
CUMBRIA**

**FOR
UNITED UTILITIES**

24th September 2004

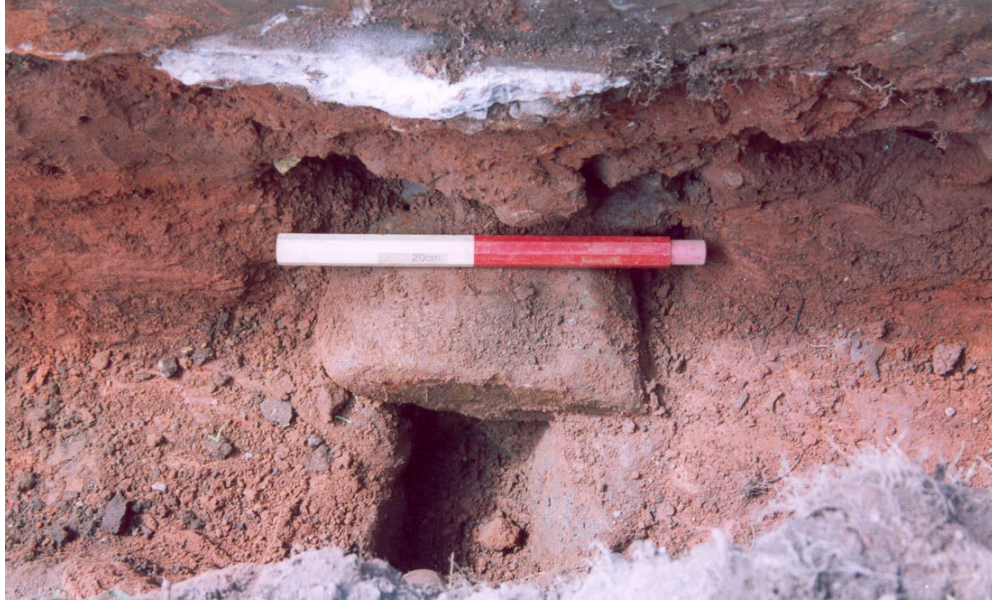
5.22.2 A stone capped culvert was observed within this trench, aligned east – west and measured 0.20m wide x 1.0m in length (Plate 1).

Plate 1: Trench 19: Sandstone capped culvert (Photo: K Denham)

- 7.1 The only archaeological remains of any significance which were observed during the watching brief consisted of a possible 19th century or later stone wall foundations within trench 24 and two stone capped culverts observed within trenches 18 and 19. Both the single flint scraper from trench 1 and the medieval pottery from trench 26 were found in isolation within the mixed subsoil and could not be linked to any features or deposits.

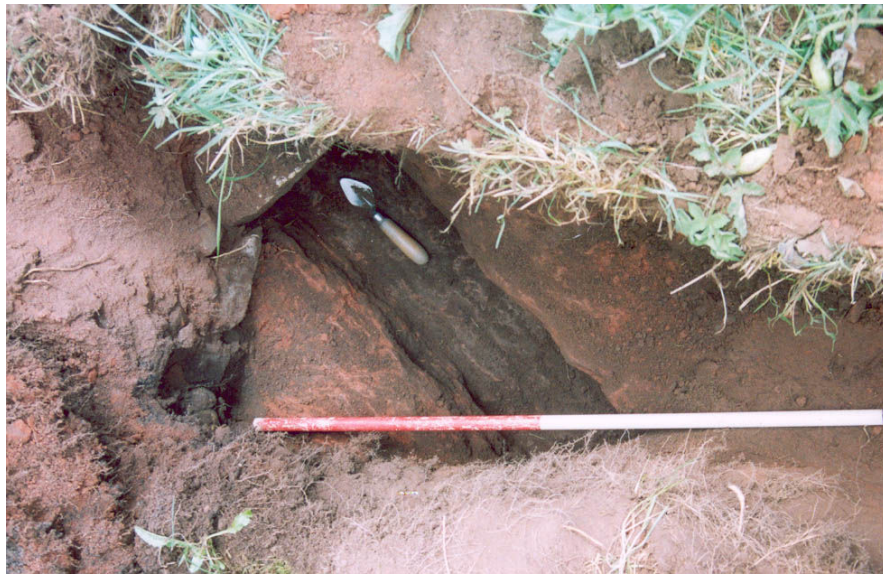
5.21.2 A stone capped culvert was observed within this trench, aligned east – west and measured 0.20m wide x 1.0m in length (Plate 2).

Plate 2: Trench 18: Sandstone Culvert (Photo: P Crompton)

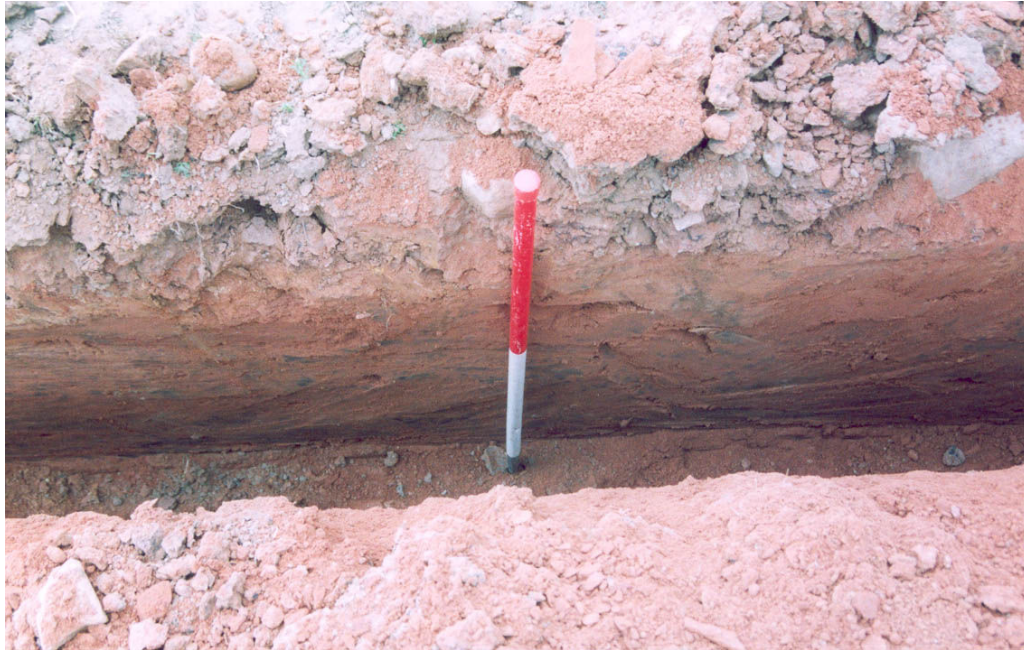
Plate 3: Natural substrate overlain by modern overburden within an archaeologically sterile trench (Photo: K Denham)

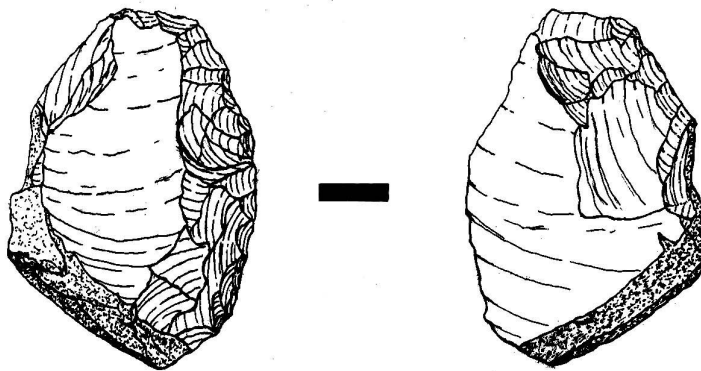
- 6.2 The assemblage also included 1 piece of worked, cortical flint. This took the form of a scraper with evidence of pressure flaking with a serpentine edge. The flint has been imported to the area and is possibly of Neolithic origin.

- 6.3 The flint has been pressure flaked along the right hand margin of the dorsal face and proximal end, with evidence of retouch along the same margins. The ventral face has had flakes removed on the left hand margin at the proximal end, possibly to reduce the thickness of the tool for ease of handling. The bulb of percussion has been removed at this point by a sharp, obliquely struck blow.

Figure 4: Flint scraper recovered from trench 1 (100)
Scale 1:1
