Client Report No. 76/05

**DESK BASED ASSESMENT
AND REPORT ON
AN ARCHAEOLOGICAL
WATCHING BRIEF ON
LAND AT MONKHILL,
CUMBRIA**

**FOR
UNITED UTILITIES**

11th April 2005

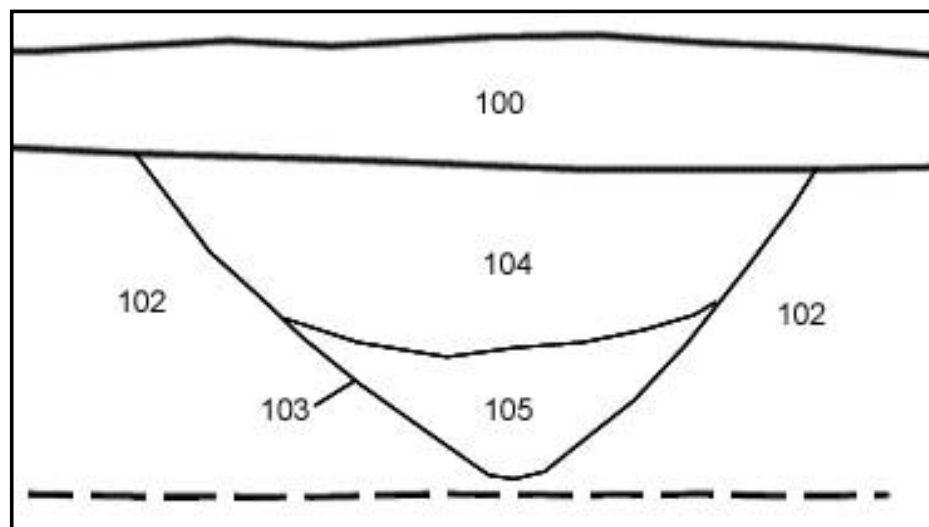
Figure 5:

- 5.3.7 **AREA A-** The first area of archaeological interest was situated on the verge of the side road 40 metres south of the main east-west road (see figure 4). In this instance a probable small, v-shaped linear feature (see plate 2) was observed (103). This was filled by a primary deposit of mid-brownish grey sandy loam (105), possibly formed through the initial erosion of the sides of the linear, and then a secondary deposit of very dark brown silty clay (104).
- 5.3.8 No dating evidence was recovered from any of these deposits. It is believed that from its profile (figure 5) and what could be observed in both sections of the cable trench it was a small linear field boundary ditch. However the nature of the watching brief meant that only a limited view was possible, making any further interpretation difficult.

East facing section of Area A showing possible linear 103 (Scale 1:20)

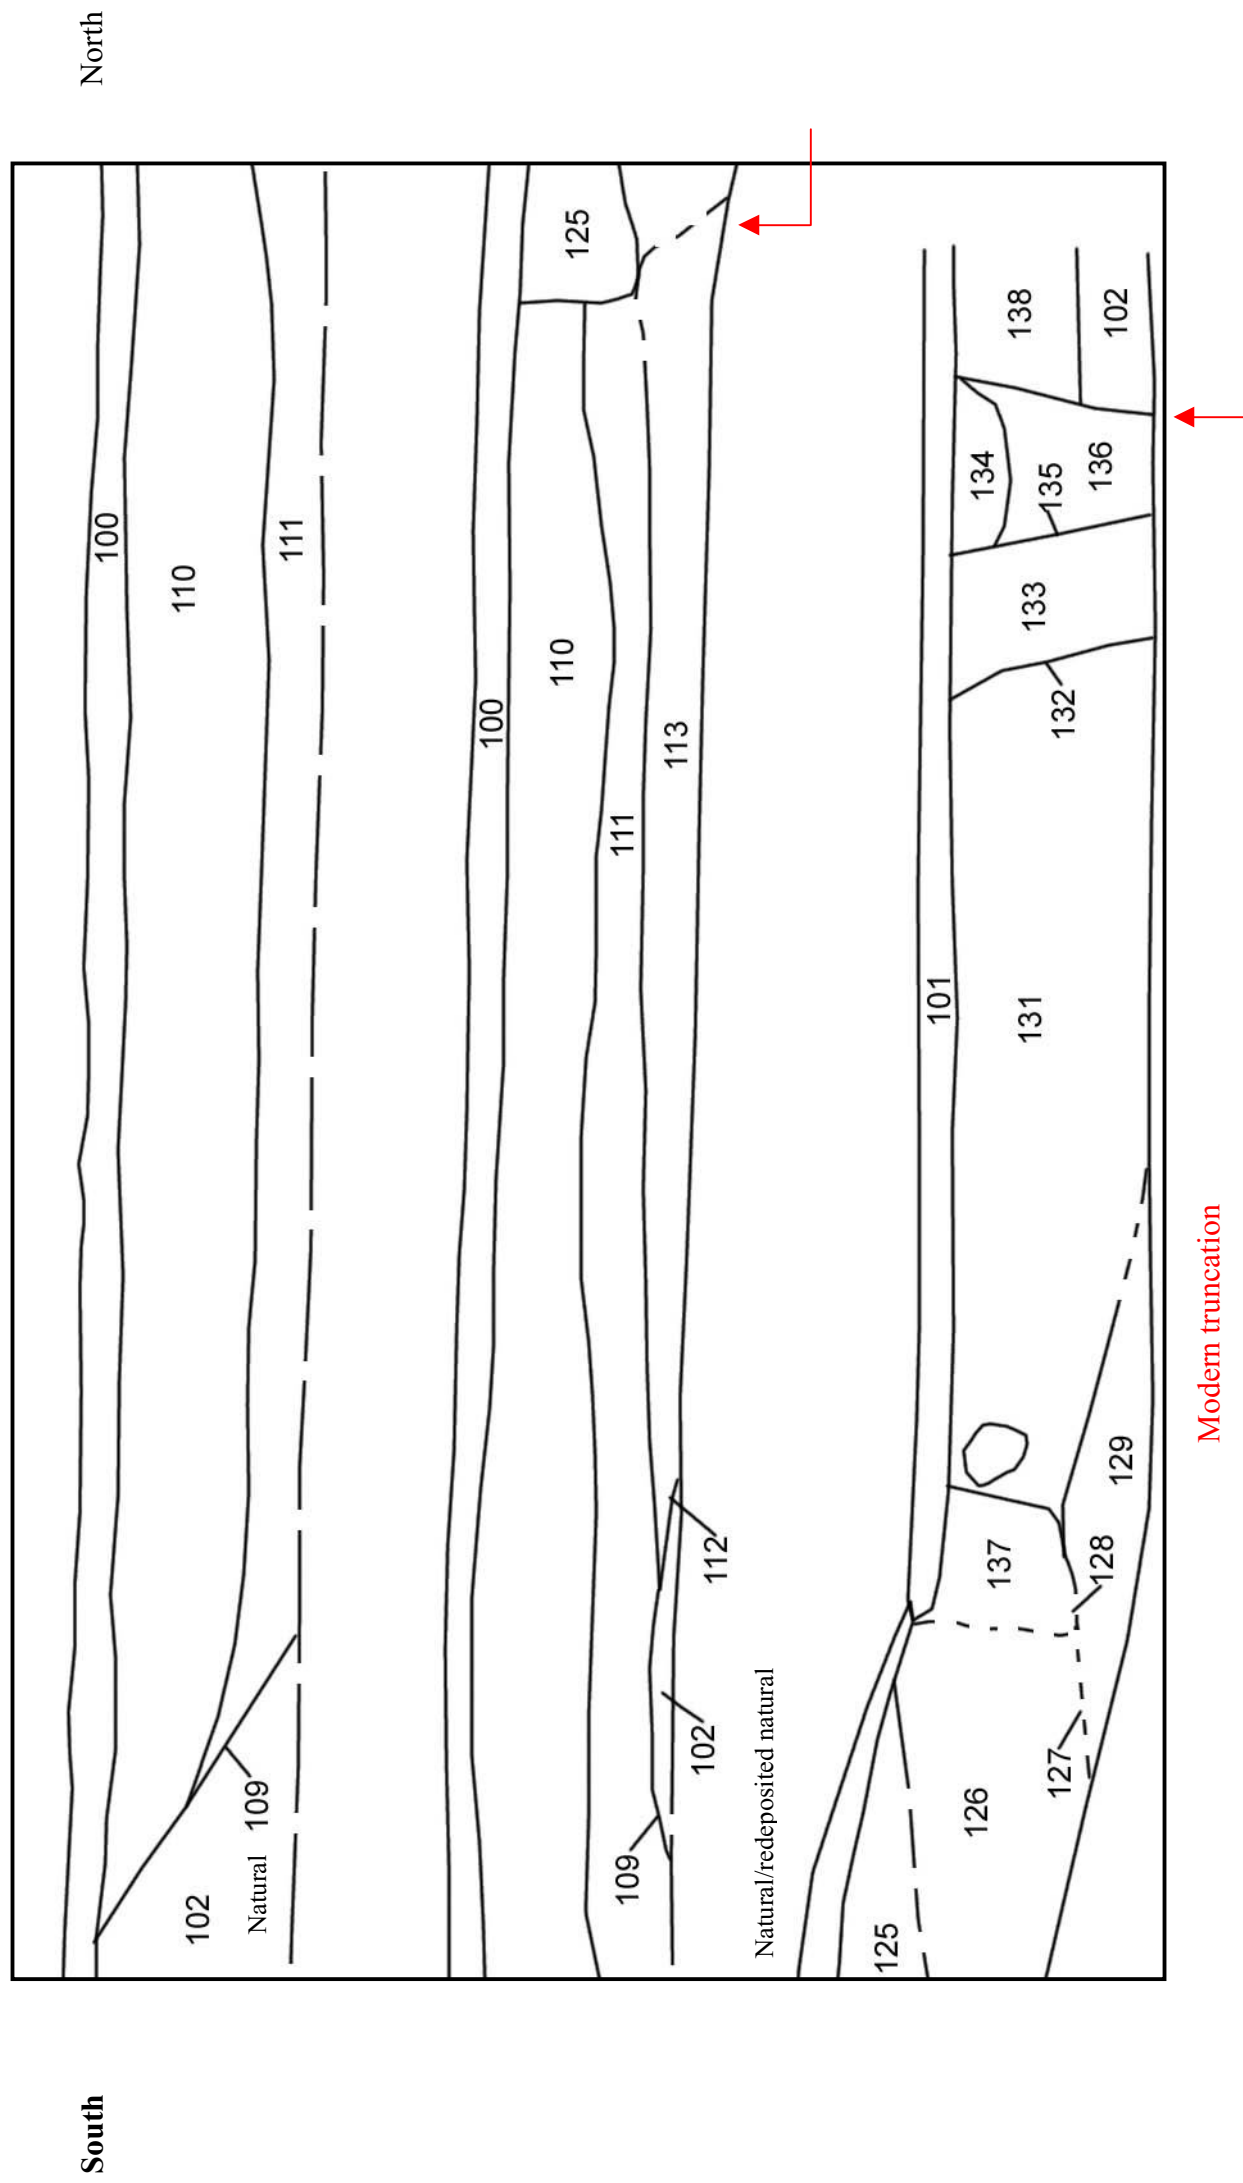
- 5.3.9 **AREA B-** (see figure 4) This area was also situated on the same verge as Area A although much closer to the main road. Here the natural (102) appeared to have been truncated and a number of deposits were observed along the base of the pipe trench. The most likely interpretation for this is for one or possibly two substantial cut features (Figure 6) to be running across the line of the pipe trench.

- 5.3.10 The cut for the southernmost feature (109) is only visible at the top of the southern edge. As with all of the deposits within this area the depth of the cable trench and the amount of truncation through modern services in this area severely hampers full investigation and interpretation. The small amount of cut 109 visible shows a uniform moderate slope on its southern side. The northern side is harder to determine. A small 'island' of possible redeposited natural was visible after 6 metres that may represent the northern side of the of this substantial feature or some deliberate infilling.

Figure 6: East facing section of Area B showing archaeological deposits and modern truncation (Scale 1:20; Split into 3 sections to retain scale)

- 5.3.11 The northern side of this small area of possible natural dips down again, and this is possibly another cut feature 112. As only a very small portion is visible it is not possible to describe. However the northern edge of this potential cut feature is not visible due to the level of modern truncation towards the north (see figure 6) and the depth of the trench. The archaeological deposits filling this feature are visible for four metres from its southern edge before a series of service trenches disturbs it, the natural (102) is not visible again for a further five metres.

- 5.3.12 Filling this possible second cut feature is a uniform dark greyish brown clay loam (113). Only the upper surface of this deposit is visible and it is not known how deep this deposit may go. Its appearance suggests that it has been partially formed through the gradual washing in of surrounding soils rather than a rapid or deliberate backfilling event.

- 5.3.13 Overlying 113 and also forming the fill of 109 was a dark greyish brown sandy silt deposit (111). If the small deposit of mid orange brown silty clay (102) is natural which was identified between 109 and 112 the two cut features, then this deposit would suggest that cut 112 had silted up prior to the final infilling of feature 109.

- 5.3.14 After both potential features had been inilled the remaining depression was sealed by context 110, a mottled mid-brown silty sand deposit which runs across both features before being truncated by modern services to the north. As with the earlier deposits context 110 produced no finds to assist in dating this final phase of infilling. Context 110 was then cut by a series of modern service trenches.

- 6.1 Both features 109 and 112, the probable substantial east-west oriented ditches, lie close to the projected line of the Vallum. Although the depth and general character of the features are impossible to interpret within the confines of the small cable trench it would appear likely that the deposits observed are part of the Vallum itself.

- 6.2 Cut feature 109 measures approximately 6m and the potentially earlier feature 112 between 3.2m and 7.3m; both potentially wide enough for the Vallum and possible suggesting some form of recut.

- 6.3 If the small island of natural is interpreted as redeposited, both contexts 111 and 113 would be filling the same feature with context 112 being a tip line rather than a cut. Although the width of the cut features taken as a whole (9m) would be on the wide side for the Vallum it is possible that the Vallum is running across the trench at a slight angle which would explain the excessive width.

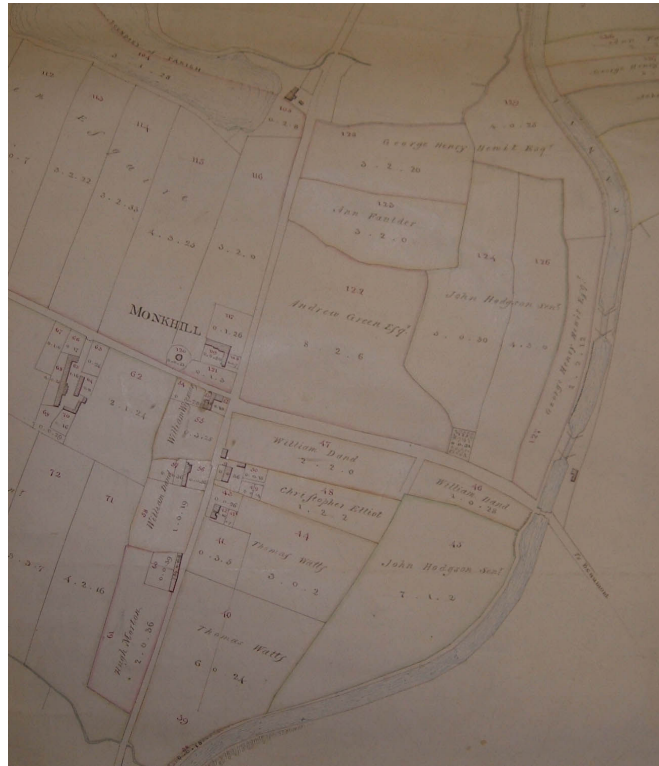
Plate 1: Detail from 1831 Corn Tithe (Carlisle Archive: QRX1), north is to the right of the picture.

- 5.1.14 A comparison of the historic mapping also shows changes in the enclosures, and growth of the settlement. The 1831 Corn Tithe shows relics of the earlier strip fields particularly to the south-east of the village (plate 1). On the 1866 1st

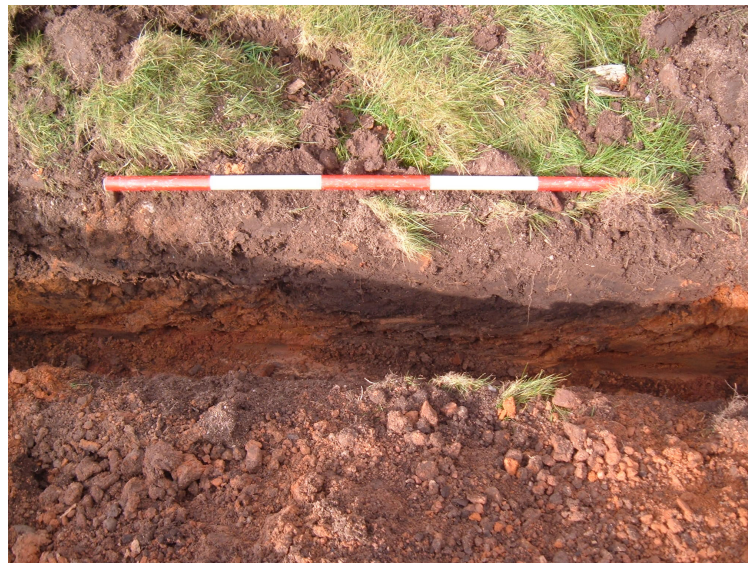
Plate 2: Detail of feature 103 facing west
