**REPORT ON  
AN ARCHAEOLOGICAL  
WATCHING BRIEF IN  
THE BASEMENT OF CLUB XS  
WEST WALLS, CARLISLE**

**For  
MR J PATTINSON, CARLISLE GLASS**

12<sup>th</sup> April 2004

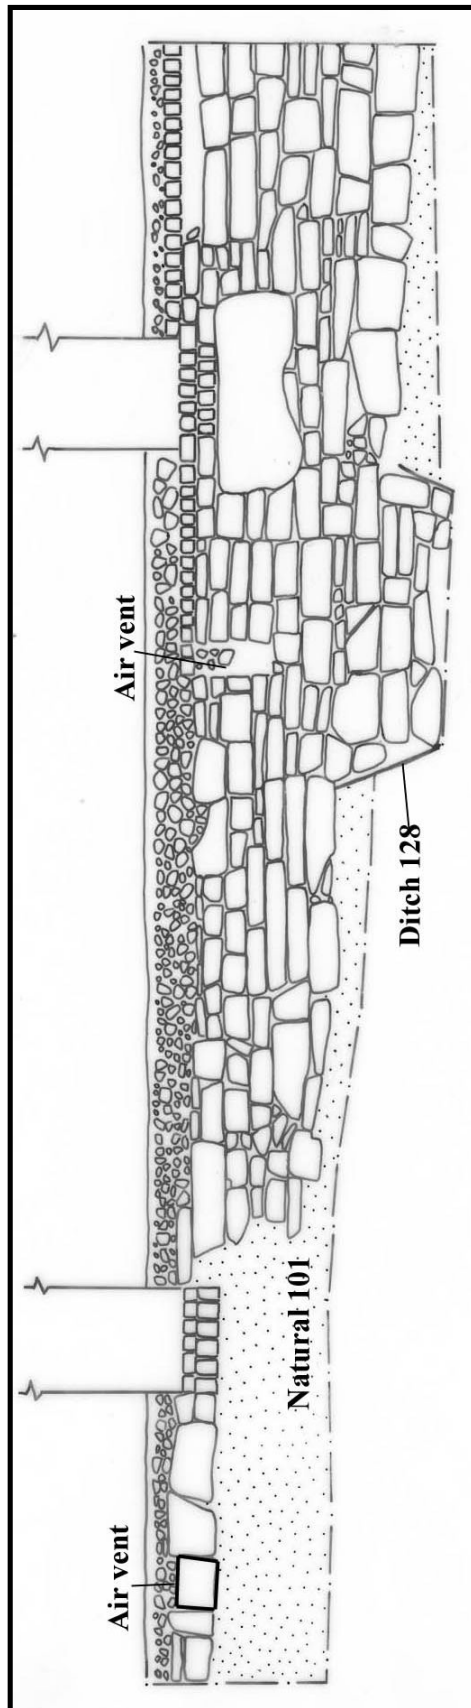
Figure 7: North west facing section inside club XS.  
Scale 1:40

5.6.7 The southeast wall had two brick columns set onto piers of concrete above the sandstone courses (see figure 7). This suggests an open area through

- 5.7.2 The ditch (128) was exposed intermittently as work progressed, and was found to contain two fills (secondary fill 119, primary fill 118,125,126 and 127) (see Figure 7). The secondary fill only survived where the ditch was observed running below the wall line of club XS and four context numbers were issued for the same deposit as it was observed during the course of the redevelopment programme.

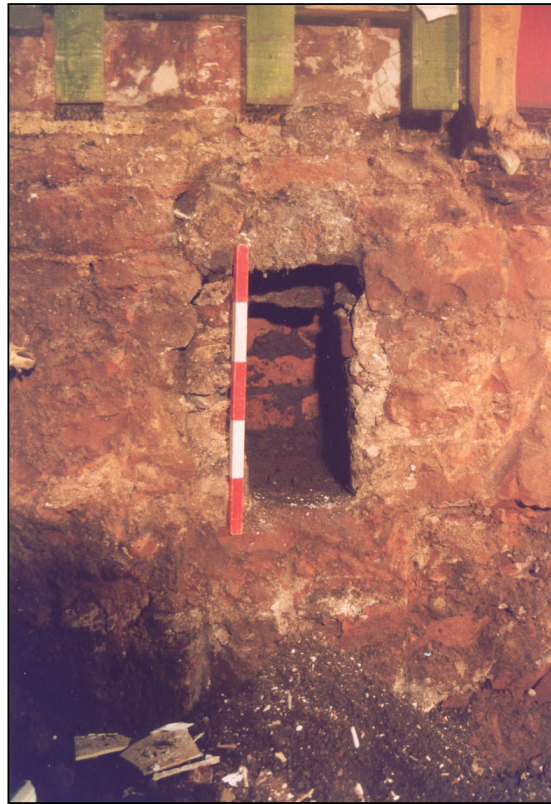
5.6.3 The northeast wall consisted of 19<sup>th</sup> century factory made bricks. Revealed at the most northerly corner was a drain course (129) (see plate1) associated with the construction of the school house that curved round to the northwest and exited through the north west wall of the building. The sides of this feature were constructed out of brick with the base and capping constructed out of sandstone slabs.

PLATE 1: (above) Drain 115  
PLATE 2: (below) Air grate 116

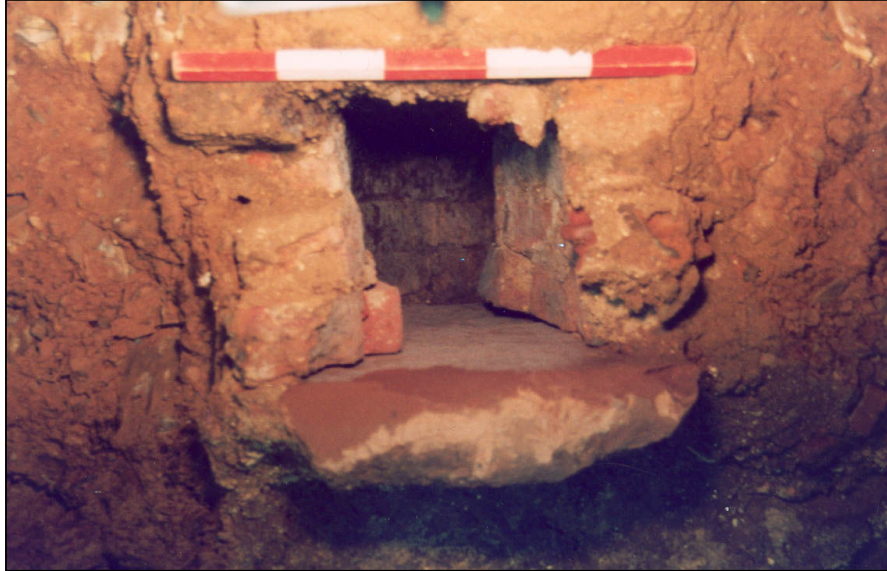
5.6.4 When this portion of the wall had been undermined the brick lined drain channel was observed to continue through the northeast wall towards the upper level of the building. At the rear of the building adjacent to the city wall, several large blocks of red sandstone were recorded. It was unclear whether they were associated with context 100 or with the city wall as detailed examination of this area was impossible due to health and safety concerns.

PLATE 3: above Drain 116 continuing under north west wall

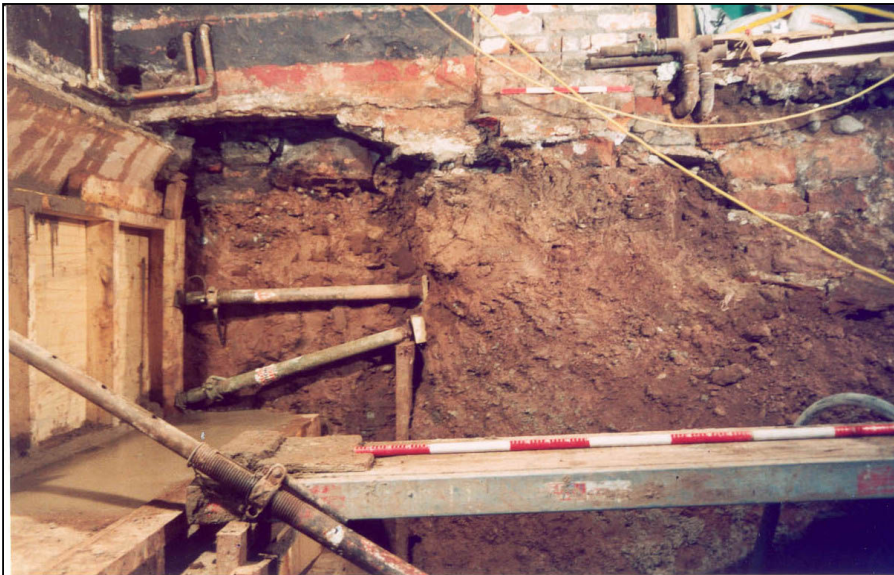
5.6.5 Both the northwest and southeast walls were brick built for the main above the floor level, there was no visible use of handmade bricks in any of the recorded walls. Both had stepped courses of sandstone blocks beneath the bricks and both contained what were probably air vents into the original building as the ventilation grate (116) survived in situ in one of these voids (see plate 2). The stepping seemed to follow the natural slope of the embankment at the two ends and provides even foundations for the brick courses of the building to be laid on.

PLATE 4: below: Detail of natural boulder clay below south east wall
