NORTH PENNINES ARCHAEOLOGY LTD

Project Designs and Client Reports No. CP/107/04

**REPORT ON
AN ARCHAEOLOGICAL
BUILDING RECORDING PROJECT
AT WESTLANDS FARM
CROSBY
MARYPORT
CUMBRIA**

**NGR NY 07380 38445
Planning Application No. 2/04/1214**

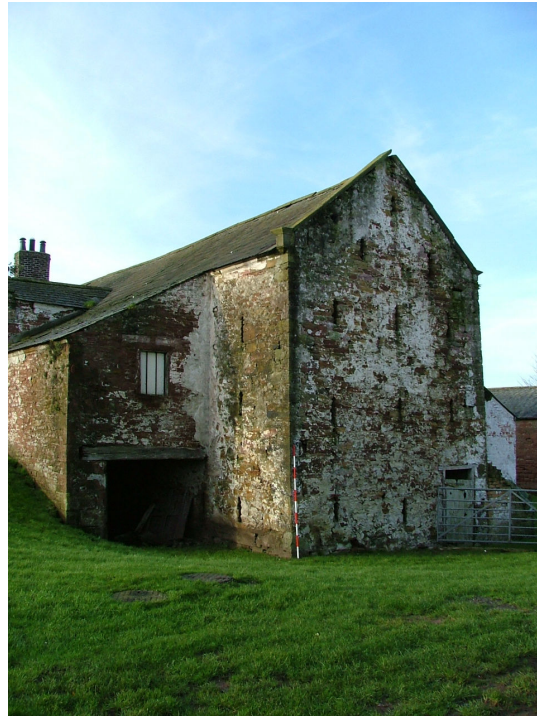
Plate 3 – North-east elevation of the bank barn, showing the coping stones and kneelers on the gable

- 5.2.5 The north-east elevation of the bank barn (Plate 3) has five rows of ventilation slits, consisting of one close to the apex of the roof, the second row down contains two, the third and fourth rows down each have three, and the fifth has two. Ventilation slits are common in stone-built barns, although square or triangular holes are also used. They allow air to circulate within the building, and are often related to the unpleasant process of threshing of corn using a hand-flail (Plate 7).

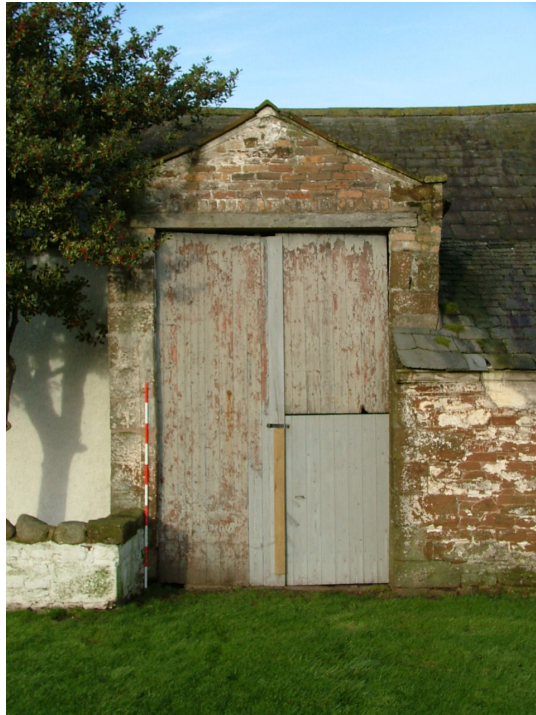
Plate 4 – Large doorway in south-east facing elevation of bank barn

- 5.2.3 In the south-east facing elevation there is a large gabled doorway projecting from the barn (Plate 4). The quoins to the left of the doorway consist of blocks of well dressed sandstone masonry. Above the doorway, bricks have been used to construct the gable. The top of the gable has, like the north-eastern elevation, coping stones terminating in kneelers. This doorway would have allowed for the access of laden carts from the road, carrying cereals to be threshed in the barn.

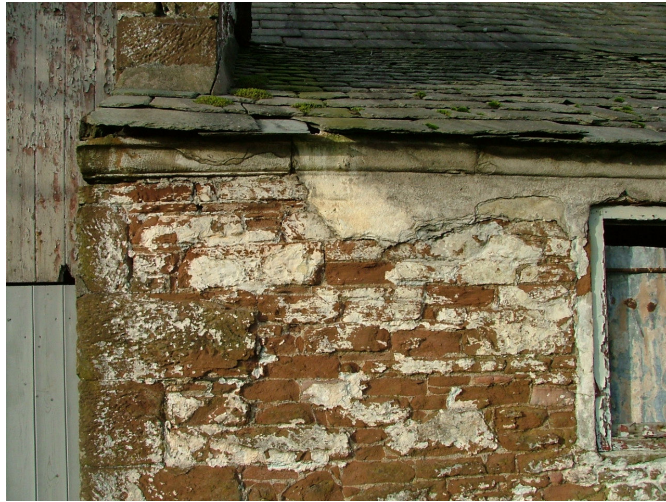
Plate 6 – Cornice of outshut (below slates), SE facing elevation of bank barn

- 5.2.4 To the right of this large doorway is a outshut (a ‘lean-to’) (Plate 1), which is of two storeys. The upper storey is accessed from inside the upper level of the barn, and the lower level accessed through a large doorway at ground level on the north-eastern elevation (Plate 5). The ground level of this outshut could have been used for either storing a cart, implements or fodder. The roof of the outshut is covered in Cumbrian slate compared to the Welsh slate of the main barn. This outshut appears to be contemporary with the main barn, despite the fact that it obscures ventilation slits and a possible blocked window at ground level (See 5.4.2 below). The cornice on the barn, located at eaves level (just below the roof) matches that on the outshut (Plate 6).

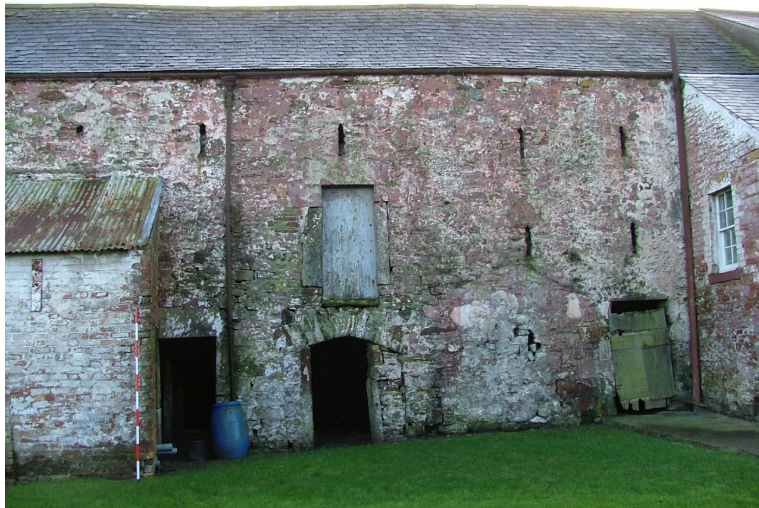
Plate 8 – North-west elevation of bank barn

- 5.2.7 The north-west elevation faces into the courtyard, with the stable block located opposite (Figure 5). At ground level, there are three doorways visible (Plate 8), a further doorway has been blocked-up and is hidden behind the later brick-built 'lean-to' (See 5.4.1). The blocked-up doorway originally gave access to the loose box or stable, described in 5.2.6, from the courtyard. Two of the doorways visible in plate 8, give access to byres for cattle, the middle doorway (with the arched head) would have originally led into a cart shed, although it has been blocked-in slightly on each side. Each of these doorways leads into rooms with low ceilings of *c.*2.0 metres in height, and this is characteristic of housing for cows in a bank barn⁸. The cartshed in a bank barn is generally located beneath the threshing floor of the upper level, and this is certainly the case at Westlands Farm⁹.

- 5.2.8 The doorway above the cartshed entrance, at the upper level (Plate 8), is known as a 'Winnowing Door', and these domestic-sized doorways were used to provide a through draught for the process of winnowing the cereals after they have been threshed on the floor of the upper storey. 'Winnowing' was the process of separating the lighter chaff of the cereals from the heavier kernels, and was generally undertaken within barns, with the large double doors and smaller winnowing door being opened to provide the through draught to blow away the chaff¹⁰.

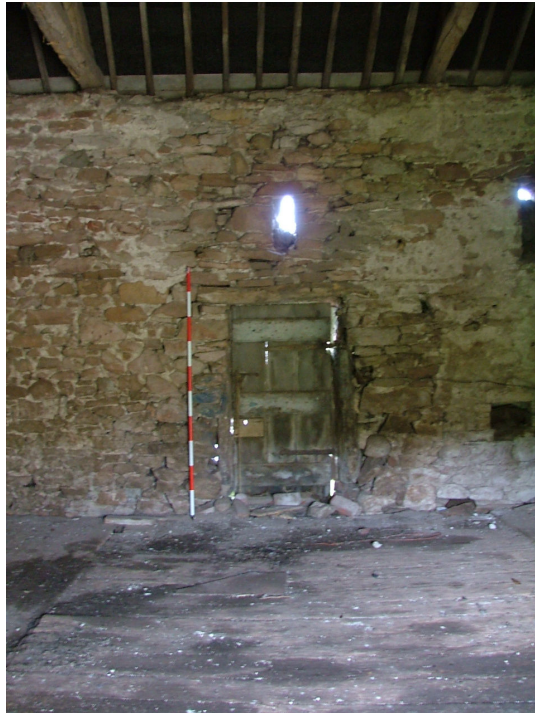
Plate 9 – Interior of bank barn, upper level, showing winnowing door and large timbers for the threshing floor

- 5.3.1 The upper level of the bank barn is accessed through the large double doors on the south-east facing elevation. The floor of the barn at the doorway is of sandstone flags, but this gives way to large oak timbers, measuring *c.*2.50 metres, laid lengthways, these extend from the entrance across the whole width of the barn to the winnowing door (Plate 9).

- 5.3.2 Either side of the threshing floor are floor boarded storage areas. To the right of the winnowing door (Plate 9), set in the floor is a trap door; this would have been used to transfer straw to the animals below¹¹. Above the trap door, set into the wall, are two niches (Plate 10), possibly used to house essentials such as drink and food for when the threshing process was being undertaken. To the right of these niches there is a length of timber set horizontally into the wall, with another niche set into the wall above (Plate 11). Its position directly above the trapdoor suggests it may be connected to that, as the trapdoor opens upwards towards the wall, hence the timber could have been used to secure the open door to the wall.

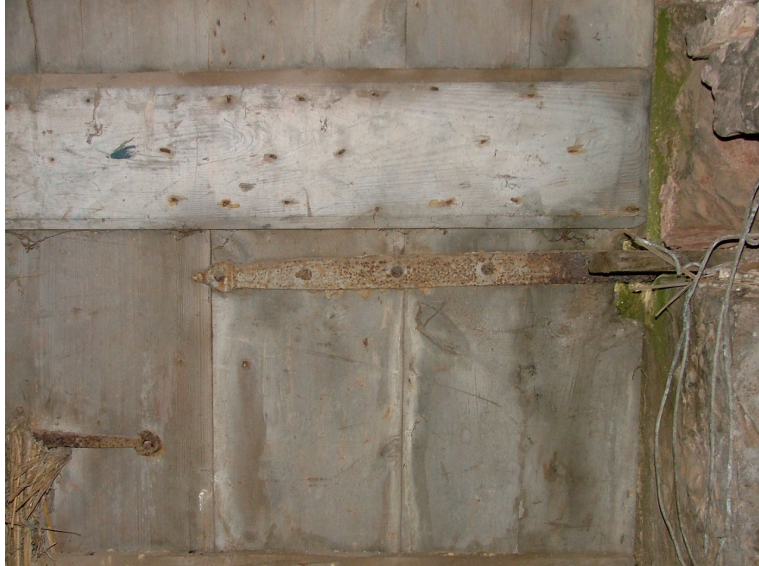
Plate 12 – Spearhead strap hinges, winnowing door of bank barn

- 5.3.4 The Spearhead strap hinges on the interior of the winnowing door (Plate 12) could date to the late 17th or early 18th century¹², although it is likely that these styles were in existence for a long period of time.
