**REPORT ON
AN ARCHAEOLOGICAL
BUILDING RECORDING PROJECT
AT HEMBLES GATE
TARN ROAD
BRAMPTON
CUMBRIA**

**FOR
MR F LOWE
PENTAKAN LTD**

**NGR NY 5357 6052
Planning Application No. 1/04/0628**

20th October 2004

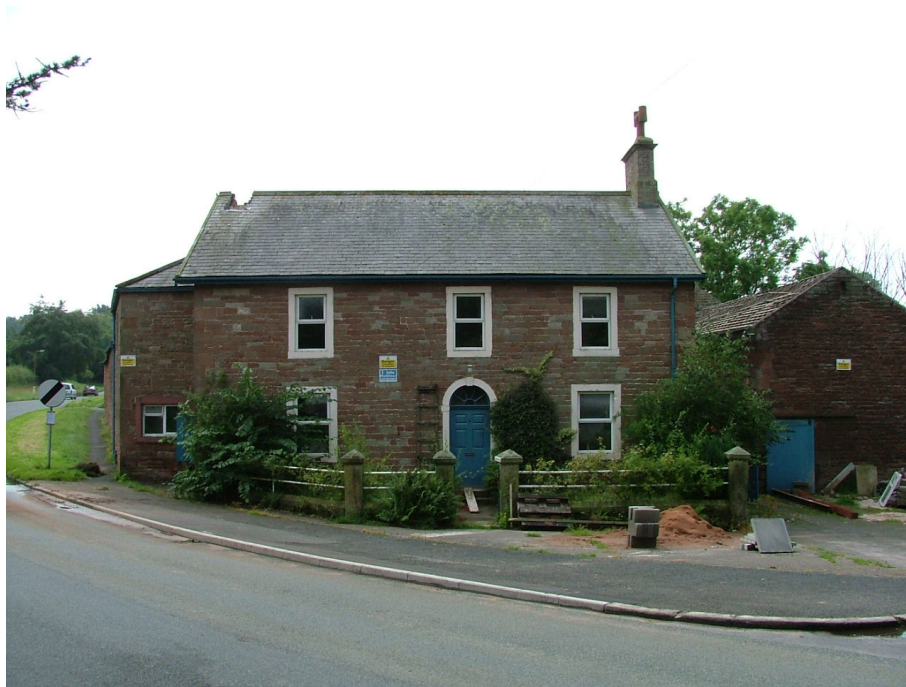
Plate 1 – Hembles Gate Farm, Tarn Road, Brampton

- 2.1 Hembles Gate Farm (Plate 1) is located less than 1km south-west of the market town of Brampton, on Tarn Road (B 6413), which heads towards Talkin Tarn *c.*1.5km to the southwest. The farm is sited at a height of *c.*100m above sea level, right beside Brampton Beck, a small stream that begins *c.*2km south-west of the farm, close to Brampton Station.

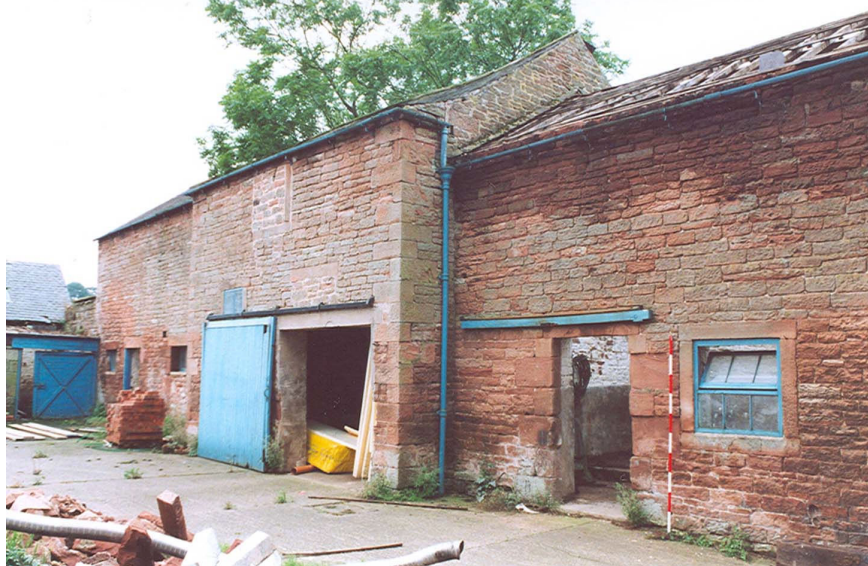
Plate 2 – Range A – Eastern elevation

5.1.1 Range A is located on the western side of the farm, and is constructed of coursed red sandstone masonry. Although the roof of the northernmost structure in this range has been stripped, the remainder of the roof coverings were of Welsh slate with sandstone ridge tiles. This range consists of three buildings, a byre (cow house), a bank barn and a central structure.

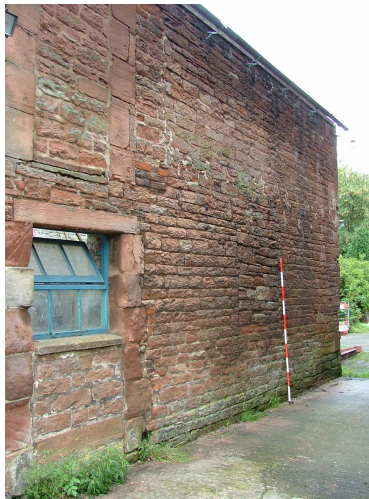
Plate 3 – Byre, range A

- 5.1.2.1 This building measures *c.*15.4m by *c.*5.5m and was originally of two storeys, however the joists and beams of the upper floor have been removed and at the time of survey the roof of the byre was no longer covered. On the east facing elevation of this buildings (facing into the courtyard) there are several blocked apertures at both ground floor and first floor level (Plates 3 and 4). At ground level, one original doorway has been blocked-up to create a window (1), and a possible window has been blocked-in towards the gable end (2) (beside the ranging pole in Plate 3), although this aperture had no window surrounds.

- 5.1.2.2 At first floor level, a doorway has been in-filled (Plates 3 and 4). It is most likely that this was originally a pitching hole, as there was no evidence for an external stone staircase, and a wooden ladder or similar would have obscured the doorway at ground level. Pitching holes are common in farm buildings, as they were used for the transference of hay or straw from the carts, to the dry conditions of the hayloft at first floor level. There is a window, with sandstone surround (3), and an unblocked doorway with dressed sandstone blocks making up the jambs (4) (Plate 4).

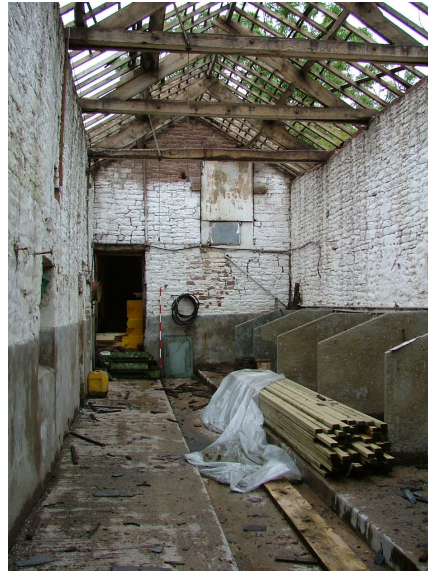
Plate 5 – Byre, Range A - Interior

- 5.1.3.2 This building is of six bays, the roof trusses are basic triangles of tie-beam and principal rafters constructed of machine-sawn timber. Each truss has a single angle strut on the western side. The floor and stalls are of concrete with a central passage, which allowed for the easy collection of manure to be used as fertiliser. There are eight stalls, all except one of which are double, providing accommodation for a maximum of fifteen cattle. The ceramic feeding troughs and metal water troughs are still *in-situ*, as are the vertical iron tethering bars, which were used to secure the cows. Ropes would have been used to tether the cow to the stall, and the vertical pole allowed the rope to move up and down, enabling the cow to lie down³.

- 5.1.3.3 The majority of the walls have been lime-washed (from stall height to the eaves), a common wall covering in Cumbria, which acts as a coating and disinfectant. Evidence for the first floor was not immediately observed as would be expected. Rafter holes were not visible, although they could have been filled in prior to the walls being whitewashed. There must have been a first floor at some point, due to the presence of the pitching hole already described. It is possible that only one half of the byre had another floor, as in the southern elevation there is a large doorway (6), with another pitching hole at an upper level (Plate 5). This doorway leads into the central section of the range.

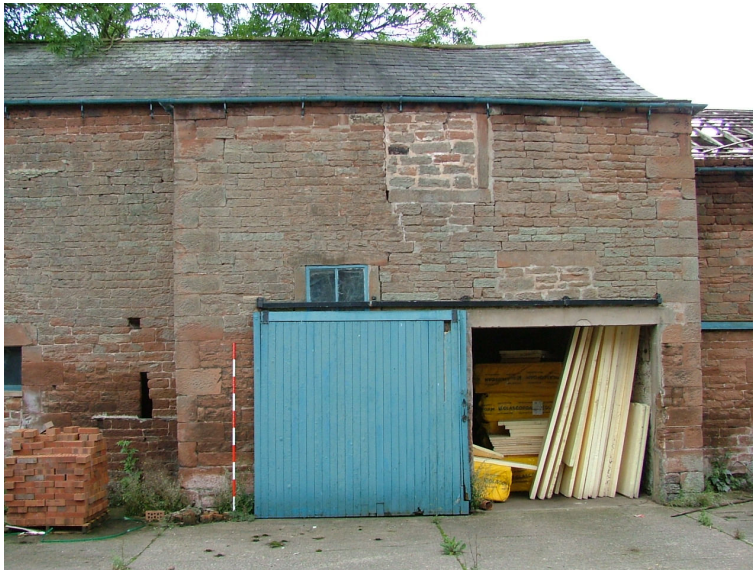
Plate 6 – Central section of Range A

- 5.2.2 The central section of this range projects out into the courtyard by *c.*1.0m and has alternating long and short sandstone quoins. This projection is often characteristic of threshing barns, where a canopy with cheeks was used to protect the main large doors into the barn where the hand-flail threshing of cereals was carried out during the winter months. There is, however, no evidence for the large doorways associated with threshing barns. Instead, a large modern doorway (7) with concrete lintel has cut through a blocked-up window at first floor level, a further window remains unblocked to the left, and another has been blocked and is situated just below the eaves.

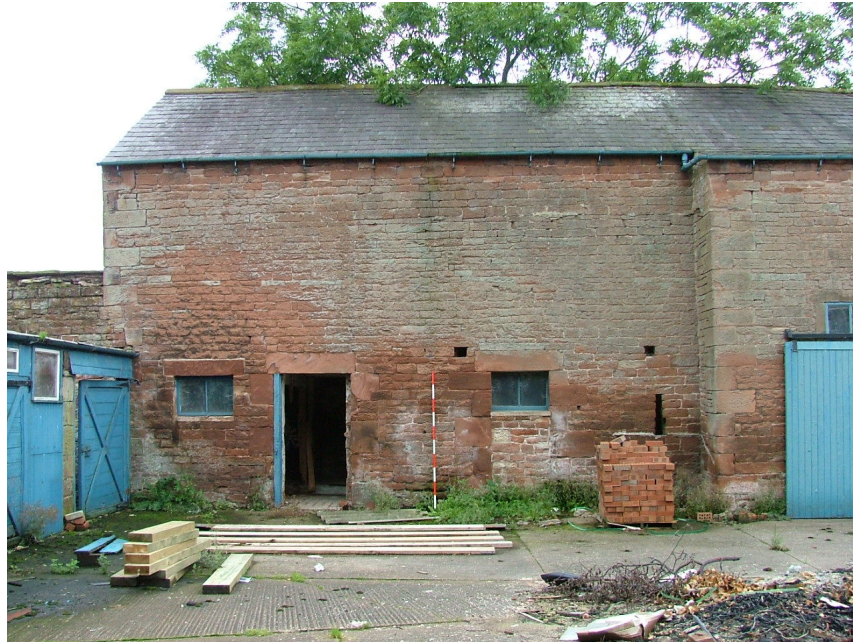
Plate 7 – Southern end of Range A

- 5.2.3 To the left of the central section (Plate 7), there is a single ventilation slit, a blocked-up doorway converted to a window (8), an unblocked doorway (9) and a window (10), all with sandstone lintels. The doorways have dressed sandstone blocks making up the jambs. Along this part of the elevation, there are no apertures at first floor level.

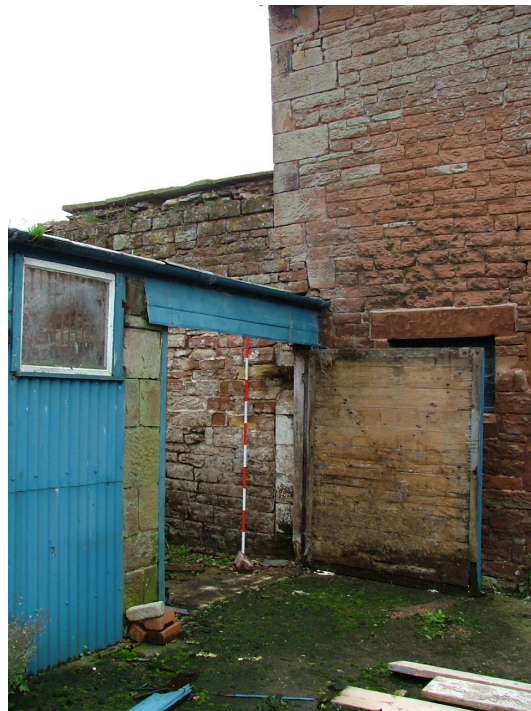
- 5.2.4 The southern gable end of this range is separated from the courtyard by a wall that continues from this range to the gable end of Range B (Figure 5). This wall appears to have been constructed after Range A, as some of the quoins of the range have been removed to accommodate the wall and give it stability (Plate 8).

Plate 8 – Southern end of Range A, showing the wall built into the quoin

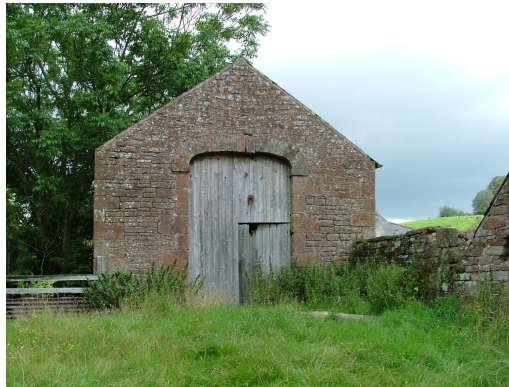
Plate 9 - Large doorway in southern gable end of Range A

- 5.2.5 In the southern gable end of Range A is a large doorway **(11)** that is accessed up the bank behind the farm (Plate 9). This doorway allowed for laden carts of cereals, hay or straw to be brought to the farm and taken straight to the dry conditions of the first floor of the barn. This building can be described as a bank barn, as access to the first floor is via a bank, however, it is not a true bank barn as described by Brunskill⁴. At Hembles Gate, the land does rise to the south-west of the farm, but it is possible that the bank which gives access to this doorway has been man-made, and constructed in connection with the mill-race and culvert (Brampton Beck) that flows right behind this range. The doorway itself has nicely dressed jambs and voussoirs.

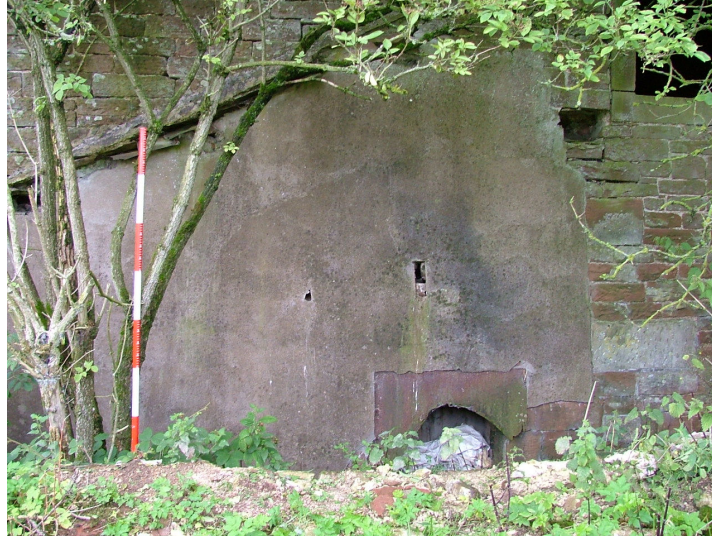
- 5.2.7 Midway along this elevation, there is a circular hole cut into the wall **(12)**, with the remains of a square metal plate that originally surrounded the hole (Plate 10). This hole would have been for the axle of a waterwheel, which was driven by the mill race (Plate 11), and which subsequently drove machinery situated inside the central section of this range. Until recently, there appears to have been either a building or a roof over this part of the mill race, as the scarring for the roof can clearly be seen on Plate 10, as can the remains of the render. This structure would have protected the waterwheel against frost, especially if it was not in constant use, and would have allowed the grease to stay on the bearings longer⁵. In some cases, scarring from the waterwheel itself can be observed etched into the wall through use over the years, this can give an indication of the diameter of the wheel⁶, however, there was no evidence of this at Hembles Gate.

Plate 10 – West elevation, Range A – waterwheel axle hole and scarring of roofline

Just above the waterwheel axle hole, to the right, is a window with sandstone surrounds (just visible in the top right hand corner of Plate 10). This window would have been undercover when the roof over the wheel was in existence.

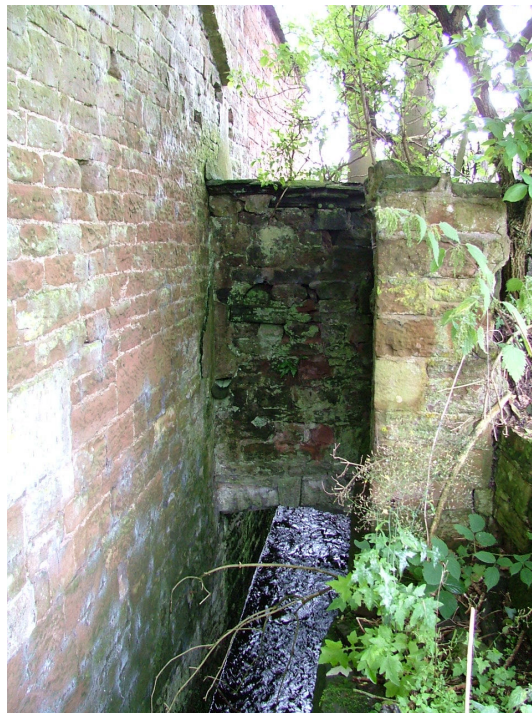
Plate 11 – Western elevation of Range A, mill race

- 5.2.6 The western elevation of the central section of this range and the bank barn was difficult to observe due to overgrown vegetation. A mill race flows alongside this range and the ground level is higher at the southern end of the elevation than it is at the northern, consequently it was not possible to photograph all the features along this elevation.

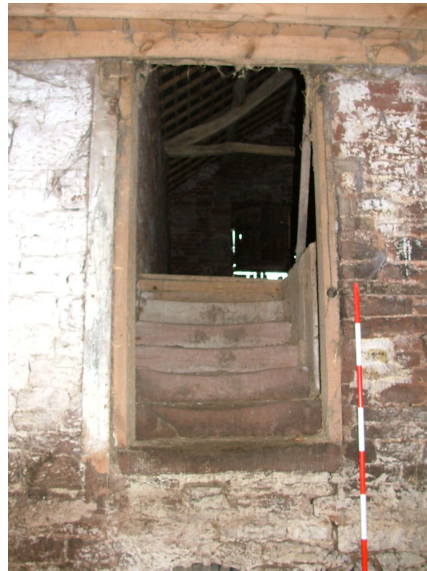
Plate 12 – Doorway in Range A, gives access to the bank barn

- 5.2.8.1 The interior of the central section of Range A is accessed via the large modern doorway (7) from the courtyard (Figure 5). The floor is of concrete and the walls have been limewashed. To the right of the entrance is the doorway that allows access into the byre (6). To the left of the main entrance is another doorway (13) set at a height of c.1.0m above ground level. There were no steps *in-situ* at the time of survey from ground level, therefore presumably at some time wooden portable steps were used. This entrance gives access to the first floor of the 'bank-barn' via five stone steps (Plate 12).

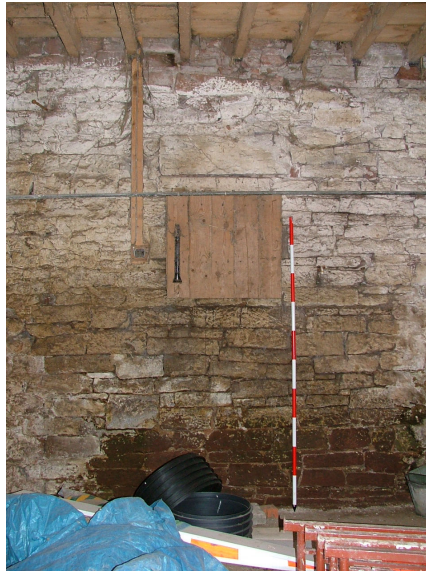
Plate 13 – Wooden door covering axle hole, Range A

- 5.2.8.2 On the wall opposing the entrance to the central section is a small wooden door with an iron handle measuring c.0.8m by c.0.8m, that has been nailed to the wall, above which is a large piece of dressed sandstone (Plate 13). This would appear to relate to the axle hole observed on the external western elevation of this range. This would suggest that it was in this room that the gearing for the waterwheel and the machinery that drove the thresher was located, although there is no other evidence visible.

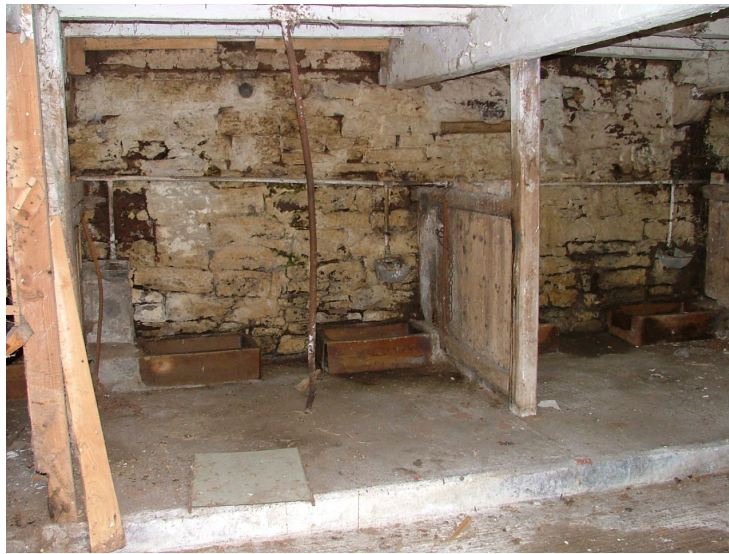
Plate 14 – Stalls in southern end of Range A

- 5.2.8.3 At the southern end of Range A, at ground floor level, is another byre, this one is smaller than the one at the northern end measuring c.8.8m by c.5.4m. The floor has been concreted providing a central manure passage, however, in this byre, the four double stalls are of timber. Still *in-situ* are the ceramic feeding troughs, metal water troughs and iron tethering bars with chains. The walls and the timbers of the ceiling have been limewashed. Supporting two of the beams for the floor above are nicely carved corbels (Plate 14).

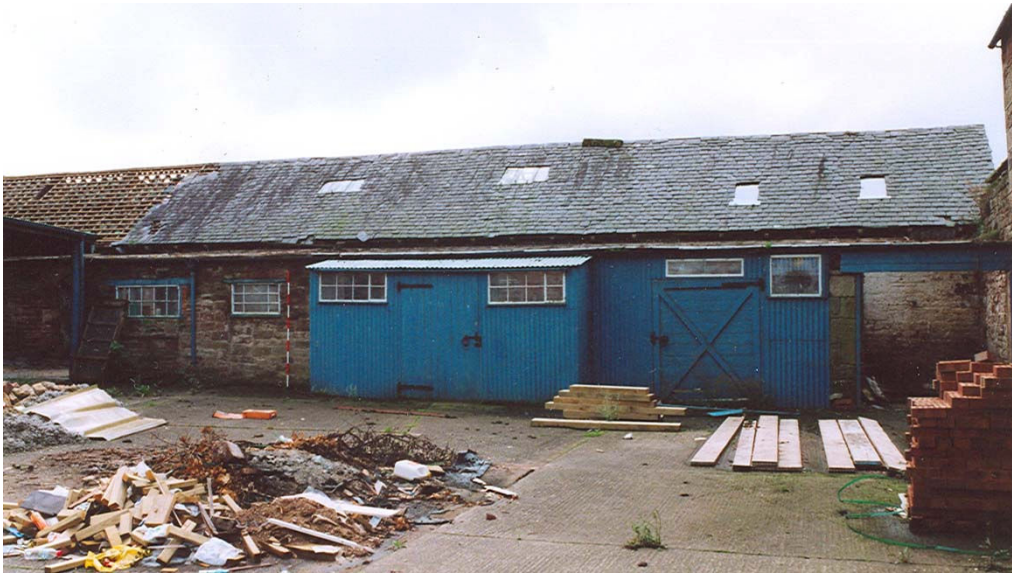
Plate 15 – Range B (Slated structure behind the later lean-to)

- 5.3.1 This building measures *c.*30m along its southern elevation by *c.*5.4m, and is of single-phase construction of coursed and dressed red sandstone masonry. What remained of the roof covering was of Welsh slate with sandstone ridge tiles, with skylights inserted into the north facing side. To the northern elevation of Range B, is a later lean-to of stone, corrugated sheeting and timber, this has obscured one of the three arched doorways that are located along this elevation (Plate 16). The arched doorway at the western end of this elevation has been partly filled in (14) with a modern door inserted. These archways have nicely dressed jambs and voussoirs of red sandstone and there is a slight chamfer along the edges (Plate 17). There are three small windows along the northern elevation, one of which was originally a doorway (15), these windows have sandstone lintels, which display tool marks.

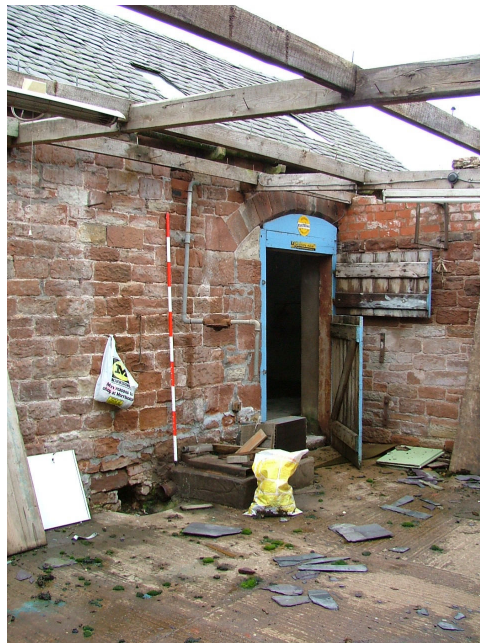
Plate 16 – Range B, partly filled-in arched doorway

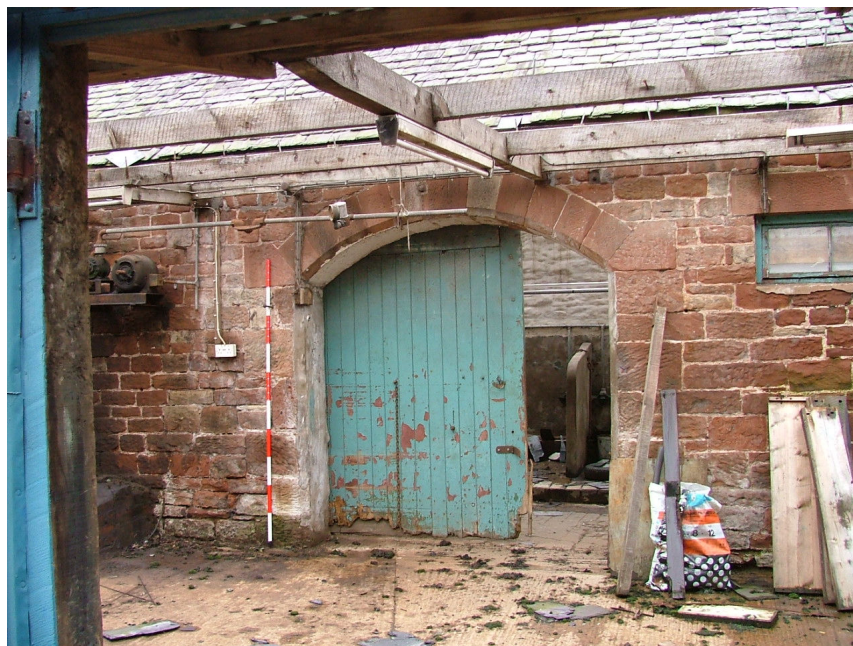
Plate 17 – Range B, arched doorway at eastern end of northern elevation

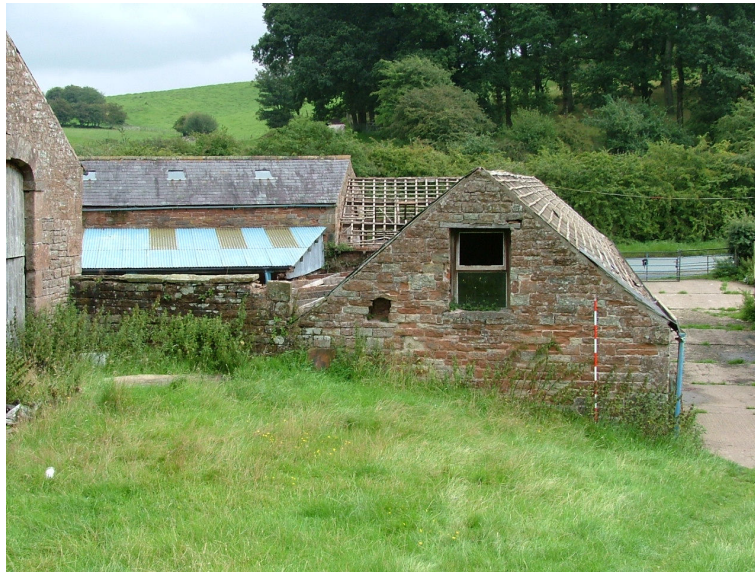
Plate 18 – Western gable end of Range B

- 5.3.2 On the western gable end of Range B, there is a single window close to the apex of the roof (Plate 18). Most of this elevation is obscured by the bank, which allowed carts to enter the first floor of Range A (southern end) through the large double doorway (11).

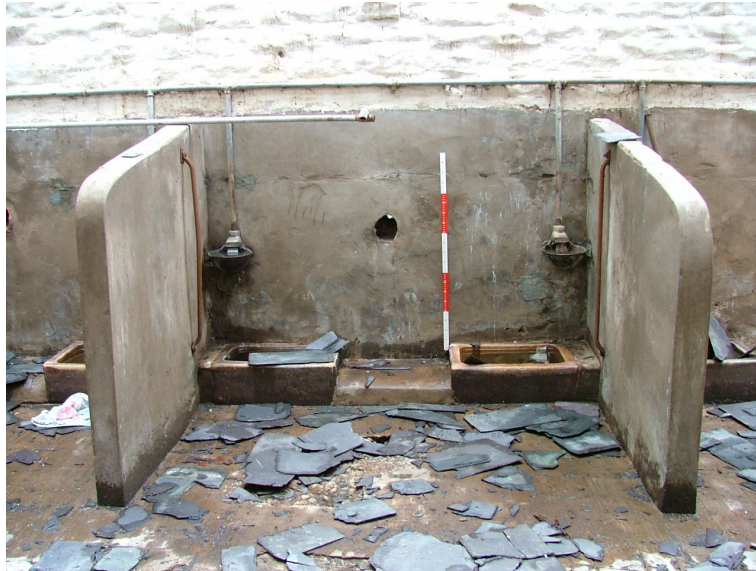
Plate 19 – One of the double stalls in Range B

- 5.4.2 The middle and eastern sections of the range have been used as the milking parlour. The two sections are separated by a stone partition wall. Both sections have concrete floors with a central manure passage, and the stalls are of concrete with ceramic feeding troughs, metal water troughs and tethering bars are still *in-situ*. The walls have been plastered from ground level to the height of the top of the stalls; the remainder of the wall is limewashed to the eaves (Plate 19).

- 5.4.3 The middle section is of five bays and there are five double stalls and one single stall, providing accommodation for a maximum of eleven cows. The king post roof trusses of machine sawn timber in this section display carpenter's marks of III to VI, running east-west (Plate 20). The eastern section of this range is accessed through a large doorway (**18**) in the partition wall dividing it from the central section. This part of the range is of four bays with five double stalls providing accommodation for a maximum of ten cows.

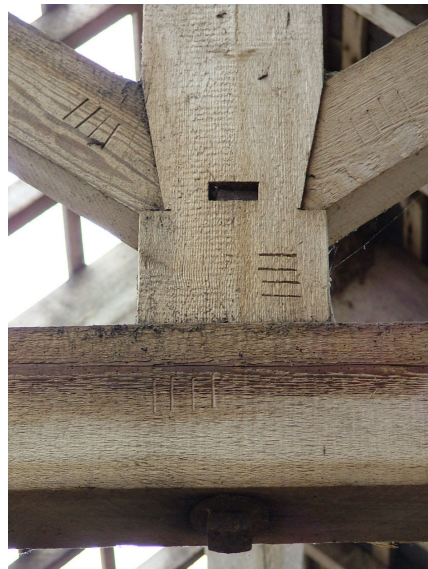
Plate 20 – Carpenter's (or assembly) marks on a roof truss in Range B

- 5.4.4 Of the three roof trusses in this section, only one has a carpenter's mark. This is on the eastern-most truss and has the mark VIII, therefore the carpenter's marks do not run in number order from east to west, except from the middle to the western end. Attached to one of the trusses in the eastern section are three metal plates, which are prize's won by the farmer (possibly John Foster, who is listed as being at Hembles Gate in 1954 – see Appendix) at Brampton Agricultural Show in the 1950's (Plate 21).

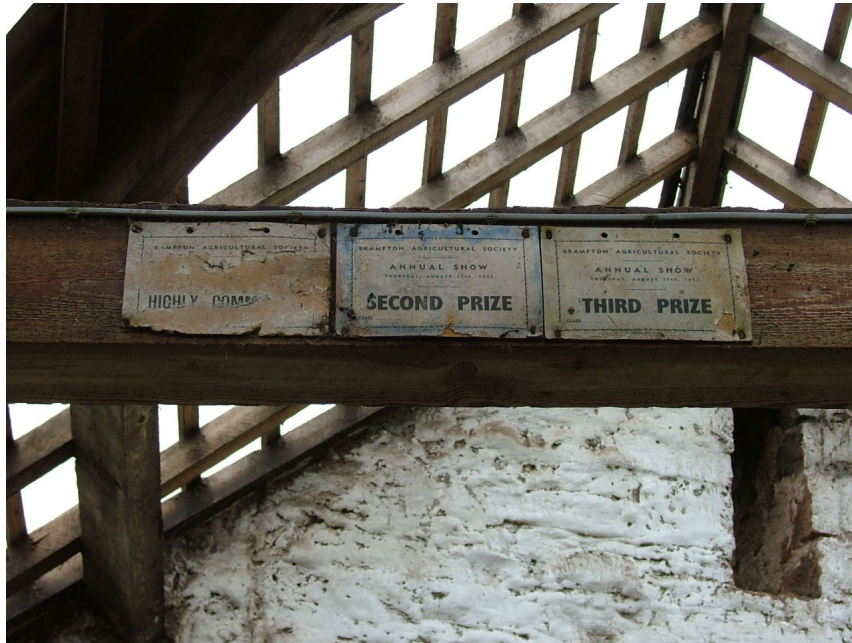
Plate 21 – Prize's won at Brampton Agricultural Show – Range B

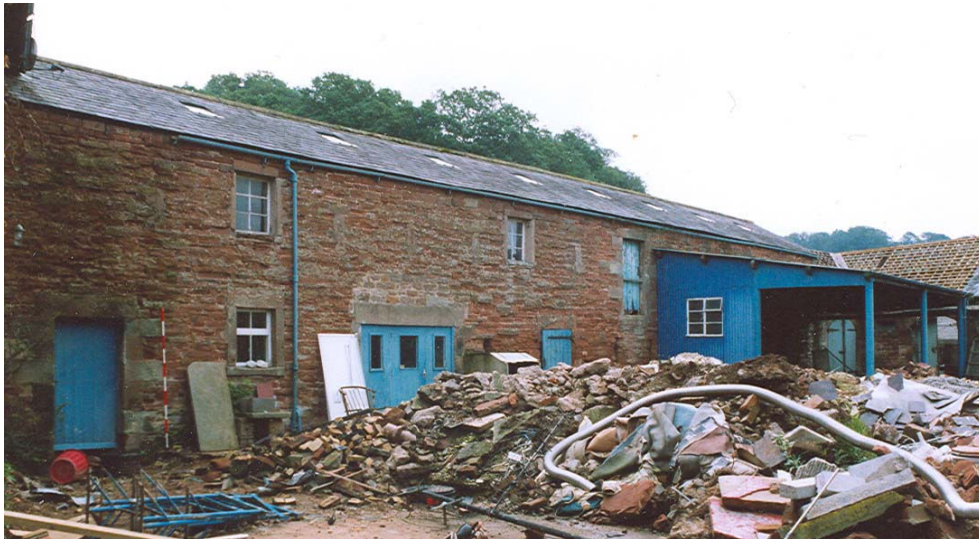
Plate 22 – Western elevation of Range C

- 5.5.1 Range C runs parallel to Tarn Road and links the rest of the farm buildings with the farmhouse (Figure 5). It is constructed in a similar manner to the rest of the farm buildings, but unlike them, this range has ventilation slits at ground and first floor level all along the western facing elevation. A more recent addition to this elevation is the blue ‘lean-to’ made from corrugated metal sheeting and timber. Most of the range is of two storeys; however, at the southern end there is a single-storey room with a large arched doorway (19) similar to those in Range B. The roof is of Welsh slate with skylights inserted to provide extra light for the first floor.

- 5.6.6 The addition of an extra floor to an earlier single-storey building is, however, not evident on the western facing elevation (Plate 22). It is possible that the rubble masonry shown to the right of the earlier gable in Plate 28 may be related to the rebuilding of the range, creating a wider and taller structure, in which case the western elevation would be of single-phase construction. The quoins observed at ground floor level, in the calf pens, may relate to this earlier gable, which could be the remains of a building to the south of this wall (where the single-storey loose box/stable is located, as described in 5.6.1).

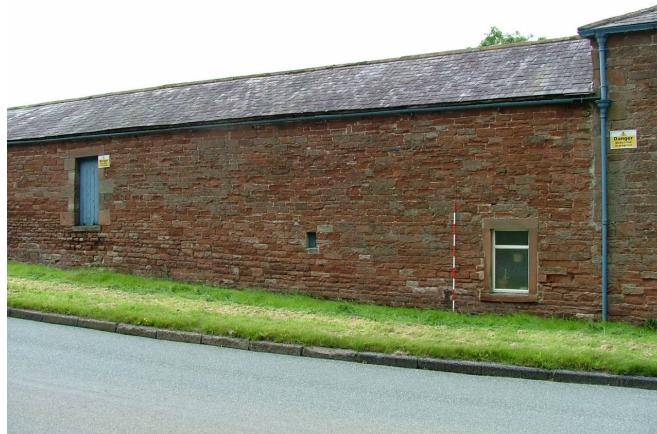
Plate 23 – Eastern elevation of Range C

- 5.5.2 The eastern elevation of Range C faces the main road (Plate 23). Along this elevation there is a pitching door at first floor level and a window (20), which belongs to the washroom of the farmhouse. This range appears to butt up against the quoins of the farmhouse from an approximate height of 1m from the ground (beside the blue drainpipe in Plate 23). This would suggest that Range C was possibly constructed after the farmhouse, although the similarity of the stonework continuing from the farmhouse to the farm buildings, below where the quoins start, contradicts this. It therefore seems more likely that Range C was originally only one-storey high and that where the walls have been raised is from where the quoins of the farmhouse start.

- 5.6.7 The doorway observed on the eastern, external elevation of Range C (Plate 23), would have allowed for the transference of hay, straw or grain from loaded carts on the roadside to this first floor loft. The storage of straw or hay at first floor level was common practice as it kept the bales dry, but it also provided insulation for the animals below.

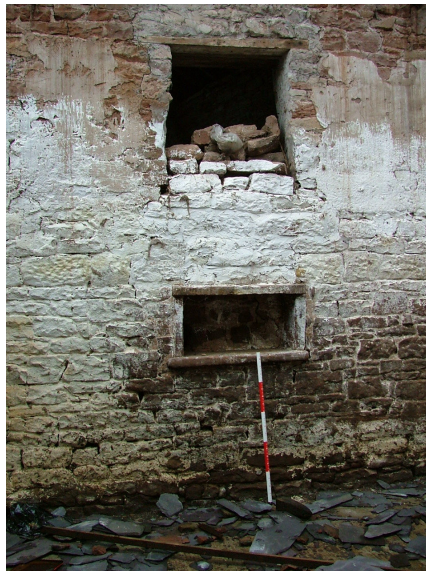
Plate 24 – Recess and window in gable – Range C

- 5.6.1 The southern end of the range is of one-storey and is more a continuation of Range B. This part of the range appears to have been most recently used as a stable or loose box, as the hay rack is still *in-situ*. In the northern gable of this room, there is a recess (**24**) in the wall at ground level with a window above (Plate 24).

- 5.6.2 This recess may have been used for the storage of grooming tools, medicine or candles⁸, used while attending to horses, which may have been stabled in this room. The window above could have been used to move hay from the loft of the next part of the range.

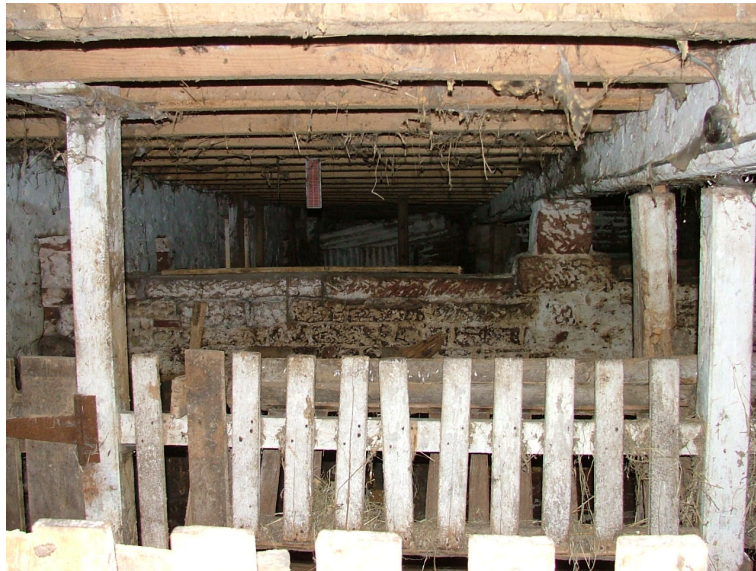
Plate 25 – Low ceiling of the calf pens in Range C

- 5.6.3 The next two doorways along the western elevation of Range C (**21 & 22**), give access to calf pens, two either side of each doorway. The floor of these pens is of concrete, but the stall divisions and the feeding troughs are of timber. These pens have low ceilings, which only just allow a person to stand straight. Separating each pair of pens is a stone wall of dressed red sandstone that supports the beams for the ceiling above (Plate 25). The walls have been limewashed. At the base of the wall of the first calf pen (set into the gable end), there are the remains of some quoins, which presumably belonged to an earlier building (Plate 26).

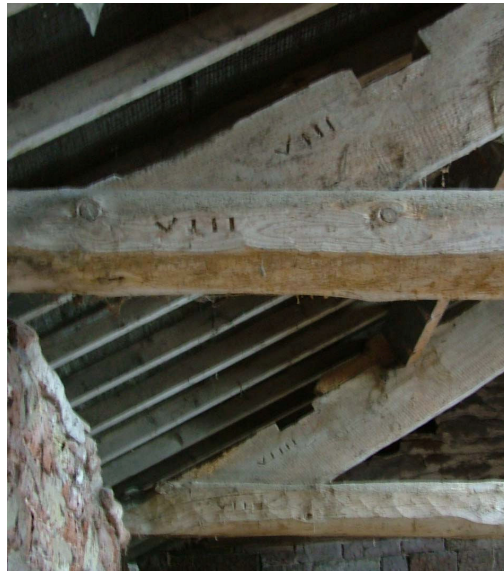
Plate 27 – Carpenter's marks – Range C

- 5.6.4 The first floor of Range C is of ten bays and extends over the whole of the range of farm buildings and over the washroom of the farmhouse. The roof trusses are basic triangles of tie-beam and principal rafters, which rest on sandstone wall plates. The timbers used in the construction of the roof are hand-cut and bark is still visible on some of the wood. Carpenter's marks are visible, and run in order (north-south) from I to VIII. These numerals are deeply cut, probably from using a chisel and they are quite different from those observed in Ranges A and B (Plate 27). Un-used slots for purlins are visible in these timbers, this suggests that either the timbers have been re-used, or that the most recent roof covering needed smaller holes for the purlins, and were therefore cut further up the truss (Plate 27). The underside of the roof has been felted.

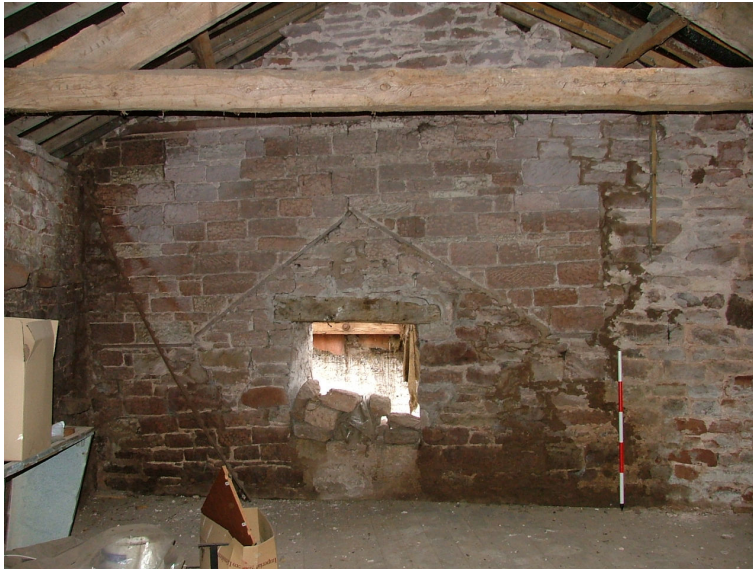
Plate 28 – Scarring of an earlier building in the southern gable end of Range C

- 5.6.5 In the southern gable end of this range, there is scarring in the wall of a smaller gable that suggests there was an earlier building on the site (Plate 28). The stonework directly above this scarring is well-dressed coursed sandstone, yet the masonry to the right and that which makes up the apex of the roof, is roughly dressed rubble sandstone. This is further evidence that there may, at one time, have been a single-storey building on this site (See 5.6.2).

- 6.5 Range C is the only range of the farm that displays evidence of there having been an earlier structure on the site. The scarring of a roofline and the quoins seen at the southern end of the range, and the way that the range butts up against the quoins of the farmhouse at the northern end, suggests that there was a single-storey building on the site, prior to its conversion to two-storey. There is a possible difference in building stone along the eastern elevation of this range (Plate 23) but the sandstone has weathered somewhat and therefore this is not immediately apparent. There is no evidence of an extra storey having been added on the western elevation (Plate 22), but this is possibly because the whole building was not only heightened but also widened, and that the whole western elevation was re-built
