Project Designs and Client Reports No. CP/142/04

**REPORT ON
AN ARCHAEOLOGICAL
BUILDING RECORDING PROJECT
AT LOW GREEN FARM
GILCRUX
MARYPORT
CUMBRIA**

**MURRAY PROPERTY
DEVELOPMENTS LTD**

**NGR NY 1154 3815
Planning Application No. 2/04/0656**

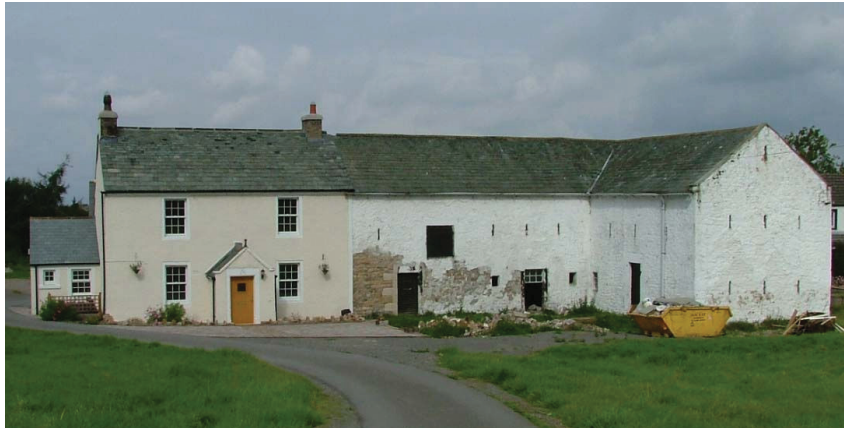
Plate 1 – Low Green Farm, Gilcrux

- 2.1 Low Green Farm (Plate 1) is located just less than 1km south of the River Ellen, in the centre of Gilcrux (Figure 1), a village 8km north of Cockermouth and approximately 8km west of Maryport, which is on the Cumbrian coast. The farm is sited at a height of c.80m above sea level.

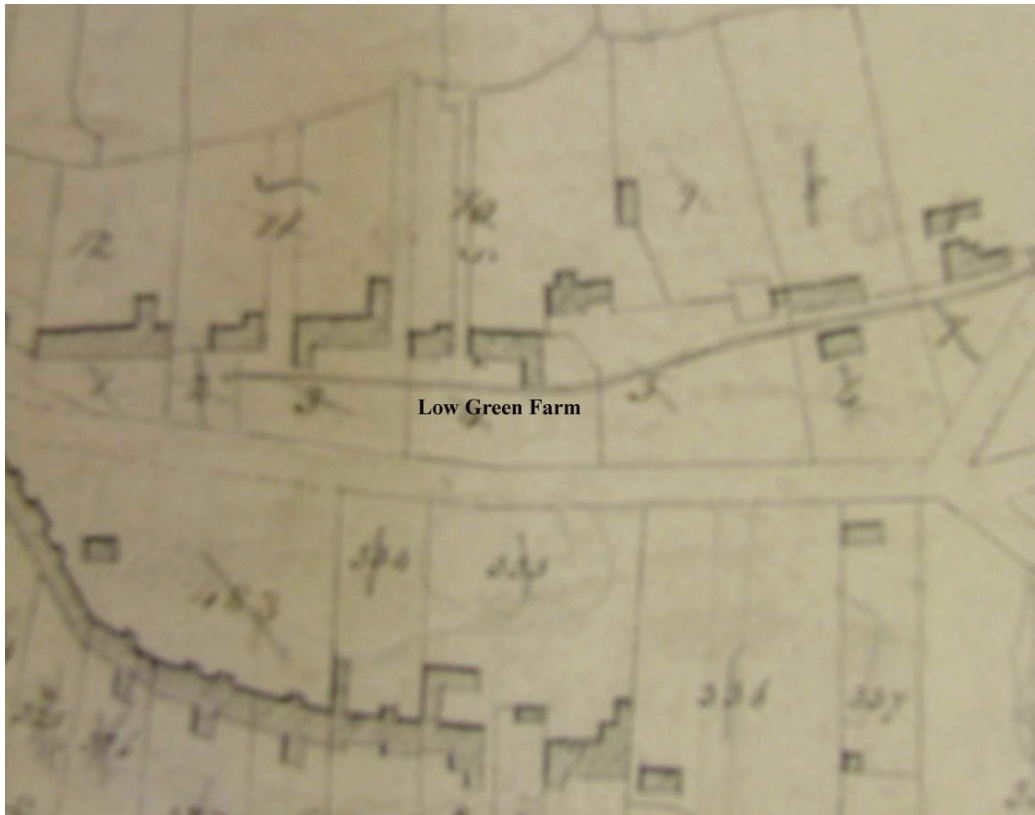
Figure 2 – Tithe Map of 1841

- 2.3 The survey is concerned with two buildings, which date from at least 1841 as they are present on the tithe map of that date (Figure 2). They adjoin the farmhouse, which has a date stone of 1711 at the front entrance and another of 1675 to the rear. There is another range of farm buildings to the rear, which like the farmhouse, do not form part of the present survey. This range was probably built before 1866, as it is present on the First Edition Ordnance Survey map of that date.

- 6.2 It is difficult to date buildings such as these at Low Green Farm, cartographic evidence shows that these buildings were in existence by 1841 (Figure 2), although it is highly likely that they were constructed some time before that. Brunskill has noted that the rebuilding of yeomen's houses in the late 17th and early 18th centuries was often followed by the reconstruction of farm buildings or the raising of new ones¹⁴. The date stones of 1675 and 1711 on the farmhouse may hint at some rebuilding being undertaken at Low Green Farm. The initials could also refer to the Younghusband's who were yeoman farmers here in 1841.

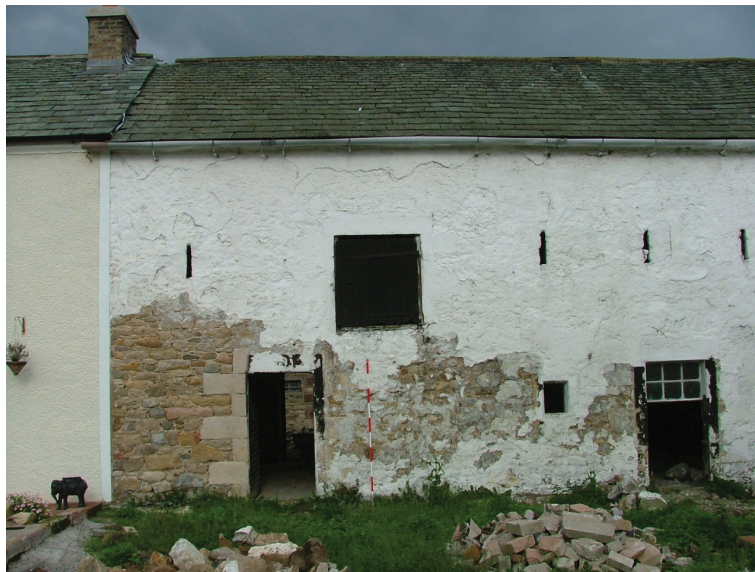
Plate 2 – Building A, Eastern Elevation

- 5.1.2 At ground level on the eastern elevation (Plate 2), there were originally two entrances, however one has more recently been blocked in and used as a window (although at the time of survey the blocking had been removed). The unblocked doorway has nicely dressed sandstone blocks for its jambs and lintel. There are two small windows along this elevation, and one blocked-up ventilation slit. Above these doorways at first floor level, there is a pitching hole, which was used for the transferring of hay or straw from the dry conditions of the upper level. Unblocked ventilation slits are visible along this elevation.

- 5.1.1 This building is attached to the northern gable end of the farmhouse, but due to the recent renovation of the farmhouse, it is not possible to assess if Building A butts up against the dwelling, or if it is a continuation. The building measures *c.*10.9m by *c.*5.75m and is constructed of uncoursed rubble masonry, a mixture of red, yellow and grey sandstone. The roof is of diminishing courses of Cumbrian slate with sandstone ridge tiles. The exterior wall of the eastern elevation has had several coats of limewash, although this is not the case on the western elevation, which is not coated. It is possible that, because this was the side facing the road, the limewash may have been used for aesthetic purposes. However, limewash was also applied to stone or clay walls to absorb some moisture, thus preventing walls from getting too damp, but as limewash is not completely impervious to water, it also allowed walls to breathe². In a village with so many springs³ (a small stream flows just in front of these buildings), the use of limewash may have been mainly functional.

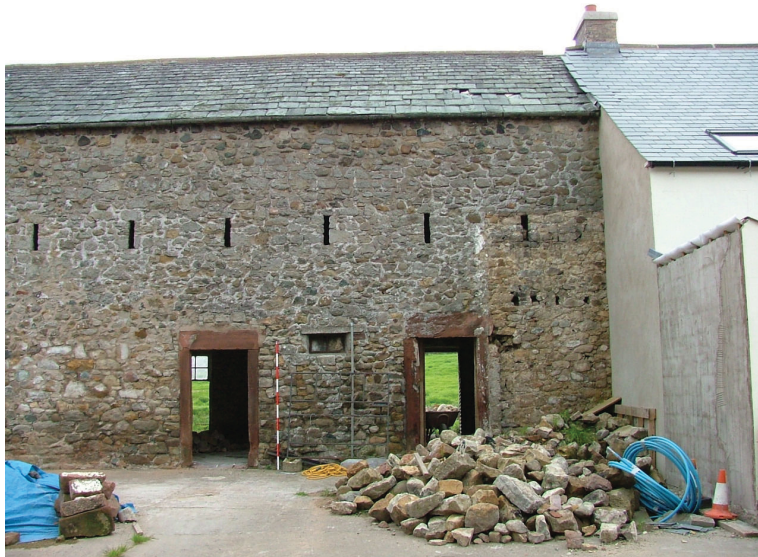
Plate 3 – Western Elevation of Building A

- 5.1.3 On the western elevation of Building A (Plate 3), there are a further two doorways, both with red sandstone lintels and jambs. One of the lintels has tool marks to its upper half, this gives a simple decorative effect. Between the two doorways is a small window, with a blocked ventilation slit just to the left. The proximity of the window to the blocked vent suggests that the window is a later insertion.

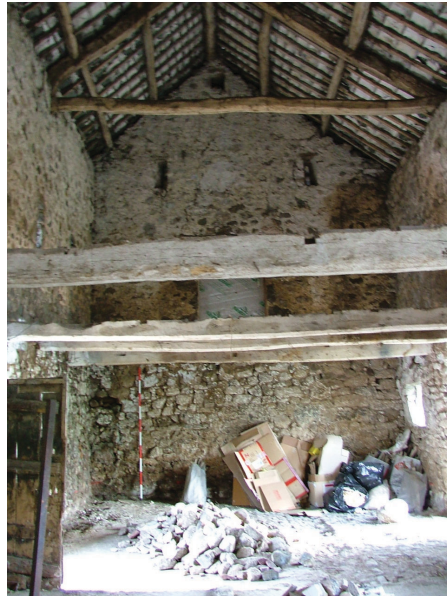
Plate 4 – Northern gable end of Building A

- 5.2.3 The first floor was most likely the hay loft, and there would originally have been holes in the floor that would have allowed for the pushing of hay into feeding troughs in the rooms below. Accommodating animals below hay lofts was a common practice as it provided insulation in the winter. This building is of four bays with a simple principal rafter roof, the trusses of which are of hand cut timber. On the northern gable end is a further pitching hole (with a wooden lintel) similar to the one described in 5.1.2. On the same elevation are two ventilation slits and an owl hole. All of these have been obscured by the addition of Building B, and therefore Building A must have been constructed earlier (Plate 4).

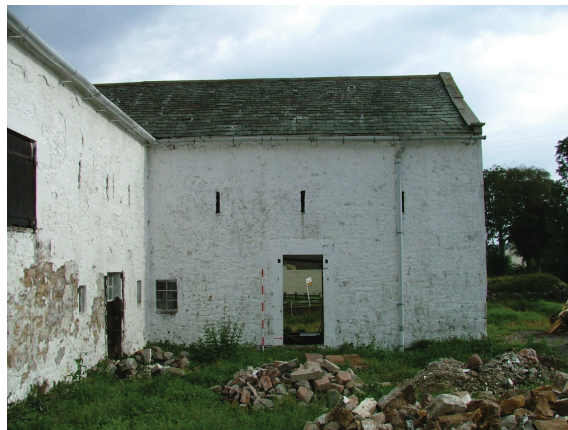
Plate 5 – Southern elevation of Building B

- 5.3.2 On the south facing elevation is a tall doorway measuring over 2m in height (Plate 5), much taller than those on the east and west facing elevations of 'A'. It has a nicely dressed lintel and jambs, into which there are four square recesses just below the lintel (two on each side). The upper holes are larger and deeper than the two below, suggesting that at one time there may have been a canopy or porch projecting from the top of the doorway. There is a sandstone step at the base of this entrance that does not appear to be a later addition, which suggests that this doorway was not intended to give access for animals. On the eastern gable end (Plate 6) seven ventilation slits are clearly visible, each measuring approximately 50cm in height and 10cm wide externally.

- 5.3.1 Building B measures *c.*13.7m by *c.*6.3m, and like Building A is constructed of uncoursed rubble sandstone masonry. This barn is located at a right angle to Building A, with its western end butting up against the gable end of 'A'. This building has also been limewashed on all elevations except the western. The roof is a continuation of that over Building A, built of the same materials, this suggests that either the roof over 'A' was re-laid when 'B' was constructed, or both were re-covered at a later date. The eastern gable end of Building B has coping terminating in kneelers, and although this is the only part of the roof where coping and kneelers could have been used, it is noticeable that this is the gable end that faces the road. This simple architectural detail would have been easily seen by passers-by.

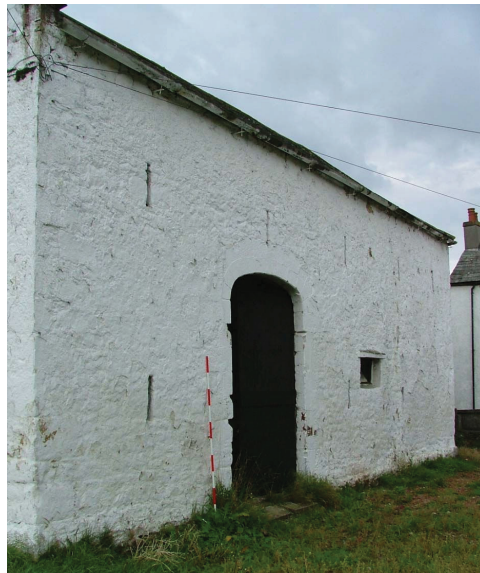
Plate 7 – Northern elevation of Building B, showing the large ‘threshing’ doorway

- 5.3.3 The north facing elevation has a large doorway that is over three metres in height and has 17 nicely dressed voussoirs making up the arch with dressed masonry for the jambs (Plate 7). This entrance would have allowed for fully laden carts to enter the barn, but it would also have been originally intended for assisting in the hand-flail threshing of cereals, a practice that would have been carried out on nearly every farm up to the early 19th century prior to mechanisation, and perhaps later depending on the availability of other forms of power. The hand-flail threshing of cereals involved the beating of the corn on a clean surface, such as stone flags, to separate the grain from the stalk. The process was generally carried out just inside the barn at the through-entry, in the line of opposing doors⁶.

- 5.3.4 The draught through these opposing doorways provided ventilation for an extremely dusty and unpleasant occupation, as well as helping to separate the grain from the chaff and stalk. At Low Green Farm the opposing doorway to this large entrance on the northern elevation is the tall aperture already mentioned above. The presence of the four holes at the top of that doorway may have accommodated a canopy that helped channel the wind through the barn⁷. The large doorway would also have provided light through the winter months, when this process was carried out.

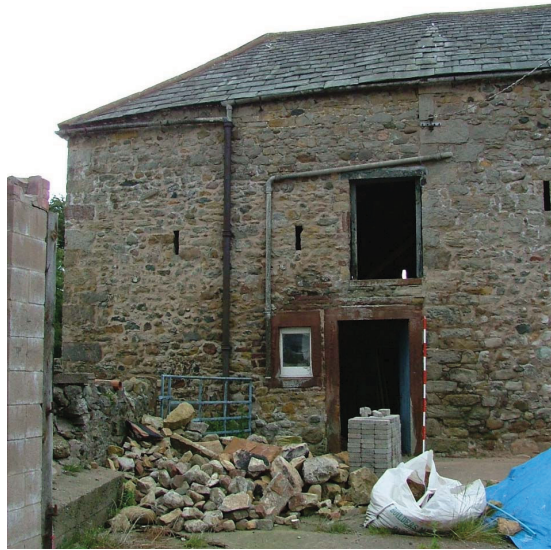
Plate 8 – Western gable end of Building B

- 5.3.4 Ventilation slits are visible along the upper storey of the northern elevation, with blocked and un-blocked ones at ground floor level. A small window to the right of the large doorway appears to be a later insertion, as the mortar around is thicker and it has a concrete lintel. There are 6 iron bolts projecting through the wall at ground floor level between the doorway and the western corner, these appear to be related to the concrete stalls inside.
- 5.3.5 On the western gable end there is a doorway with sandstone surround, and a small window at ground floor level, and another pitching door above (Plate 8). The construction break between Buildings A and B is clearly visible on this elevation. The doorway at ground level and the pitching doorway have both been built up against the quoins of Building A.

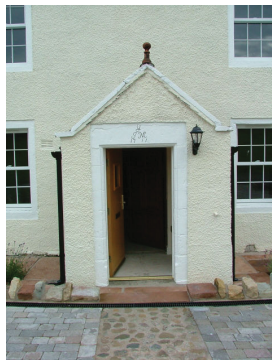
Plate 9 – Farmhouse entrance (front)

5.5.2 The doorway is a moulded square-headed opening (Plate 9). To the rear, in an outshut to the main house, is another doorway with a false four-centred arch surround⁹ (Plate 10). It is possible that the door surround to the rear is re-used from an earlier house. This doorway has a date of 1675 and the initials:-

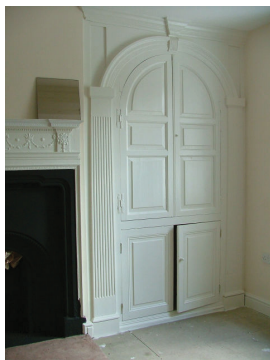
Plate 13 – Cupboard of 1725 – 1750 ¹²

¹² Compared to an example given in Lander, H., 1982, Page 78. This cupboard has arch moulding with a dropped key block

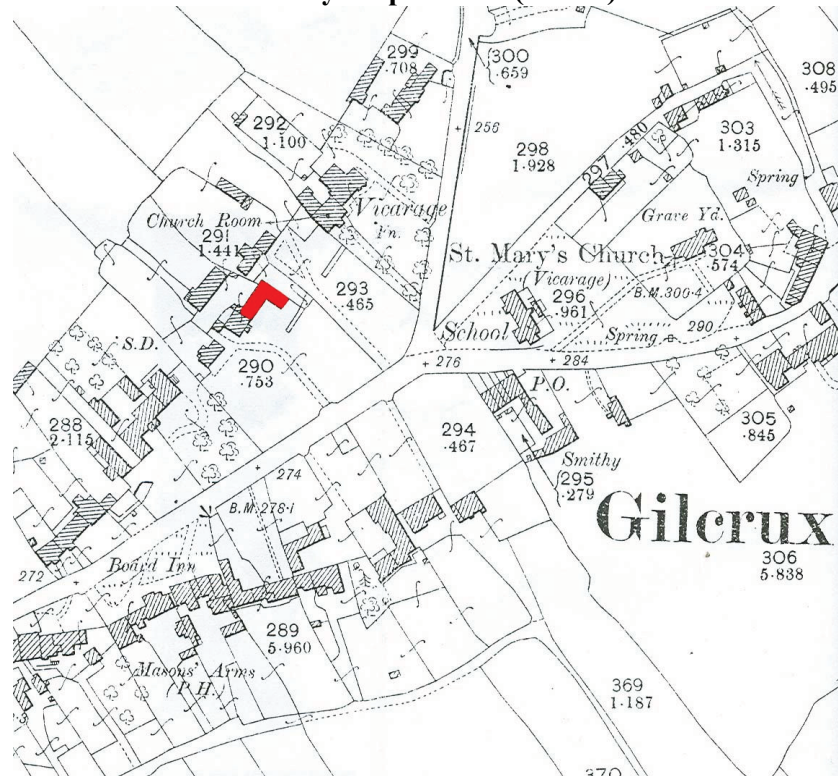
Second Edition Ordnance Survey Map of 1900 (1/2500)

Farm buildings that are the subject of this survey are in red
