## NORTH PENNINES ARCHAEOLOGY LTD

## Project Designs and Client Reports No. CP/141/04

REPORT ON
AN ARCHAEOLOGICAL
EVALUATION AT
MIDDLE FARM
NEWTON ARLOSH
CUMBRIA

25<sup>th</sup> September 2004

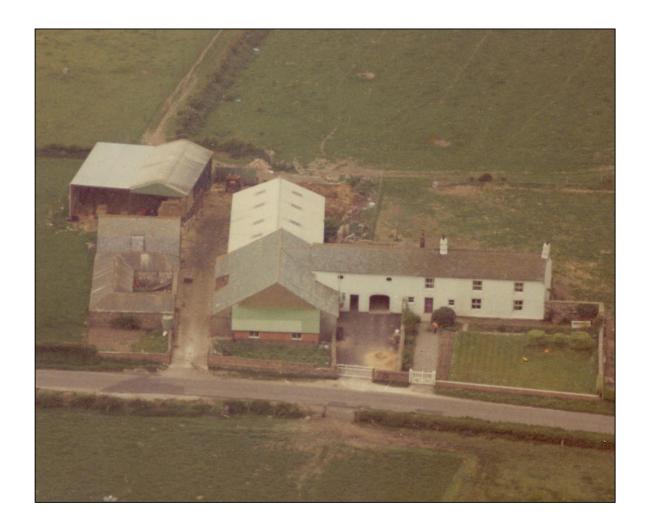
Plate 1: Middle Farm in 1976.

- 4.5.4 Middle farm at Newton Arlosh had two significant clay buildings comprising the farm house and barn and is likely to have been constructed in the mid 18<sup>th</sup> century. The complex of buildings was largely unchanged from those shown on the first and third edition ordnance survey maps to those photographed in 1976 with the exception of two new barns to the rear of the complex (see Plate1).

- 4.5.5 The front wall of the farm house collapsed in the wet summer of 1976 as a result of water leaking through the roof into the clay making the whole structure unstable. The farm house itself was demolished as a result and a new house built on the site. The barn was still in extant up until the outbreak of foot and mouth in 2001. The clay building had at some point been reinforced with breeze blocks, but with the outbreak of foot and mouth the clay building was considered to be too difficult to disinfect and was subsequently demolished. Fortunately the building was documented in a recent book on Clay dabbins so the plan of the barn is available.

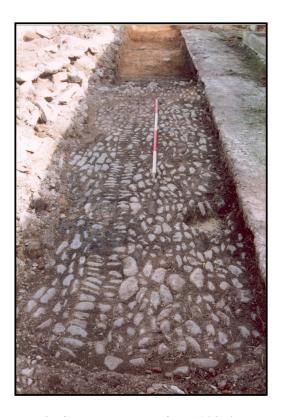
- 5.5.1 Trench 4 measured 1.5m by 20m and was excavated to a depth of 0.45m. The trench was aligned northwest-southeast and cut across the site of the original farmhouse. No evidence survived of the building itself, although an associated cobble yard surface (109) was observed in the north western end of the trench measuring 0.25m in depth. This was sealed beneath a modern demolition deposit measuring 0.30m in depth. This 19<sup>th</sup> century cobble surface (109) was laid directly onto the natural sandy gravel. No earlier deposits were recorded within trench 4.
- 5.5.2 No other features of archaeological note were observed.

Plate 3: Cobble yard surface (109) in trench 4
