**Project Designs and Client Reports No. CP133/04**

**REPORT ON  
AN ARCHAEOLOGICAL  
BUILDING RECORDING PROJECT  
AT THE FORMER BONDED  
WAREHOUSE  
BEEZON ROAD  
KENDAL  
CUMBRIA**

**FOR  
STAINSBY GRANGE (KENDAL)  
LTD**

**NGR SD 5175 9315  
Planning Application No. SL/04/0760**

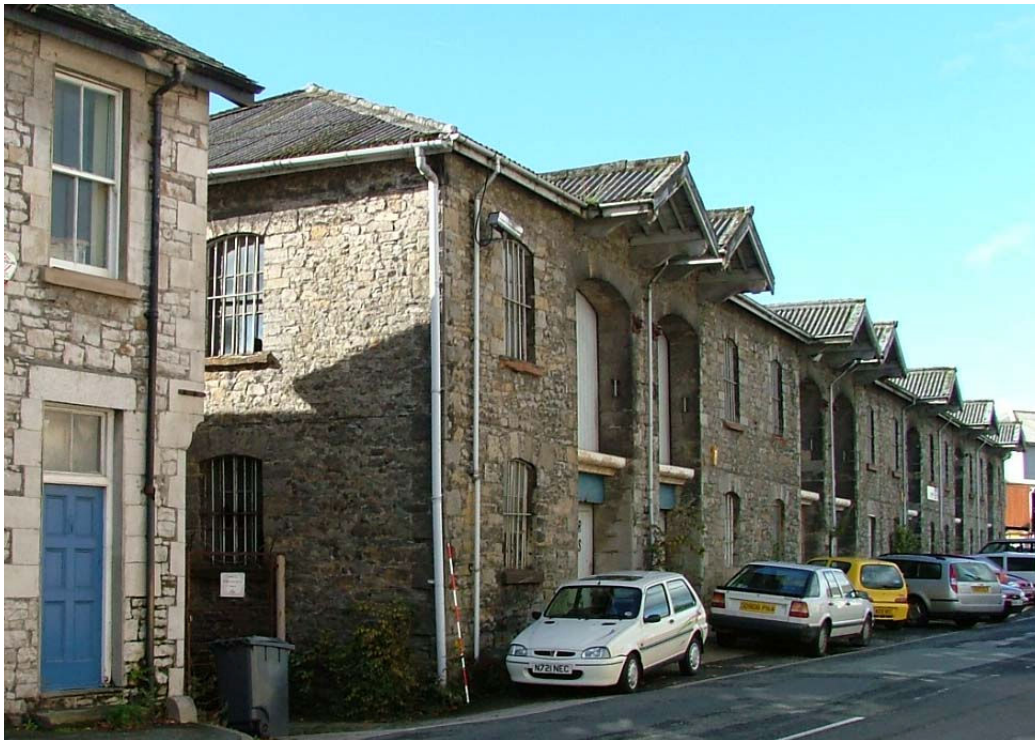
**Plate 1** – The Former Bonded Warehouse, Beezon Road, Kendal (NE Elevation)

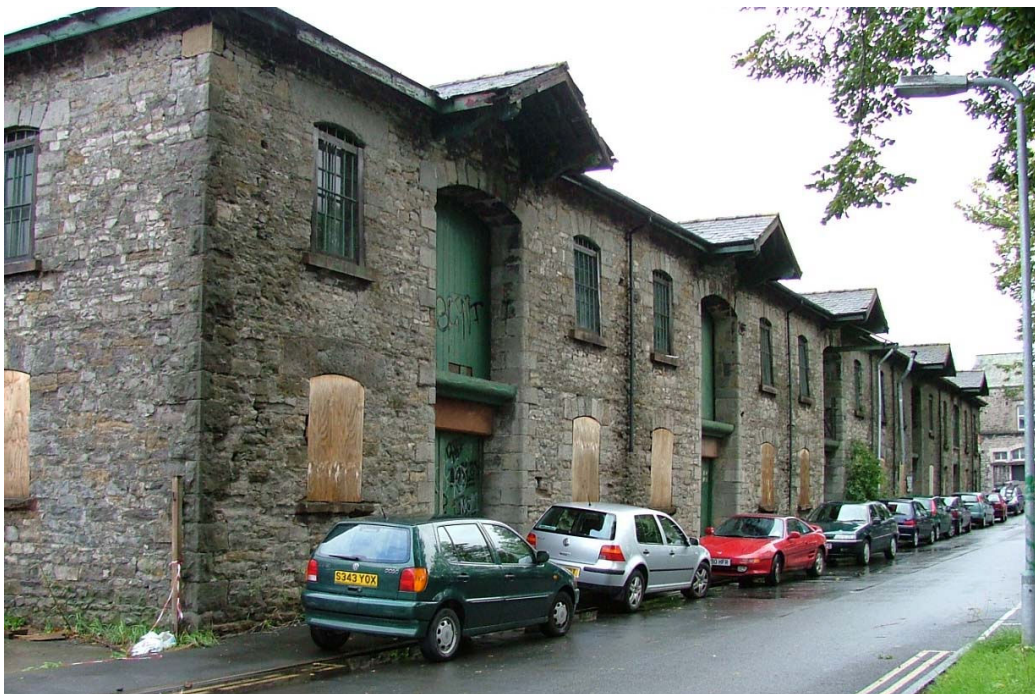
**Plate 2** - The Former Bonded Warehouse (SW Elevation facing River Kent)

6.4.1 This elevation faces the River Kent. It consists of five double doorways at ground level, with corresponding double doors above, used to hoist goods in and out of the warehouse. These doorways are recessed into apertures that have well-dressed limestone alternating long and short blocks making up the jambs, giving a decorative effect. Between the upper and lower doorways there are large red well-dressed (with tool marks visible) sandstone lintels with a cast iron lintel above that, these have the stamp of 'J LEES CARLISLE' (plate 5). One upper doorway still retains its iron hoist projecting out from the wall, along with its iron 'safety gate' (Plate 5 – BW No.10). Each of the upper doorways used for loading and unloading of goods, is protected by a gabled dormer roof projecting from the main roof structure. The dormers are all constructed of machine-sawn timber, with carved wooden supports.

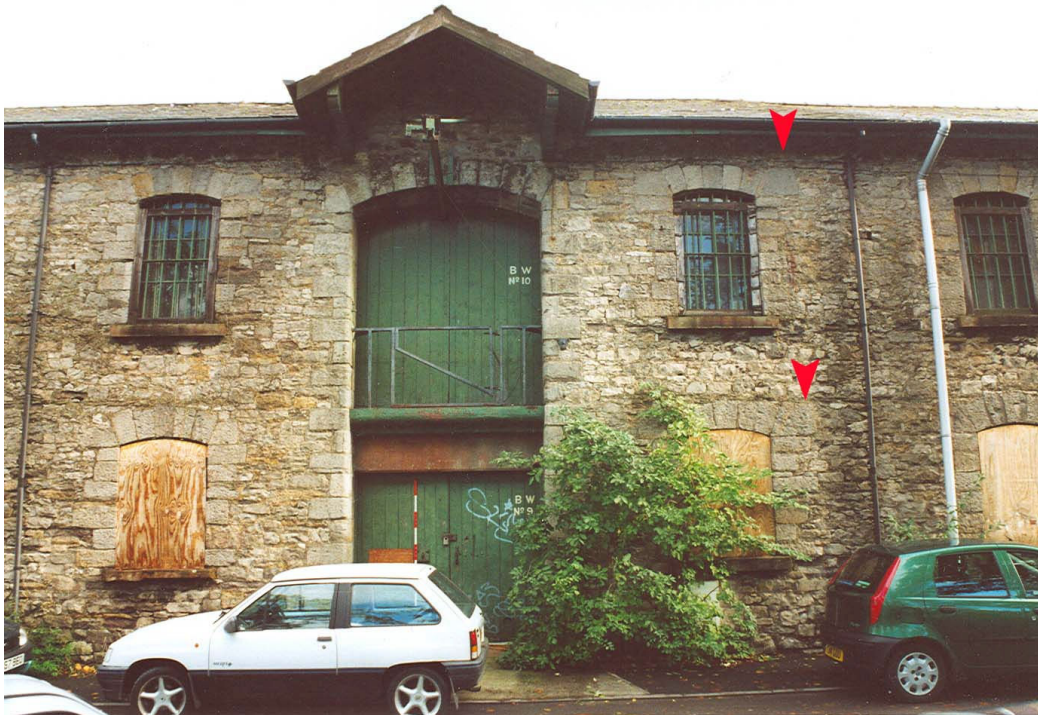
**Plate 3** – SW facing elevation – Red arrows indicate the layers of slate

- 6.1 The Former Bonded Warehouse, Beezon Road, Kendal, is of single phase construction, measuring *c.*64 metres in length, *c.*34.6 metres in width and *c.*6.8 metres to eaves height, and of two storeys (figure 6). It is built of uncoursed, roughly squared limestone masonry, with a string course of slate just above ground floor window height, and another just below the eaves (plate 3). These would have been used to level up the masonry.

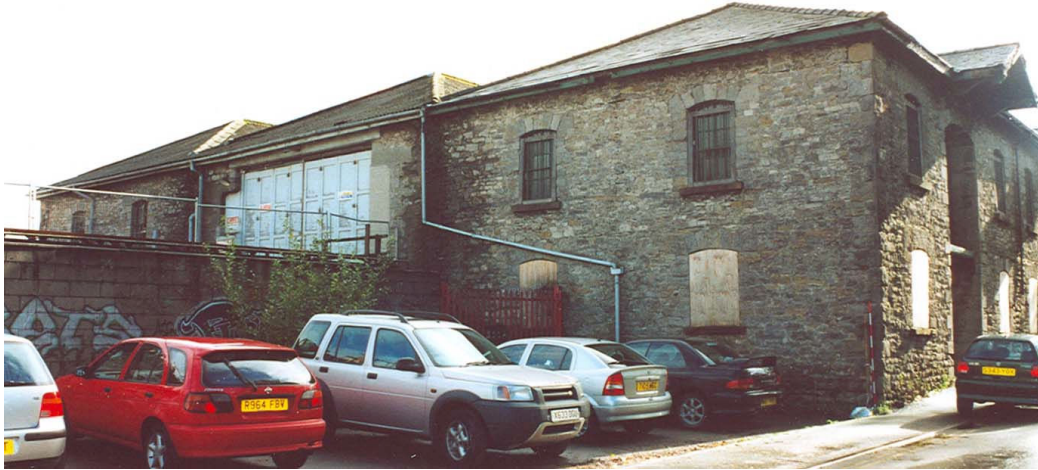
**Plate 4** – NW Elevation showing roof structure

with skylights inserted to provide light for the middle range. Since the building has become unoccupied, and therefore not maintained, the valleys between the roofs have become blocked, causing water to penetrate into the structure and down the walls of the end elevations, in particular the NW elevation, which can be seen on plate 4.

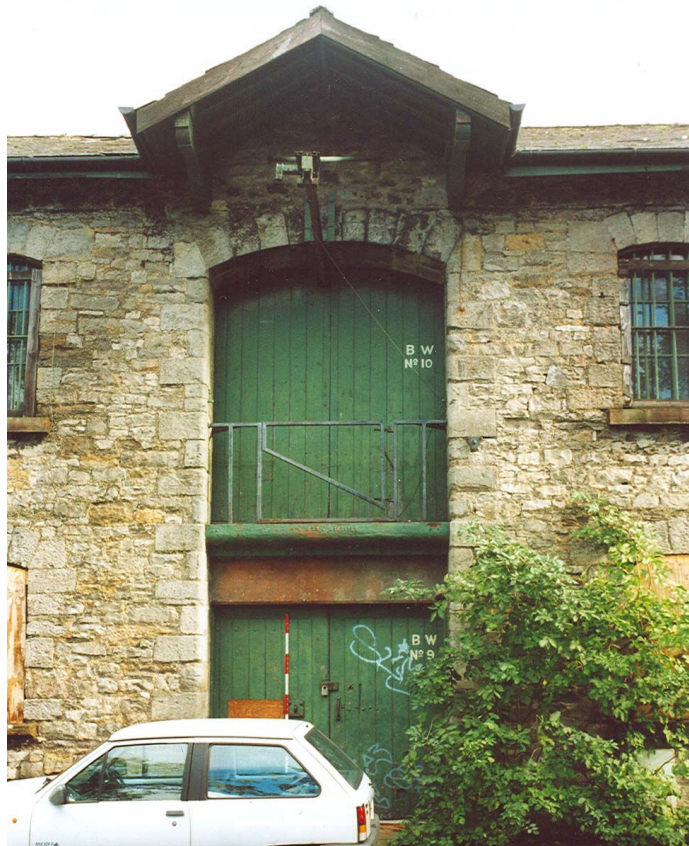
**Plate 5** – SW Elevation, View of doorways with sandstone and cast iron lintels and hoist still *in-situ*

6.4.2 Between the double doorways there are windows at both ground and first floor level. One of the large first floor loading doorways at the southern end of the elevation has more recently been converted to a window, with uncoursed roughly dressed limestone masonry used to fill in the aperture. Below this towards the end of the elevation, at ground level, there is a standard doorway, into which access could not be gained as a suitable key was not available. It is possible that this entrance once gave access to an office (figure 6).

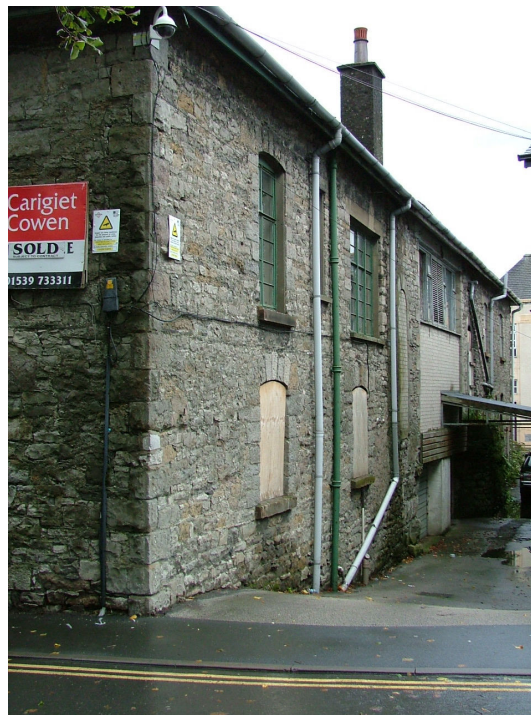
**Plate 6** – SE facing Elevation

6.5.1 The SE elevation of the warehouse faces Sandes Avenue, but is largely obscured by the office building, which hindered the photographing of this part of the building (Plate 6).

6.5.2 The ground level at this part of the building is noticeably different looking eastwards, and is considerably lower than that on the SW facing elevation, by *c.*1.60 metres (Plate 6). The SW facing elevation does, however, not appear to have been originally any lower as the doorways are level with the current road surface. It is therefore possible that prior to the warehouse being constructed an area of ground closest to the river was raised to prevent the warerooms at ground level from being at risk of flooding when the river levels rose.

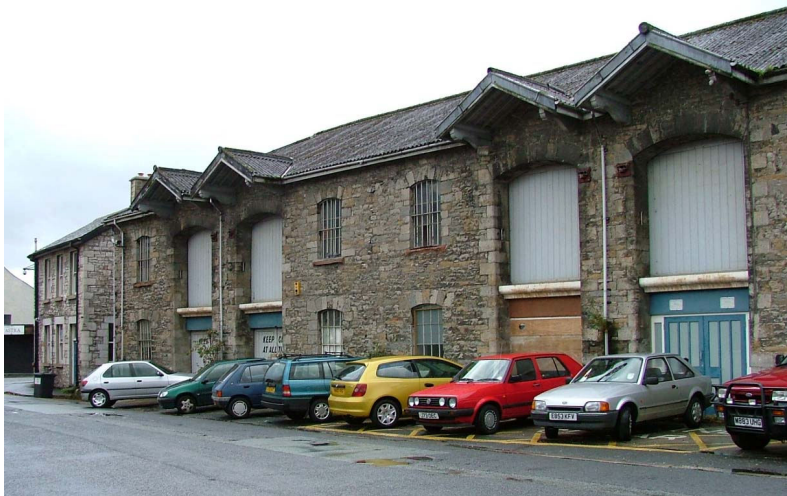
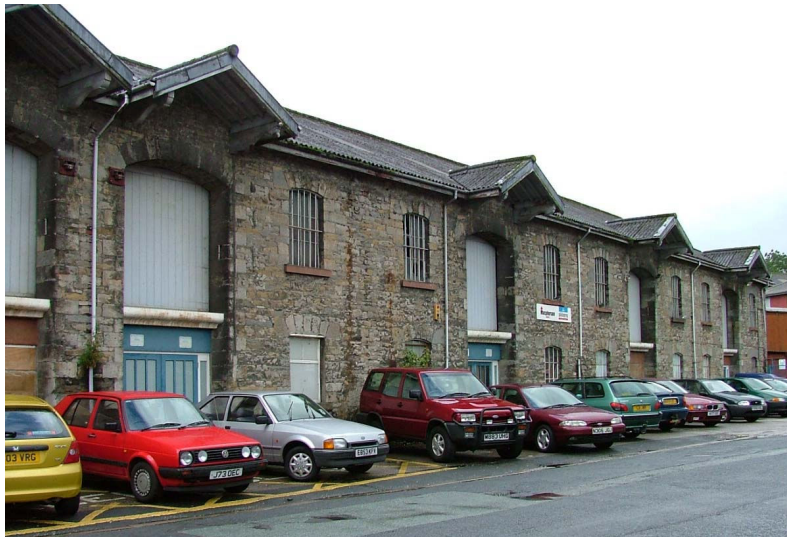
- 6.6.1 The NE elevation differs from the opposing SW elevation in that it has more loading doors, seven in total, of which four are in two pairs. This may reflect the fact that the warehouse, although bonded, was originally constructed also to house free goods as many of the town's shopkeepers and traders lacked warehouse space<sup>11</sup>. It would appear, certainly from the internal arrangement that the eastern side of the warehouse was therefore for goods on which duty was not required to be paid. The presence of more loading doors along this elevation could suggest that the security of the goods stored inside was less paramount than that in the western range of the warehouse.

Plate 7 – NE Elevation looking south

Plate 8 – NE Elevation looking north

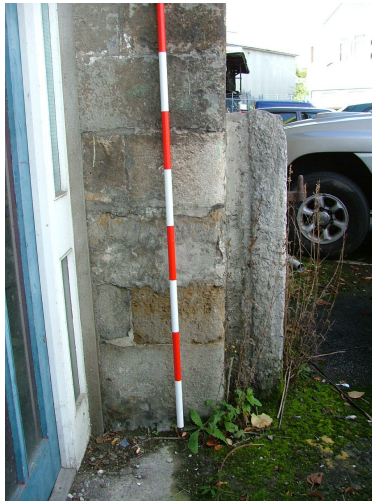
**Plate 9** – NE Elevation, gate post

- 6.6.2 Set into the jambs surrounding the upper doorways are metal bars, one either side of each doorway. These were presumably used for tying up ropes or fastening chains connected with the hoists.
- 6.6.3 The only other feature of note along this elevation is the presence of a limestone gate post butting up against the wall beside the central double doorway (plate 9). This suggests that there was one time an area of enclosed land beside the warehouse

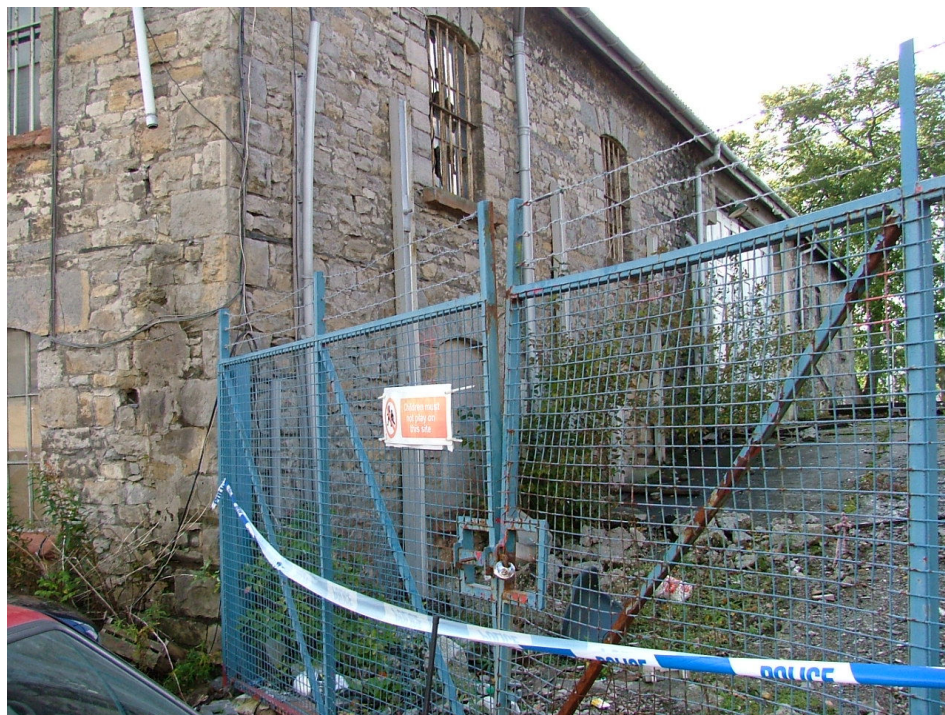
**Plate 10** – NW Elevation from the east

- 6.7.3 From what could be observed of this elevation, it was possible to see that the ground level has been raised since the warehouse was constructed, as the access ramp up to the large doorway obscures two of the ground floor windows (plate 10). There was evidence that originally this elevation was the same as the SE elevation. Either side of the large central doorway was the remains of door jambs that appeared to be arched at the top. These appeared very similar to the surrounds of the two doorways at first floor level on the SE elevation. It is possible to suggest that the large door aperture has been widened by effectively removing the two doorways. It is, however, also possible that this large doorway was originally larger than that on the opposing elevation, and that the 'arched' effect is actually corbels, this would appear to be the case when viewed internally.

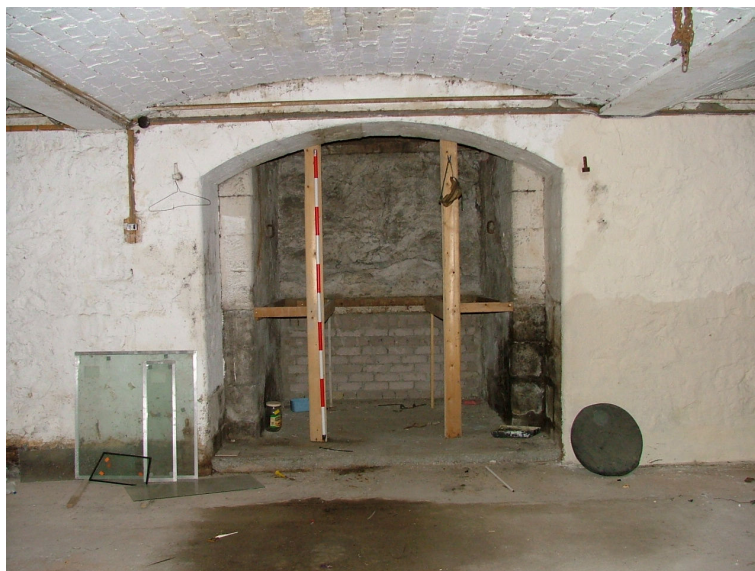
**Plate 11** – The alcove or ‘drop’ at rear of warerooms

6.8.2 The vaulted ceilings of the warerooms are constructed of brick (jack-arches), with cast iron Doric-style pillars supporting cast iron girders. This would have meant that the vaults were relatively fireproof. At the rear of each room is an arched alcove or ‘drop’ from which goods from the first floor were dropped to the lower storey (plate 11).

- 6.8.5 The alcoves at the rear of the vaults have well-dressed masonry blocks making up the jambs and voussoirs of the arched head (plate 11). They measure *c.*2.20 metres wide at the front, *c.*2.20 metres deep and *c.*2.50 metres high at the back. Originally a wooden trap door would have been used to drop goods from the first floor to the ground floor. The scarring for the extent to which these doors dropped from above is still visible, and is represented in Figure 8a. The goods would have easily slid down the opened trap door to below. Iron fittings for the ropes or chains for the trap door are still *in-situ* either side of the alcove.

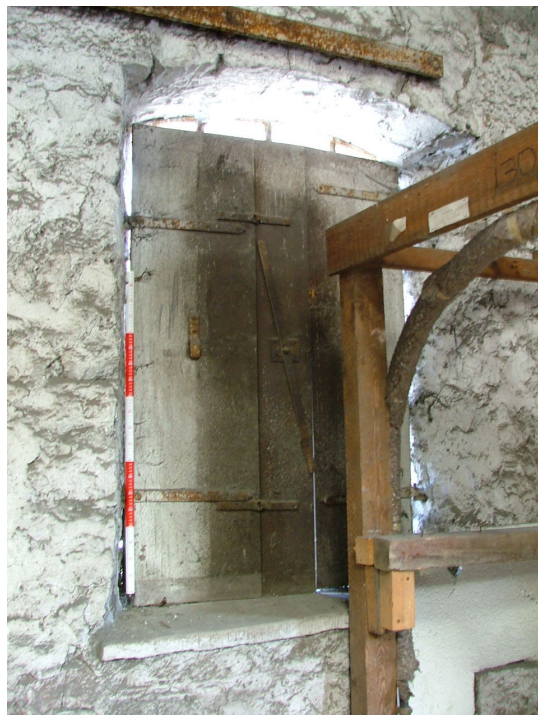
**Plate 12** – Wooden shutter, first floor Eastern Range

- 6.9.2 In the eastern range, the original shutters for the windows are still in place, complete with iron fittings (plate 12), as are the large solid timber sliding doors to the loading bays seen from the exterior (plate 13). Large stones project from the wall, in some cases over 2 metres beyond the door apertures. These appear to correspond to the end of the metal track that carries the wheels for the sliding doors, and therefore it would seem that the function of these large stones is to stop the door from coming off its rails (plate 14). Large stones at the other side of each door, which also project from the wall, house iron loops to which the padlocks for the doors would be fastened when closed (also visible on plate 14).

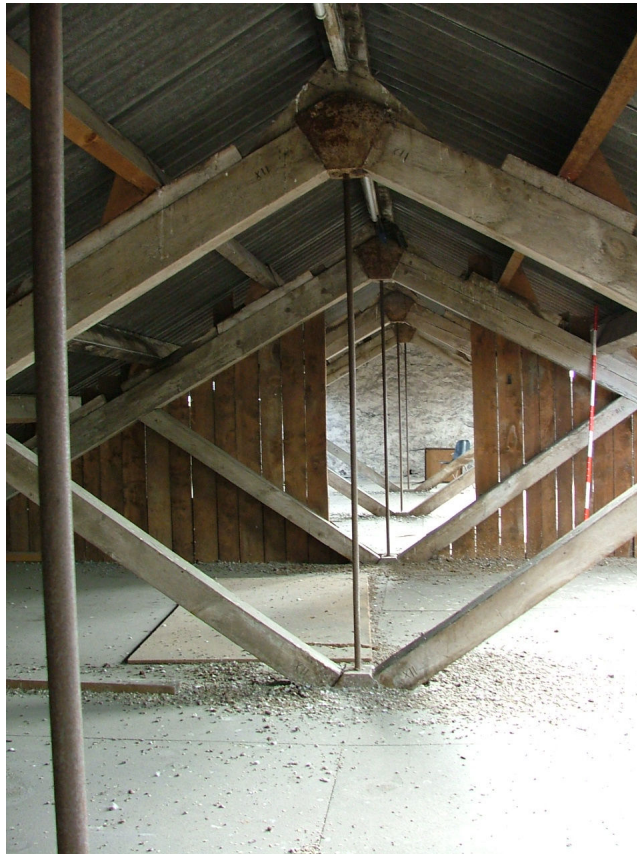
**Plate 15** – Roof structure of Eastern Range as seen from a modern floor inserted in the rafters

- 6.9.3 The eastern range had been divided, at its southern end, by four stone gable walls, with central doorways in each. (figure 9).
- 6.9.4 The roof of the eastern range is constructed of machine-sawn timber making up the tie beams and struts, with iron tie rods acting as king-posts (plate 15). The use of wrought iron in roof construction generally began in the early 18<sup>th</sup> century, when wrought-iron bolts would be used to stiffen mortice and tenon joints<sup>12</sup>. Carpenter's or assembly marks were observed on some of the trusses, although they did not appear to run in order lengthways along the range.

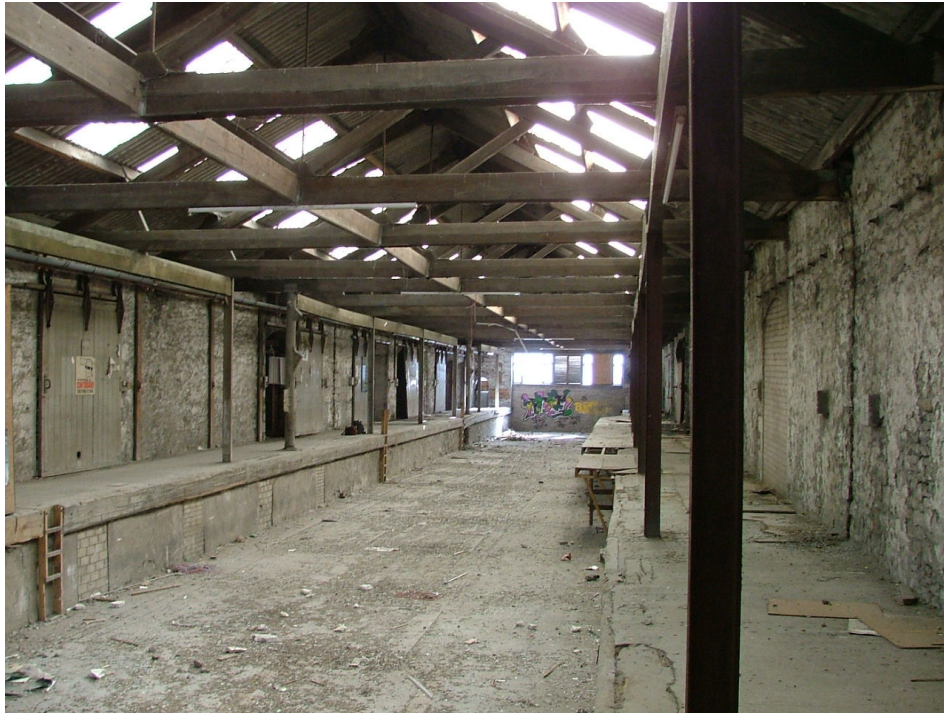
**Plate 16** – Central section of warehouse at first floor level, view looking towards the SE elevation

- 6.10.1 The central section of the warehouse was accessed through the large doorways from the eastern range (visible on the left hand side of plate 16). This range of the warehouse was where, originally, the rail trucks were brought into the building. According to Dunderdale, there was originally a double line of rails and two turntables within the section<sup>13</sup>, although they no longer exist. The two ‘platforms’ do, however, still exist and can be clearly seen on plate 16. The present concrete floor surface in the central channel is most likely a later addition, as it is at the same level as the later ramp built up to the NW facing elevation. It is possible that the original floor surface of the central channel was much lower to allow the rail trucks to be brought into the building from the siding, and for the top of the trucks to be level with the platforms.

- 6.10.2 There was no evidence within the floor of the platforms for the trapdoors that would have been used to move goods from the first floor to the ground floor vaults. The only part of this range where there may have been any indication of these doors was in the vertical sides of the platforms, where bricked-up apertures were observed (plate 16). These were, however, only visible on the eastern side of the range (as can be seen in plate 16) and were not noted on the western side.

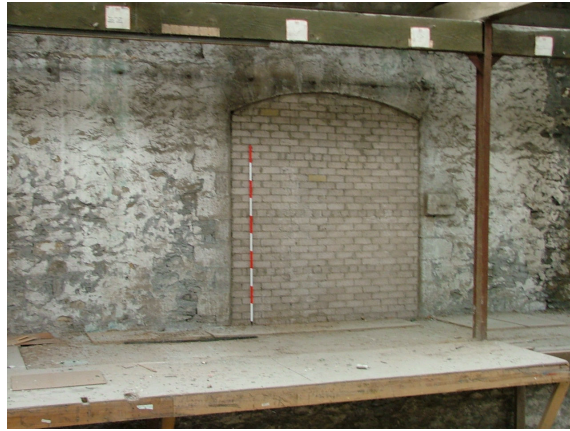
**Plate 17** – Blocked-up doorway of western range, as seen from the central section

- 6.10.3 On the western side of the central range, all the large doorways have been bricked-up; therefore there was no access to the first floor of the western range (plate 17). Only one of the original doorways still retained its sliding door (BW No.10), although behind it was also bricked up (plate 17).

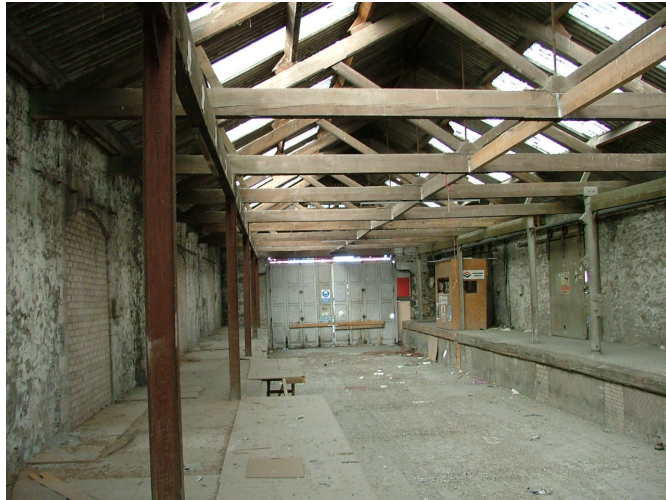
**Plate 19** – Roof structure of central range – note the central timber 'binders' joining all the tie beams below the base of the iron rods, and the vertical girders on the left and pillars on the right-hand side platform

- 6.10.4 The roof structure in the central section of the warehouse was more complicated than that of the eastern range. Although it was the same arrangement of tie beams, principal rafters, struts and iron rods, there were also central longitudinal ‘binders’ that connected each tie beam (plate 19). Supporting the roof trusses on the western side were timbers, which were themselves supported by ‘I’ section, what appear to be, RSJ’s (rolled steel joists), stamped with the name ‘Lancashire Steel MFG Co Ltd, England (plate 19). On the eastern side of the

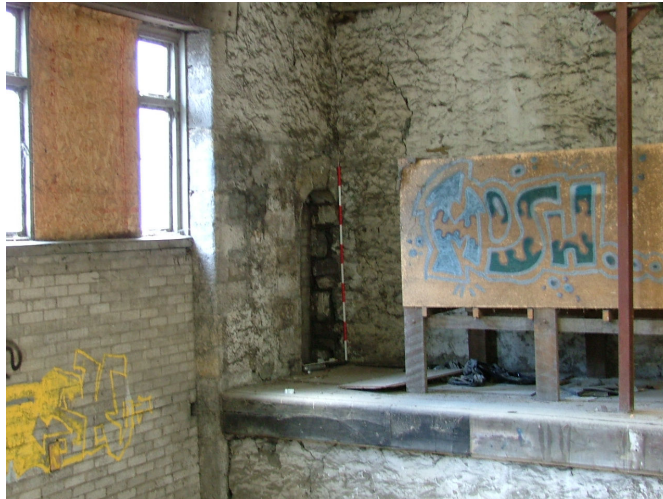
**Plate 21** – The western (blocked) of the two doorways in the SE elevation, originally accessed via external stairs into the central section of the warehouse

- 6.10.5 At the southern end of the central range, the two doorways in the SE facing elevation could be seen, one of which is now blocked-up. When these doorways were in use they were accessed by the two staircases on the exterior of the SE elevation, and each gave access to one of the platforms (plate 21).

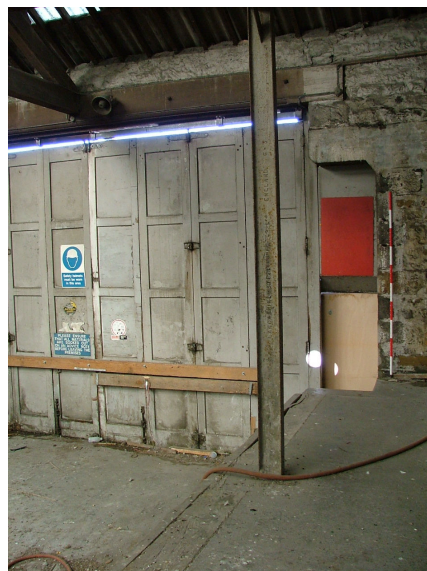
**Plate 22** – Doorway at northern end of the central range

- 6.10.6 At the northern end of the central range, there is a large door which measures the same width as the central channel (c.6.40 metres) (plate 22). The original door aperture appears to have been slightly wider (c.8.60 metres) by the use of corbels at each side. These corbels may have been the arched features observed from the exterior, although as already mentioned in 6.7.3, the external elevation could not be fully assessed due to lack of access.

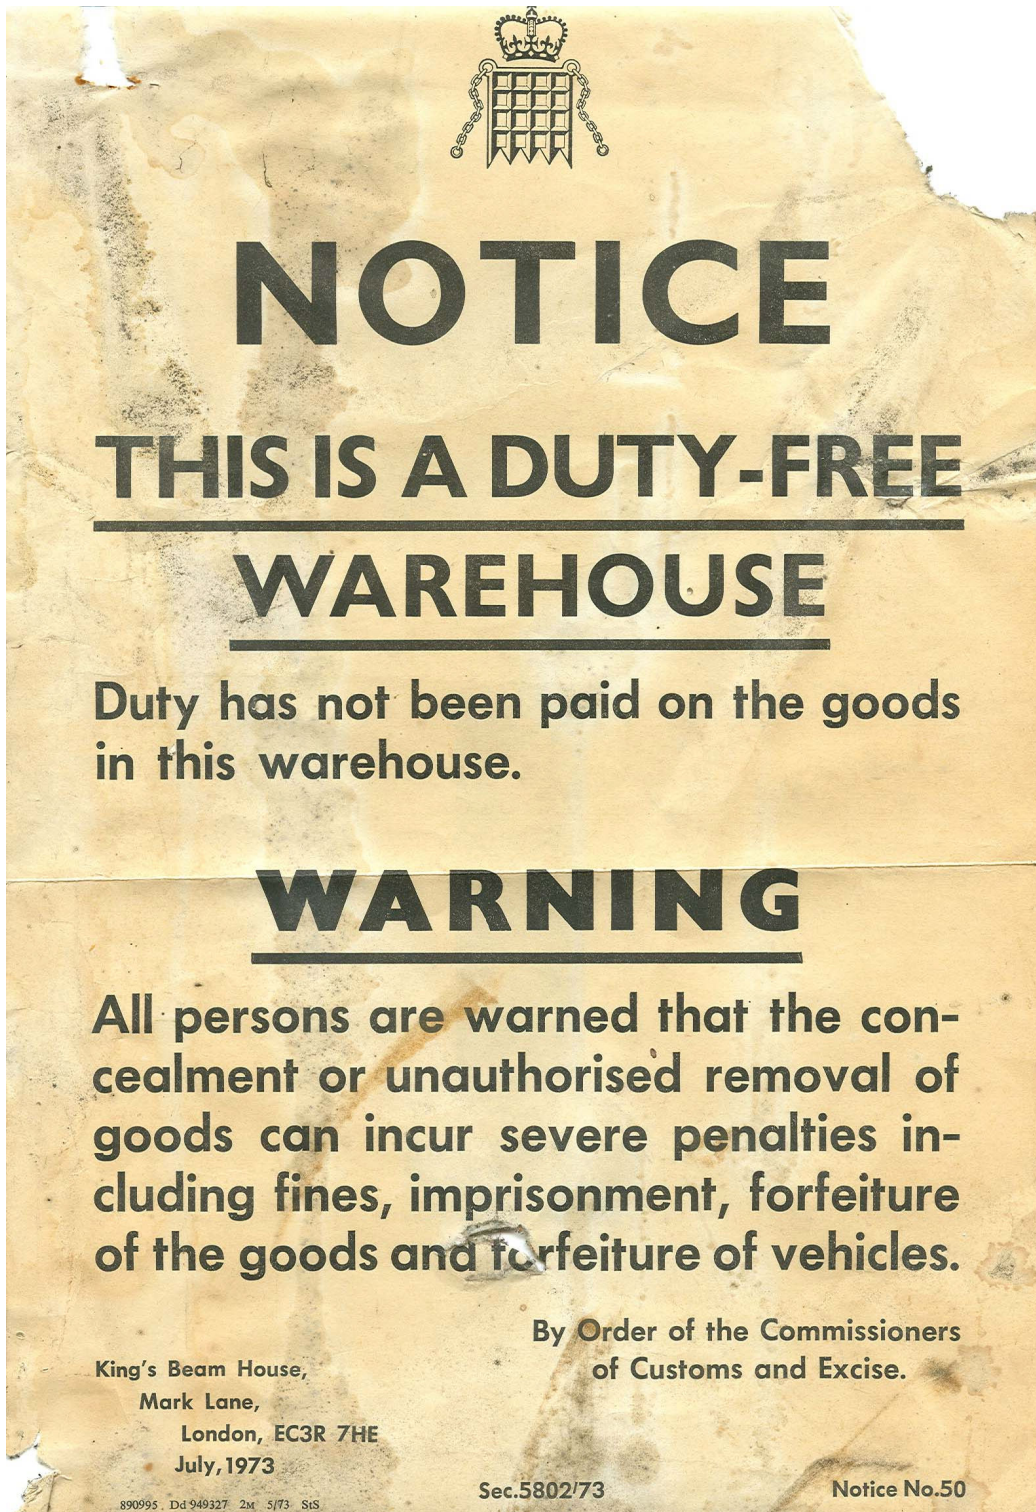
**Figure 10** – Notice found in one of the vaults of the Western Range

<b>SMR No.</b>	<b>Description</b>
6251	Maryport Town Bonded Warehouse Present on 1866 OS map, Built in 1842 (T.Bulmer & Co 1901). Situated on Lower Church Street. Of three bays.
16276	Devonshire Dock Bonded Warehouse, Barrow-in-Furness. Present on Second Edition OS map of 1895. No longer exists.
3.10	It appears that the warehouse was still being used for the storage of bonded goods as late as the 1970's. A notice on the wall of one of the vaults in the western range, produced by the Commissioners of Custom and Excise, warns of the building's status as a Duty-Free Warehouse, and dates to July 1973 (figure 10).
3.11	The warehouse has most recently been used as retail units and storage area.
