**KENT BECK BRIDGE,
NEASHAM,
Co. DURHAM**

**ARCHAEOLOGICAL BUILDING
RECORDING
CP. No: 1439/11
DATE 08/04/2011**

DOCUMENT TITLE: Kent Beck Bridge, Neasham, Co. Durham
DOCUMENT TYPE: Archaeological Building Recording
CLIENT: Environment Agency
CP NUMBER: 1439/11
OASIS REFERENCE: northpen3-98499
PRINT DATE: 08/04/2011
GRID REFERENCE: NZ 3235 1015

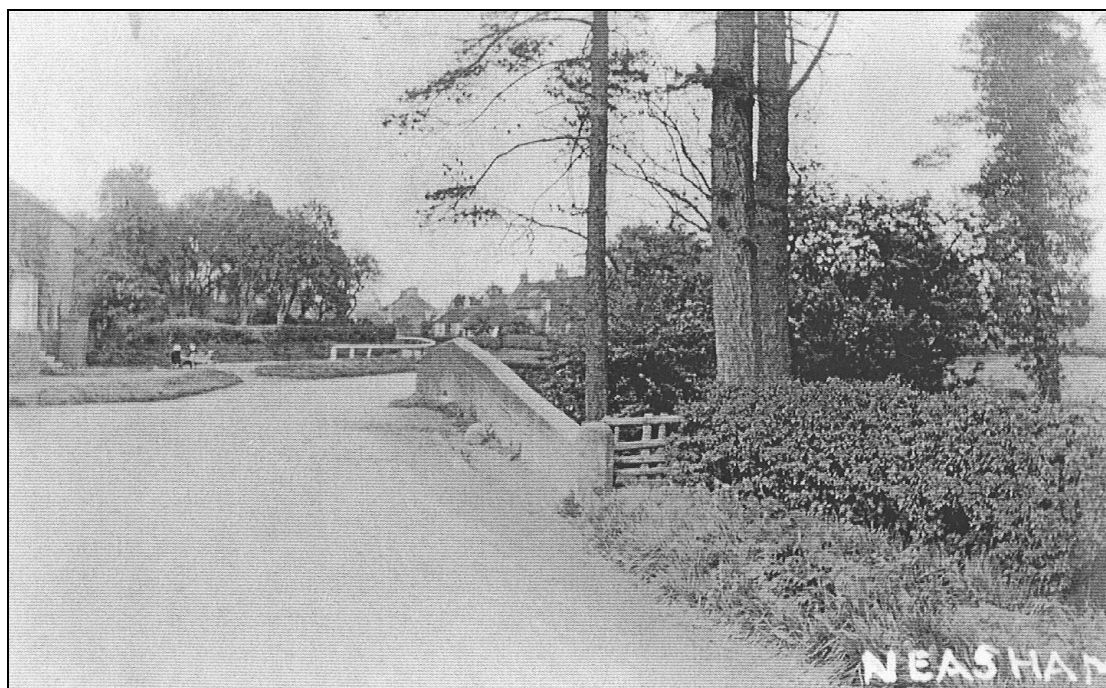
Plate 1: View looking east showing Kent Beck Bridge c.1920

- 4.2.1 From the road which leads into Neasham from the west, it is clear that there have been recent modifications or alterations undertaken to the bridge as shown by the modern concrete 'brickwork' and capping stones (Plates 4-7). This modern structure may relate to the strengthening of the bridge following the flood event in 2000, as noted in 3.2.13 above. From the road, therefore, it is not possible to fully appreciate the earlier bridge structure. It is also clear that up until the 1920s at least, the road over the bridge had a definite hump as shown on the historical photograph reproduced as Plate 1.

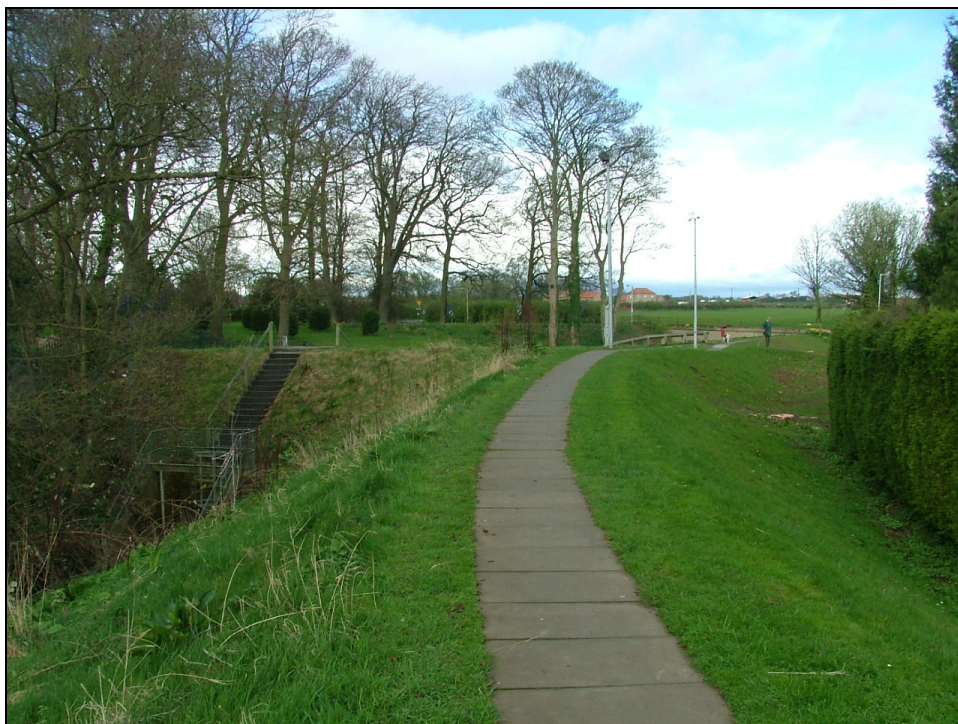
Plate 2: View looking north showing flood defences along the Kent Beck

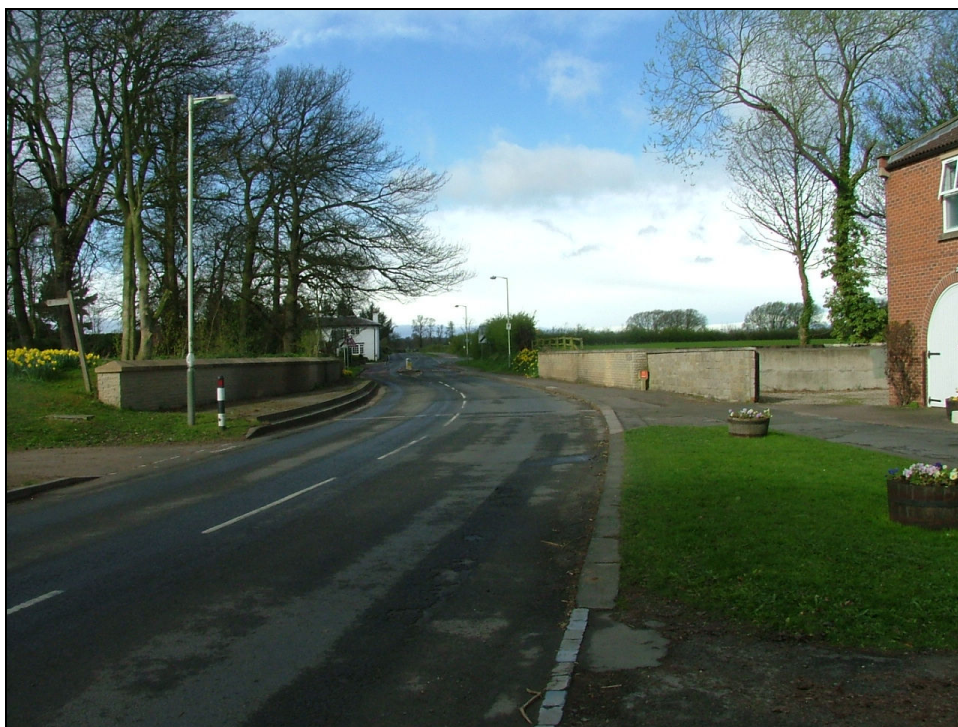
Plate 4: View looking west showing Kent Beck Bridge as being of modern construction

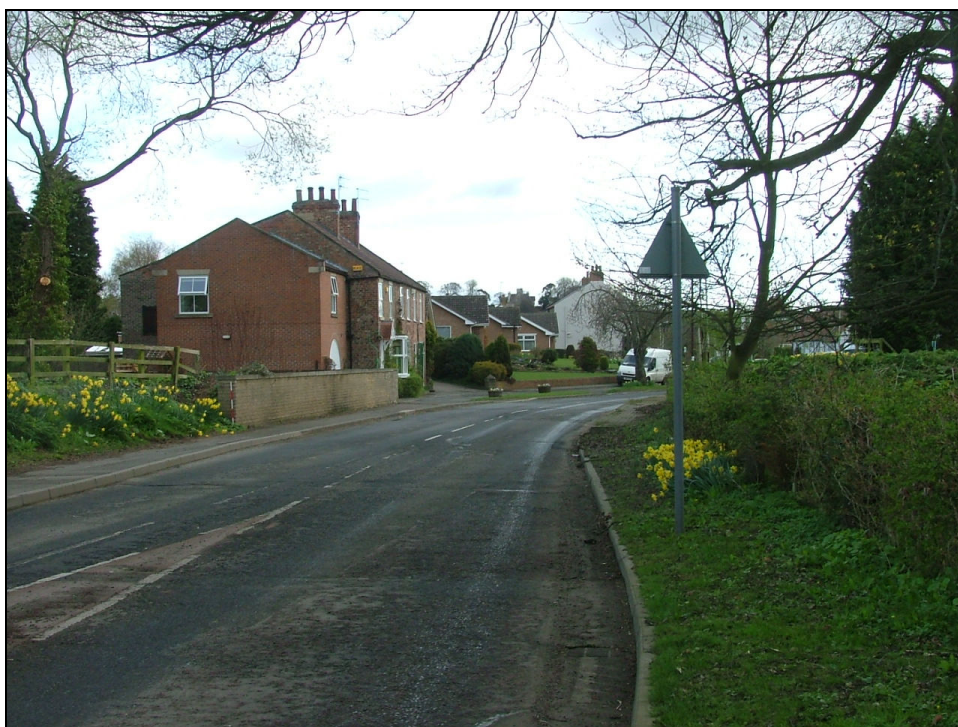
Plate 5: View looking east showing the modern north wall of Kent Beck Bridge

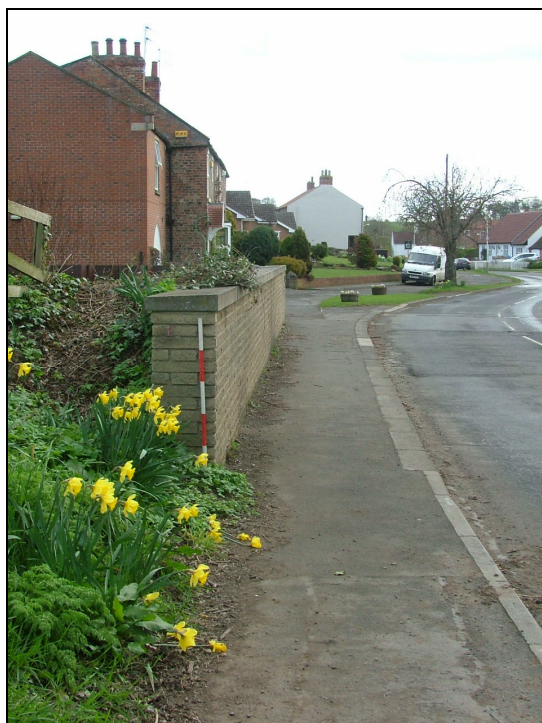
Plate 6: View looking east showing the modern north parapet of Kent Beck Bridge (Scale = 1m)

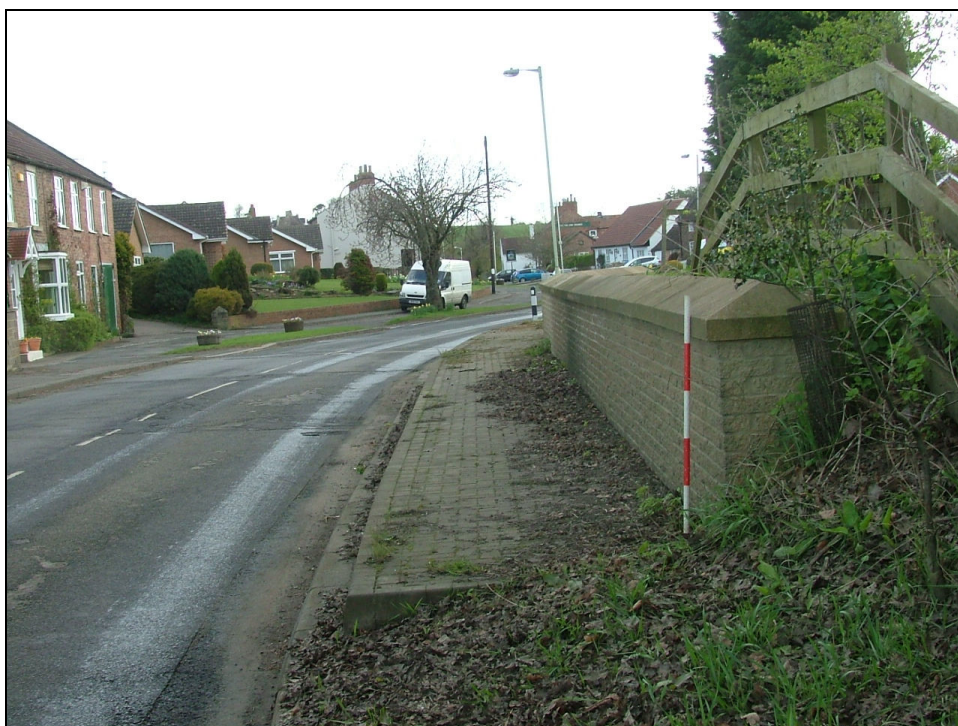
Plate 7: View looking east showing the modern south parapet of Kent Beck Bridge (Scale = 1m)

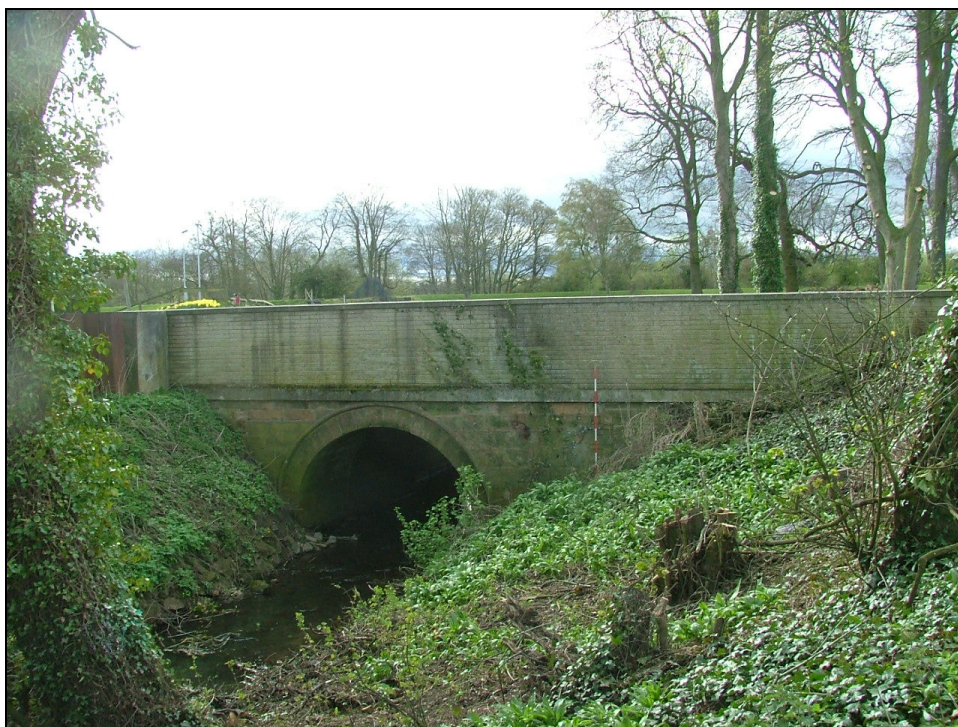
*Plate 8: View looking south showing the north elevation of Kent Beck Bridge
(Scale = 2m)*

- 4.2.2 The north side of the Kent Beck Bridge clearly displays evidence of an earlier structure as shown by the arched stonework and decorative roll moulding which provides a hint of architectural detail to the bridge, which presently cannot be appreciated, but which suggests that this side of the bridge was clearly 'on show' at some point (Plate 8). The roll moulding itself, which runs around the top of the voussiors, is a single band which measures 0.10m wide (Plate 9). The voussoirs, the stones which make up the arch, spring from piers to either side of the opening (Plate 10). Structurally, the function of an arch such as this one at Kent Beck Bridge, is to support the downward loads which come upon it, and turn this into lateral thrust which runs around the ring of the arch and pushes the voussoirs against each other. The voussoirs then push against the abutments or springings of the arch¹⁵.

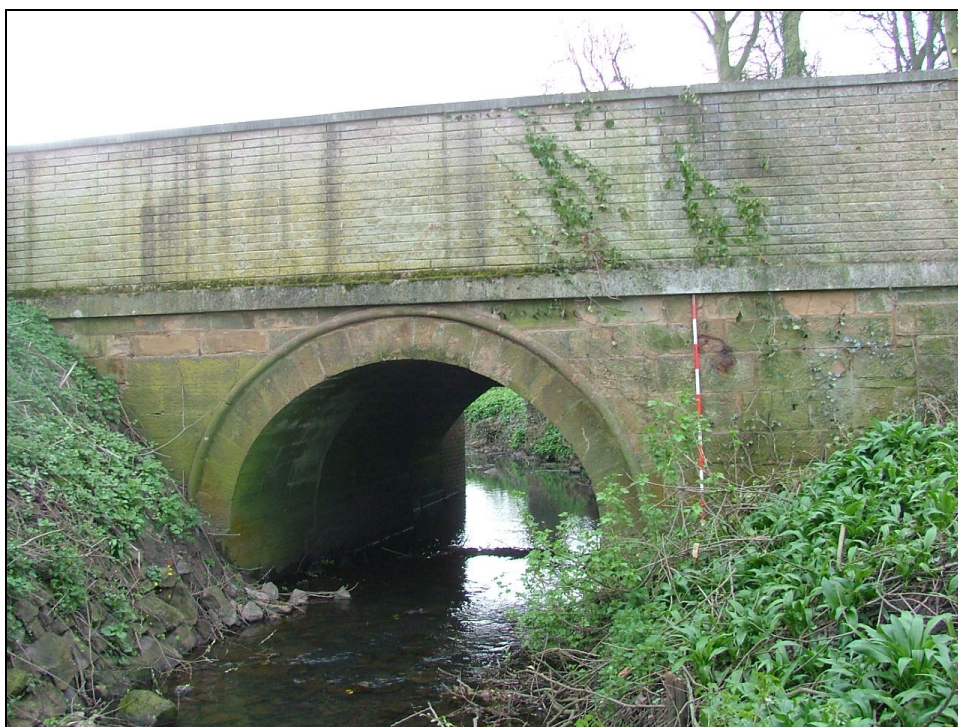
*Plate 9: North elevation of Kent Beck Bridge showing the masonry of the
archway with modern 'brickwork' above (Scale = 2m)*

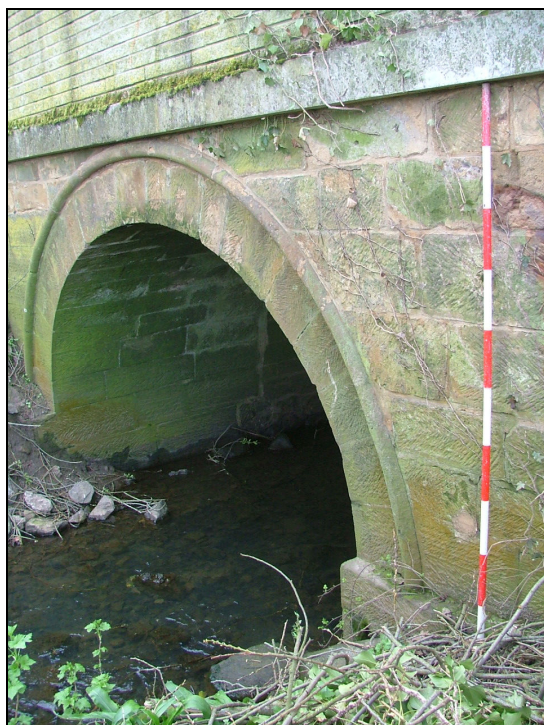
Plate 10: Detail of the roll moulding, north elevation of Kent Beck Bridge

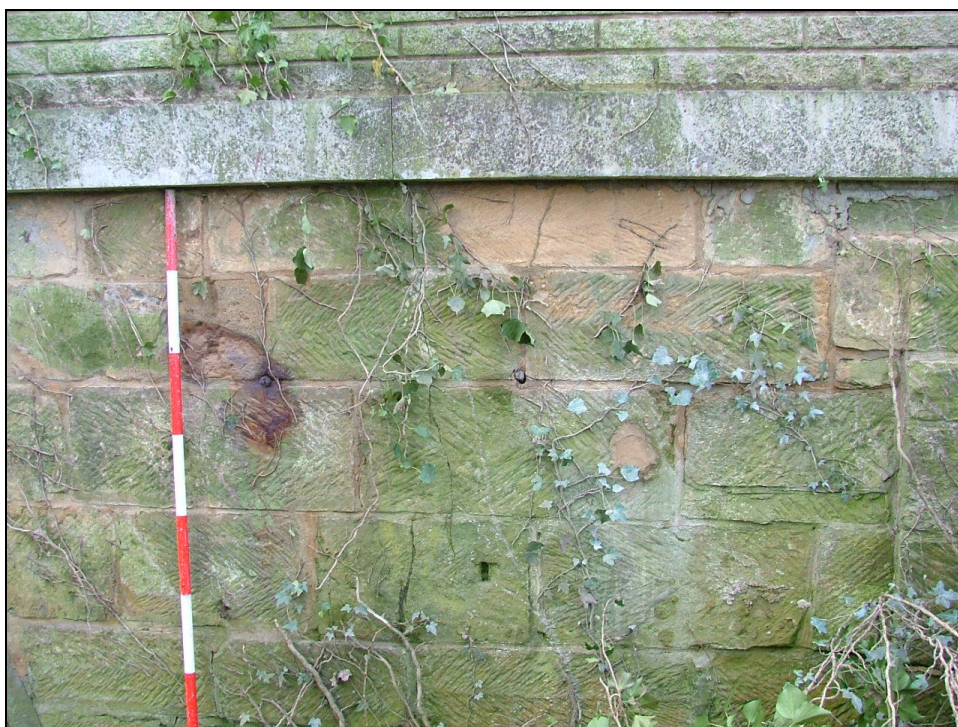
- 4.2.3 The arch opening in this elevation measures approximately 2.25m in height at its apex from the bottom of the beck. To either side of the arch, the stonework consists of coursed, well-dressed blocks of masonry, which has been tooled to create a herring-bone effect (Plate 11). There are the remains

of some iron fittings in the north elevation, possibly suggesting that there was a plaque or some form of signage fixed to this masonry at some point (Plate 11).

Plate 11: Detail of tooled masonry and remains of iron fittings, north elevation of bridge

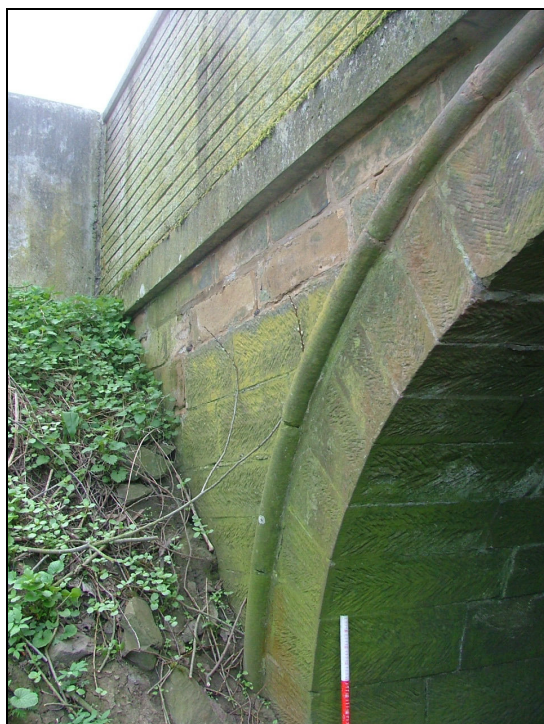
- 4.2.4 There is some evidence for rebuilding of the north elevation, prior to the modern reconstruction, as shown by changes in the masonry to either side of the archway (Plates 12 and 13). There is a slight projection of masonry to the west side of the archway, possibly the remains of a buttress (Plate 14).

Plate 12: East side of archway showing change in the masonry, north elevation

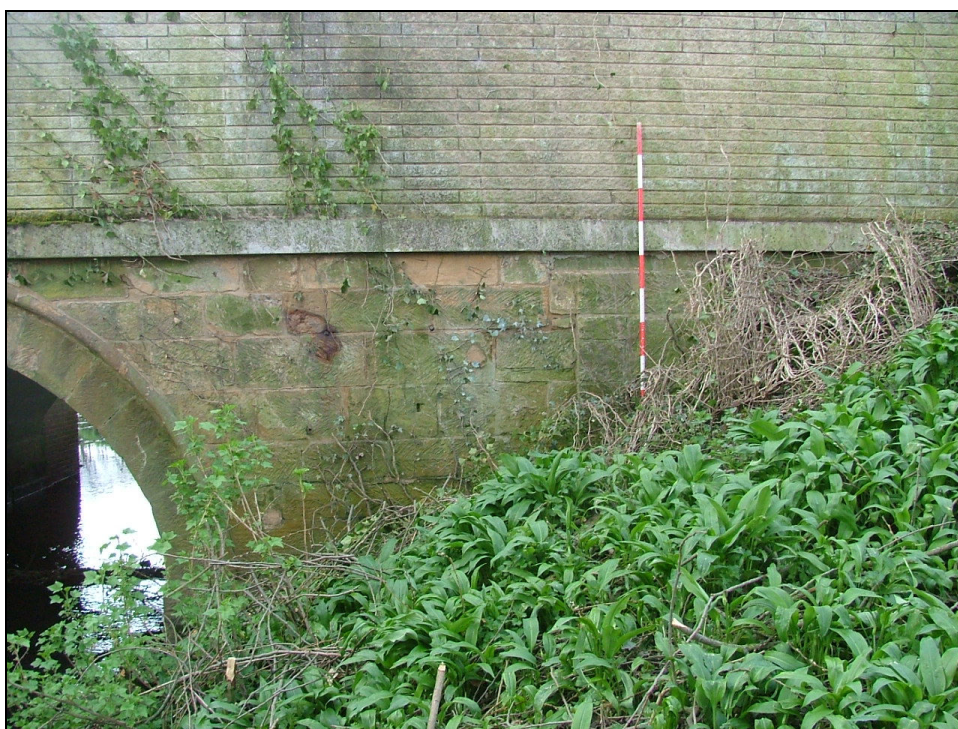
Plate 13: Change in the masonry to the west side of the archway (left of the ranging pole), north elevation

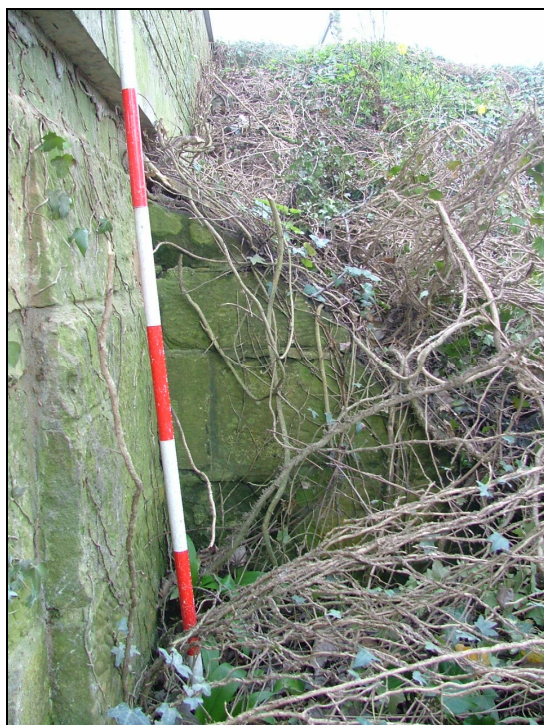
Plate 14: Possible remains of a buttress, north elevation

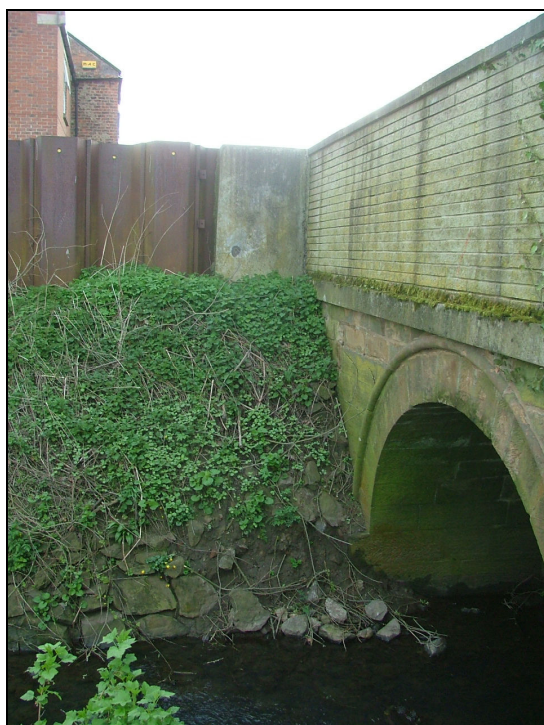
- 4.2.5 Set above the coursed masonry of the earlier bridge, there are 18 courses of concrete 'bricks' above a concrete string course, which separates the two, which measures 0.19m in height (Plate 9). This concrete 'brickwork' is surmounted by concrete capping stones. To the east side of the north elevation, steel piling has been installed which leads off the end of the bridge parapet in a northerly direction (Plate 15).

Plate 15: View looking east showing the steel piling to the north of the parapet, north elevation of bridge

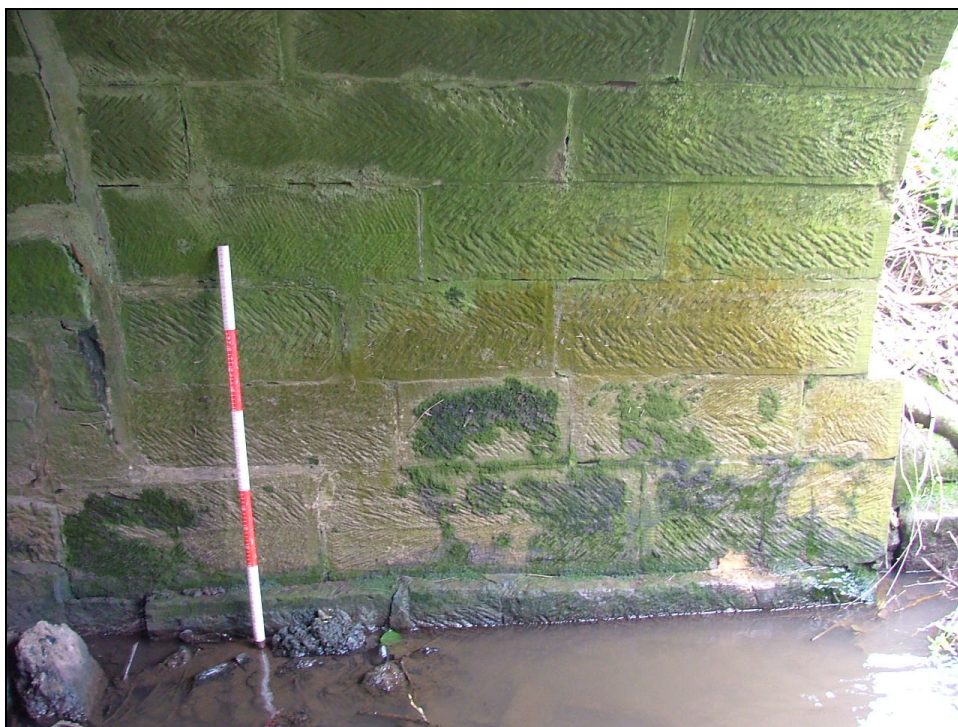
Plate 16: North side of bridge, west elevation, showing slight plinth and vertical break in masonry to left of ranging pole (Scale = 1m)

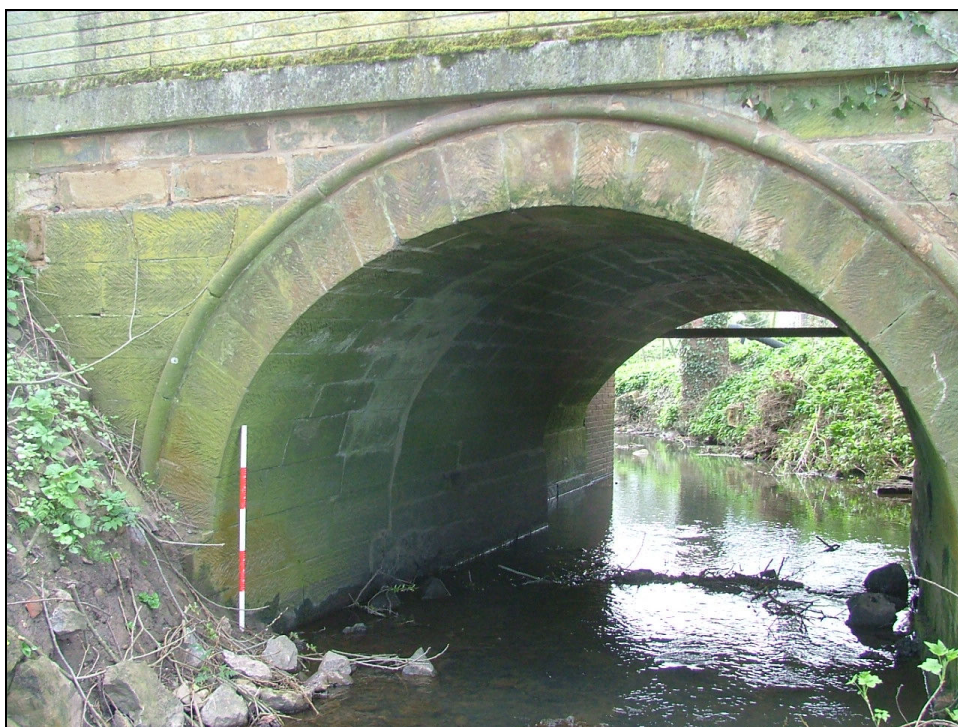
- 4.2.6 The underside of the bridge displays evidence for having been widened or altered at three different times as shown by vertical breaks in the masonry and the addition of modern brickwork. The earliest structure of the bridge may be the north side, which has the decorative roll moulding; this section measures approximately 1.94m in width, and has a slight plinth to its western side (Plate 16). To the south side of this, there is another section of masonry (which follows the same profile of the archway) which measures c.3.35m in width. The tooling on this stonework does not display the same herring bone pattern noted to the north, which may be further evidence that the two sections are not contemporary (Plates 17 and 18).

Plate 17: View looking south showing the underside of the bridge. A break in the masonry of the arch can clearly be seen (Scale = 1m)

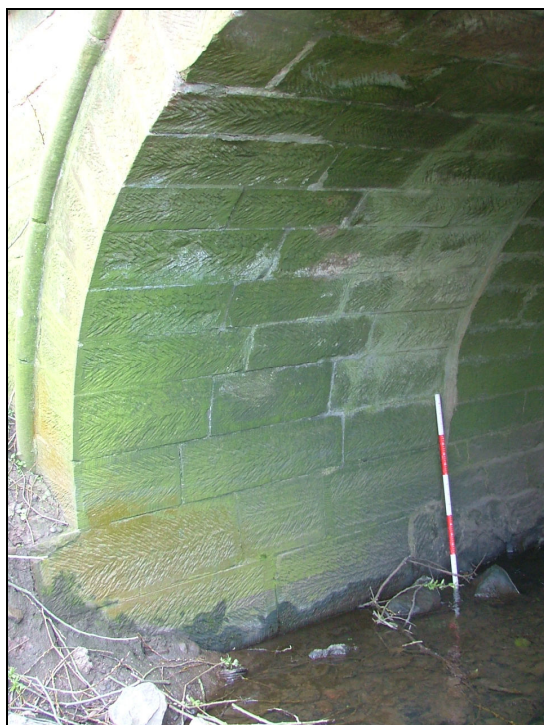
Plate 18: Detail of vertical break in masonry, underside of bridge (Scale = 1m)

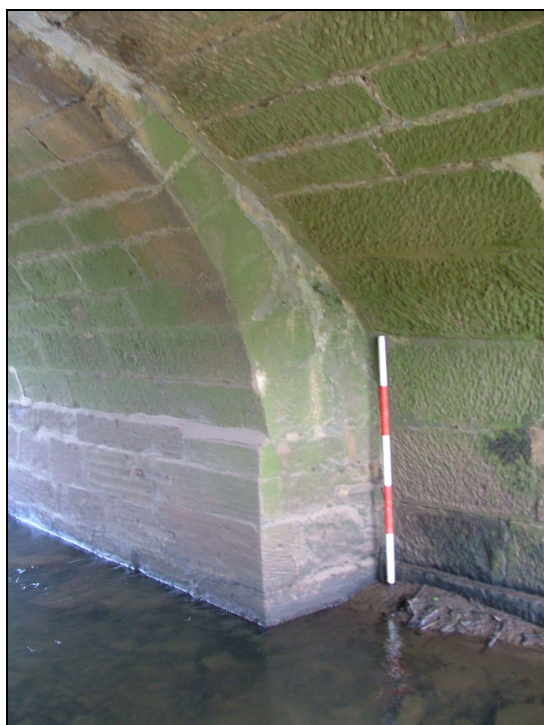
Plate 19: Detail of south side of bridge showing addition which is set back from earlier structure (Scale = 1m)

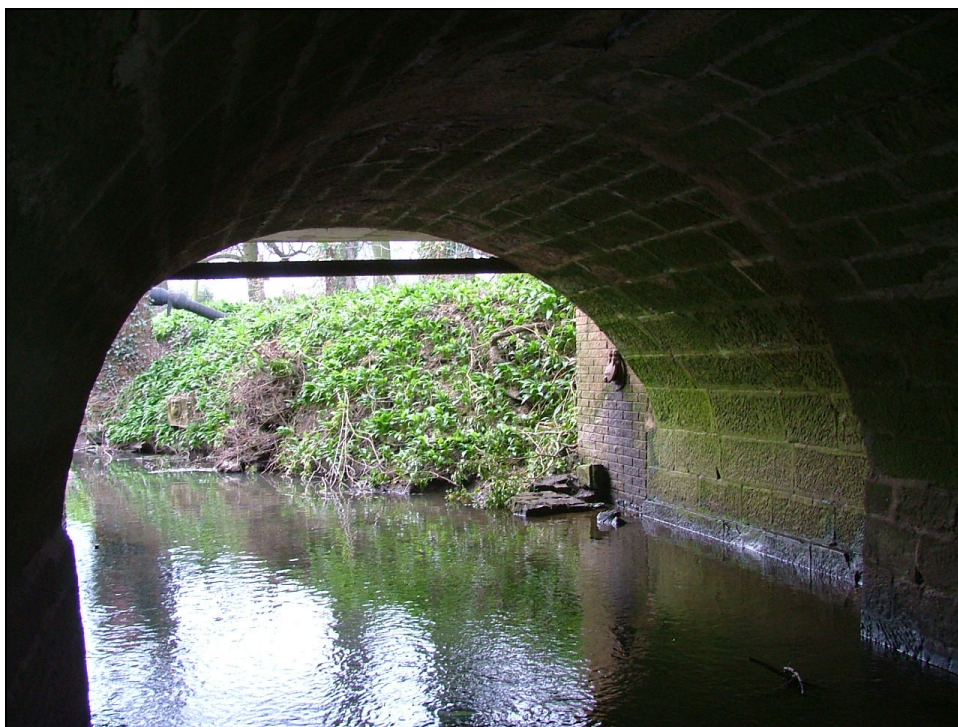
- 4.2.8 The southern end of the bridge displays the most recent modifications in the form of 'brickwork' abutting the set back section of masonry (Plate 20). This modern addition measures approximately 1.60m in width, and has a square headed concrete lintel, quite different from the arched opening of the north elevation (Plates 22 and 23). It is just possible to note the arched profile of the masonry structure within the bridge from the south, but due to the addition of the recent modifications it was not possible to note any architectural features on this stonework.

Plate 20: View looking south showing the set back addition to the south side of the earlier bridge

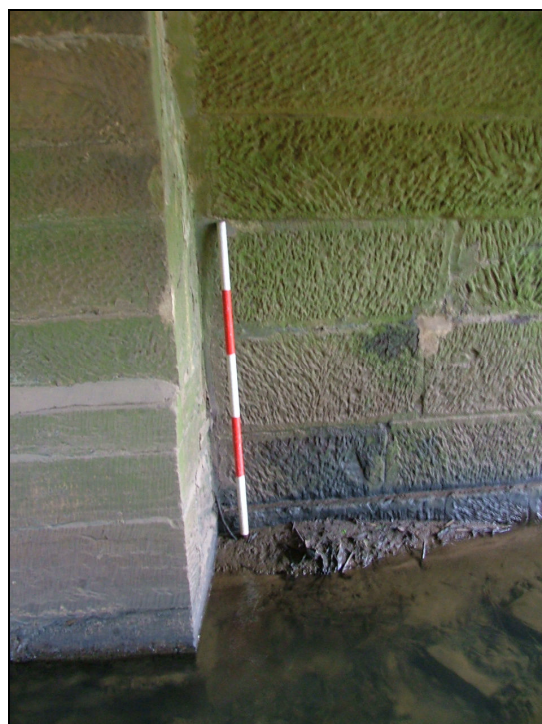
- 4.2.7 To the south side of this, the masonry of the underside of the bridge is set back by 0.70m to show a further addition to the structure which measures c.3.50m in width (Plates 17, 19 and 20). The tooling on this masonry, as seen from the underside of the bridge, is not the same as the herring bone style noted on the stonework of the northernmost section (Plate 21).

Plate 21: Detail of tooled masonry of south side of bridge underside (Scale = 1m)

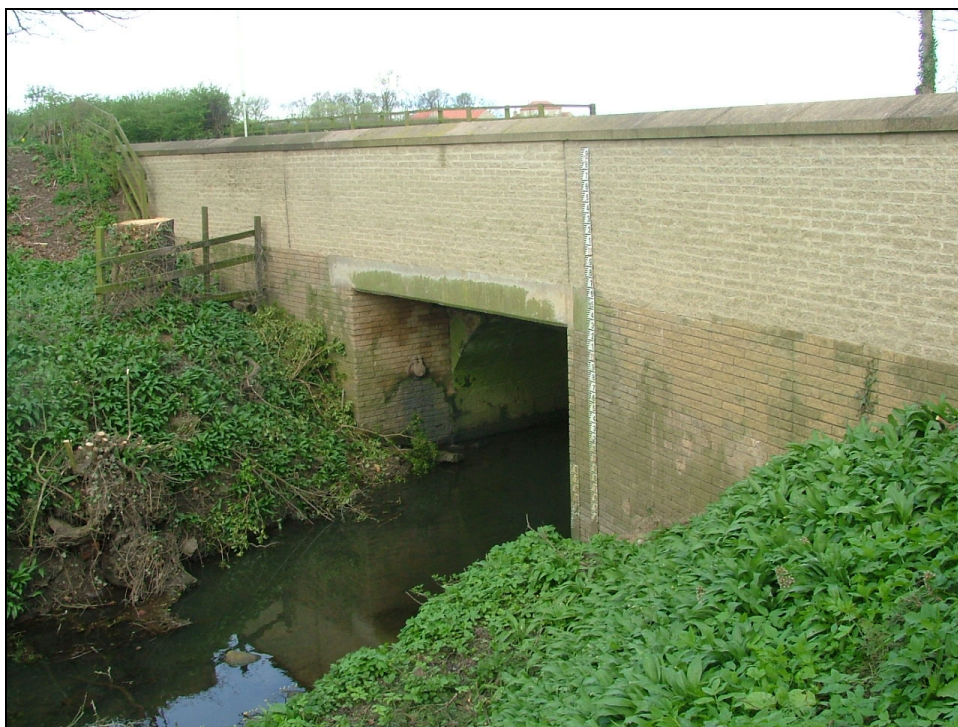
Plate 22: View looking west showing the modern addition to the bridge, with the arch of the later phase of masonry just visible to the right

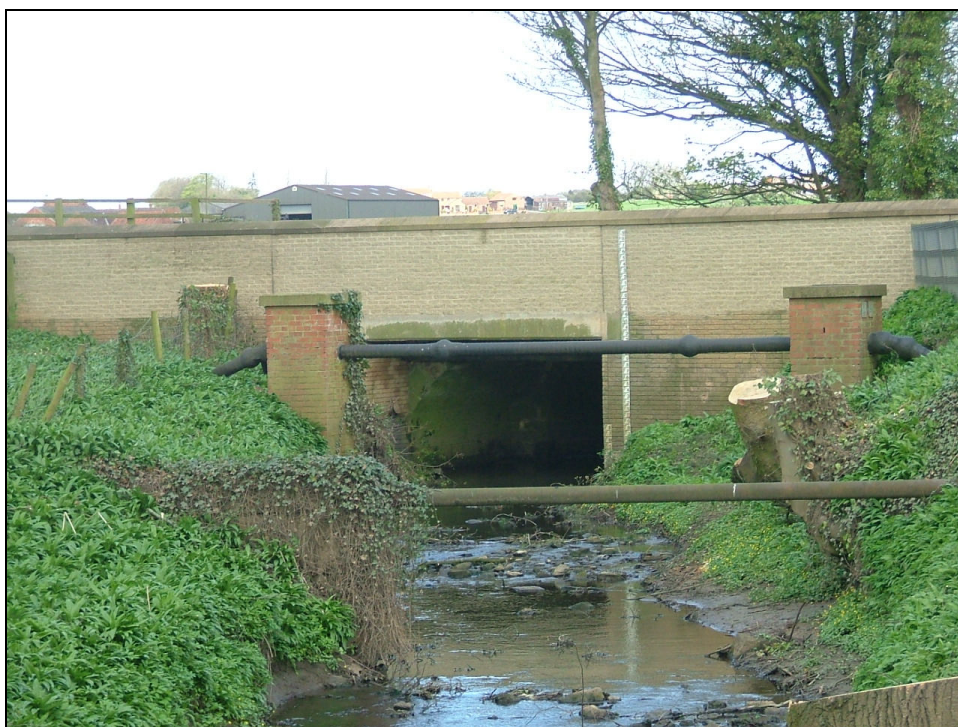
Plate 23: View looking north showing the south elevation of Kent Beck Bridge
