NORTH PENNINES ARCHAEOLOGY LTD

**REPORT ON
AN ARCHAEOLOGICAL
DESK-BASED ASSESSMENT,
BUILDING SURVEY AND
FIELD EVALUATION AT
HALL FARM
MORLAND
CUMBRIA**

**FOR
HEATHERVILLE LTD**

**NGR NY 6000 2245
Planning Application No.
3/03/0690**

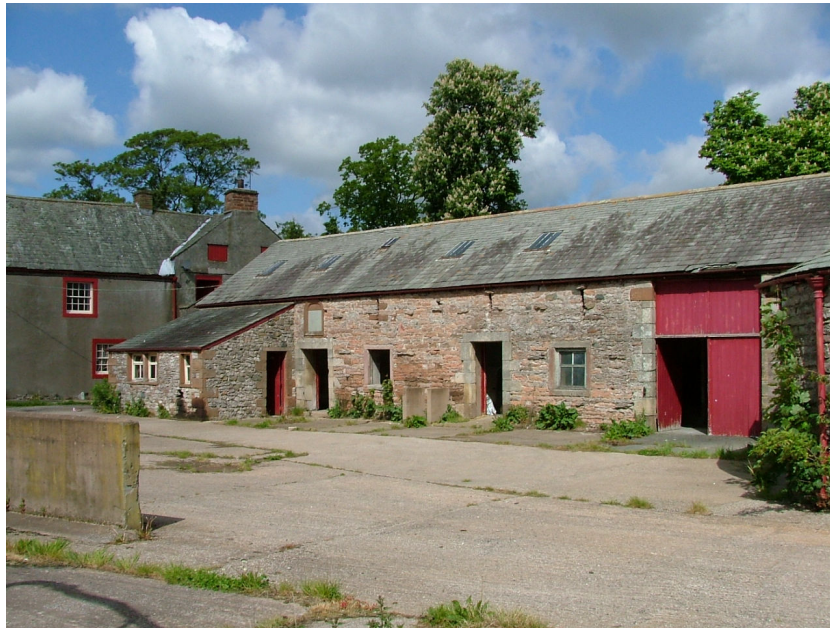
Plate 2. South-eastern elevation of the Threshing Barn (Building 1), with the farmhouse in the background to the right

- 4.2.4 On the south-eastern elevation (Plate 2) there was at one time four standard doorways (two are now blocked up - see Figure 1), with nicely dressed jambs utilising alternating long and short stones – with a slight chamfer carved from the edges, and lintels made from single pieces of sandstone, again with a slight chamfer. On the same elevation is a large double doorway that extends up to eaves level, this also has nicely dressed jambs with a wooden lintel. This doorway corresponds to another on the opposite elevation (See below).

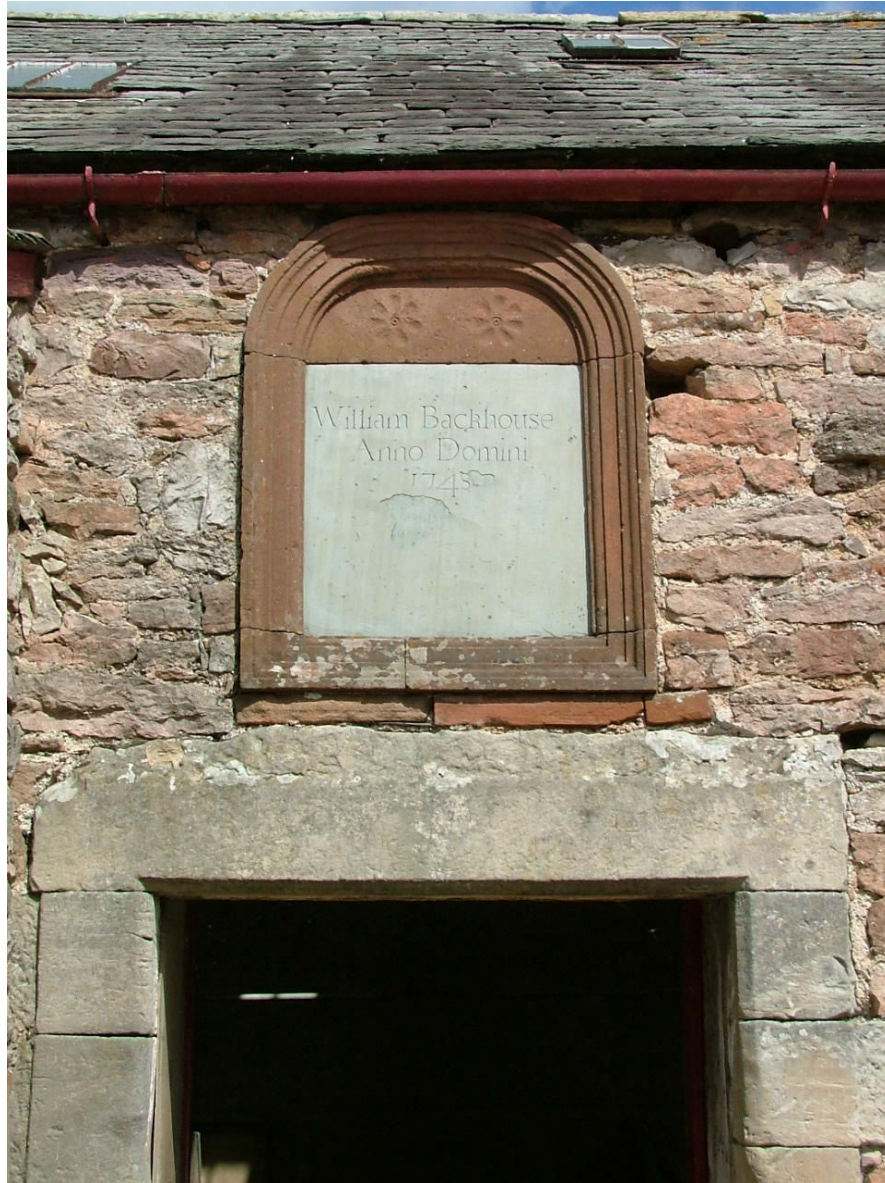
Plate 3: Dated Inscription.

- 4.2.5 Above one of the doorways on this elevation is a dated inscription set in a red sandstone panel with a moulded frame and rosette decoration (Plate 3). The inscription, in an inserted slate panel, reads *William Backhouse Anno Domini 1748*.

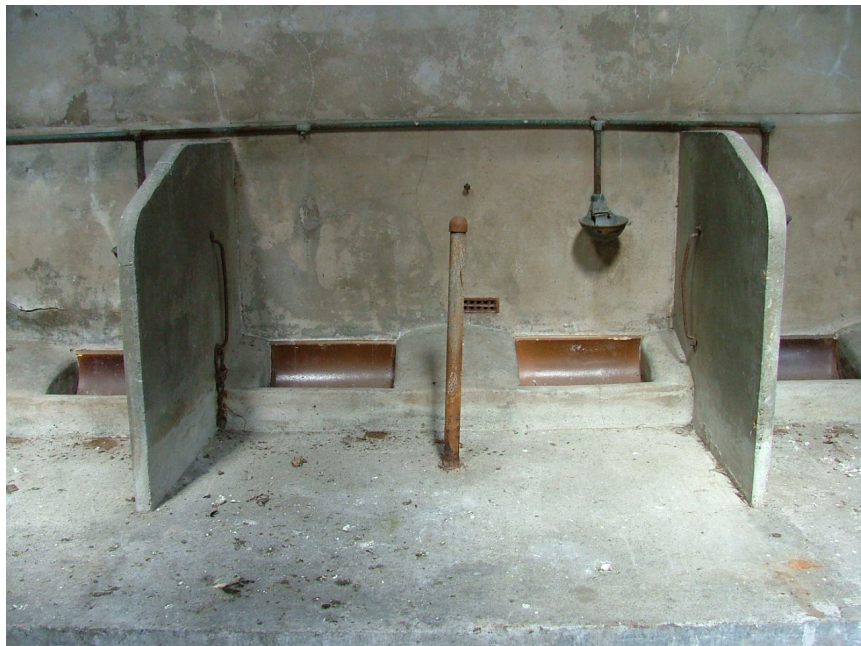
Plate 5 – Concrete double stall in Building 1

4.3.1 The barn was last used as a milking parlour and byre. Along the north-western elevation of the barn are concrete stalls that provide accommodation for 28 cows at one time (See Figure 1). Several of the stalls have iron tethering posts in-situ. Each double stall has two ceramic feed troughs and metal water troughs (Plate 5). A channel runs behind the stalls, allowing for the collection of manure.

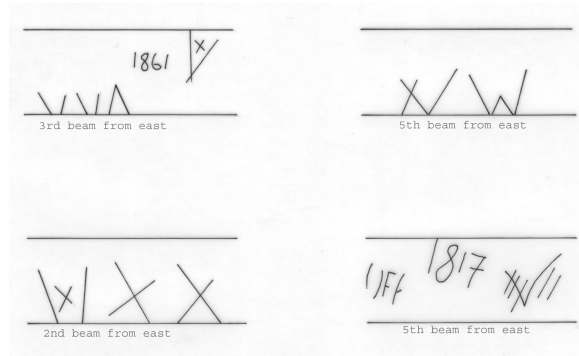
Figure 2 – Schematic sketch of beam marks

4.3.4 In the north-eastern side of the barn, the roof timbers bear a variety of marks. A date of 1861 is visible on one, with another possible date of 1817 on another. The other scratch marks included may be tallies, as these beams would have been reachable from the floor of the upper storey (Figure 2). However, there is also the possibility that these marks may have been made by the timber merchant.

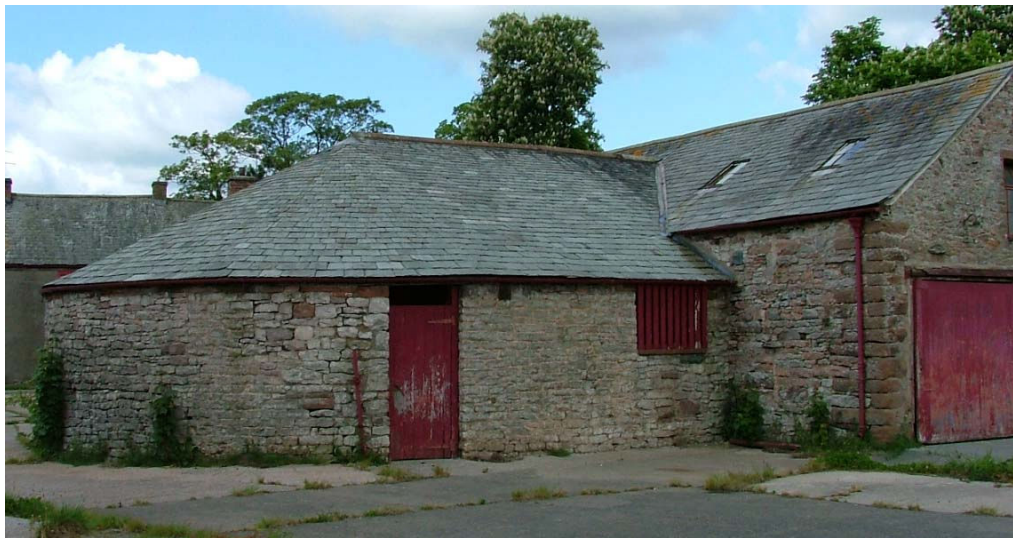
Plate 6 – The gin-gang (Building 2) from the south-east

- 4.4.1 On the south-east facing elevation of the barn is a semi-circular structure known as a gin-gang (also known as a gin-case or horse engine house). This building is of coursed rubble and squared sandstone masonry, as well as patches of uncoursed rubble masonry. The gin-gang extends c.9.10 metres from the wall of the barn, and obvious construction breaks indicate that the gin-case butts up against the barn, and therefore was built later. It stands to a height of c.2.40 metres to eaves level. The roof is of Cumbrian slate with sandstone ridge tiles and cast iron guttering.

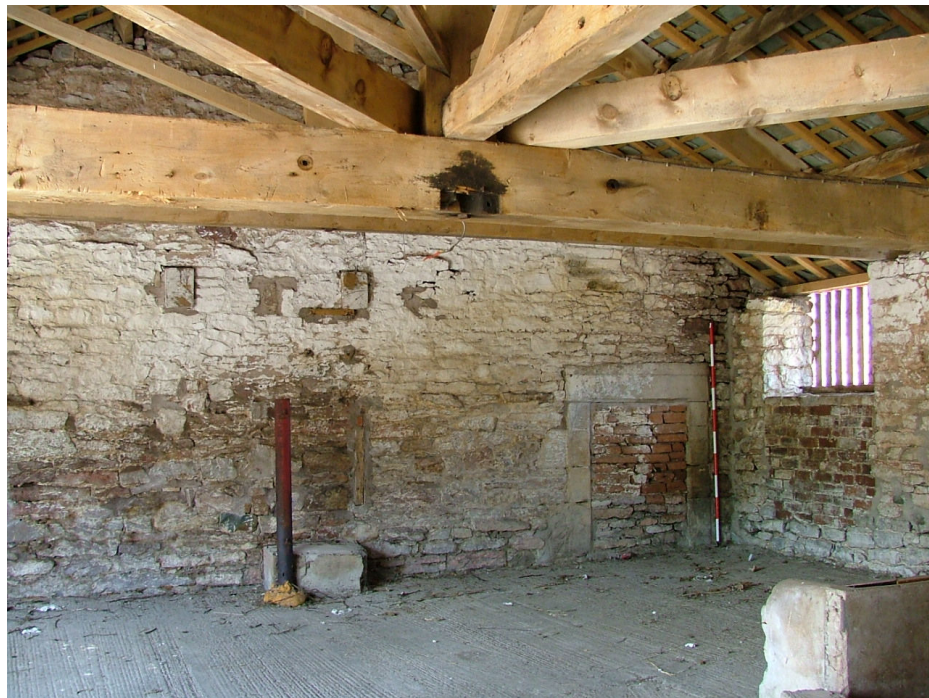
Plate 7 – Interior of gin-gang showing blocked doorway and ventilation slits

4.5.1 The gin-gang appears to have most recently been used as a shed for stock – there is a ceramic trough set into a small wall projecting from one of the walls. The floor has been concreted and most of the walls are lime-washed, a common wall coating that has been used for centuries in Cumbria. Blocked ventilation slits and the blocked doorway of the barn are visible (Plate 7).

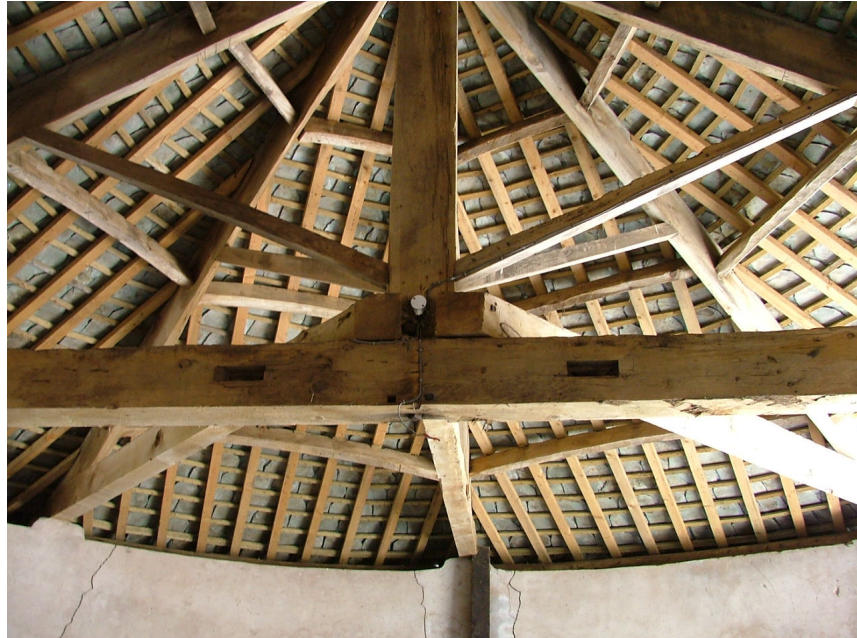
Plate 8 – Roof structure of gin-gang

4.5.2 The roof structure is extremely well made of machine sawn timber, and consists of two king-post roof trusses, one of which supports the rafters for the semi-circular roof (Plate 8).

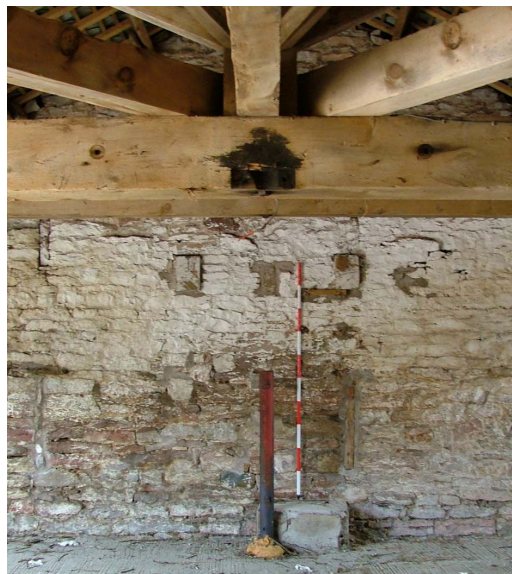
Plate 9 – Timber stumps and blocked hole, gin-gang

There is some archaeological evidence for the gearing that was driven by the horses to power the threshing machine. There are the stumps of two large timbers slightly projecting from the barn wall, as well as a blocked up hole (Plate 9), which may have housed the drive shaft, and on one of the beams is a rebate, which could have held a horizontal axle. The height of the timbers suggests that an overhead rotary mechanism was utilised, with the horses walking beneath the gearing, rather than over⁷. The gin-gang at Hall farm would have had a maximum diameter of 9 metres (29.5 feet).

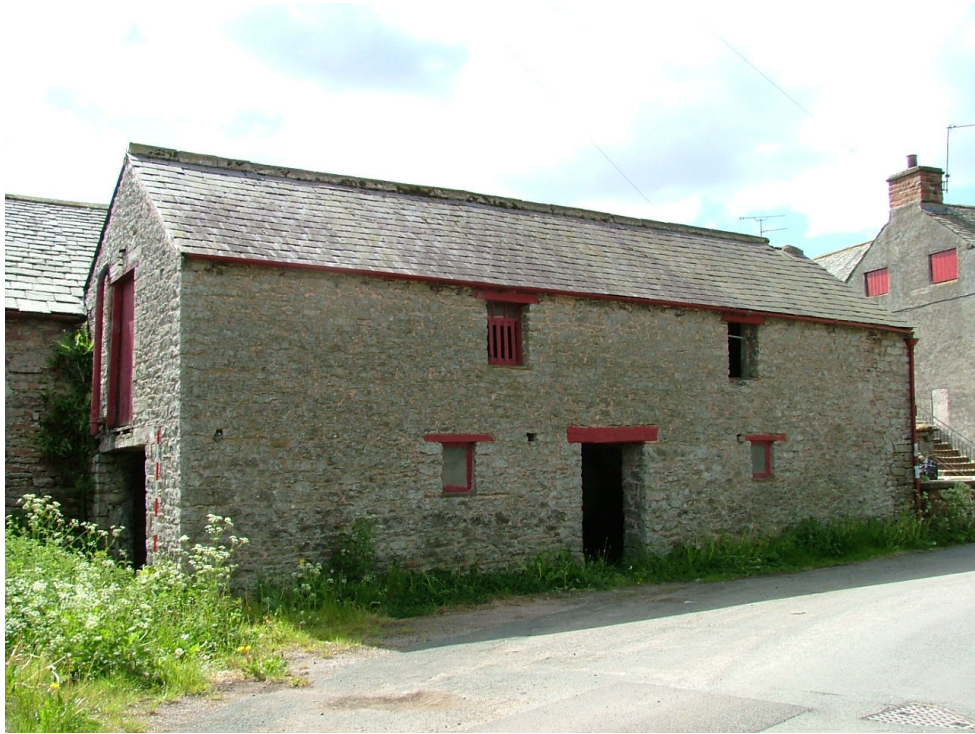
Plate 10 – NW Elevation of Building 3

- 4.6.2 On the north-west facing elevation, beside the road, is a doorway and two windows at ground floor level, with a further two at first floor level (Plate 10). On the north-east facing elevation is a larger doorway, which may originally have given access for carts. Above this entrance, at first floor level, is another doorway that may have been used as a ‘pitching’ doorway, through which hay or straw could be taken from laden carts and stored, and vice versa. On the south-west facing elevation is a window at first floor level, and at the apex of the roof there appears to be the remains of a chimney stack, which was presumably removed when the roof was re-covered in Welsh slate (Plate 11).

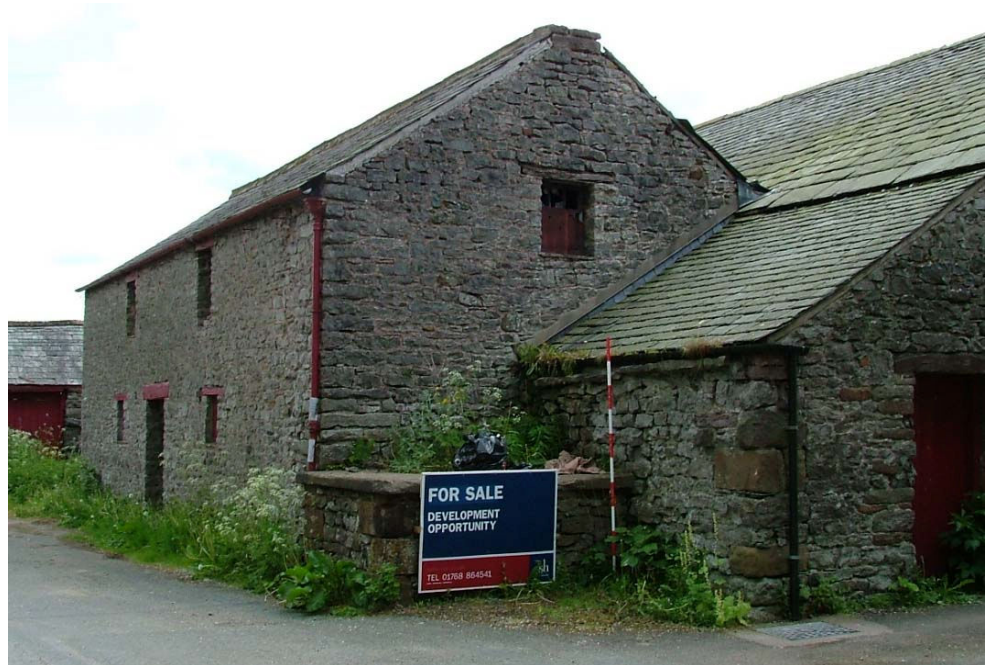
Plate 11 – SW facing elevation of Building 3, showing window and remains of chimney stack

4.6.3 This chimney could relate to a small aperture, which is visible between Building 3 and Building 5, and is located c.2.0 metres above ground floor level. Within Building 5 is a small 'fireplace', which could have provided heat to dry grain spread on the first floor of Building 3 (See Building 5 below).

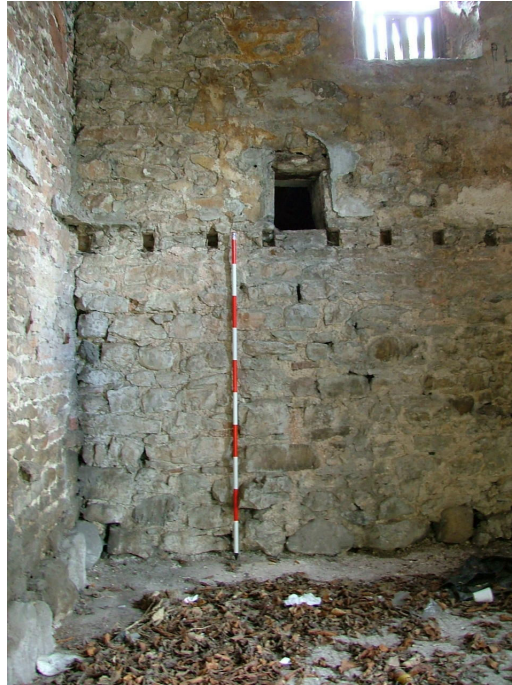
Plate 12 – Joist holes and ‘vent’ in Building 3 (SW end)

4.7.2 The building is of two floors on one side (north-eastern), while the south-western side is open to the roof. The building is of five bays with collar-braced roof trusses. The first floor has at one time, extended the full length – joist holes are visible in the walls of the SW end. The aperture or 'vent' already mentioned is located just above where the first floor would have been (Plate 12), thus suggesting that it may have been used to allow warm air into the first floor to dry grain. The presence of a chimney stack on the same elevation, could indicate that this building once housed a bothy for farm workers; however there is no evidence for a fireplace and the position of the window suggests that there was not one in place.

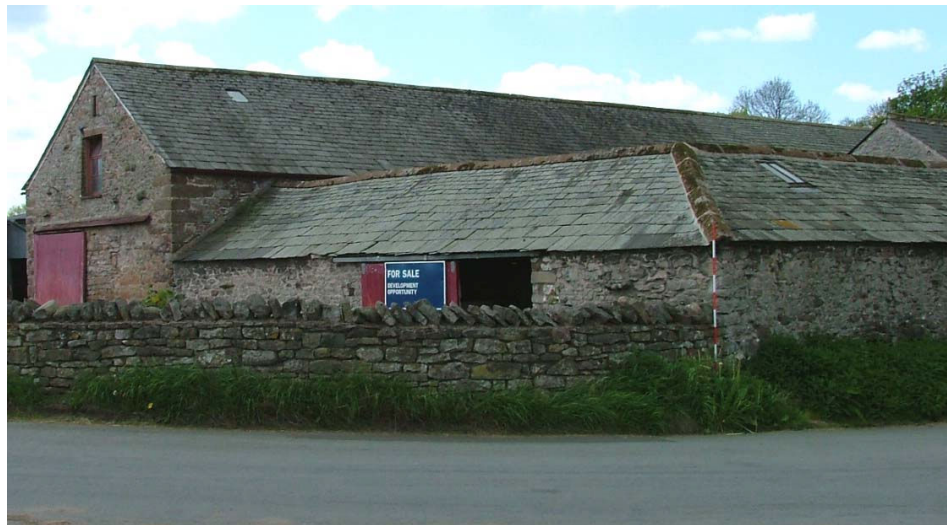
Plate 13 – Building 4 from the north, with Building 1 in the background

4.8.1 On the north-west facing elevation of Building 1, is a building that consists of three small ranges surrounding a small courtyard (Figure 1). All three ranges are of single-phase construction, are single-storey and are of uncoursed rubble masonry, with a Cumbrian slate roof and sandstone ridge tiles. Skylights have been inserted in the roof to provide extra light. Building 4 butts up against the north-western elevation of Building 1.

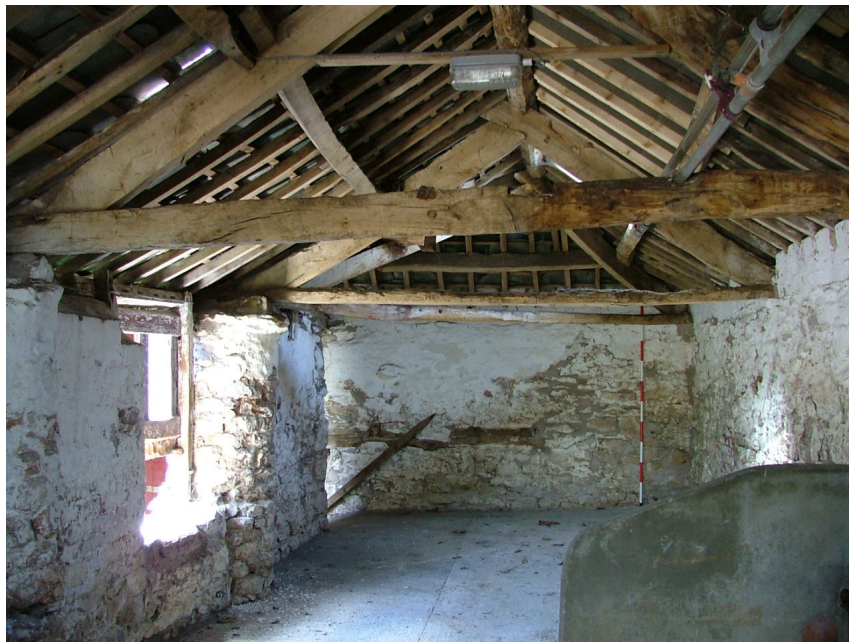
Plate 14 – One of the ranges in Building 4, on the left are the circular stone piers that support the roof.

- 4.9.2 The timbers that make up the internal roof structure are of very poor quality compared to those in the other buildings. They all appear to be hand-cut and display signs of re-use, with peg-holes, mortice holes and other joints that no longer correspond to its current use. The roof trusses are supported, on the inner walls that surround the courtyard, by stone-built circular piers (Plate 14 and Figure 1). It is possible that when this building was constructed, the stone piers did not have walls between them, and that therefore cattle were able to roam from the roofed section into the small courtyard (the circular piers prevented stock hurting themselves on sharp corners). This would have resembled a small version of a foldyard, where cattle were kept through the winter months, sheltered from the elements and where manure could be easily collected through the large doorway on the south-west facing elevation. Foldyards became increasingly common from the mid-eighteenth to the early nineteenth century, as the value of manure as a fertiliser was realised and there was a better understanding of livestock rearing⁸.

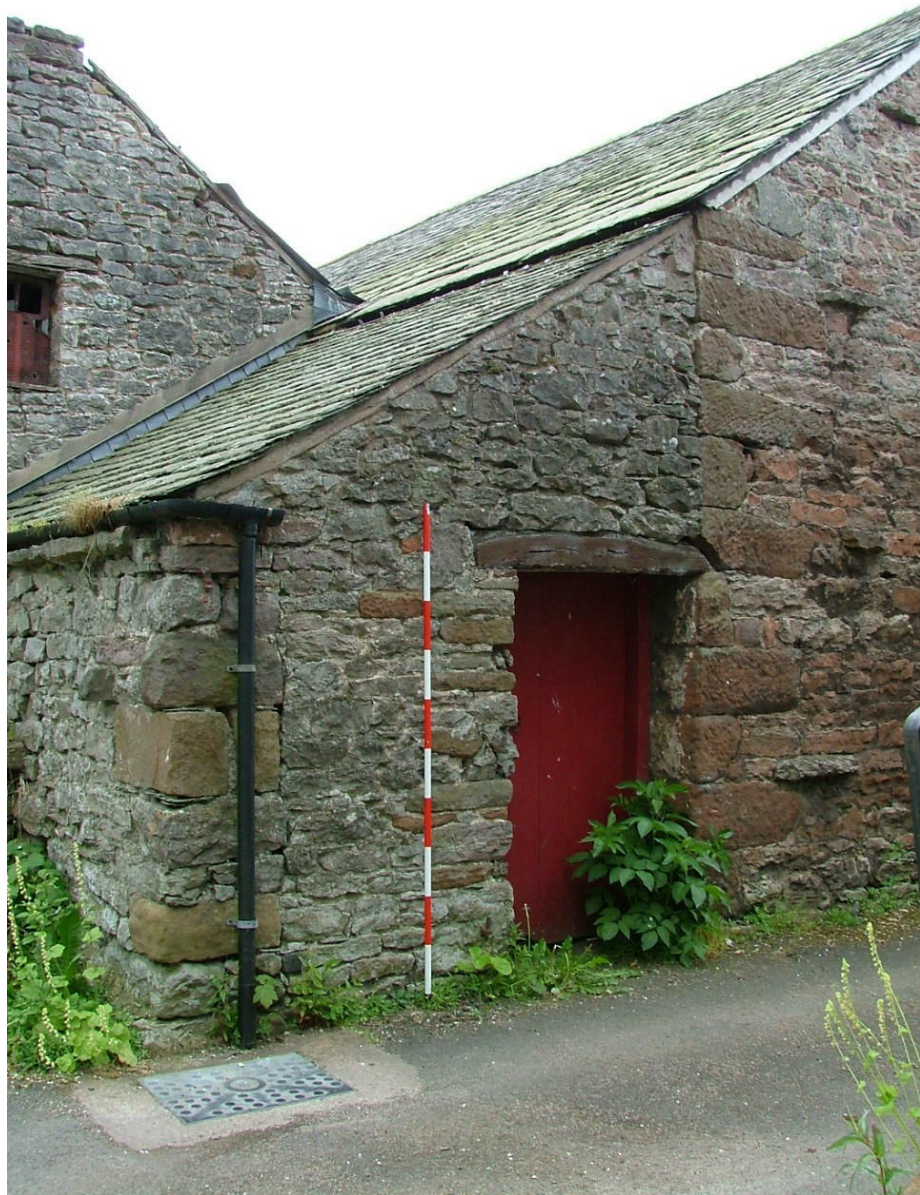
**Plate 15 –Building 5**

- 4.10.1 Building 5 is a 'lean-to' that butts up against Building 1 on its north-western facing elevation, as well as Building 3. It is constructed of uncoursed rubble masonry with roughly dressed red and grey sandstone quoins. The structure measures c.3.4 metres by c.2.6 metres. The roof is relatively new, being of Welsh slate, however, the original eaves level may be indicated by a course of projecting stones, just below the guttering.
- 4.10.2 Beside Building 5, facing the road is a plinth (Figure 1), which was used for placing the metal milk churns ready for collection.

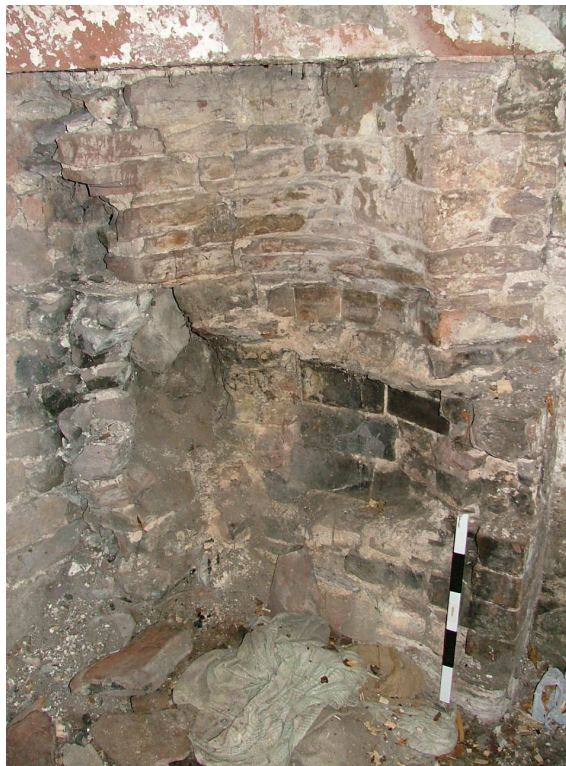
Plate 16 – 'Fireplace' in Building 5

4.11.2 This structure is accessed through a doorway on the south-west facing elevation, which has a wooden lintel. The doorway appears to be a later addition, as a clear construction break is visible beside the quoins on Plate 15, suggesting there was a larger entrance at one time. Within the interior, in the opposite corner to the entrance, is a small fireplace set across the 45° angle. This is a semi-circular brick-lined structure to a height of c.1.0 metres, extending upwards in stone, with a large red sandstone lintel (Plate 16). It is likely that there was once a chimney stack extending beyond the roof, but this has presumably been removed when the building was re-roofed. To the left of this fireplace, is an aperture measuring c.0.50 metres by c.0.40 metres, and at a height of c.1.60 metres above ground level. This 'vent' has already been described above, and may have allowed for the movement of warm air from Building 5 (heated by the fire), to the first floor of Building 2, to provide the right conditions for drying grain.

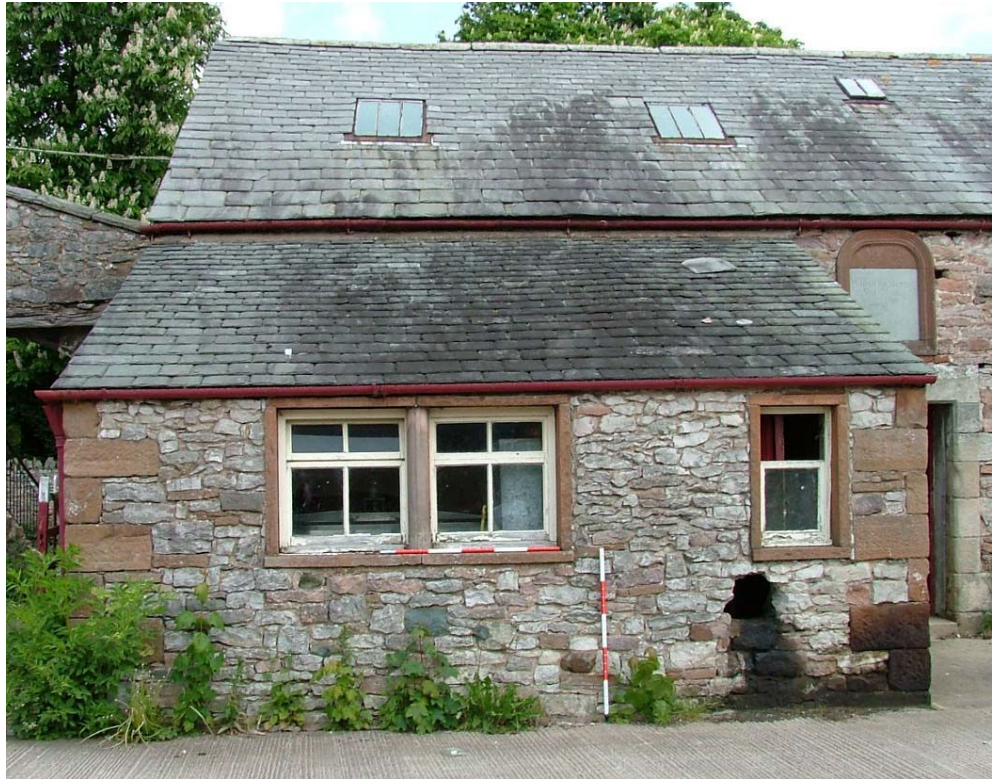
Plate 17 – Building 6.

- 4.12.1 On the south-east facing elevation of Building 1, is the only structure of the range that does not appear on the First Edition Ordnance Survey Map of 1859, and is also not evident on the Second Edition of 1916. This is a well built ‘lean-to’, which currently houses the milk tank. It is of uncoursed rubble masonry, with nicely dressed sandstone quoins and window and door surrounds. There are two windows on the south-east facing elevation, one of which is mullioned. On the southern elevation, is a large doorway with a modern sandstone lintel, this may originally have allowed for the storage of a cart or trailer, but such a large entrance was also necessary for the insertion of the large milk tank.
