**Project Designs and Client Reports No. CP/118/04**

**REPORT ON  
AN ARCHAEOLOGICAL  
BUILDING RECORDING PROJECT  
AT CHAPEL HOUSE FARM  
CASTERTON  
KIRKBY LONSDALE  
CUMBRIA**

**NGR SD 6210 7805  
Planning Application No. 5/02/0623**

11<sup>th</sup> August 2004

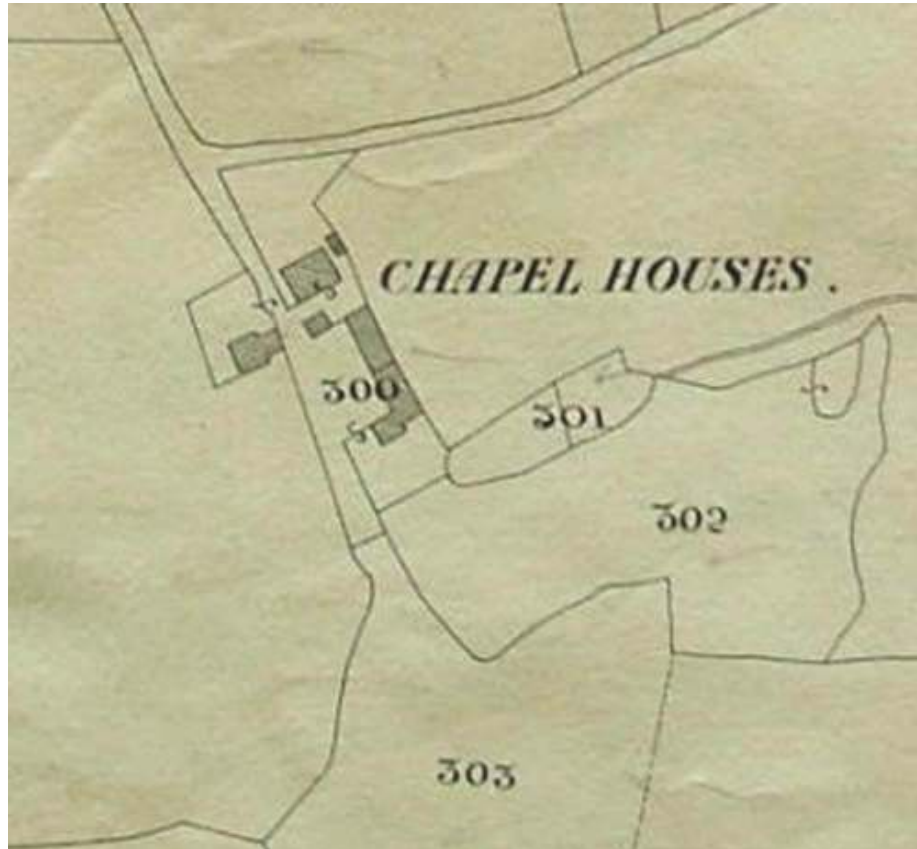
**Figure 2:** Tithe Map of 1843

- 1.4 The survey involved two ranges of farm buildings, both of which incorporate buildings visible on the Tithe Map of 1843 (Figures 2 and 3).
- 1.5 Chapel House Farm ceased to function as a working dairy and young stock enterprise in November 2002.

4.2.1.1 Barn B is located to the south-west of Barn A and associated buildings (Figure 3). It is constructed of uncoursed rubble red sandstone, limestone and granite masonry. The corners of the building are roughly quoined, and the whole structure is not as nicely built as Barn A. The gabled roof is of Welsh slate, with five glass panels inserted to provide extra light. The barn measures *c*20 metres in length, but is unusual in having a wider western end to one side of the large doorways measuring *c*9.5 by *c*9.3 metres, and a longer thinner eastern end measuring *c*.10.3 by *c*.6.5 metres (Figure 6). This unusual form can be easily identified on the Tithe Map of 1843 (Figure 2).

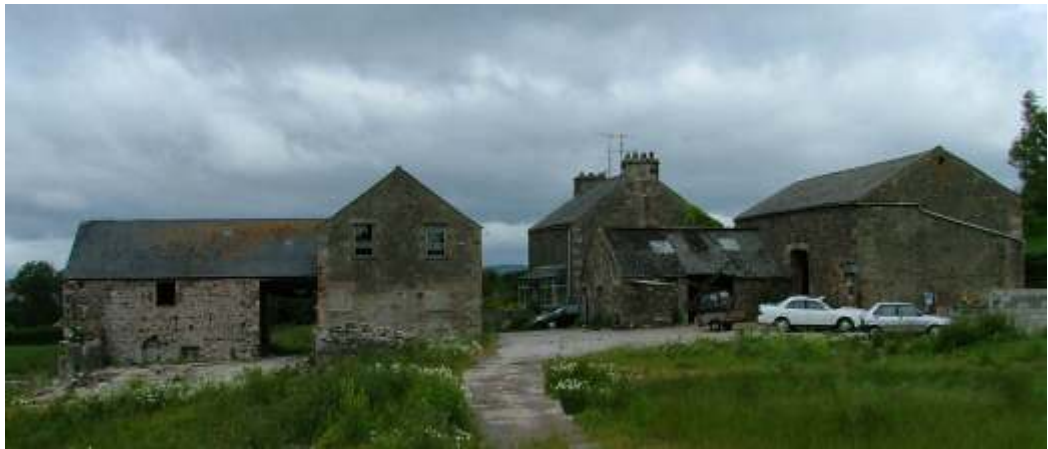
Plate 1: Chapel House Farm, Casterton

- 1.2 Chapel House Farm (Plate 1) is situated in the Lune Valley, 0.5 kilometres to the east of the river and 1 kilometre south-west from the market town of Kirkby Lonsdale (Figure 1). The village of Casterton is 1½ kilometres to the north. The farm is sited at the base of a west-facing slope, at a height of c.70 metres above sea level.

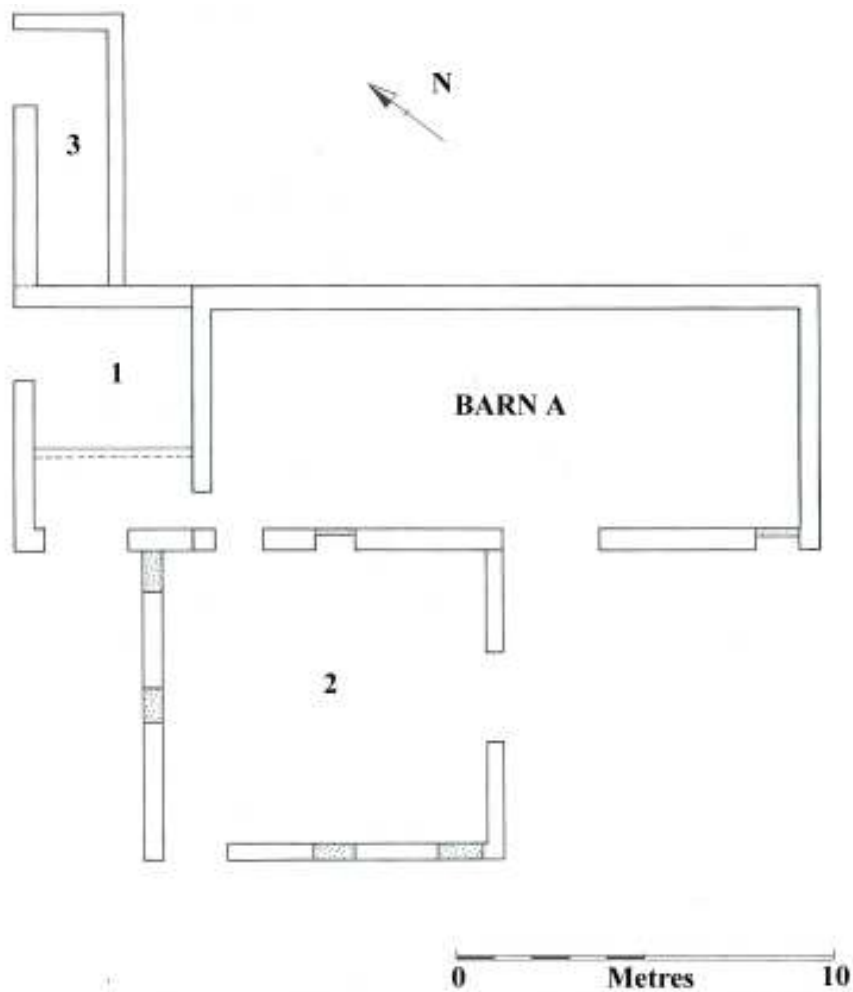
**Figure 4:** Ground Floor Plan of Barn A and adjoining buildings

- 4.1.1.1 Barn A is located within the north-eastern range of buildings at Chapel House Farm (Figure 3). The barn measures *c*16.70 metres in length and *c*7.10 metres in width. It is of mass wall construction, consisting of coursed, nicely dressed red sandstone, limestone and granite masonry. The courses are made up of larger blocks of stone at the base of the walls rising to smaller blocks further up the elevation (Plate 2). The gabled roof is constructed of asbestos corrugated sheeting with clear corrugated skylights on the South West facing side; it has plastic guttering and a metal ridge plate. There are owl holes in both end elevations.

- 4.1.1.3 On the south-western elevation is a large doorway with 17 dressed stone voussoirs creating a shallow archway (Plate 2). The door jambs are also nicely dressed, and are made up of red sandstone and limestone. Set above the archway is a row of thin stones, extending the width of the doorway, these were possibly used to distribute the weight of the wall above over the doorway. This entrance presumably allowed for the access of carts into the barn to unload cereals or hay, as well as providing light into the building. There are a further three entrances into the barn, one to the right of the large entrance, which has subsequently been blocked up with concrete breeze blocks, two within Building 2 (one of which has also been blocked up with breeze blocks – See Building 2 below) and a further doorway between the barn and Building 1 (See Figure 4).

4.1.3.1 Attached to the North West facing elevation of Barn A is a small two-storey gabled structure measuring *c*4.75 metres by *c*7.15 metres. It is of uncoursed rubble sandstone and granite masonry, with red sandstone long and short quoins. The roof is of Welsh slate. A straight construction break between Building 1 and Barn A indicates that Building 1 was constructed after the barn.

4.1.3.2 At ground level there are two large entrances, one in the North West elevation and another on the South West facing elevation (Figure 4). The former is arched with dressed red sandstone voussoirs; the other has a horizontal stone lintel. There is another doorway at first floor level on the North West facing elevation (Plate 6). Above this aperture is a metal girder projecting from the wall, this presumably allowed for the hoisting of sacks to the first floor. The two doorways at ground level would have allowed for the access of carts. The height of these entrances suggests that these were for unladen carts, and therefore this building could have been a cartshed, with a grain store above.

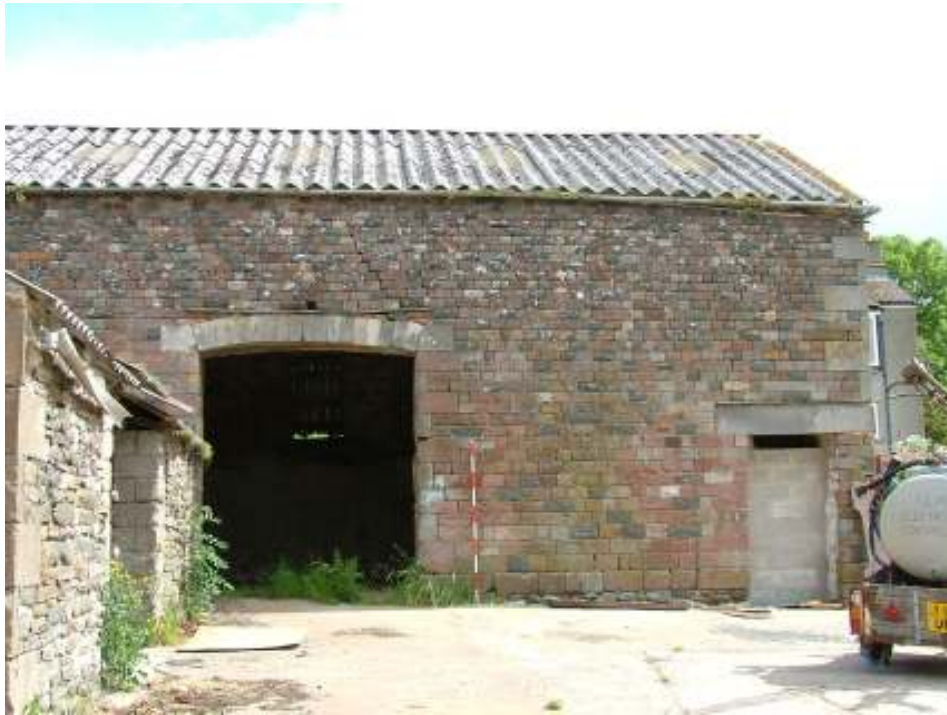
**Plate 2:** South-west facing elevation of Barn A

- 4.1.1.2 The quoinstones visible on Plate 2 are only apparent on the upper half of the barn on the south-west and eastern elevations (Plates 2 and 3). The 1<sup>st</sup> Edition Ordnance Survey map of 1860 shows a building continuing along the same orientation as Barn A (Figure 5), which has since been demolished. Therefore the position of the quoinstones most likely indicates that the missing building was of one storey. Any scarring from the roof of the missing structure would be hidden behind the modern render on the eastern elevation of Barn A.

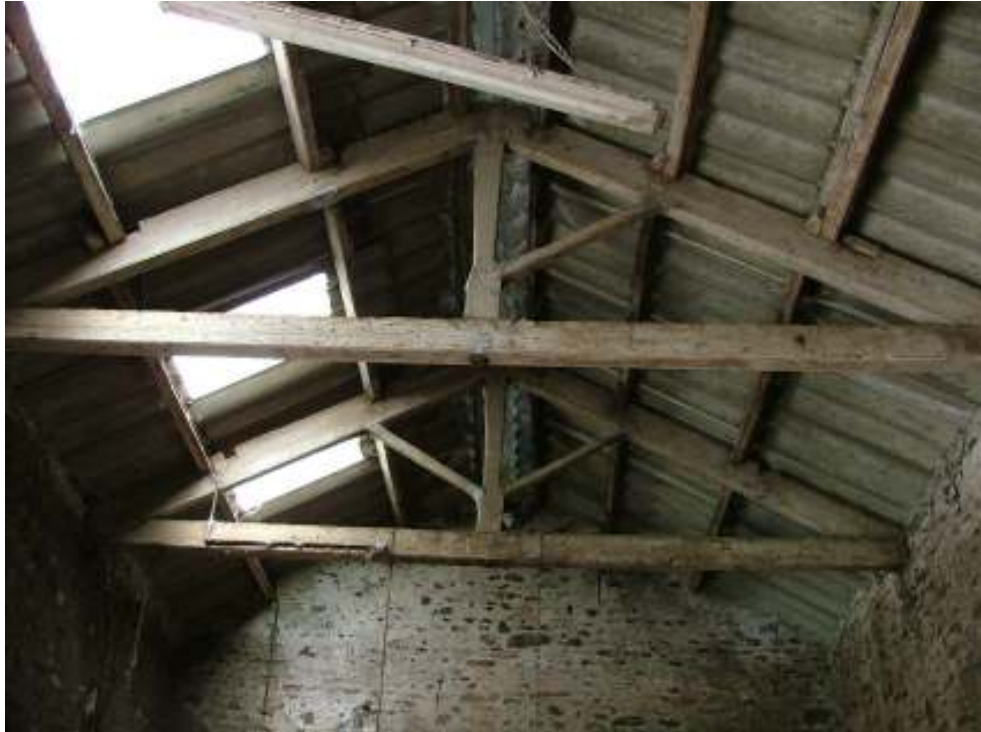
**Plate 4:** Roof structure in Barn A

- 4.1.2.2 The barn is of six bays with a roof structure of king-post construction made from machine-sawn timber. The king-posts are secured to the tie beams with iron bolts. King-post roofs became popular in British farms from the early 18<sup>th</sup> century after F Price illustrated them in *The English Carpenter* (1733), and from the early 1800's, imported softwood was used in their construction.<sup>2</sup> No carpenters marks were observed due to the height of the roof (Plate 4).

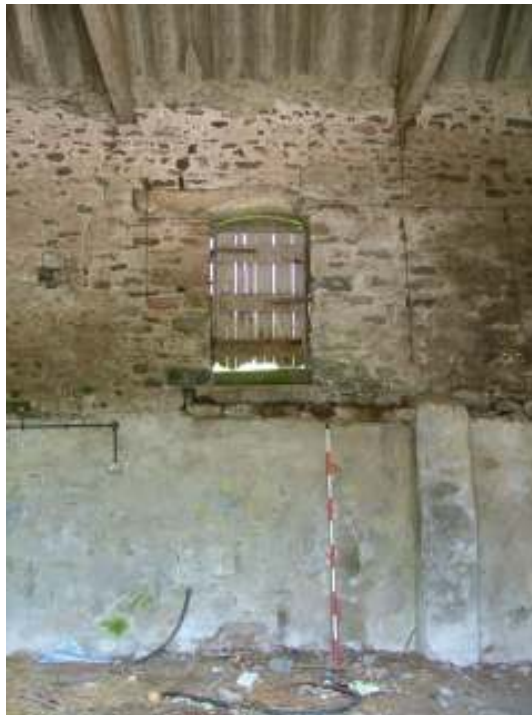
**Plate 5:** Barn A, first floor doorway

- 4.1.2.3 At the eastern end of Barn A, to the right of the entrance, and at a height of approximately two metres from ground level, are joist holes that indicate that there was at some time a first floor. A doorway in the north-eastern elevation at the same level also provides evidence for an upper floor (Plate 5). This doorway, with its large wooden lintel, is accessed externally at ground level, as the barn has been built into the slope. There are some projecting stones visible just above the scale, which may be the remains of a staircase.

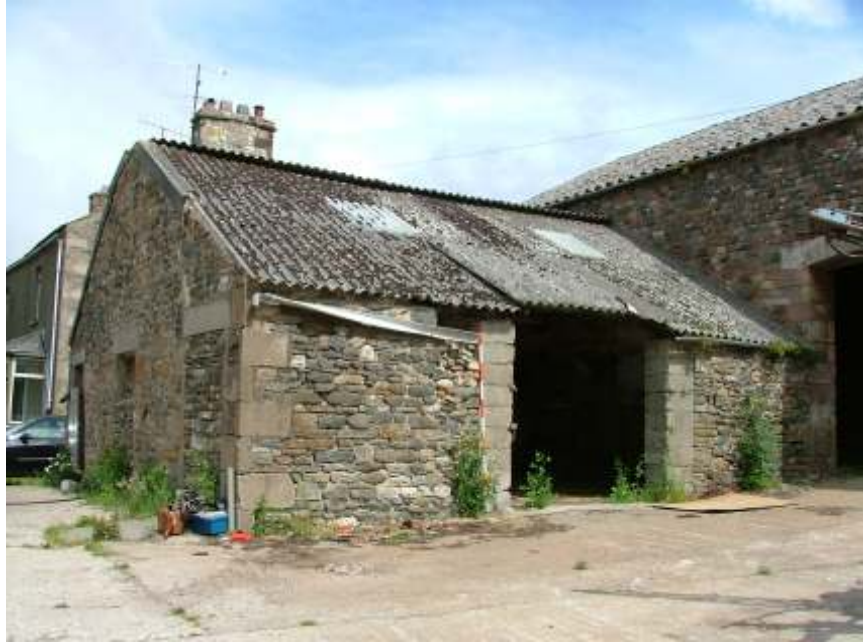
**Plate 7:** Building 2 from the south

4.1.5.1 Building 2 is situated on the South West facing elevations of Barn A and Building 1. It is a single-storey structure measuring *c*9.60 by *c*8.40 metres, and is constructed of uncoursed rubble sandstone and granite, with red sandstone alternating long and short quoins. The gabled roof is of asbestos sheeting with clear skylights.

4.1.5.2 There were, at one time, several entrances into this building, but many have subsequently been blocked up. On the north facing elevation there is one that has been blocked in with concrete breeze blocks, with another converted to a window. On the west facing elevation, two of the doorways have been blocked up, one of which has been converted to a window. All of these entrances have nicely dressed sandstone lintels and jambs made up of alternating long and short stones. On the south facing elevation is a large doorway that appears to be modern.

4.1.5.3 Clear construction breaks are visible where this building butts up against Barn A and Building 1, therefore Building 2 was constructed later.

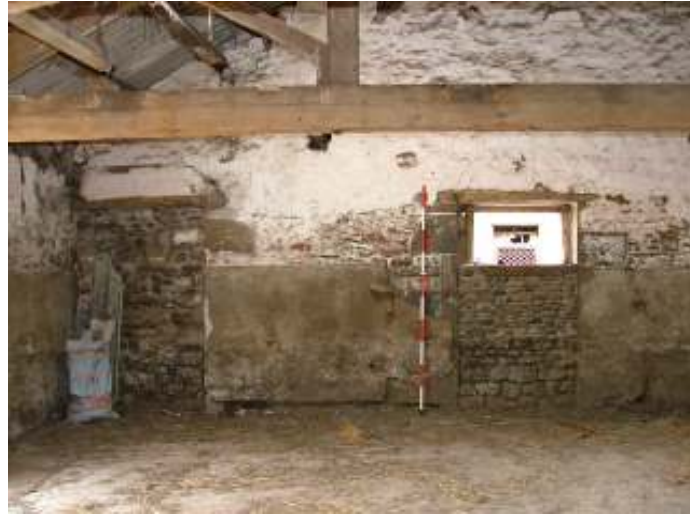
4.1.6.1 The floor of this building has been concreted over and the walls have been plastered to a height of *c*1.30 metres above ground level, above this the remainder of the wall is lime washed (a wall coating that has been used for centuries as a coating and disinfectant) (Plate 8).

**Plate 8** – Interior of Building 2 showing blocked doorways

- 4.1.6.2 The blocked doorways are clearly visible, and they appear to have been blocked in after the plaster has been applied to the walls, as the uncoursed and roughly coursed rubble masonry used, is uncovered. The wooden lintels of these doorways are also clearly visible (Plate 8). The roof consists of two trusses of queen post construction with clasped purlins, made from machine sawn timber (Plate 9).

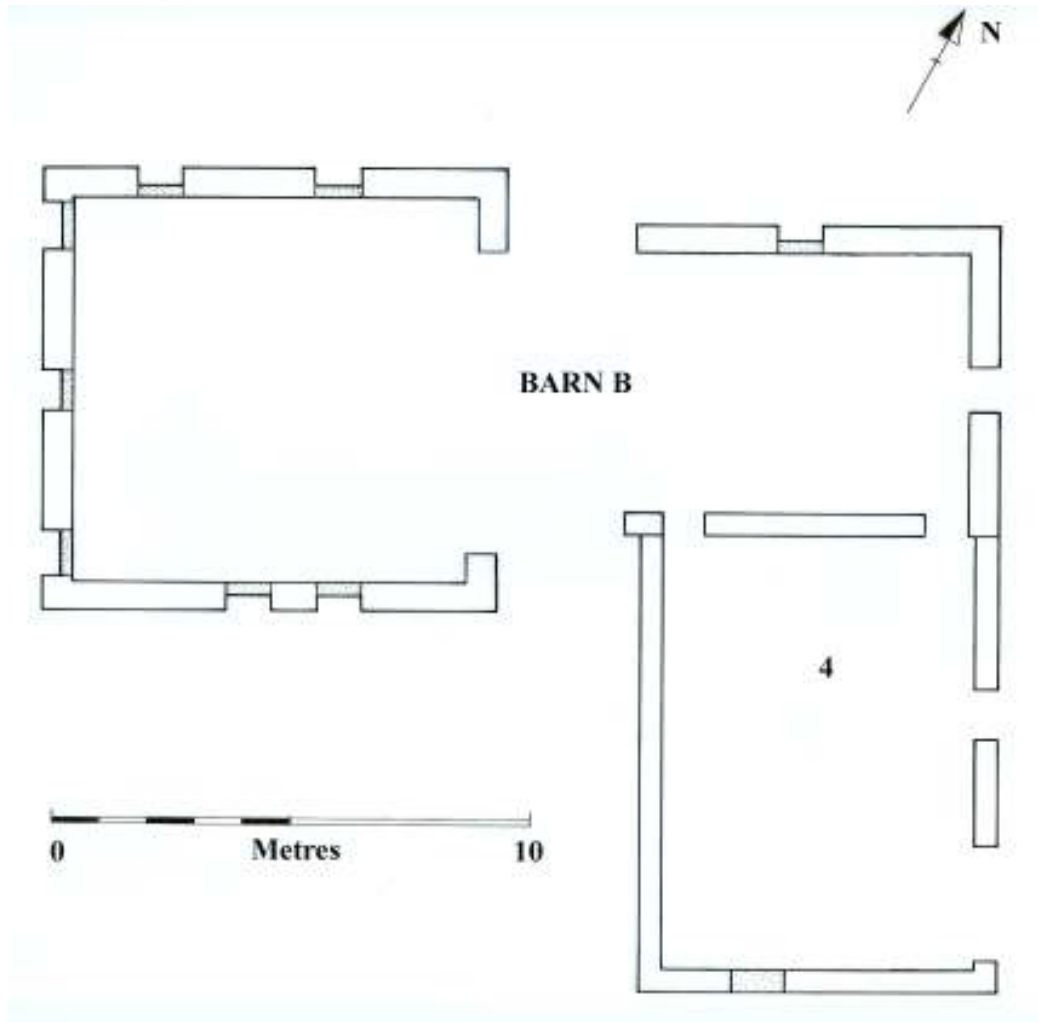
**Figure 6:** Ground Floor Plan of Barn B and adjoining building

- 4.1.2.5 The central doorway has been heightened, with another lintel added to create a window.
- 4.1.2.6 On the north west facing elevation (Figure 6), there are a further three apertures apart from the large entrance already described. To the left of the large threshing door is an entrance that still retains its door, but has been blocked up with concrete breeze blocks. This doorway has a dressed red sandstone lintel with alternating sandstone blocks making up the jambs. The two other apertures are to the right of the threshing doorway, and can just be seen on Plate 10 above. These may originally have been doorways, but the external ground level appears to have been raised.

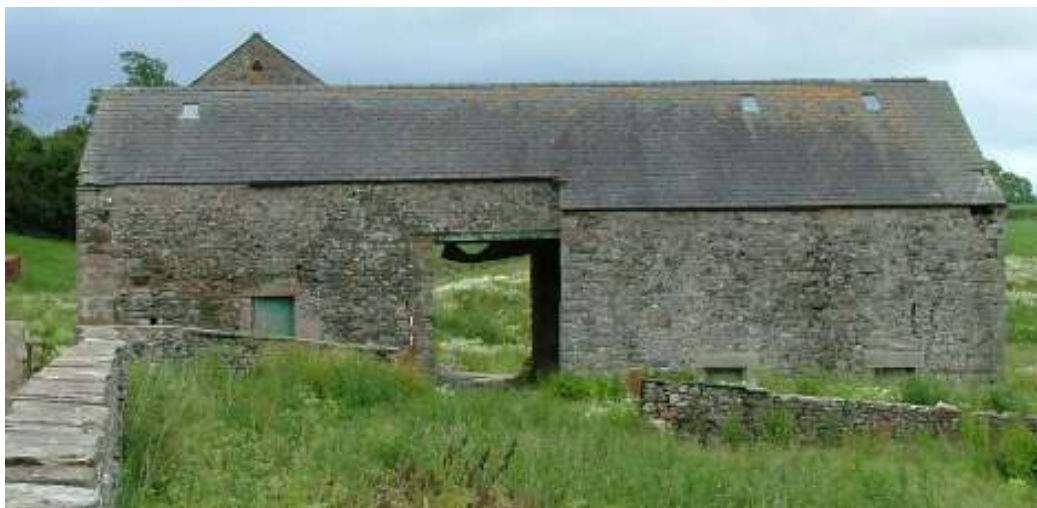
**Plate 10:** Barn B viewed from the north – clearly shows opposing doorways

- 4.2.1.2 There have been, at one time, several entrances into this barn. On the north west facing and the south east facing elevations are large opposing doorways that extend in height to eaves level (Plate 10). These doorways would have allowed for fully laden carts to access the barn, as well as for providing a through-draught for the threshing and winnowing of cereals, when hand-flail threshing was used to remove the grain from the stalk (prior to mechanisation). Hand-flail threshing required adequate space, light, height and controlled ventilation, as it was not a pleasant process<sup>5</sup>.
- 4.2.1.3 There are three doorways (now blocked with a single-course of concrete breeze blocks) on the south west facing elevation. These entrances are now partly below a pile of demolition rubble, therefore their full height cannot be seen (Plate 11).

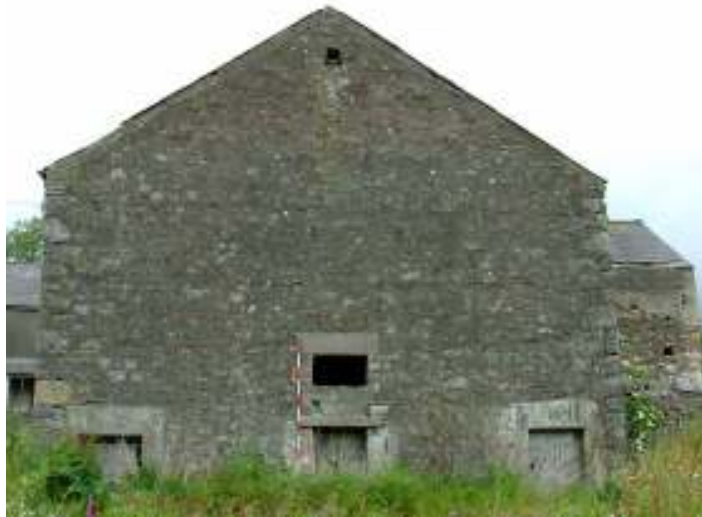
**Plate 11:** South West facing gable end of Barn B – showing 3 doorways

- 4.1.2.4 These entrances have dressed sandstone lintels and slightly chamfered door jambs. On a stone that makes up part of the door jamb for the left-hand side doorway, are the initials:

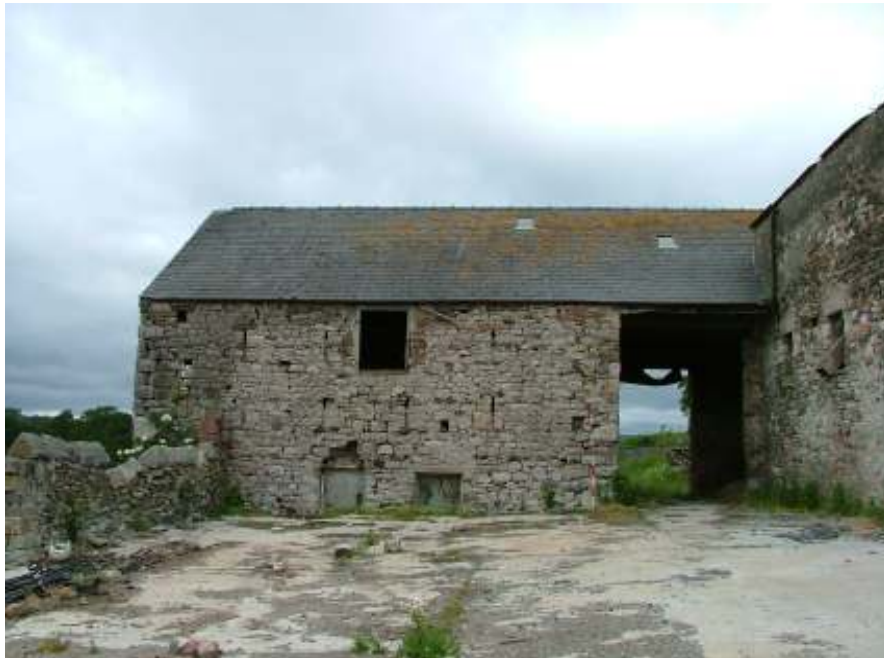
**Plate 12:** South East facing elevation of Barn B, showing large doorway, two small apertures at ground level and pitching door at first floor level

- 4.1.2.7 On the south east facing elevation, there are two small blocked-up apertures to the left of the large threshing door already described above (Plate 12). These do not appear to have been once doorways or windows, but may possibly have been hatches for pigs, although any evidence for the small yards usually associated with pig sties may have been destroyed by later building work.
- 4.1.2.8 On the north east facing gable end, is a further doorway (unblocked), with dressed sandstone lintels and door jambs, with a window to either side. There are two rows of ventilation slits, which are particularly visible on the south east facing elevation (Plate 12). They are not as apparent on the other elevations due to the application of modern render. There are owl holes at the top of each gable end.

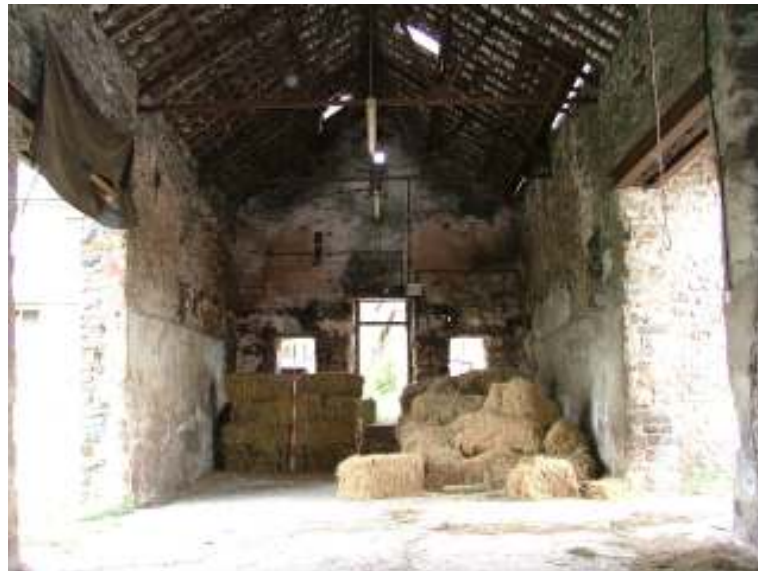
4.2.3.1 The interior of Barn B is open to the roof, the trusses, purlins and ridge beams of which are all constructed of cast iron, with cast iron girders as lintels over the threshing doors. The floor has been concreted over, so there is no evidence for earlier floor surfaces. From ground level, the walls are plastered to a height of c2.10 metres, consequently most of the blocked apertures are not visible on the inside. There is evidence that there was, at one time, a first floor. In the western end of the barn is a pitching hole at first floor height, although no joist holes were observed at this end, the plaster appears to have covered them. The first floor may have been used to store hay, and the hole would have allowed for the easy transference of hay to the outside. In the eastern end of the barn there is another pitching hole at first floor height and joist holes are visible, however, the floor must have been put in place at a later date, as the floor would cut across the windows and doorway on the north east gable end (Plate 13).

**Plate 13:** North East gable end of Barn B,  
the joist holes for first floor are just above the plaster line.

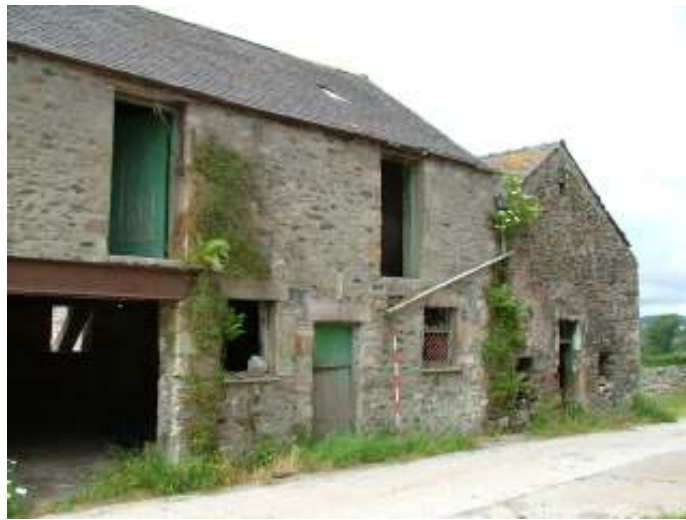
**Plate 14:** North East facing elevation of Building 4, with the gable end of Barn B

4.2.4.1 This two-storey structure butts up against Barn B at a 90° angle to the eastern end. It measures c9.6 metres by c7.5 metres, and is constructed of uncoursed rubble masonry with sandstone quoins. It is similar to Barn B in construction, but cartographic evidence suggests that Building 4 was constructed after 1899, as it does not appear on the Ordnance Survey map of that date (See copy of this map on the CD-Rom).

- 4.2.4.2 On the north east facing elevation there are two windows and two entrances at ground level, one is a standard doorway with masonry jambs and lintel, the other is larger with a cast iron lintel (Plate 14), and presumably allowed access for machinery or animals. There are two doorways at first floor level.
- 4.2.4.3 On the south facing elevation, there is a blocked doorway and two blocked windows, these appear to have been blocked in when a lean-to was added to this gable end, as the holes for the roof purlins are visible (Plate 15). There are two windows at first floor level on this elevation.

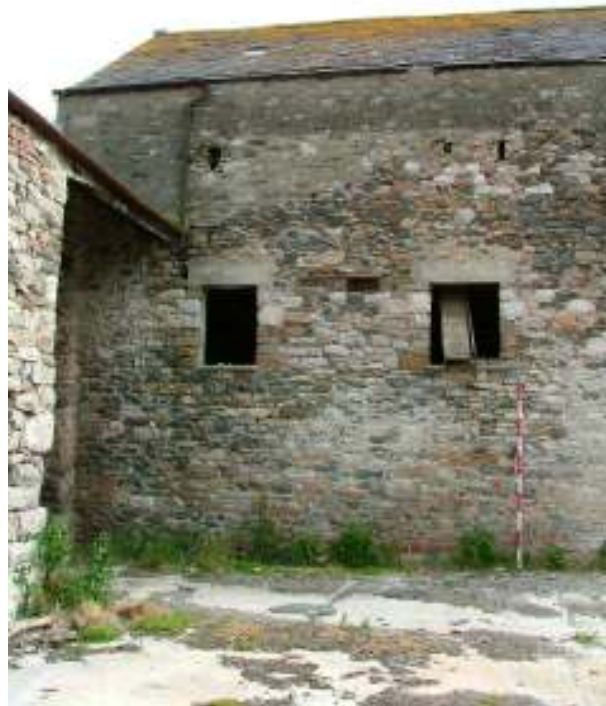
- 4.2.5.3 Set within the concrete that covers the ground outside the south west facing elevation of Building 4 and the south east facing elevation of Barn B are two rows of timber stumps (five in each row) running parallel with Building 4, these are all that remains of a ‘telegraph pole’ barn (an open sided structure) that once stood on this site. The scarring of the gable end is still visible (Plate 16).

**Plate 16:** South West facing elevation of Building 4, shows wooden chute and scarring of a demolished building
