NORTH PENNINES HERITAGE TRUST

Project Designs and Client Reports No. CP/49/03
--

**REPORT ON
A LEVEL III BUILDING
SURVEY AT
DENTON MILL,
NAWORTH
CUMBRIA**

**FOR
COUNTRYSIDE
CONSULTANTS**

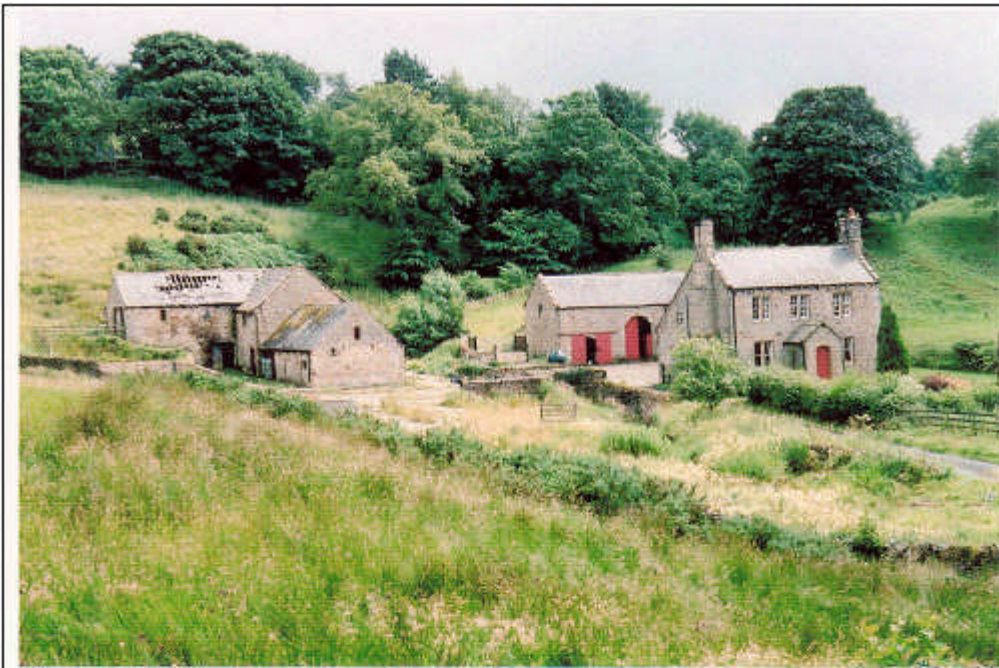
Figure 2

General view of the site from the north with the mill buildings on the left; Denton Mill farmhouse on the right and Scarrow Hill rising behind the buildings.
(photograph: P. Cracknell)

- 2.1 The watermill is sited in the Irthing Valley, one Mile (1.5 km) to the south of the river on the eastern bank of Castle Beck, a small stream that joins the river Irthing just upstream of Lanercost Old Bridge.
- 2.2 The mill is sited at a height of c.120 metres above sea level in a sheltered position (Figures 1 & 2) with the hillside of Scarrow Hill rising steeply to the east and south-east.
- 2.3 Denton Hall, approximately one kilometre to the north-east, and Denton Foot, only 150 metres to the north, were both originally farmhouses, which incorporate, the remains of a sixteenth century bastle house tower and hall respectively², within their fabric.
- 2.4 Immediately opposite the mill, on the western bank of Castle Beck, is the farmhouse and outbuildings of Denton Mill Farm (Figure 2).

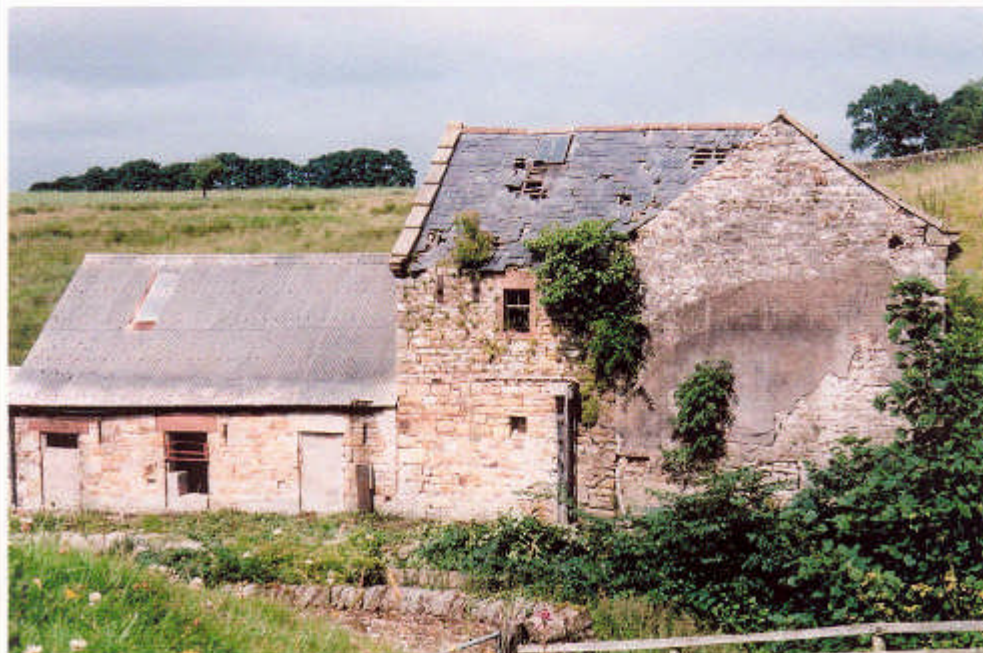
Figure 3

South-west elevation showing the three phases of building.
(photograph: P. Cracknell)

- 5.1.1 As previously stated, the building is currently derelict but has, most recently, been used as a byre and hayloft. The building ceased to function as a working mill at around 1900³ and has probably served as a domestic dwelling and byre since that date.
- 5.1.2 The mill buildings are L-shaped in plan with a single storey extension to the north-western arm, which is clearly a later addition to the original building. The longer north-eastern arm of the original mill building is built across the contour line of the hillside, resulting in only one storey at first floor level at the north-eastern end. The remainder of the building is of two storeys.
- 5.1.3 Careful examination of the fabric shows that the present L-shaped building has at least three distinct phases of construction (Figure 3).

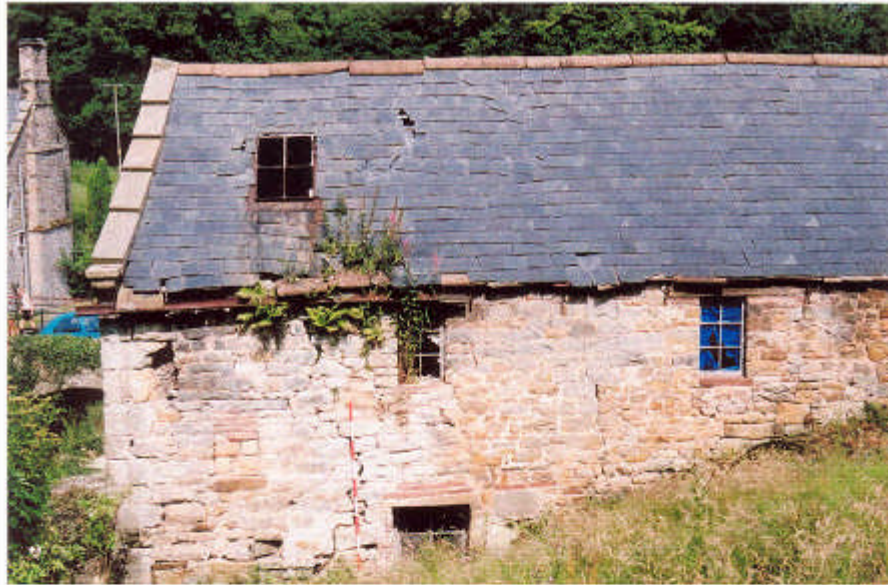
Figure 5

Part of the south-eastern elevation showing several of the original red sandstone roof tile-stones at eaves level, partly covered by the later roof of slates.
The scale measures 2 metres.
(photograph: P. Cracknell)

- 6.2.3 On the south-eastern elevation several roof tiles of red sandstone from the original roof remain in-situ at eaves level (see Figure 5). That these alterations took place at more or less the same date as the building of Denton Mill Farm is supported by use of the kneelers and stepped gable coping stones (see Figure 9). These architectural details appear on the farmhouse, barn, extension to the mill buildings and on the south-western gable, where the stepped gable sits rather uncomfortably on the earlier masonry (see Figure 12). In addition, the extension encroaches on the right-hand door jamb of the Phase 1 entrance. The second stone down (marked with an arrow on Figure 10) is inscribed with:-

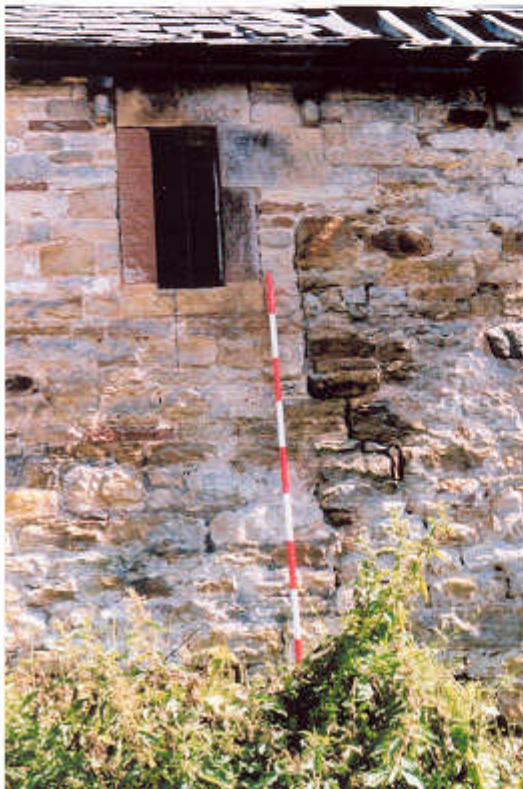
Figure 6

The original position of the north-eastern end of the Phase 1 building can clearly be seen just to the right of the ranging pole where there is a vertical construction break.
The scale measures two metres.
(photograph: P. Cracknell)

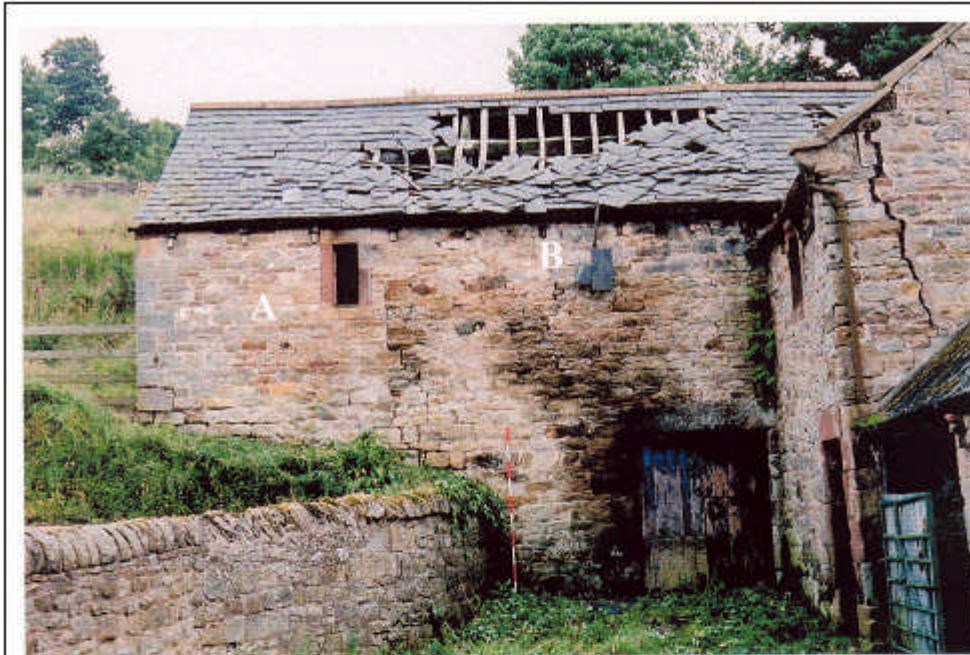
Figure 7

The Phase 2 extension of the north-eastern end of the original mill building (A) and the heightening of the north-western wall above the main entrance of the Phase 1 building (B).

Figure 8), with a new doorway allowing internal access between the extension and the original mill building. In addition the wall above the original main entrance of the Phase 1 building on the north-western elevation was heightened by 5 courses (see Figure 7). The whole building was re-roofed in Welsh slate

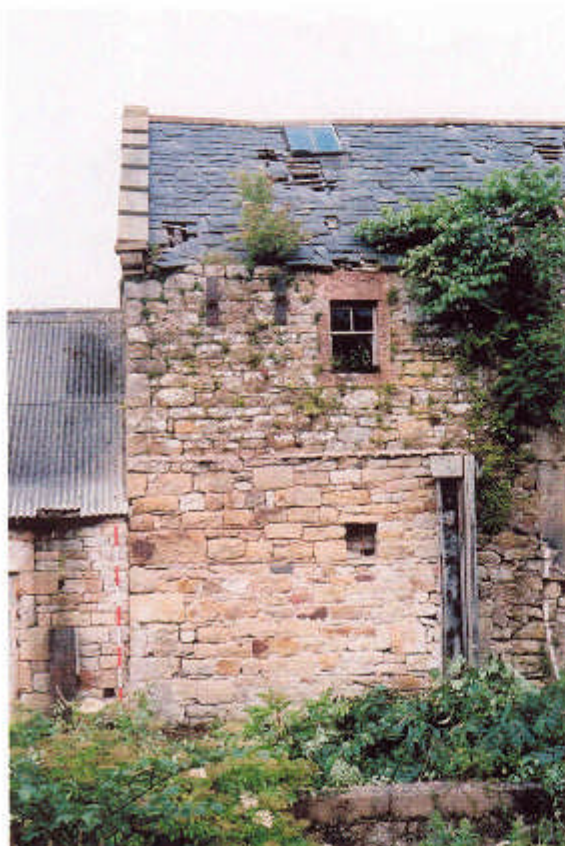
Figure 8

Phase 2 extension at right angles to the original building.

- 6.2.2 The house immediately opposite the mill - Denton Mill farmhouse, on the western bank of Castle Beck was built in the first half of the nineteenth century, together with the L-shaped range of farm buildings to the west. At the same date, or soon after, the mill was extended by c.3 metres at the north-eastern end (See Figure 7) and an extension was added at right angles to the existing building (See

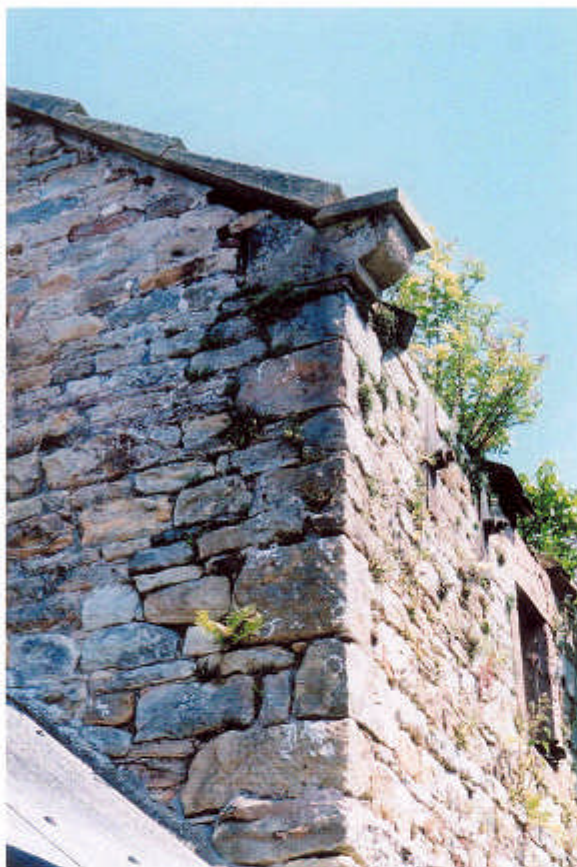
Figure 9
The kneeler and stepped gable coping on the Phase 2 extension.
(photograph: P. Cracknell)

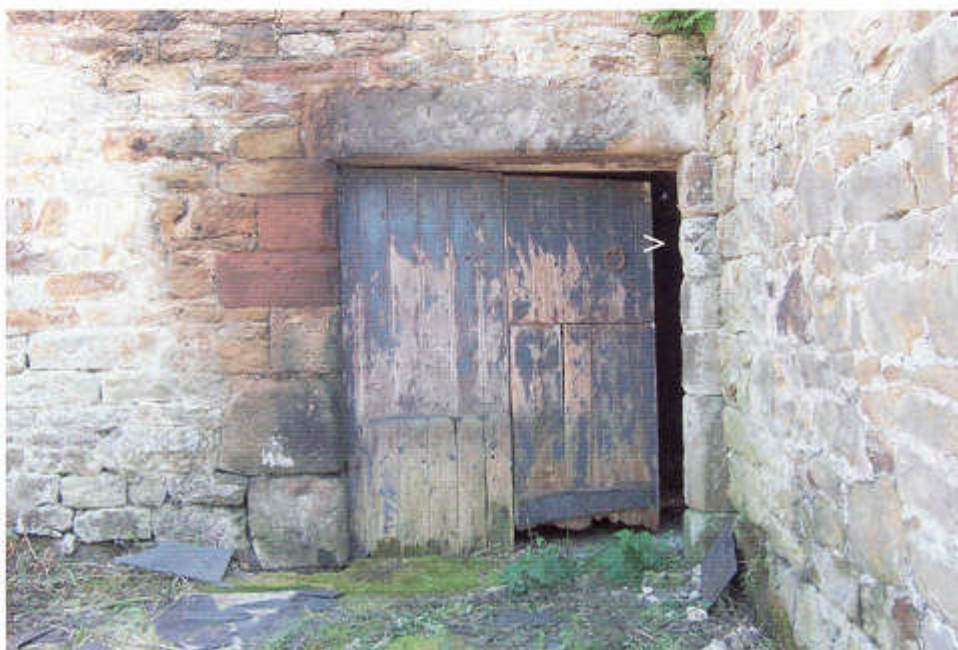
Figure 10
The main entrance to the Phase 1 building. The arrow points to the stone of the right-hand door jamb with the inscriptions hidden behind the Phase 2 extension wall.
(photograph: F. Wooler)

R.W. 1724

I. F. 1726

W. 1726 H

C.R. 1796

- 8.4 On the First Edition Ordnance Survey map of 1863 the mill farmhouse and complex of outbuildings are shown as they exist today.
- 8.5 The inscriptions of the doorway of the Phase 1 building in the north-western elevation provide a *terminus ante quem* for the Phase 1 building, i.e. built before 1724, and a *terminus post quem* for the Phase 2 extension, i.e. built after 1796.

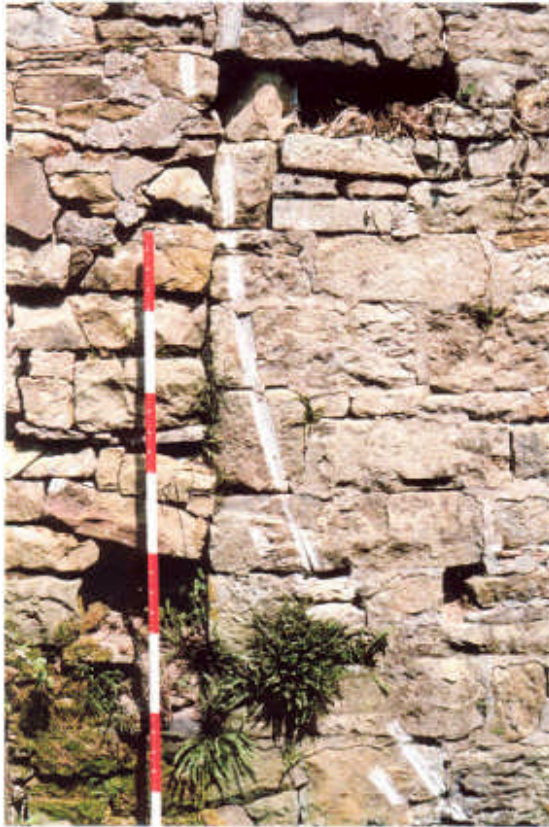
Figure 11

The chalked-in scarring on the south-western gable of the Phase 1 building showing evidence for two wheels of a slightly different diameter.

- 7.3 The south-western gable wall showed the scarring produced by the waterwheel at several points, and in one area showed evidence for two wheels of a slightly differing diameter (Figure 11). The diameter of the wheel was c.5.80 metres, occupying the full width of the gable end of the original Phase 1 building (see Figure 12).

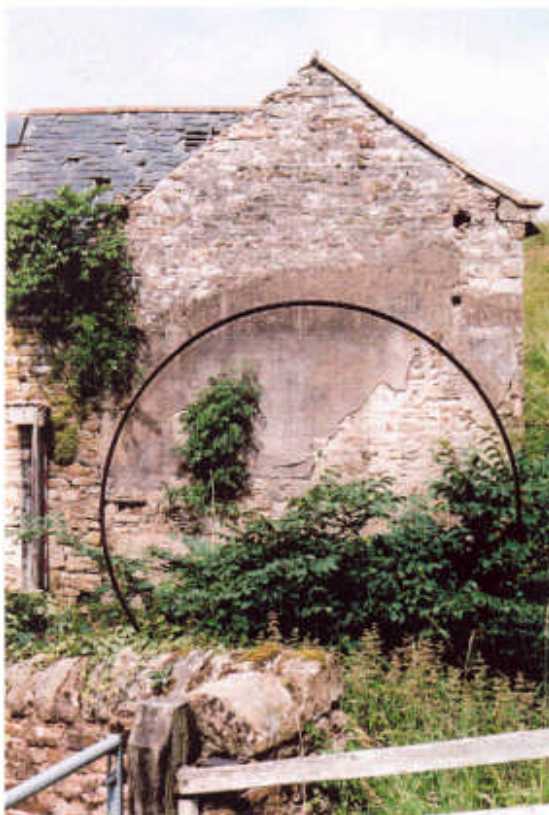
Figure 12

The south-western gable of the Phase 1 building with the circle of the waterwheel added.

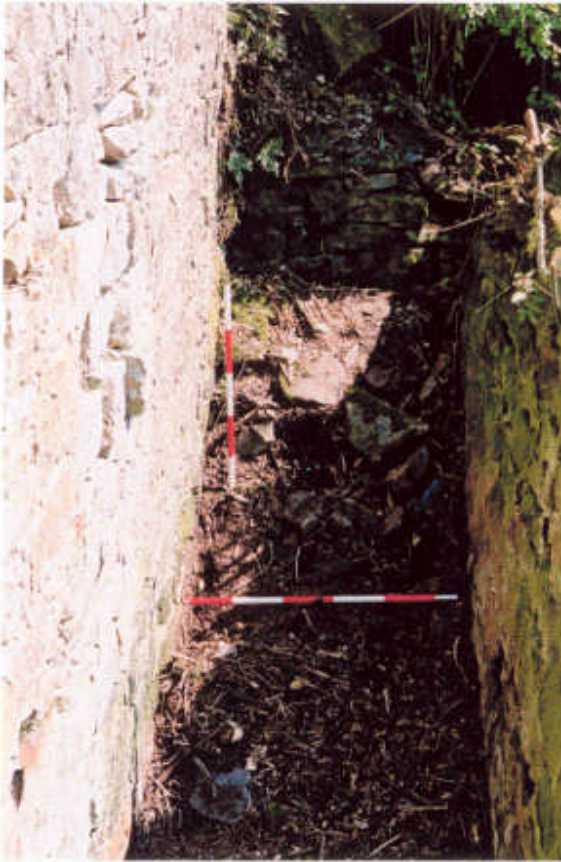
Figure 13
The wheel pit viewed from the north-west.
It has been cleared of vegetation and debris
but not bottomed.
The scales measure one metre.
(photograph: P. Cracknell)

- 7.4 The north-western end of the wheel-pit was buried below modern concrete but was probably at about the same position. The tailrace turned at right angles to the wheel-pit returning water to Castle Beck (see Figure 15). Due to scope of the project the wheel-pit was not cleared to the base and there was at least a further 1.2 metres of debris filling the base of the wheel pit. The pit was clearly wide enough to accommodate a wheel of up to one metre in width (see Figure 13). On the top of the masonry separating the wheel-pit from the beck are two large sandstone blocks with large iron bolts set into their upper surface.

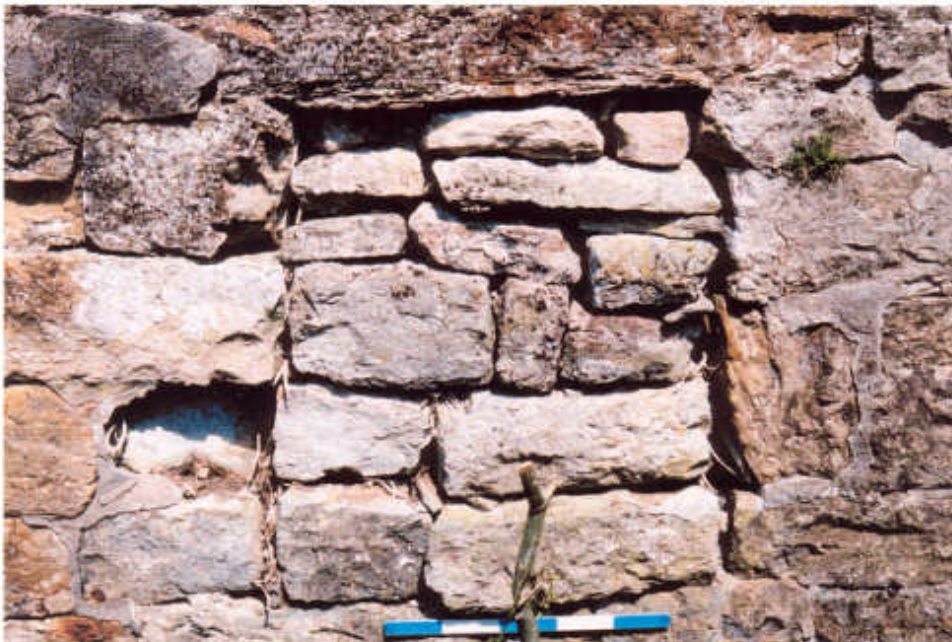
Figure 14
The blocked opening for the drive shaft of the water wheel
in the south-western gable
of the Phase 1 building.
The scale measures 500 millimetres.
(photograph: P. Cracknell)

- 7.5 The gap between the two sets of bolts measured approximately 800mm and would have originally held the bearing of the wheel drive shaft and gives a maximum width for the final wheel. The drive shaft would have entered the mill through a small squared opening in the south-western gable wall, (no blocked in) measuring 0.95m by 0.85m (see figure 14).
