Farm Buildings at East Benridge, Fairmoor, Northumberland

Standing Building Assessment January 2007
carried out on behalf of Mr David Taylor by Peter F Ryder

Planning Application Reference CM/20060871.
NCCT Ref CM7/1;6539
Oasis Reference No: peterfry1-22584

Peter F Ryder
Historic Buildings Consultant

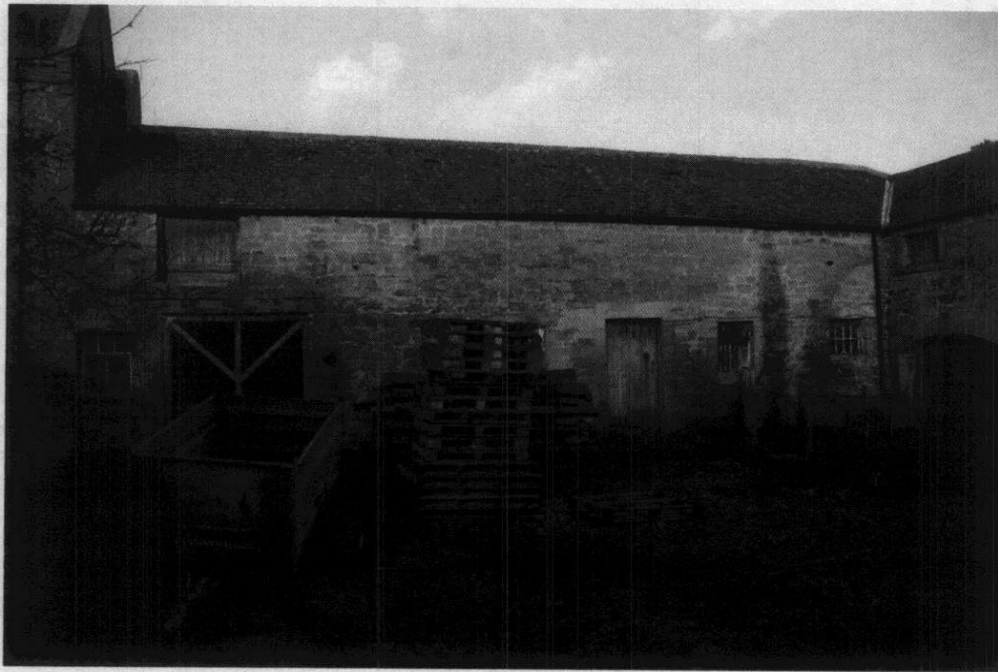
Range A South Side

The west end of the range adjoins the farmhouse; set hard up against its quoins is a 20th-century window with tooled-and-margined blocks in its east jamb and sill; a little to the east is a large opening with a timber lintel. This is probably of 20th-century date, and has been created by enlarging an earlier doorway, the east jamb of which survives¹. Further east is a boarded doorway between a pair of part-slatted windows, all with alternating block surrounds of tooled-and-margined blocks; internally the doorway has brickwork around its jambs, and all three openings may be insertions in older walling. Close to the east end of the wall is an 8-pane fixed window, without any cut dressings, which also looks like an insertion; internally its west jamb awkwardly avoids an earlier wall locker. At loft level there is a small boarded pitching door, again without cut dressings, above the large timber-lintelled opening.

The range is much altered and has few features of specific interest; the ground floor doorway and flanking windows on the south have alternating-block surrounds of typical later-19th century character, as has the pitching door and blocked loft opening on the north. Internally the remaining stall divisions and series of posts are of some interest but of relatively minor significance.

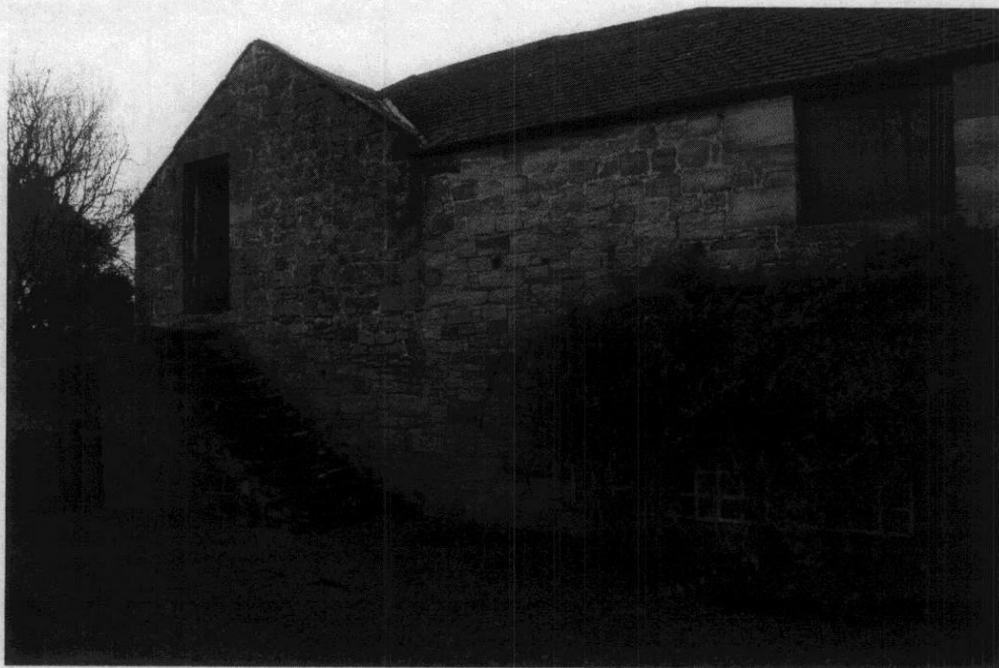
Range A (and north end Range B) from north-west

The rear (north) wall of the range is partly obscured by climbing plants. The west part of the wall is concealed by the former boiler house, an added block (in the whitish hammer-dressed stone) set in the angle between the range and the east end of the north range of the farmhouse; it has a red pantile roof pent against the taller range behind. There is a boarded door at the west end of its north wall, and a disturbed area that might represent a blocked opening on the east. Internally there is an irregular patch of brickwork at this end of the wall, but no sign of any opening in the external face of the wall seen within the boiler room. Further east are traces of a blocked door - the west jamb clearer than the east - that seems to relate to the earlier phase of walling, as may a bricked-up window at the east end of the range, concealed

externally by re-facing in the later masonry. At loft level are two square openings with alternating-block jambs, the western blocked and the eastern holding a boarded pitching door.

The north end of the range has the earlier stonework at ground floor level, behind an added stone external stair which rises eastwards to a boarded door in an alternating-block surround; the upper section of wall has quoins to east and west, showing that it pre-dates the heightening of the wall of the adjacent range A.

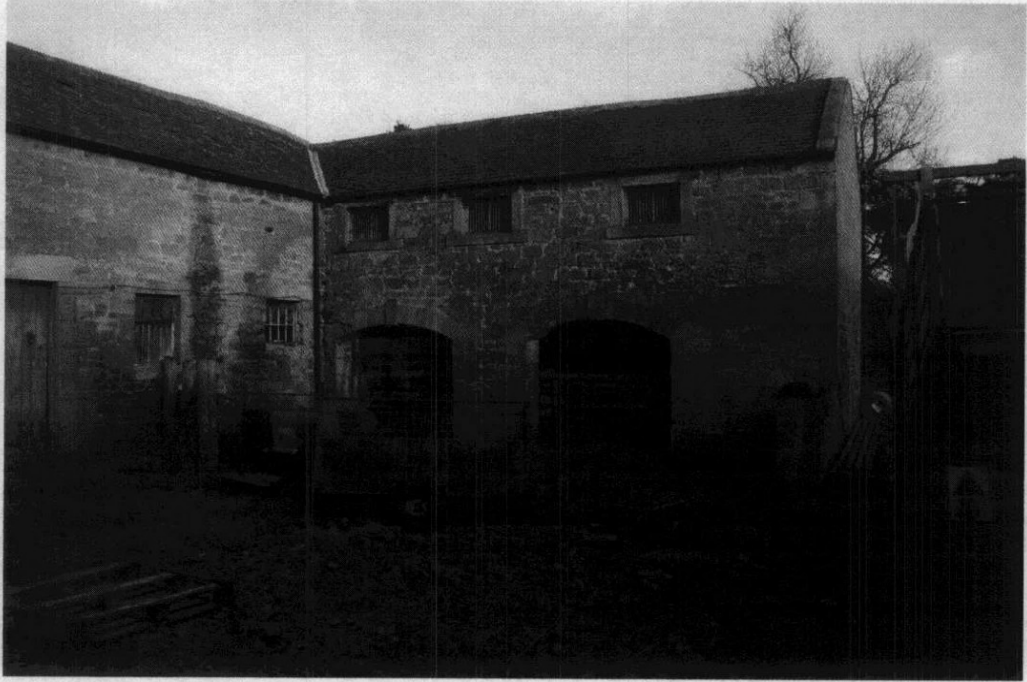
Range B from west

The west elevation, towards the yard, has a pair of segmental arches with alternating-block jambs and raised keystones, with three granary windows above; these are each elongate rectangular openings with the long blocks that form the sills and lintels extending beyond the single uprights that form the jambs. They hold wooden frames with beaded edges in which a central mullion divides two sections with close-spaced vertical slabs; internally they are closed by pairs of hinged boarded shutters, with wooden sills forming horizontal shelves c 150mm below the external opening.

The principal features of this range are the two segmental arches on the west, the granary windows and the external stone stair and doorway at the north end. These are all of later 19th-century date and contemporary with the building. The slatted openings and internal shutters of the granary windows are characteristic of the area but of relatively minor interest. The possible carved stone in the internal face of the south wall remains mysterious, but is a feature of some interest.

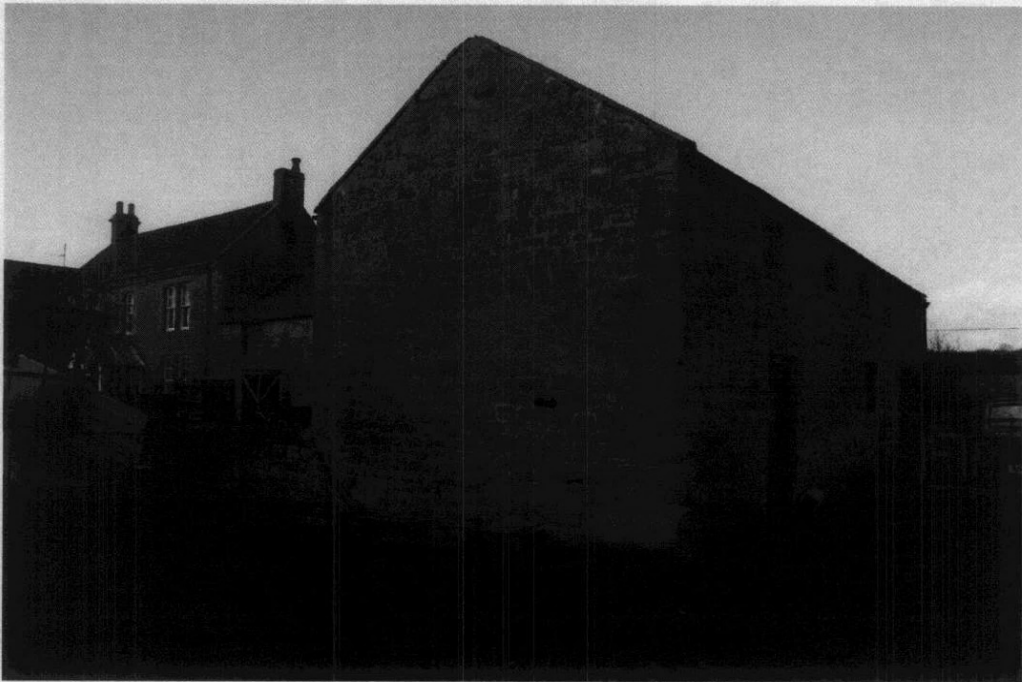
Range B from south-east

The south gable end of the range has no openings; a low contemporary wall extends c 3 m to the west²; the lower part of the south-east angle is cut to a curve, up to a neatly-carved stop at mid-height. The rear (east) elevation has a folding boarded door near its south end, in what looks to be an inserted opening, with a chamfered lintel that has been rendered over. Further north is a small boarded window in an alternating block surround, and at the north end a

large opening with a timber lintel and cemented jambs, apparently formed by enlarging an earlier doorway, part of the north jamb of which survives. Above are five granary windows of the same type as those on the west.

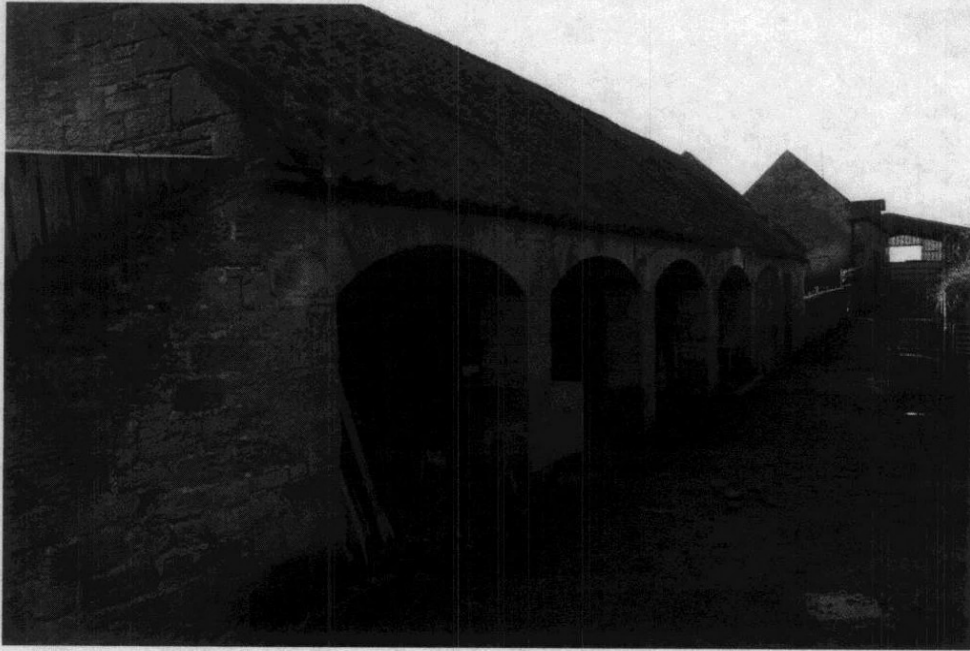
Range C from north-east

On the north, towards the yard, is an attractive arcade of five segmental arches carried on plain square piers; the third pier from the east is a little wider than the others, and in fact marks the original west end of the building. The first four arches, which have rounded glinters⁴ at the base of each pier open into the main cart shed; the fifth, which is rebated and carries a pair of boarded double doors, opens into a separate compartment, and to the east of the arcade is a doorway into a second separate room at the west end of the range, lit by a 4-pane sash window set centrally in the west gable end, with an alternating-block surround and a slightly-projecting sill.

This is quite an attractive building, its principal feature being the arcade of segmental arches on the north; the survival of the glinters at the base of the piers is a feature of interest here, as is the fireplace in the western compartment of the range. The pigsties at the east end are an interesting but only partial survival.

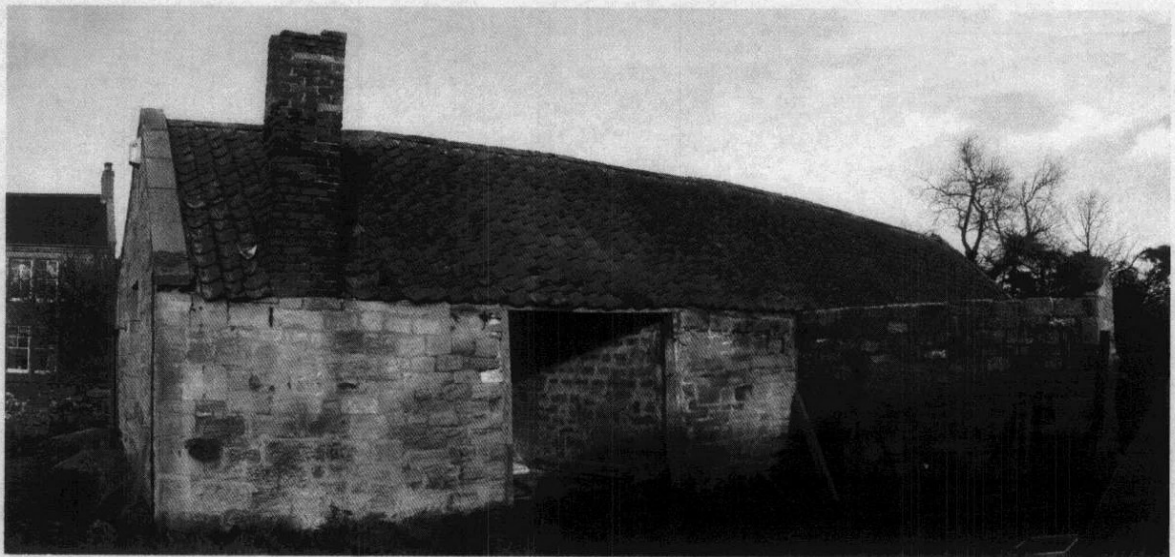
Range C from south-west

The south(rear) elevation of the range has a brick stack, now in poor condition, rising from the eaves near the west end, and then a large inserted opening that corresponds with the fifth arch of the arcade; east of this are the ruins of a projecting block; little survives of its gabled south end, which presumably held a doorway, but most of the west wall stands, and rather less of the east. In the wall of the main range behind this block is a ragged straight joint that marks the original south-west angle (its quoins removed) before extension to the west.

At the east end of the range have been a pair of attached pigsties; their side walls have a square-edged coping to a sloping section (the ends of the sties themselves) and an arched one to the attached yards. The east wall of the yards has a central pair of entrances; the medial wall is of brick; the front wall of the sties themselves has been removed.

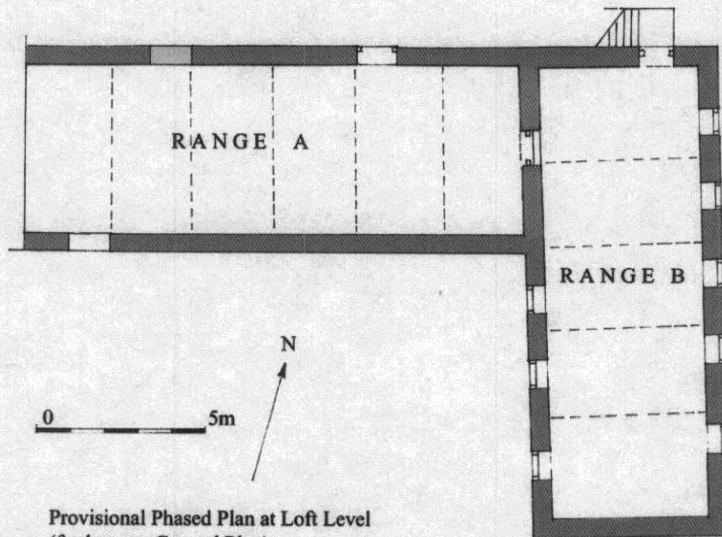
Provisional Phased Plan at Loft Level
(for key see Ground Plan)
