NEWTON GREENS FARMHOUSE

NEWTON ON THE MOOR
NORTHUMBERLAND

*ARCHAEOLOGICAL WATCHING BRIEF
JANUARY 2009*

Archaeological Watching Brief January 2009

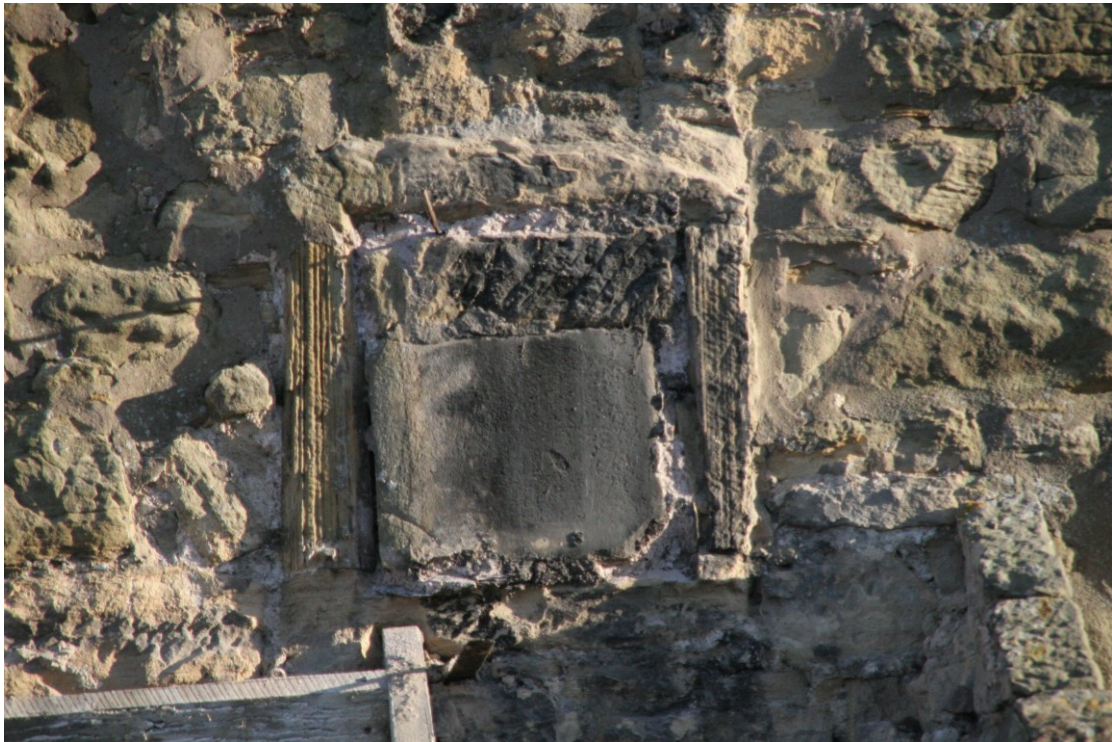
The newly-exposed window in the west gable

The removal of an old stack of engineering brick which rose adjacent to the south end of the wall, serving a boiler in the wash house, allowed a better examination of a small blocked window at first-floor level. This proved to be c 0.46 m square, with a narrow chamfered surround cut from four stones; the southern jamb was badly decayed. This window may well be an original feature of the house; its style would go with a late-17th or early-18th century date

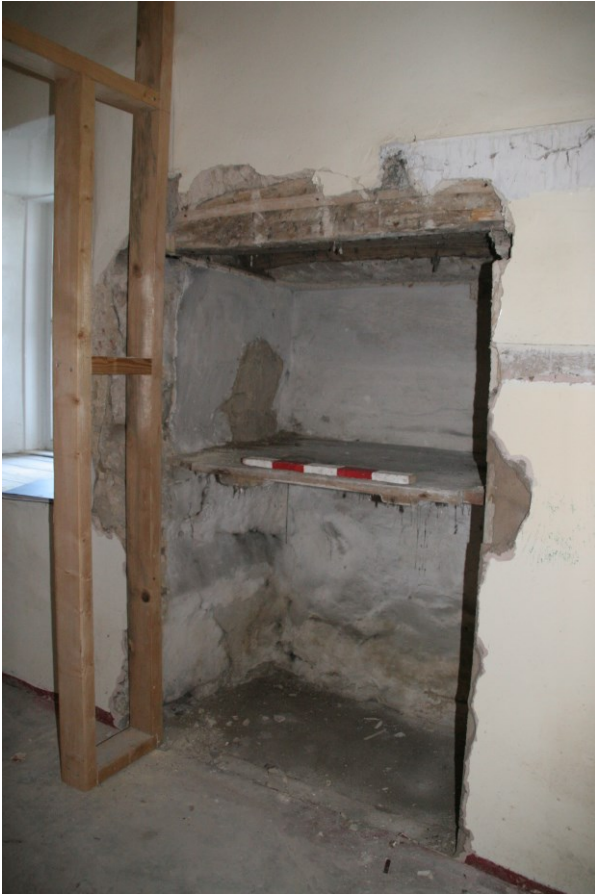
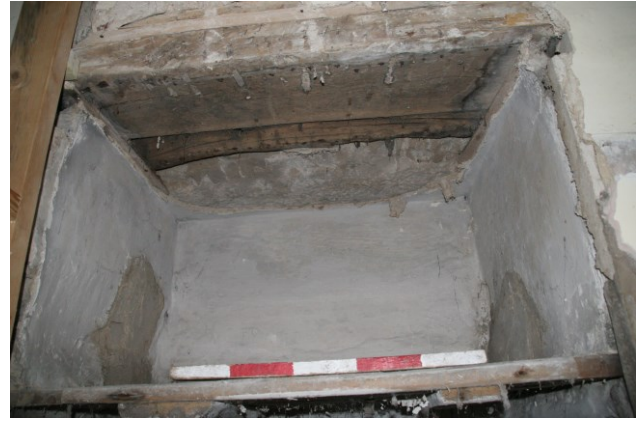
Left and above. A newly-exposed recess, formerly a cupboard but originally the north door of the house.

The removal of stoothing on the internal face of the north wall of the house revealed a hitherto-unsuspected recess formed in a former doorway opening, in the small understair room, midway between the present doorway into the kitchen within the rear wing, and the small window with a curious asymmetric internal splay that looks round the west side of the wing.

The recess, 1.02 m wide on the internal face of the wall, splaying slightly to 0.95 m at the face of the blocking 0.72 m back, was partly concealed by plaster, although large squared blocks in the internal west jamb appeared to course in with the walling. The recess had clearly been used as a cupboard prior to its concealment, and retained one wooden shelf; its internal lintel was an old timber, but beyond that were stone slabs.

It seems likely that this opening represent an original north door contemporary with the house; it is set more or less opposite the apparent remains of a first-floor opening on the south (previously interpreted as a doorway). The present doorway is of 1889, with a '1668' doorhead re-set above it. Might there have originally been an opposed pair of doorways here, with the 'upper doorway' (or window) set directly above the southern?)

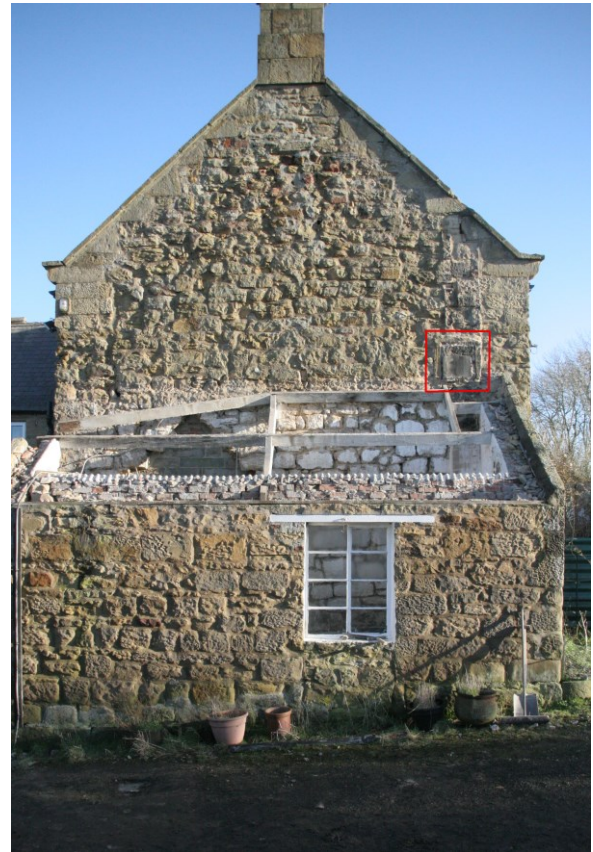
West gable end; new opening just visible (left) above wall of roofless Wash House; to right (outlined in red) is original first-floor window exposed by removal of stack (see front cover for enlarged view)

The principal structural intervention made in the current works is at the west end of the building, where a new doorway was broken through the original west gable wall to allow direct access into a later outbuilding, a former wash house. Both faces of the wall, 0.95 m thick, are of roughly-coursed irregular pieces of sandstone, with smaller rubble in parts; the core proved to be of rubble, in a crumbly soft brownish mortar. The new opening, c 2.3 m high and 1.52 m wide, was made 1.15 m from the north-west angle.
