# NEWTON GREENS FARMHOUSE

NEWTON ON THE MOOR  
NORTHUMBERLAND

*ARCHAEOLOGICAL WATCHING BRIEF  
JANUARY 2009*

## Archaeological Watching Brief January 2009

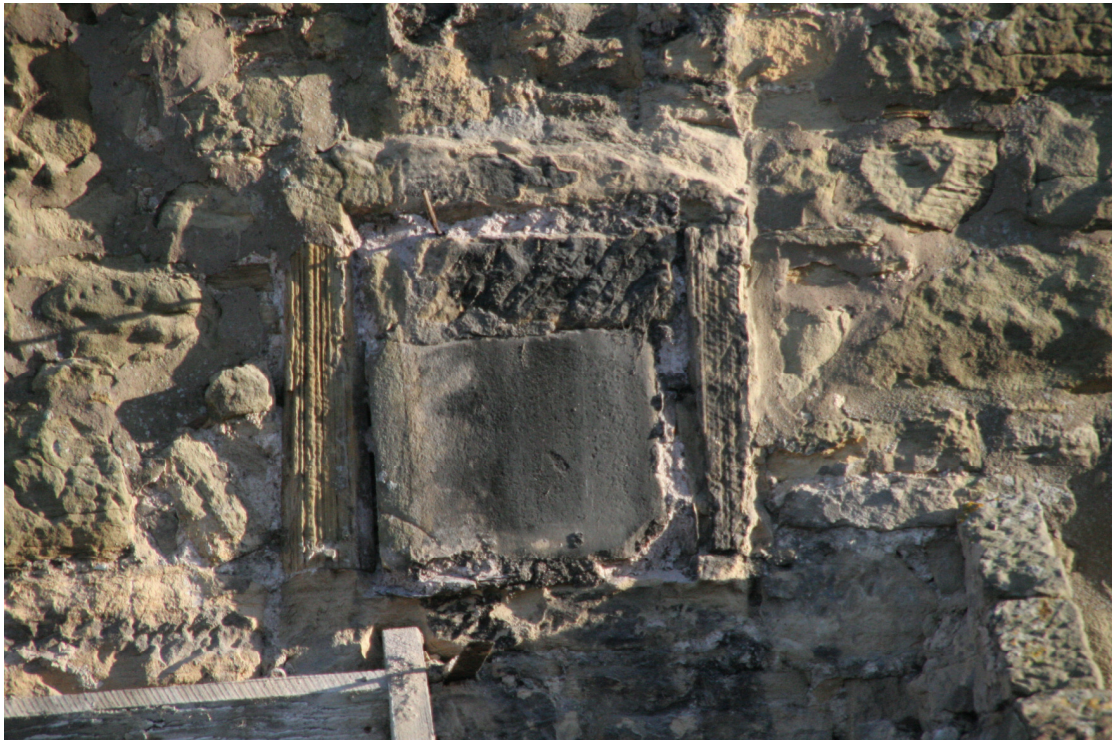
*The newly-exposed window in the west gable*

The removal of an old stack of engineering brick which rose adjacent to the south end of the wall, serving a boiler in the wash house, allowed a better examination of a small blocked window at first-floor level. This proved to be c 0.46 m square, with a narrow chamfered surround cut from four stones; the southern jamb was badly decayed. This window may well be an original feature of the house; its style would go with a late-17<sup>th</sup> or early-18<sup>th</sup> century date

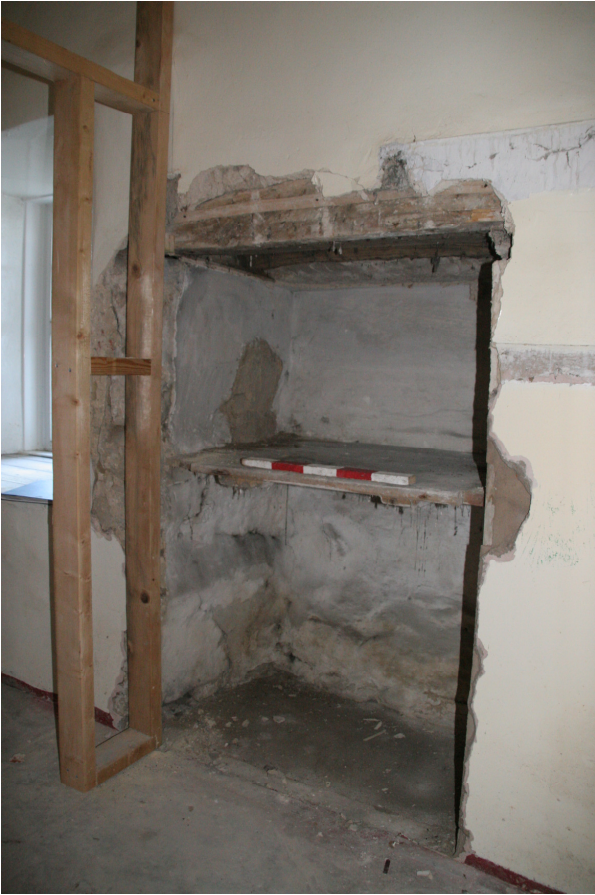
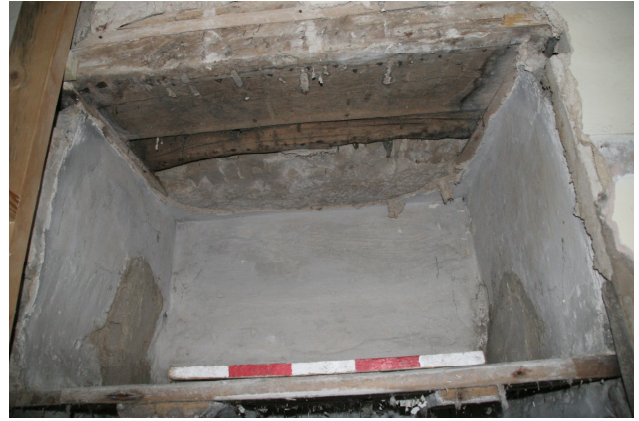
*Left and above. A newly-exposed recess, formerly a cupboard but originally the north door of the house.*

The removal of stoothing on the internal face of the north wall of the house revealed a hitherto-unsuspected recess formed in a former doorway opening, in the small understair room, midway between the present doorway into the kitchen within the rear wing, and the small window with a curious asymmetric internal splay that looks round the west side of the wing.

The recess, 1.02 m wide on the internal face of the wall, splaying slightly to 0.95 m at the face of the blocking 0.72 m back, was partly concealed by plaster, although large squared blocks in the internal west jamb appeared to course in with the walling. The recess had clearly been used as a cupboard prior to its concealment, and retained one wooden shelf; its internal lintel was an old timber, but beyond that were stone slabs.

It seems likely that this opening represent an original north door contemporary with the house; it is set more or less opposite the apparent remains of a first-floor opening on the south (previously interpreted as a doorway). The present doorway is of 1889, with a '1668' doorhead re-set above it. Might there have originally been an opposed pair of doorways here, with the 'upper doorway' (or window) set directly above the southern?)
