**Improvements within the grounds of
Knock Castle, Largs, North Ayrshire:
Archaeological Mitigation**

Data Structure Report

by Alan Matthews

issued 20th June 2011

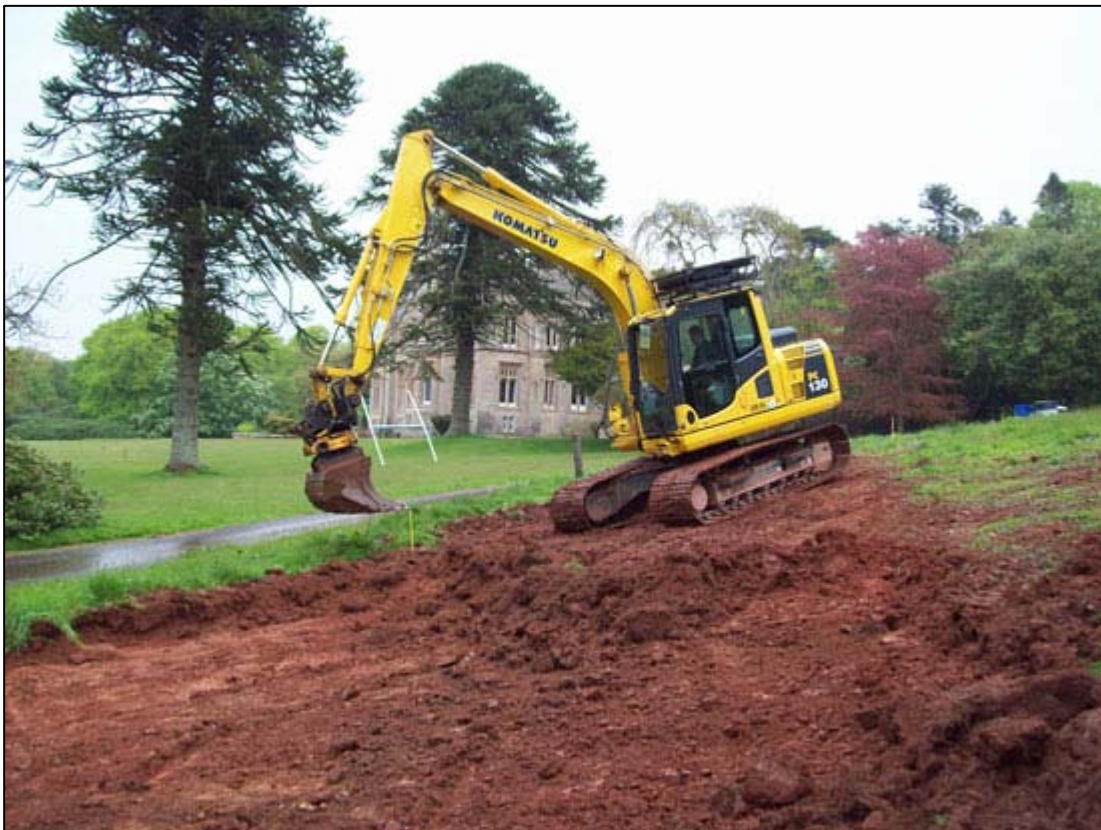
Figure 4b: Excavating for the Ha-ha

12. Archaeological monitoring of stripping for the placement of a ha-ha was undertaken on the 5th of May 2011 (Figure 4b). This involved stripping to archaeologically sterile subsoil along the length of the proposed ha-ha and included the full breadth of the proposed remaking of the slope to the south-east of the ha-ha. This included an area approximately 490m² long and varying from approximately 8m to 5m wide, narrowing at the northern end (Figure 5a).

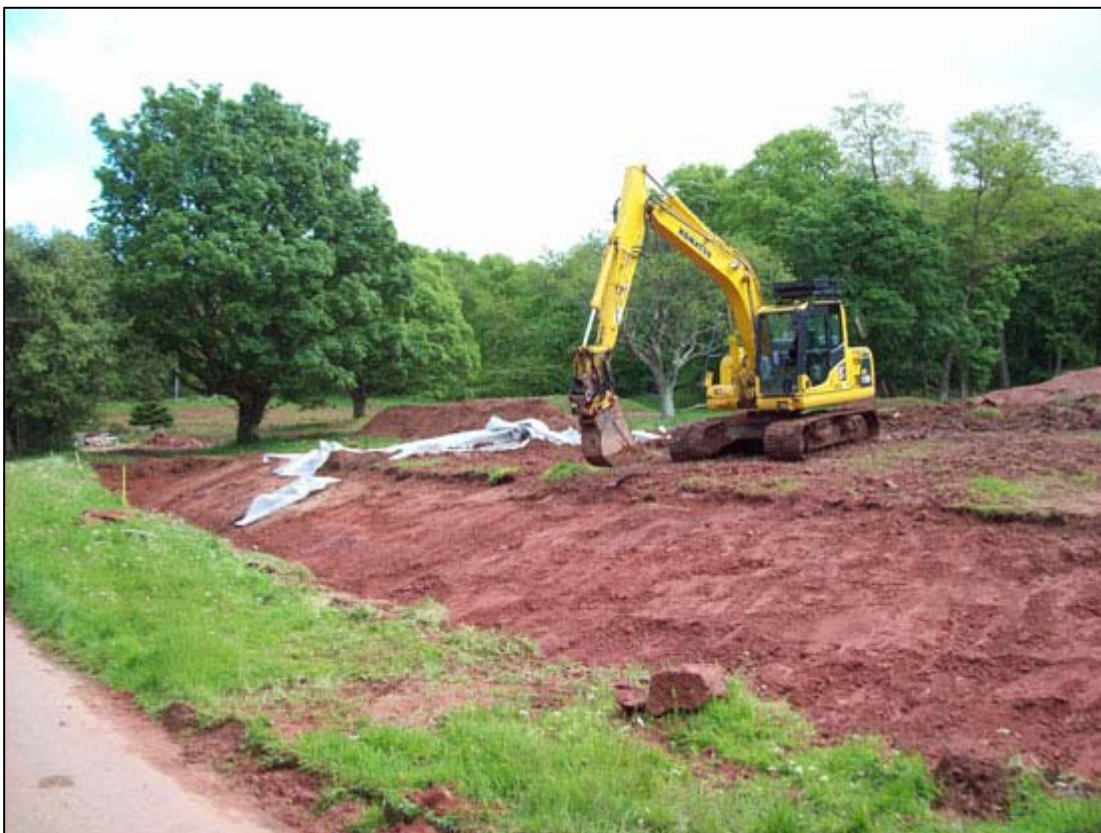
Figure 5b: Excavating for the Drainage

15. Archaeological monitoring of the excavation for the placement of drainage began on the 13th of May 2011 (Figure 5b). This excavation work included the northernmost four lines of drainage, with additional spurs running off of each, with ran directly into a main drain placed at the base of the ha-ha. Upon commencement of archaeological monitoring the re-deposited subsoil (001) which covered most of the area had already been removed down to the top of the original topsoil (002). There was no possibility of impacting on significant archaeological remains during this work removal of the re-deposited subsoil.

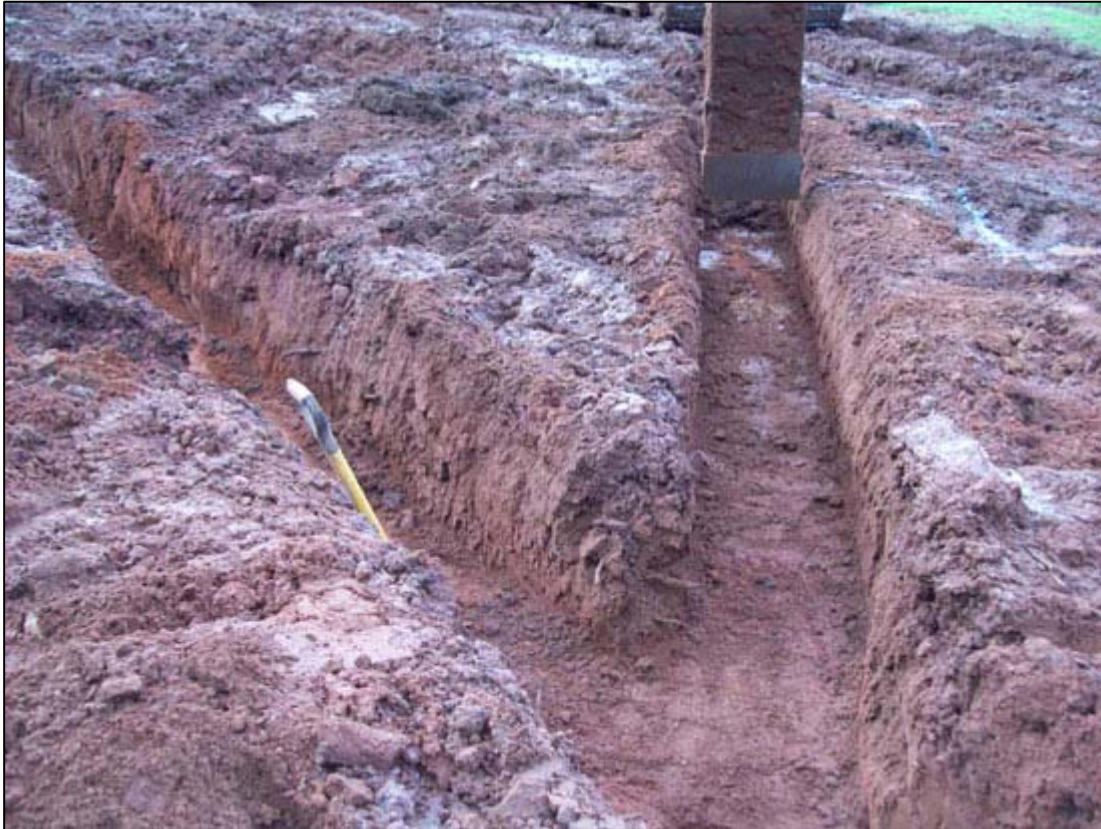
Figure 6a: Drainage tracks

16. The tracks for the drains were excavated to a depth of approximately 600mm from the surface of the original topsoil layer (002) and to a width of approximately 400mm (Figure 6a). The first 100mm to 200mm of the sediments exposed was buried topsoil (002). The remainder of the sediments exposed was archaeologically sterile subsoil and occasional concentrations of bedrock which had to be broken up by the digger (Figure 6b). No significant archaeological material was observed in the course of this monitoring work and no anthropic material was observed other than that which would relate to the modern (20th or 21st century) use of the site.

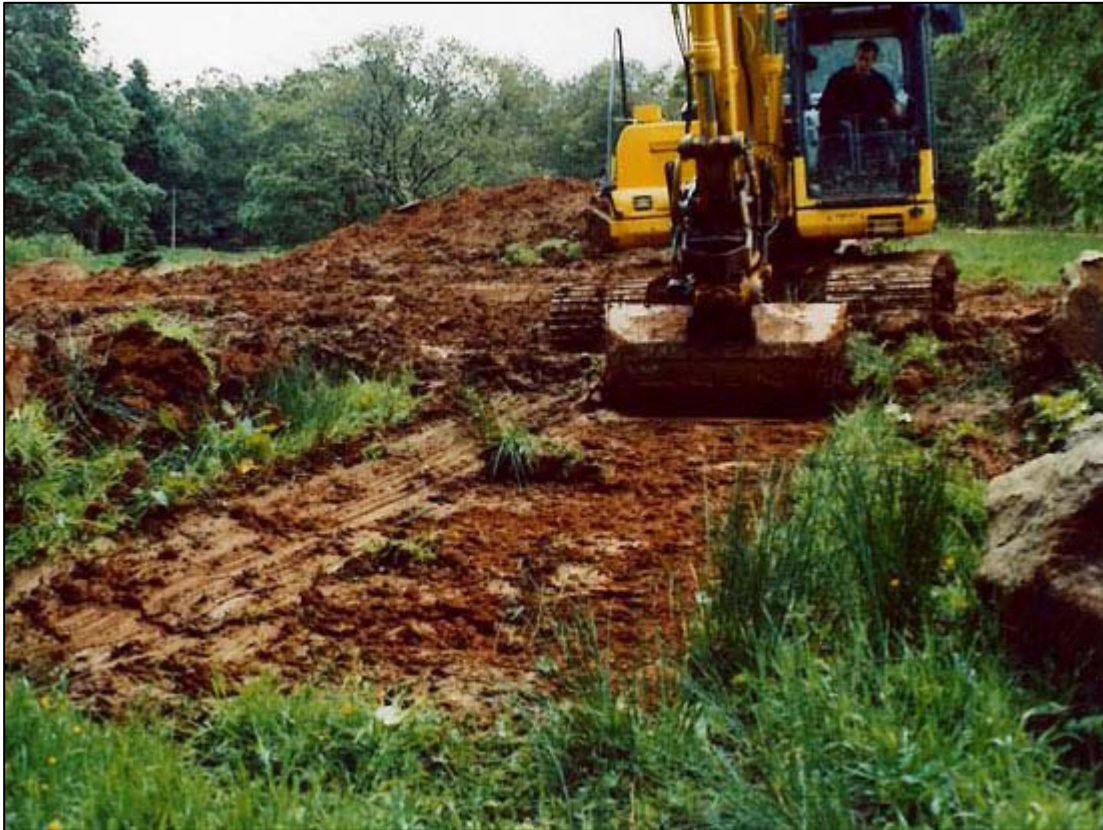
Figure 7a: Area stripped for access

21. Observations carried out during the monitored strip for the placement of the ha-ha suggested that the only significant disturbance which had taken place within the development area was the large scale and unfinished landscaping works which constituted the early part of these development works. However, the *in-situ* subsoil exposed by the stripping for the ha-ha showed no indication of disturbance and contained no significant archaeological features. However, given the shallow depth of the topsoil it is difficult to say for certain if the exposed surface of the subsoil represents a geological surface or the result of some long ago landscaping project in the castle grounds. Similar results were achieved during the strip of the small area for machine access (Figure 7a).
