**Bridgegate, Irvine, North Ayrshire
Archaeological Monitoring**

Data Structure Report

issued 30th August 2011

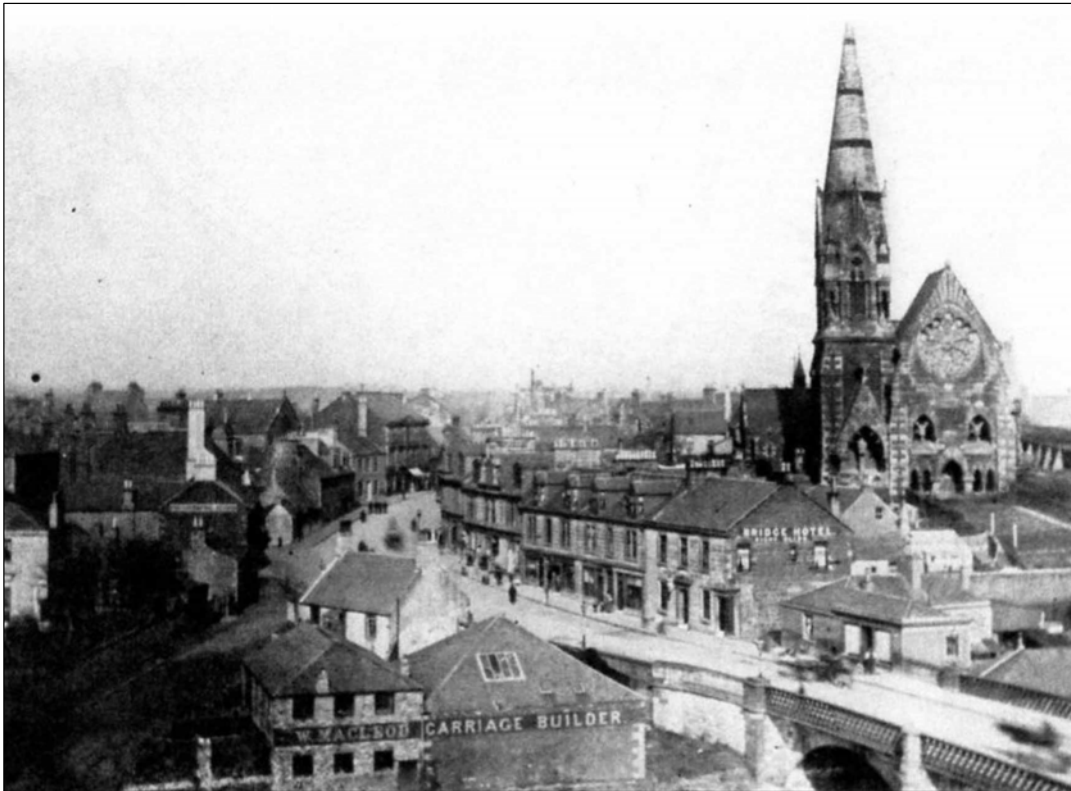
7. The density of street frontage shown either side of Bridgegate, and on Hill Street which joins Bridgegate from the south, is consistent across the available late eighteenth to mid nineteenth century mapping (Figures 1a and 1b). The construction of the Trinity Church in 1863, to the south of Bridgegate, led to the demolition of a section of the southern frontage (Figure 2a) to provide space for the ramped access to the church.

Figure 2a: Late 19th century view of Bridgegate after construction of Trinity Church

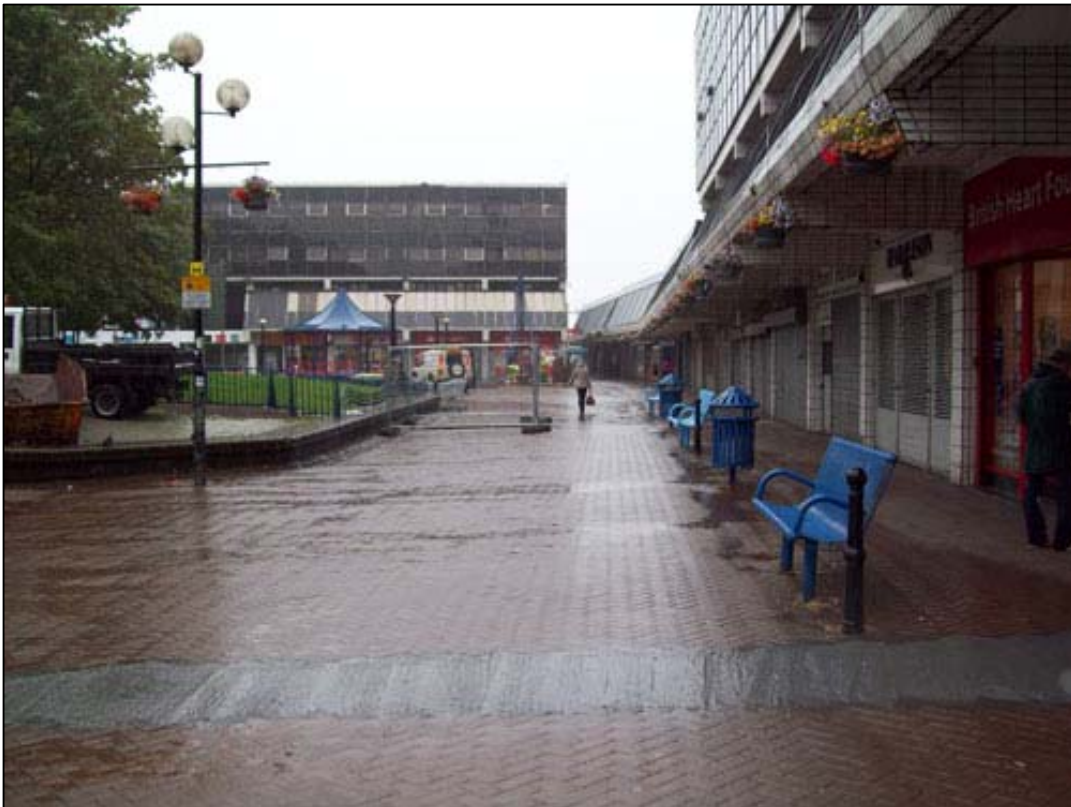
8. Radical change in the 1970s came with the redevelopment of Irvine by the Irvine Development Corporation. The whole northern frontage of Bridgegate, the southern frontage below Hill Street and the Irvine town bridge were demolished – being replaced by Bridgegate House and the Rivergate Mall. In conjunction with this the remaining portion of Bridgegate was pedestrianised (Figure 2b).

Figure 2b: Modern view of Bridgegate

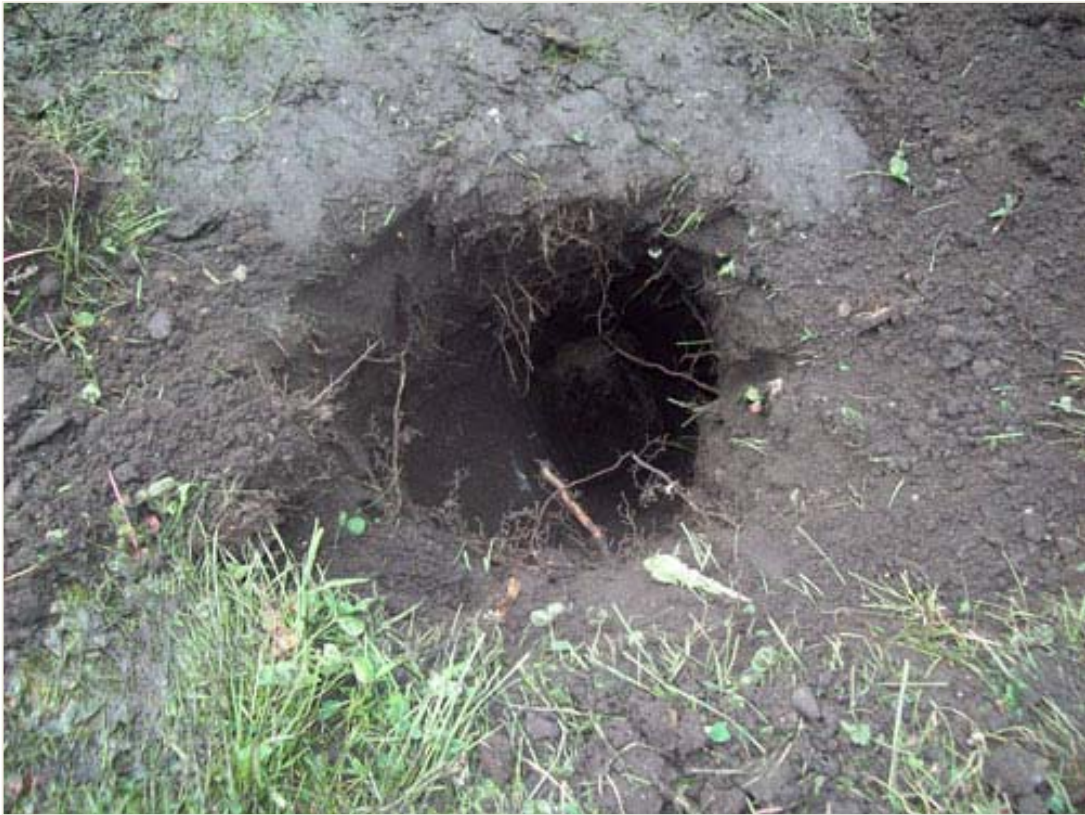
Figure 3a: Test Pit 4

- ❖ Test Pit 4 was 0.5m by 0.45m and 1.3m deep (Figure 3a) and contained the same stratigraphy as Test Pit 1 with 1.2m depth black humic silt sand (003) garden soil with inclusions of CBM in the form of glazed tile and brick over a natural yellow sand (004). As did Test Pit 6, which measured 0.6m by 0.6m by 1.2m deep with (004) visible in the base of the test pit, and Test Pit 8, which measured 0.6m by 0.4m by 1.2m deep with (004) present in the last 100mm.

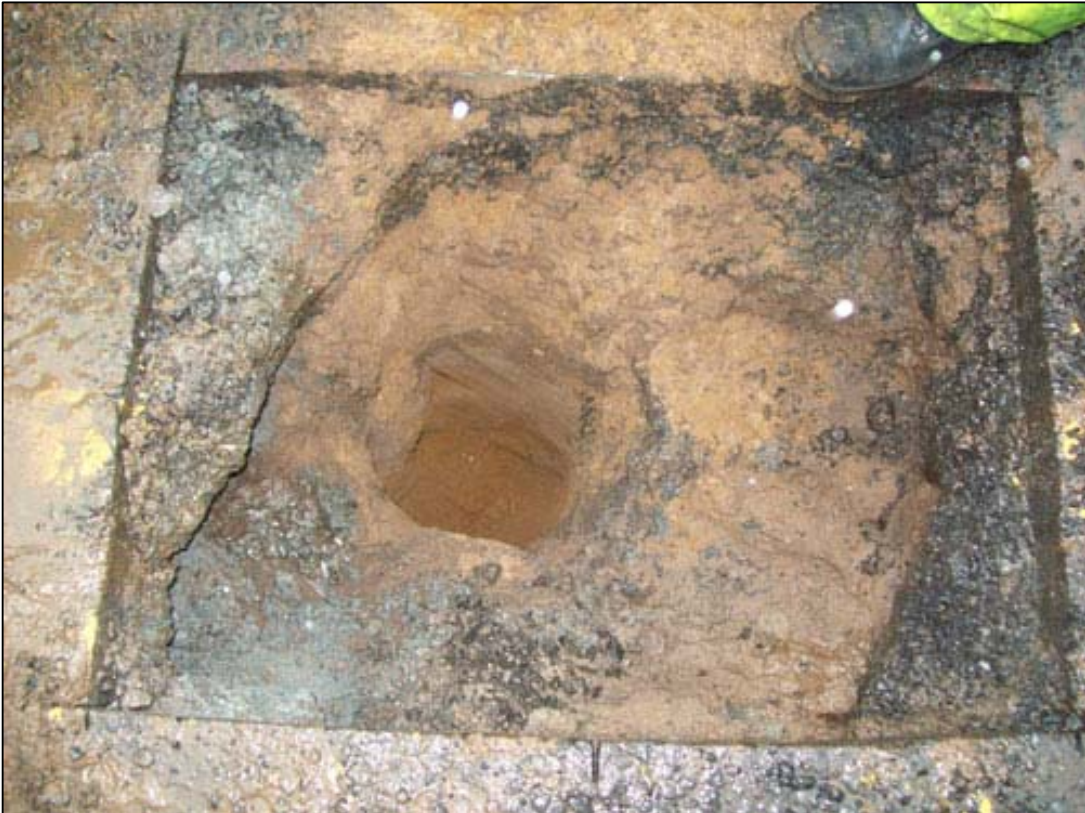
Figure 3b: Test Pit 9

17. Three test pits (TP9, 10 and 11) in total were dug at the crossing of High St with Bridgegate and Bank Street:
- ❖ TP9 measured 1m by 0.75m and 1.3m deep (Figure 3b) and contained 360mm of tarmac (009) and 940mm of natural orange sand (018). Service ducts were present in the Northeast half of the test pit;

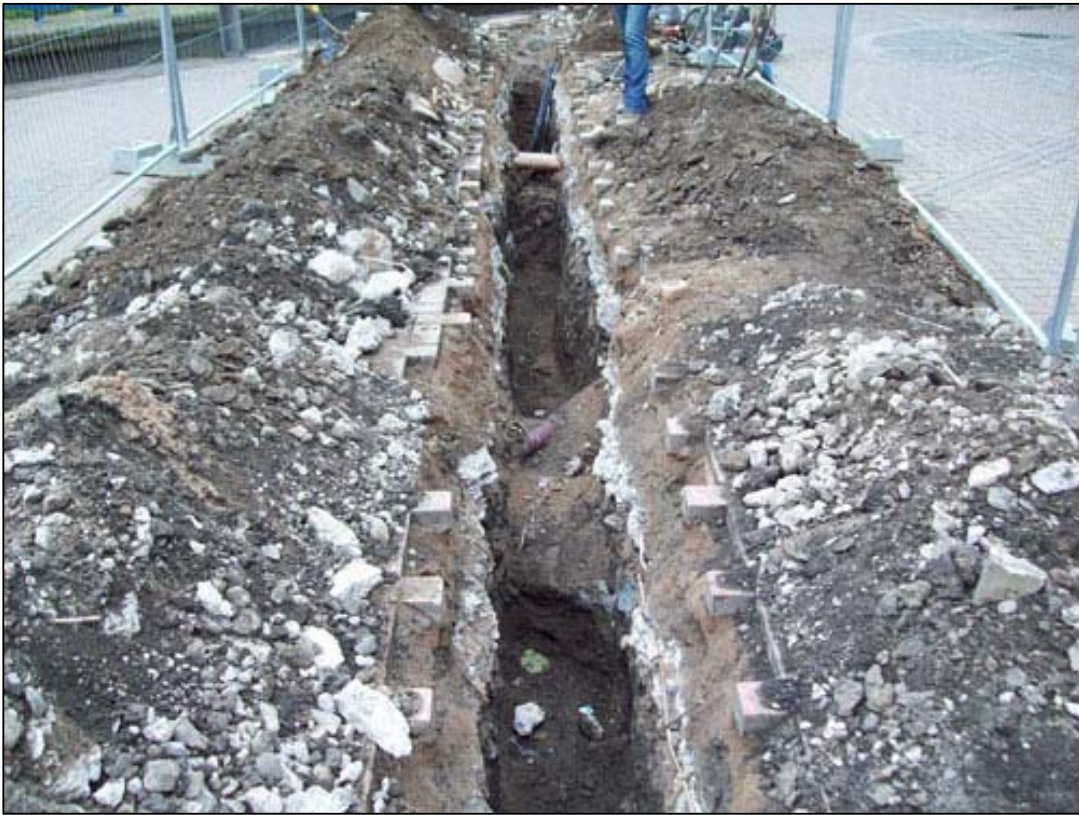
Figure 4a: ST1A

- ❖ ST1A was 13.6m long by 0.6m wide and 1.2m deep (Figure 4a). The stratigraphy revealed was similar to that of ST1 with (007) being 200mm deep and (008) varying in depth from 200mm to 700mm. Under (008) was (009) a very compact mottled dark and mid brown sandy silt with frequent pieces of CBM, in this case yellow and red brick as well as glazed brick, as well as occasional plastic sheeting and wood. This in turn overlay (010) a mid brown sand that formed the base of the trench;

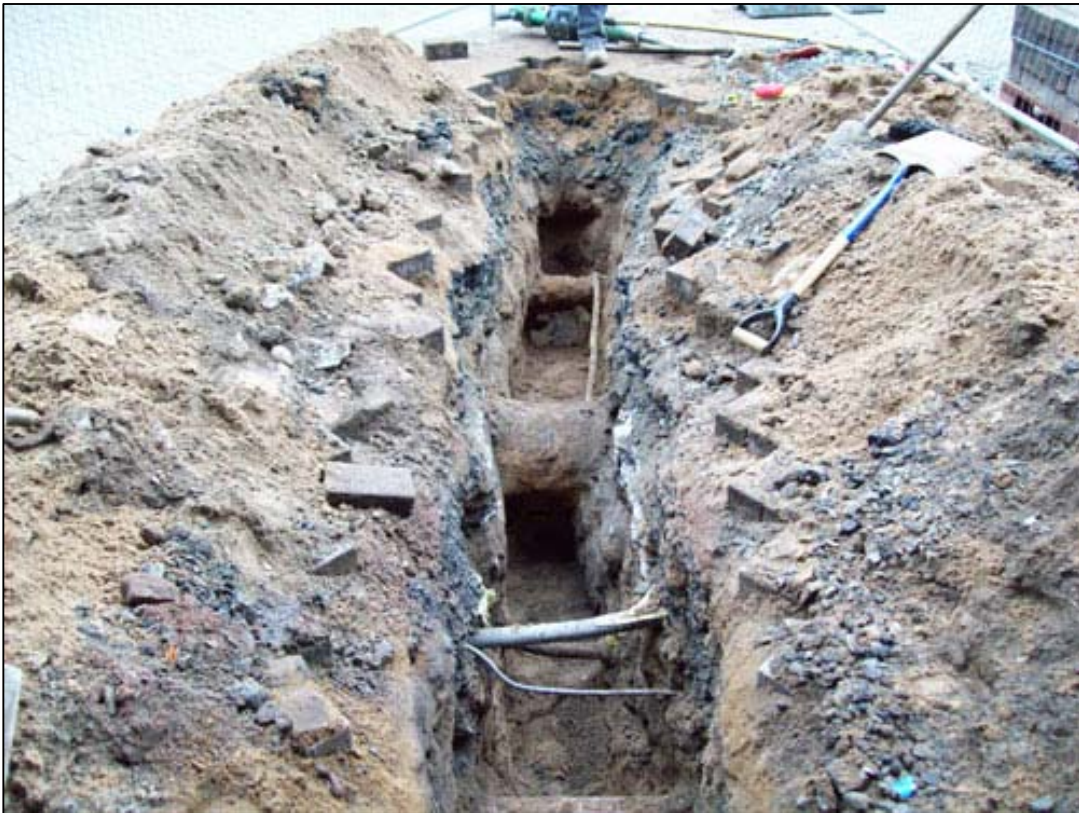
Figure 4b: Northern end of ST7

- ❖ ST4 was 7.15m long by 0.7m wide and up to 1.1m deep (Figure 4b). The stratigraphy revealed for the majority of the trench consisted of 60mm of monoblock (005), over 100mm of light brown bedding sand (006) which in turn overlay 250mm of reinforced concrete (007). Below this lay 100-360mm of Type 1 Hardcore (014) which in turn overlay 670mm of (024) a compact dark grey brown silty sand with frequent sub-angular and sub-rounded medium stones with occasional CBM (yellow brick). However at the northern end, the first 3m of the trench had nothing but Type 1 (014) below the bedding sand (006) to the full depth of the trench. Within the southern end of the trench a large piece of slate (025) was observed in the base of the trench within (024), approximately 3m in length and extending outwith both sides of the trench;

trench a concrete block (018) extended 1.4m out from the modern building front, it extended outwith the sides of the trench and was 400mm deep; and
