**Lamlash Community Hall, Arran:  
Archaeological Mitigation**

Data Structure Report

issued 25th November 2011

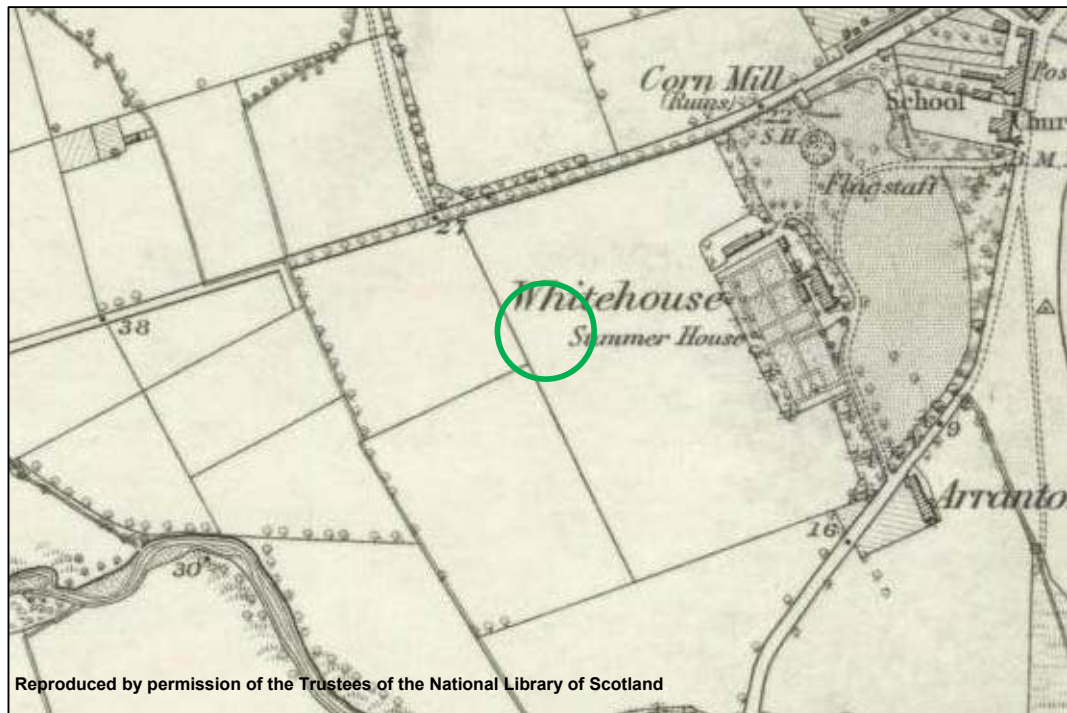
Figure 1: Detail 1<sup>st</sup> edition Ordnance Survey (1868)

5. The hall was originally built in 1914 by the Admiralty as accommodation for the fleet arriving at Lamlash on agricultural land (see Figure 1 for the original agricultural landscape). In 1917 the hall was converted into a convalescent hospital for soldiers.

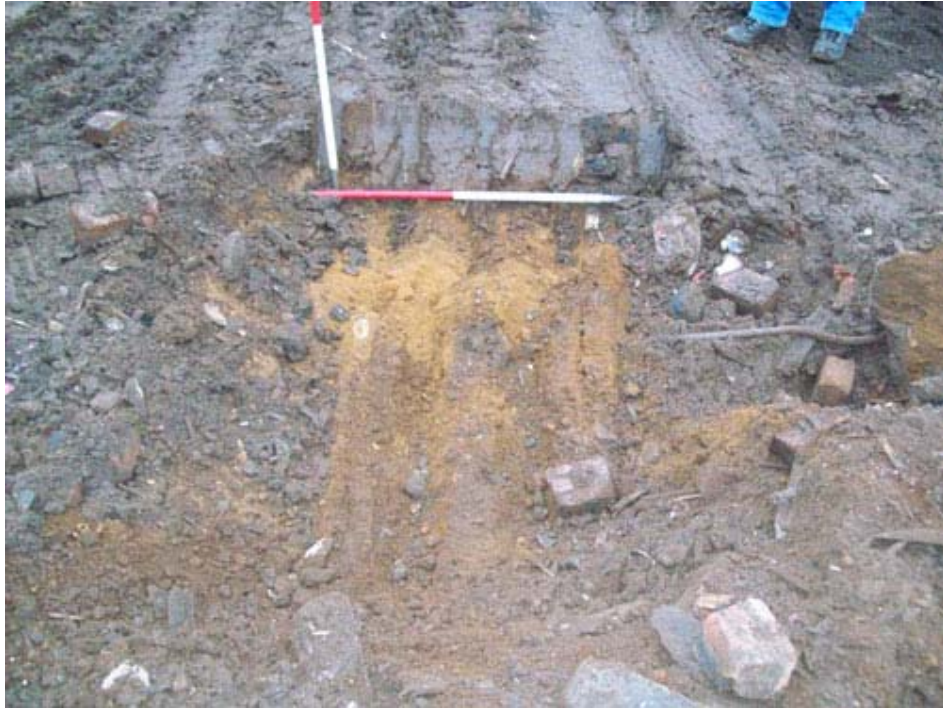
Figure 3a: Sample Pit 4

14. In total nine sample pits were excavated and recorded along the lines of the grubbed out foundations. The pits were generally 1.5-2m long and 1.2m wide, which revealed a similar strata to the monitored foundations, with the orange sand natural (004) present under the mid grey brown silty sand (002) with red brick, ceramic pipe and building detritus inclusions. The level of the (002) varied from 100mm to 350mm in depth but this was due to the demolition crew using demolition rubble to level off areas within the site.
15. In both the monitoring of the grubbing out of the foundations and the excavation of the sample pits no archaeological features were observed. A walk over inspection was made over the whole area but only modern detritus was observed.
